Educational Suitability Summary Report

Rosedale School

Date: 08/11/2016

Score 25% Very Unsatisfactory

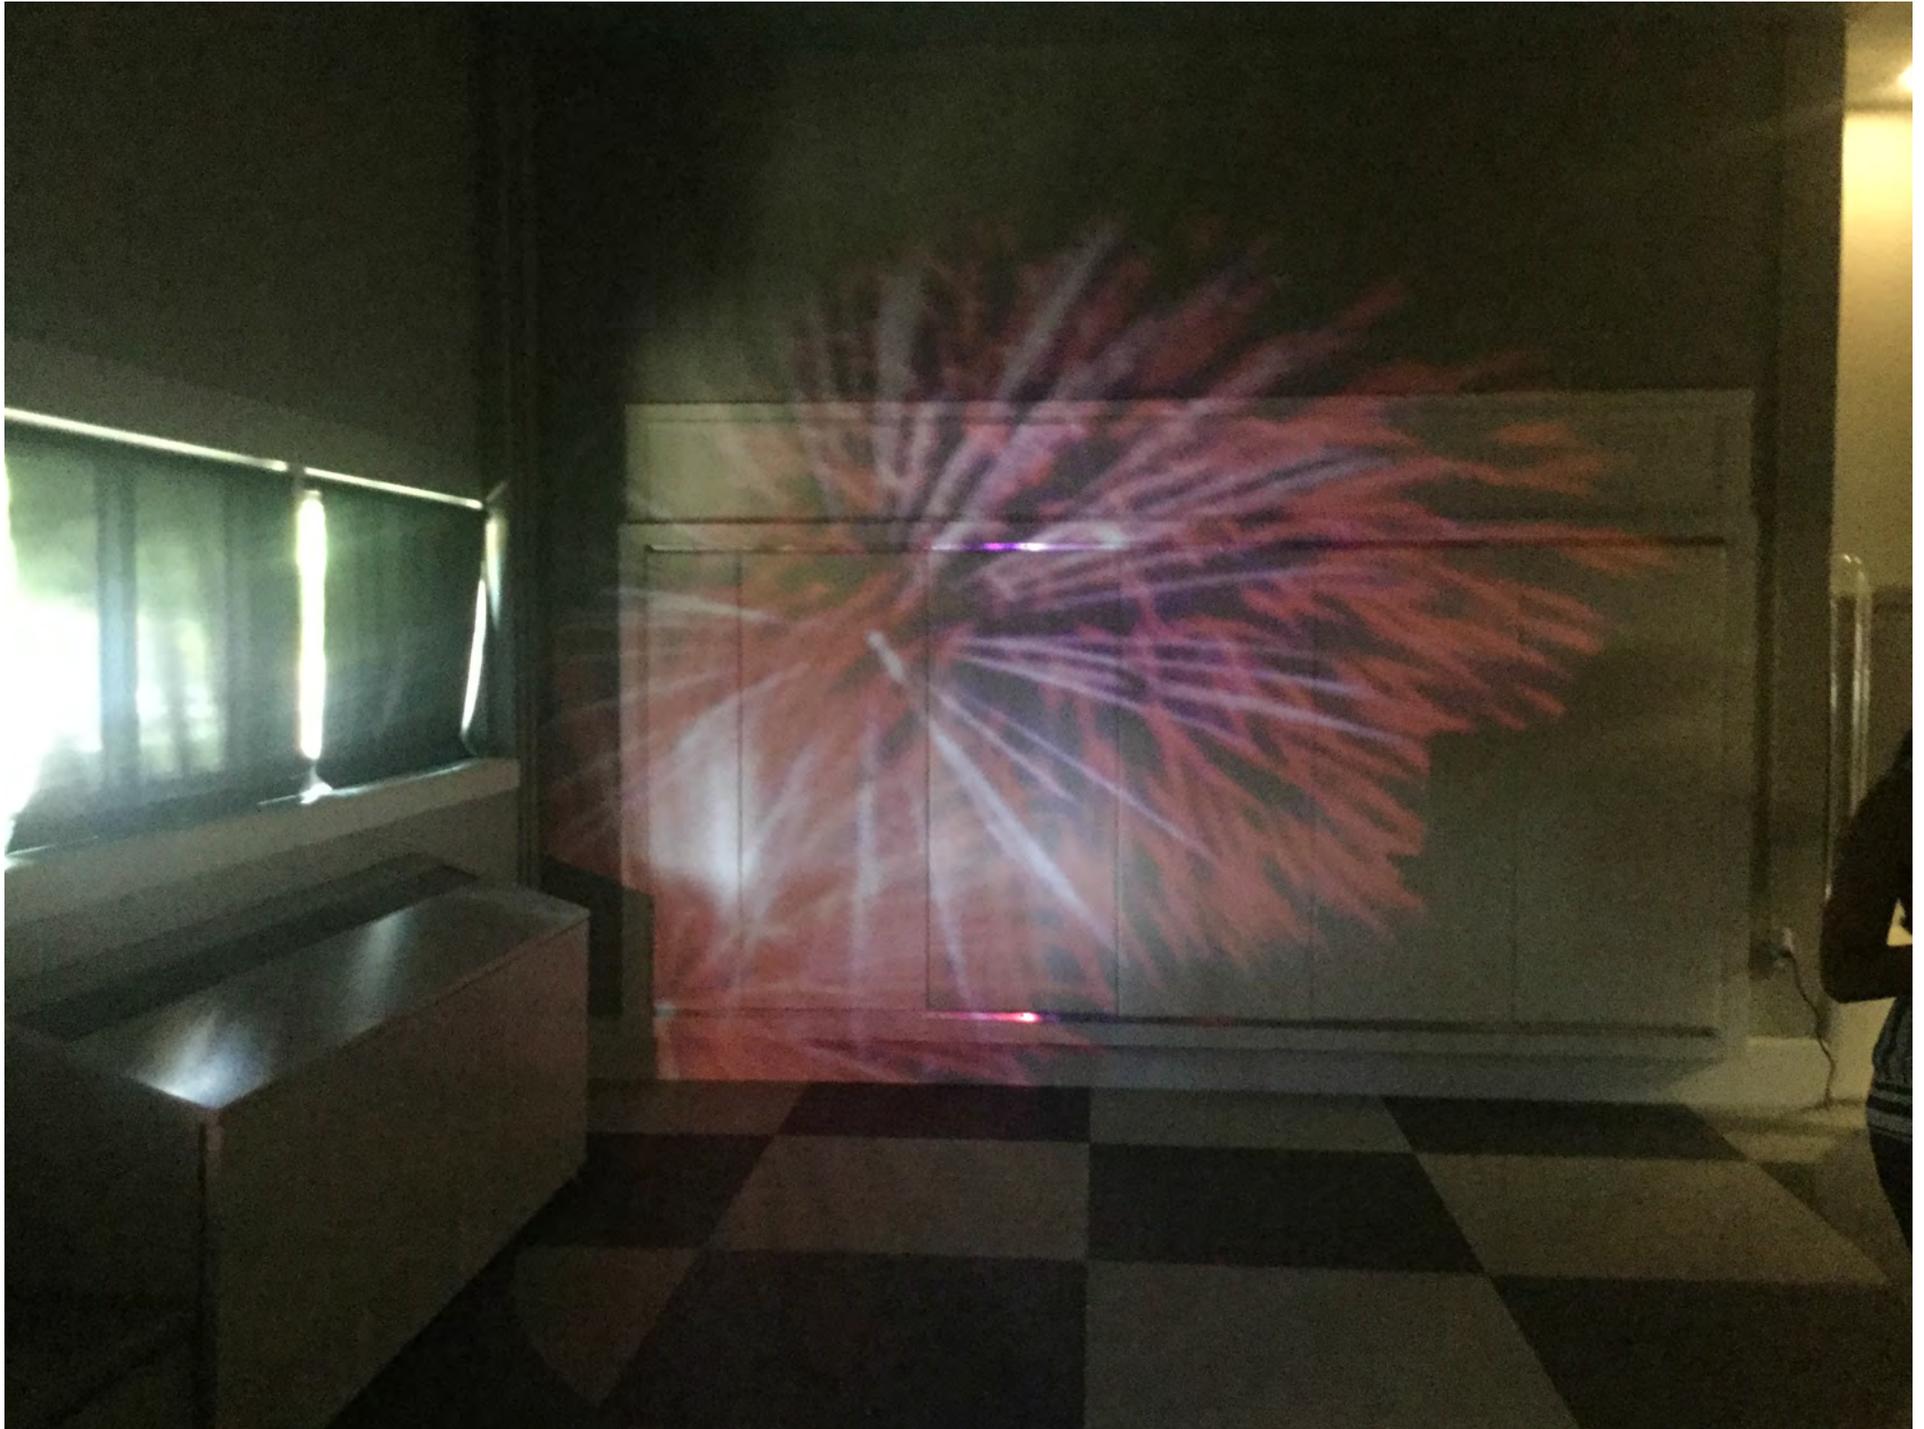
3.15 Sensory Room

3.15	Are Special Education support spaces appropriately configured per the ed spec?	1						Comments	1.00 1.00
1) Very unsatisfactory - Support spaces are disconnected from served spaces, too small, do not meet needs 2) Unsatisfactory - Support spaces are connected, but too small, inadequate for needs 3) Average - Connected, moderate size, but need some renovations or updates to function well 4) Good - Connected, good size/layout, meets needs/functions well 5) Very good - connected, generous size, nice condition, functions appropriately N/A) Does not apply.								The storage space and restrooms are lacking. The laundry facilities are unsatisfactory and difficult to access.
