## Educational Suitability Summary Report

Anderson High School – BLDG 009

Date: 06/16/2016

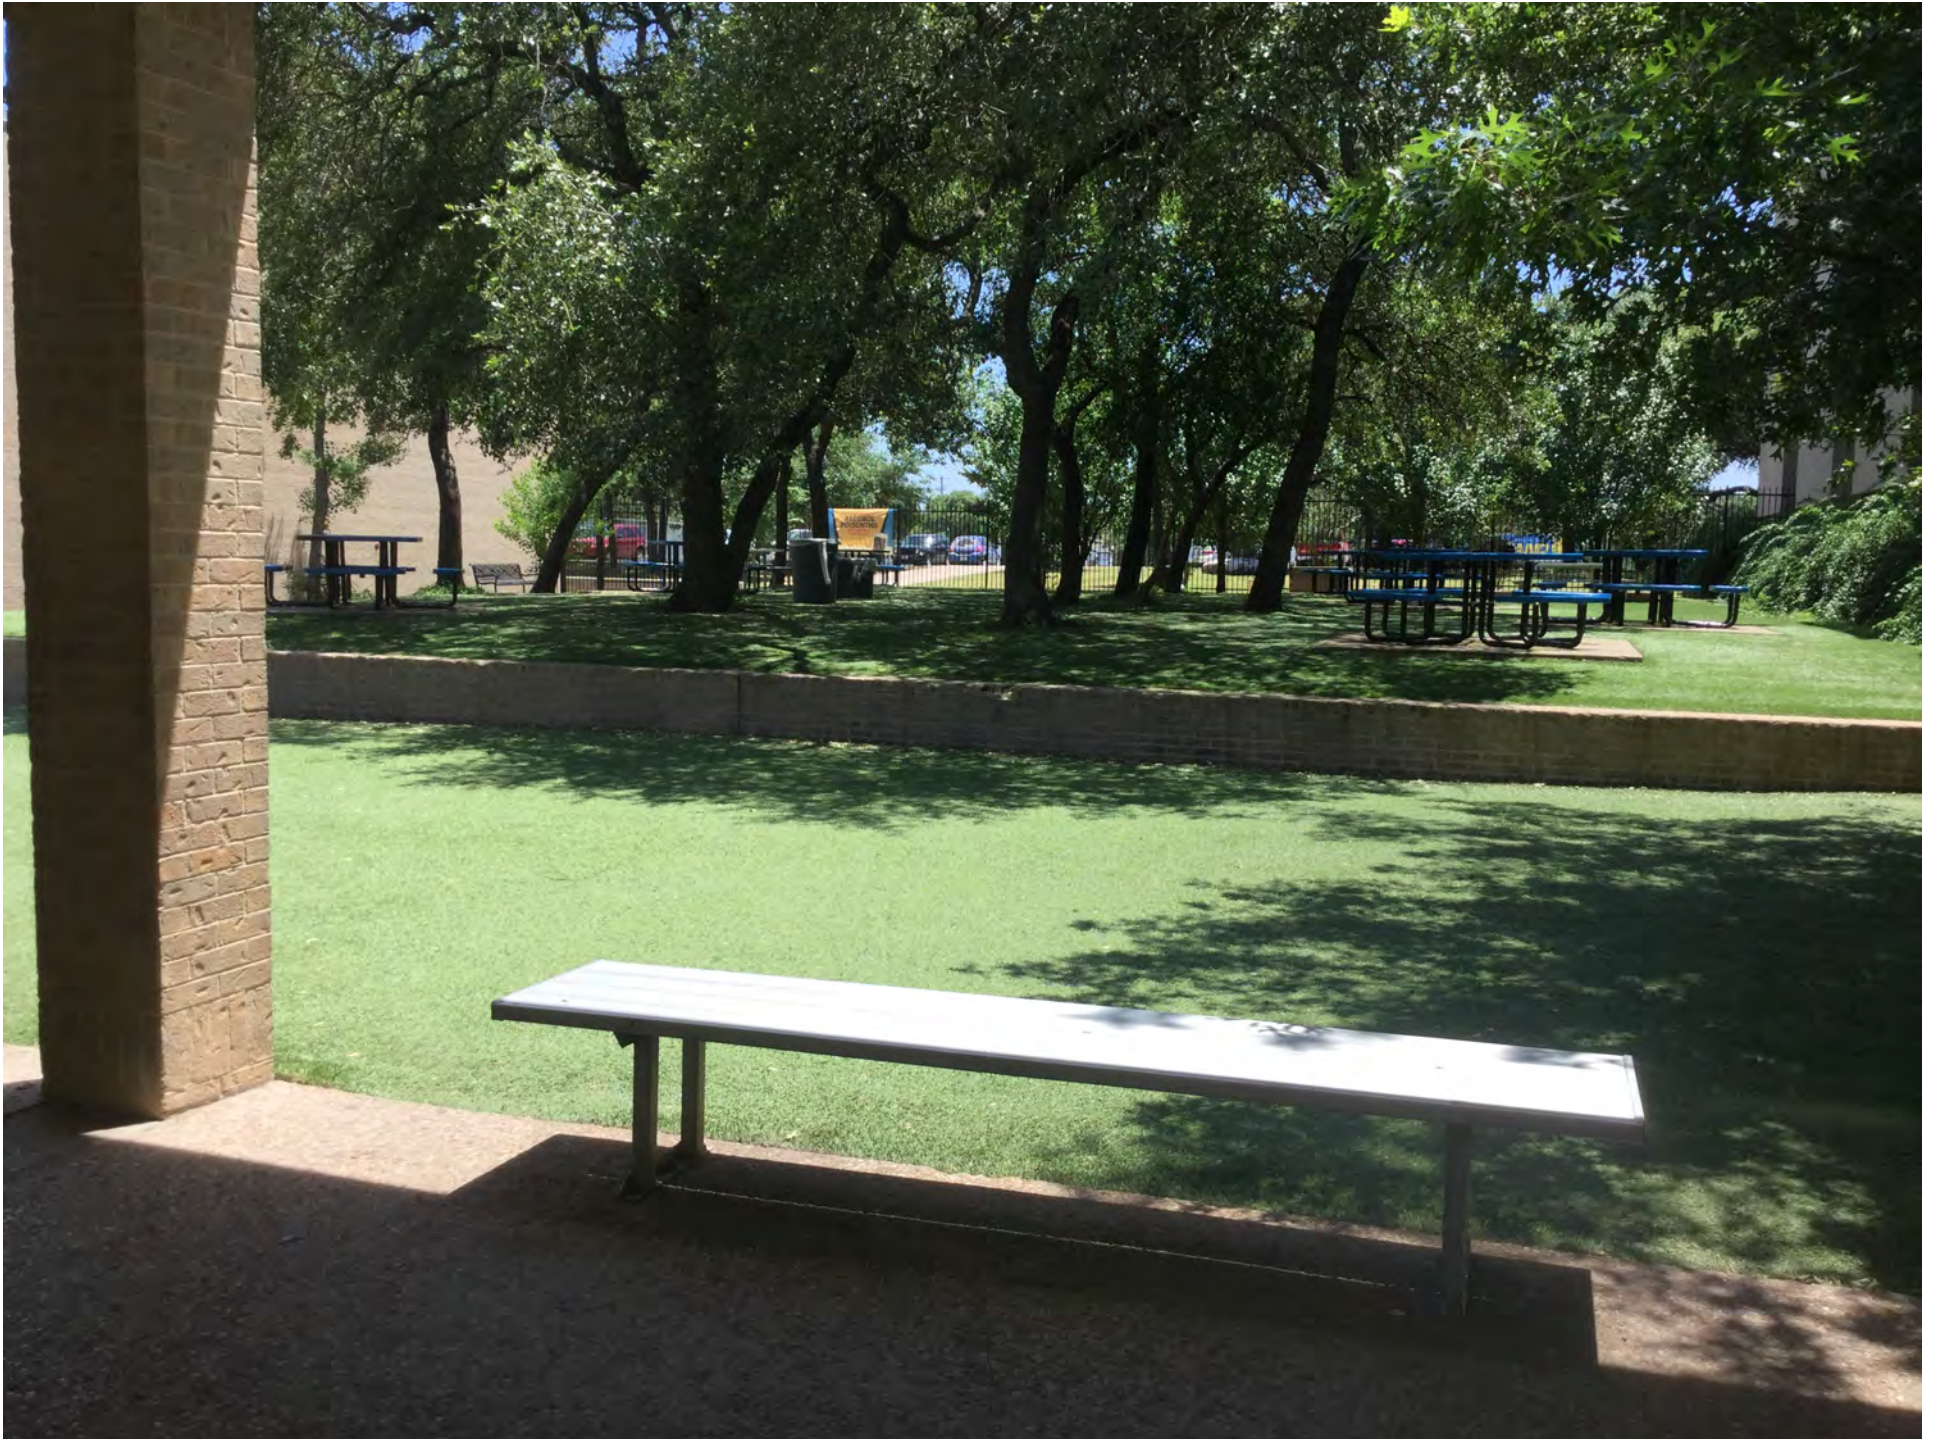
Photo 1.  
1.2 Outdoor Space

1.2	Are opportunities provided for outdoor learning (outdoor classrooms, gardens, etc.)?					5		Comments	1.00 5.00
1) Outdoor space exists is not developed 2) Outdoor space for learning exists but not connected to classroom learning areas. 3. Outdoor learning spaces exist and are accessible but not in good condition. 4. Outdoor learning spaces need minor improvements to function well. 5. Outdoor learning spaces are in excellent condition. N/A) Does not apply.								There are plenty of garden spaces and outdoor courtyard areas.	
								see photo 1

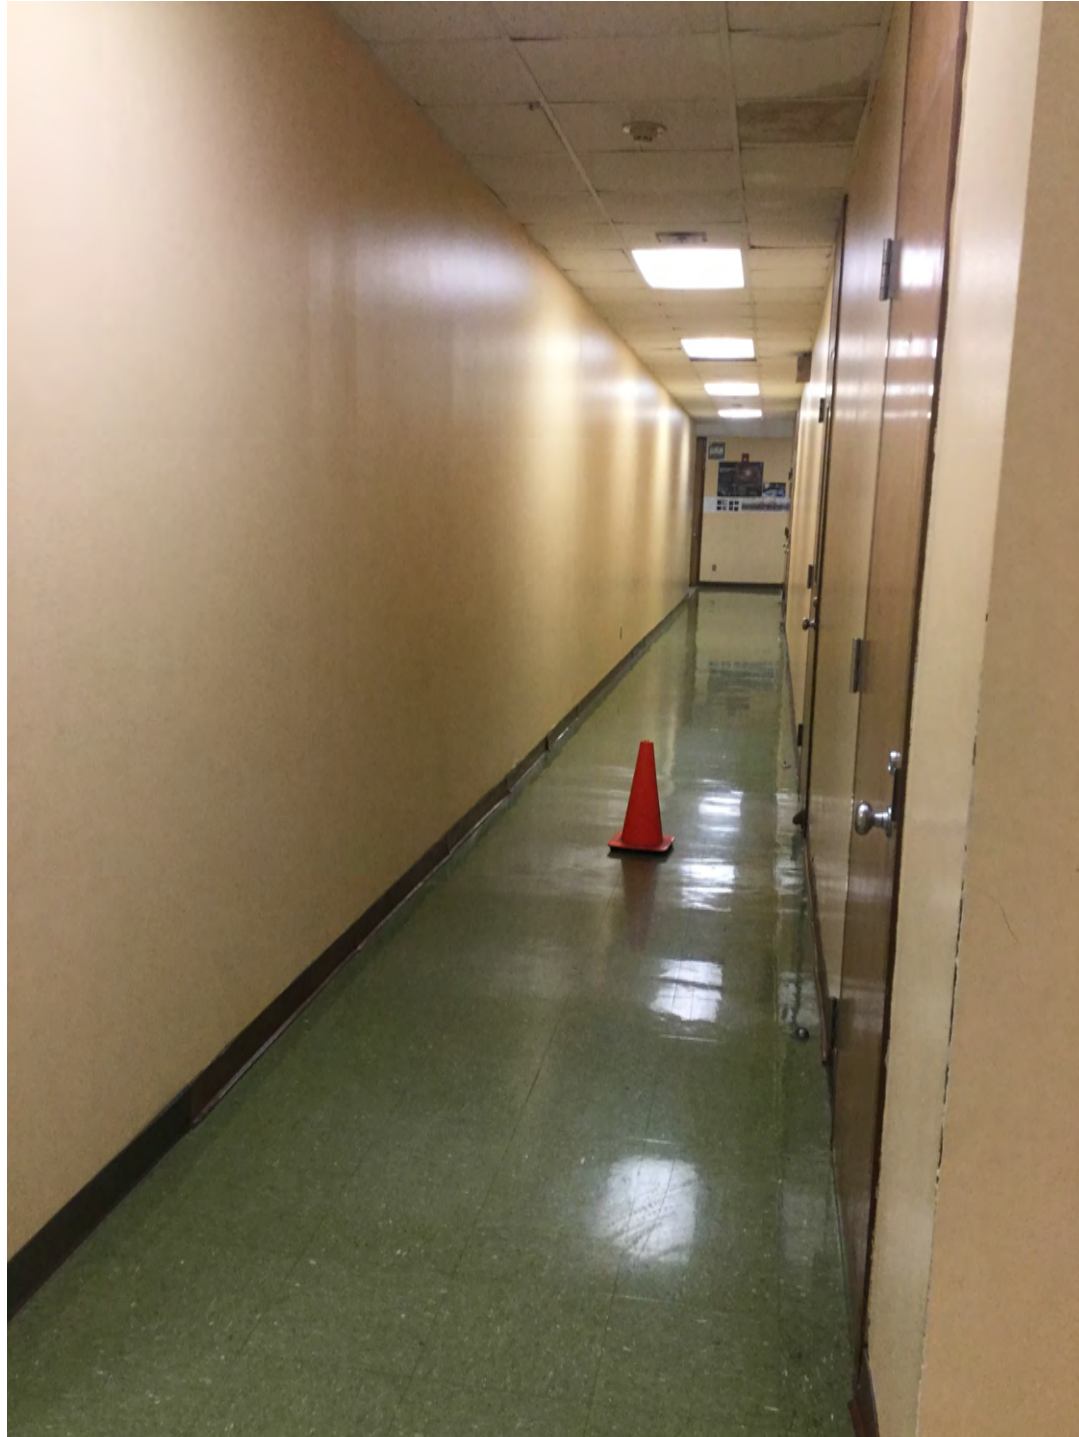
Photo 2.  
2.1 Hallway

1) Primary circulation is 5'-0" to 6'-0" wide. 2) Primary circulation is 6'-0" to 7'-0" wide 3) Primary circulation is 7'-0" to 8'-0" wide 4) Primary circulation is 8'-0"-10'-0" wide 5) Primary circulation is 10'-0"+ wide N/A) Does not apply.							Most of the hallways are well-sized; however, there are some small connecting hallways that are sometimes difficult for faculty to supervise.	see photo 2

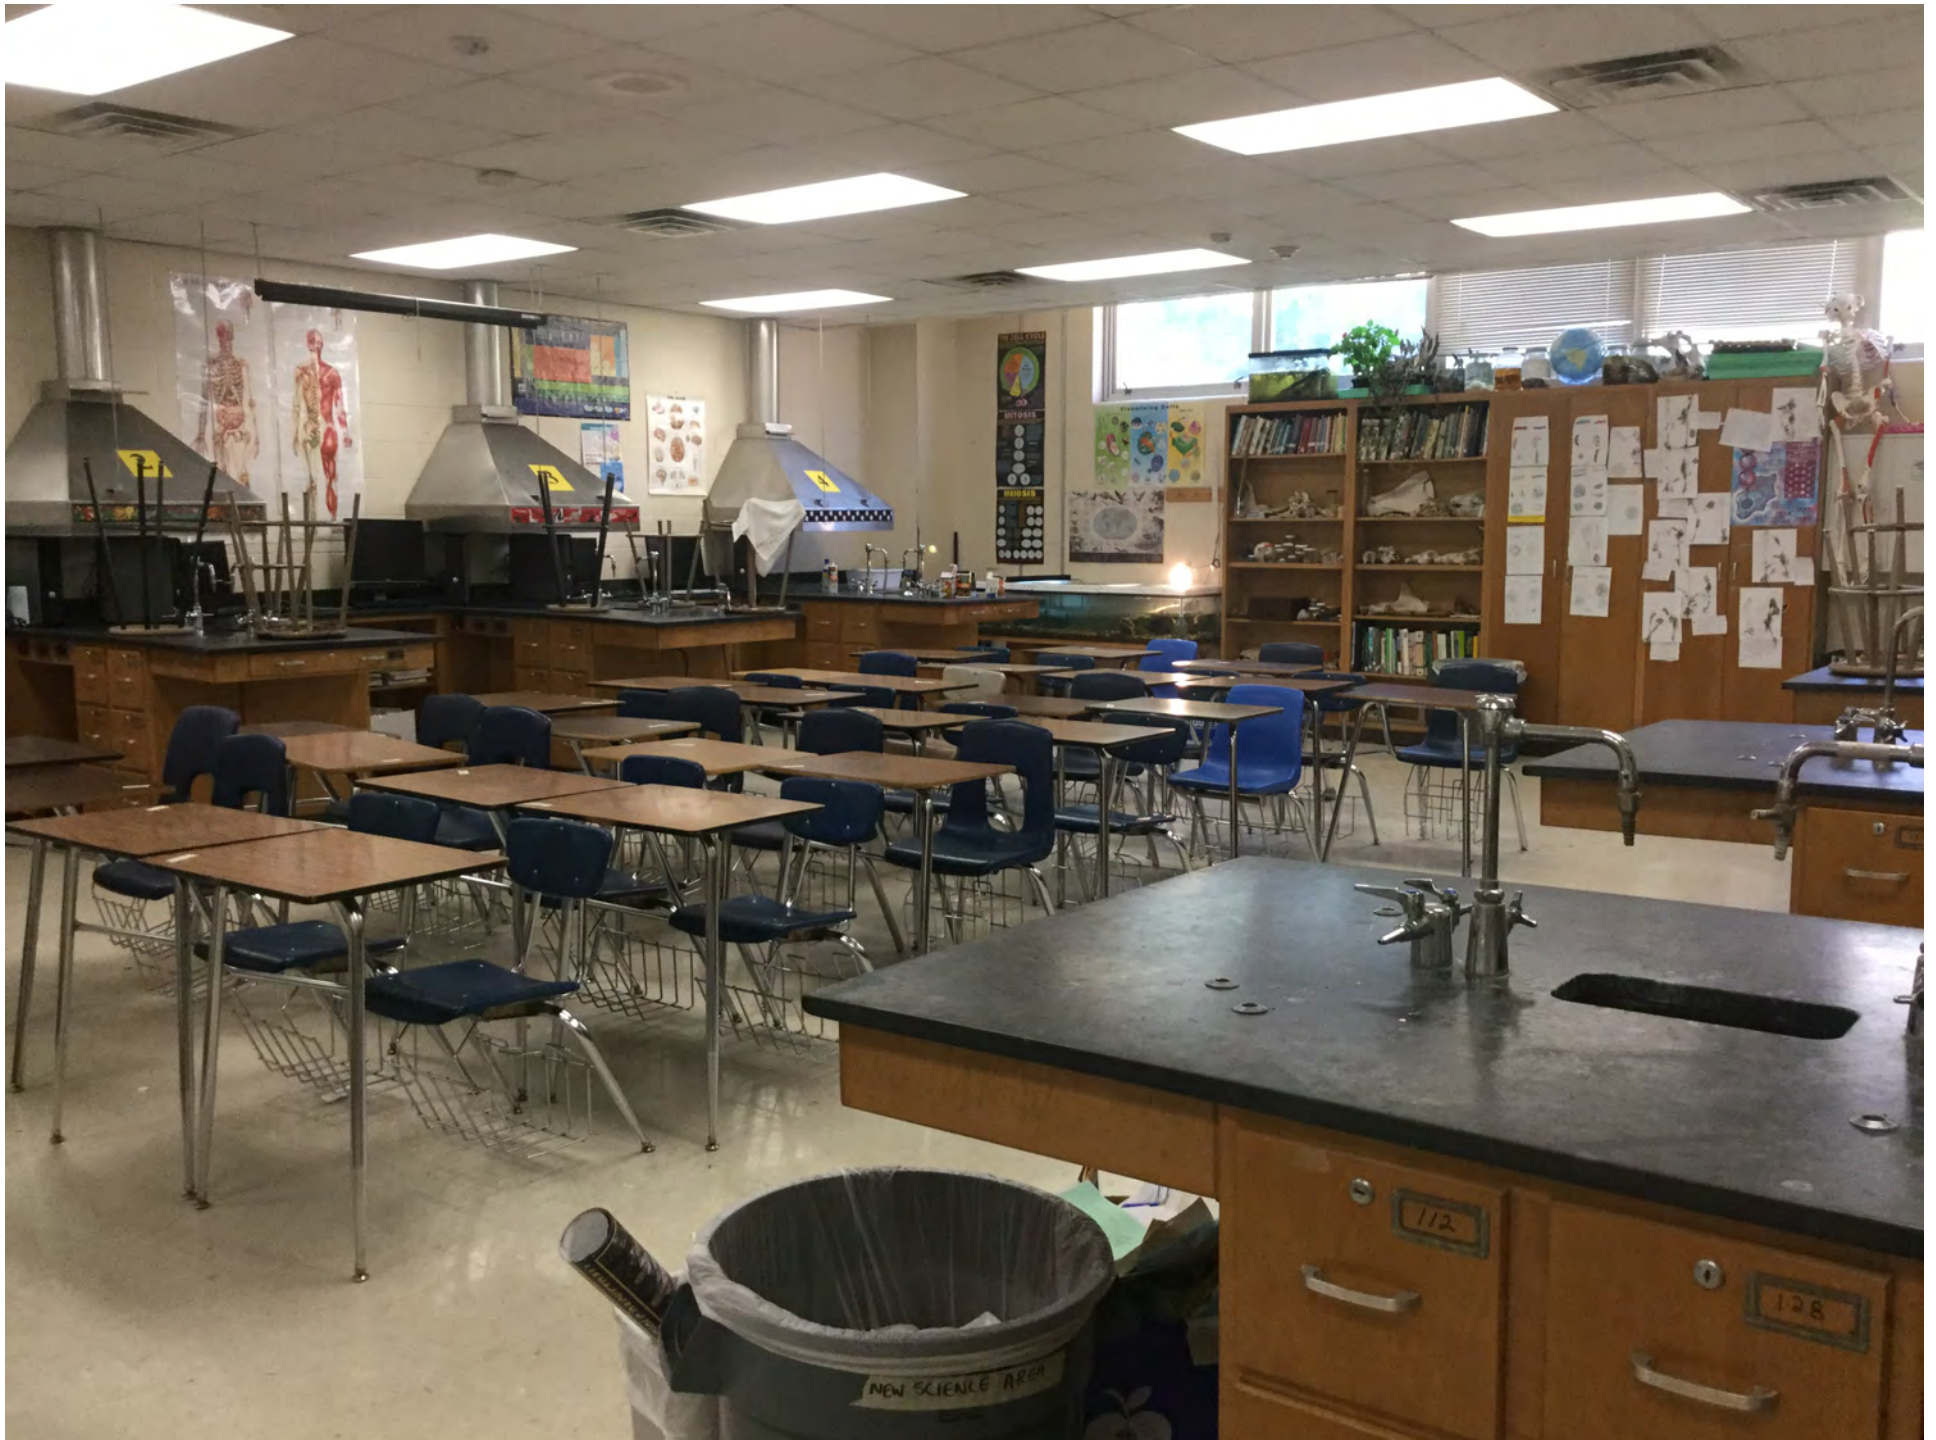
Photo 3.  
3.4 Science Room

3.4	Are Science Classrooms/Labs appropriately configured per the ed spec?			3				Comments	1.00 3.00
1) Very unsatisfactory 2) Unsatisfactory 3) Neutral 4) Satisfactory 5) Very Satisfactory N/A) Does not apply. (Elementary schools)									see photo 3

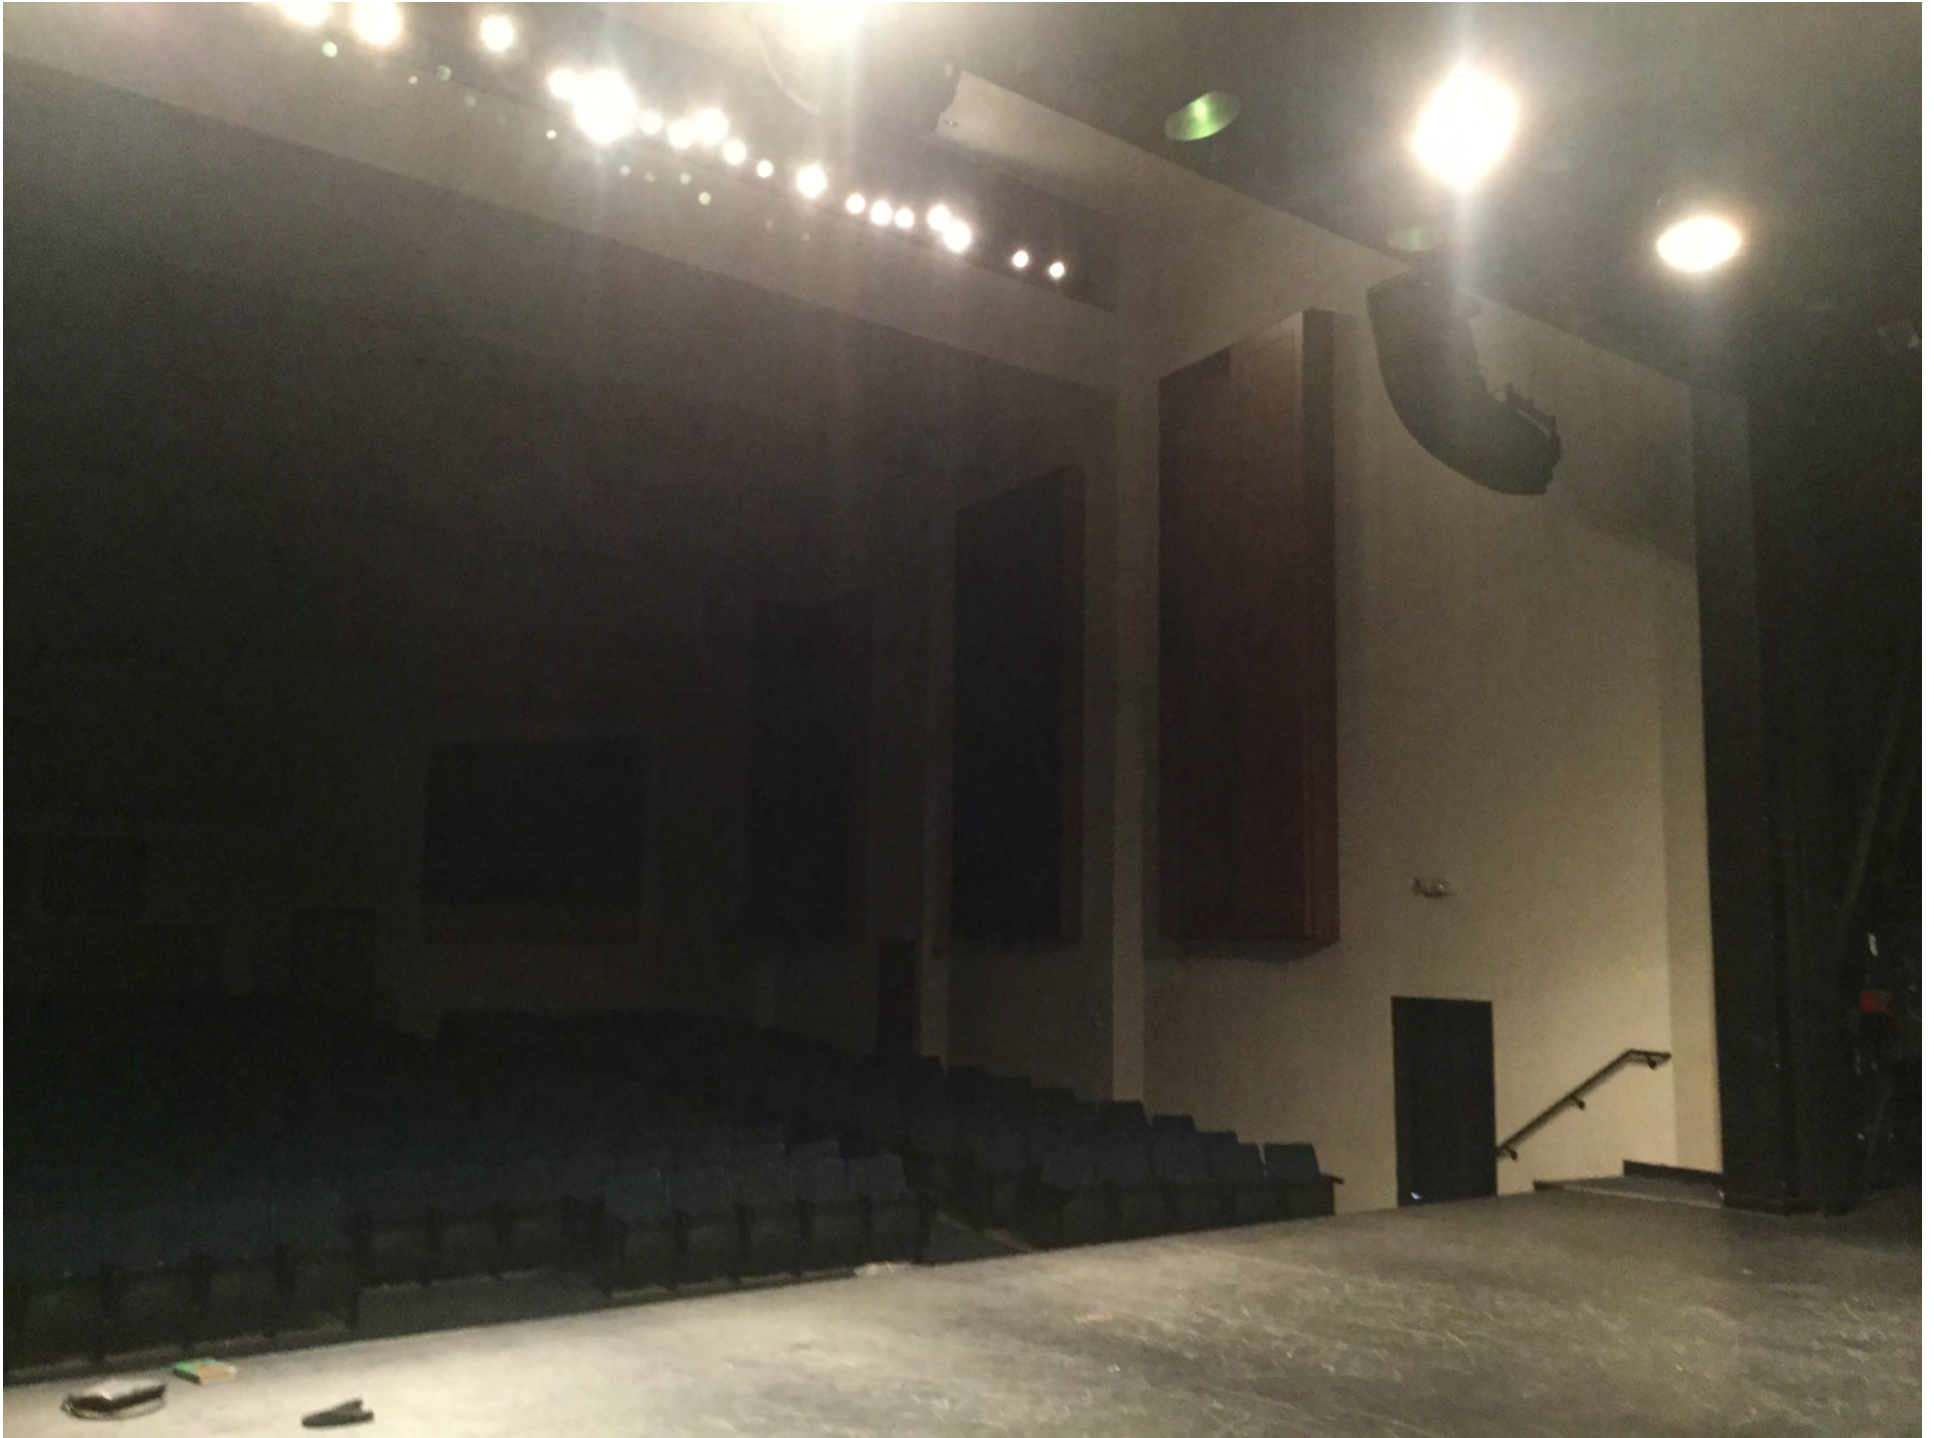
Photo 4.  
3.8 Auditorium

3.8	Are music, drama, or performance spaces appropriately configured per the ed spec?				4			Comments	1.00 <b>4.00</b>
1) Very unsatisfactory 2) Unsatisfactory 3) Average 4) Good 5) Very good N/A) Does not apply.								It is reported that the campus needs an auxiliary band space for the number of students. The auditorium is undersized for the needs of the program and has outdated lighting equipment. <i>Principal Comment: Theater is undersized for our large student enrollment.</i>	
								<b>see photo 4</b>

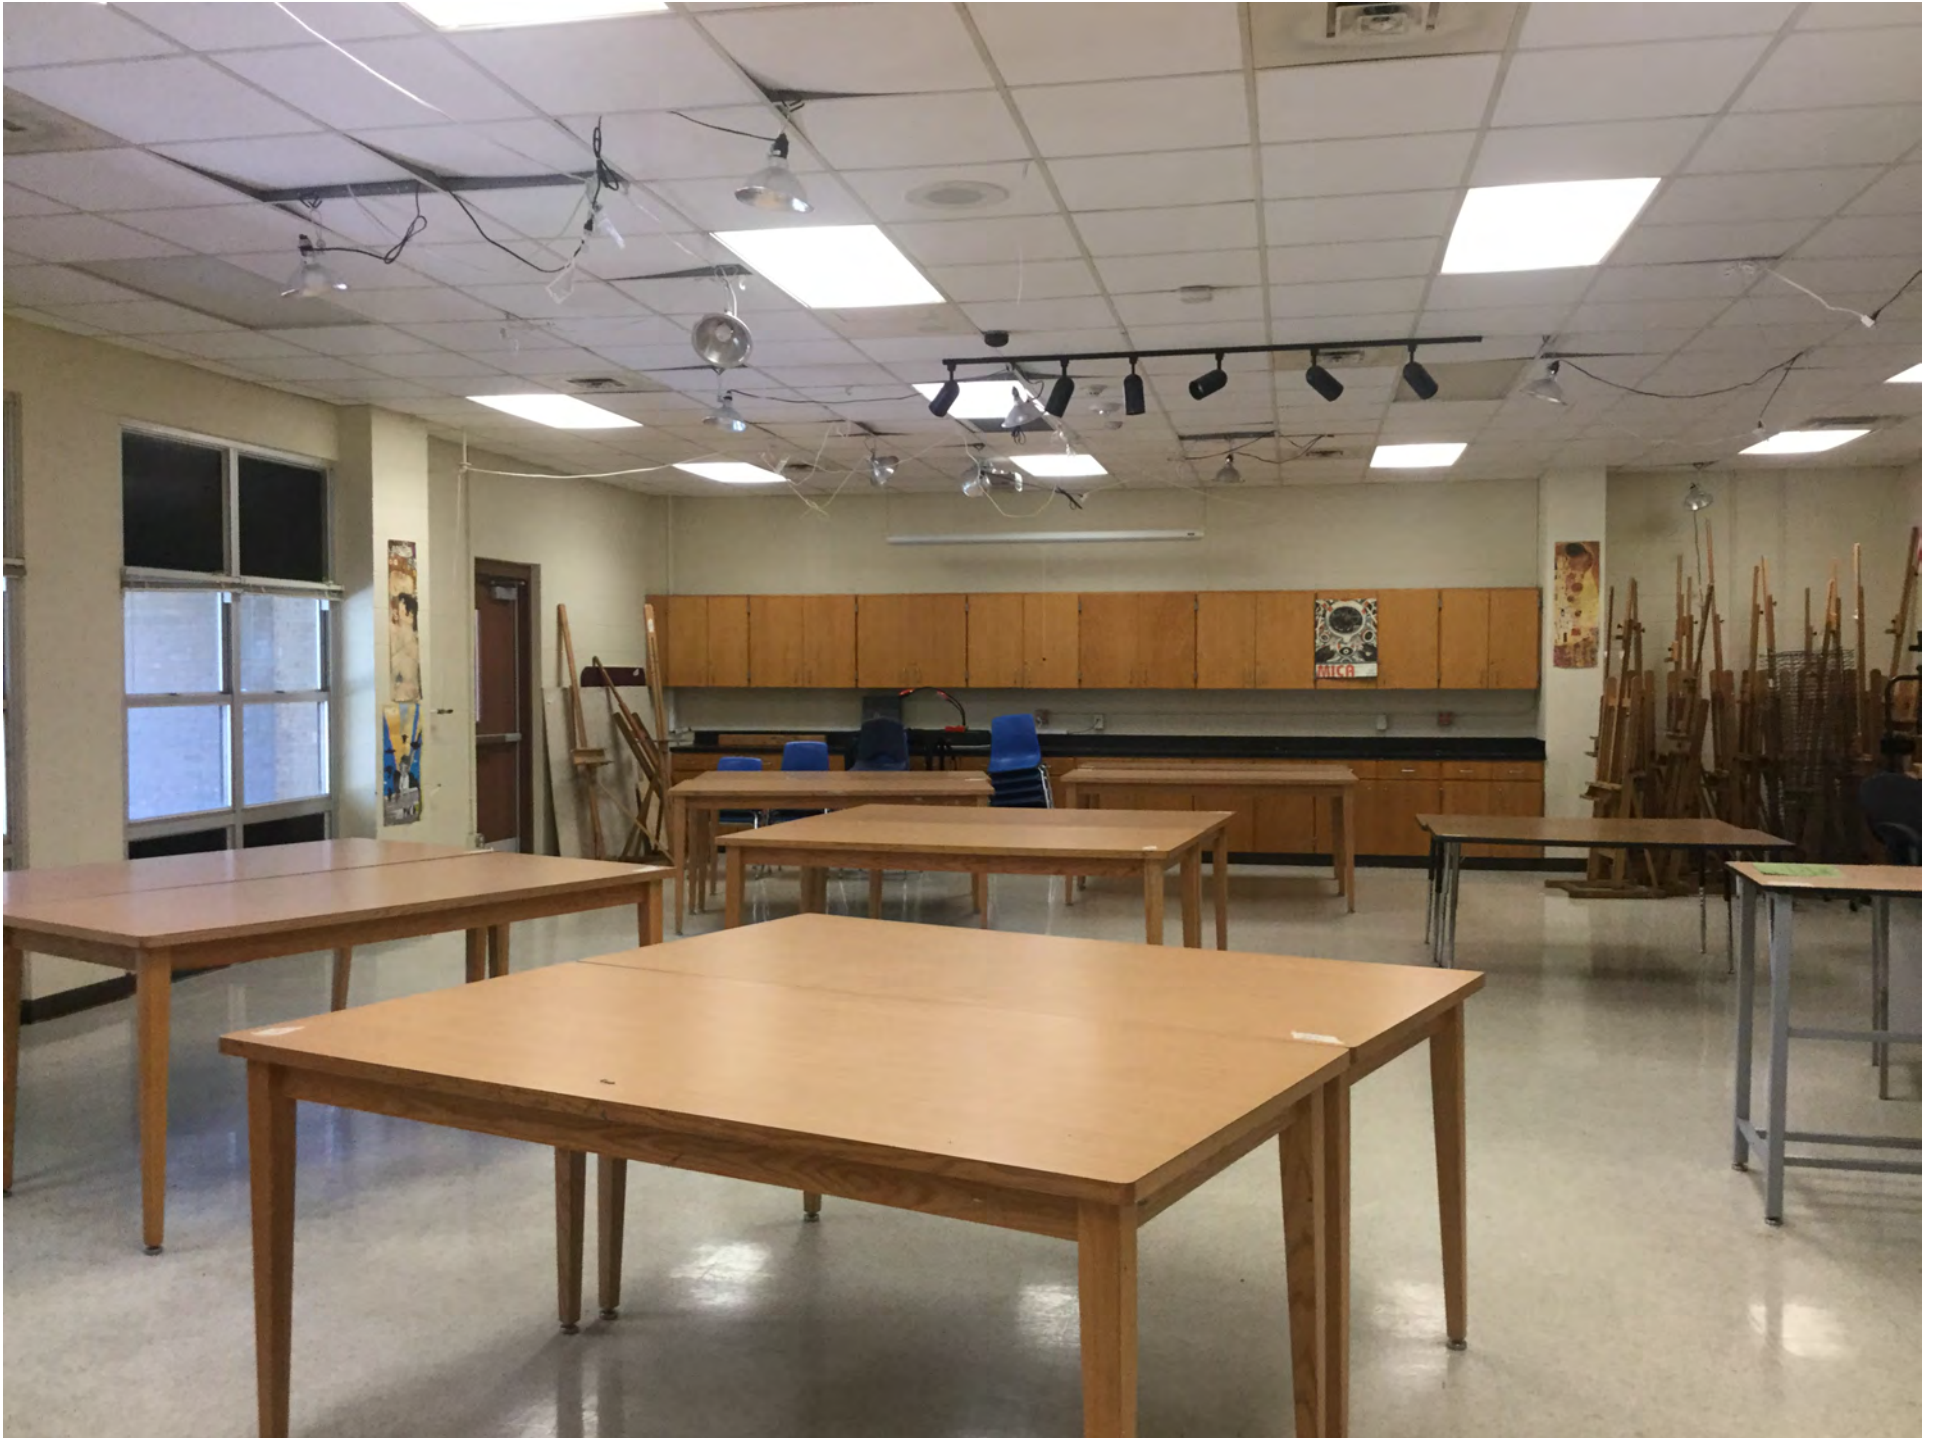
Photo 5.  
3.10 Art Room

1) Very unsatisfactory 2) Unsatisfactory 3) Average 4) Good 5) Very good N/A) Does not apply.														The art room in the building is well configured. However, the art space is very limited in relation to the number of students.		see photo 5

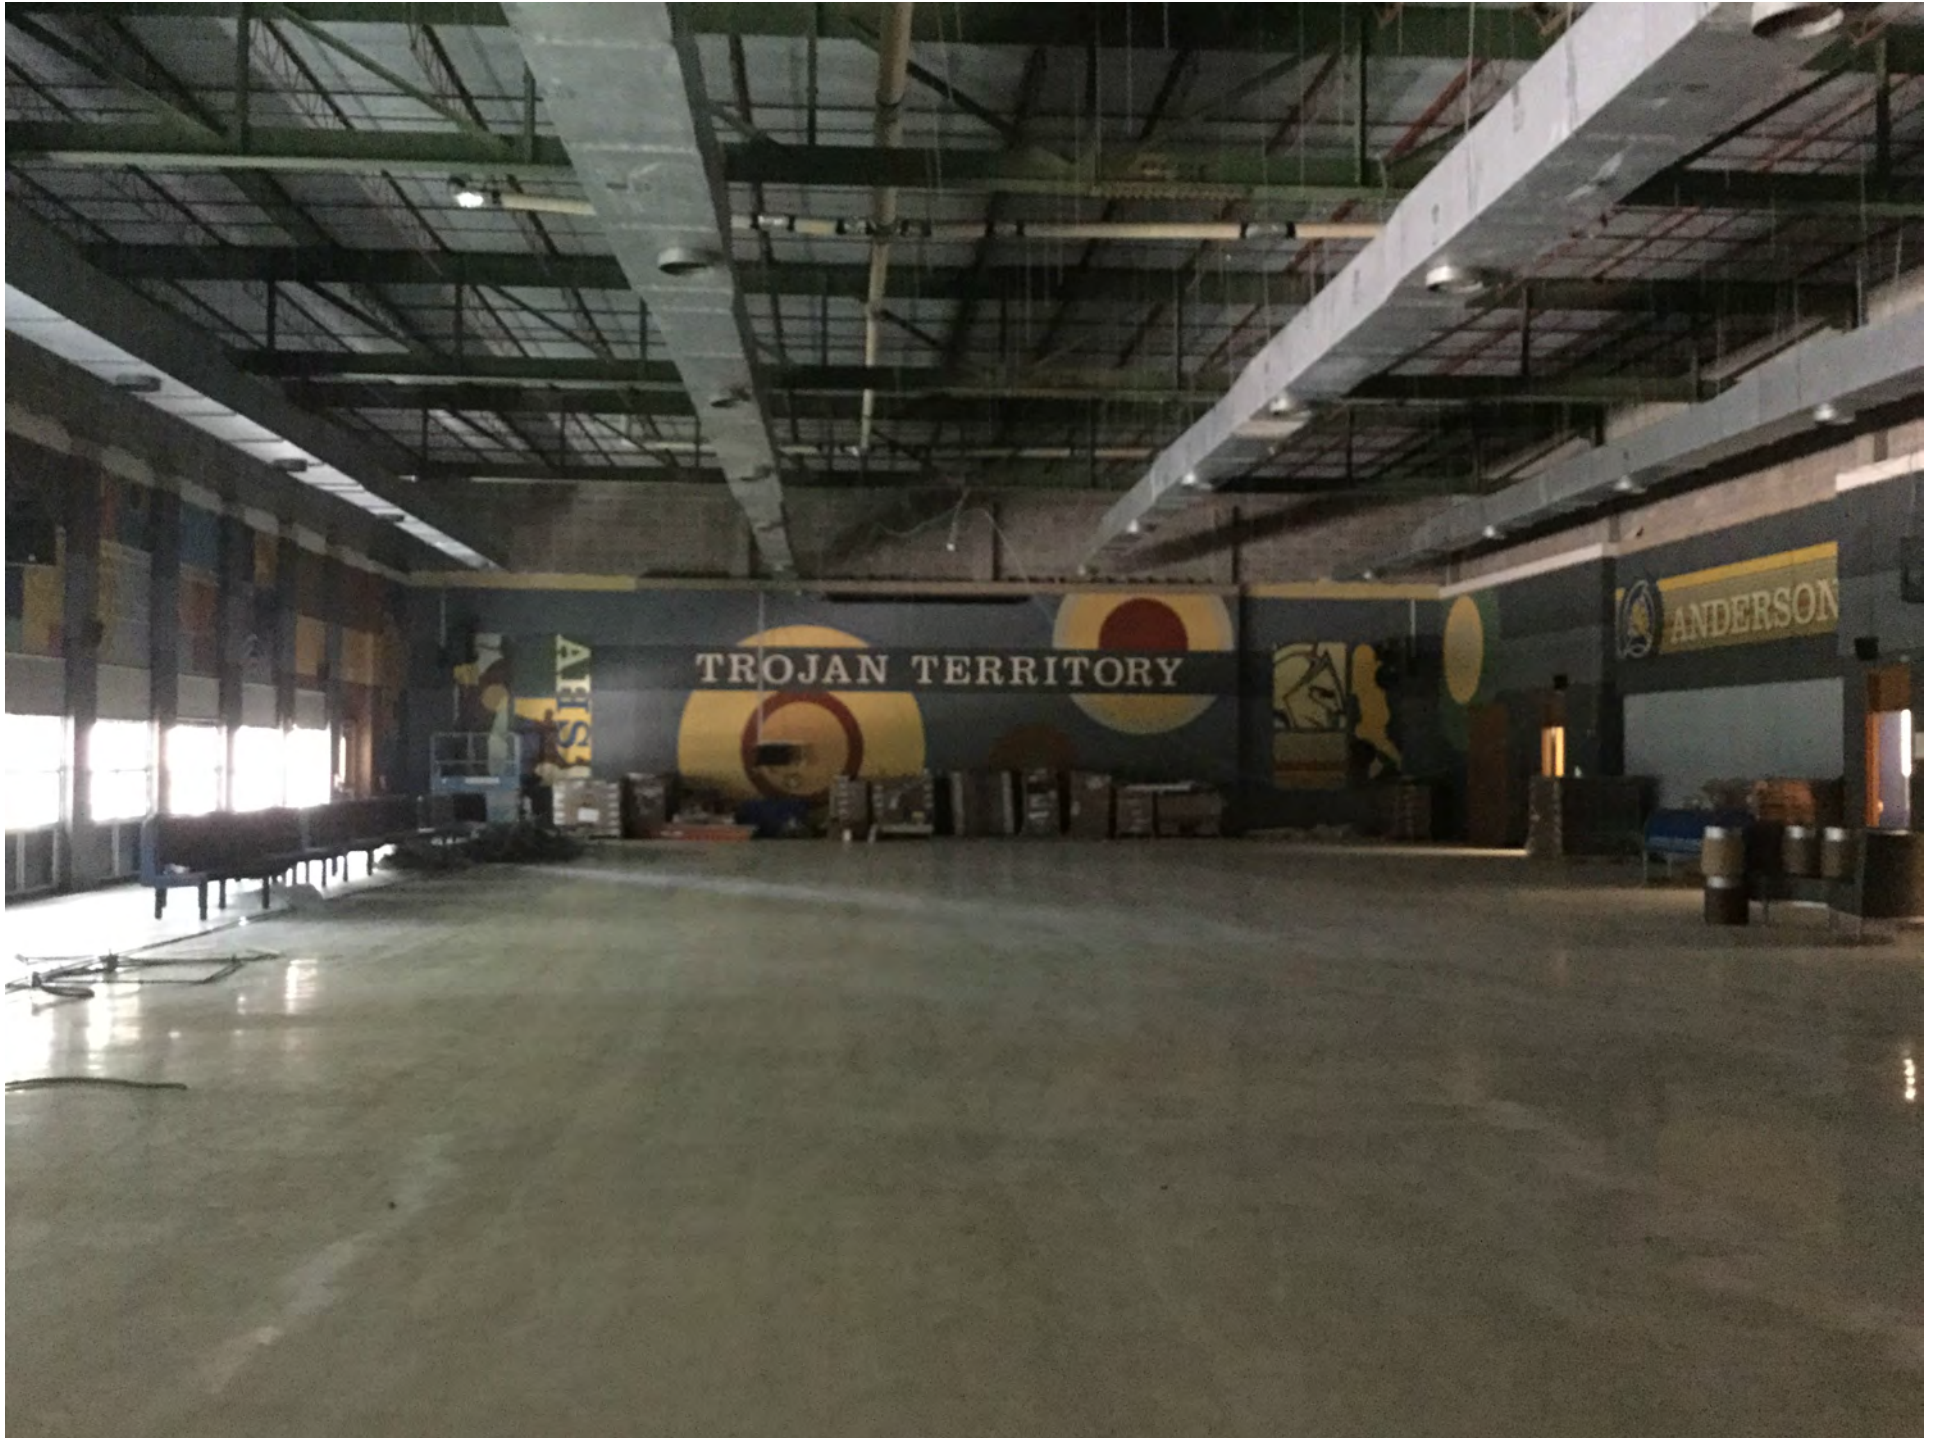
Photo 6.  
3.16 Dining Facility

3.16	Are the student dining facilities appropriately configured?			2									Comments	1.00 <b>2.00</b>
1) Very unsatisfactory - Too small, poor circulation, inflexible seating in poor condition 2) Unsatisfactory - Too small or inadequate circulation, seating in poor condition 3) Average - moderate size, with adequate circulation, seating in okay condition 4) Good - good size, adequate circulation, seating in good condition 5) Very good - good size, adequate circulation, seating in good condition, with more than one option for eating space (ex: connection to outdoor eating space) N/A) Does not apply.													Although the cafeteria is a moderate size, there is currently one lunch period for 2700 students. Even with three lunch periods, this space would be somewhat undersized. The cafeteria and serving areas are currently undergoing renovations that are reportedly improving circulation.

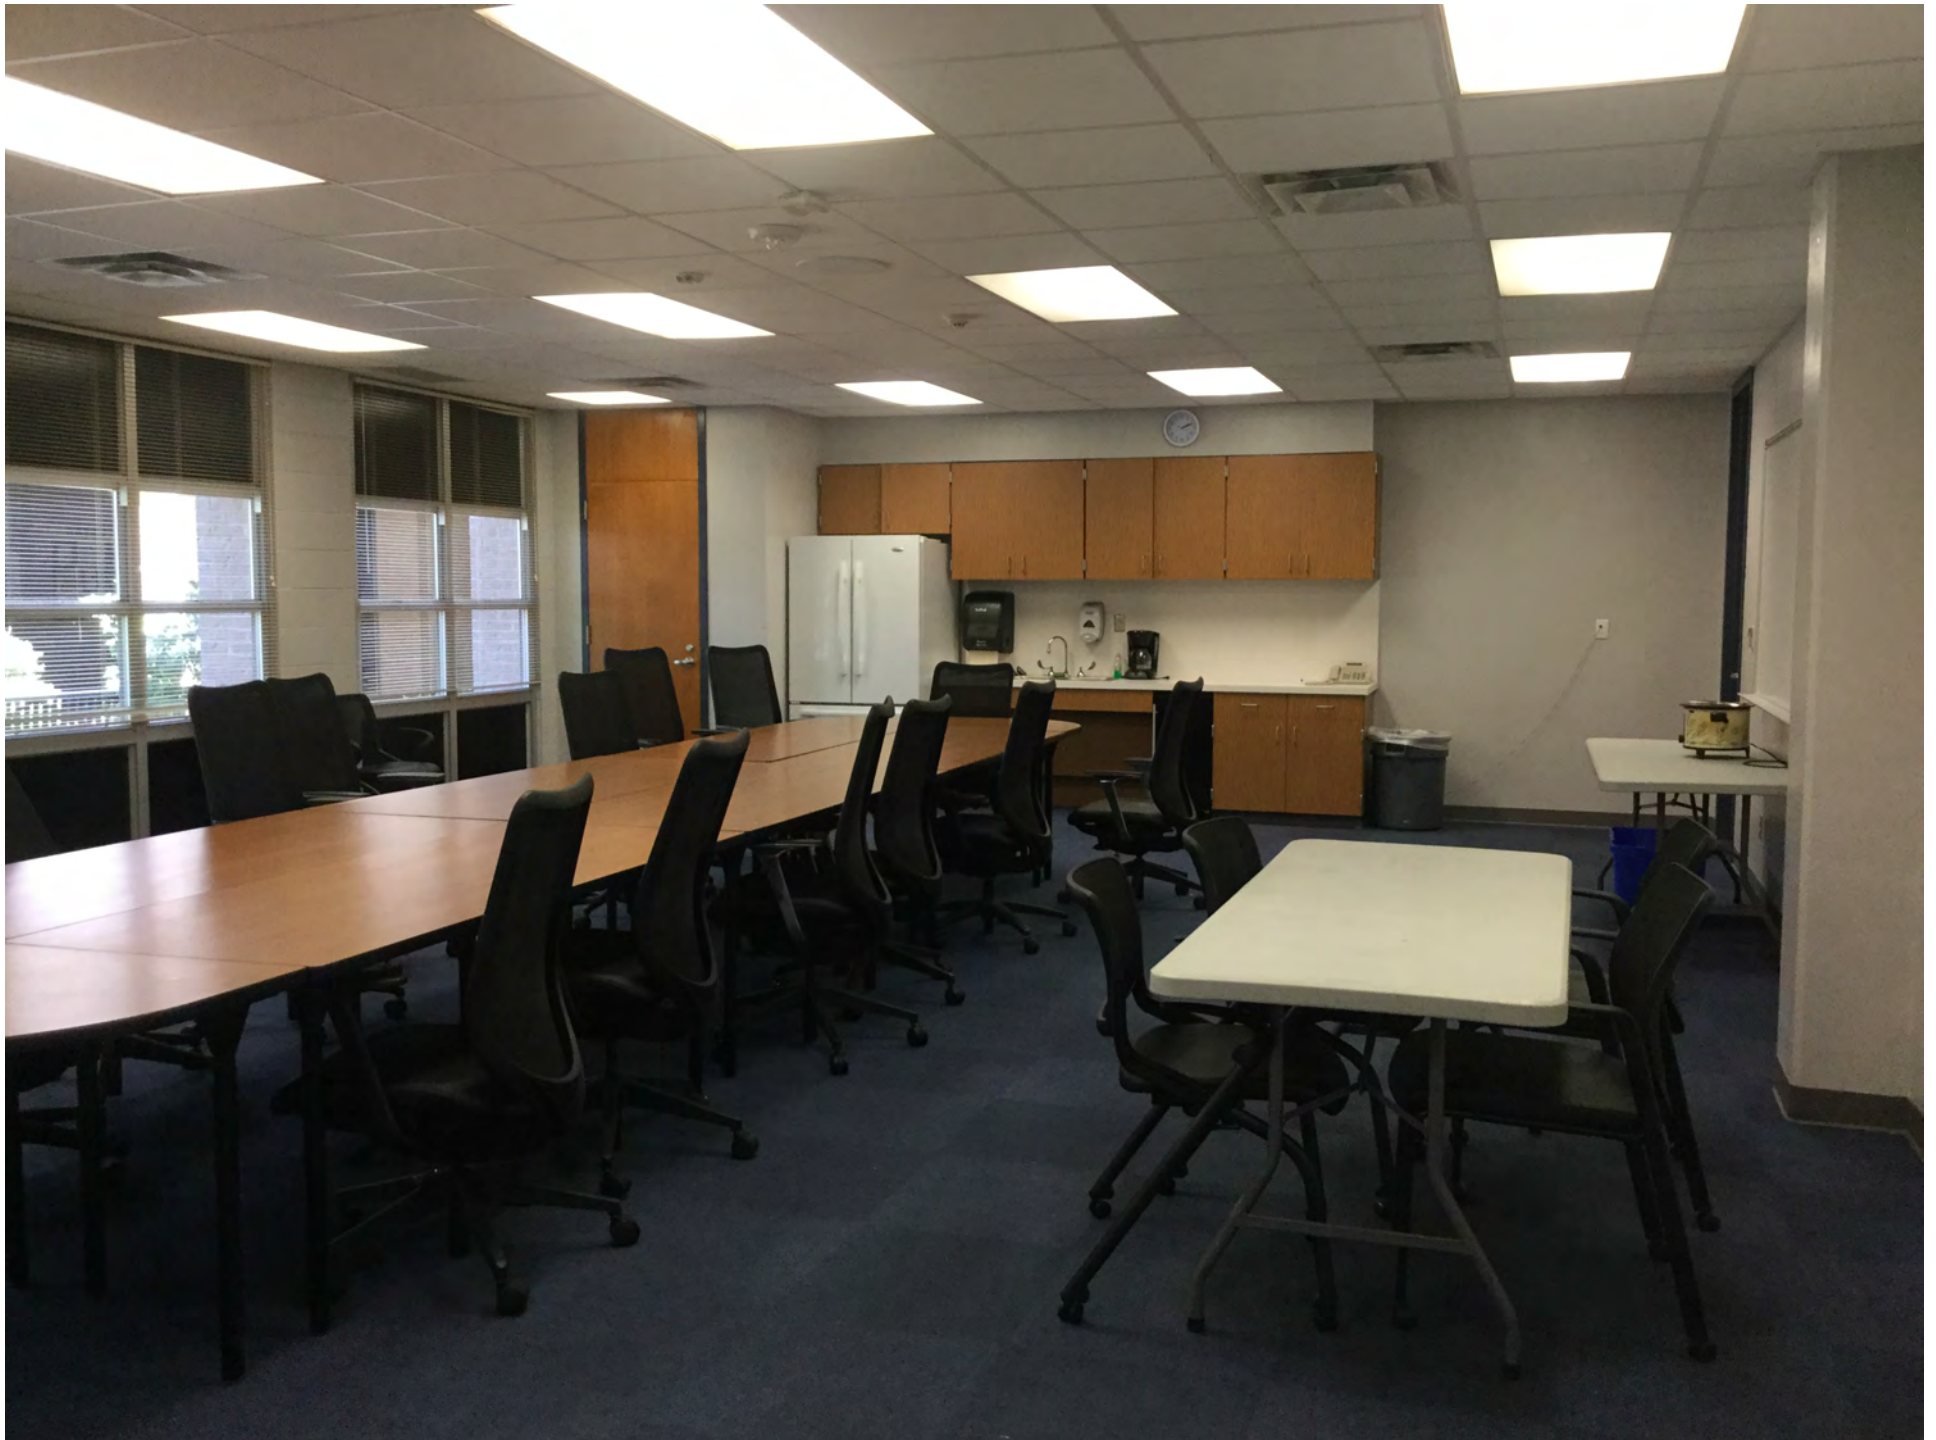
Photo 7.  
Meeting Space

1) Very unsatisfactory - no common spaces or meeting rooms or in very poor condition 2) Unsatisfactory - a few common spaces or meeting rooms in unsatisfactory condition 3) Average - a few common spaces and meeting areas needing updates 4) Good - multiple common spaces and meeting rooms in good condition 5) Very good - adequate common spaces and meeting rooms of excellent quality N/A) Does not apply.								Principal Comment: Old style of desks limit group work. The campus conference room is used for departmental chair meetings, administrator meetings, removal hearings - it is never available for classroom use. It is the only large conference room on campus and it is always booked with a meeting.

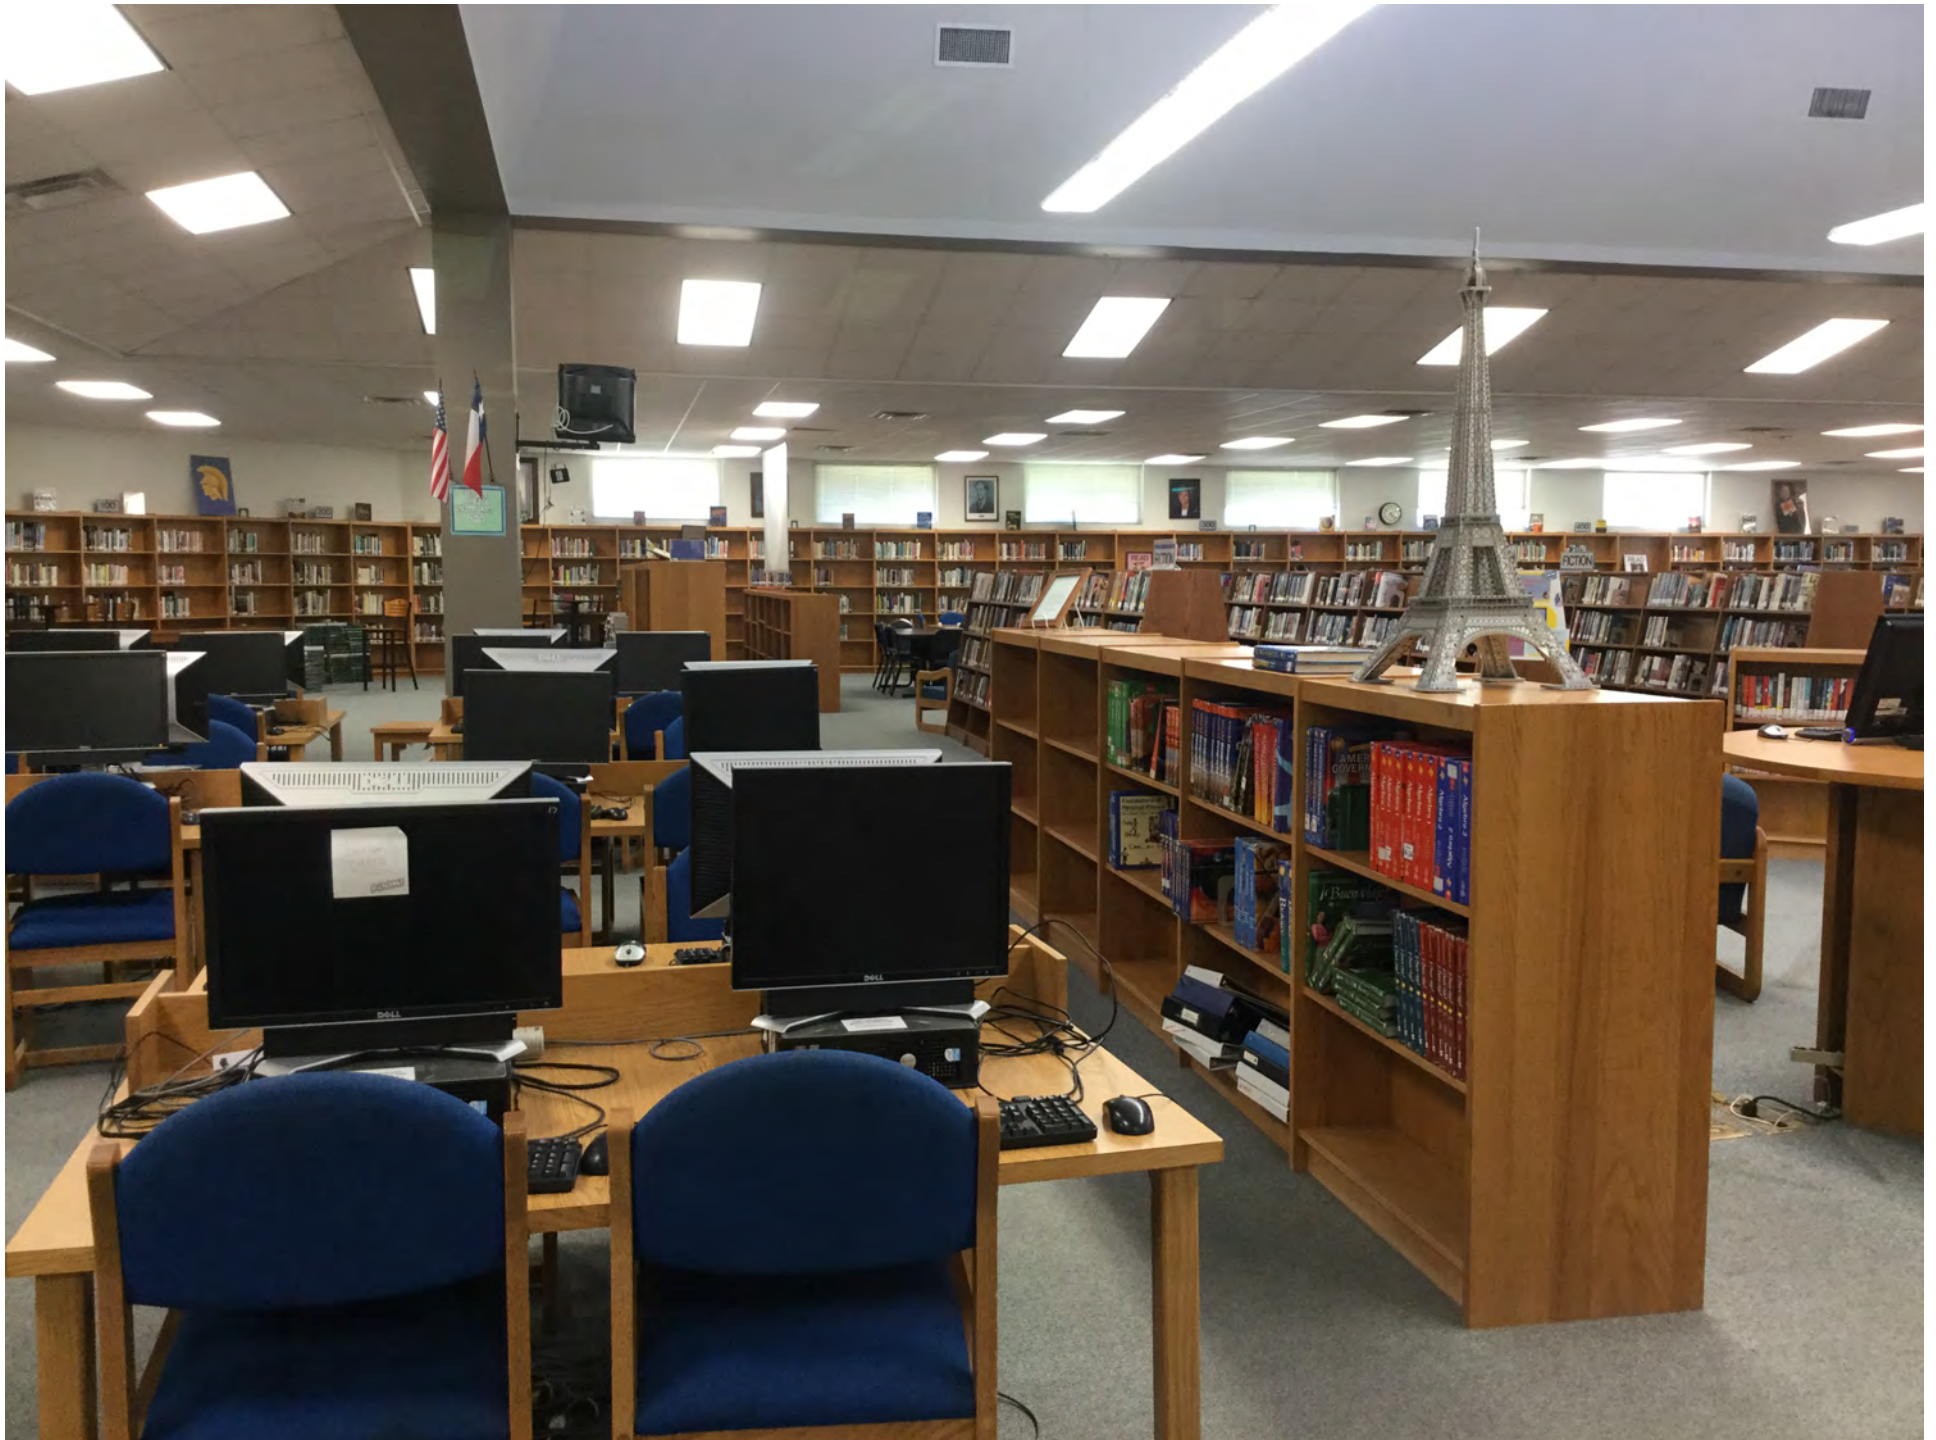
Photo 8.  
5.4 Library

5.4	How well does the Library/Media Center support collaborative work in small groups (4-8 students)?					5		Comments	1.00 <b>5.00</b>
1) Very unsatisfactory 2) Unsatisfactory 3) Average 4) Good 5) Very good N/A) Does not apply.							There are many small group tables throughout the space.
