## Educational Suitability Summary Report

Anderson High School – BLDG 009

Date: 06/16/2016

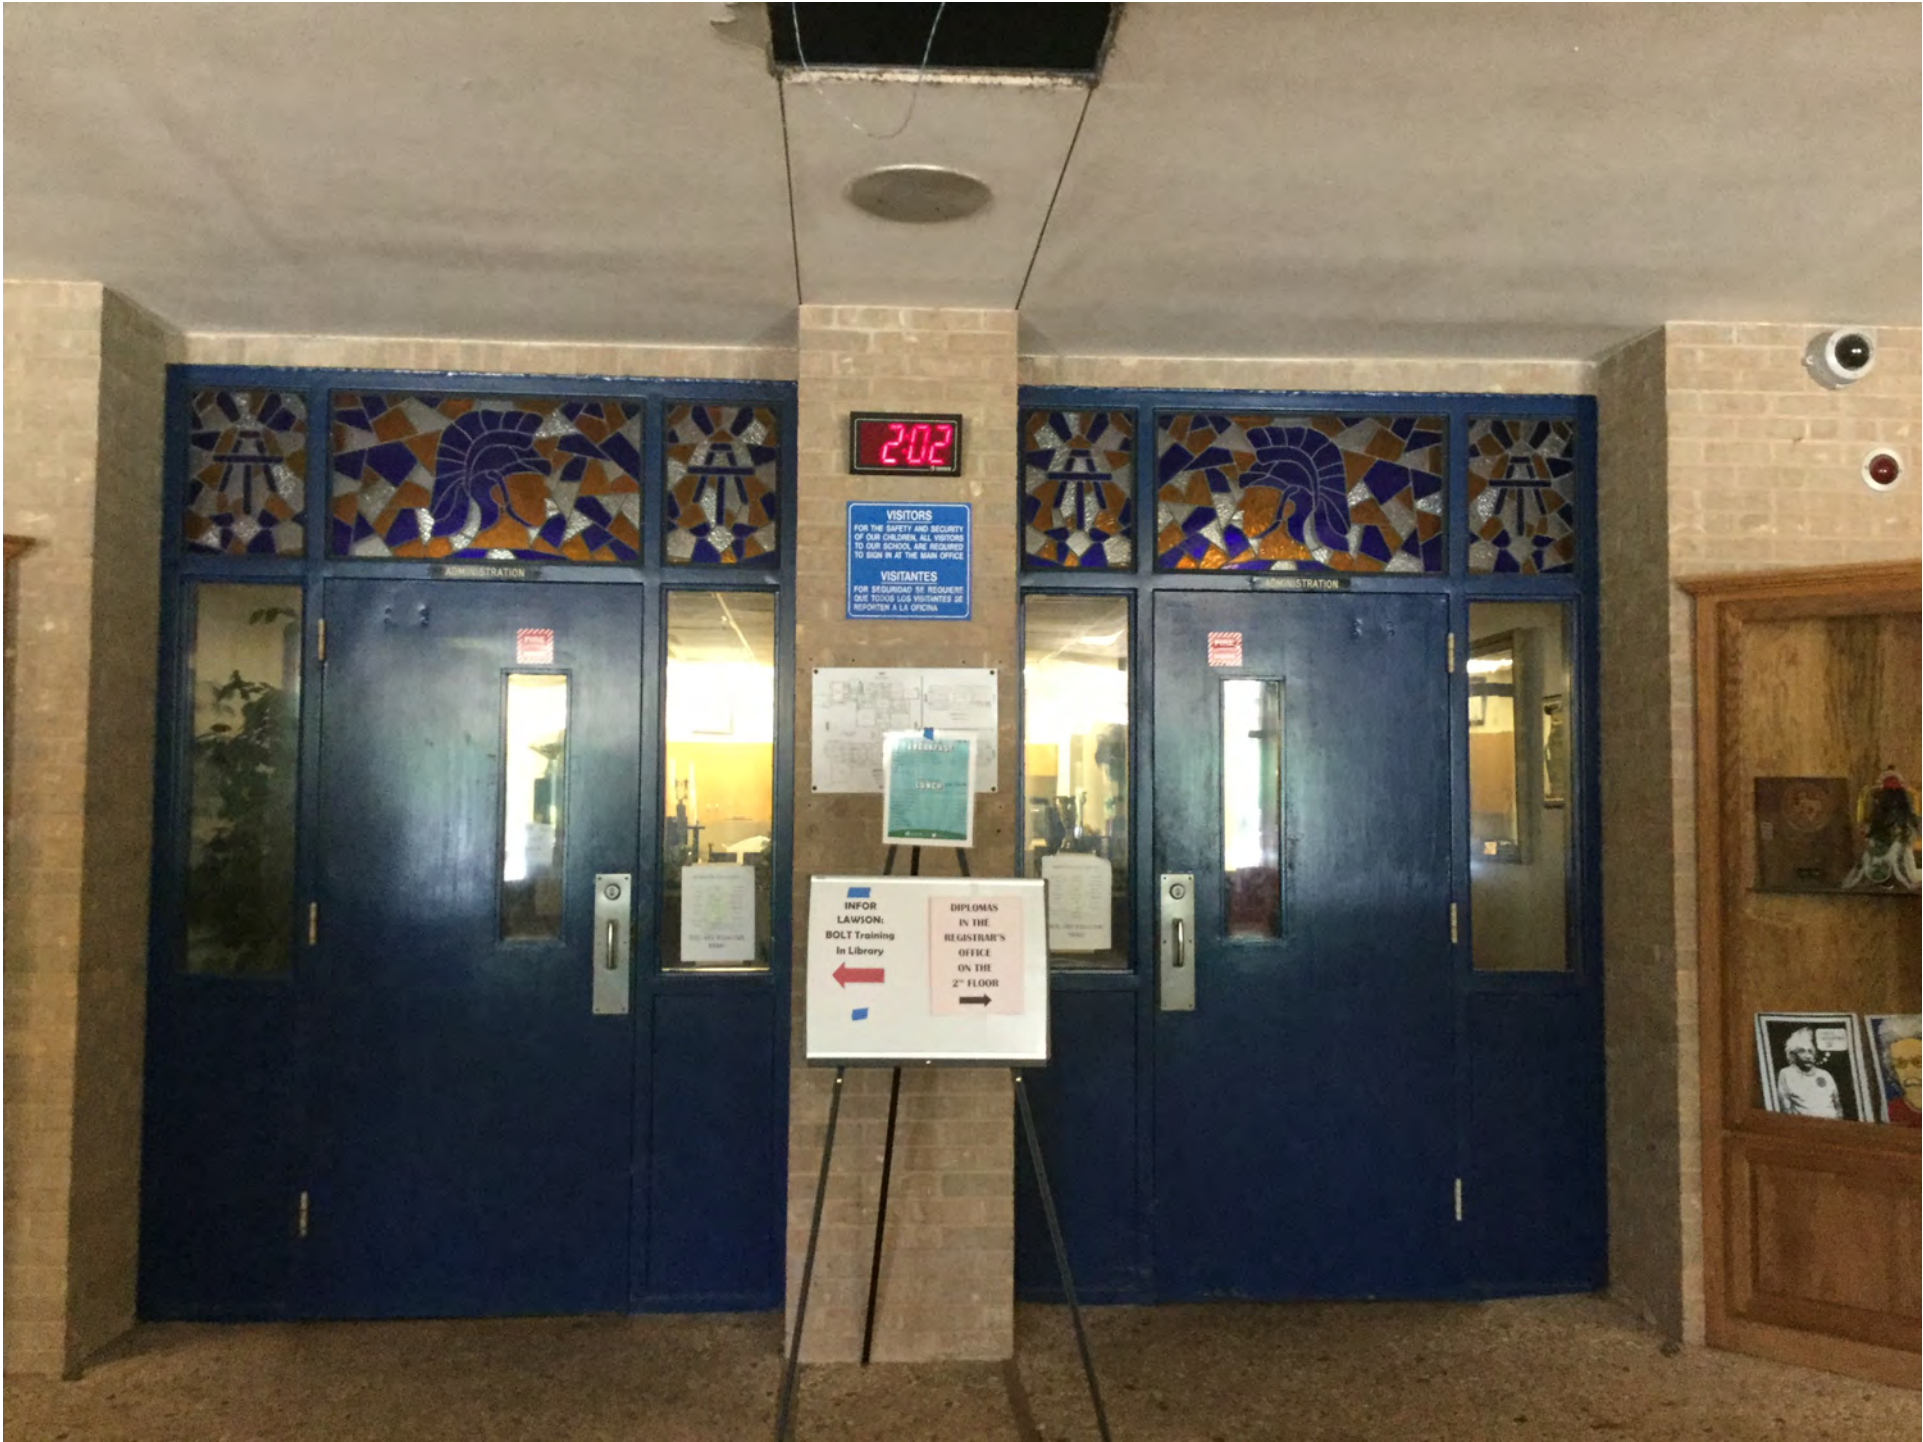
Photo 9.  
6.3 Main Office

6.3	Is the main office properly located and configured with a secure vestibule to the main corridor?			3				Comments	1.00 3.00
1) Very unsatisfactory - No secure vestibule, office located far from main entry. Allows visitors access to school unsupervised. 2) Unsatisfactory - No secure vestibule, office located somewhat far from main entry, minimal supervision of visitors. 3) Average - Office close to entry, views of front door, but no secure vestibule 4) Good - Office is well-located with a secure vestibule, but needs updates 5) Very good - Office well-located with secure vestibule and all appropriate security features. N/A) Does not apply.									Principal Comments: There is no secure vestibule and this allows visitors access to classrooms without signing in-multiple points of entry around campus.
									see photo 9
