Educational Suitability Summary Report

Bowie High School – BLDG 013

Date: 08/8/2016 - (Rev 1 – 11/17/16 – AISD Construction Dept Comments)

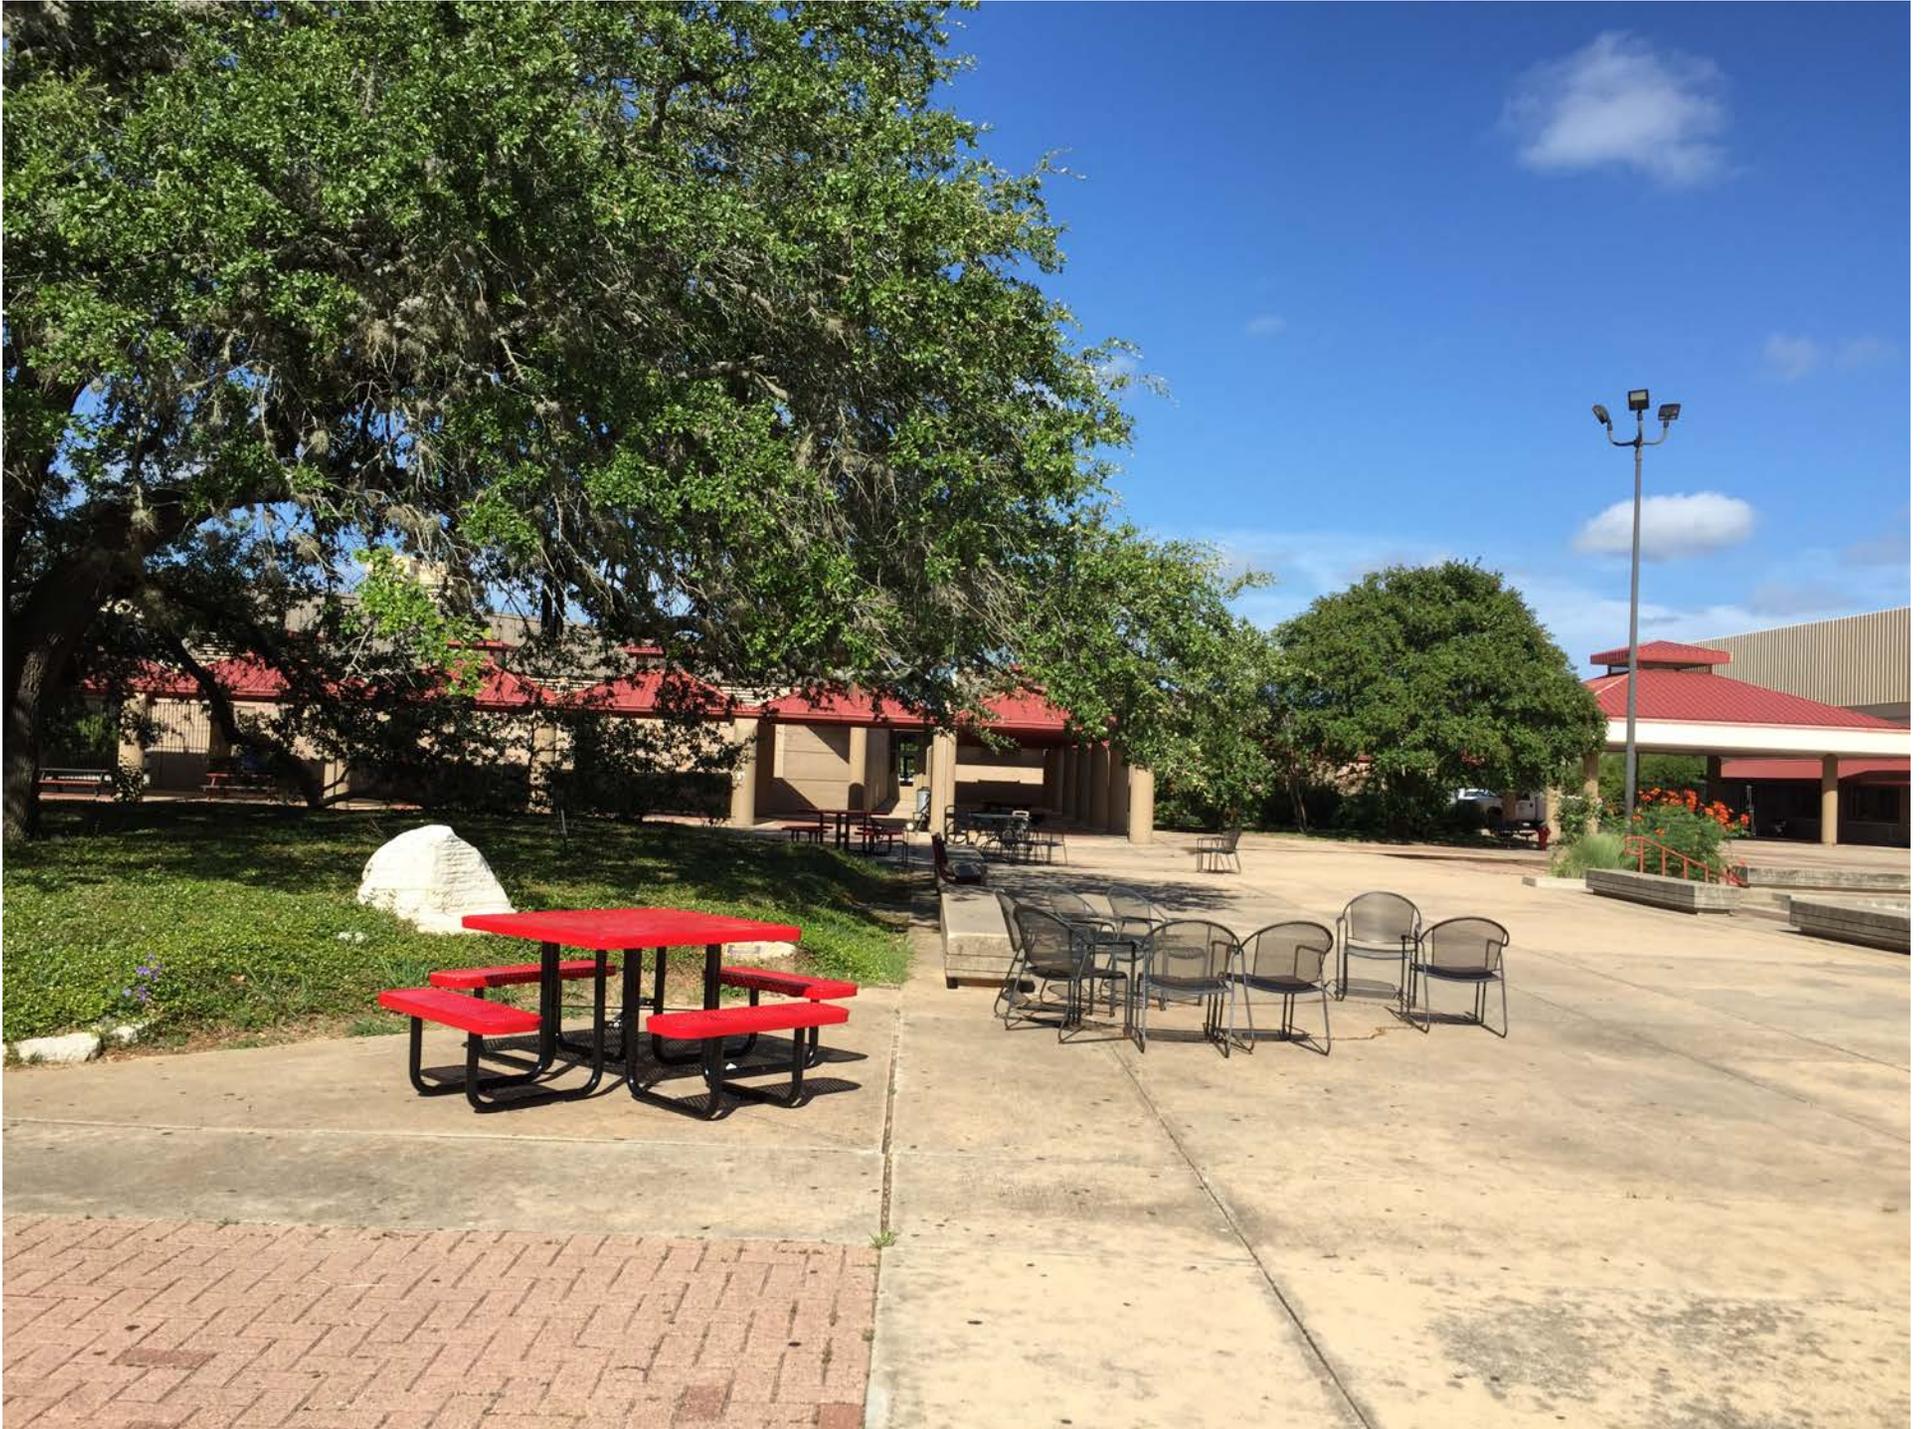
Photo 1.
1.2 Outdoor Courtyard Space

1.2	Are opportunities provided for outdoor learning (outdoor classrooms, gardens, etc.)?				4			Comments	1.00	4.00
1) Outdoor space exists is not developed 2)Outdoor space for learning exists but not connected to classroom learning areas. 3. Outdoor learning spaces exist and are accessible but not in good condition. 4. Outdoor learning spaces need minor improvements to function well. 5. Outdoor learning spaces are in excellent condition. N/A) Does not apply.										
		see photo 1

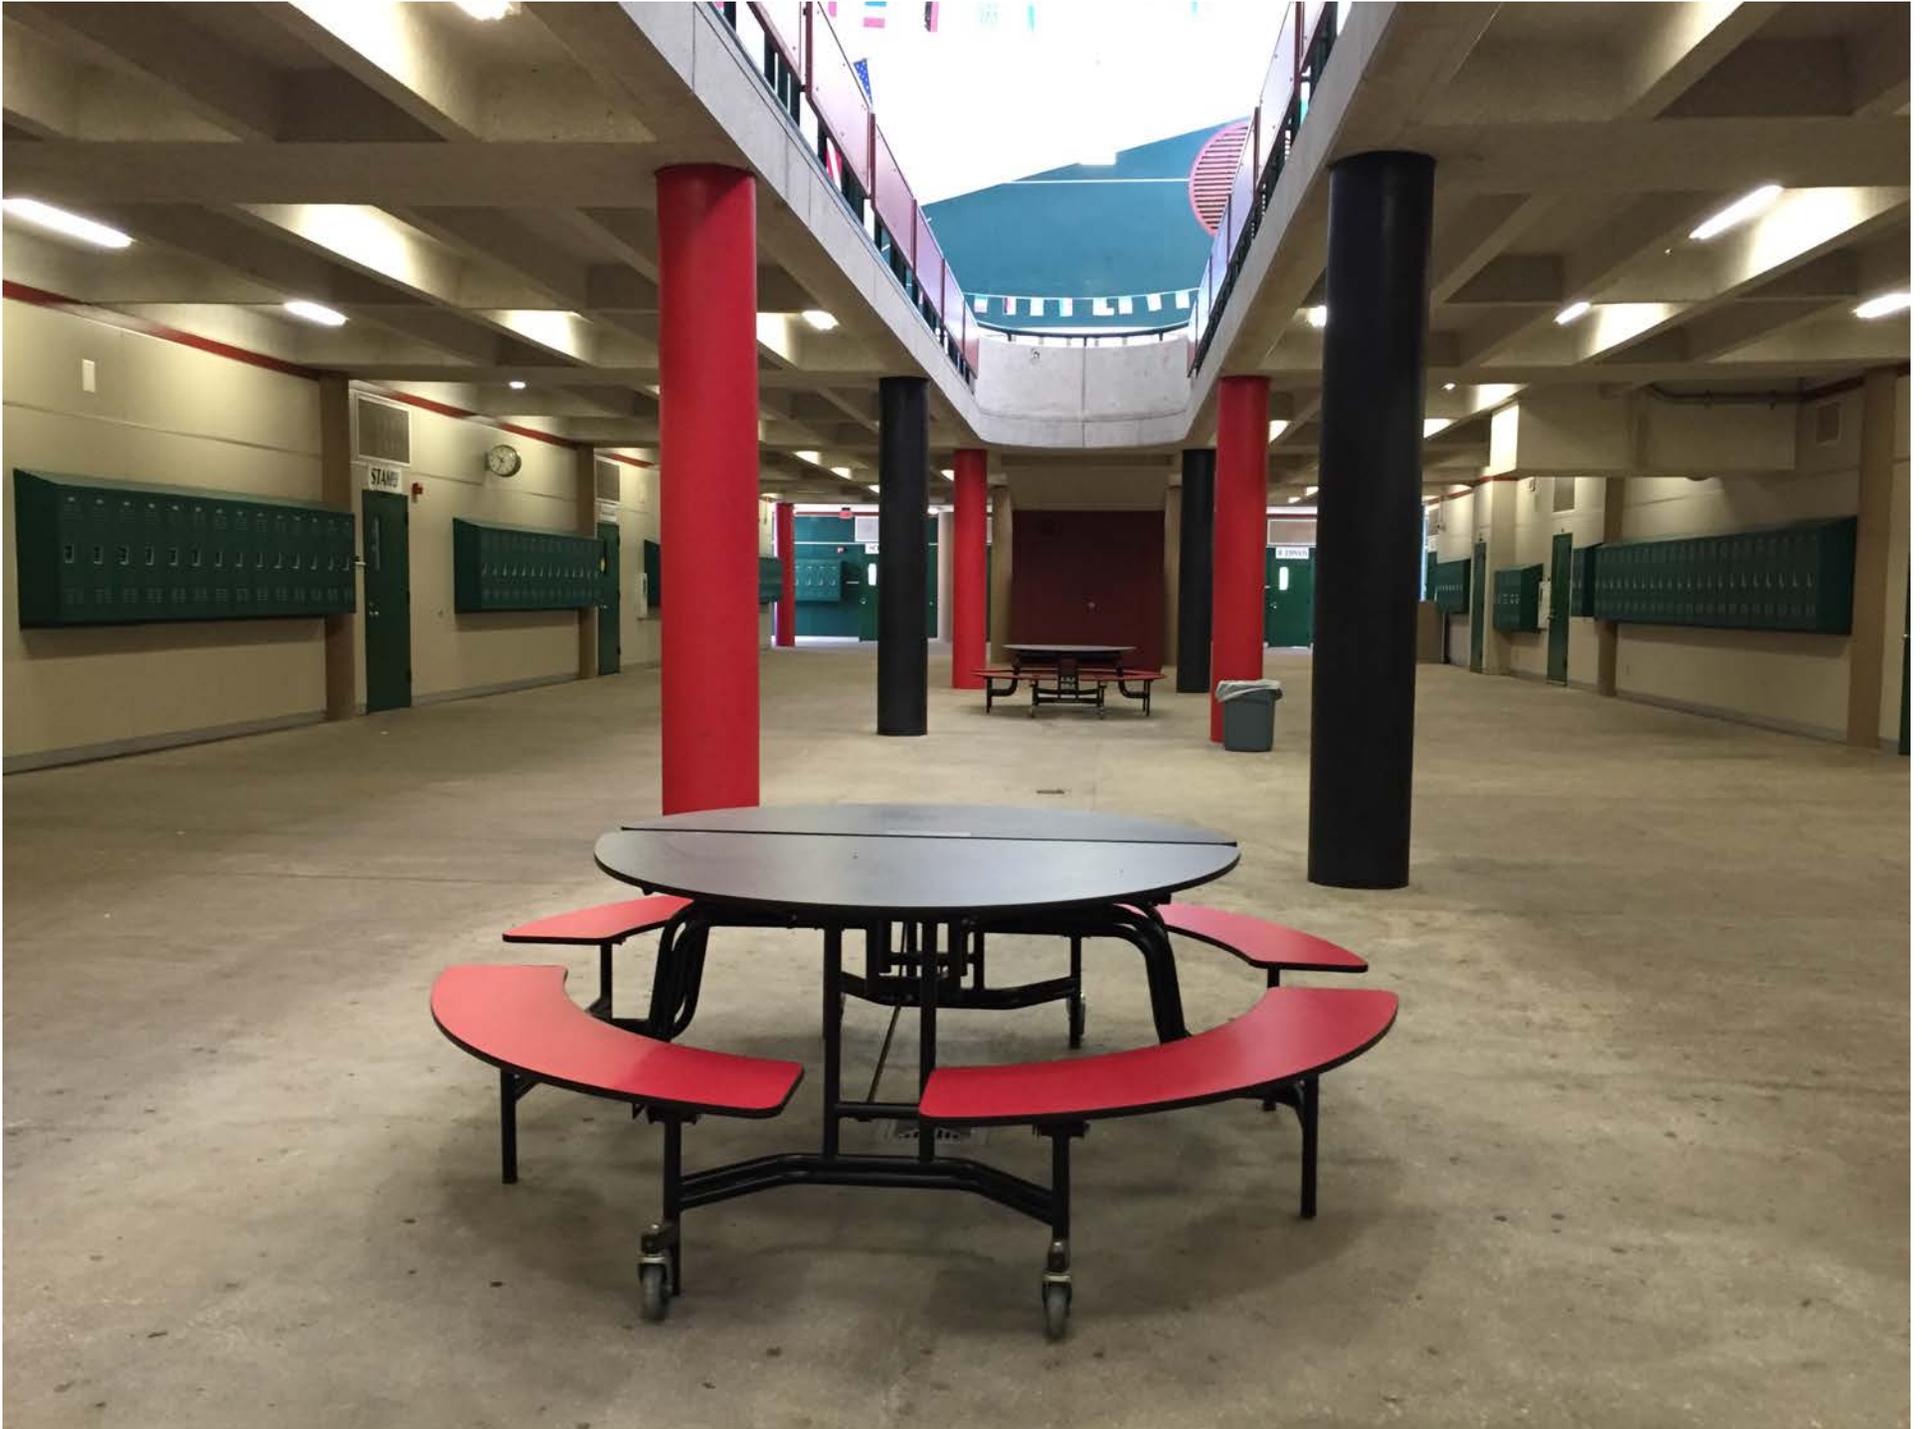
Photo 2.
2.1 Corridor

The circulation routes are wide enough to safely and effectively accommodate student movement but are unconditioned and not desirable. The corridors lack a finished look with flooring, conditioned space and acoustic ceiling.

1) Primary circulation is 5'-0" to 6'-0" wide. 2) Primary circulation is 6'-0" to 7'-0" wide 3) Primary circulation is 7'-0" to 8'-0" wide 4) Primary circulation is 8'-0"-10'-0" wide 5) Primary circulation is 10'-0"+ wide N/A) Does not apply.								The hallways are unconditioned and loud as there are no acoustic ceilings.	see photo 2

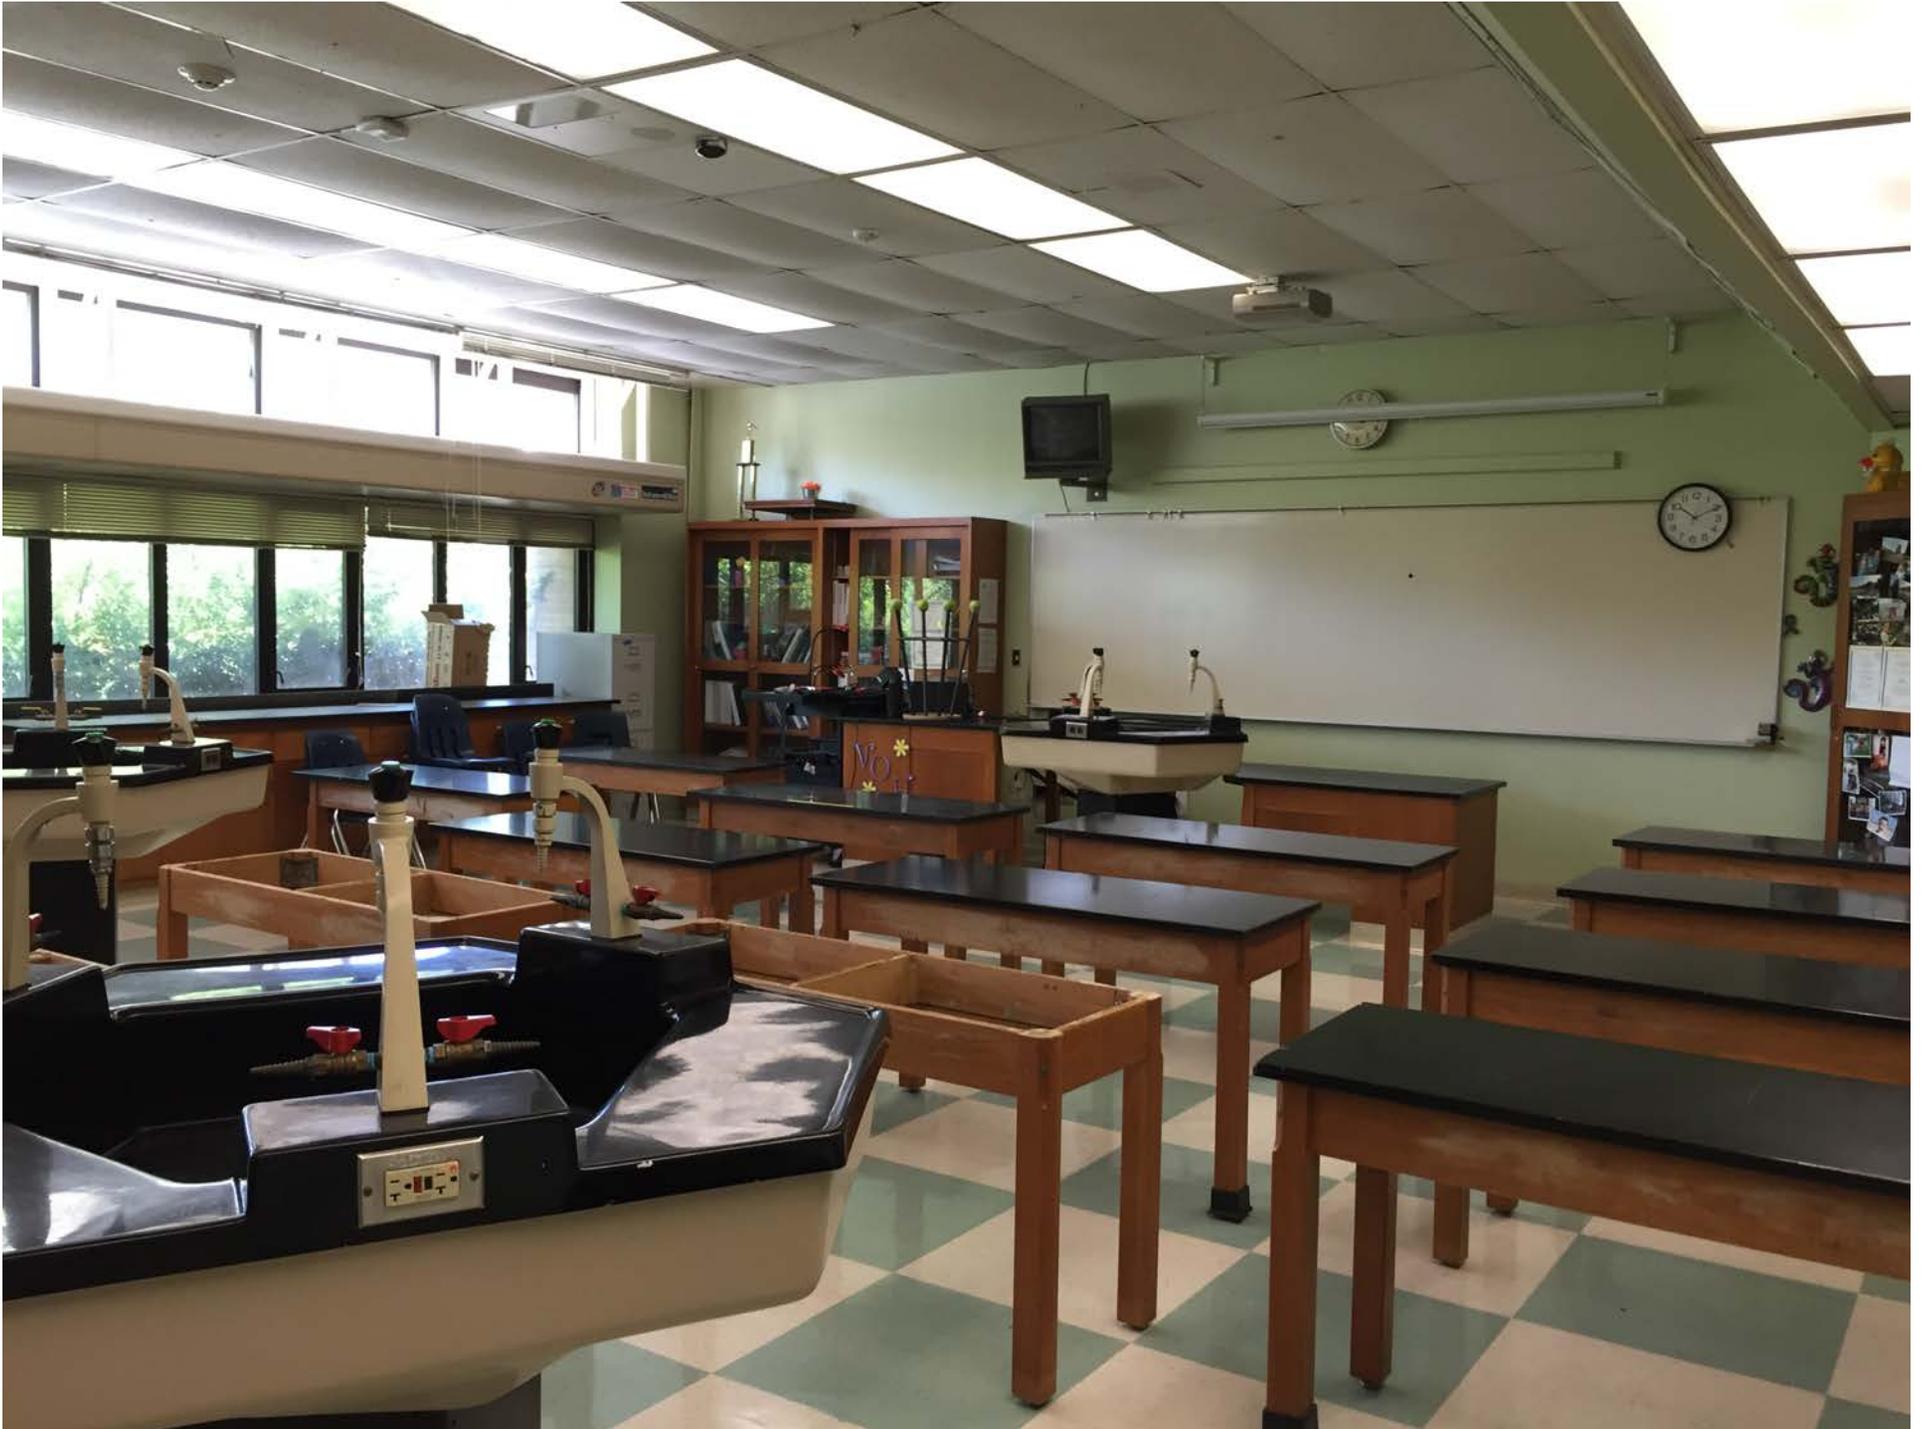
Photo 3.
3.4 Science Room

3.4	Are Science Classrooms/Labs appropriately configured per the ed spec?		2					Comments	1.00	2.00
1) Very unsatisfactory 2) Unsatisfactory 3) Neutral 4) Satisfactory 5) Very Satisfactory N/A) Does not apply. (Elementary schools)				The newer science labs are in good condition, but the majority are inadequate in size and dated. Lab tables are broken and appear undersized for high school students. Most of the science classrooms have fixed tables and are difficult to accommodate the number of students.					see photo 3

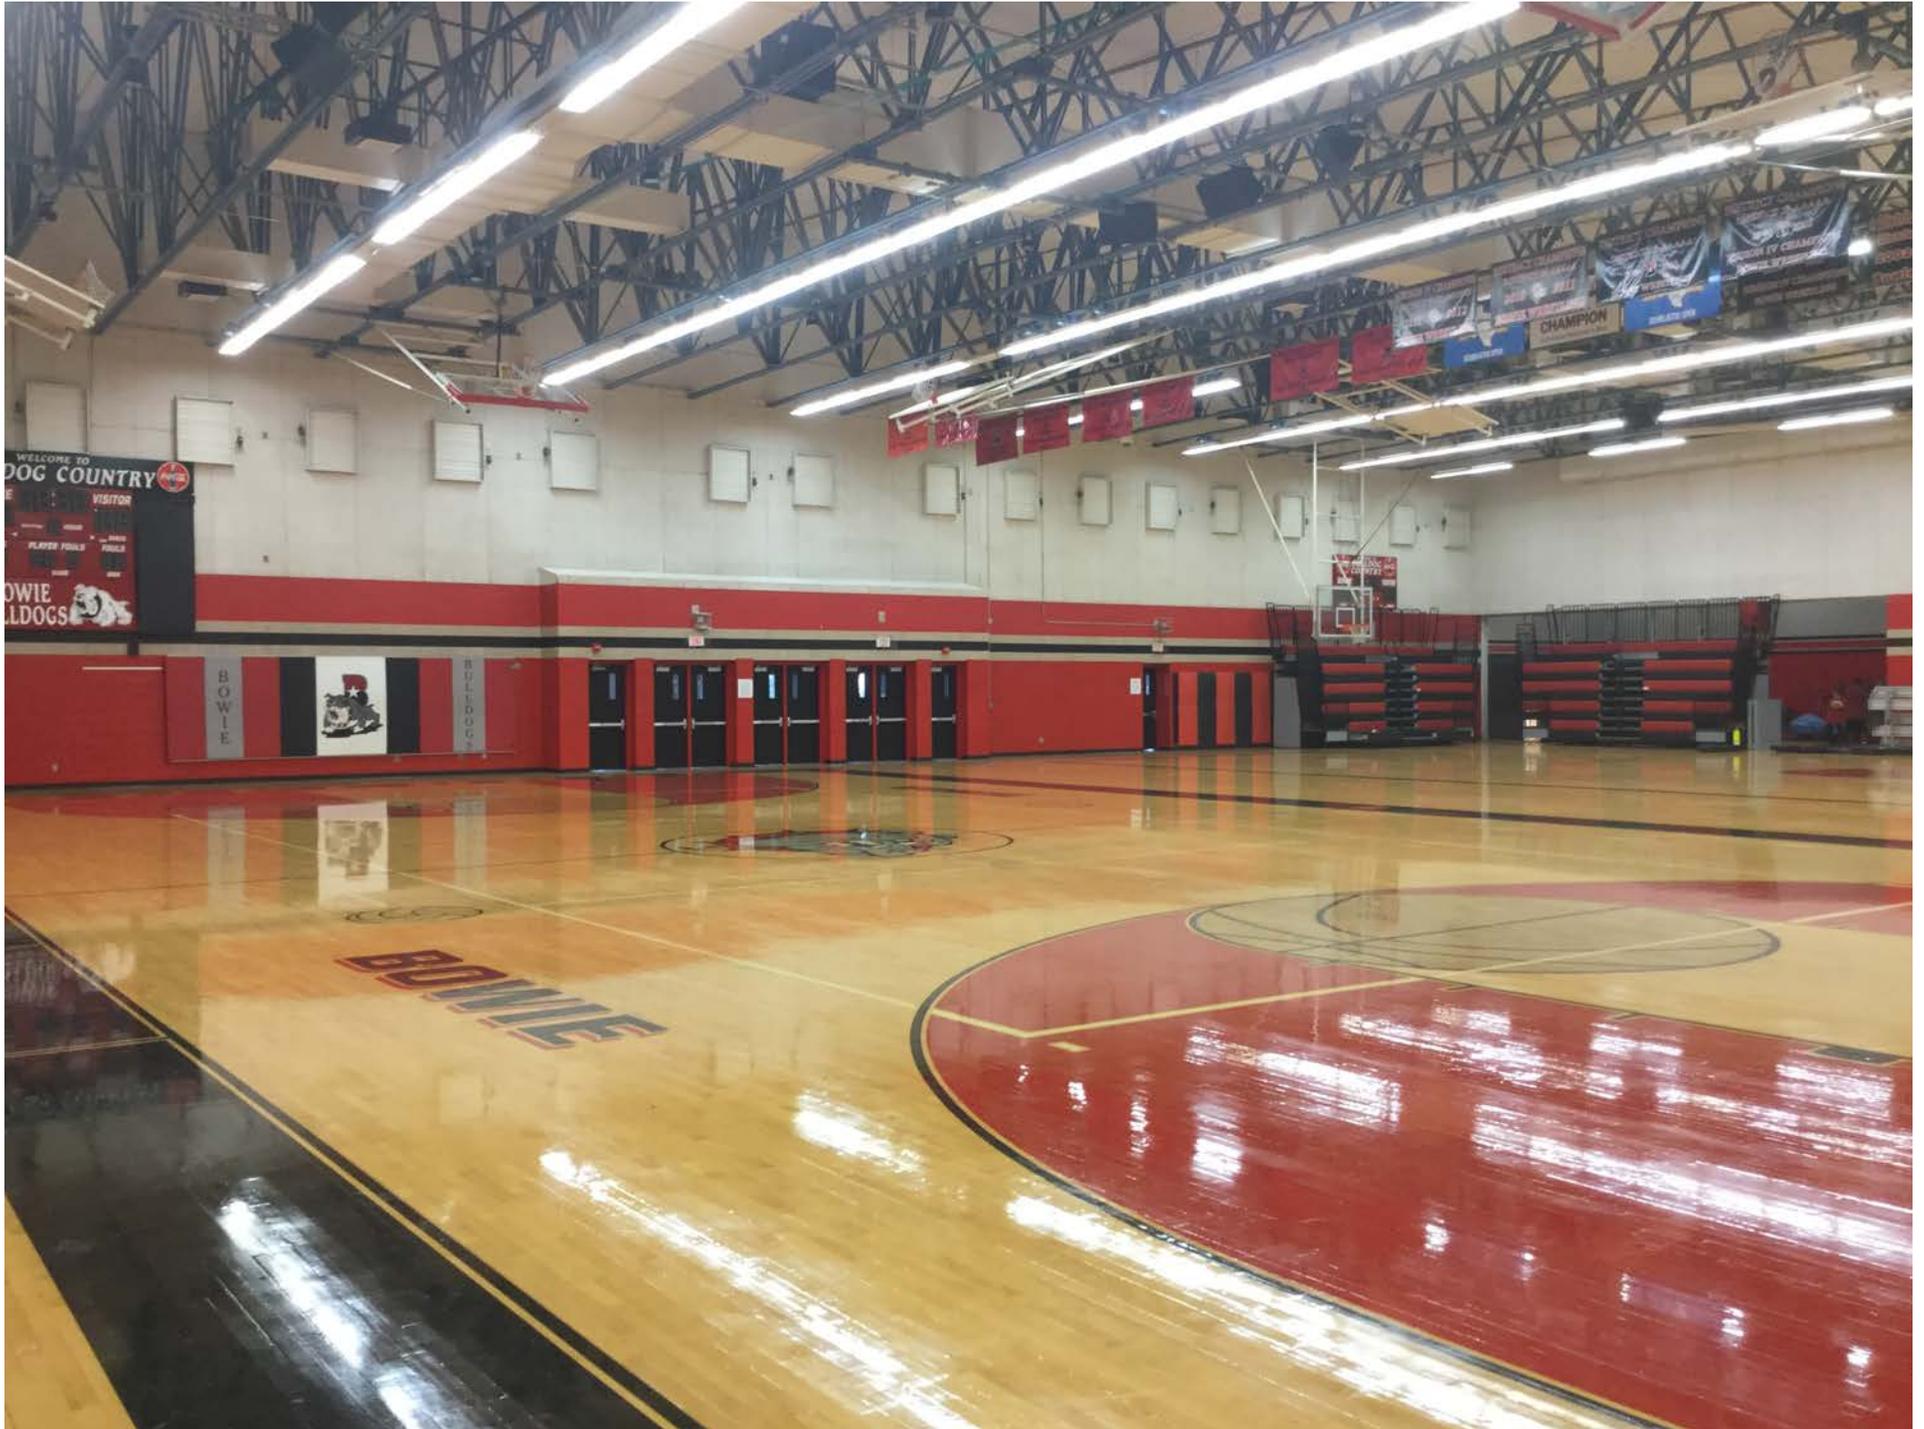
Photo 4.
3.6 Gym

1) Very unsatisfactory 2) Unsatisfactory 3) Average 4) Good 5) Very good N/A) Does not apply.								Utility gym is in poor condition and is not properly configured. Main gym is in good condition.	see photo 4

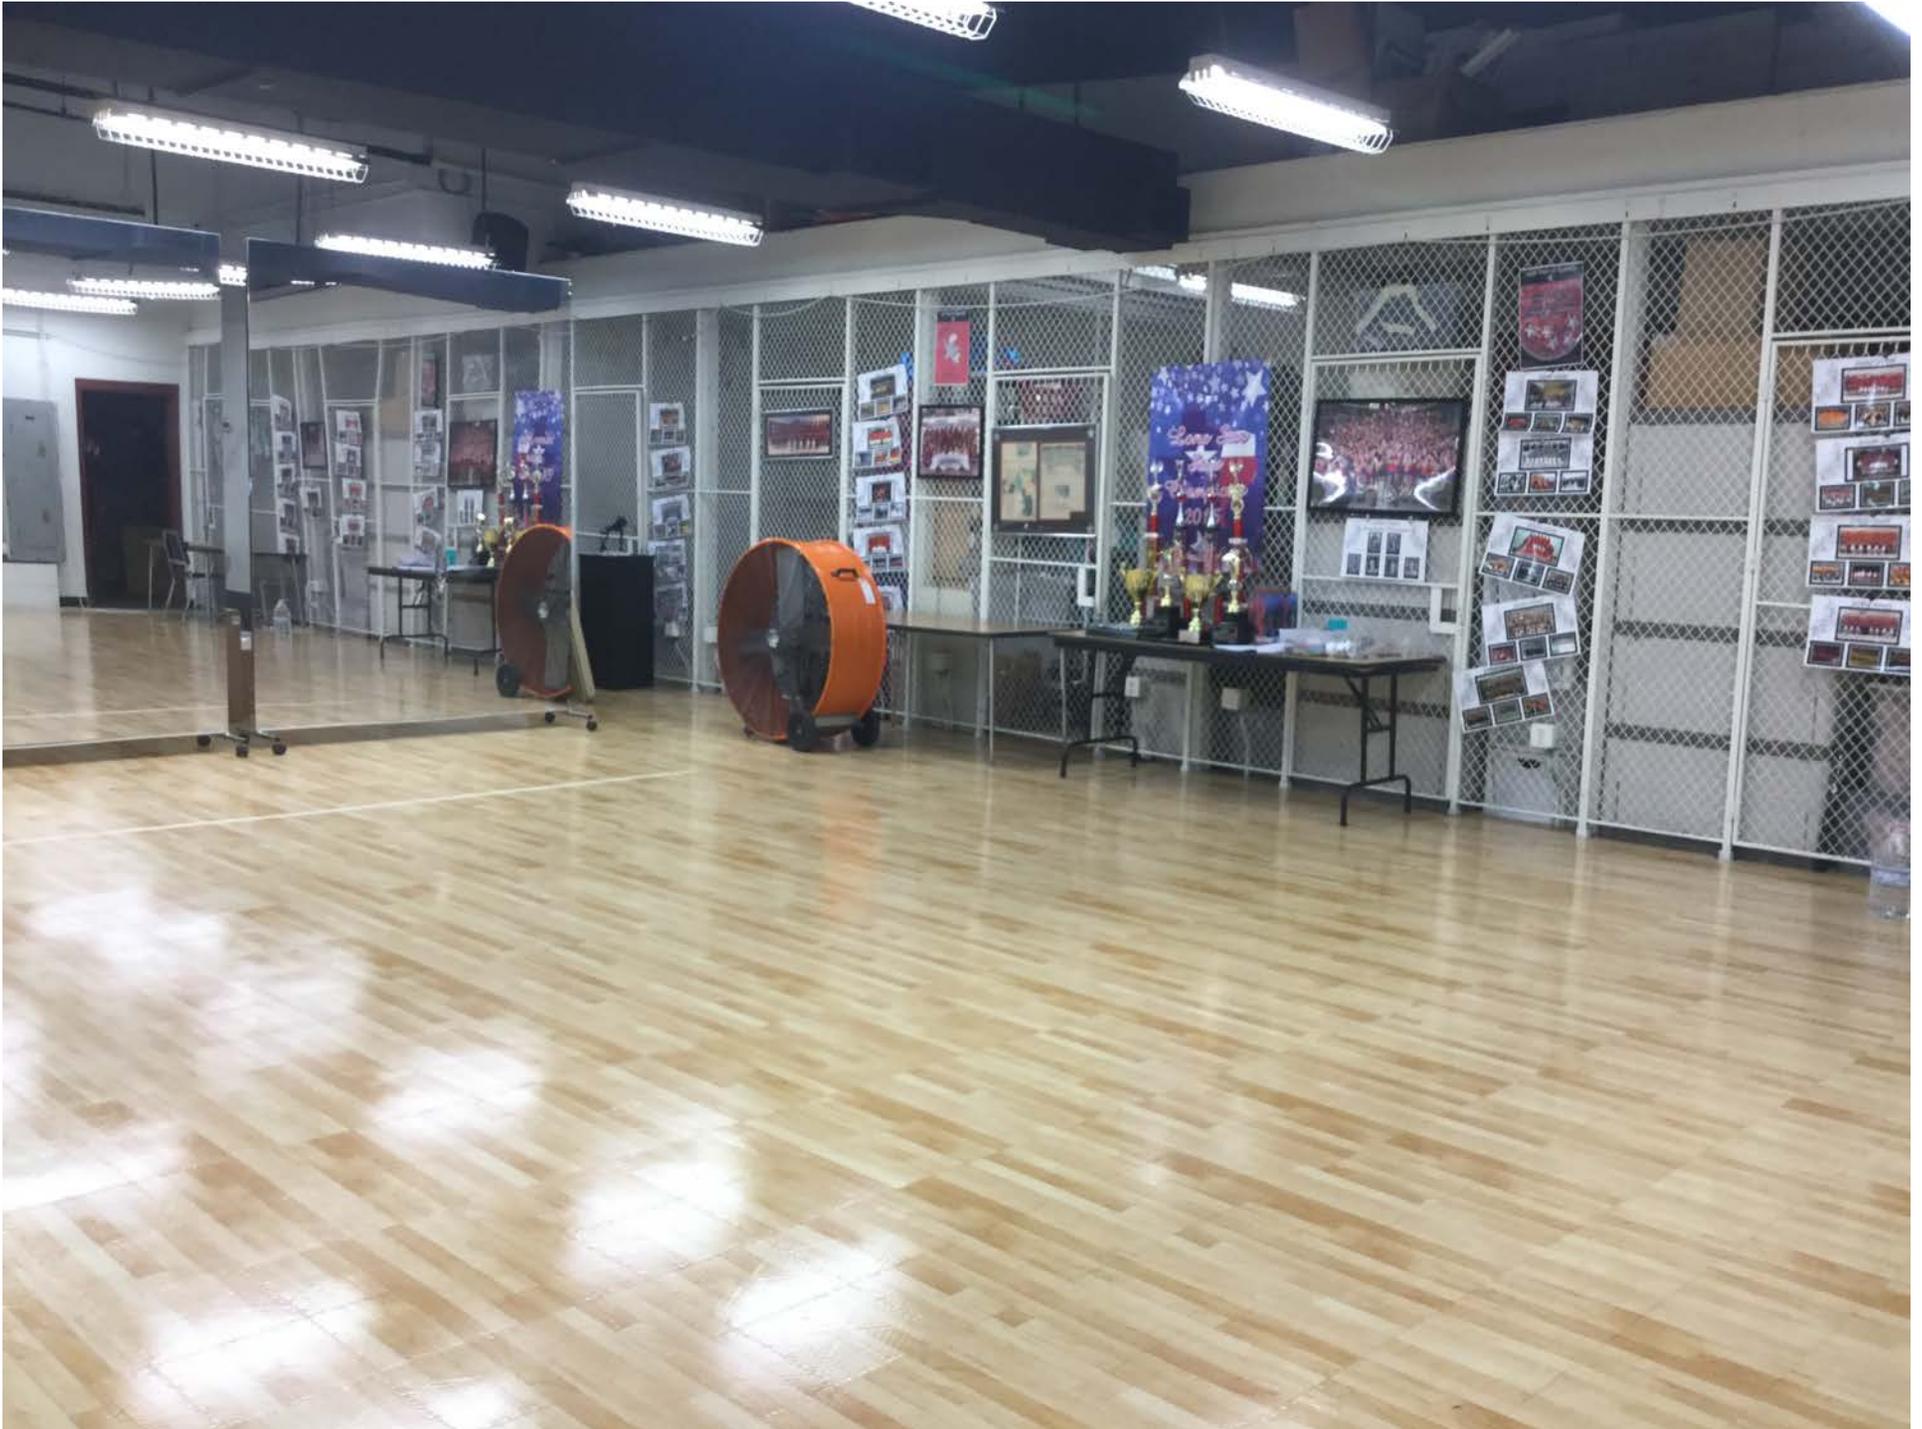
Photo 5.
3.8 Dance Room

3.8	Are music, drama, or performance spaces appropriately configured per the ed spec?			3				Comments	1.00 3.00
1) Very unsatisfactory 2) Unsatisfactory 3) Average 4) Good 5) Very good N/A) Does not apply.								The music rooms need updates. The dance room is too small and has no storage.	see photo 5

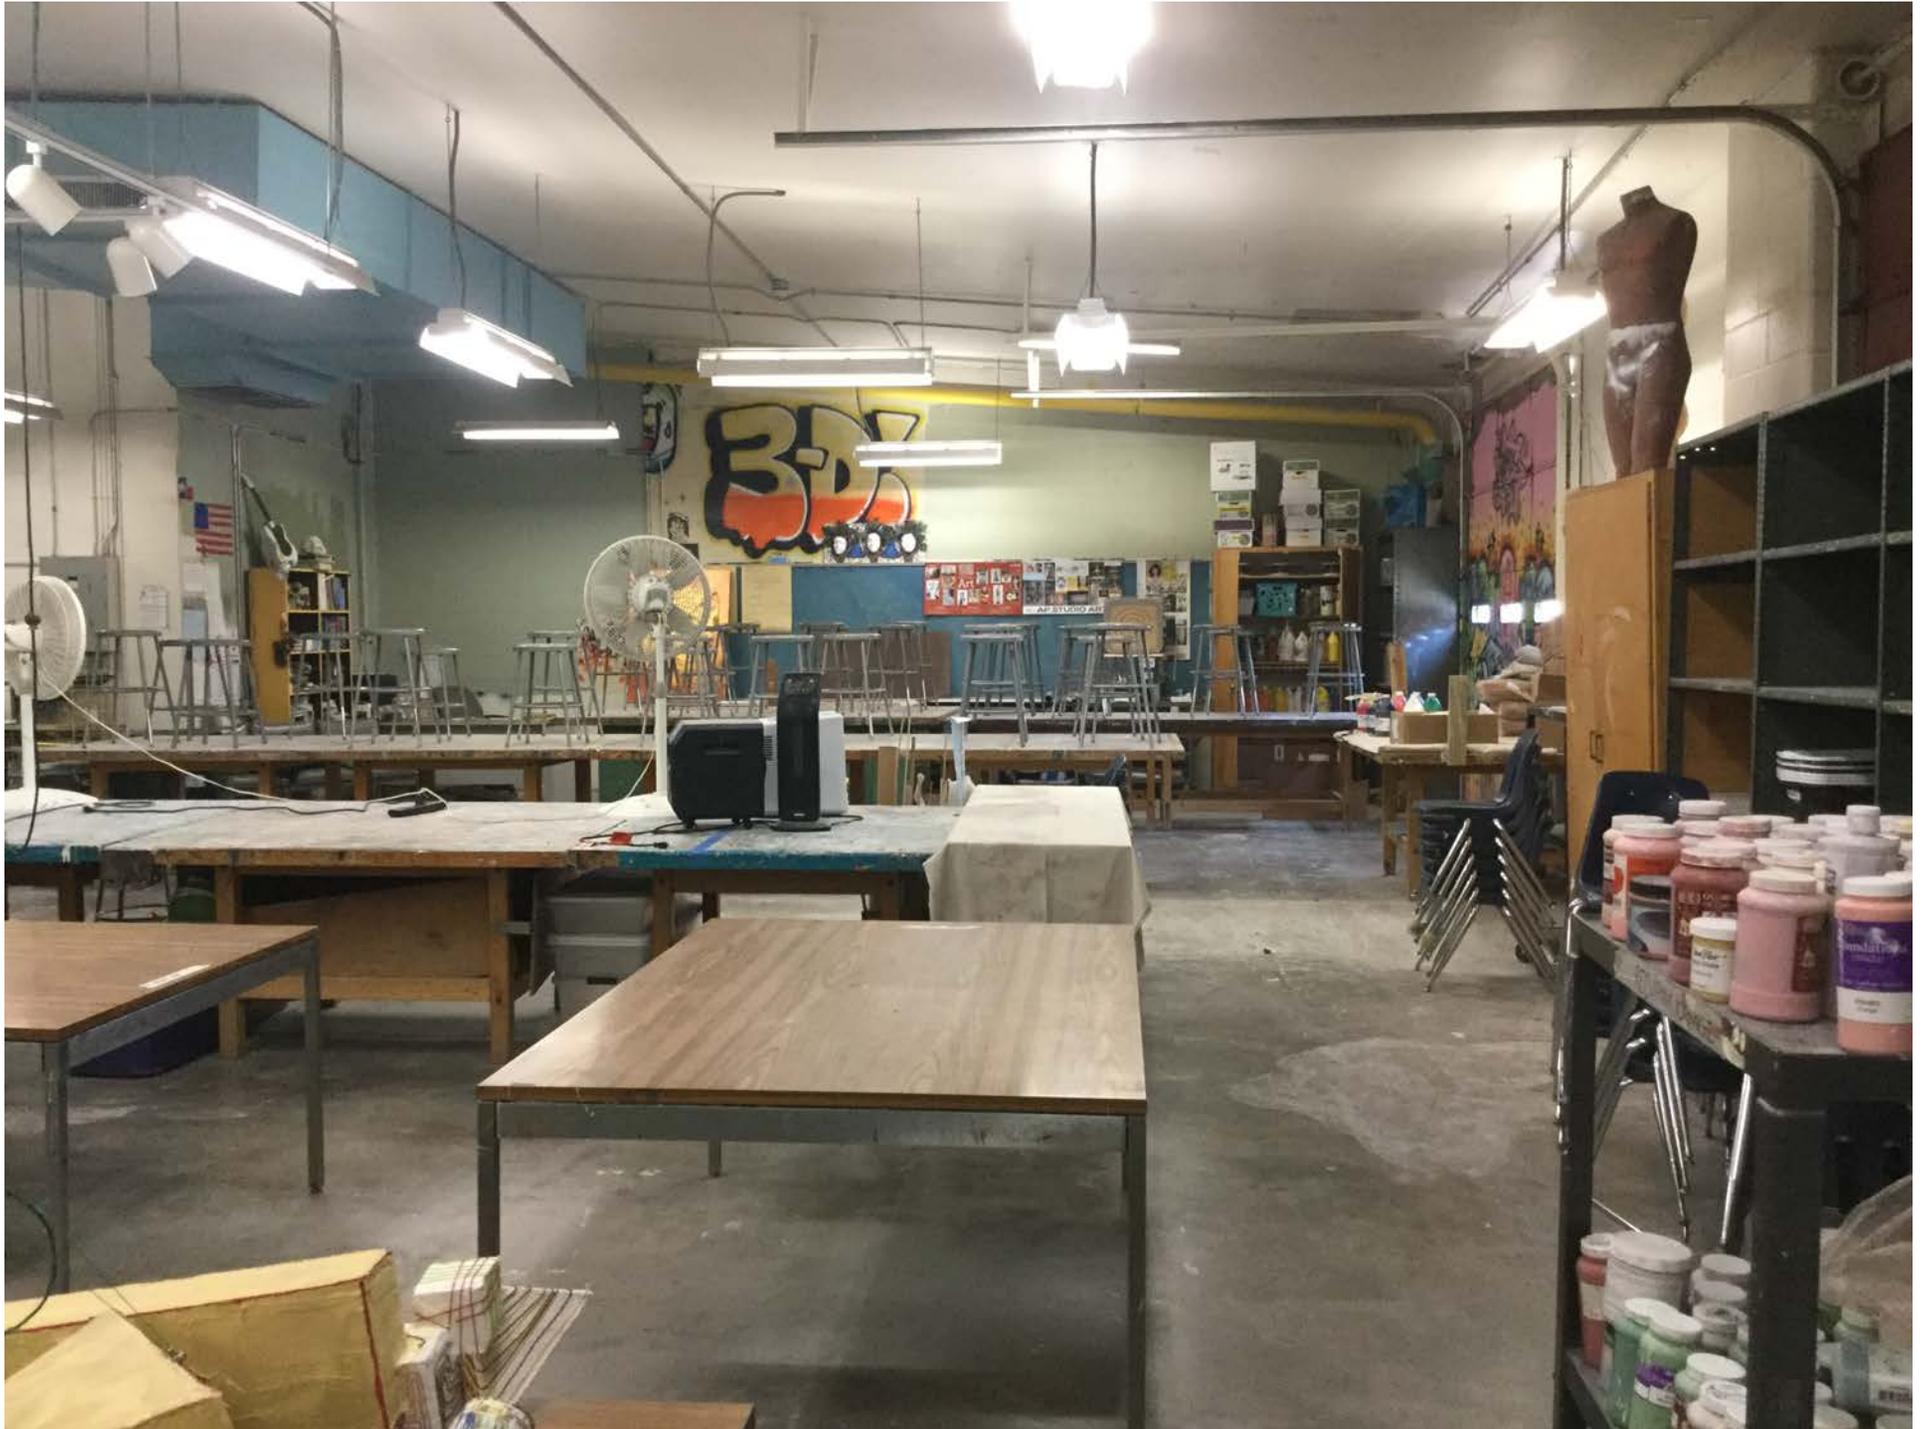
Photo 6.
3.10 Art Room

1) Very unsatisfactory 2) Unsatisfactory 3) Average 4) Good 5) Very good N/A) Does not apply.								The art rooms are in a separate garage building.	
								see photo 6

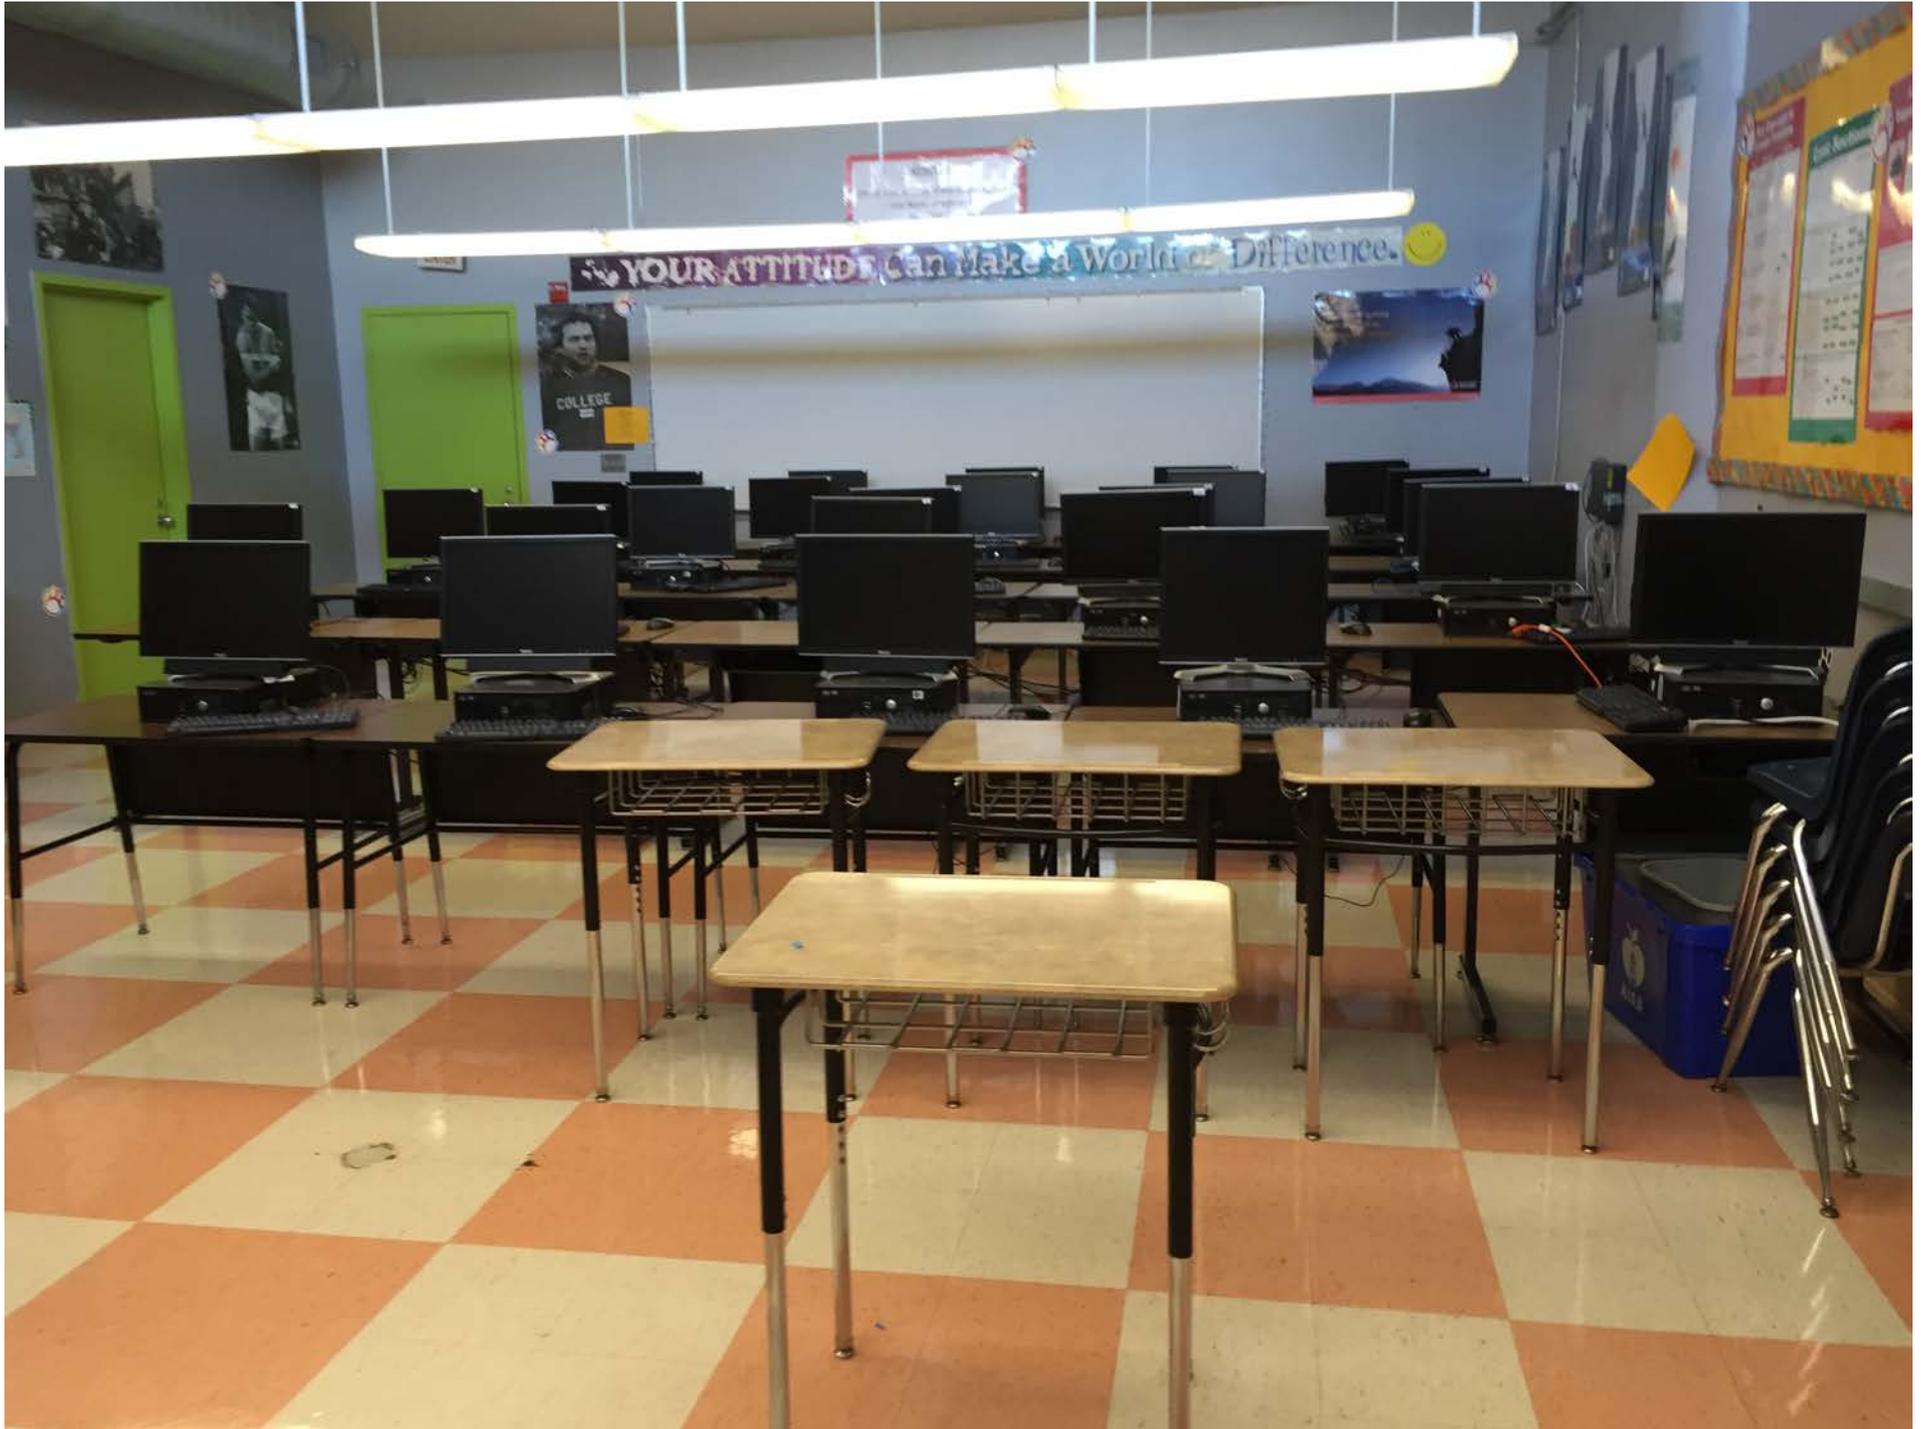
Photo 7.
3.12 Computer Lab

3.12	Are computer lab spaces appropriately configured?			3				Comments	1.00 3.00
1) Very unsatisfactory 2) Unsatisfactory 3) Average 4) Good 5) Very good N/A) Does not apply.								The computer lab is undersized for the current student body. Technology is old and outdated. Computer science is in a portable.	
								see photo 7

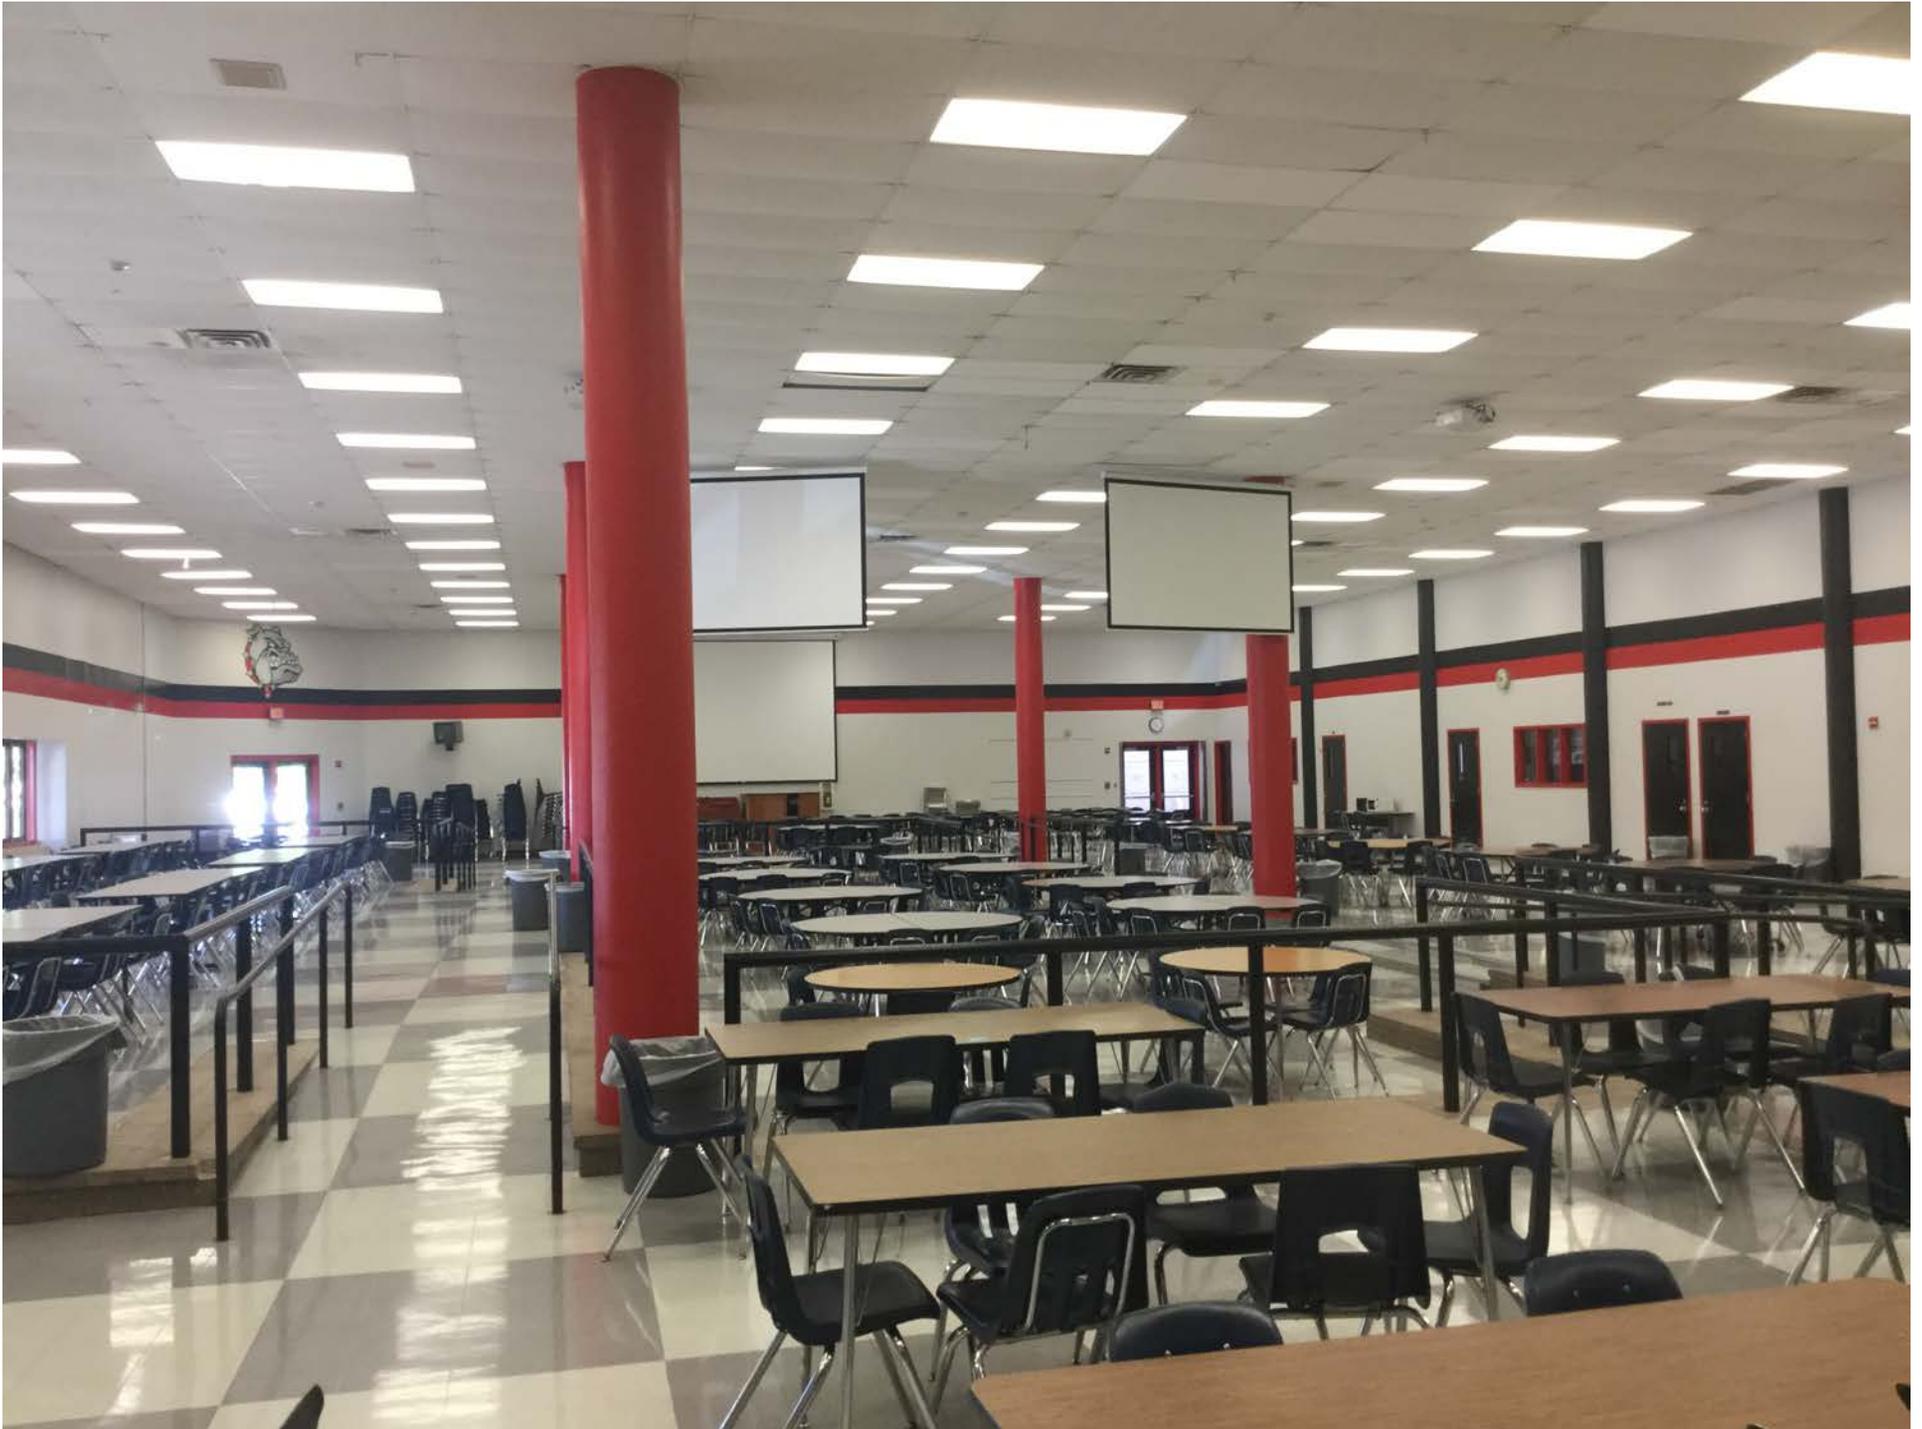
Photo 8.
3.16 Cafeteria

3.16	Are the student dining facilities appropriately configured?			3				Comments	1.00	3.00
1) Very unsatisfactory - Too small, poor circulation, inflexible seating in poor condition 2) Unsatisfactory - Too small or inadequate circulation, seating in poor condition 3) Average - moderate size, with adequate circulation, seating in okay condition 4) Good - good size, adequate circulation, seating in good condition 5) Very good - good size, adequate circulation, seating in good condition, with more than one option for eating space (ex: connection to outdoor eating space) N/A) Does not apply.								The cafeteria needs more space for the large amount of students. The furniture is a mix of tables.		
								see photo 8
