Educational Suitability Summary Report

Bowie High School – BLDG 013

Date: 08/8/2016 - (Rev 1 – 11/17/16 – AISD Construction Dept Comments)

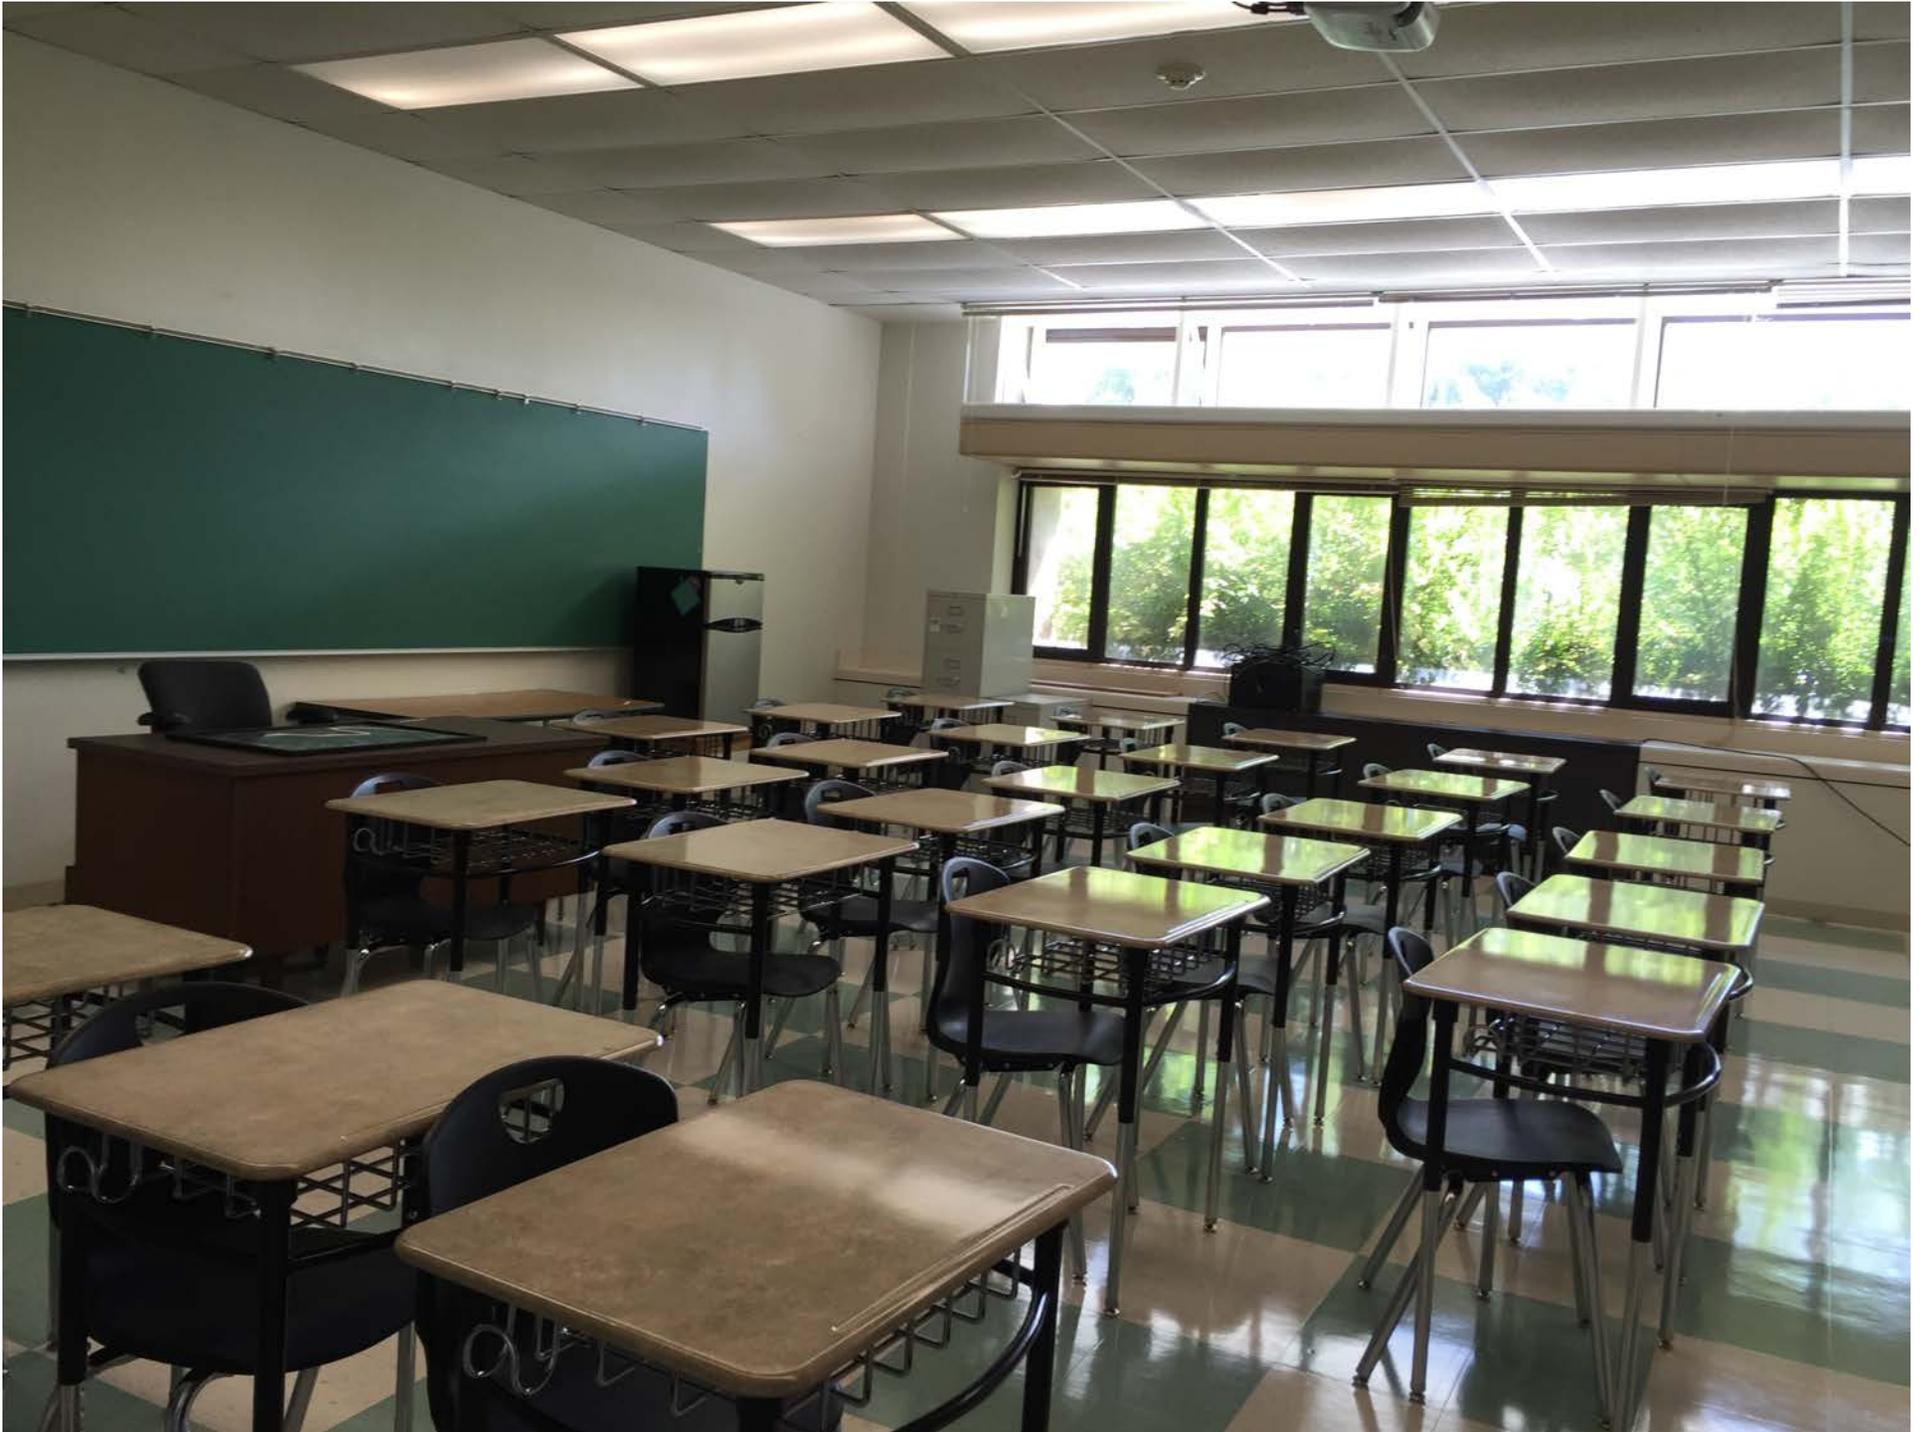
Photo 9.
4.2 Standard Classroom

4.2	Are general classrooms large enough to support project-based learning and multiple teaching modalities?			3				Comments	1.00	3.00
1) Very unsatisfactory -too small to move, set for lecture only, no connectivity, no flexibility 2) Unsatisfactory - adequate size but set for lecture only, no connectivity, no flexibility 3) Neutral - have flexibility and space for hands on or project based learning 4) Satisfactory - have flexibility and space for hands on or project based learning and connectivity for global learning 5) Very Satisfactory - space for hands on learning, flexibility for different groupings, and connectivity for global classrooms N/A) Does not apply.

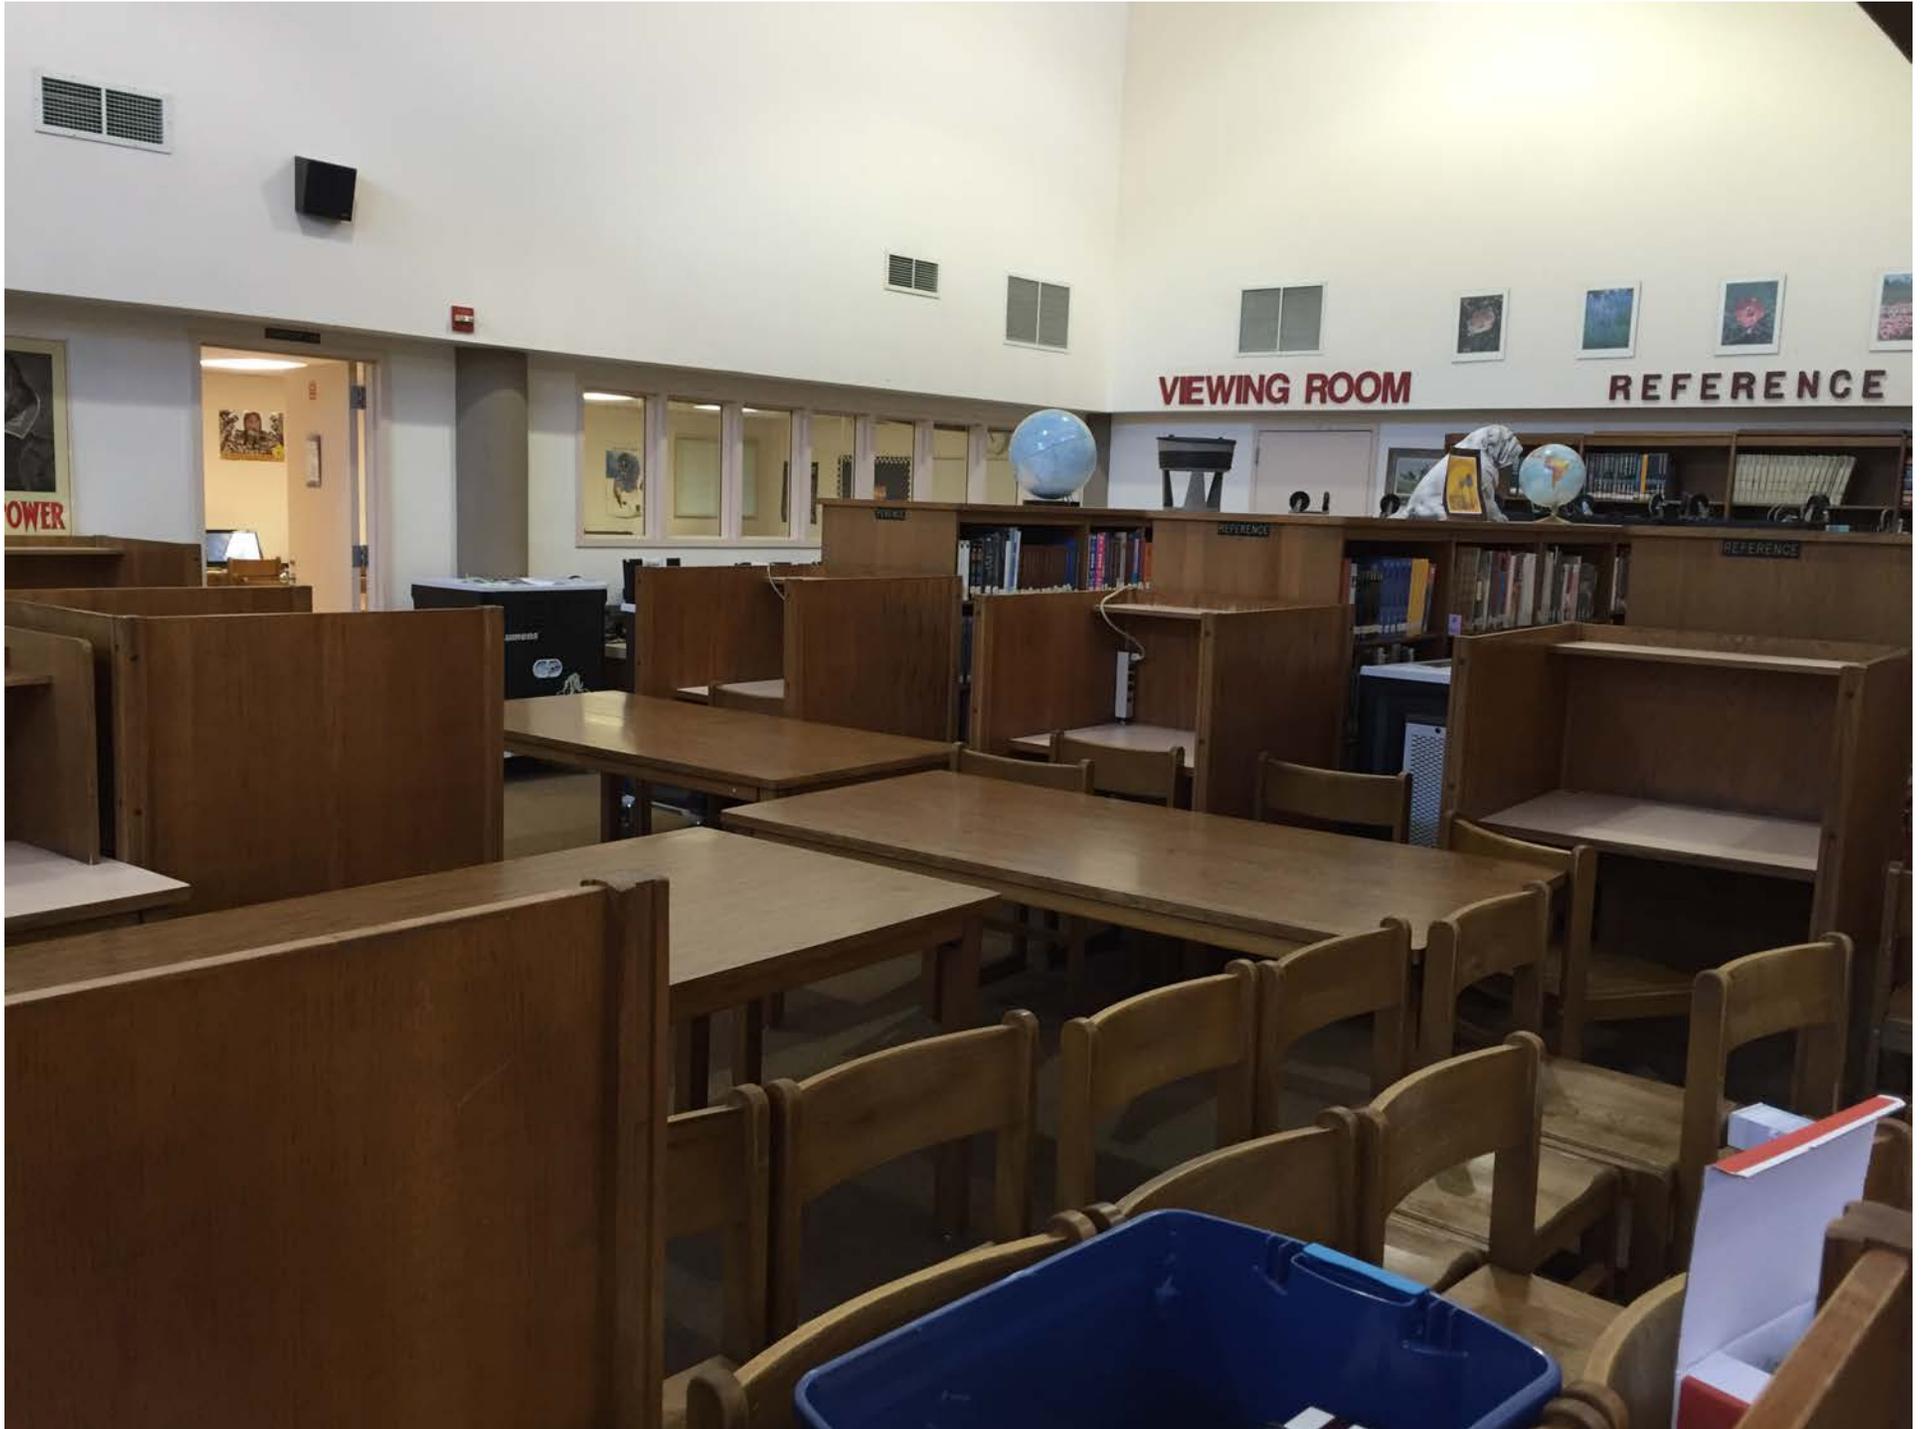
Photo 10.
5.5 Library

5.3	How well does the Library/Media Center support social interaction?			3				Comments	1.00	3.00
1) Very unsatisfactory 2) Unsatisfactory 3) Average 4) Good 5) Very good N/A) Does not apply.								The library is crowded with furniture and there are no break out spaces.		
								see photo 10
