Educational Suitability Summary Report

Crockett High School – BLDG # 008

Date: 08/08/2016 (REV1 – 12/13/2016 – SPED and CAC comments)

Score 57% Average

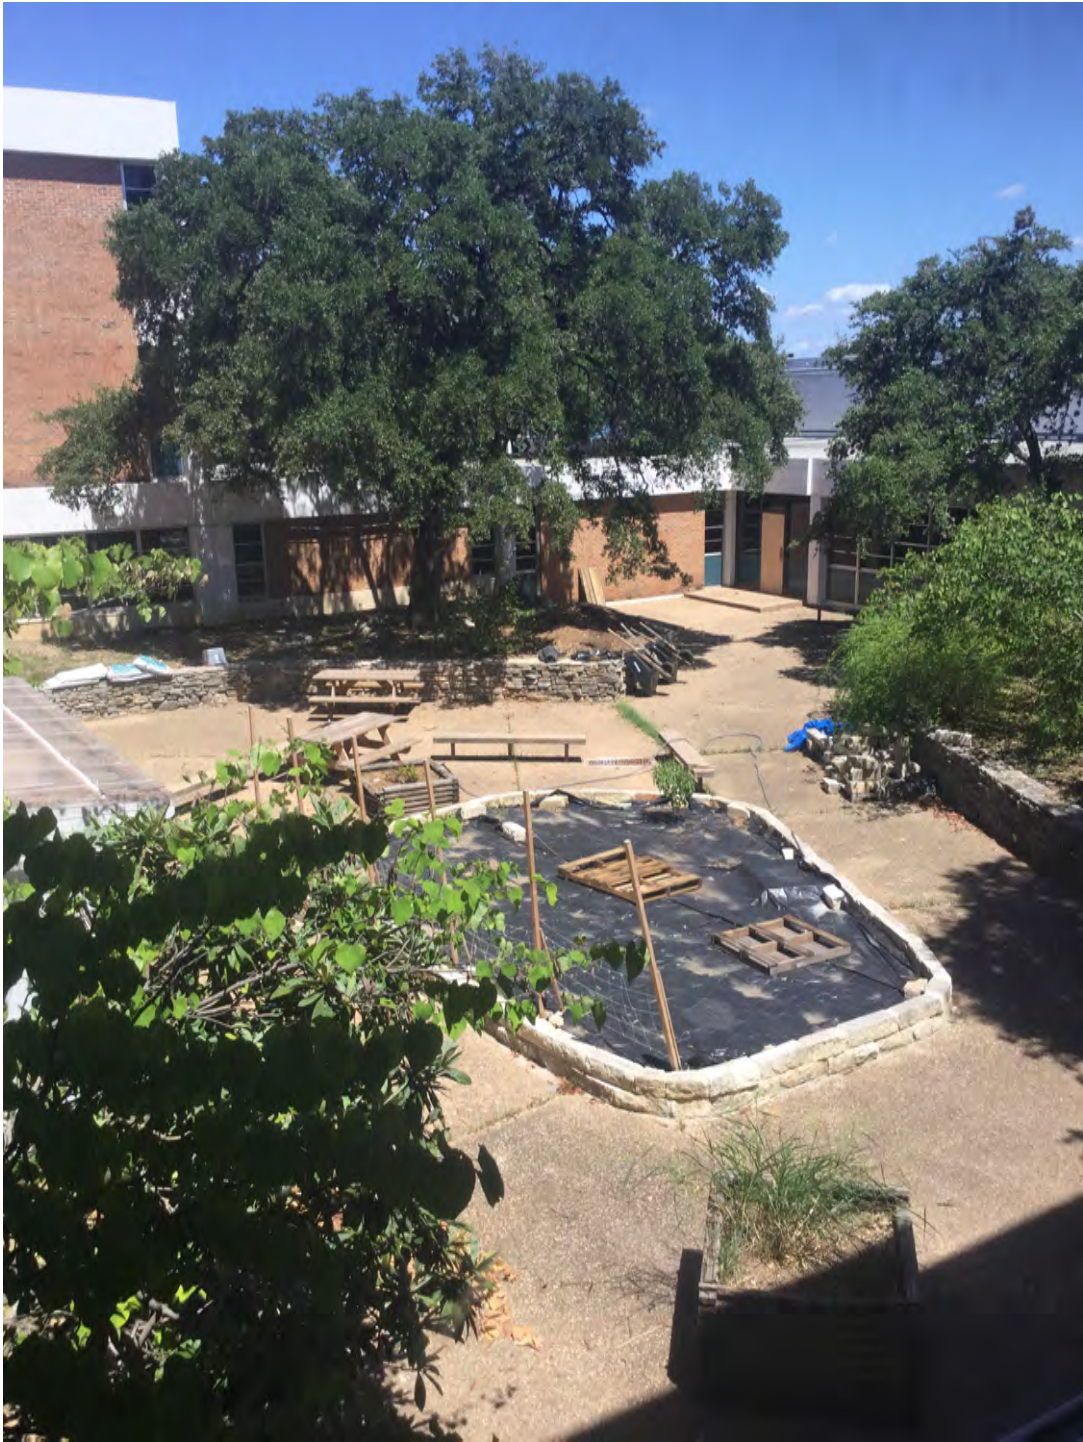
Photo 1. Courtyard garden.

1.2	Are opportunities provided for outdoor learning (outdoor classrooms, gardens, etc.)?				4			Comments	1.00 4.00
	1) Outdoor space exists is not developed 2) Outdoor space for learning exists but not connected to classroom learning areas. 3. Outdoor learning spaces exist and are accessible but not in good condition. 4. Outdoor learning spaces need minor improvements to function well. 5. Outdoor learning spaces are in excellent condition. N/A) Does not apply.							The school has several courtyard spaces that offer pleasant shade and opportunities for outdoor learning spaces. With minor improvements to help facilitate the use as an outdoor classroom (seating, learning gardens, etc.) these existing spaces would function well for this purpose.	
								See Image 1

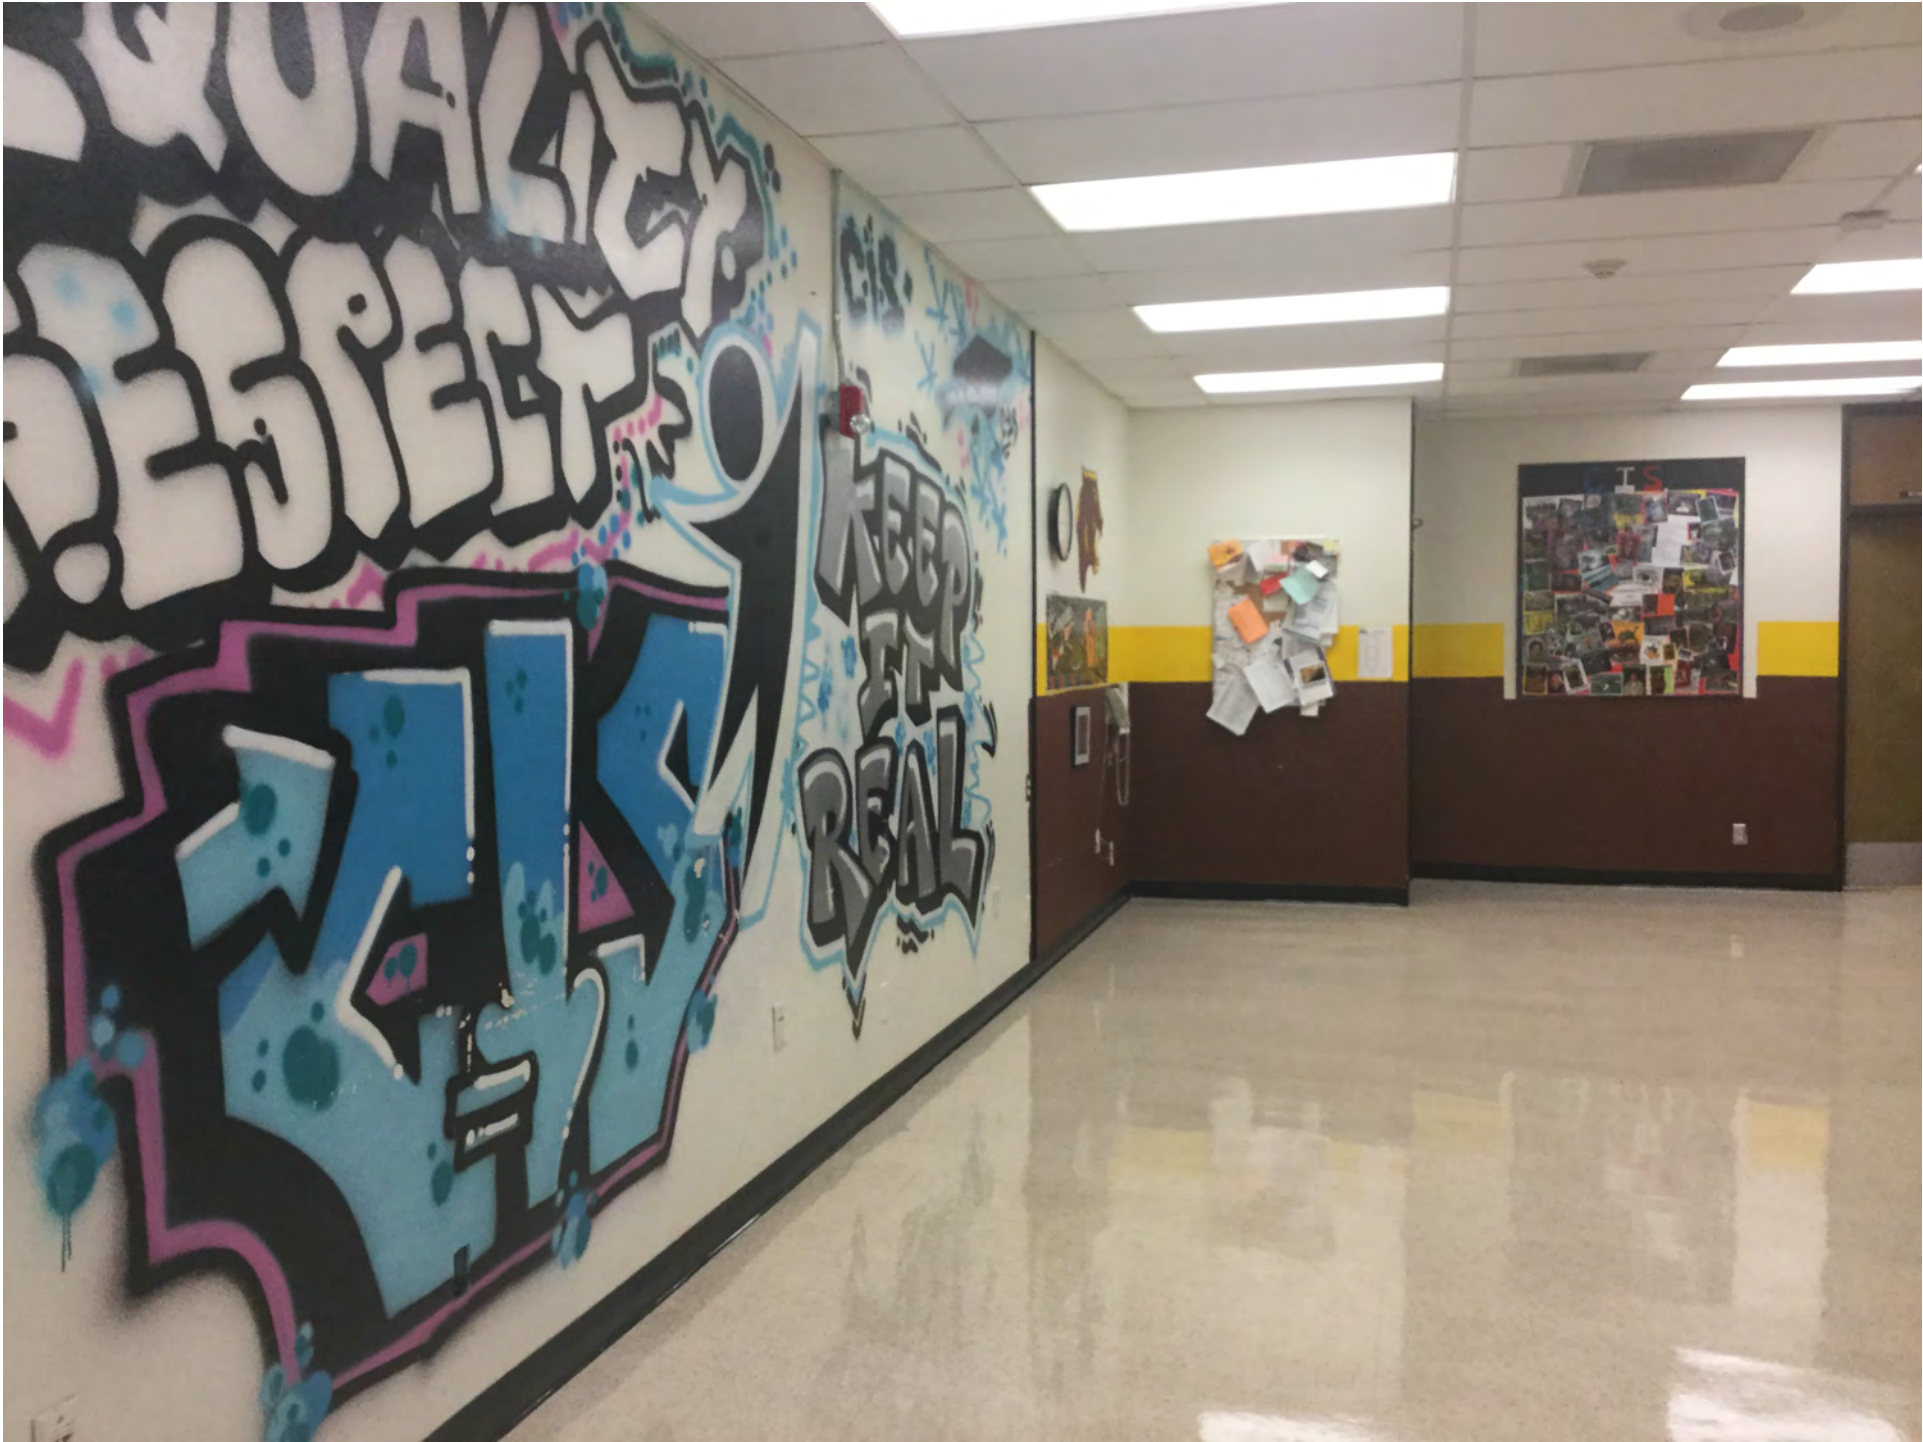
Photo 2. Corridor

1) Primary circulation is 5'-0" to 6'-0" wide. 2) Primary circulation is 6'-0" to 7'-0" wide 3) Primary circulation is 7'-0" to 8'-0" wide 4) Primary circulation is 8'-0"-10'-0" wide 5) Primary circulation is 10'-0"+ wide N/A) Does not apply.								Primary circulation is appropriately sized and well lit.	See Image 2

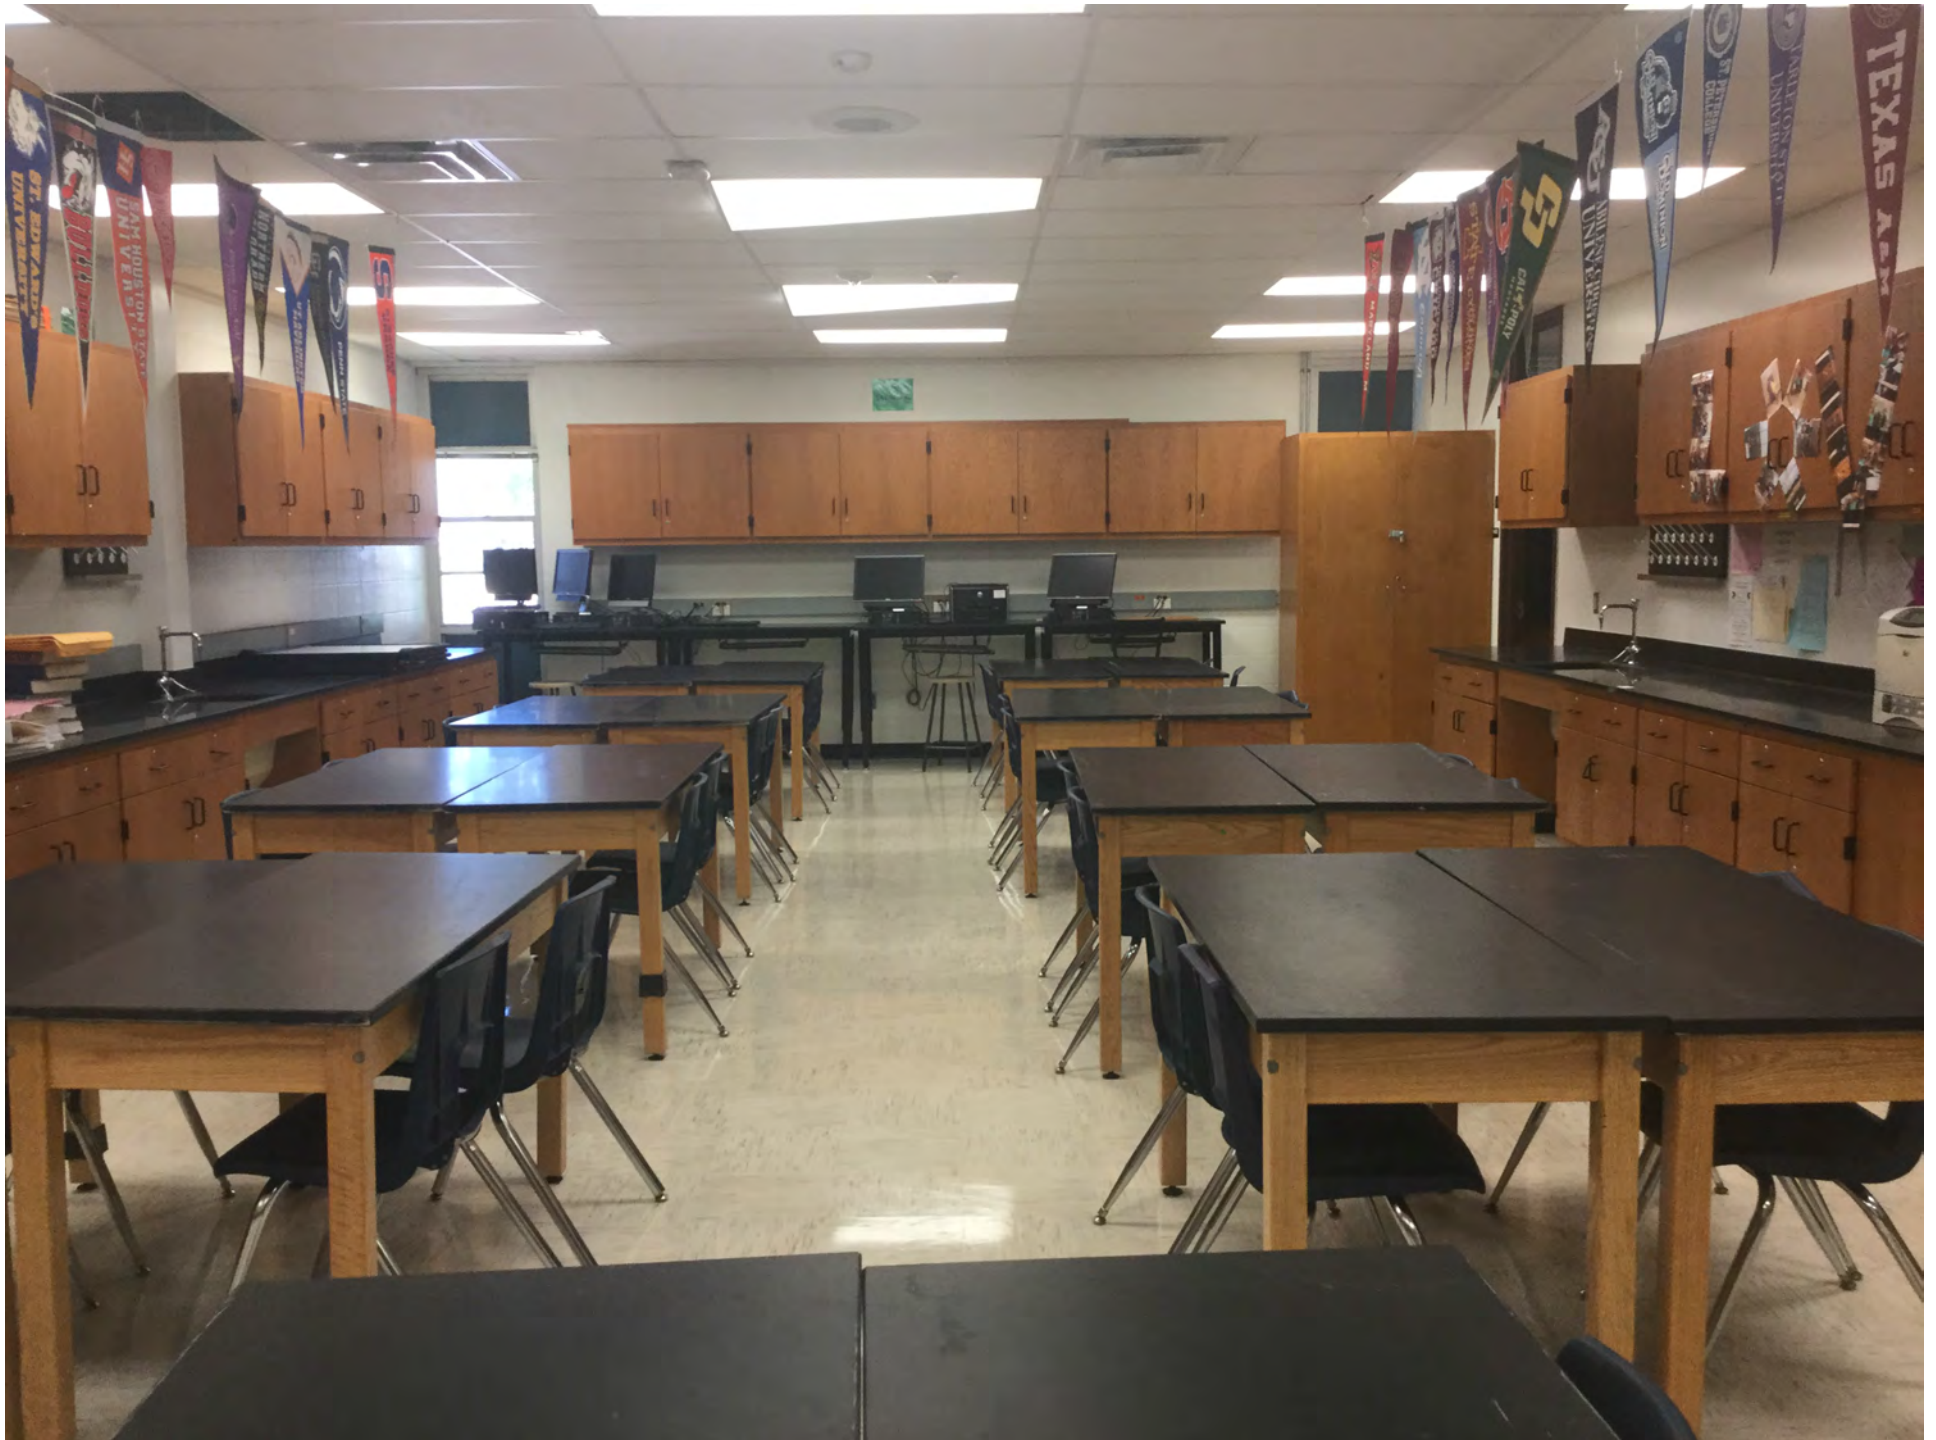
Photo 3. Science lab

3.4	Are Science Classrooms/Labs appropriately configured per the ed spec?			3				Comments	1.00 3.00
1) Very unsatisfactory 2) Unsatisfactory 3) Neutral 4) Satisfactory 5) Very Satisfactory N/A) Does not apply. (Elementary schools)									There are a mix of lab spaces with varying qualities. Chemistry labs are reportedly appropriate in size, configuration, and quality of equipment. The biology labs, however, are reportedly dated, have dated, inflexible furniture, and are subject to various leaks and rodent problems.
									See Image 3

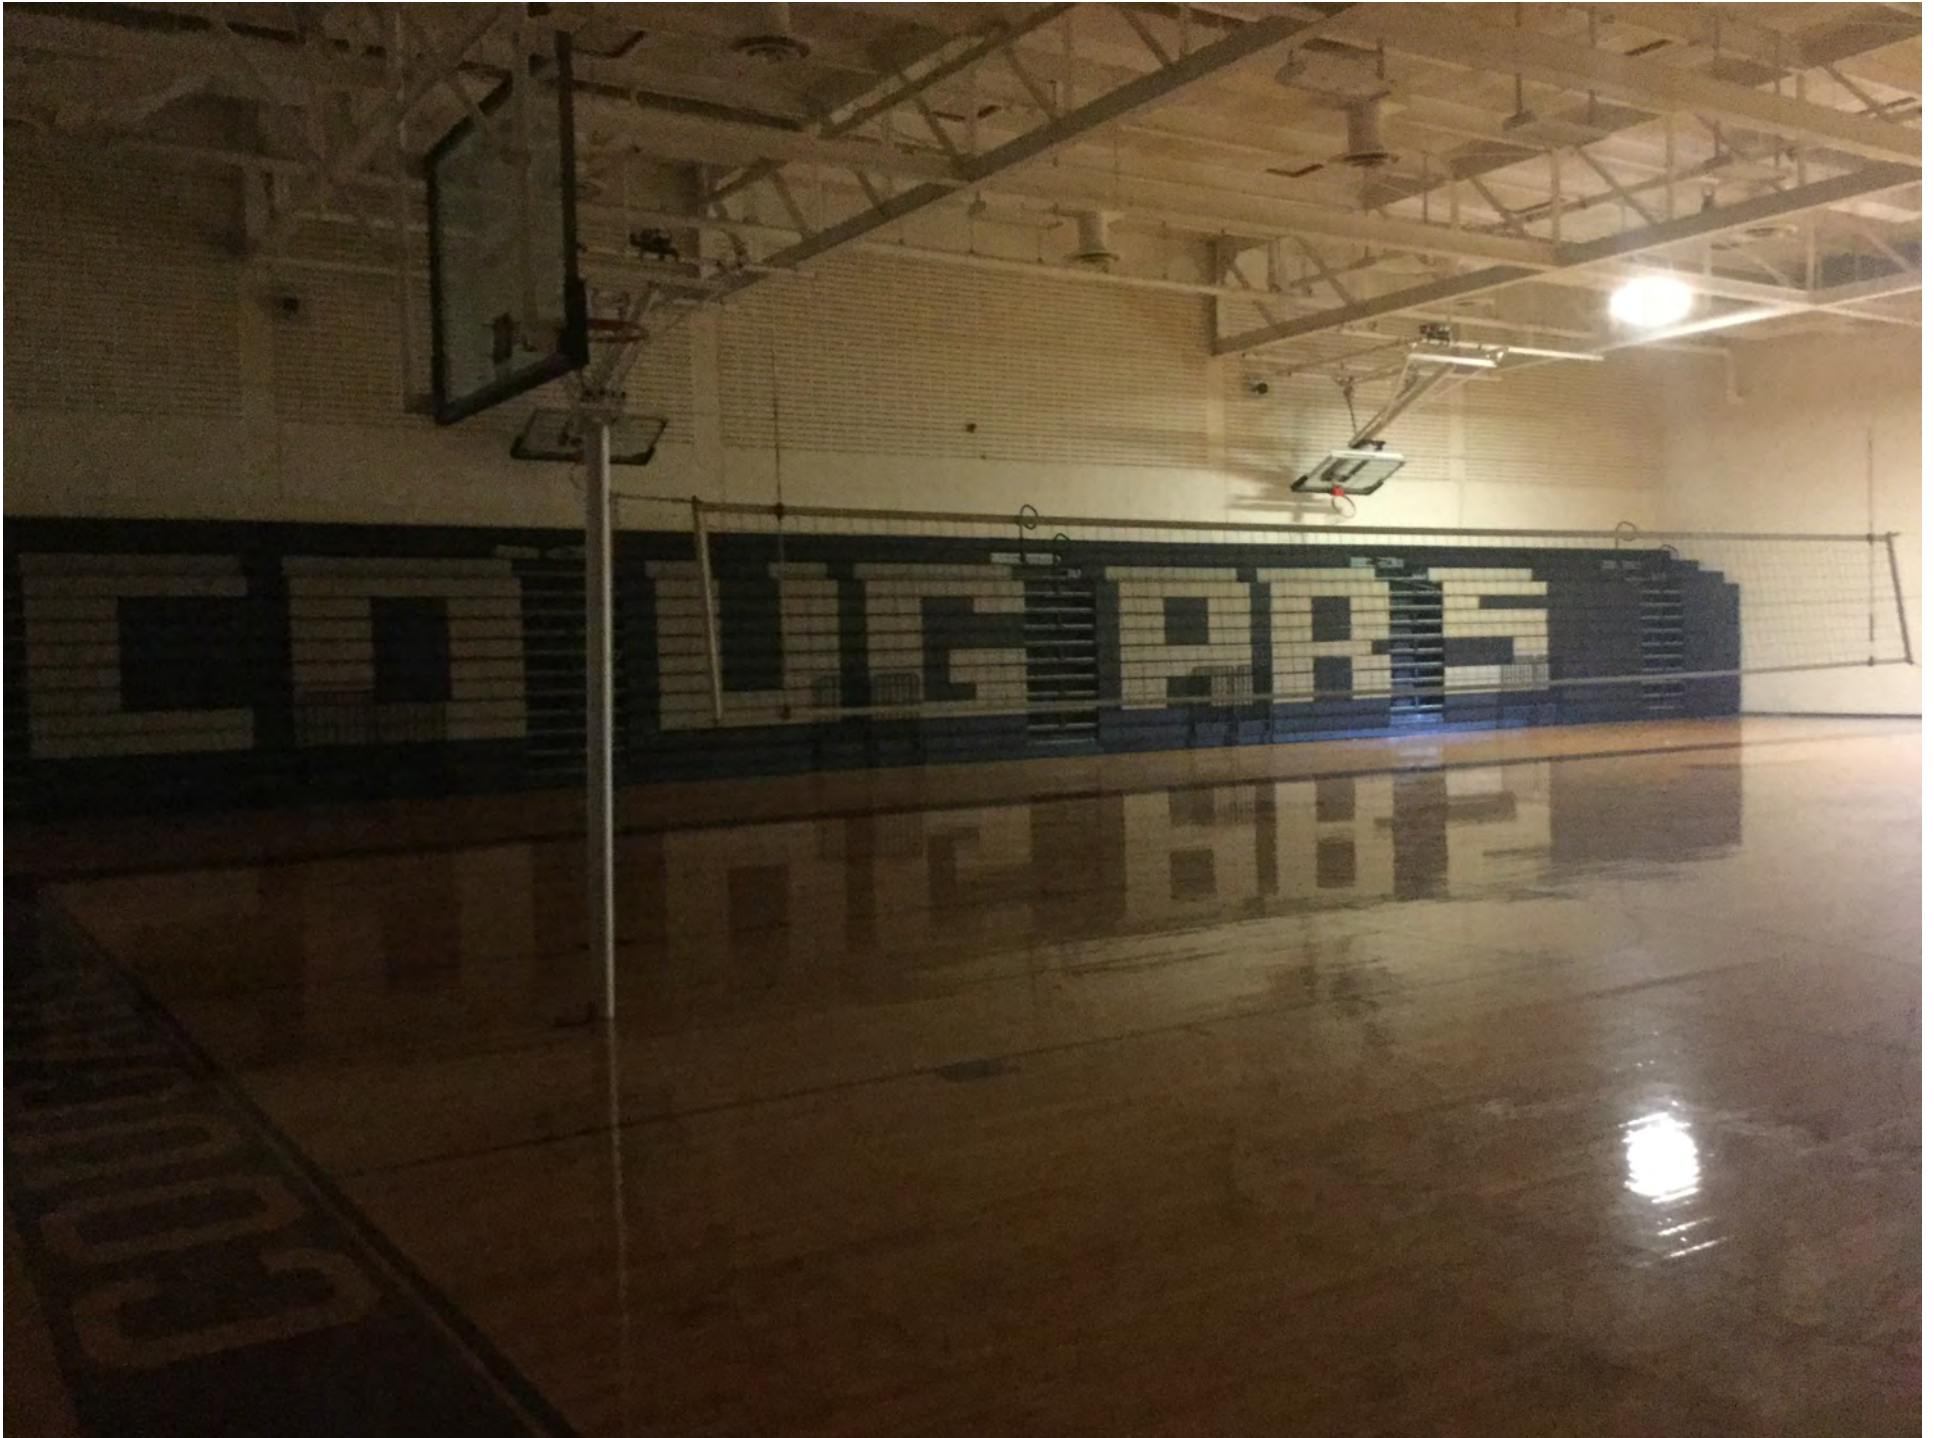
Photo 4. Gym

1) Very unsatisfactory 2) Unsatisfactory 3) Average 4) Good 5) Very good N/A) Does not apply.								The principal reports that the gyms are currently being renovated. The bleachers are in good shape, the gym equipment appears aged, but adequate, and the student capacity is undersized when compared to the current population.	See Image 4

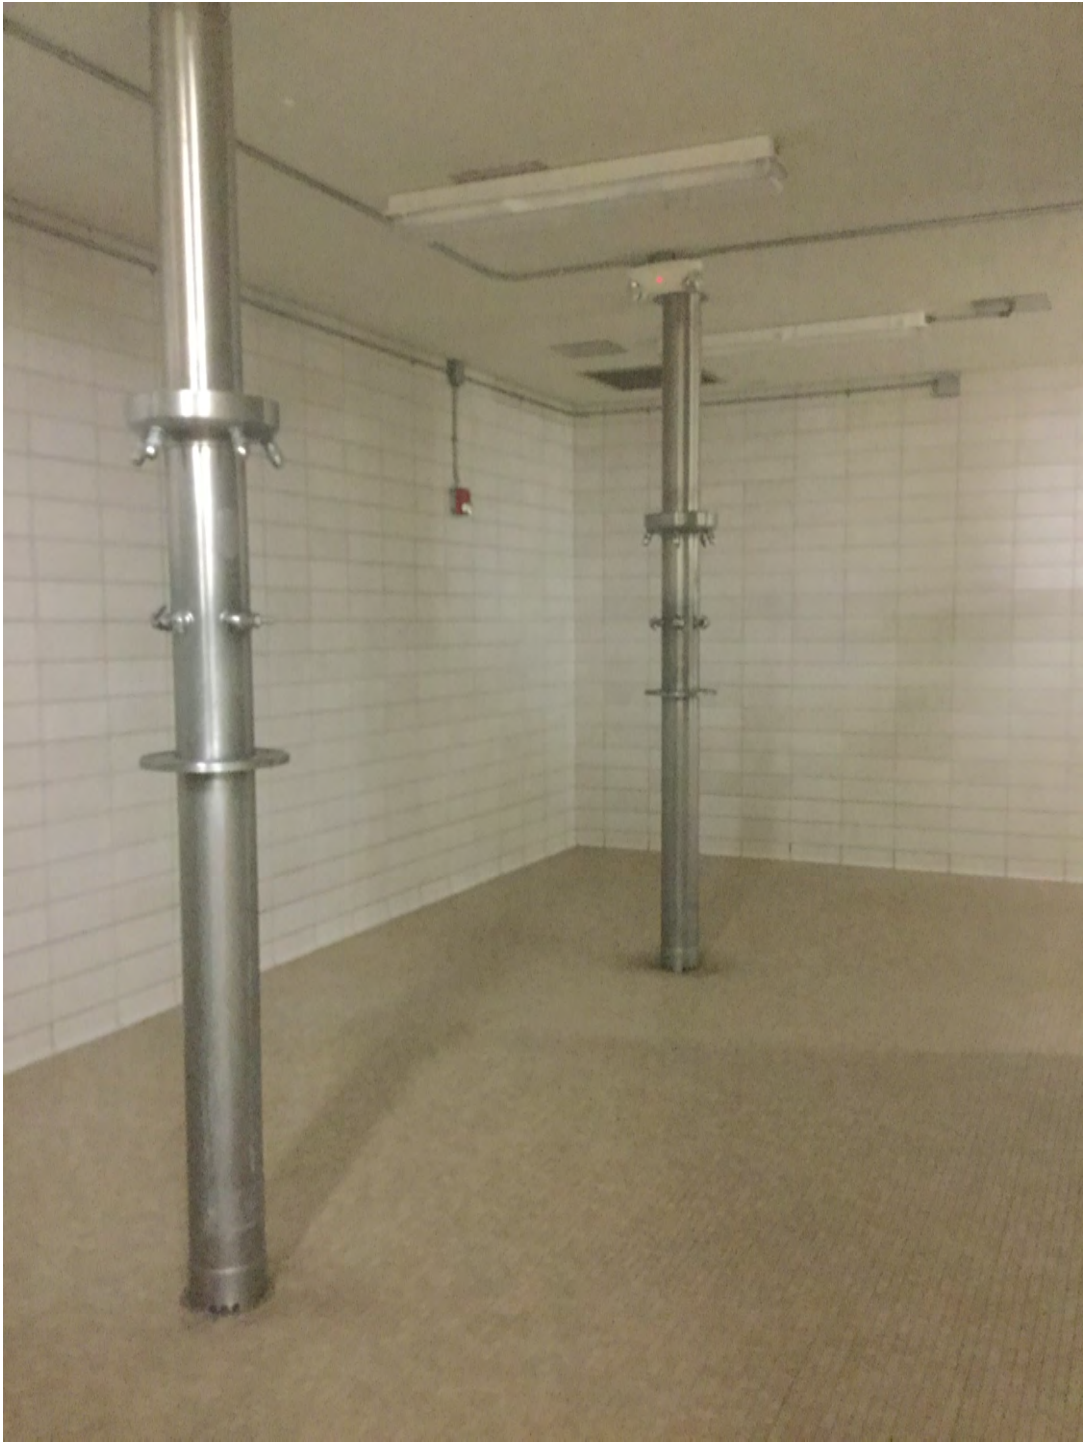
Photo 5. Locker room shower

3.7	Are Physical Education and Athletic support spaces appropriately configured per the ed spec?		2					Comments	1.00 2.00
1) Very unsatisfactory - Support spaces are disconnected from served spaces, too small, do not meet needs 2) Unsatisfactory - Support spaces are connected, but too small, inadequate for needs 3) Average - Connected, moderate size, but need some renovations or updates to function well 4) Good - Connected, good size/layout, meets needs/functions well 5) Very good - connected, generous size, nice condition, functions appropriately N/A) Does not apply.								The locker rooms are aged and pose several ADA compliance issues (i.e. raised tile lips compartmentalizing showers from restrooms and from locker areas, etc.). Additionally, toilets and showers are not fully compliant. The capacity of the locker rooms is undersized given the program's current student enrollment. The training room is reportedly "very undersized" when compared against this population. Equipment quantity and condition is a concern for all training equipment. The weight room is currently being renovated.	See image 5

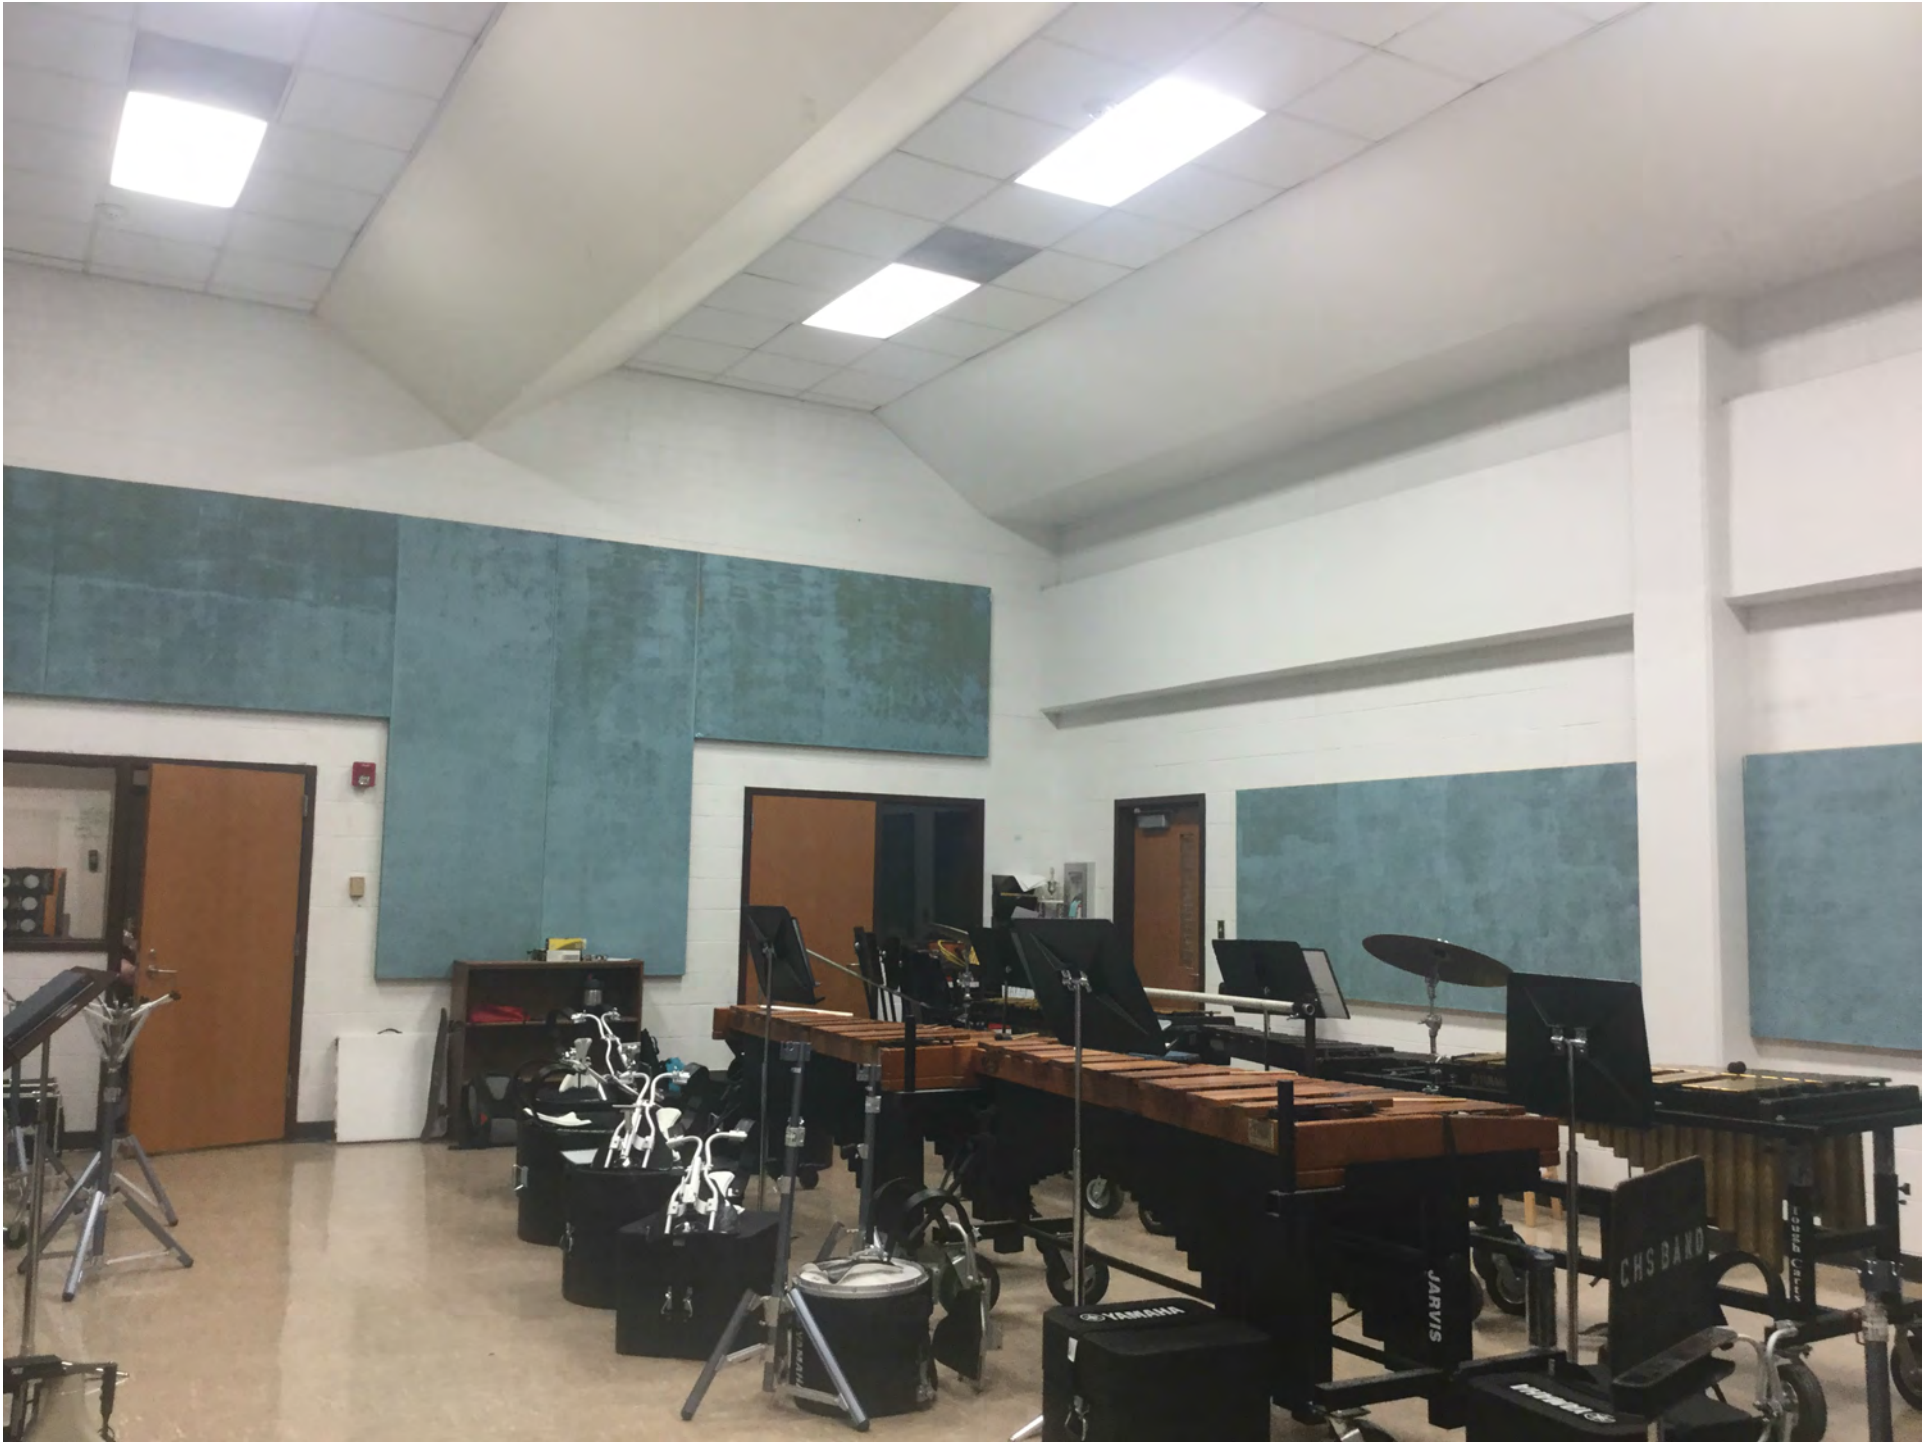
Photo 6. Band Hall

3.8	Are music, drama, or performance spaces appropriately configured per the ed spec?	1						Comments	1.00 1.00
1) Very unsatisfactory 2) Unsatisfactory 3) Average 4) Good 5) Very good N/A) Does not apply.								The band halls are aged, in poor condition, and undersized given the current program enrollment. Everything from acoustic performance to artificial lighting levels are problematic in these areas.	See Image 6

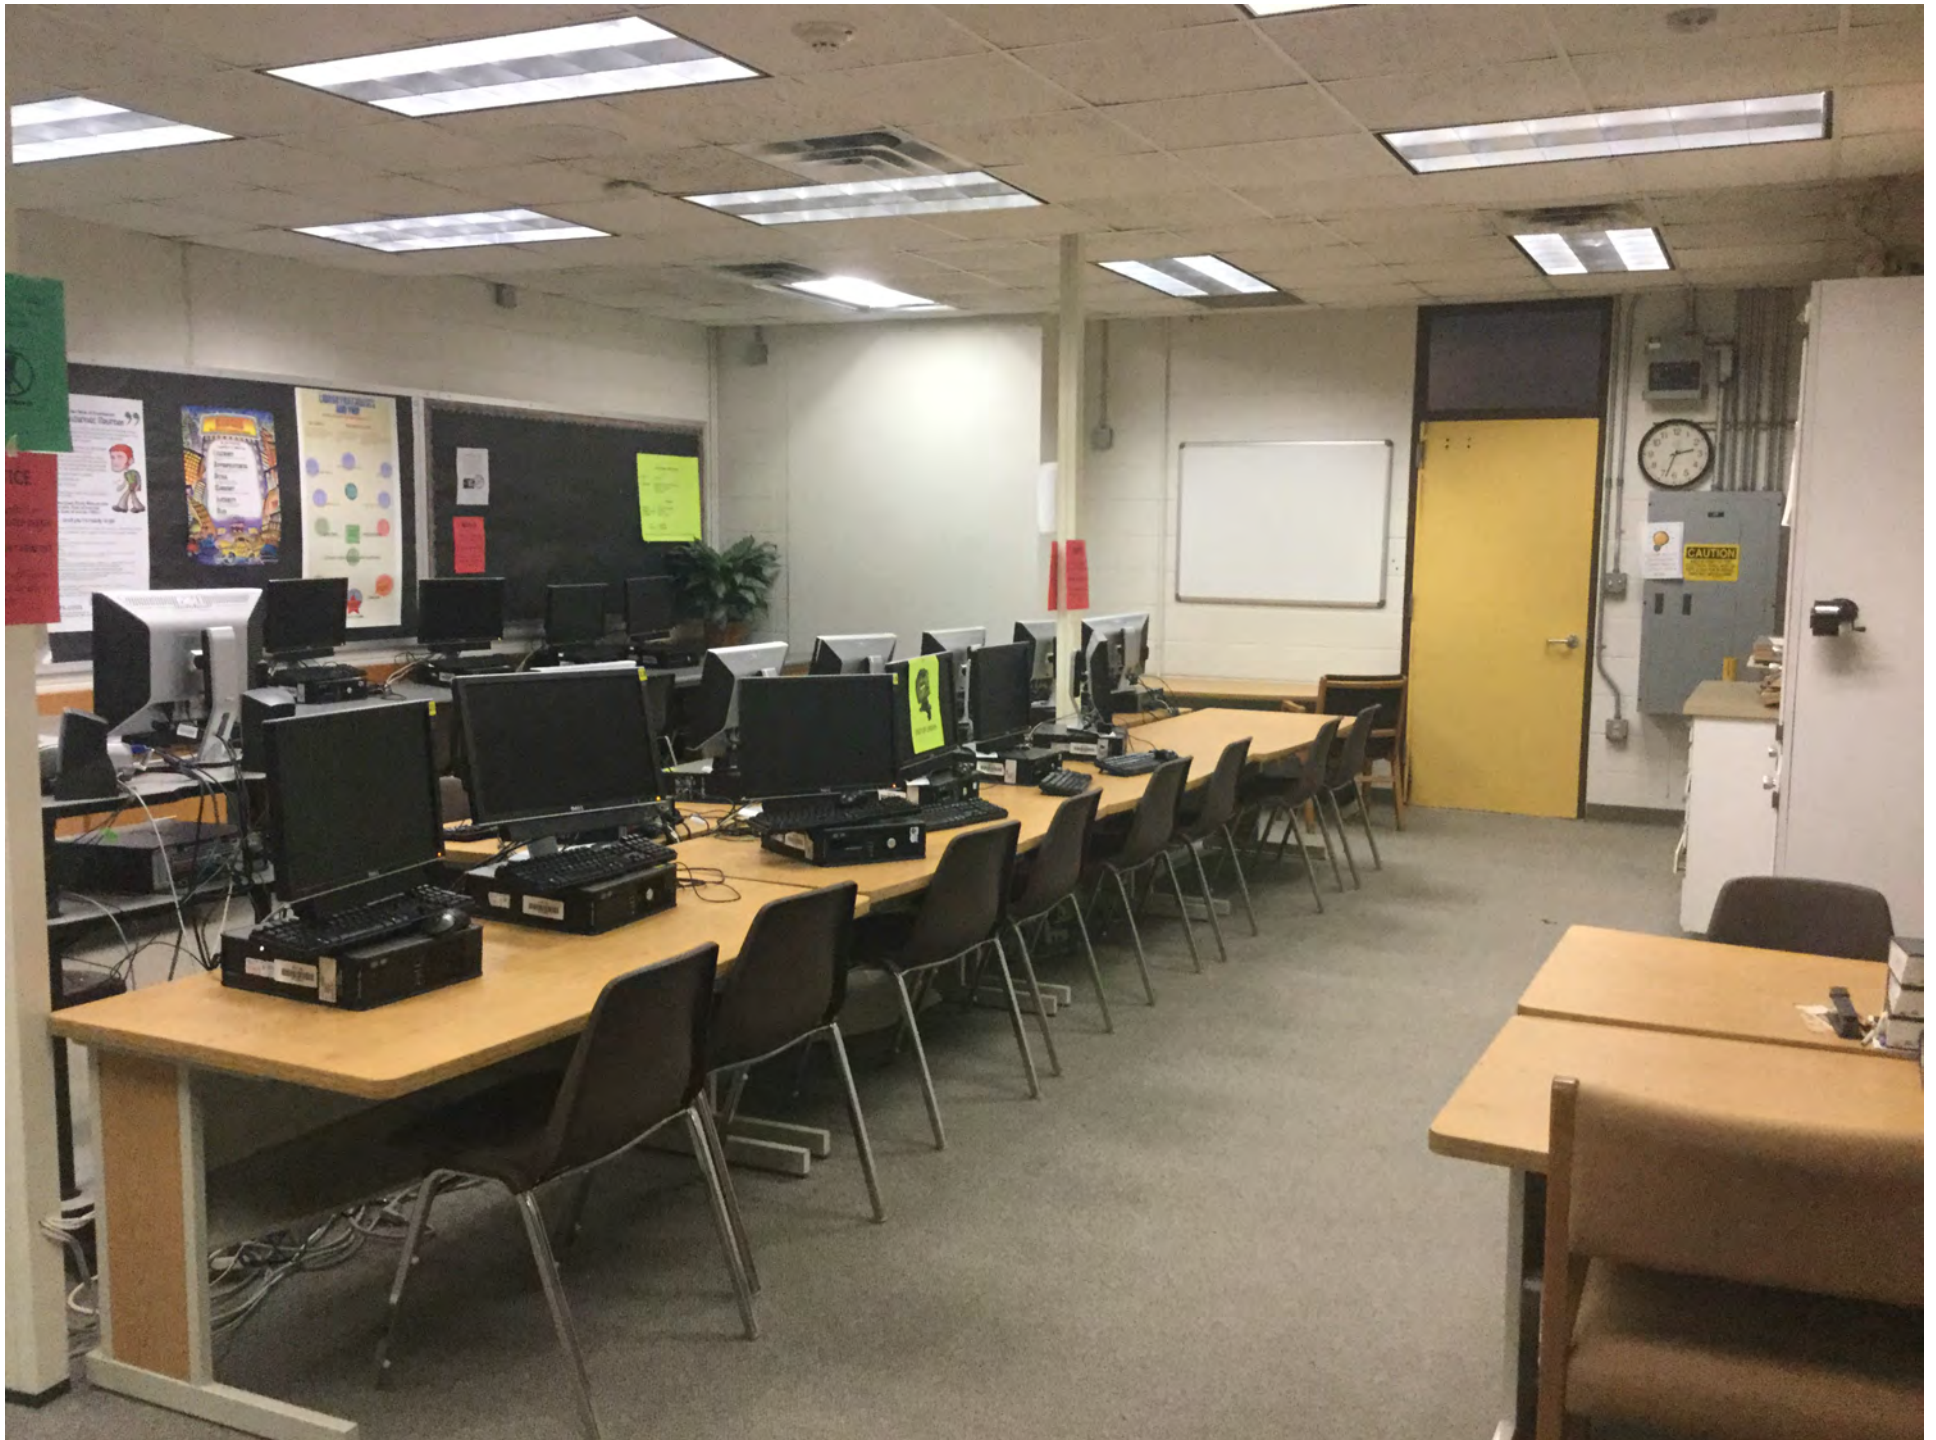
Photo 7. Computer lab

3.12	Are computer lab spaces appropriately configured?		2							Comments		1.00	2.00				
1) Very unsatisfactory 2) Unsatisfactory 3) Average 4) Good 5) Very good N/A) Does not apply.										Computer tech is currently housed in standard classrooms. A computer lab is being repurposed as a makeshift maker space, so an additional computer lab is required. Current computer labs suffer from too few power outlets. Computer equipment varies across the campus, but appears to be adequate in most cases. The principal reports many computers not being new enough to run required programs for CTE curriculum.							
See Image 7

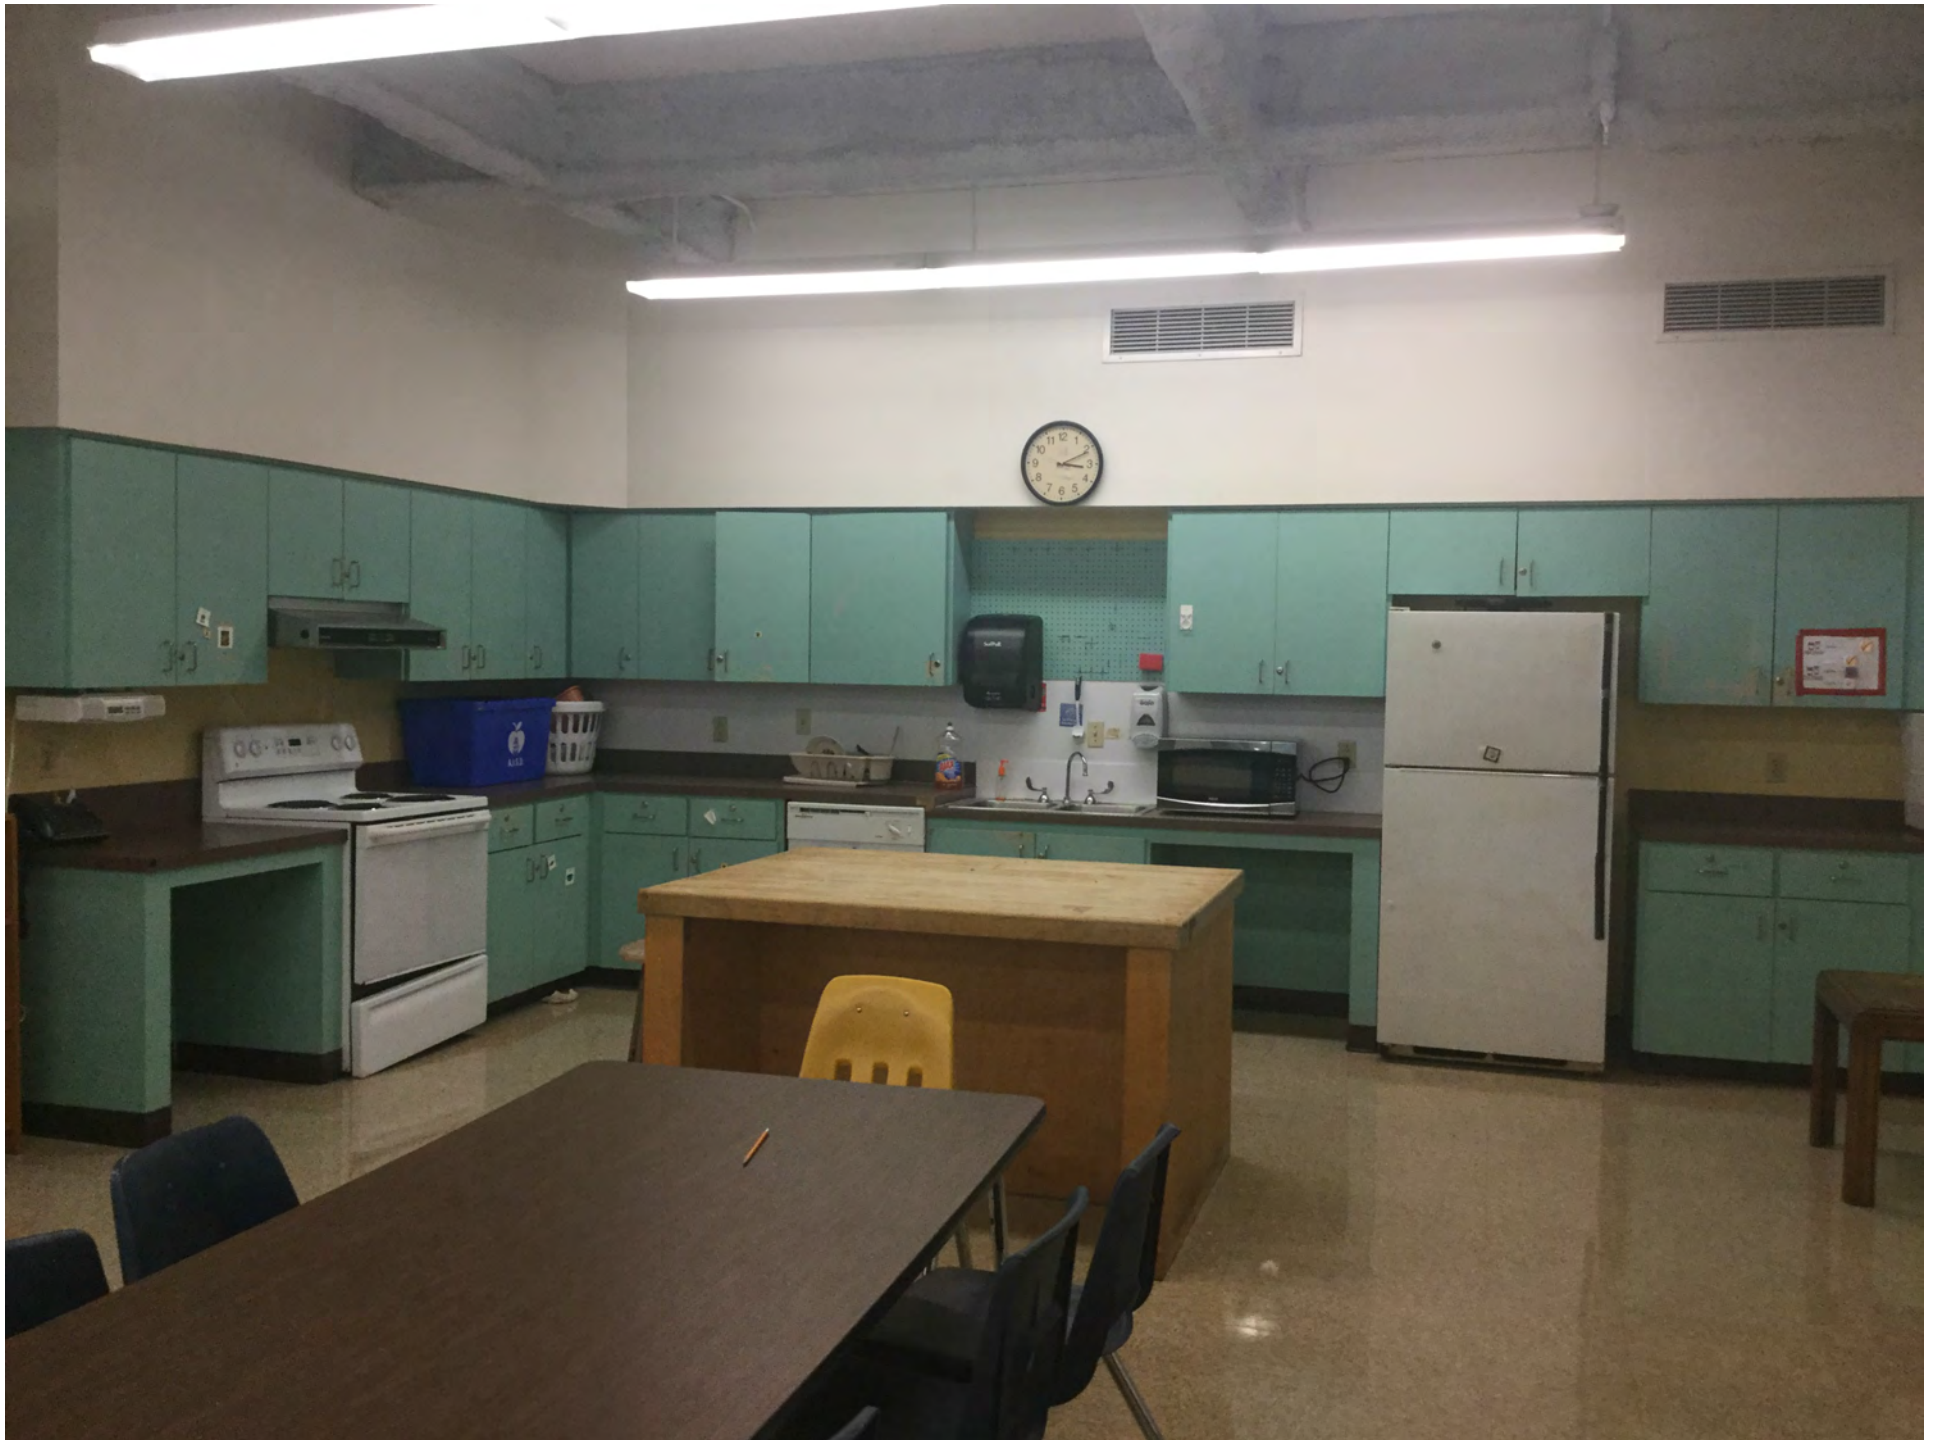
Photo 8. Special Education Classroom

1) Very unsatisfactory 2) Unsatisfactory 3) Average 4) Good 5) Very good N/A) Does not apply.						While the special education space is adequately sized, it is very aged and requires cosmetic maintenance. It is located far from the main office and school entrance. Additionally, the space has a primary entrance that is accessed from the exterior of the building, without cover. <i>SPED Dept Comment: Far from the entry is not an issue. The campus needs another classroom for SCORES (2 units - 21 kids - currently share) Resource classrooms are adequate. One LS room has lost floorspace due to wheelchair ramp.</i>				
						Score has been lowered from 4 to 3 to reflect condition						See Image 8
