Educational Suitability Summary Report

Crockett High School – BLDG # 008

Date: 08/08/2016 (REV1 – 12/13/2016 – SPED and CAC comments)

Score 57% Average

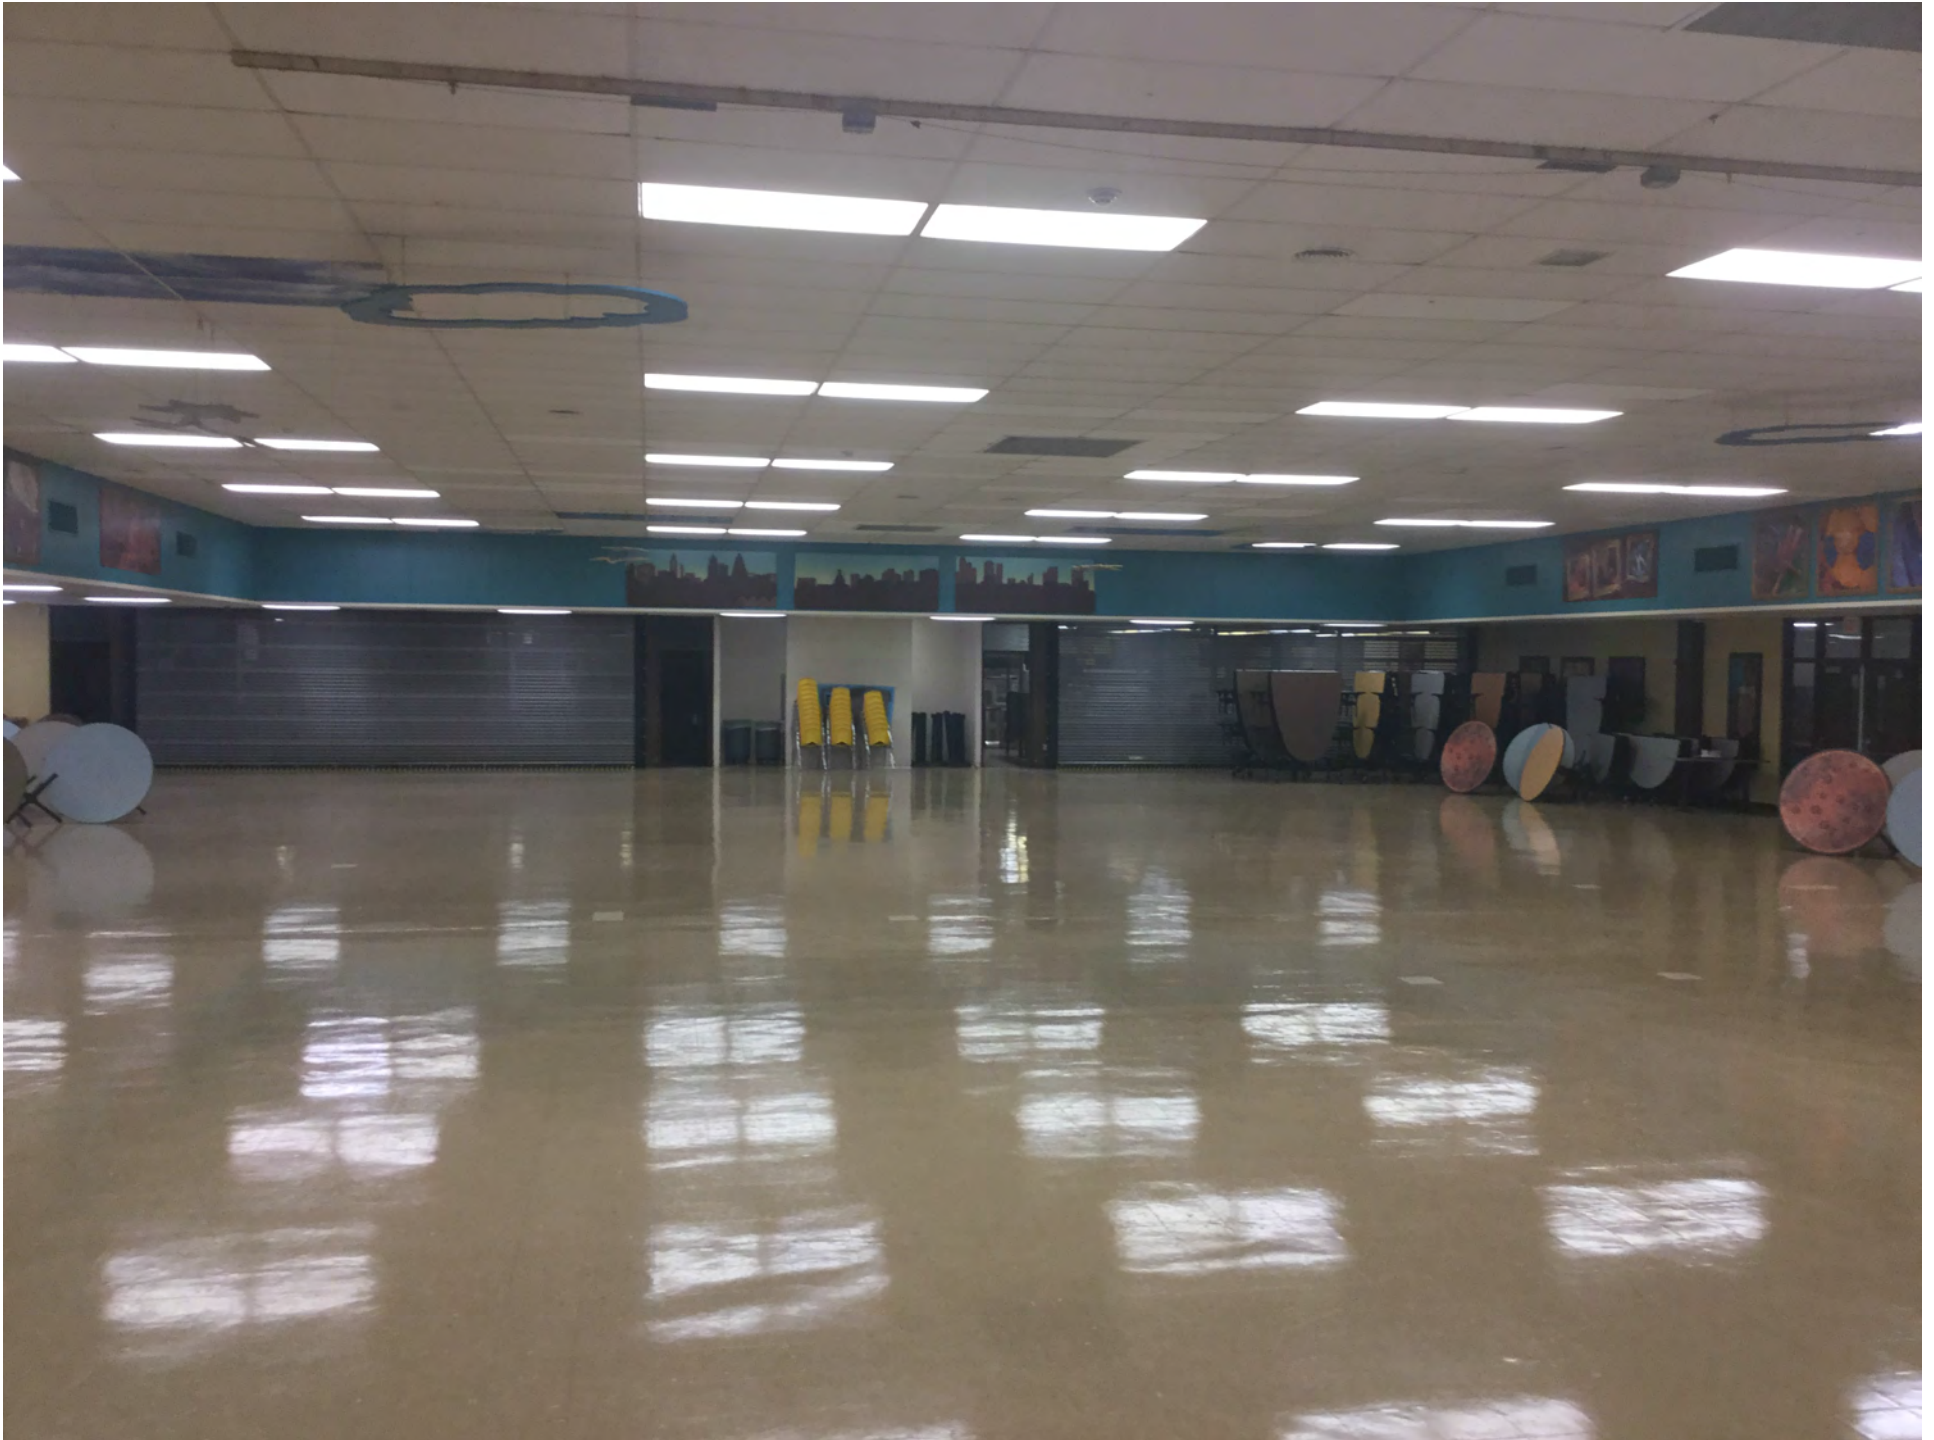
Photo 9. Cafeteria

1) Very unsatisfactory - Too small, poor circulation, inflexible seating in poor condition 2) Unsatisfactory - Too small or inadequate circulation, seating in poor condition 3) Average - moderate size, with adequate circulation, seating in okay condition 4) Good - good size, adequate circulation, seating in good condition 5) Very good - good size, adequate circulation, seating in good condition, with more than one option for eating space (ex: connection to outdoor eating space) N/A) Does not apply.						The cafeteria is currently undersized given the student population. While seating types vary, the number of seats are too few to satisfy student demand. Additional serving lines are necessary to handle the volume of students being processed during lunch and to offer new, more healthy food options.				
												See Image 9

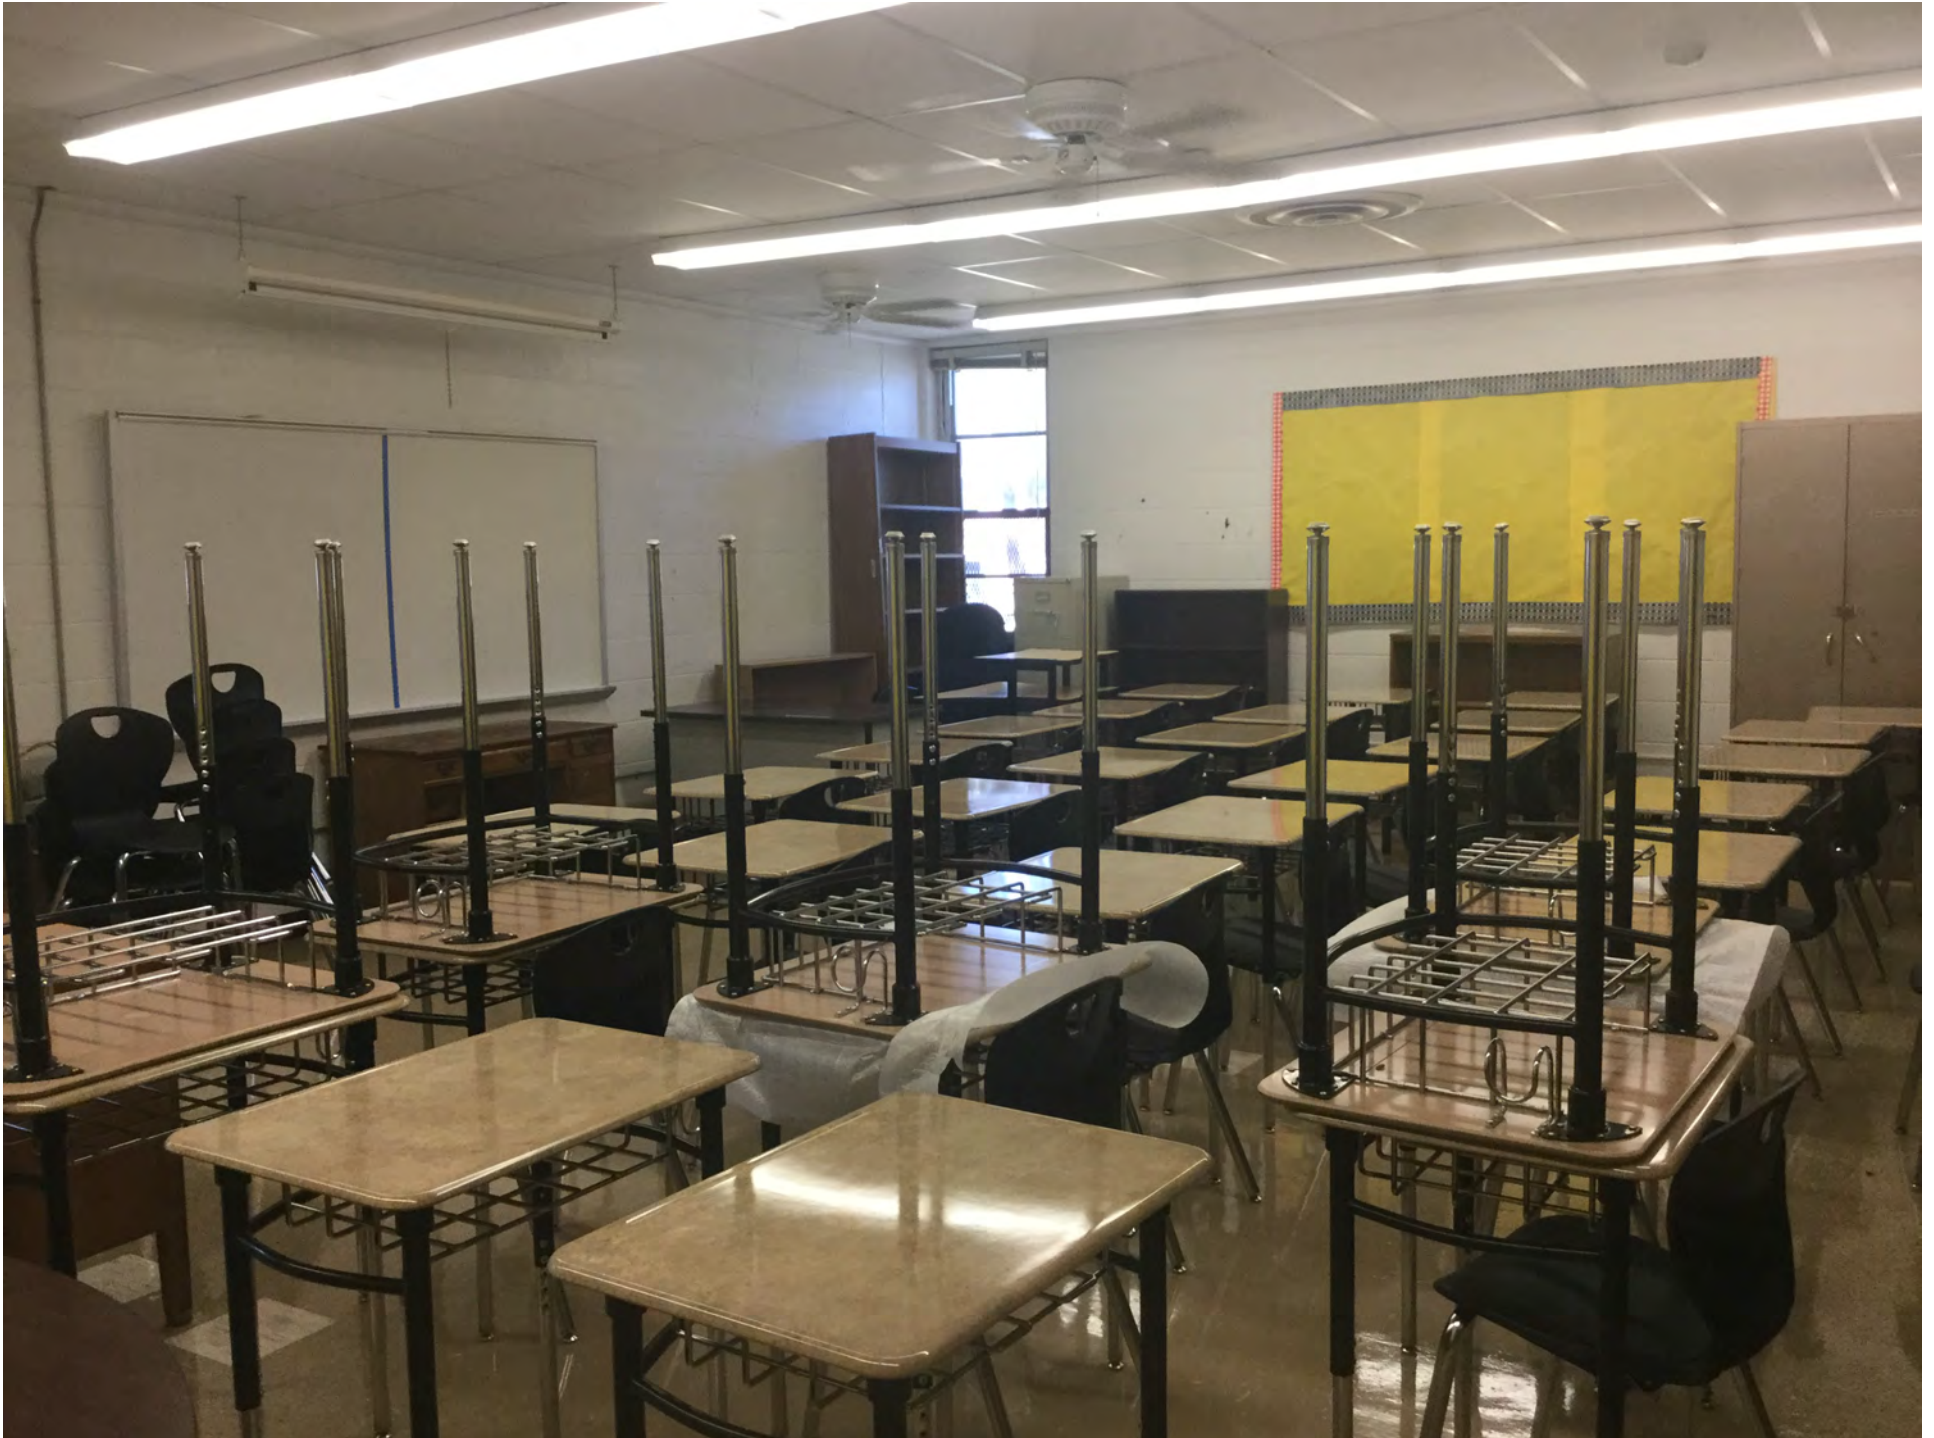
Photo 10. Classroom

4.2	Are general classrooms large enough to support project-based learning and multiple teaching modalities?			3				Comments	1.00 3.00
1) Very unsatisfactory -too small to move, set for lecture only, no connectivity, no flexibility 2) Unsatisfactory - adequate size but set for lecture only, no connectivity, no flexibility 3) Neutral - have flexibility and space for hands on or project based learning 4) Satisfactory - have flexibility and space for hands on or project based learning and connectivity for global learning 5) Very Satisfactory - space for hands on learning, flexibility for different groupings, and connectivity for global classrooms N/A) Does not apply.								General classroom spaces vary throughout the school. A mix of appropriately sized and undersized spaces are present.	
								See Image 10

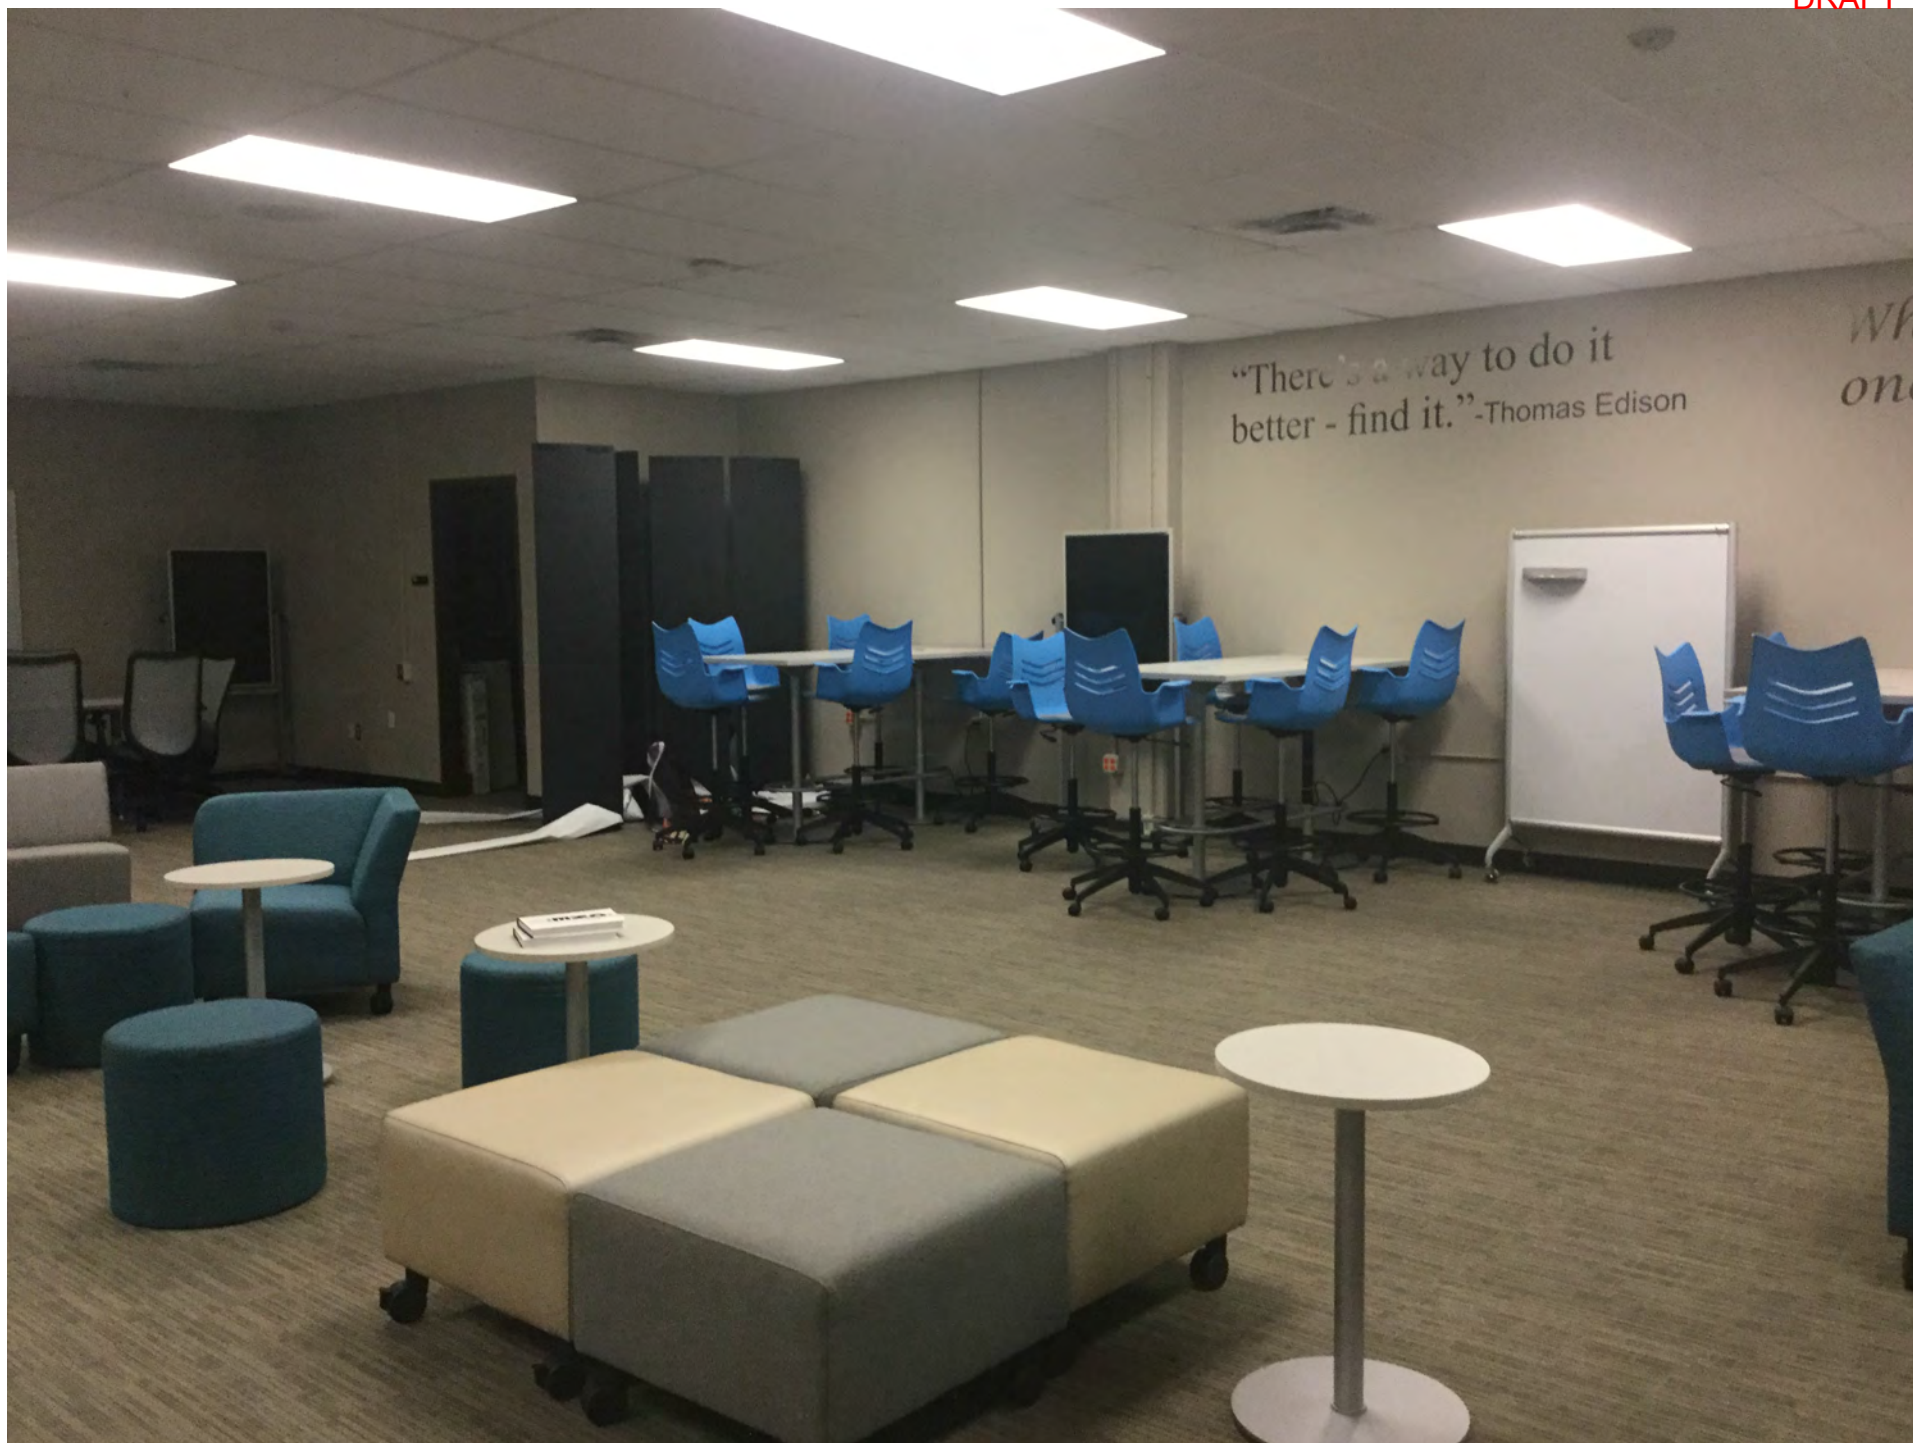
Photo 11. Student lounge

1) Very unsatisfactory - no common spaces or meeting rooms or in very poor condition 2) Unsatisfactory - a few common spaces or meeting rooms in unsatisfactory condition 3) Average - a few common spaces and meeting areas needing updates 4) Good - multiple common spaces and meeting rooms in good condition 5) Very good - adequate common spaces and meeting rooms of excellent quality N/A) Does not apply.								See image 11

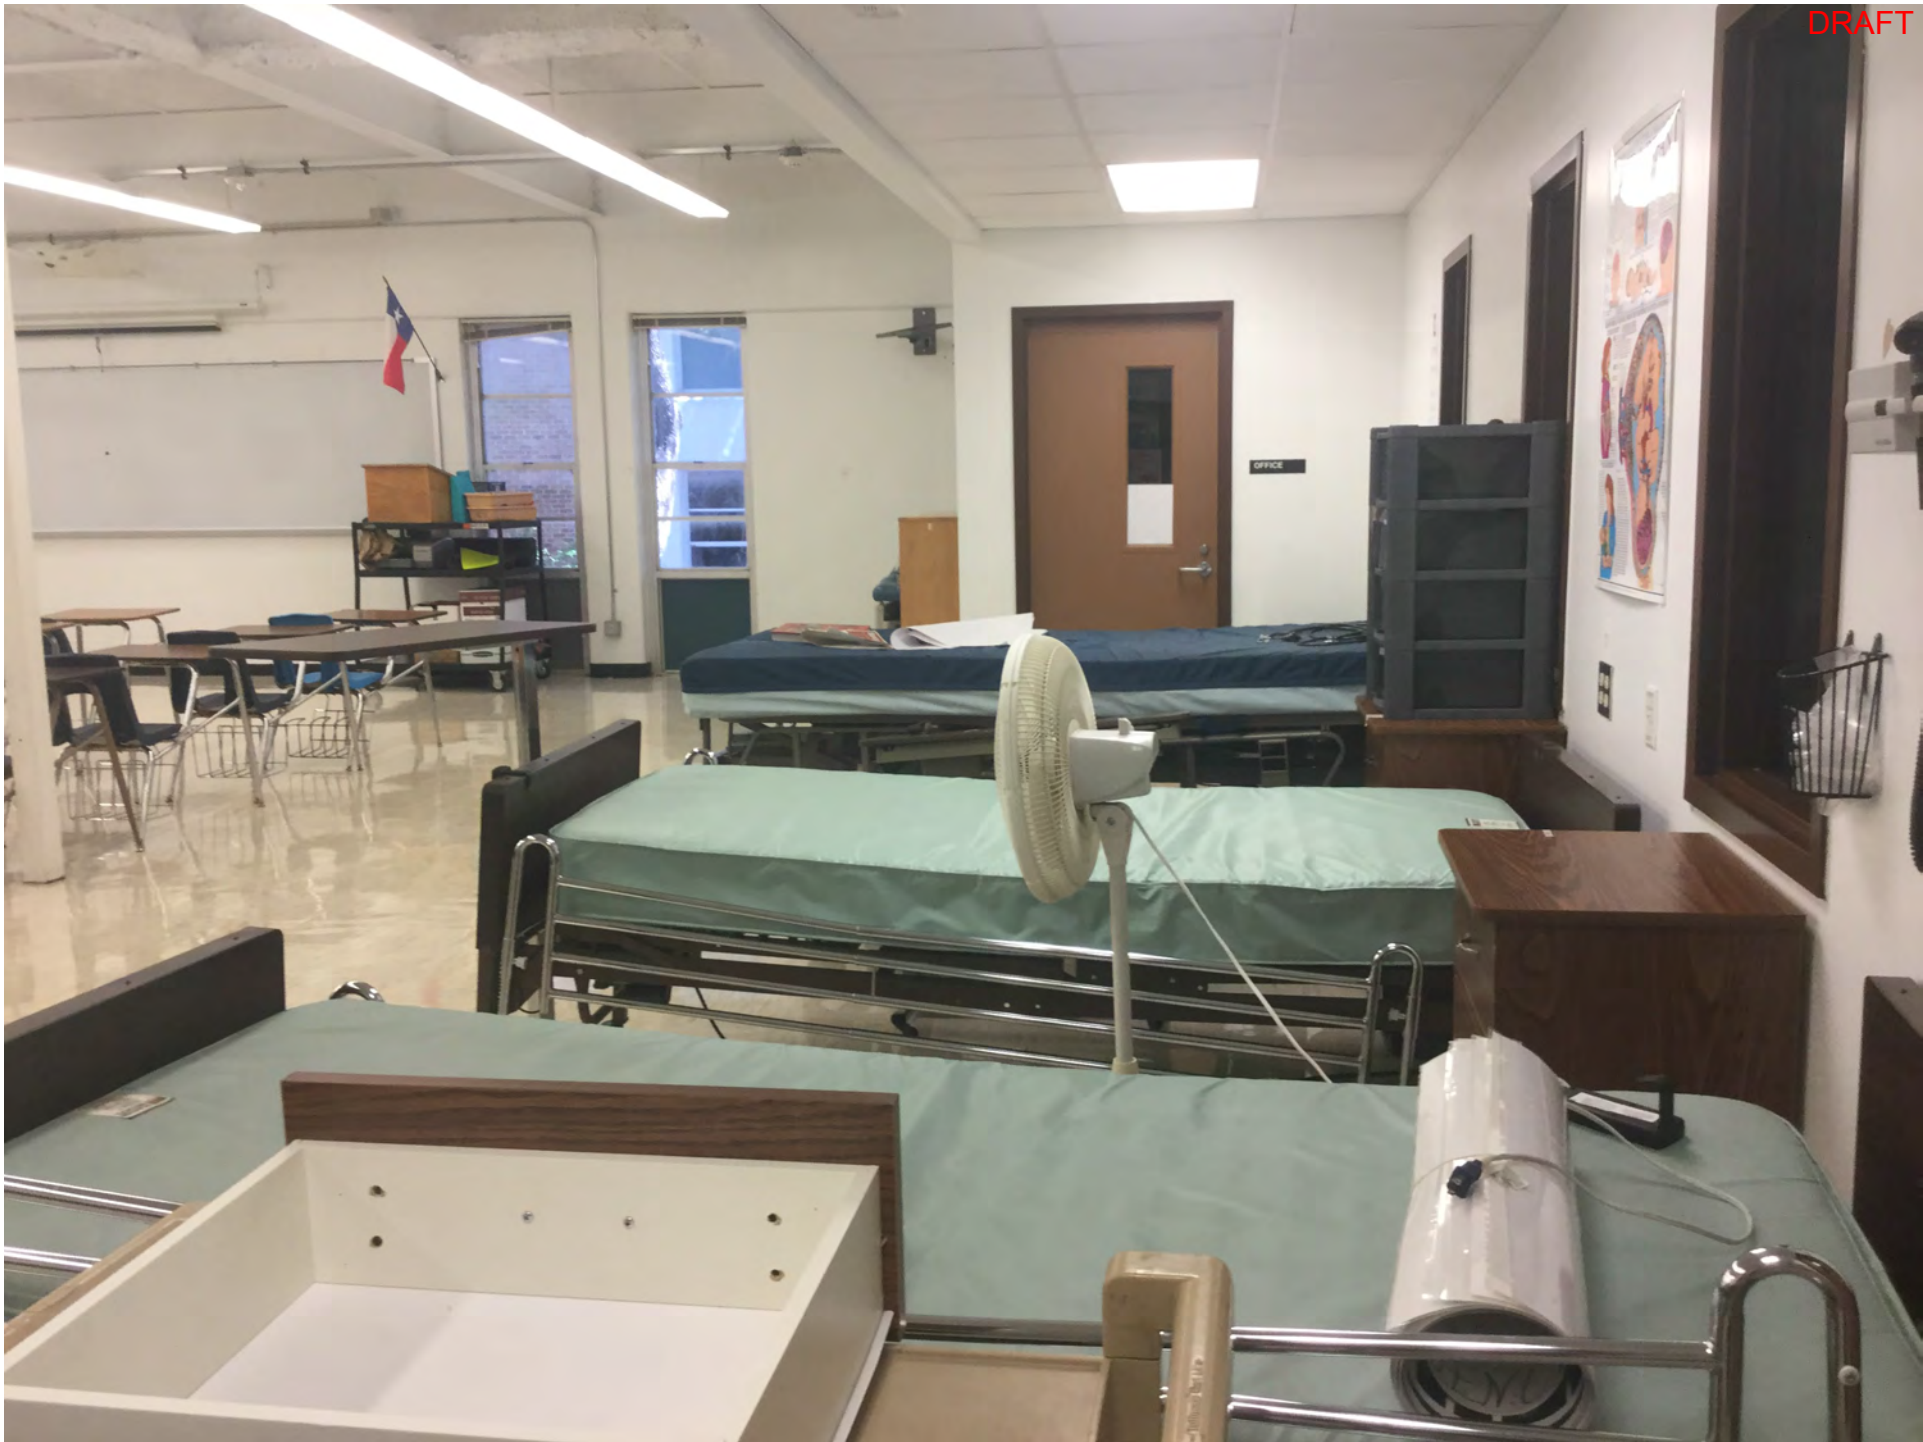
Photo 12. CTE- Health Science Room

1) Very unsatisfactory - No dedicated spaces 2) Unsatisfactory -Some spaces being used for both career education and other subjects 3) Average - A few dedicated career ed spaces, but inadequate configuration/ equipment for needs 4) Good - Some dedicated career ed spaces with adequate configuration and equipment for program needs 5) Very good - Dedicated career ed spaces with good configuration and equipment for program needs - new condition N/A) Does not apply.								While there are several spaces for CTE programs (health science lab, mechanics shop, computer tech, construction trades, etc.), a higher quality of equipment is desired as current equipment is aged and/or in rough shape. A developing entrepreneurship program is quickly developing and gaining momentum, necessitating several new CTE class and lab spaces.	See Image 12

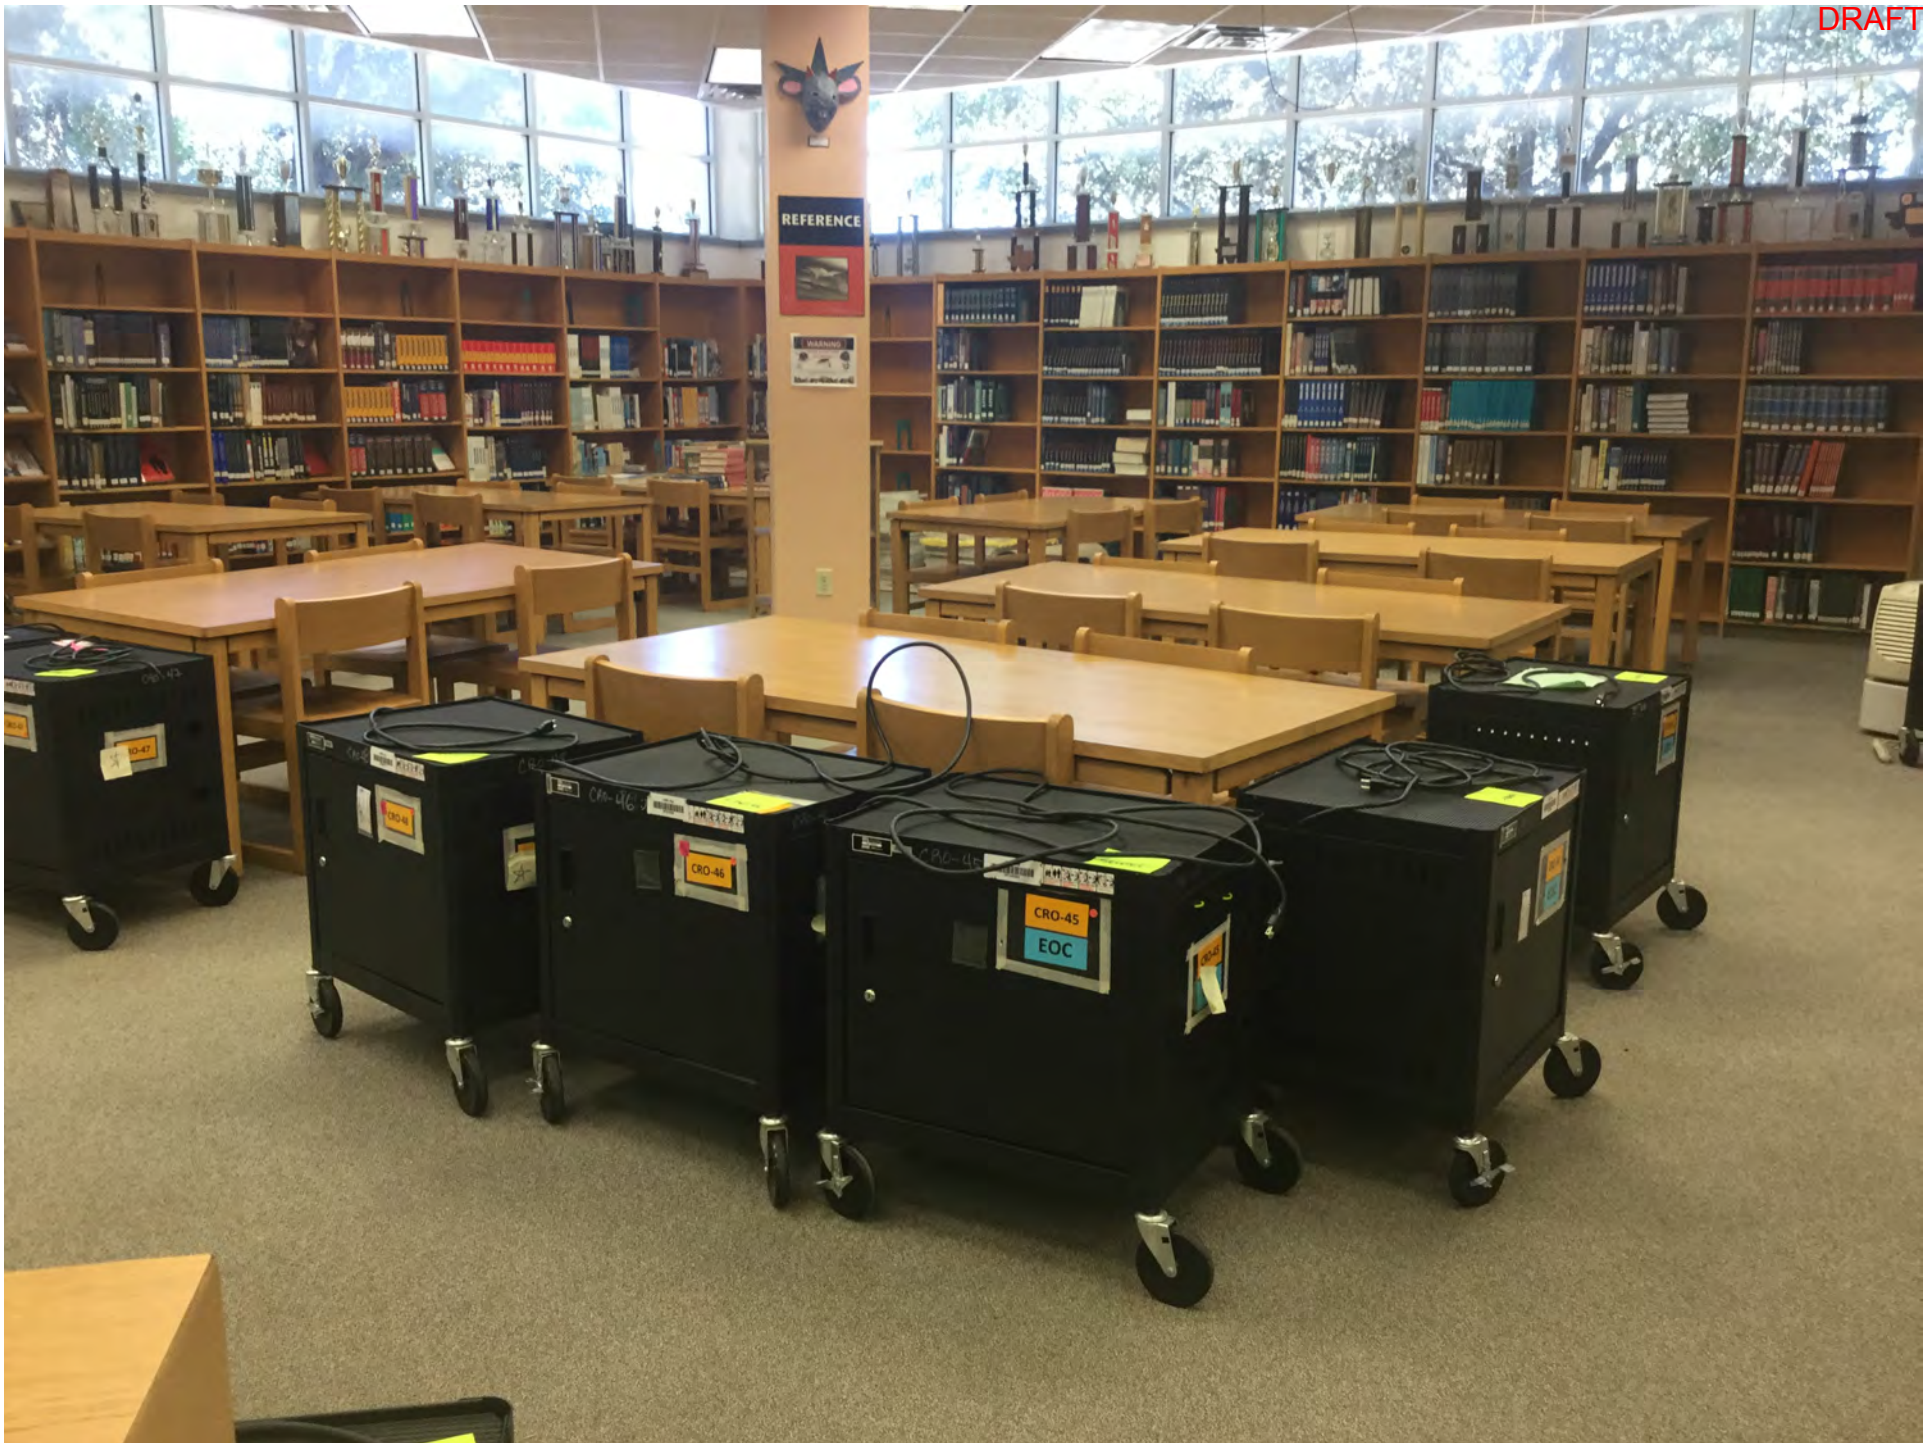
Photo 13. Library

5.3	How well does the Library/Media Center support social interaction?				4			Comments	1.004.00
1) Very unsatisfactory 2) Unsatisfactory 3) Average 4) Good 5) Very good N/A) Does not apply.								Couches, coffee tables, and lounge chairs spread throughout the space allow for informal interaction.	
								See Image 13
