Educational Suitability Summary Report

Garza Independence High School – BLDG 015

Date: 08/09/2016

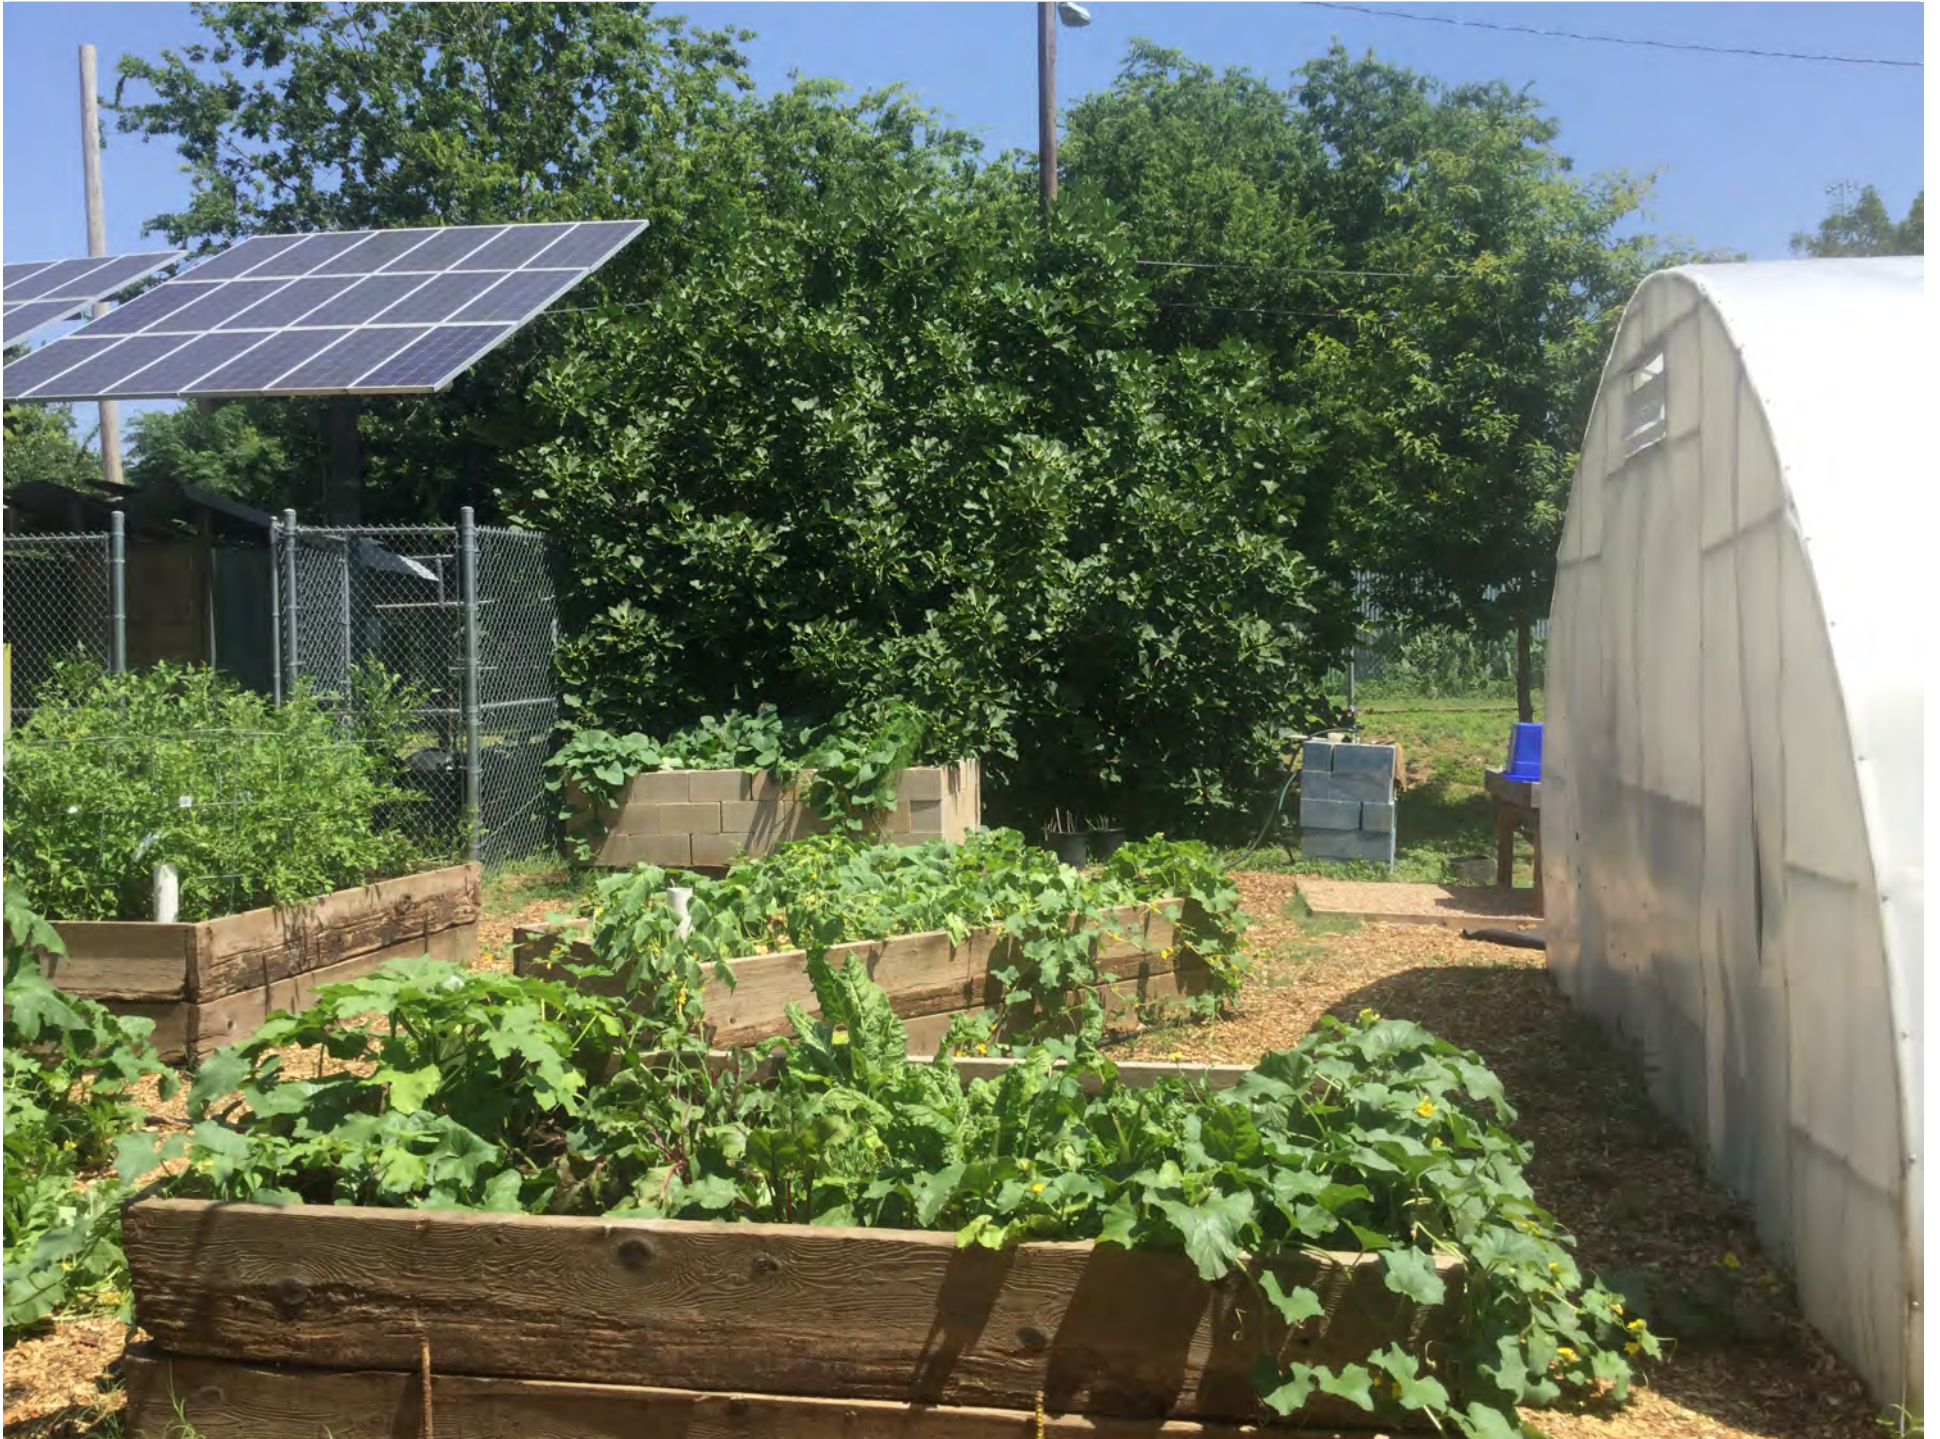
Photo 1. Outdoor Spaces

1.2	Are opportunities provided for outdoor learning (outdoor classrooms, gardens, etc.)?					5		Comments	1.00 5.00
	1) Outdoor space exists is not developed 2) Outdoor space for learning exists but not connected to classroom learning areas. 3. Outdoor learning spaces exist and are accessible but not in good condition. 4. Outdoor learning spaces need minor improvements to function well. 5. Outdoor learning spaces are in excellent condition. N/A) Does not apply.							There are beautiful garden spaces with outside furniture.

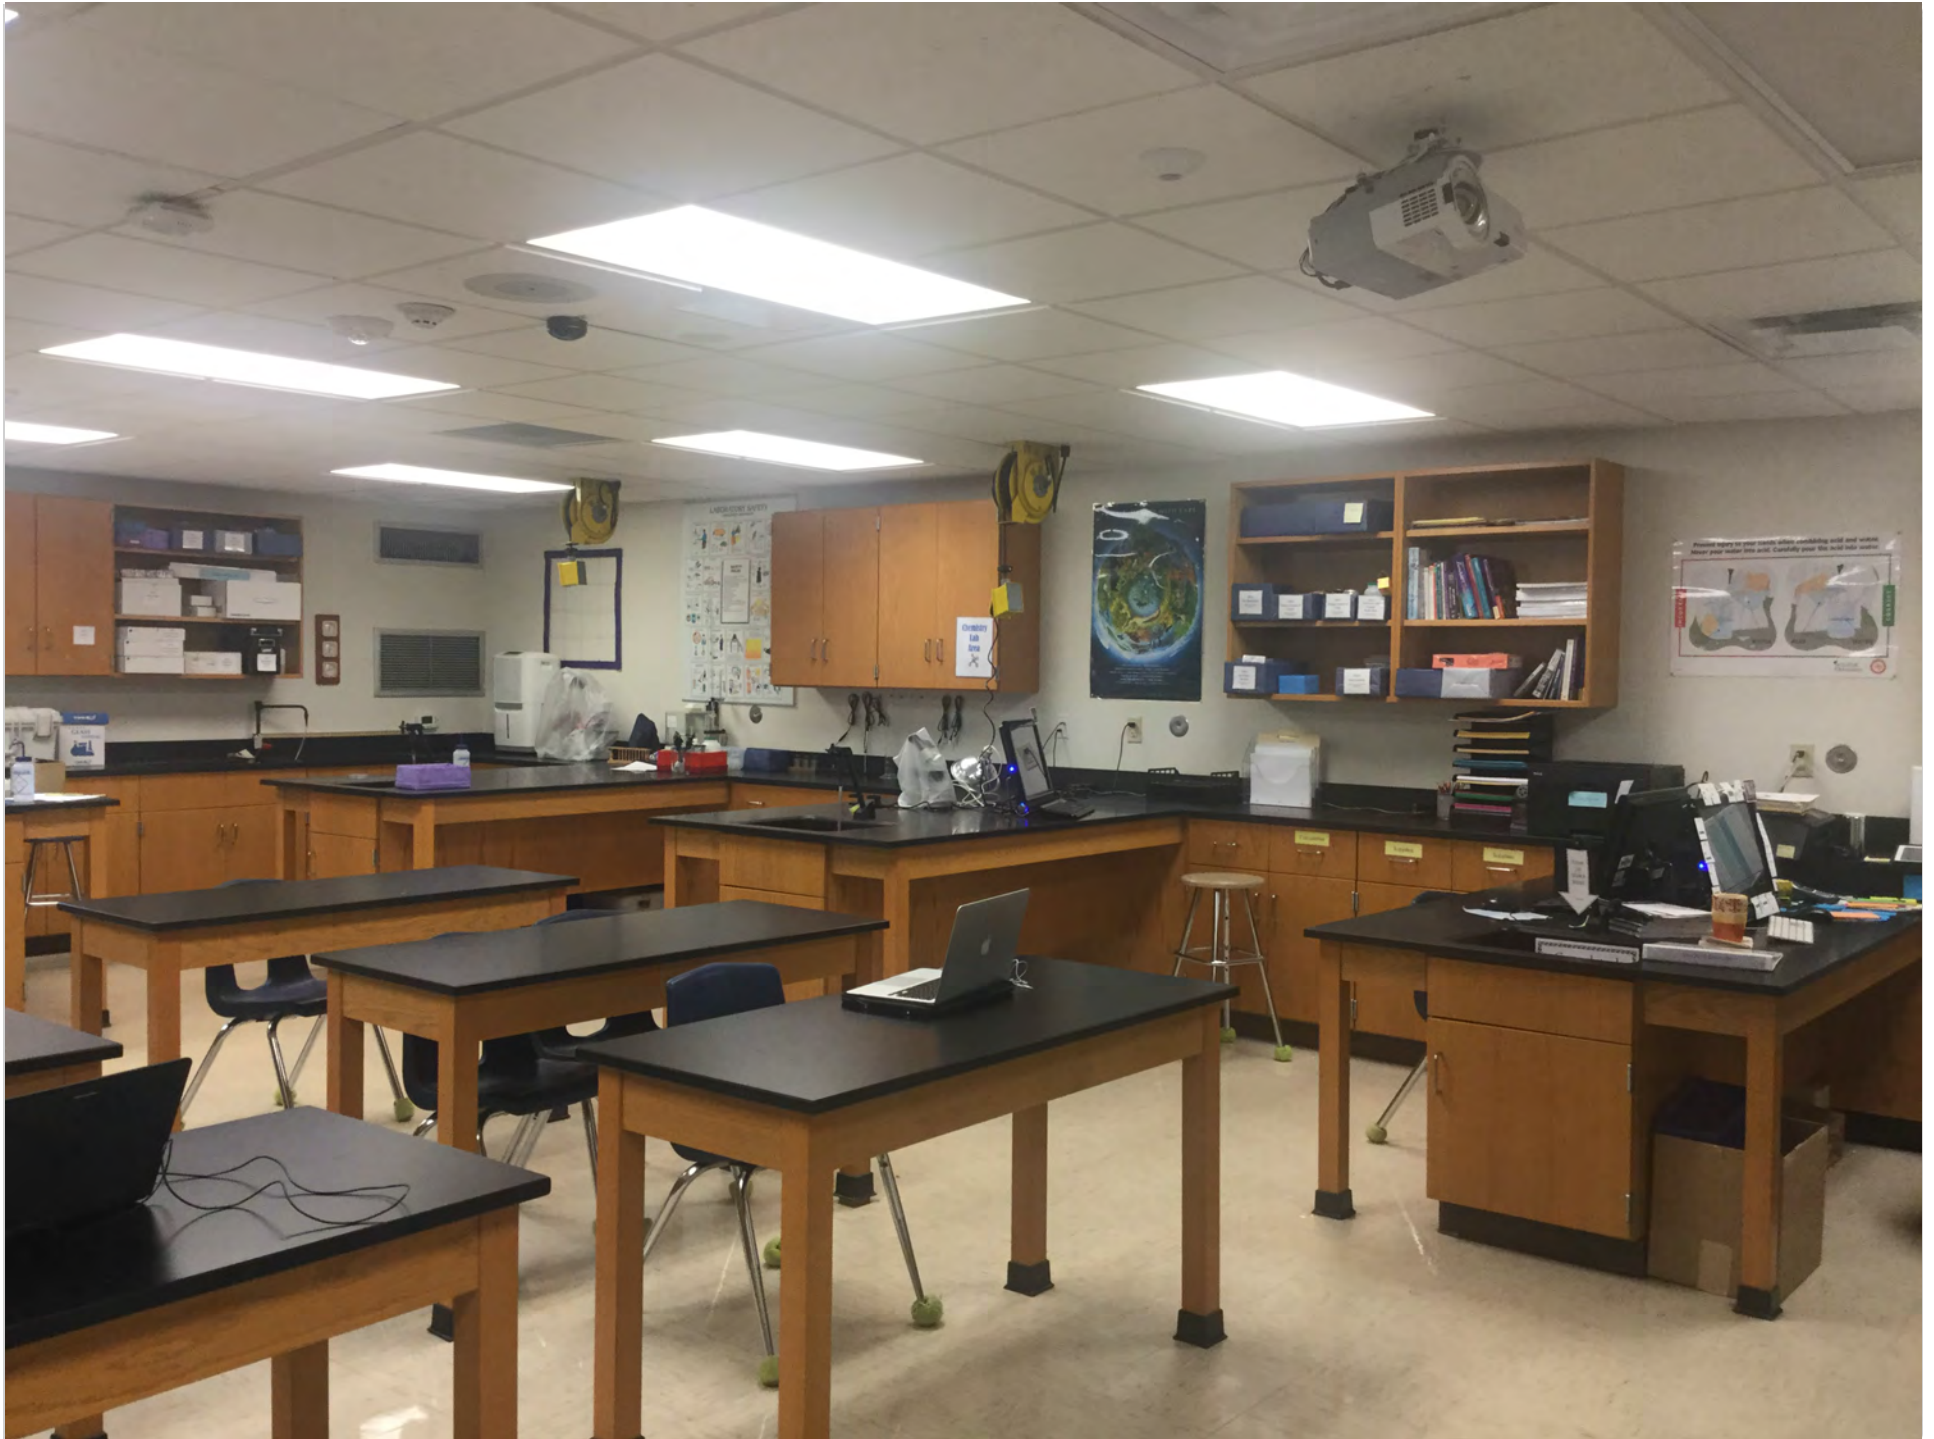
Photo 2. Science Room

3.4	Are Science Classrooms/Labs appropriately configured per the ed spec?				4			Comments	1.004.00
1) Very unsatisfactory 2) Unsatisfactory 3) Neutral 4) Satisfactory 5) Very Satisfactory N/A) Does not apply. (Elementary schools)

3.5	Are Science Classrooms/Labs support areas appropriately configured per the ed spec?				4			Comments	1.004.00
1) Very unsatisfactory - Support spaces are disconnected from served spaces, too small, do not meet needs 2) Unsatisfactory - Support spaces are connected, but too small, do not meet needs 3) Average - Connected, moderate size, but need some renovations or updates 4) Good - Connected, good size, meets needs, functions well 5) Very good - connected, generous size, nice condition, functions appropriately N/A) Does not apply. (Elementary schools)

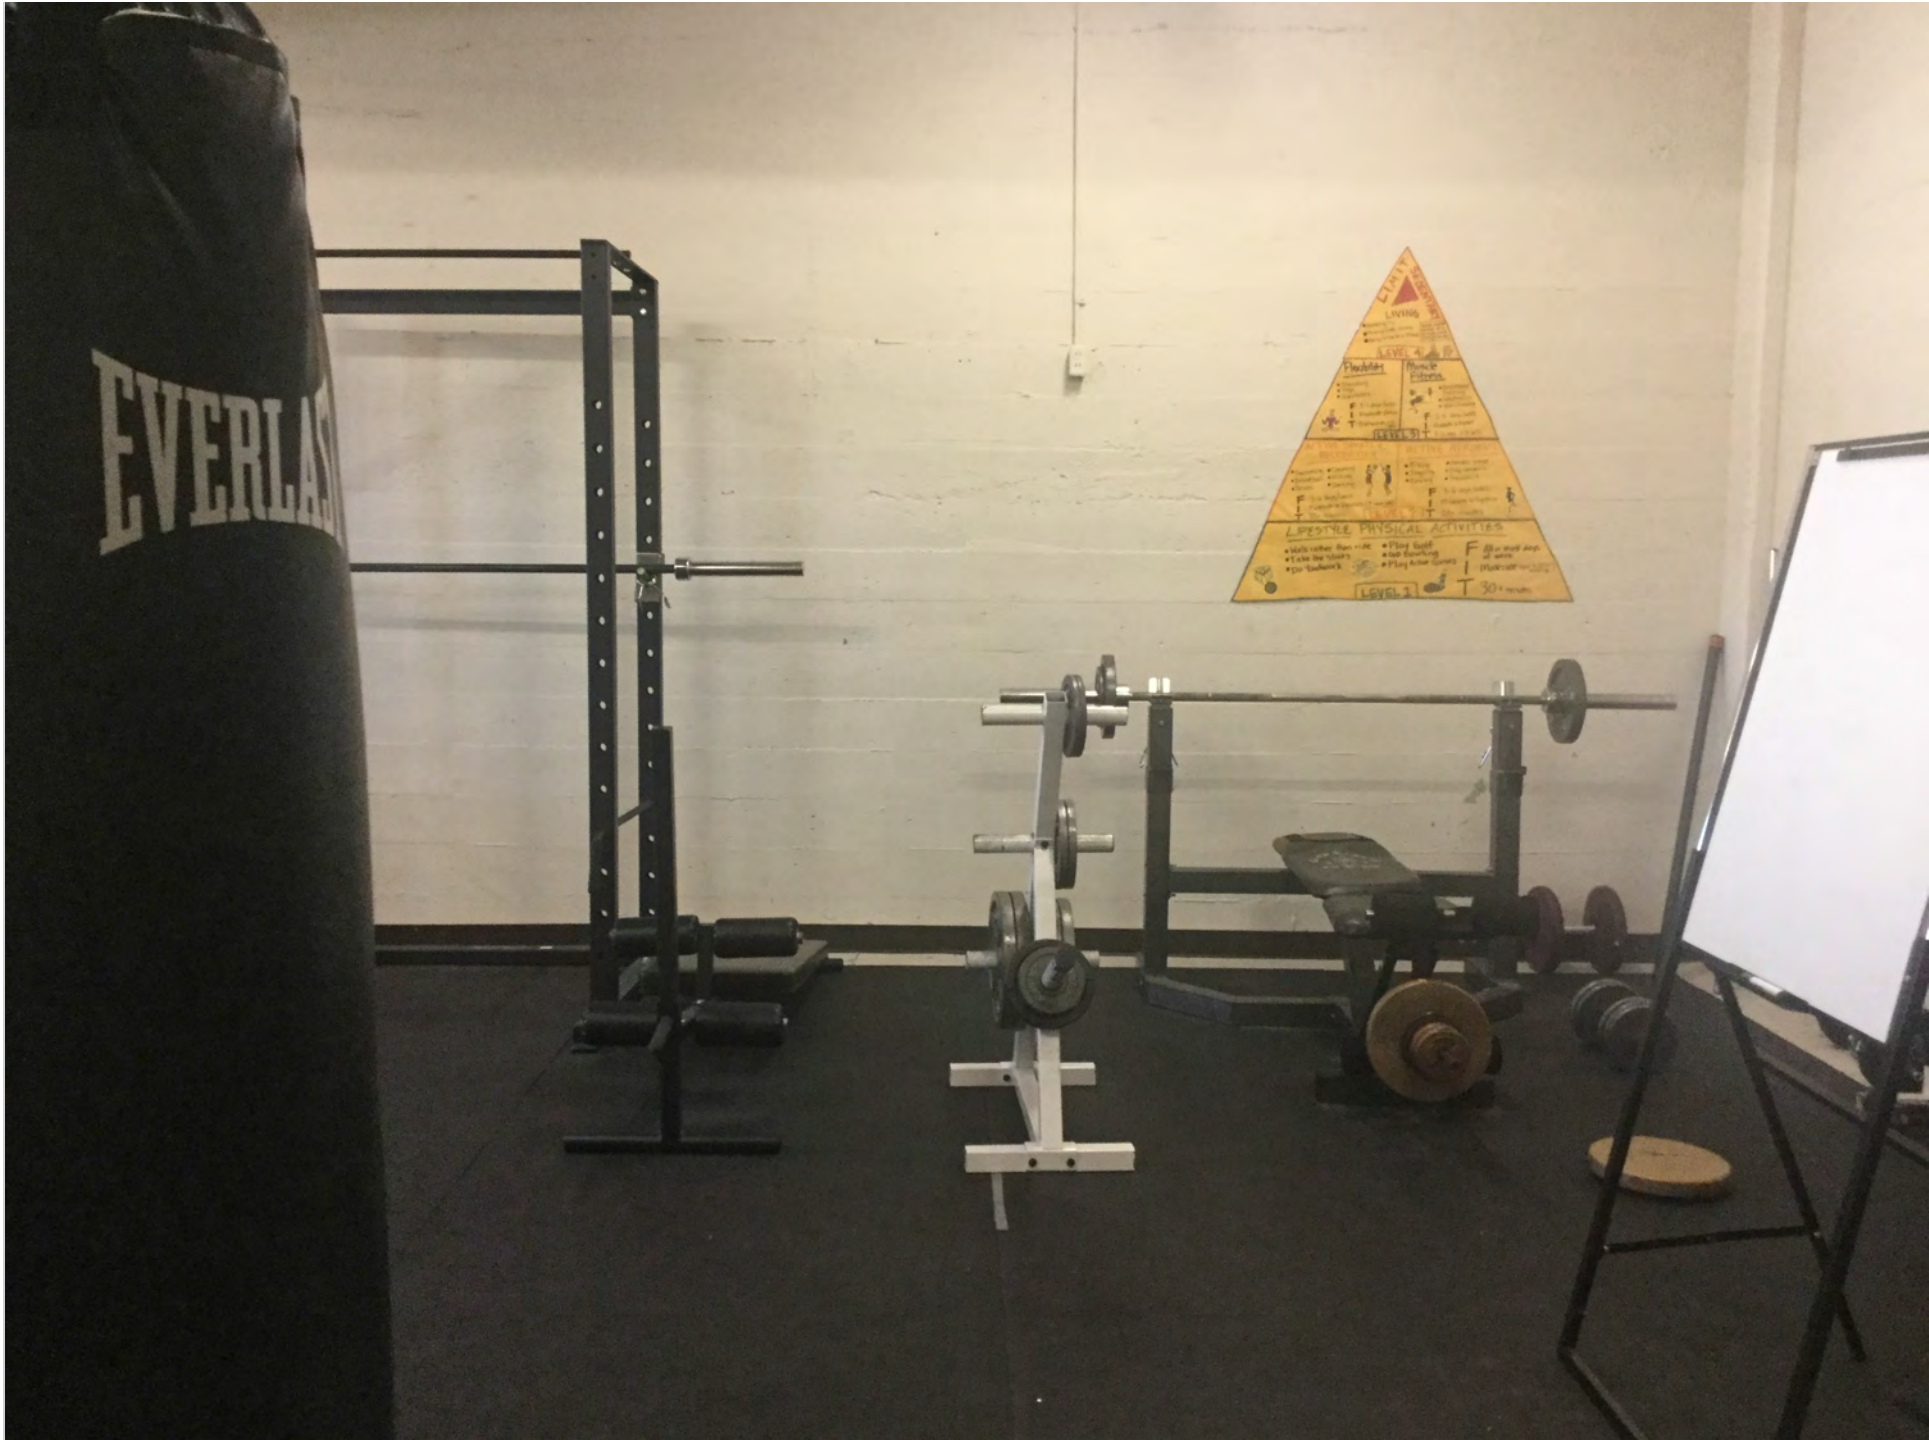
Photo 3. Weight room

1) Very unsatisfactory 2) Unsatisfactory 3) Average 4) Good 5) Very good N/A) Does not apply.								The weight room is in the basement. The gym is upstairs and has no accessible route.

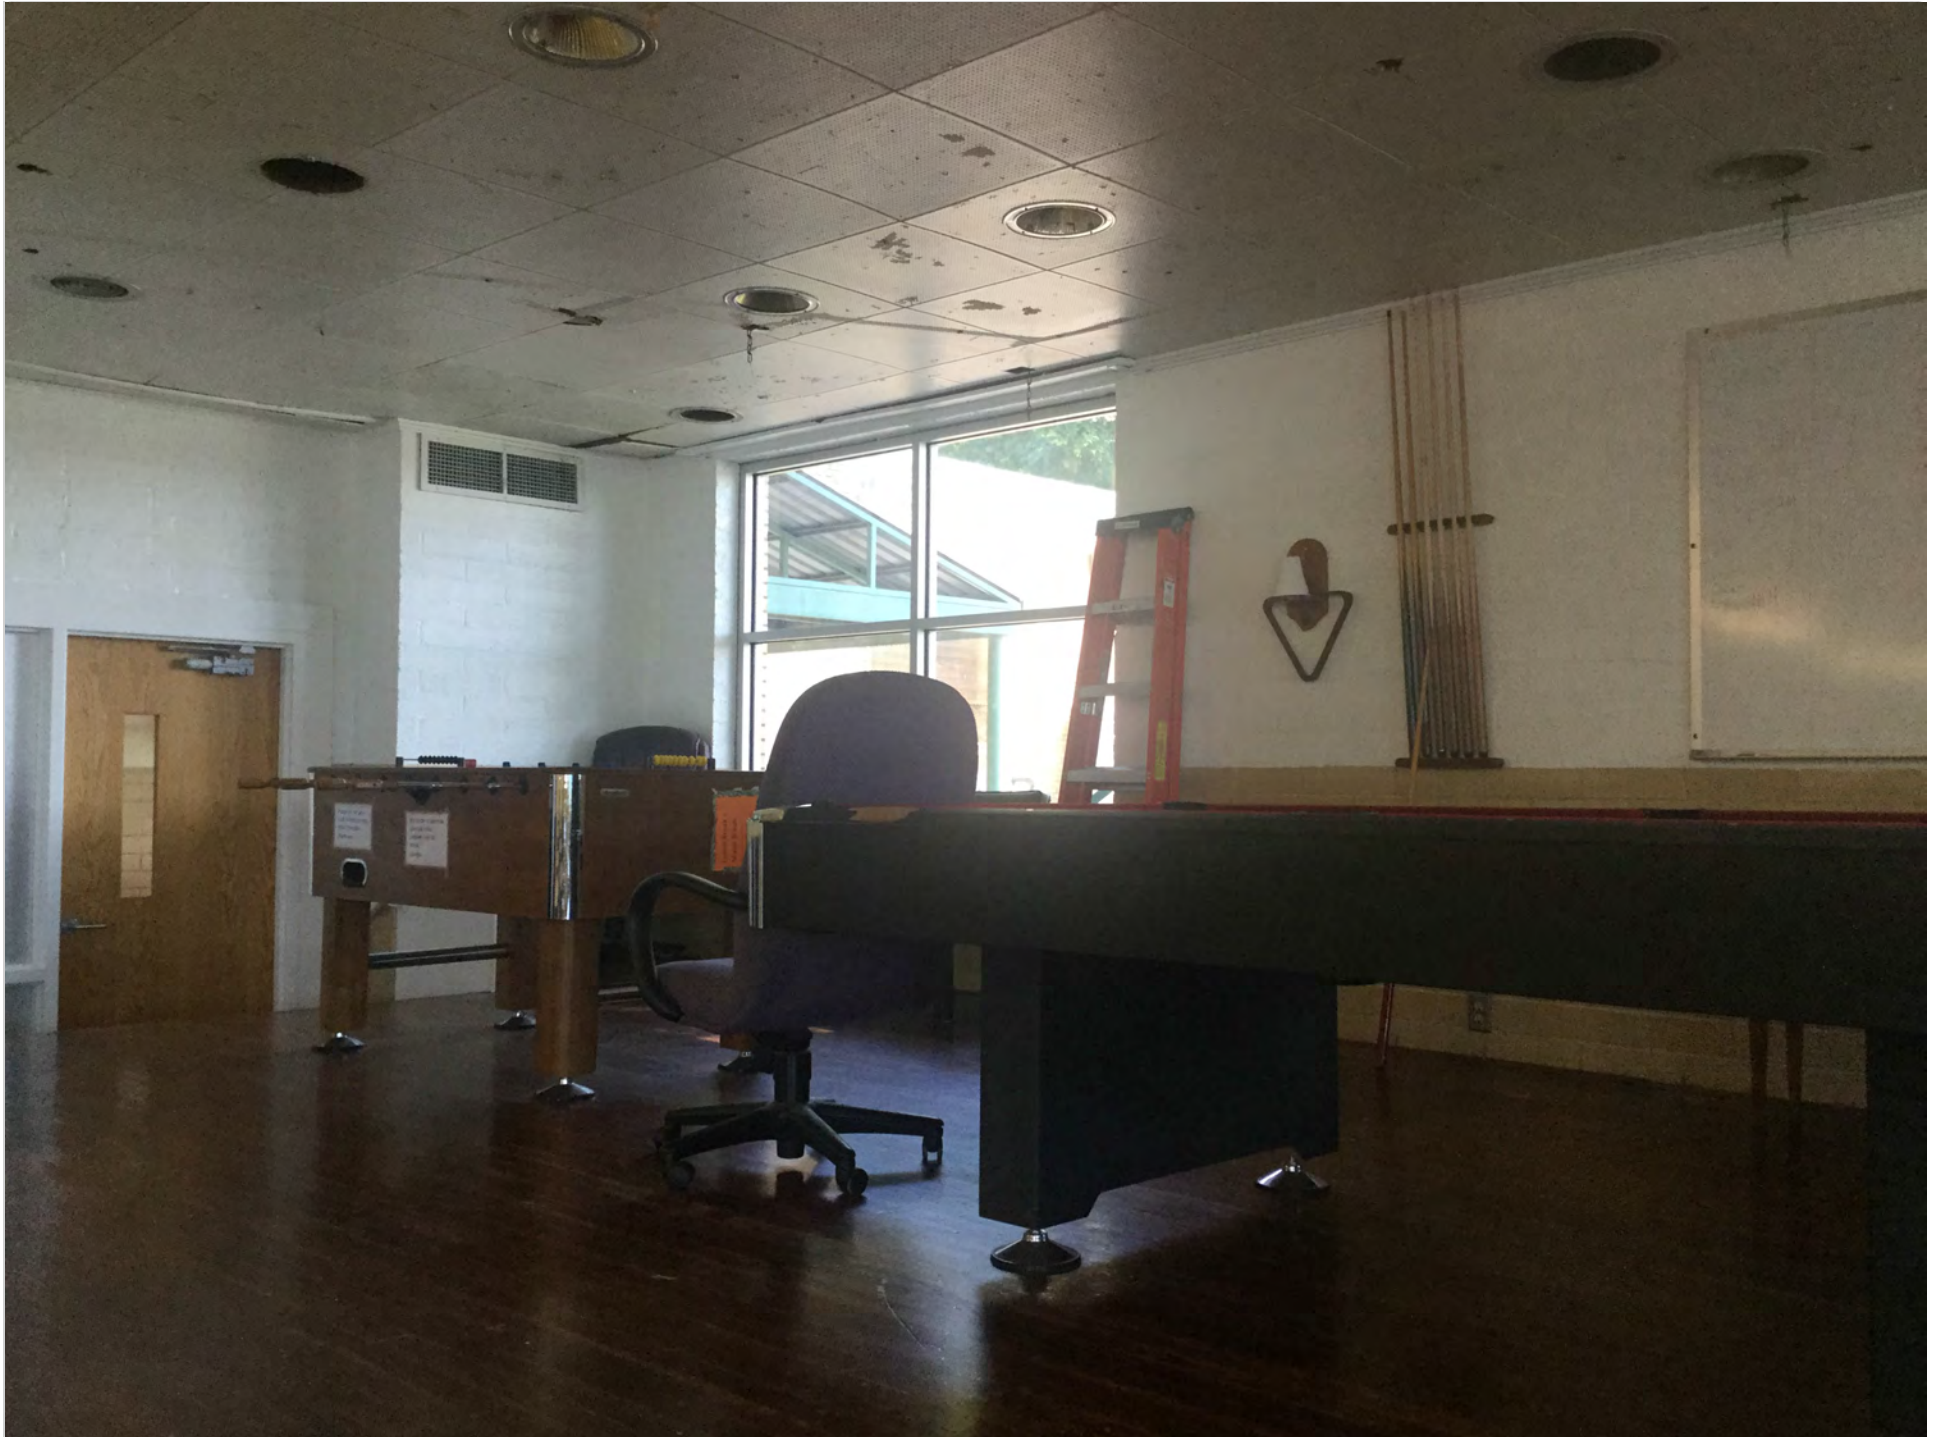
Photo 4. Performing Art Spaces

3.8	Are music, drama, or performance spaces appropriately configured per the ed spec?	1						Comments	1.001.00
1) Very unsatisfactory 2) Unsatisfactory 3) Average 4) Good 5) Very good N/A) Does not apply.								The only space available is the cafetorium which currently has pool tables and does not appear to operate has a performing arts space.

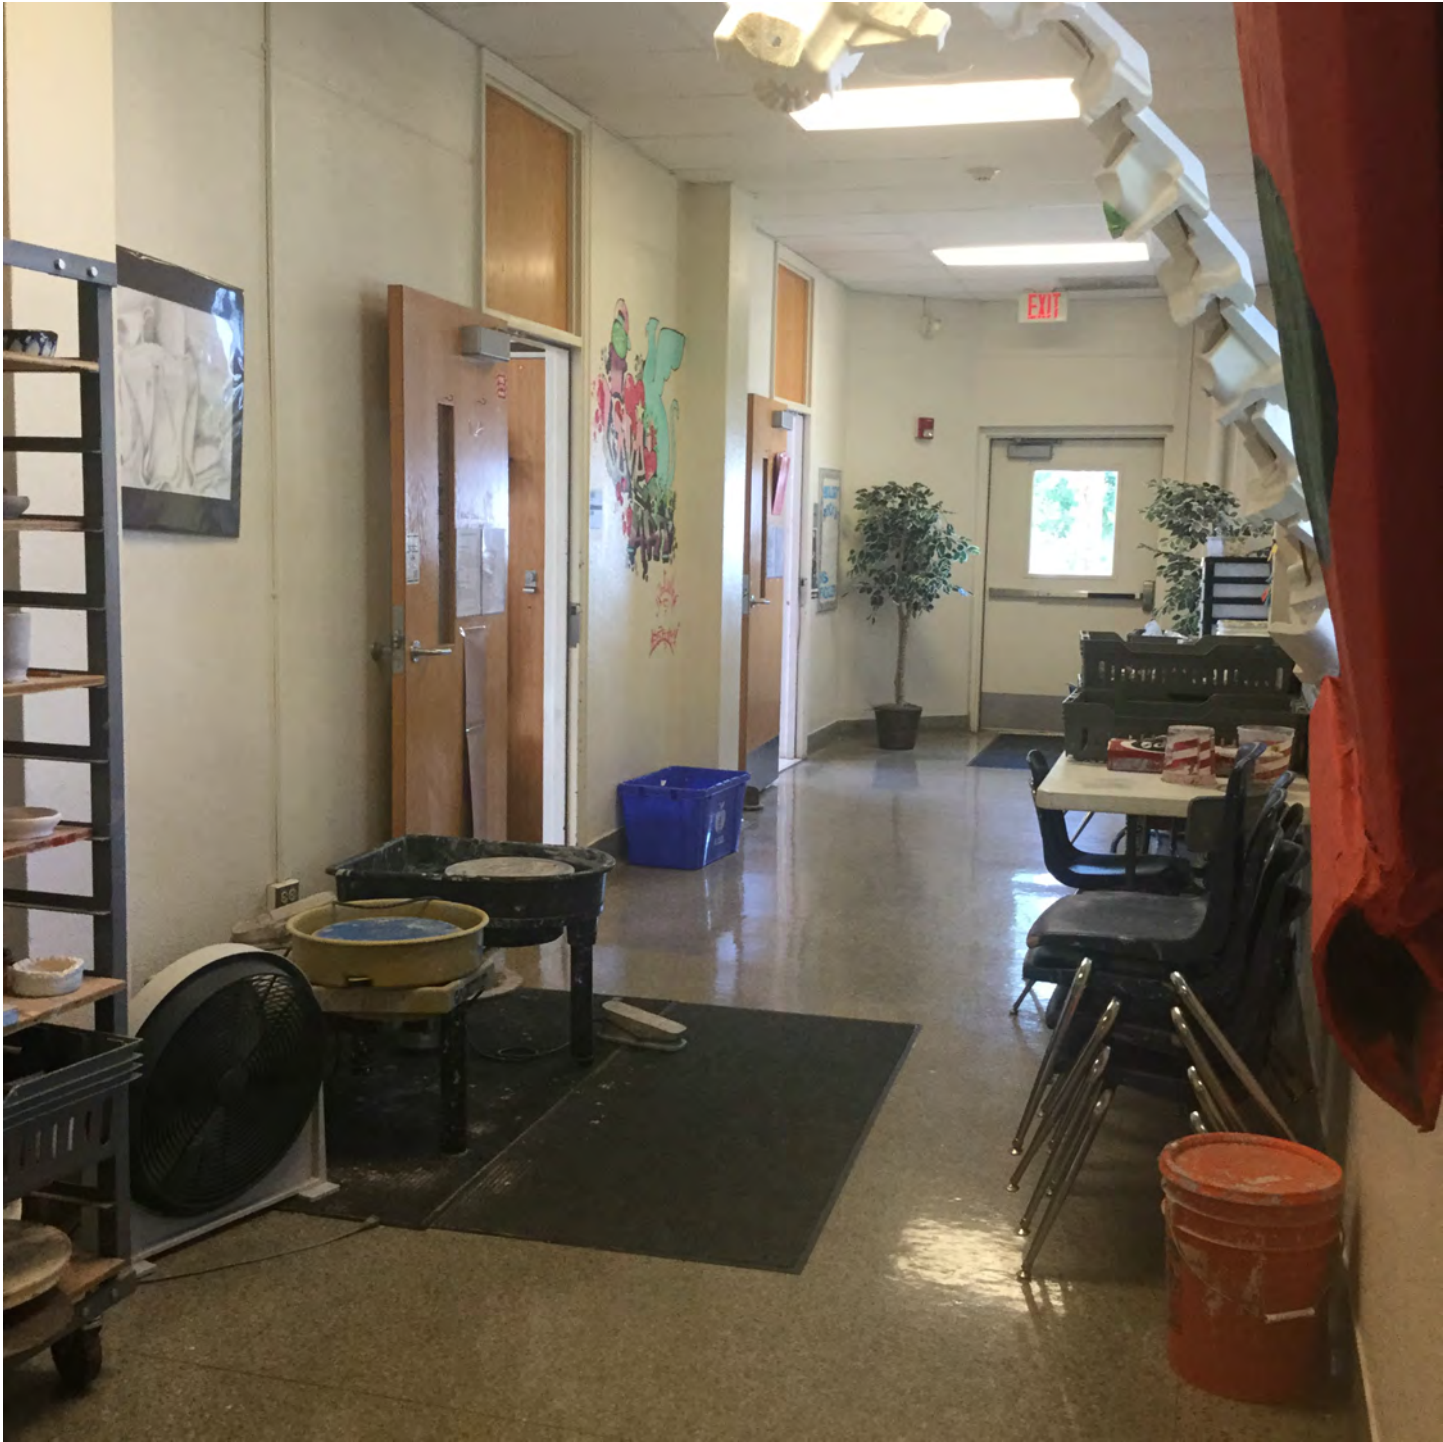
Photo 5. Art Support

1) Very unsatisfactory - Support spaces are disconnected from served spaces, too small, do not meet needs 2) Unsatisfactory - Support spaces are connected, but too small, inadequate for needs 3) Average - Connected, moderate size, but need some renovations or updates to function well 4) Good - Connected, good size/layout, meets needs/functions well 5) Very good - connected, generous size, nice condition, functions appropriately N/A) Does not apply.							There is a lack of storage, and certain art equipment spills into the hallway.

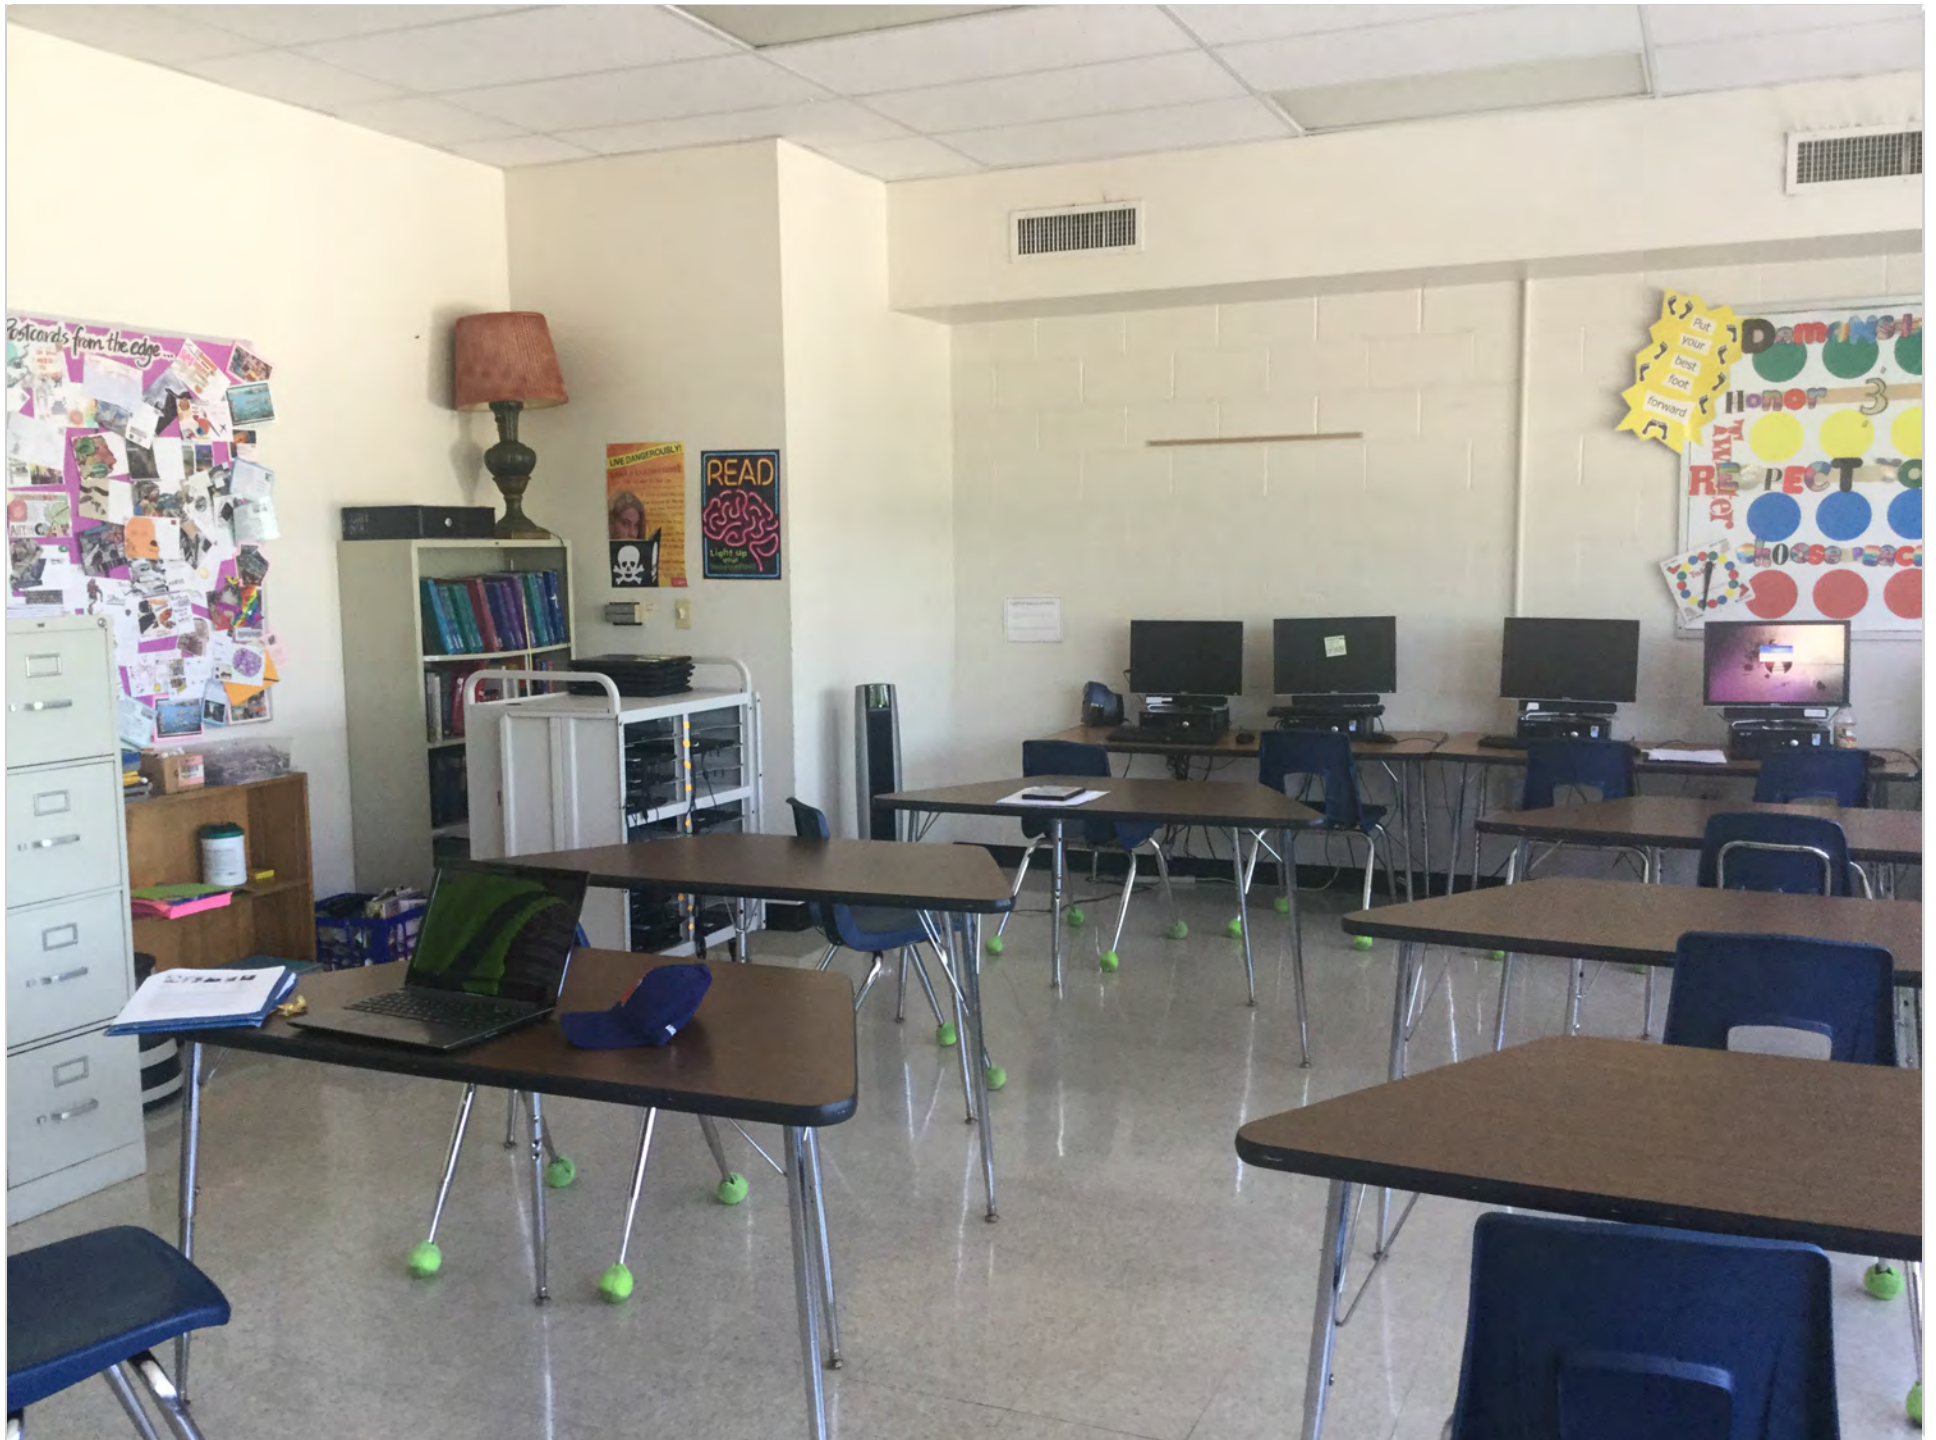
Photo 6. Classroom

4.2	Are general classrooms large enough to support project-based learning and multiple teaching modalities?				4			Comments	1.00 4.00
1) Very unsatisfactory -too small to move, set for lecture only, no connectivity, no flexibility 2) Unsatisfactory - adequate size but set for lecture only, no connectivity, no flexibility 3) Neutral - have flexibility and space for hands on or project based learning 4) Satisfactory - have flexibility and space for hands on or project based learning and connectivity for global learning 5) Very Satisfactory - space for hands on learning, flexibility for different groupings, and connectivity for global classrooms N/A) Does not apply.								The classrooms are very flexible and well sized.

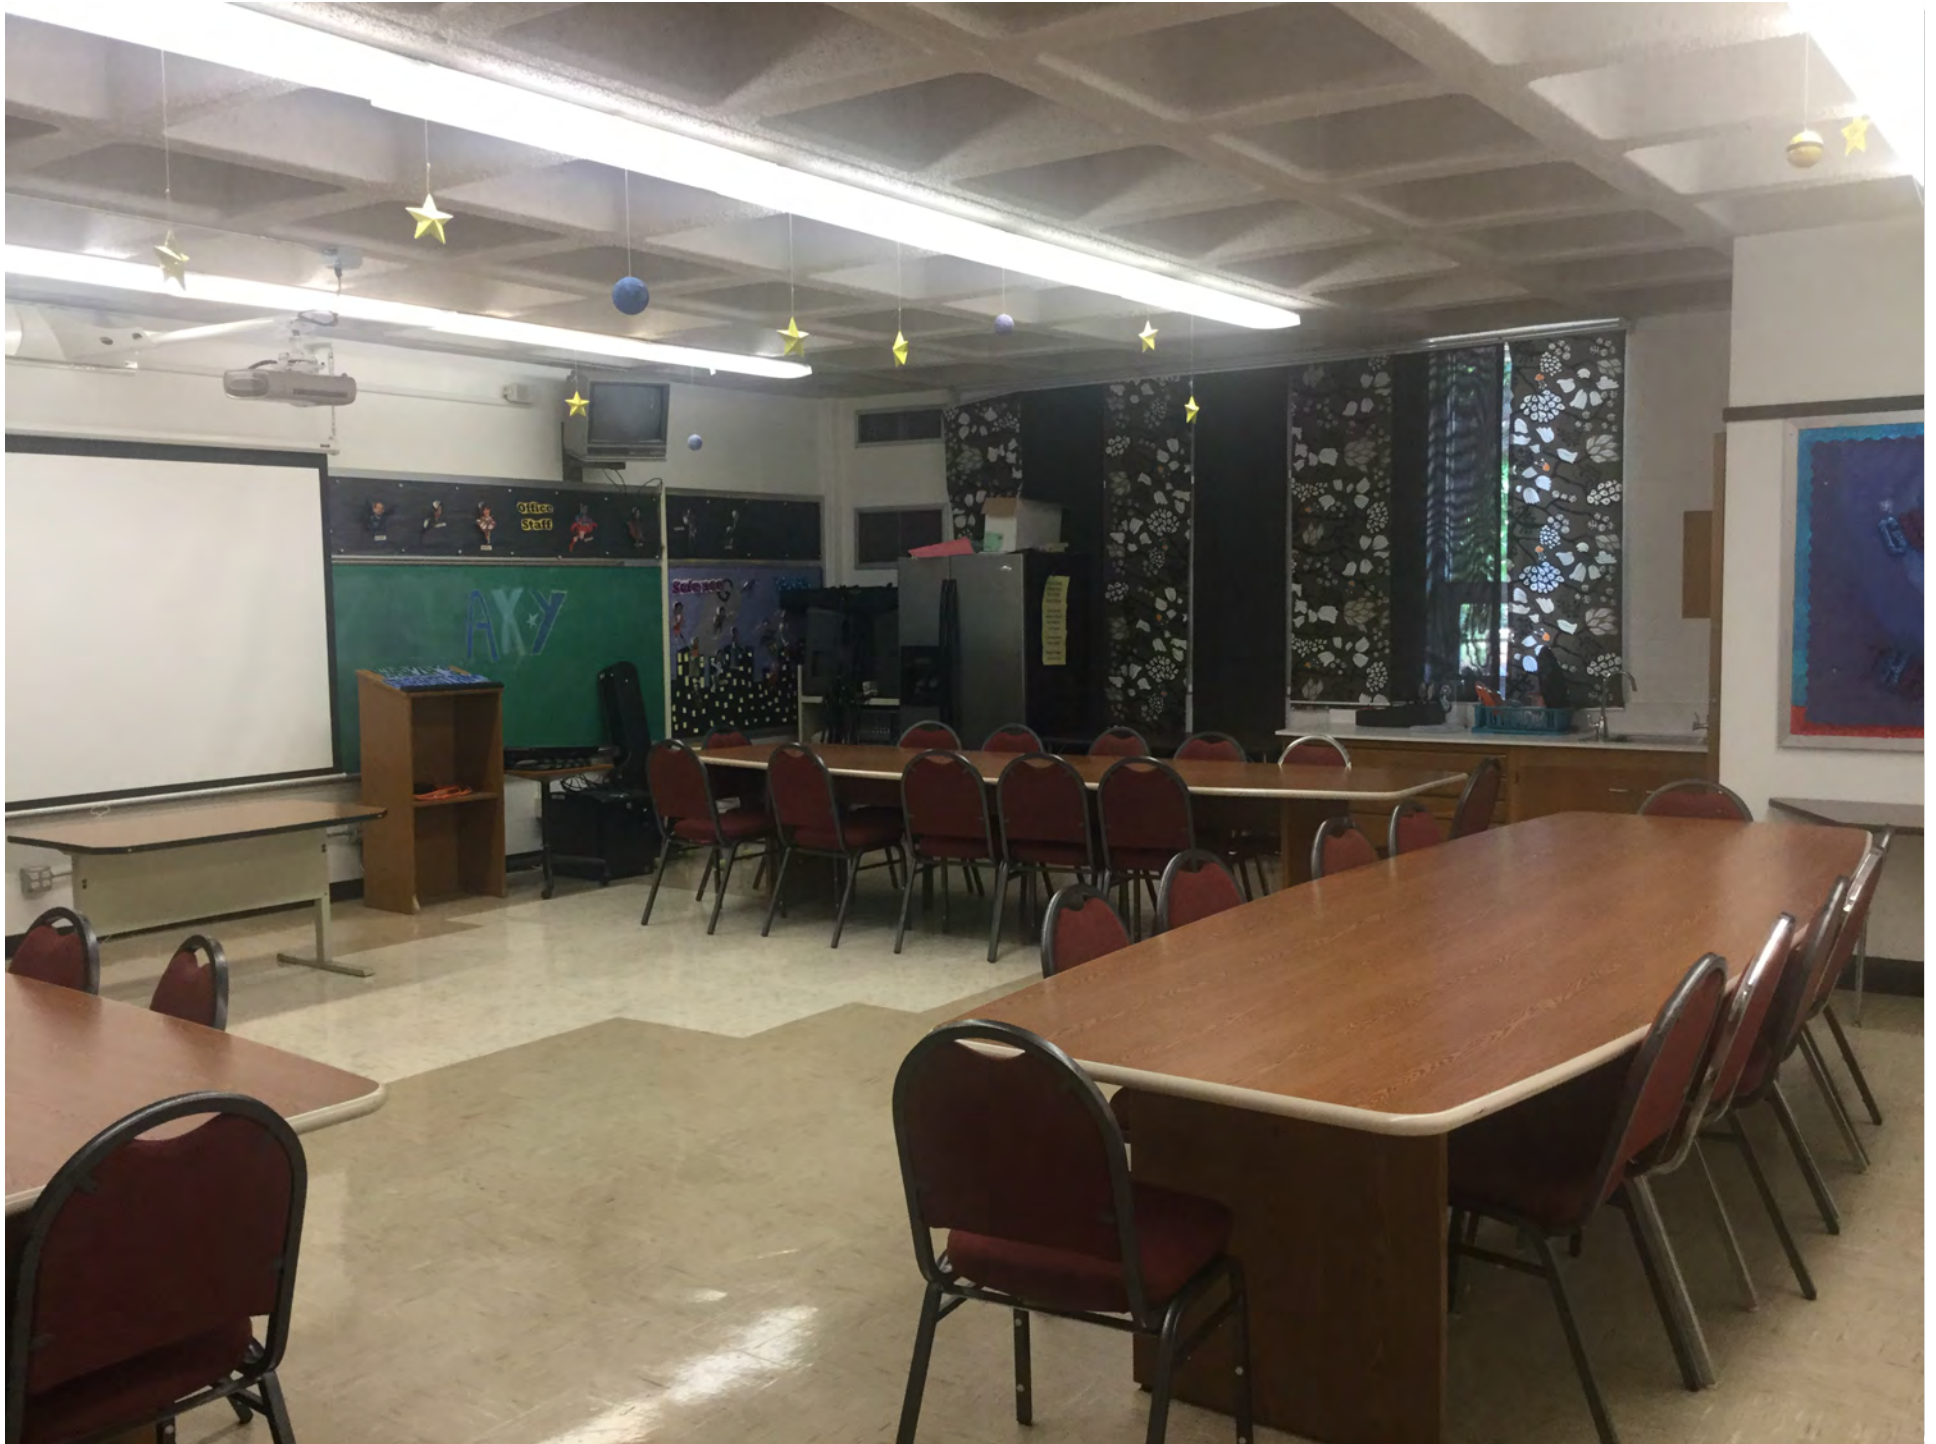
Photo 7. Meeting space

1) Very unsatisfactory - no common spaces or meeting rooms or in very poor condition 2) Unsatisfactory - a few common spaces or meeting rooms in unsatisfactory condition 3) Average - a few common spaces and meeting areas needing updates 4) Good - multiple common spaces and meeting rooms in good condition 5) Very good - adequate common spaces and meeting rooms of excellent quality N/A) Does not apply.								There are some meeting spaces throughout the campus.

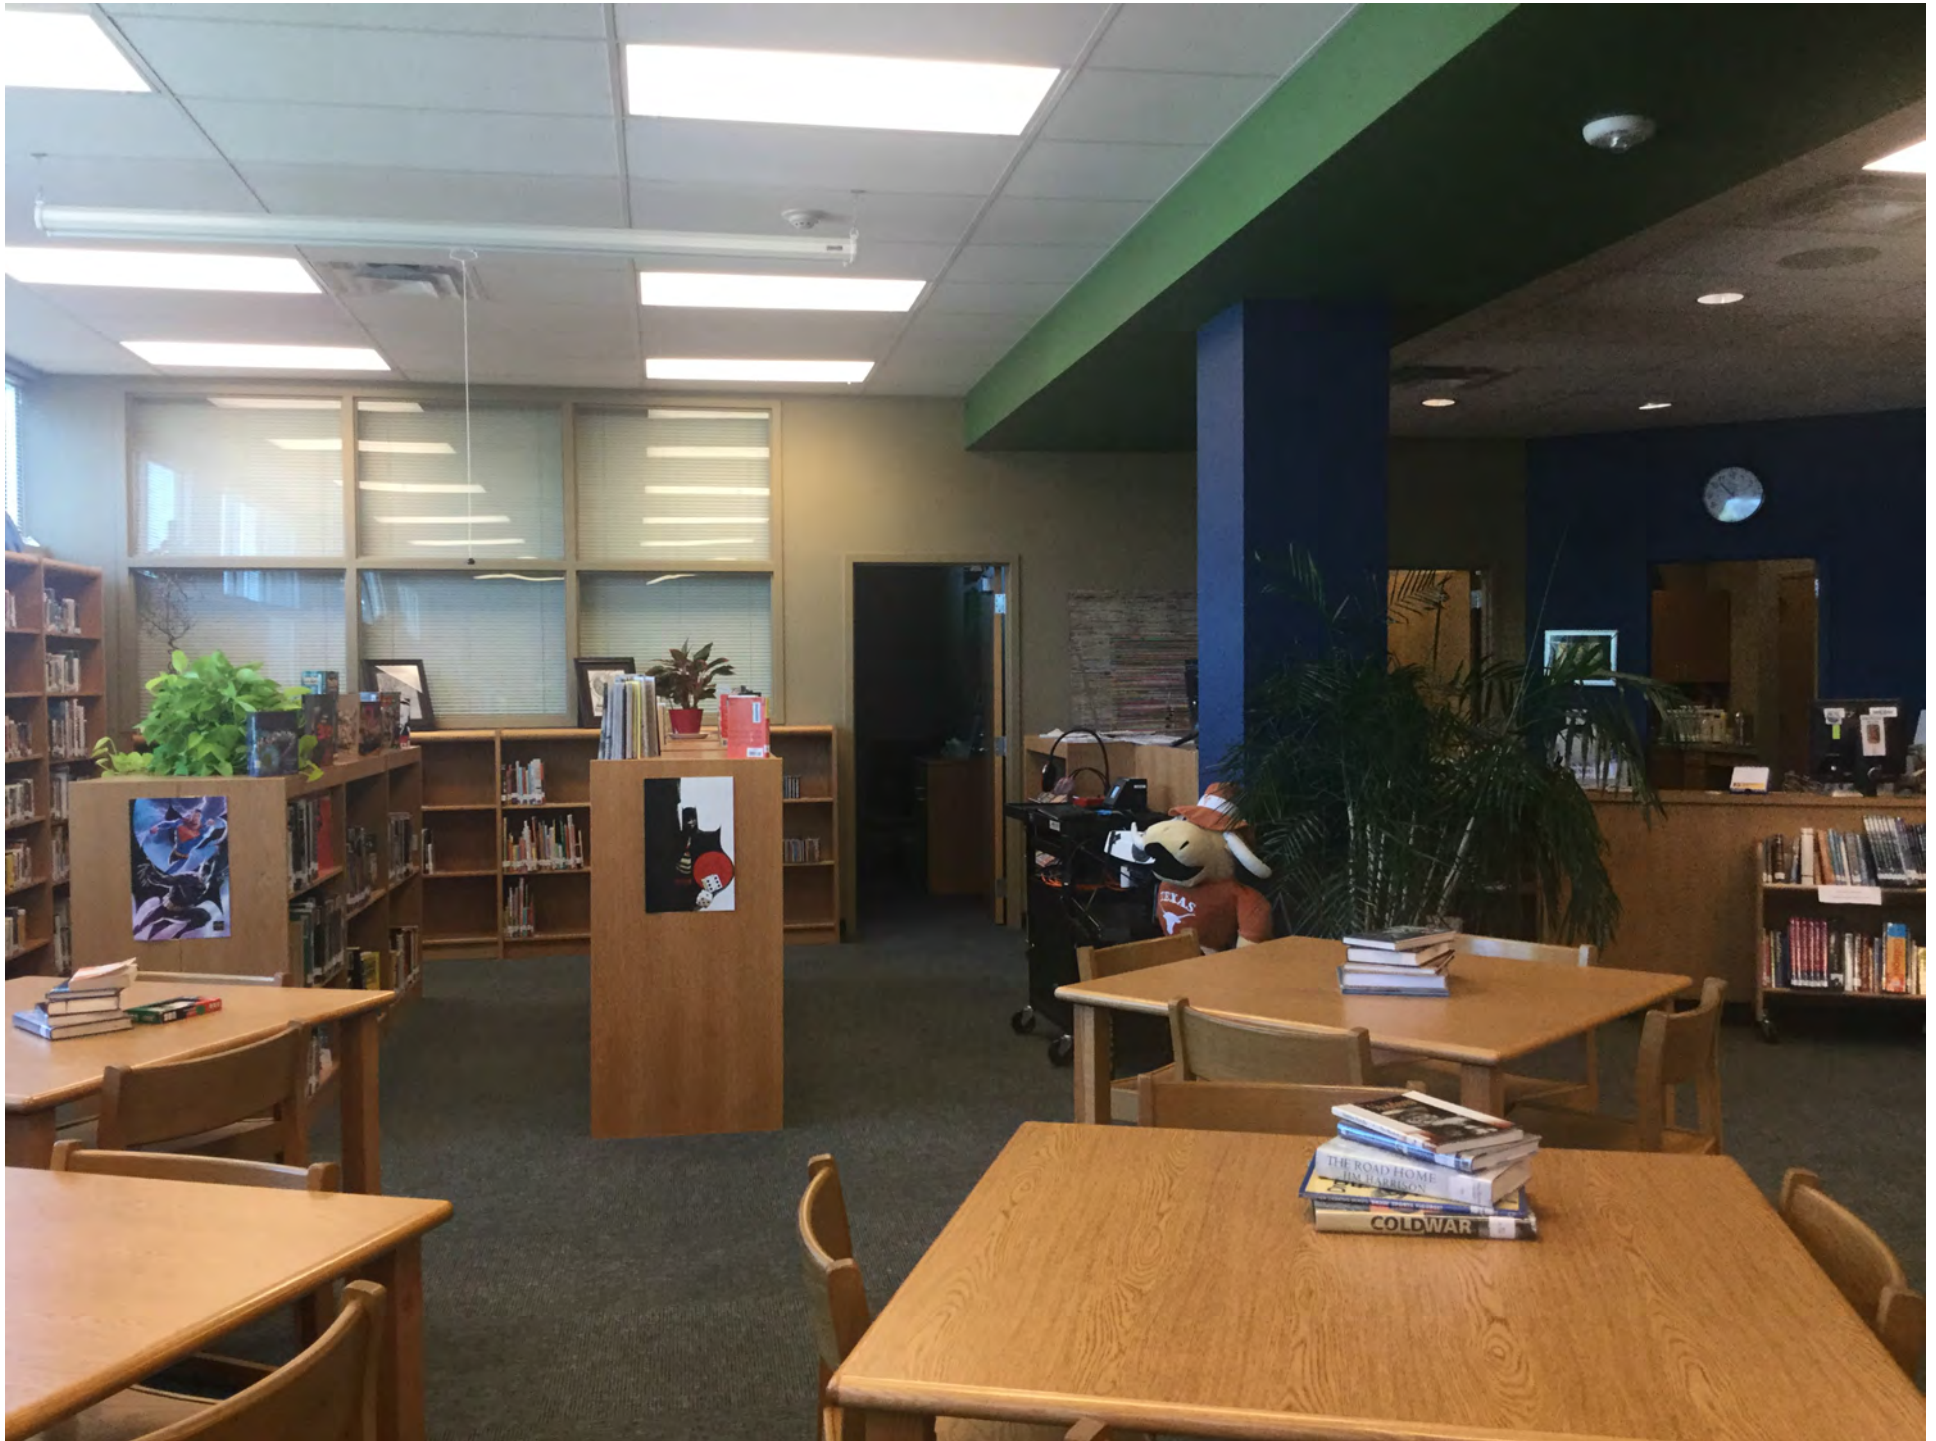
Photo 8. Library

The library is a very satisfactory size for the school size and features quiet study areas as well as a computer area with multiple computers for student use. The campus is focused on individual student learning, so large group space was limited, but the librarian reports this is an unnecessary feature for this campus. Storage for the library was very satisfactory.
