Educational Suitability Summary Report

Garza Independence High School – BLDG 015

Date: 08/09/2016

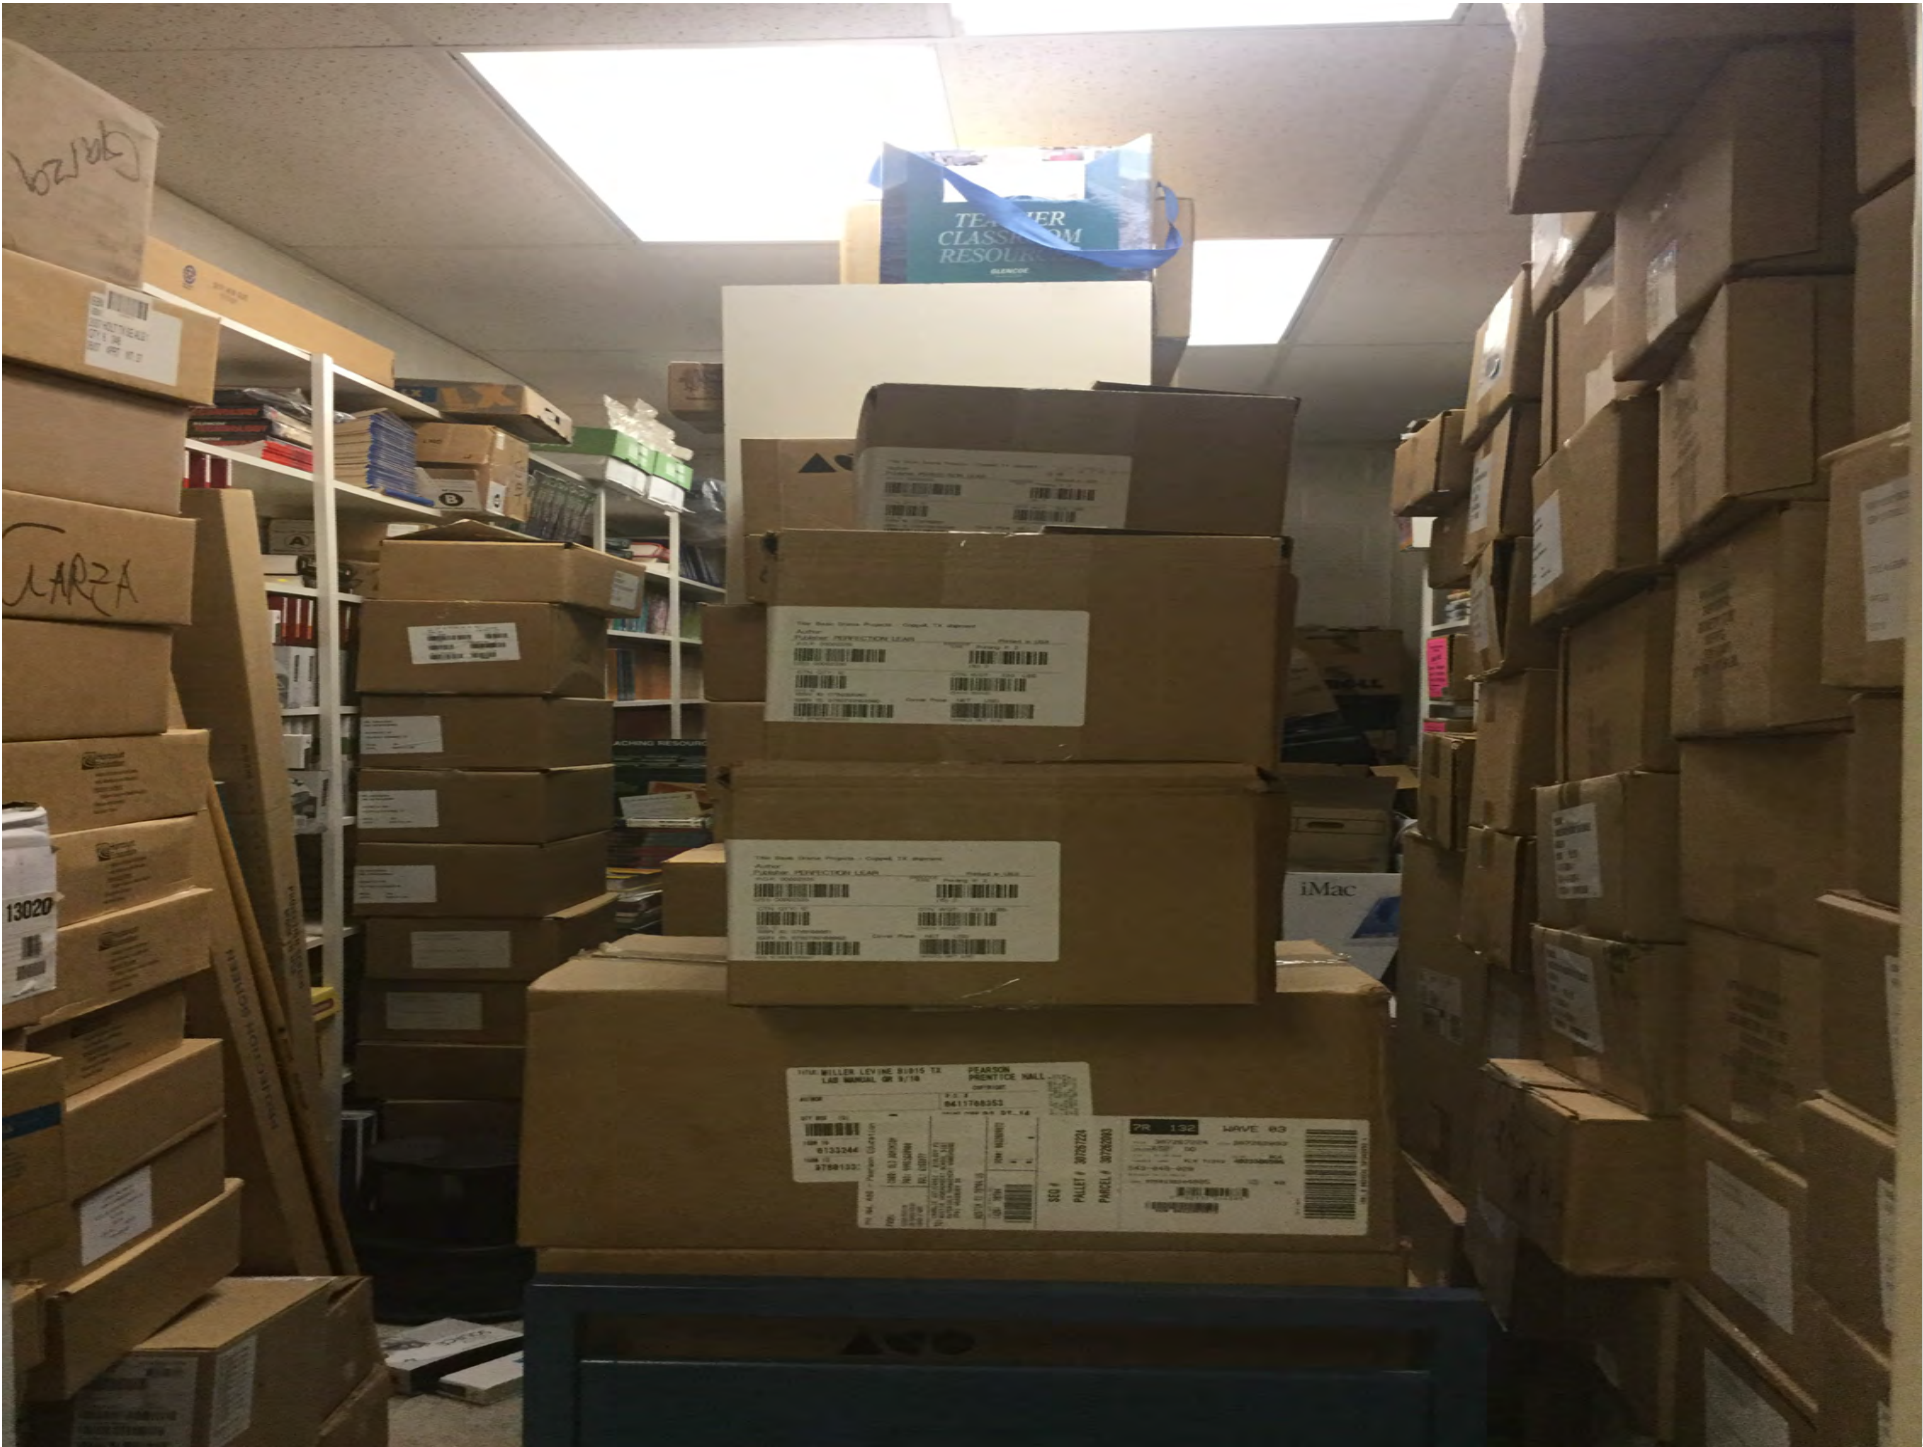
Photo 9. Storage

General building storage is inadequate for needs. They need increased general building storage. Classroom storage for instructors and students is average.
