Educational Suitability Summary Report

Liberal Arts and Science Academy (LASA) – BLDG #014

Date: 8/2/2016

Score 41% Unsatisfactory

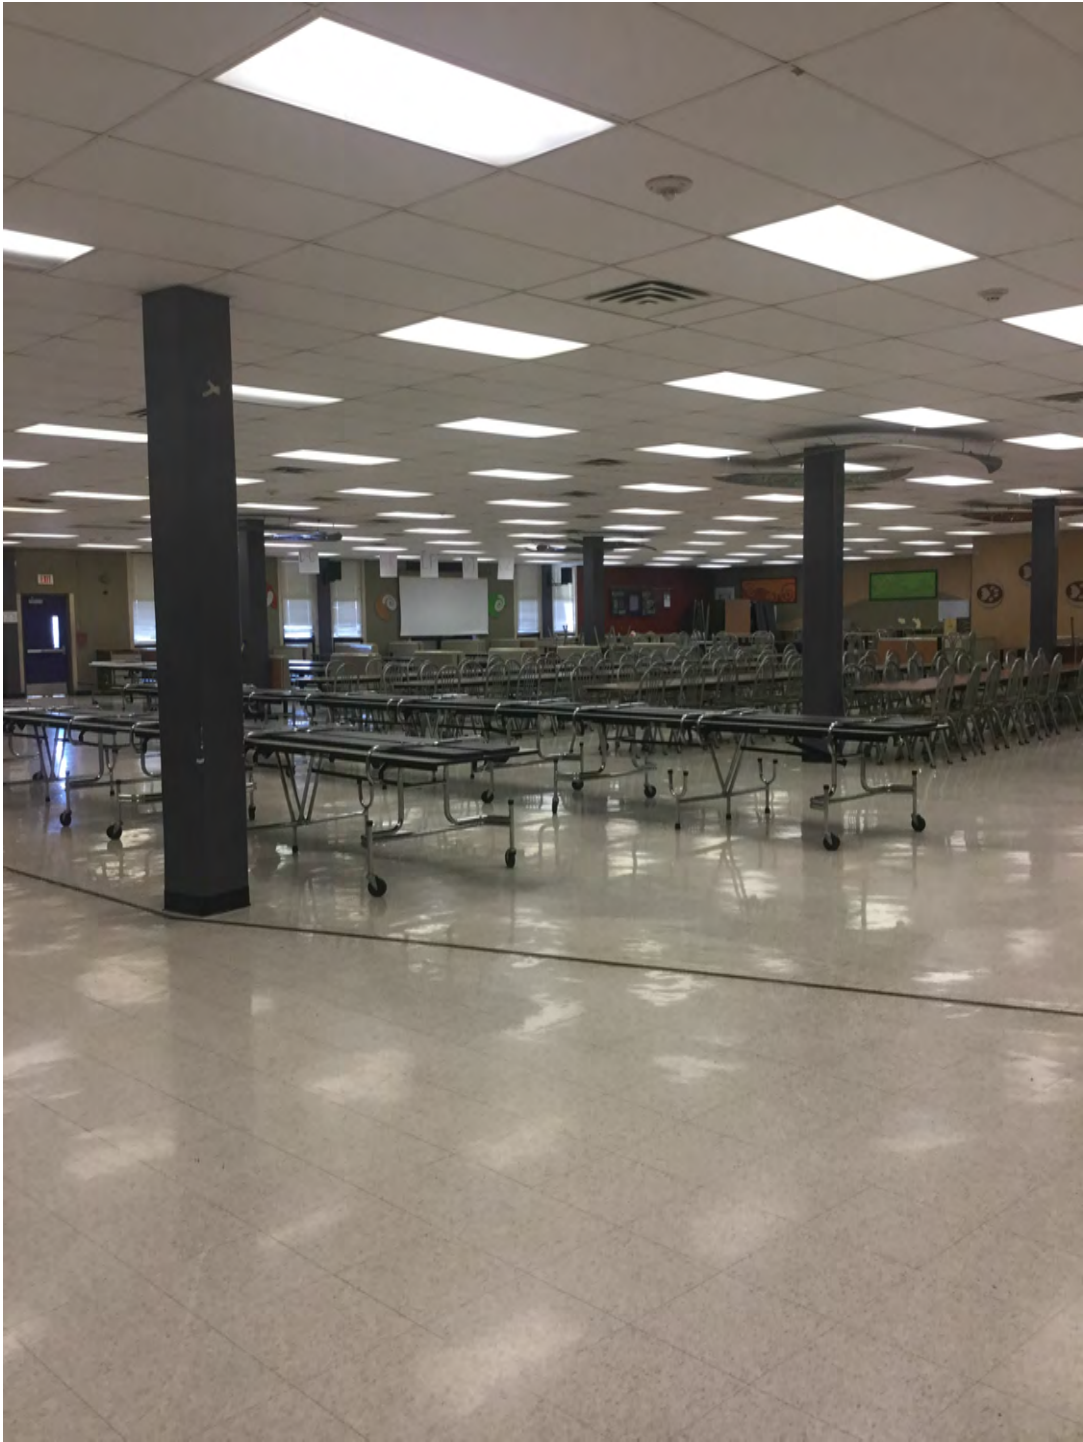
Photo 1. Cafeteria

While those interviewed expressed that the cafeteria is appropriately sized to accommodate a lunch crowd, they said that the space does not function well for meetings and other large assembly uses. To help improve performance for this type of use, staff request a properly functioning, built-in audiovisual system. Acoustics will also need to be improved as sound easily travels to and from the space.

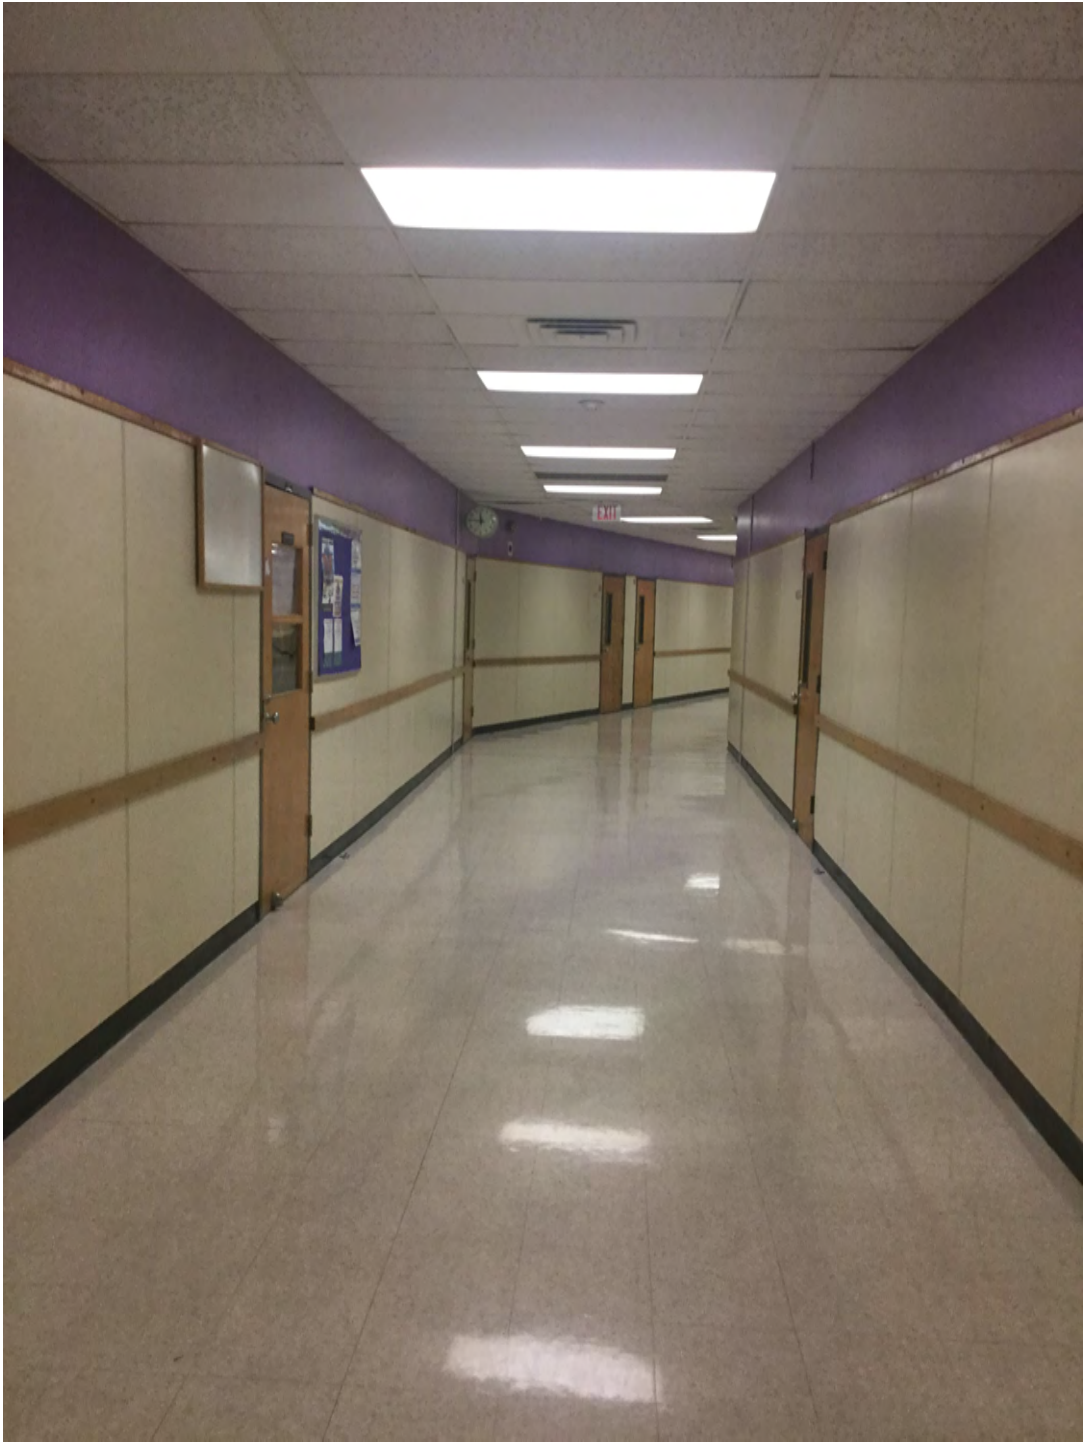
Photo 2. Corridor

The library is located on the second floor and the cafeteria is not easily accessed from the main entrance. The gym is located far from the main entry, but in close proximity to parking for after-hours events. The configuration of the school does not allow for the building to be secured from the public spaces during after-hours use. The general appearance of the school is perceived as poor by the community. Finally, corridors are appropriate in width (+/- 10'-0") and well lit.

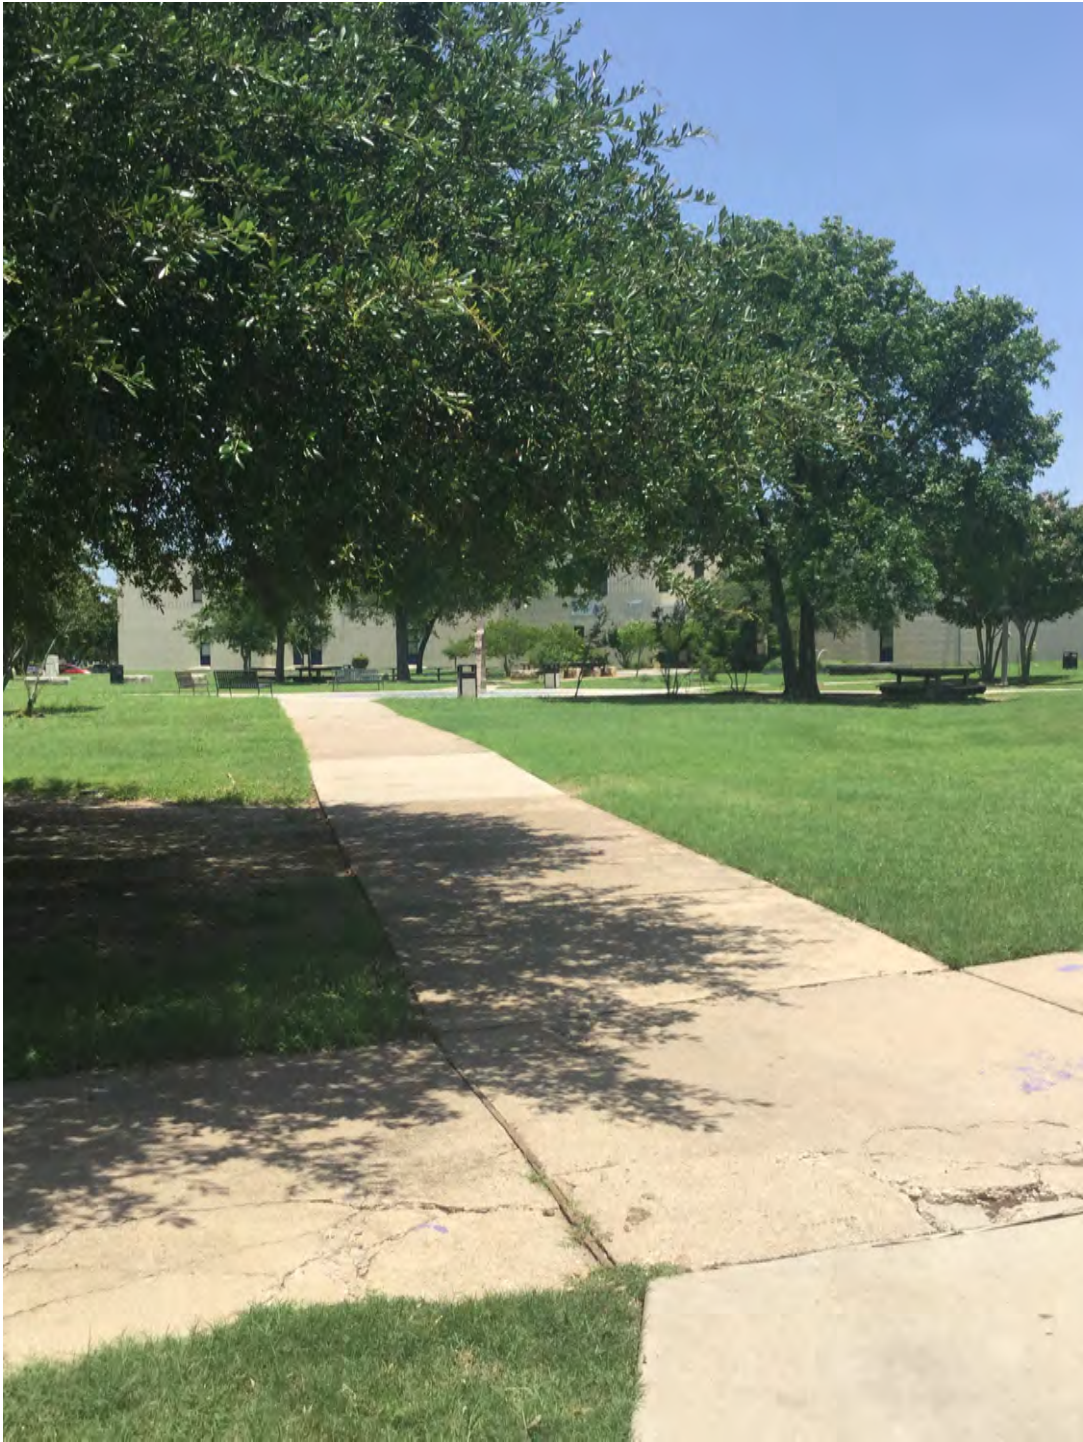
Photo 3. Courtyard

1.2	Are opportunities provided for outdoor learning (outdoor classrooms, gardens, etc.)?		2					Comments	1.00 2.00
	1) Outdoor space exists is not developed 2) Outdoor space for learning exists but not connected to classroom learning areas. 3. Outdoor learning spaces exist and are accessible but not in good condition. 4. Outdoor learning spaces need minor improvements to function well. 5. Outdoor learning spaces are in excellent condition. N/A) Does not apply.							There are many exterior spaces, including a large courtyard space, but they are all poorly maintained.

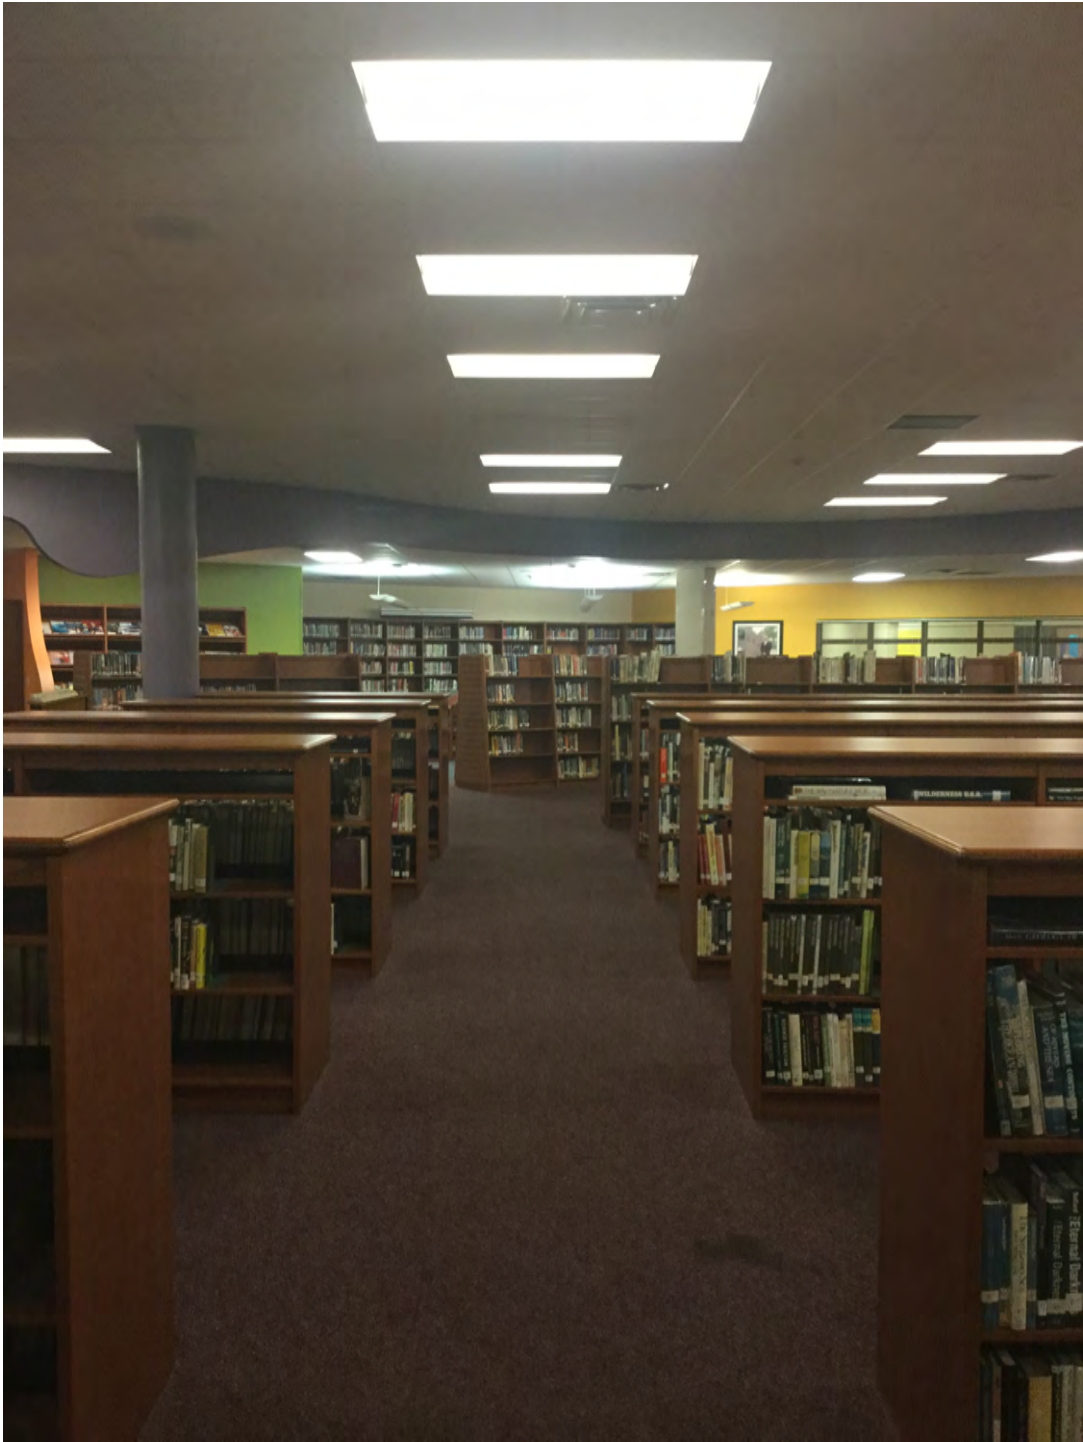
Photo 4. Library

The library is located on the second floor. The furniture is dated and does not accommodate flexibility. The space accommodates social interaction. Library technologies are insufficient in quantity and quality of computers. The Wi-Fi connectivity is a reported issue. Access to power and data outlets is limited which inhibits flexible layouts. More space could be made flexible if desktops were replaced with computer on wheels units.

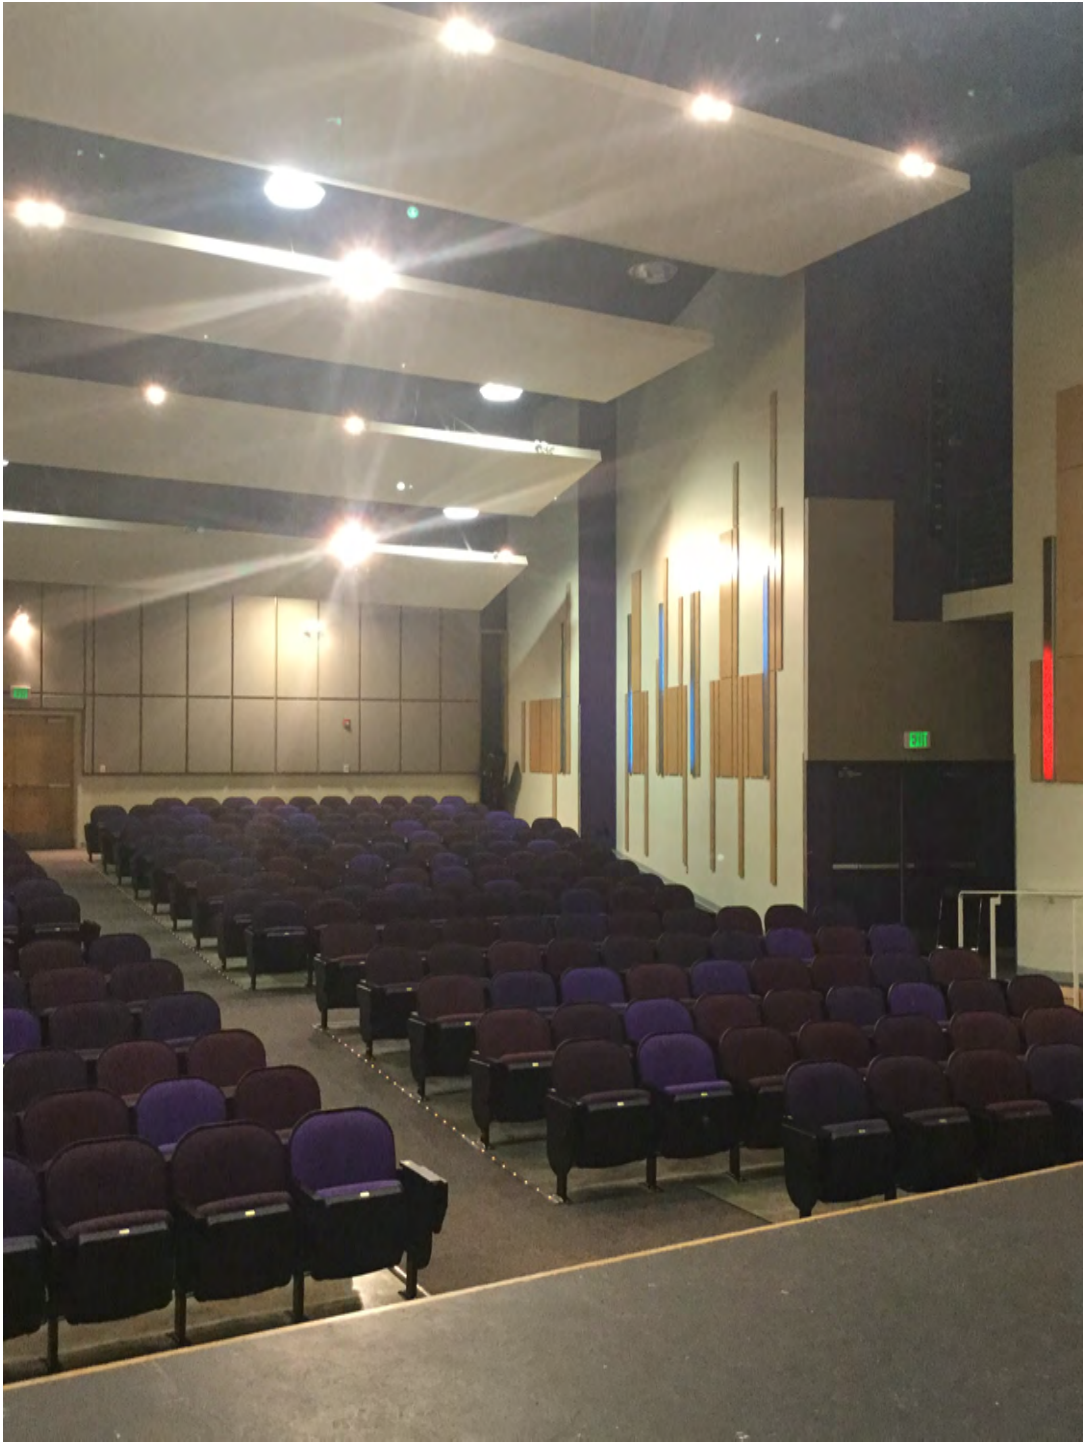
Photo 5. Auditorium

The theater is inadequate in size, as it seats a maximum of five hundred people. The staff indicates that this is not enough seating for a single grade, and particularly limits the number of faculty and parents that can be in attendance. Technology is limited in the theater, and a projection screen is needed. The

stage storage has reached maximum capacity, and items are being stacked to unsafe heights. Half of the theater shop space has been repurposed as storage. The faculty report that acoustics are a reoccurring problem; they report that whistling, potentially from wind, is constantly present in the performance space.

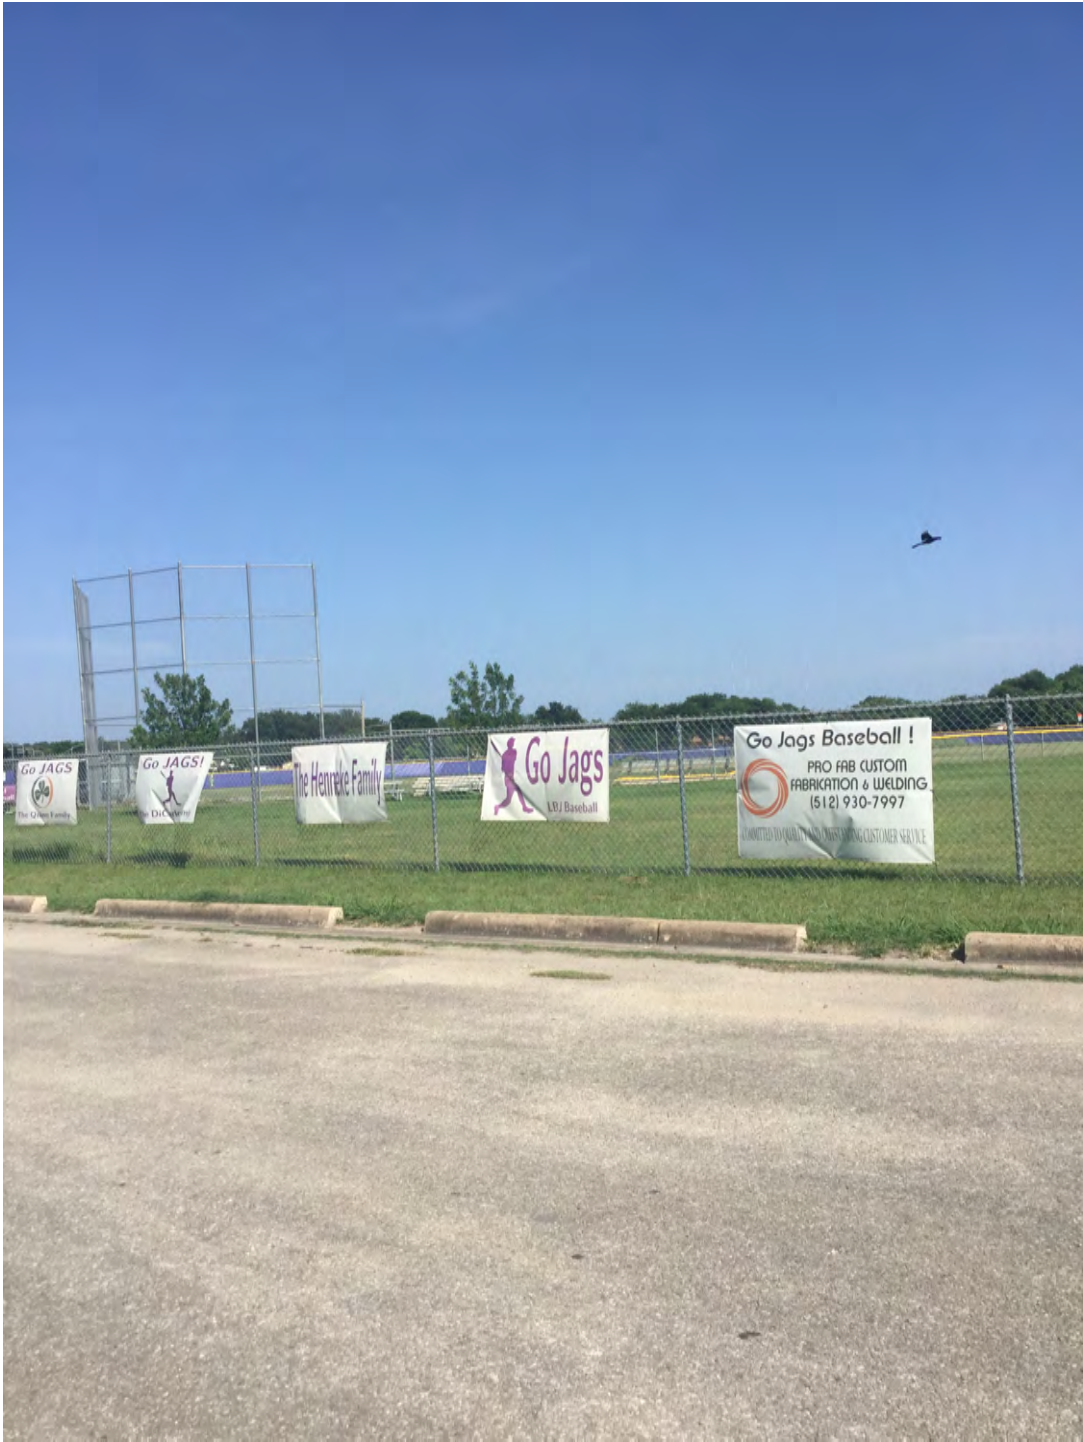
Photo 6. Playfields

The available sports fields are another reported concern. No dedicated soccer field is available, and mobile goals are used on other fields during off-hours. Only one of three football fields is irrigated and well maintained. The principal indicates that no field meets UIL certification. The others frequently flood and are riddled with potholes resulting in student injuries. It was reported that due to poor site security, the fields and equipment are regularly vandalized. Only one storage shed exists for outdoor athletics equipment. Most equipment (i.e. sleds, goals, etc.) are dated and in poor condition. The tennis courts are in adequate condition but need minor cosmetic repairs.

1.3	Are outdoor play spaces and playfields adequate in size and configuration?		2					Comments	1.00 2.00
	1) Outdoor play space exists, not developed 2) Outdoor play space exists but is not connected to gym or other athletic support areas or is too small. 3. Outdoor play spaces exist, are connected to other athletic areas, are the right size, but are not in good condition. 4. Outdoor play spaces need minor improvements to function well. 5. Outdoor play spaces are in excellent condition. N/A) Does not apply.							The fields are poorly maintained and ill equipped.

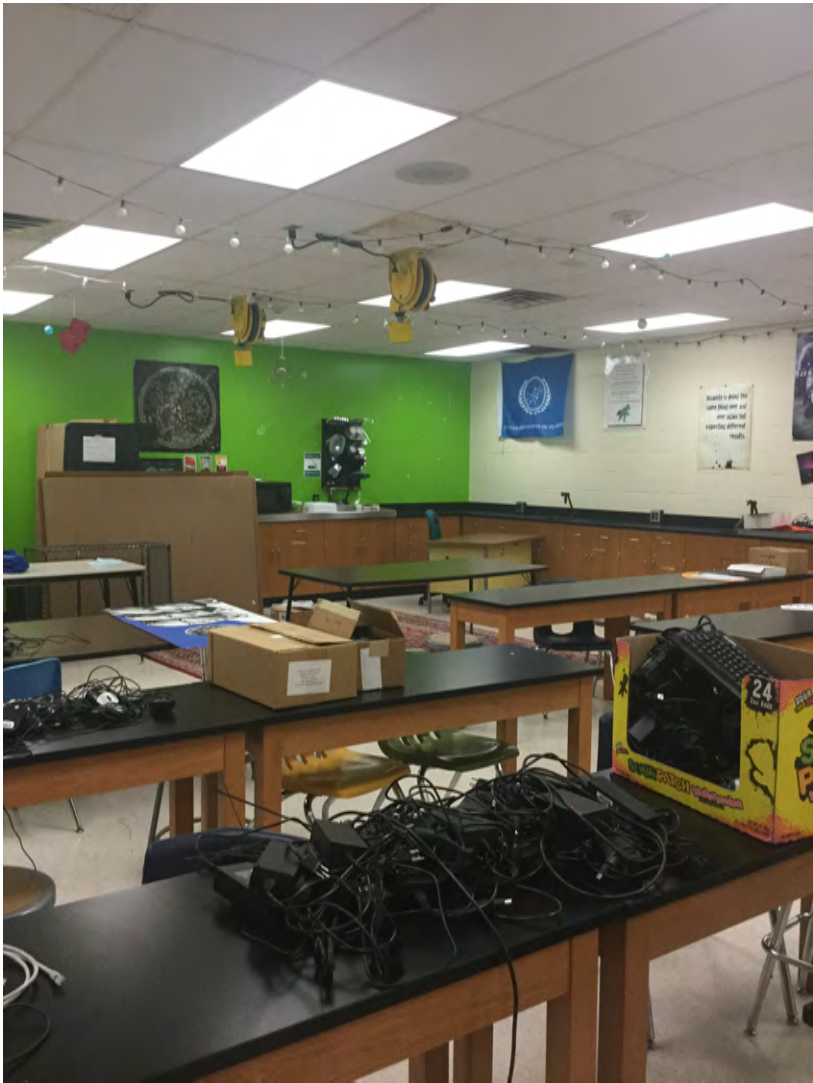
Photo 8. Science

3.4	Are Science Classrooms/Labs appropriately configured per the ed spec?		2					Comments	1.00 2.00
	1) Very unsatisfactory 2) Unsatisfactory 3) Neutral 4) Satisfactory 5) Very Satisfactory N/A) Does not apply. (Elementary schools)							The science classrooms are appropriately configured, but undersized and poorly equipped.

3.5	Are Science Classrooms/Labs support areas appropriately configured per the ed spec?	1						Comments	1.00 1.00
	1) Very unsatisfactory - Support spaces are disconnected from served spaces, too small, do not meet needs 2) Unsatisfactory - Support spaces are connected, but too small, do not meet needs 3) Average - Connected, moderate size, but need some renovations or updates 4) Good - Connected, good size, meets needs, functions well 5) Very good - connected, generous size, nice condition, functions appropriately N/A) Does not apply. (Elementary schools)							There are chemicals stored in unsecure cabinets and inadequately ventilated. There is a general lack of secure storage as aged casework is the primary storage mode.

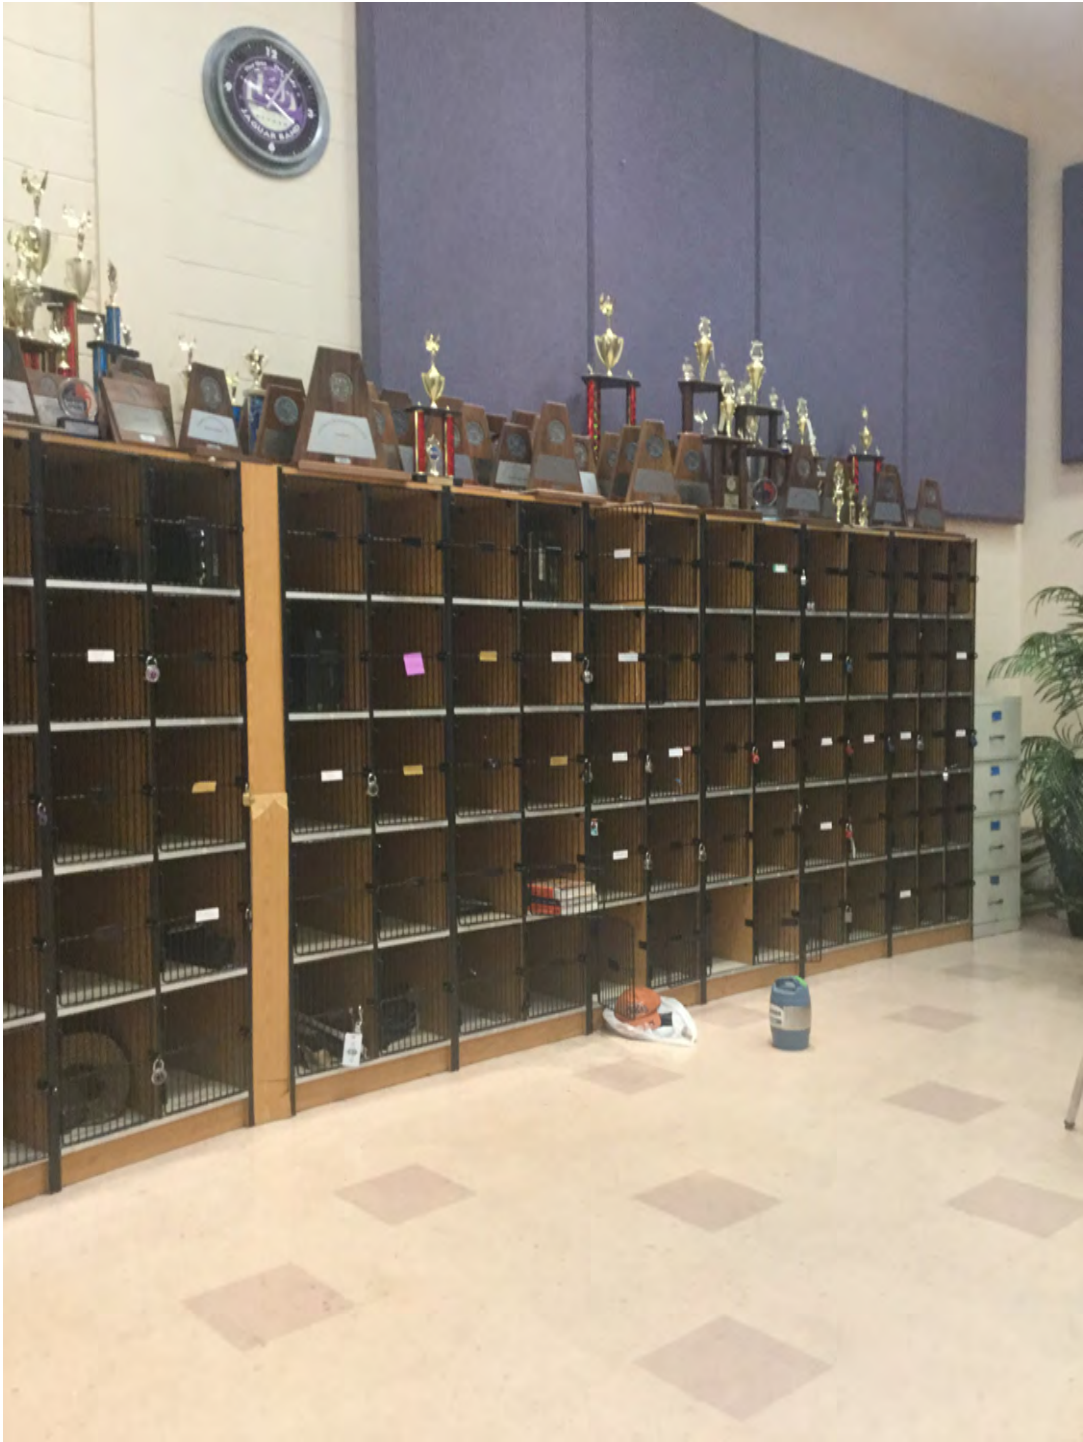
Photo 9. Fine Arts

3.8	Are music, drama, or performance spaces appropriately configured per the ed spec?				4			Comments	1.00 4.00
1) Very unsatisfactory 2) Unsatisfactory 3) Average 4) Good 5) Very good N/A) Does not apply.								The areas are appropriately configured, but very undersized.

1) Very unsatisfactory 2) Unsatisfactory 3) Average 4) Good 5) Very good N/A) Does not apply.								The visual arts classes are held in retrofitted music rooms, are undersized, and have no natural light.
