Educational Suitability Summary Report

Lanier High School – BLDG 004

Date: 08/4/2016 (REV1 – 12/13/2016 – Survey & CAC bond proposal)

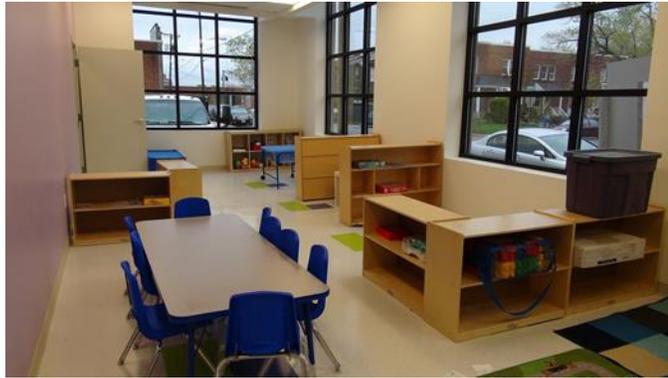
- b. Re purpose the inner office area/Lab
 - i. build space for a simulated pre-school setting that is designed for multiple learning stations (science, art, construction, dramatic play) with built in bookshelves for a children's book library/reading nook

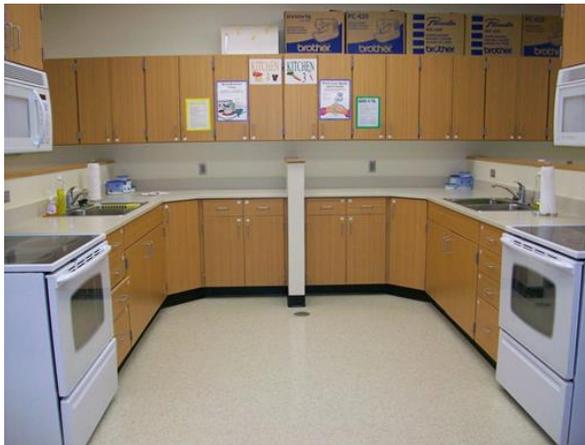
- ii. Kitchen Lab areas (2-3 kitchens depending on space) includes oven, stovetop, refrigerator, prep counter areas, dishwashers, storage and shelving - can be used for both health science and child development for health/ nutrition and food labs
