Educational Suitability Summary Report

McCallum High School – BLDG 005

Date: 7/12/2016 (REV1 – Survey & CAC comments)

Austin ISD Educational Suitability Assessment Criteria

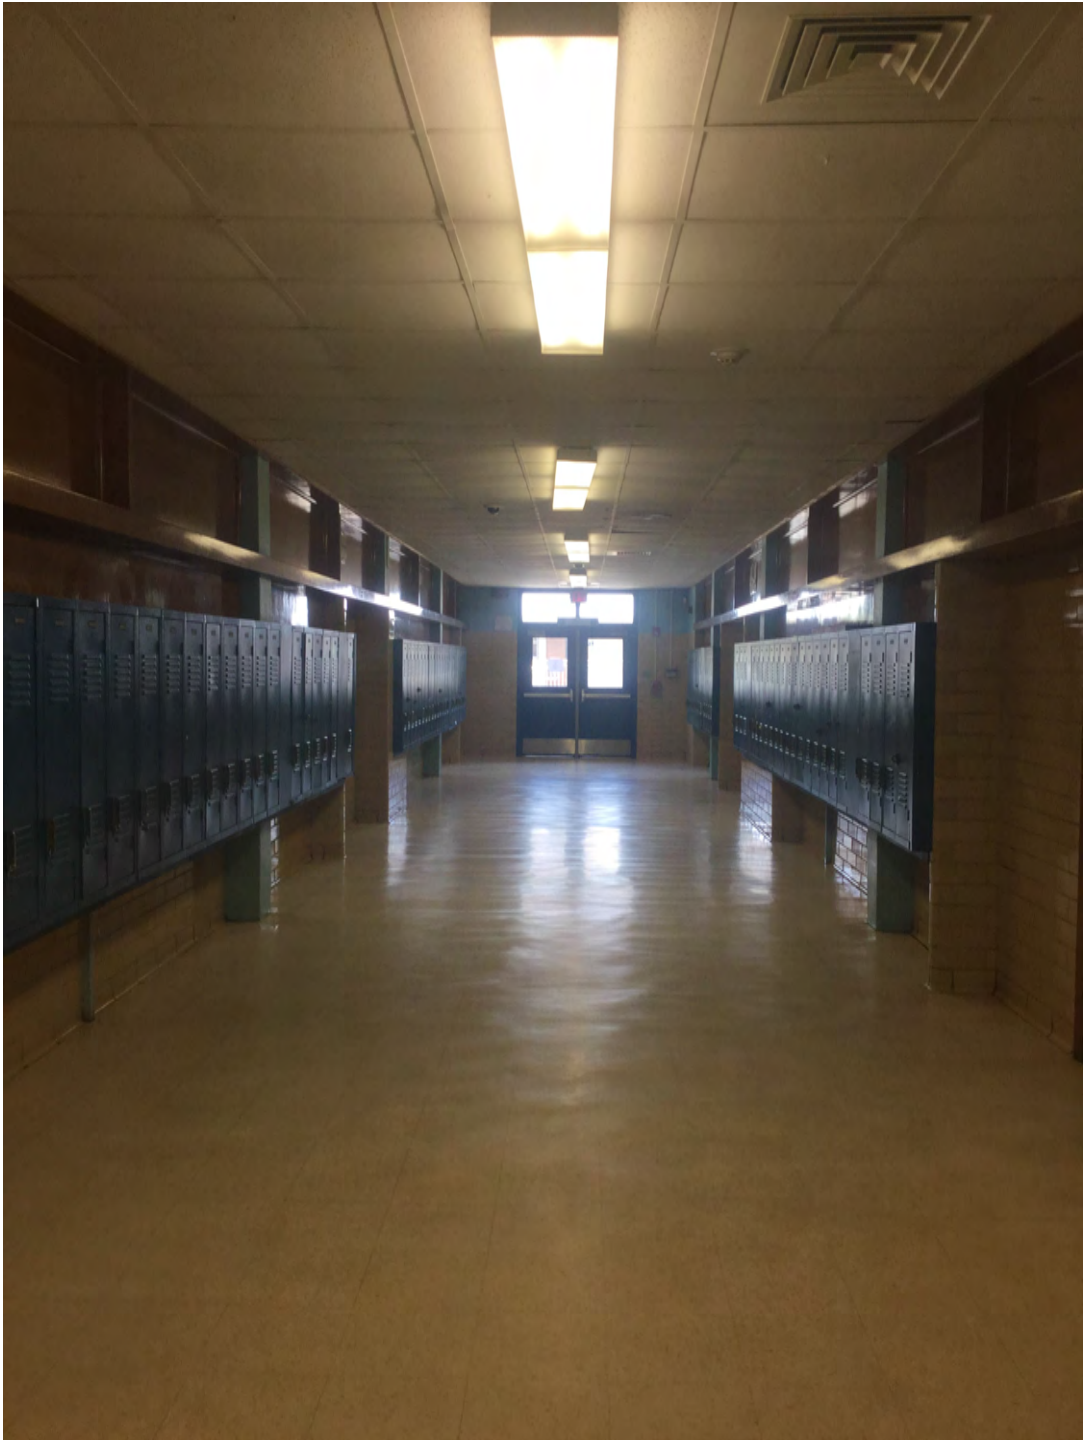
2.1 Corridor

2 - General Building		1	2	3	4	5	N/A	6.50	
2.1	Are interior circulation routes wide enough to safely and effectively accommodate student movement?				4			Comments	0.50 2.00

1) Primary circulation is 5'-0" to 6'-0" wide. 2) Primary circulation is 6'-0" to 7'-0" wide 3) Primary circulation is 7'-0" to 8'-0" wide 4) Primary circulation is 8'-0"-10'-0" wide 5) Primary circulation is 10'-0"+ wide N/A) Does not apply.

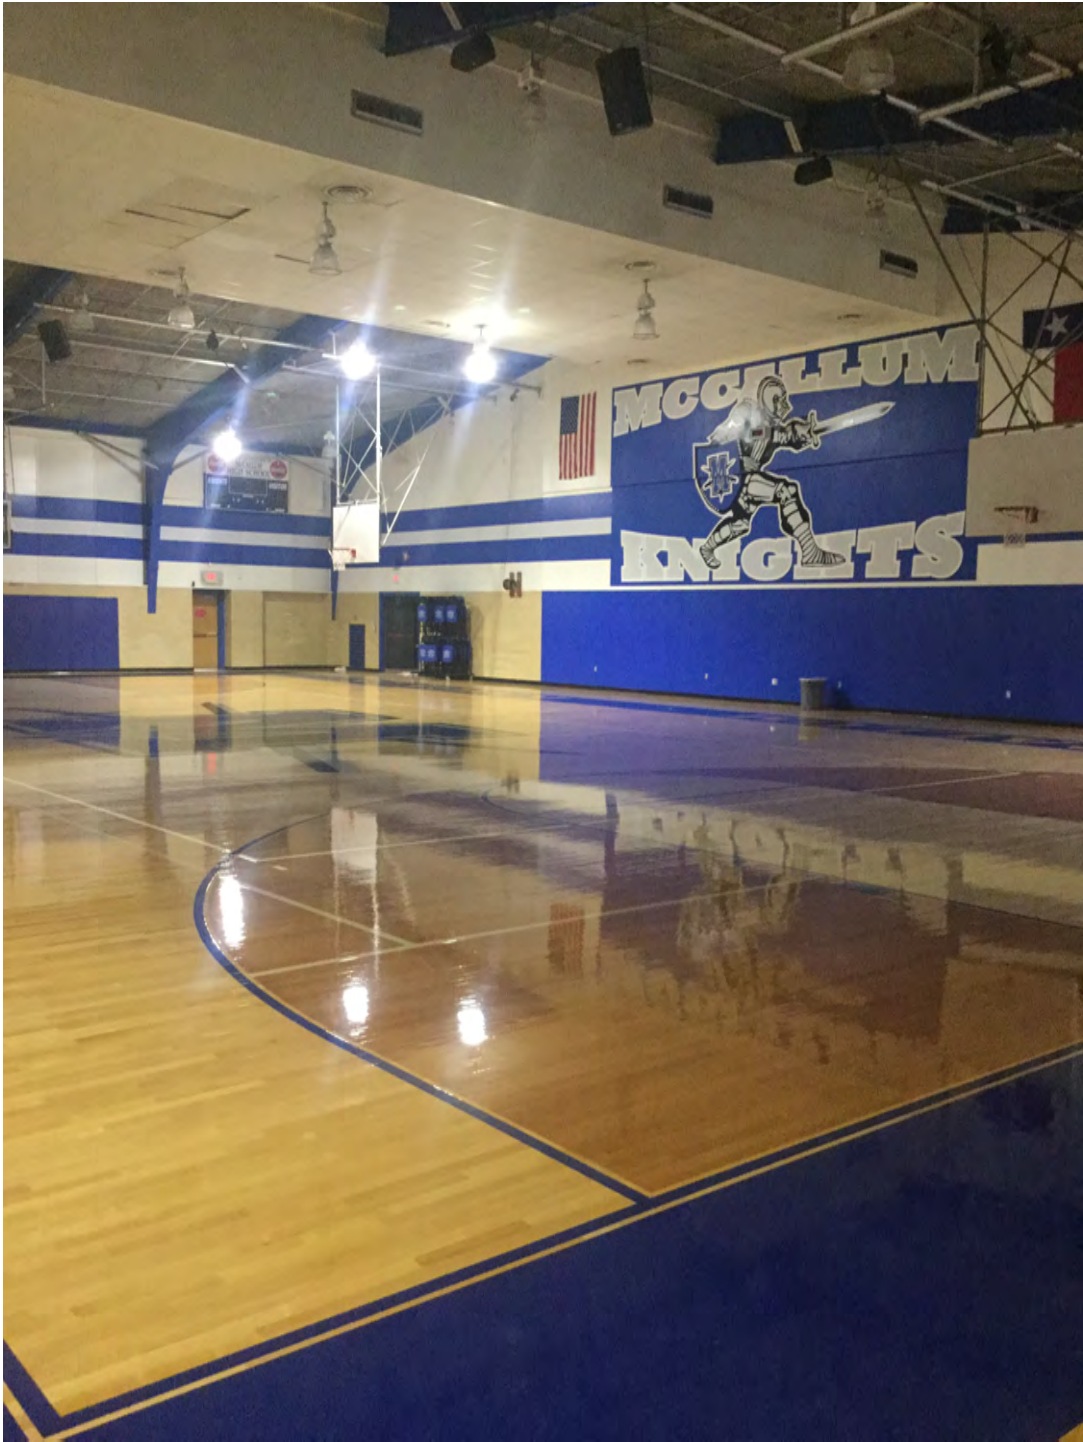
3.6 Gym

3 - Academic & Co-Curricular Support - Continued		1	2	3	4	5	N/A		
3.6	Are Physical Education and Athletic spaces appropriately configured per the ed spec?				4			Comments	1.00 4.00

1) Very unsatisfactory 2) Unsatisfactory 3) Average 4) Good 5) Very good N/A) Does not apply.								The physical education and athletic spaces were under construction at the point of the assessment. From observations in the field, these spaces were good.

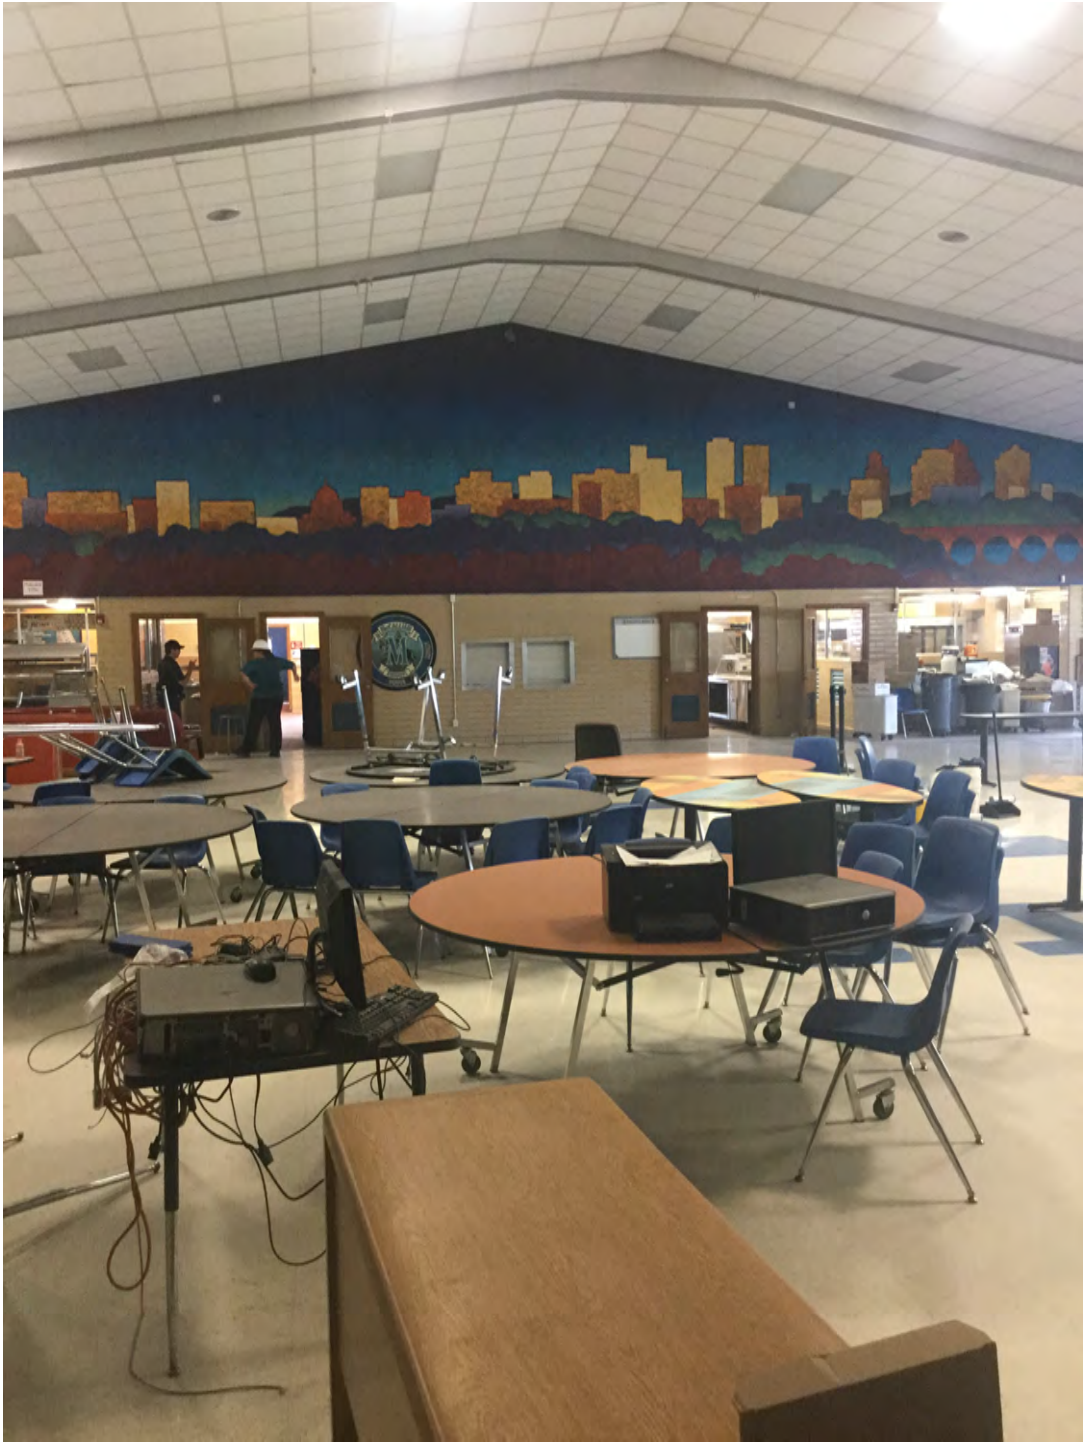
3.16 Cafeteria

3.16	Are the student dining facilities appropriately configured?			3				Comments	1.00 3.00
1) Very unsatisfactory - Too small, poor circulation, inflexible seating in poor condition 2) Unsatisfactory - Too small or inadequate circulation, seating in poor condition 3) Average - moderate size, with adequate circulation, seating in okay condition 4) Good - good size, adequate circulation, seating in good condition 5) Very good - good size, adequate circulation, seating in good condition, with more than one option for eating space (ex: connection to outdoor eating space) N/A) Does not apply.								The dining facilities are in good condition, but the principal expressed concern about overcrowding at lunch. <i>CAC comment: Cafeteria is too small for enrollment.</i>

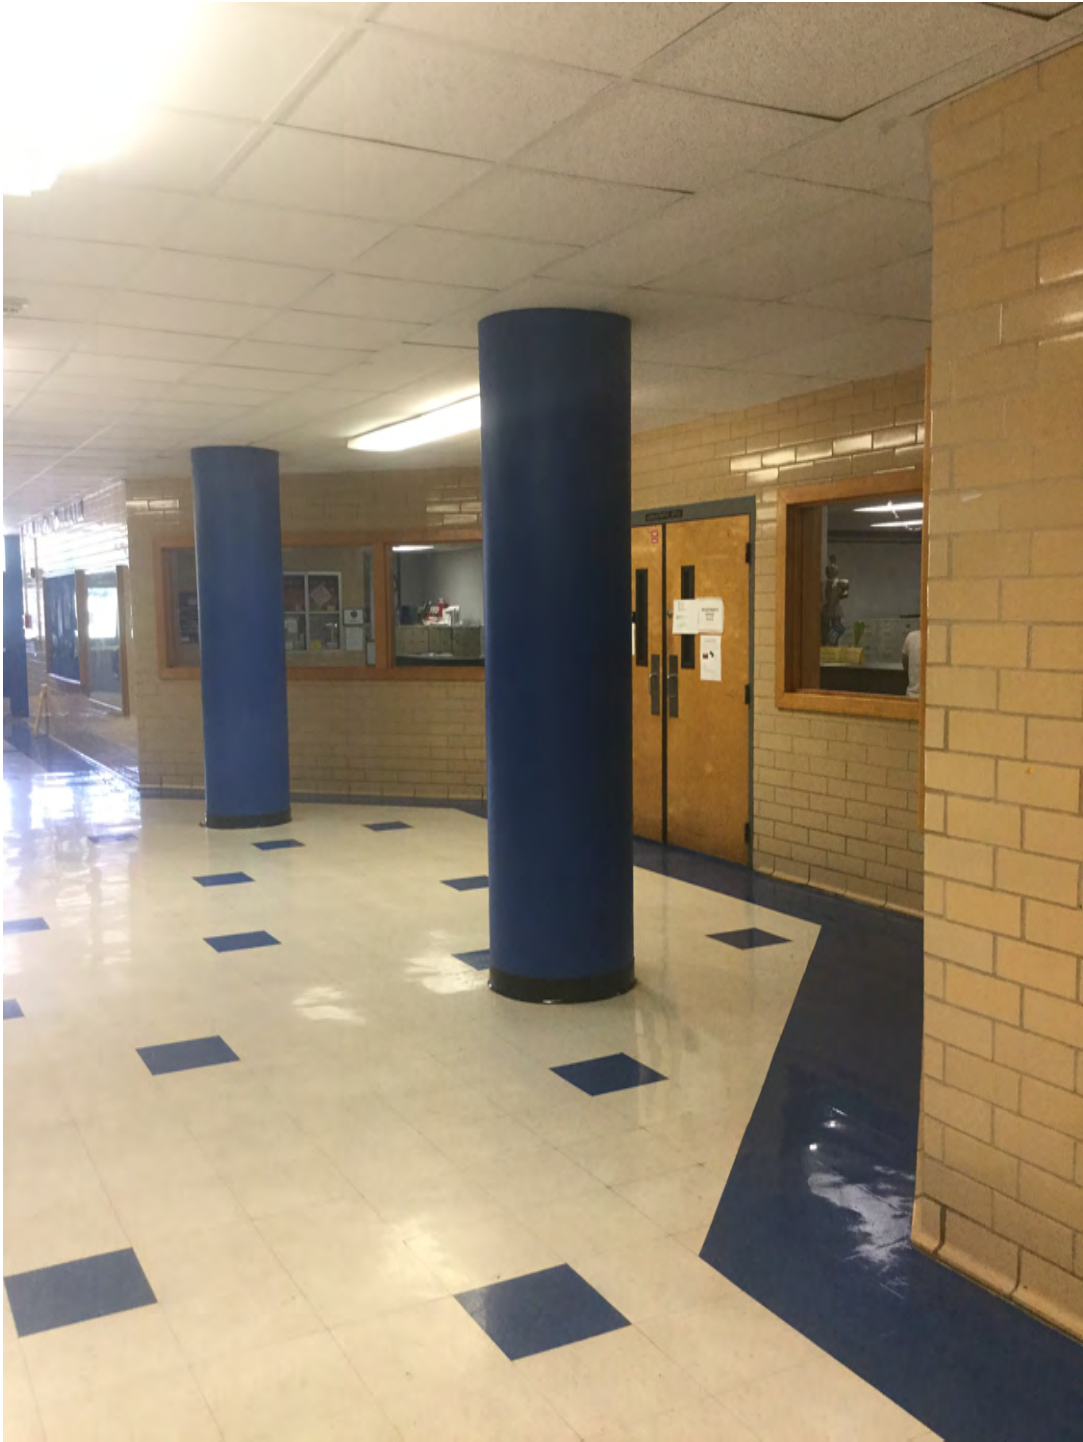
6.3 Main Entrance

The location of the central office does not create a secure vestibule; however it is located at the front entry of the building with views of the front doors. The principal expressed that there is

difficulty securing the building due to the numerous building entries. The video camera coverage of the school needs to be increased both inside and outside of the building. Interior transparency is average for faculty supervision within the school. The site lighting is also limited near the portables, in front of the gym, and at the northeast side of the school.

6.3	Is the main office properly located and configured with a secure vestibule to the main corridor?			3				Comments	1.00 3.00
	1) Very unsatisfactory - No secure vestibule, office located far from main entry. Allows visitors access to school unsupervised. 2) Unsatisfactory - No secure vestibule, office located somewhat far from main entry, minimal supervision of visitors. 3) Average - Office close to entry, views of front door, but no secure vestibule 4) Good - Office is well-located with a secure vestibule, but needs updates 5) Very good - Office well-located with secure vestibule and all appropriate security features. N/A) Does not apply.

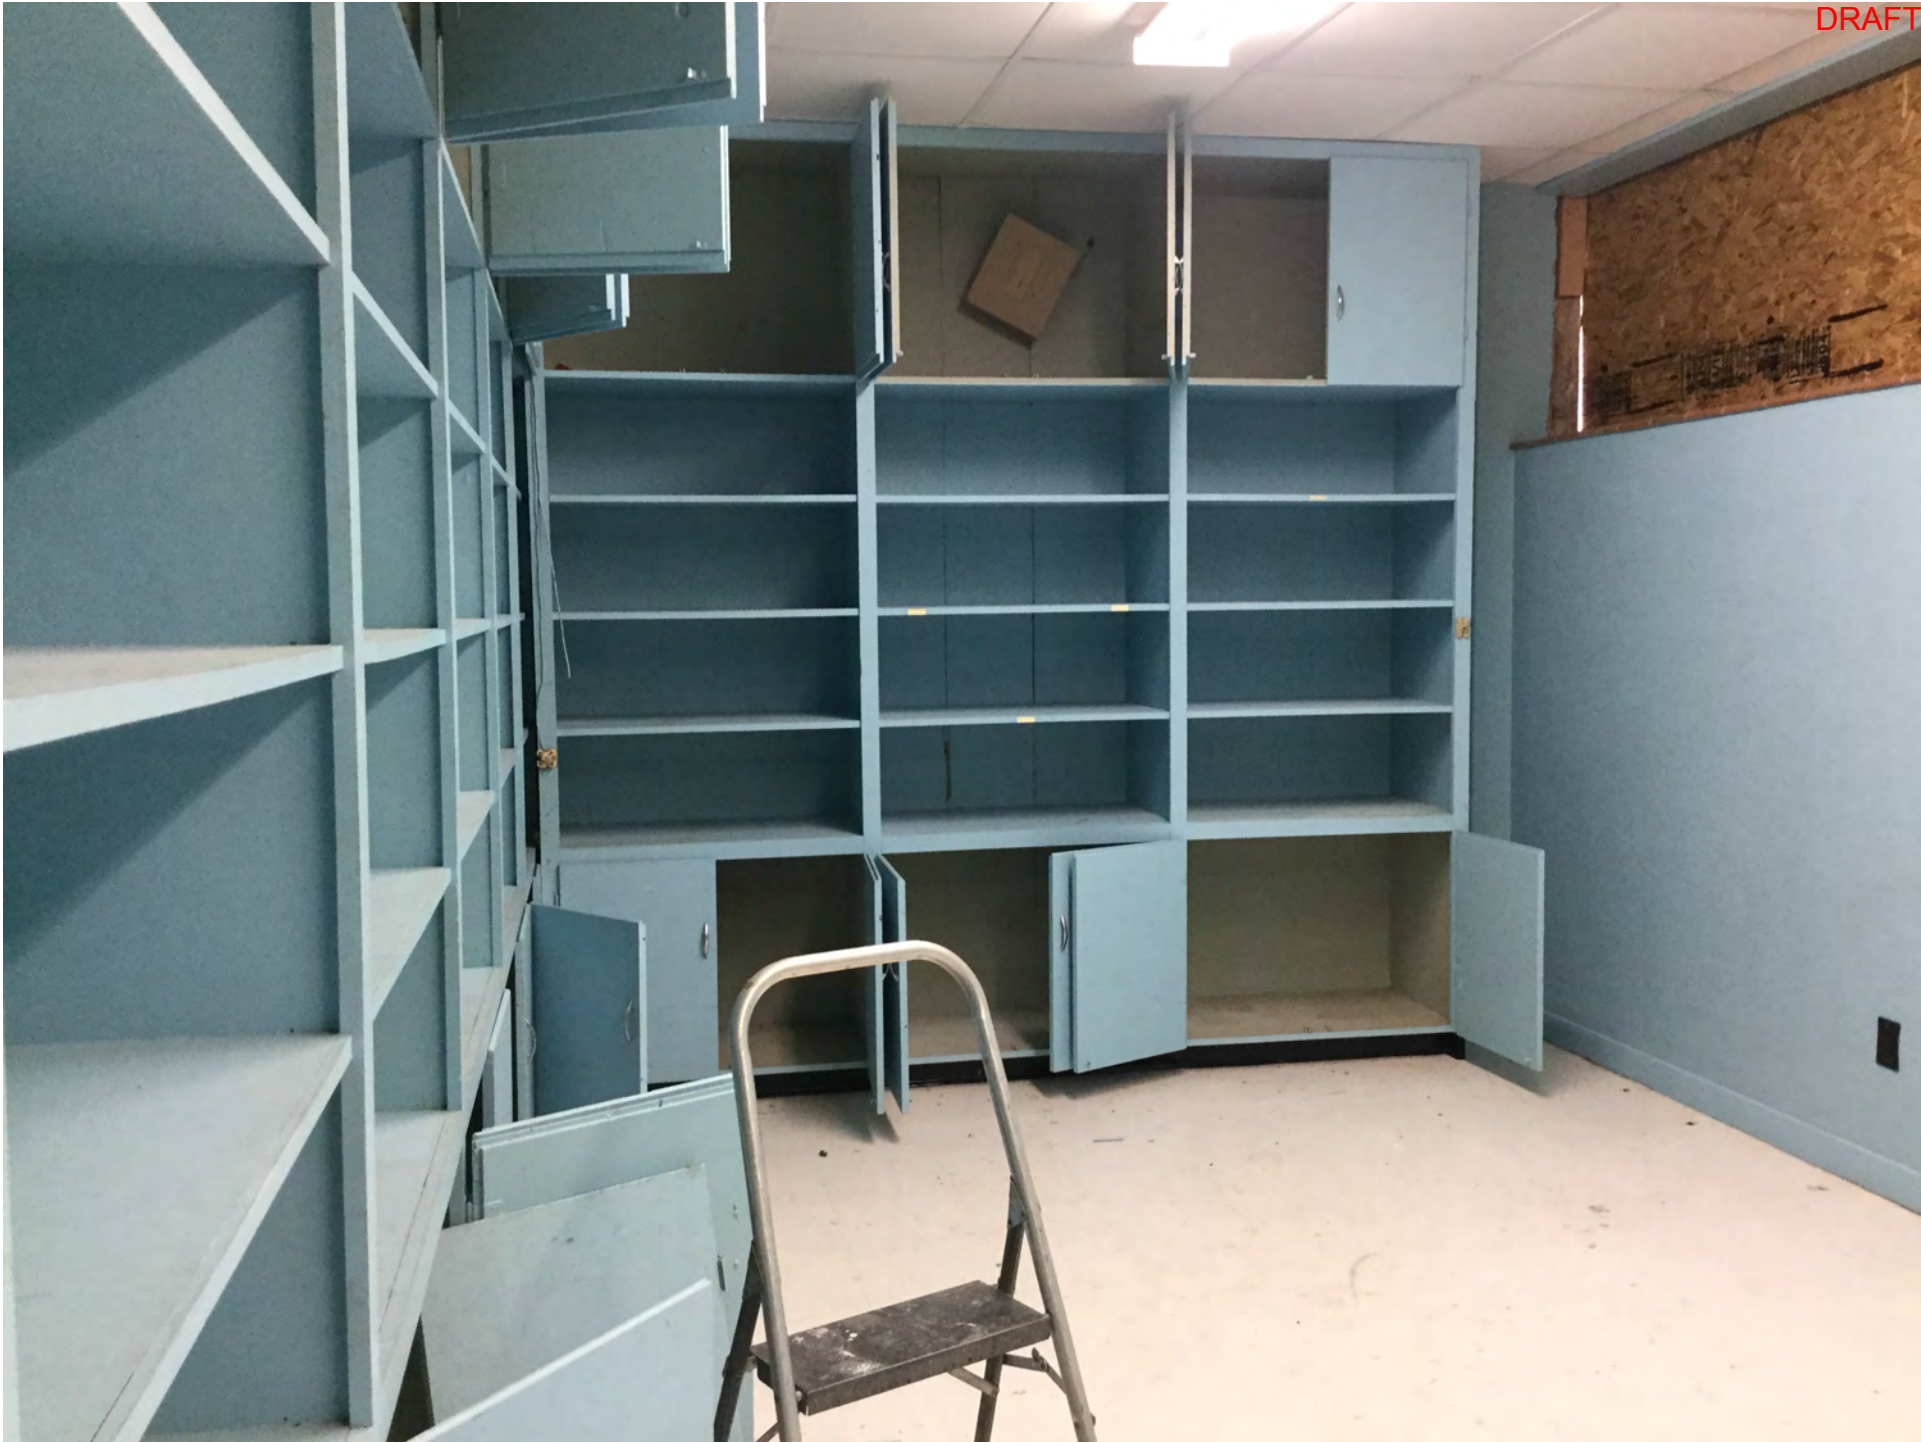
8.1 Storage

The general building storage is a low average score. While there are dedicated storage rooms for different wings of the building, these are not large spaces. The classroom storage is older and needs to be increased. The newer additions to the campus feature ample storage and cabinets in classroom spaces.

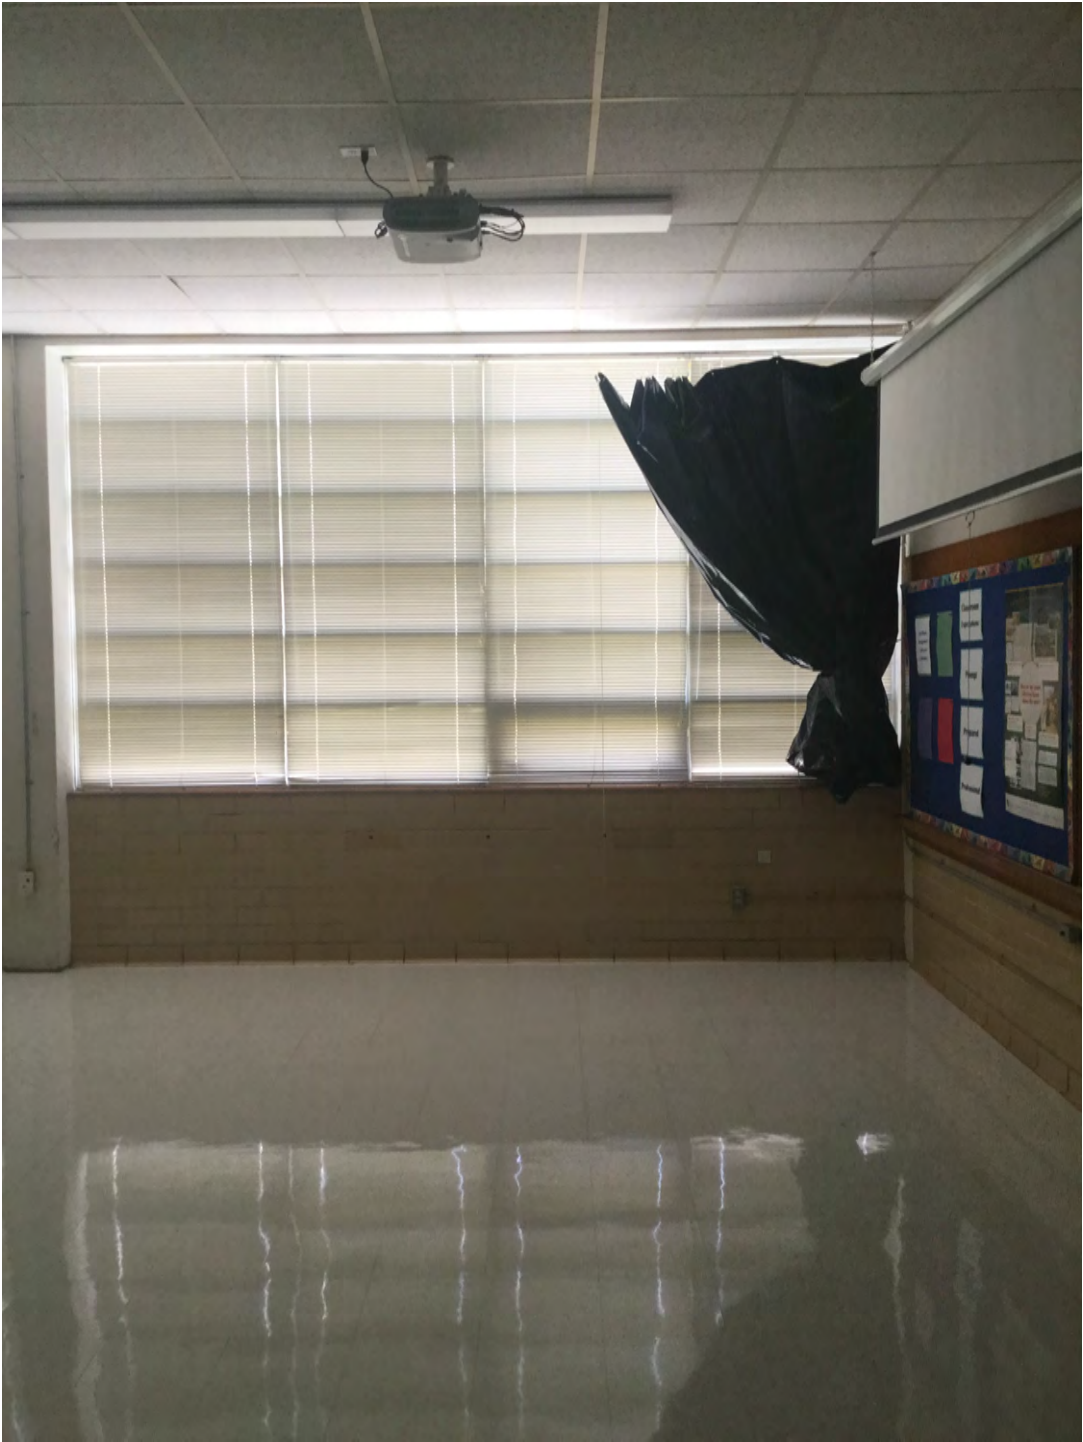
10.3 Natural Light

The classrooms have individual thermal controls; however, the windows do not have effective natural light control. The teachers have resorted to making homemade black-out curtains in some classrooms to mitigate this issue when using projectors. The artificial lighting controls varied among spaces. The older classrooms feature only one light switch, while newer spaces have several controls including dimming capabilities.

The quality of the artificial lighting is appropriate for classroom functions, while the acoustics are inadequate as HVAC makes noticeable sounds in the classrooms. The majority of classrooms have ample natural light and exterior views into courtyard spaces.
