Educational Suitability Summary Report

Reagan High School

Date: 07/25/2016 (Rev 1 – 12/12/2016 - Survey Responses)

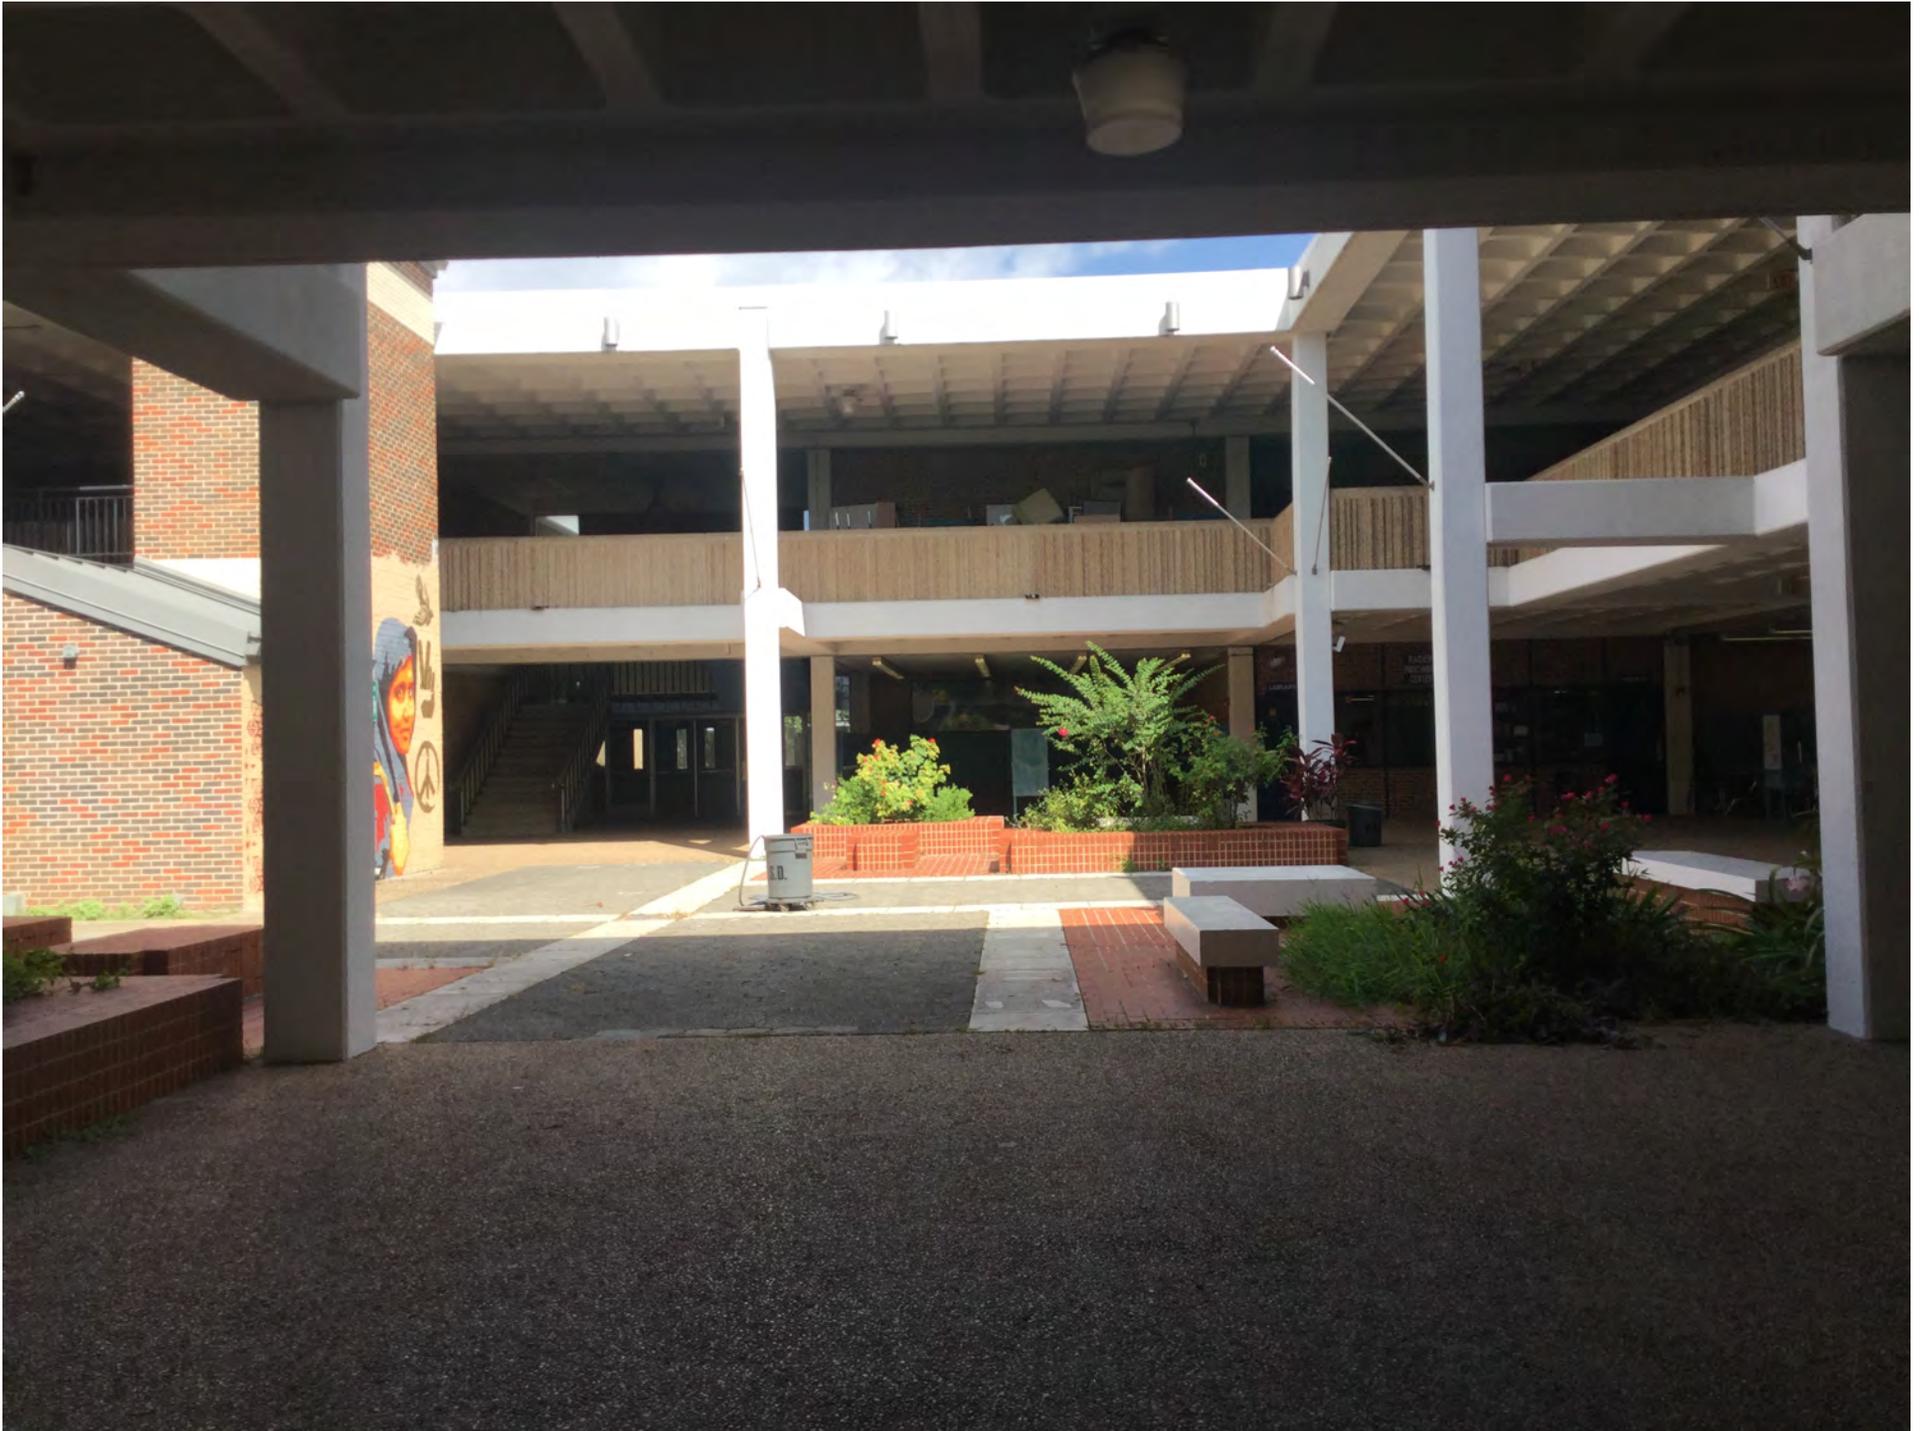
Photo 1. Outdoor spaces

1.2	Are opportunities provided for outdoor learning (outdoor classrooms, gardens, etc.)?				4			Comments 1.00 4.00
1) Outdoor space exists is not developed 2) Outdoor space for learning exists but not connected to classroom learning areas. 3. Outdoor learning spaces exist and are accessible but not in good condition. 4. Outdoor learning spaces need minor improvements to function well. 5. Outdoor learning spaces are in excellent condition. N/A) Does not apply.		See Image 1

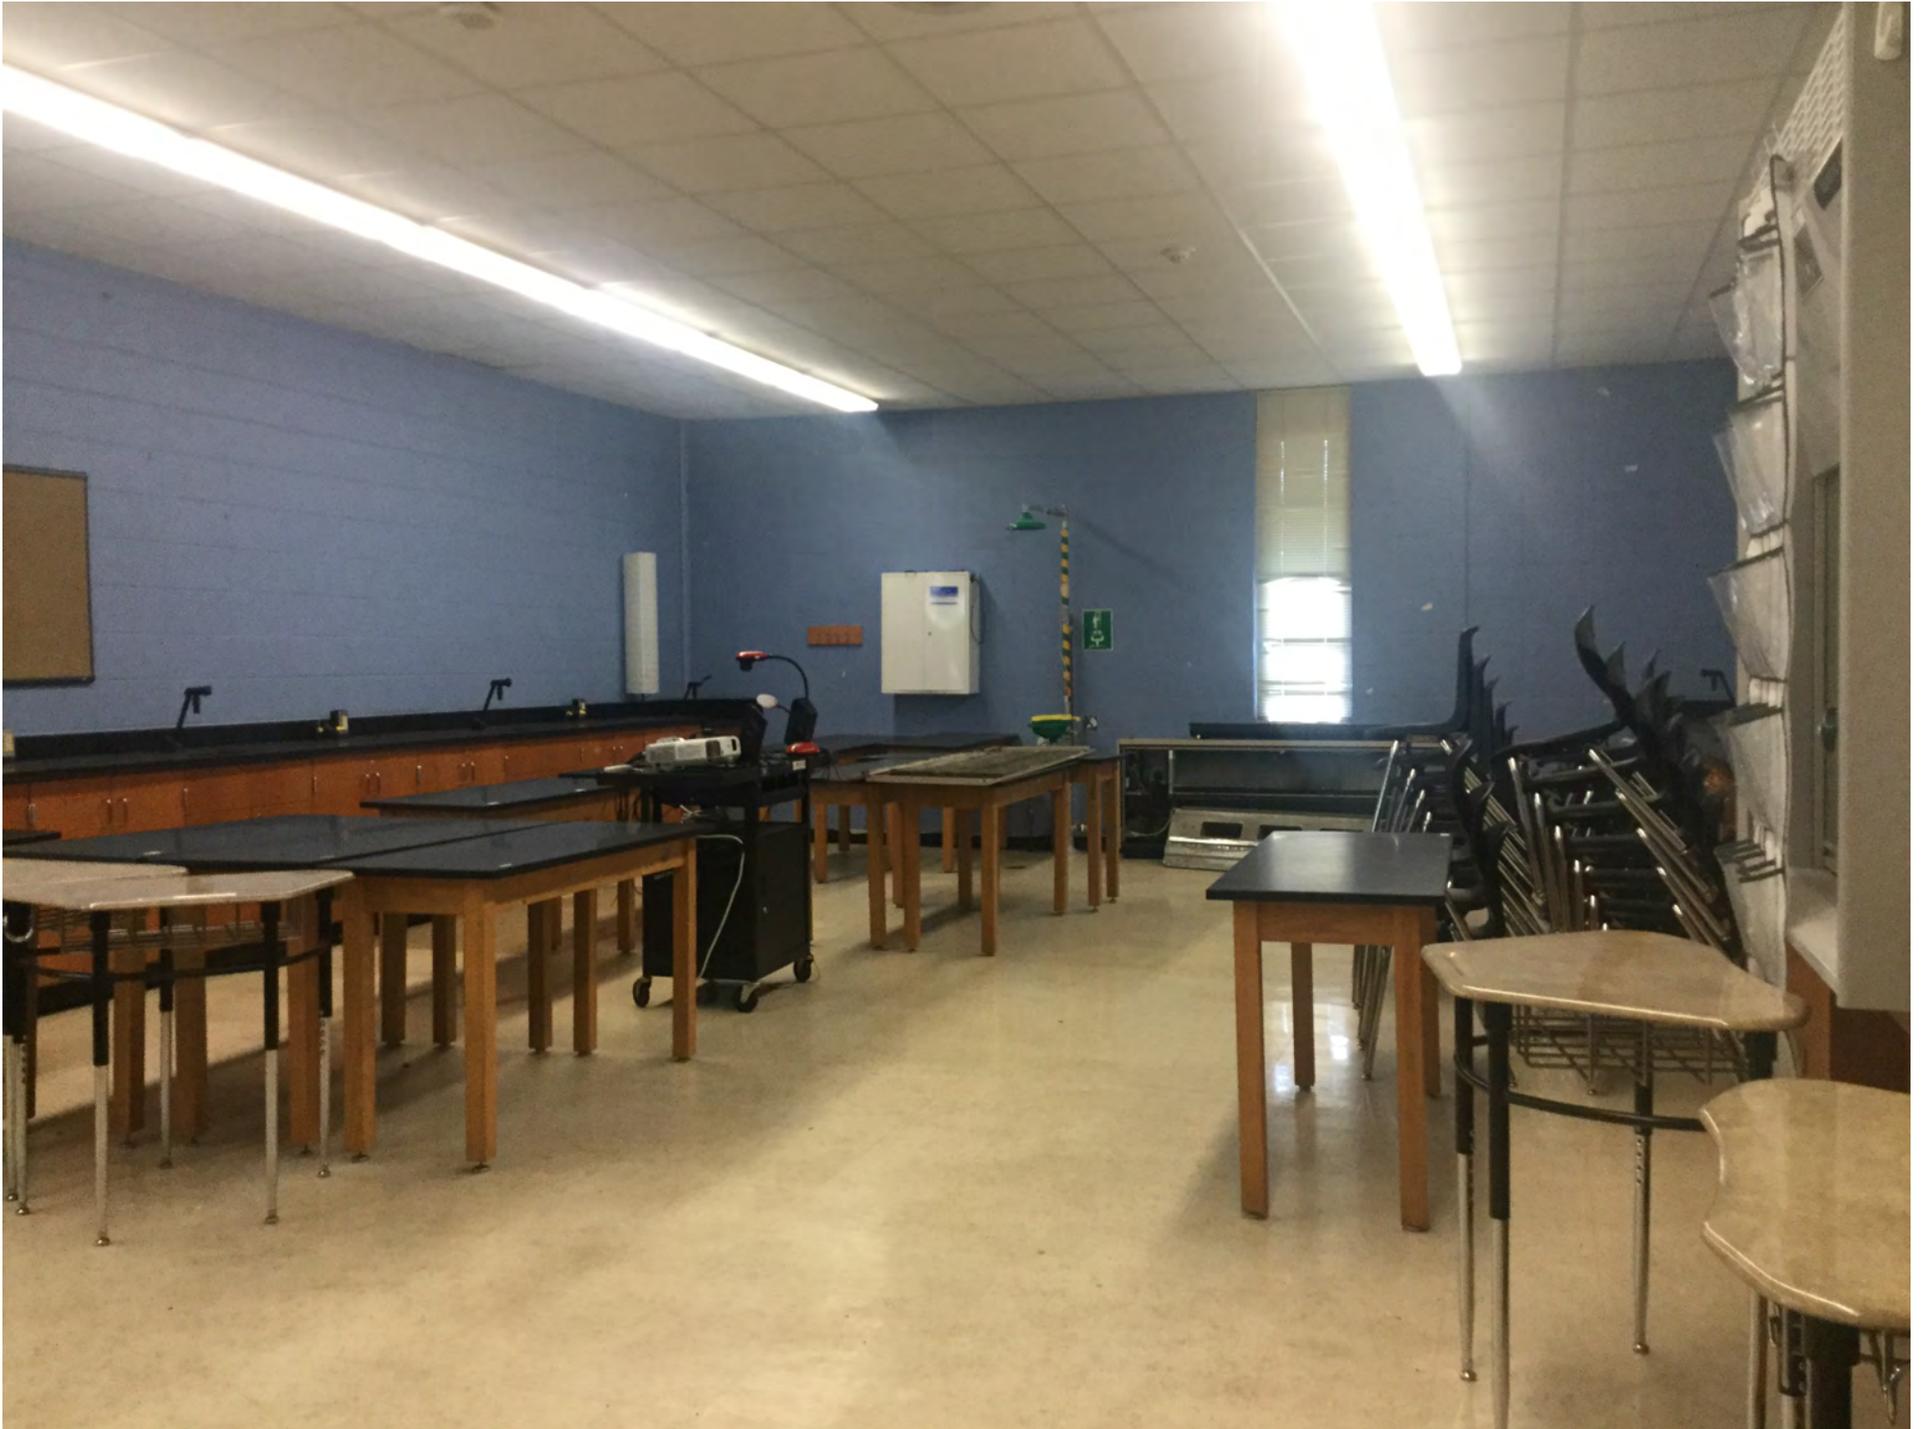
Photo 3. Science Lab

3.4	Are Science Classrooms/Labs appropriately configured per the ed spec?			3				Comments	1.00	3.00
1) Very unsatisfactory 2) Unsatisfactory 3) Neutral 4) Satisfactory 5) Very Satisfactory N/A) Does not apply. (Elementary schools)		The furniture is dated, and there is a strong odor in science classroom wing. The healthscience room is in in good condition, however, the space is not adequate.								
See Image 3

3.5	Are Science Classrooms/Labs support areas appropriately configured per the ed spec?		2					Comments	1.00	2.00
1) Very unsatisfactory - Support spaces are disconnected from served spaces, too small, do not meet needs 2) Unsatisfactory - Support spaces are connected, but too small, do not meet needs 3) Average - Connected, moderate size, but need some renovations or updates 4) Good - Connected, good size, meets needs, functions well 5) Very good - connected, generous size, nice condition, functions appropriately N/A) Does not apply. (Elementary schools)		The classrooms are lacking storage, more cabinets are needed.

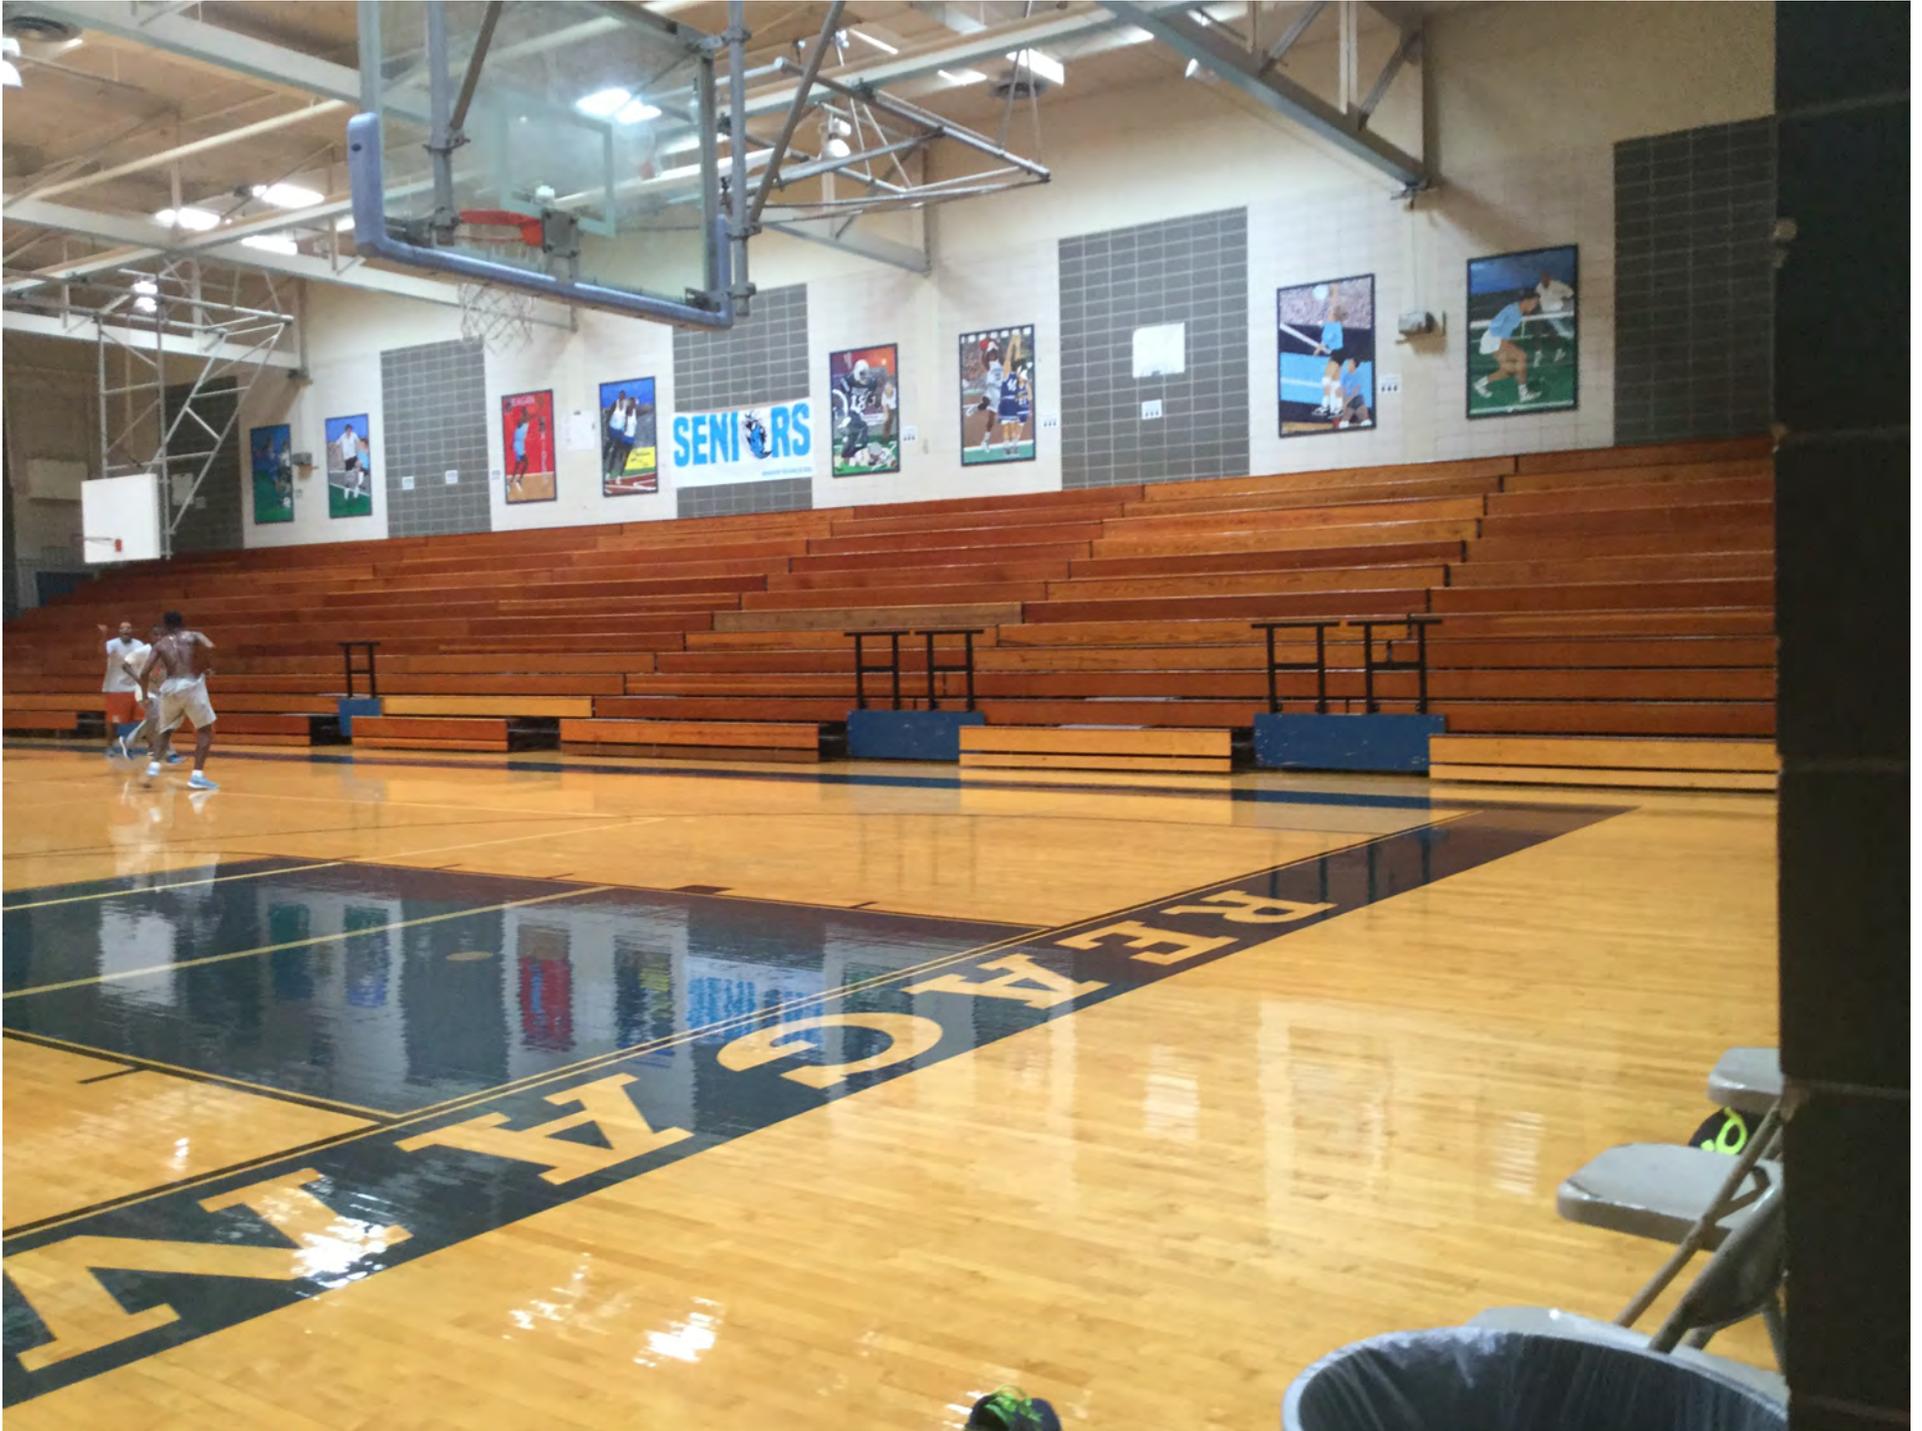
Photo 4. Gymnasium

3 - Academic & Co-Curricular Support - Continued		1	2	3	4	5	N/A		
3.6	Are Physical Education and Athletic spaces appropriately configured per the ed spec?			3					
<p>1) Very unsatisfactory</p> <p>2) Unsatisfactory</p> <p>3) Average</p> <p>4) Good</p> <p>5) Very good</p> <p>N/A) Does not apply.</p>								Comments	1.00 3.00
								The athletic spaces need new bleachers and flooring needs maintenance.	
See Image 4

The issues with athletic spaces are the gym flooring and bleachers, which need to be repaired or replaced. The 'gymnasium' is not finished and is currently unusable. Locker rooms need updating with fencing between the PE locker room into sections for use by baseball, wrestling and soccer teams. The old restrooms in the locker rooms need to be renovated. The weight room is too small and needs to be

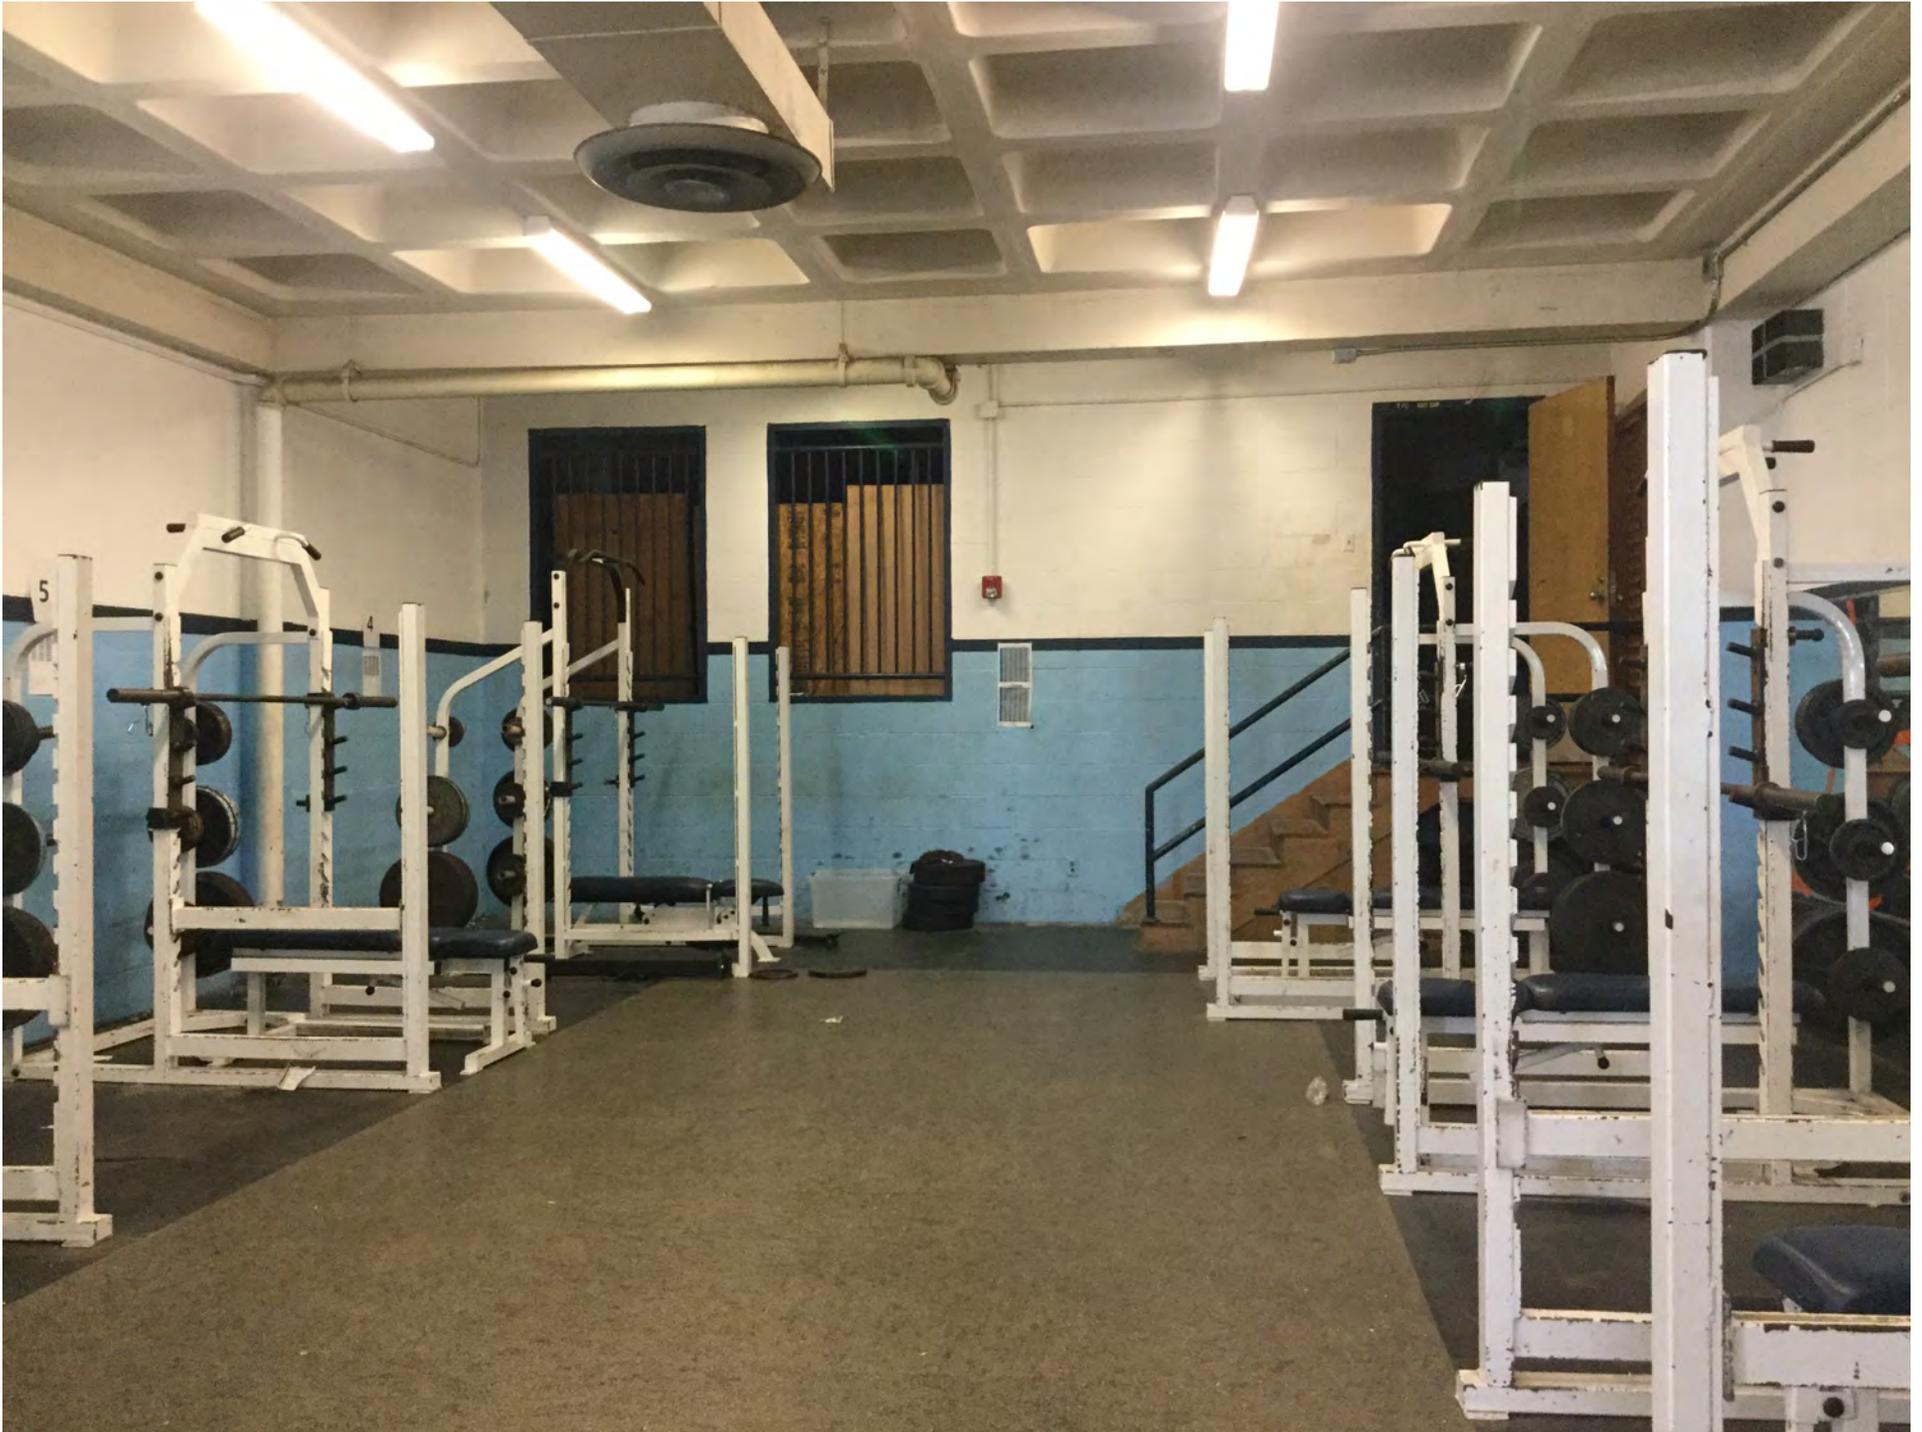
Photo 5. Weight Room

3.7	Are Physical Education and Athletic support spaces appropriately configured per the ed spec?		2						
<p>1) Very unsatisfactory - Support spaces are disconnected from served spaces, too small, do not meet needs</p> <p>2) Unsatisfactory - Support spaces are connected, but too small, inadequate for needs</p> <p>3) Average - Connected, moderate size, but need some renovations or updates to function well</p> <p>4) Good - Connected, good size/layout, meets needs/functions well</p> <p>5) Very good - connected, generous size, nice condition, functions appropriately</p> <p>N/A) Does not apply.</p>								Comments	1.00 2.00
								The weight room too small and the locker rooms are dated. There is a confusing layout with a number of corridors to the different gyms.	
See Image 5

double the current size. The equipment needs to be replaced, as it is not currently safe for the students. Also, the current exterior field is insufficient and need more space on the practice field. Currently, there is only one field space for all the sports, and the middle of the field is worn and needs to be resurfaced, either adding an automatic sprinkler system or replacing it with artificial turf. Staff mentioned that there are donors interested in funding this. More storage and practice rooms are needed in the band hall and percussion room as well as a shower and locker room. The current testing room is in the assistant principal's office and has mold. In addition, the campus has pest issues that include rodents, raccoons, squirrels, possum, and a flea infestation.

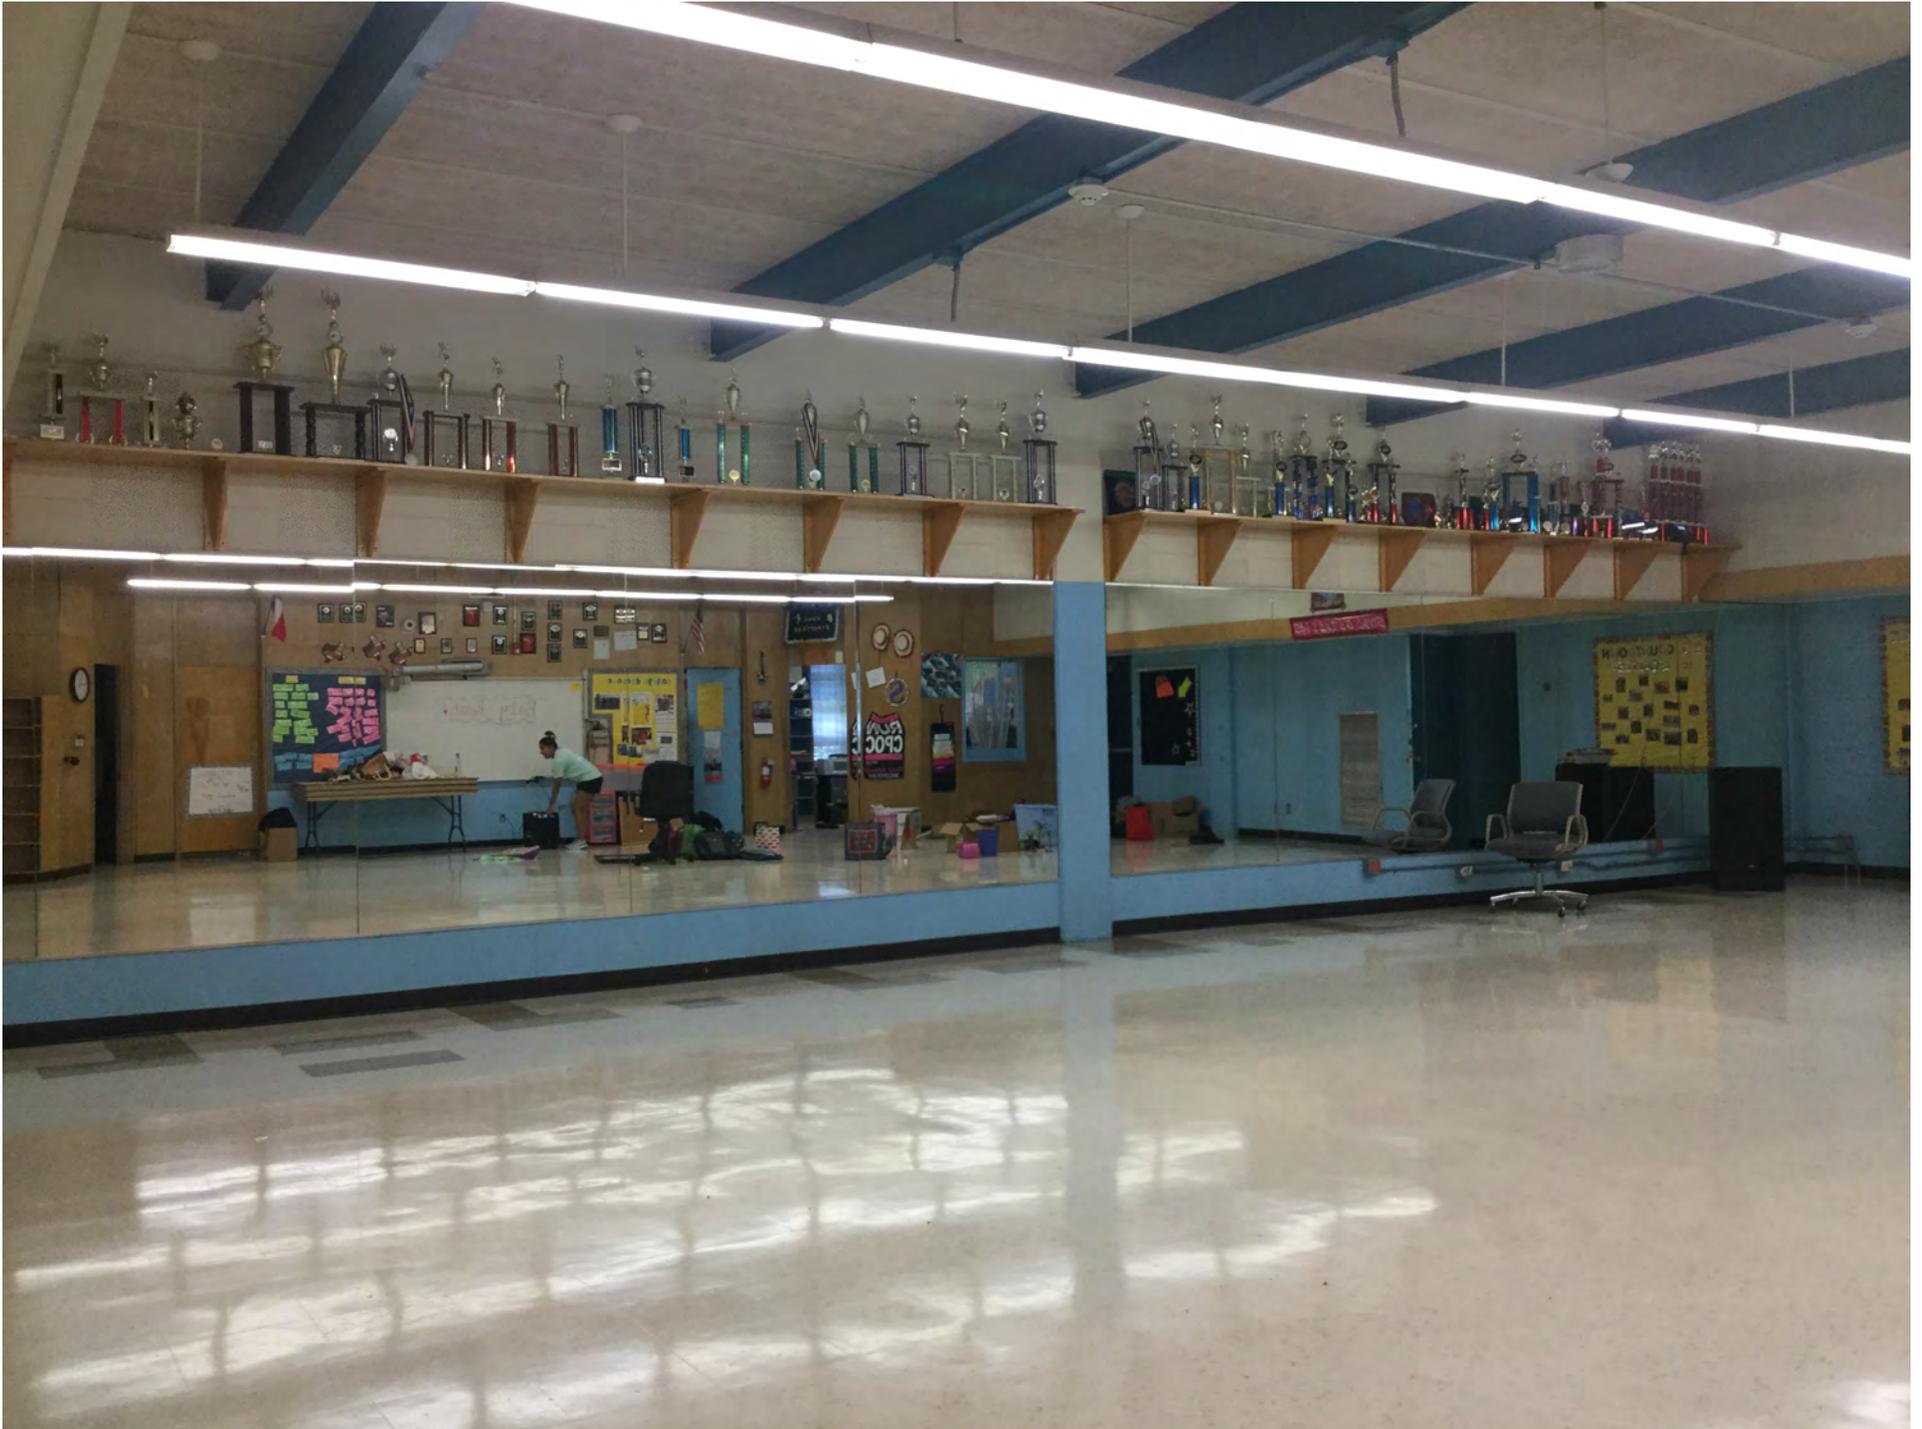
Photo 6. Dance Room

3.8	Are music, drama, or performance spaces appropriately configured per the ed spec?			3					
<p>1) Very unsatisfactory</p> <p>2) Unsatisfactory</p> <p>3) Average</p> <p>4) Good</p> <p>5) Very good</p> <p>N/A) Does not apply.</p>								Comments	1.00 3.00
								The dance studio is small and lacks both restrooms and locker rooms. The music room lacks a projector and technology.	
See Image 6

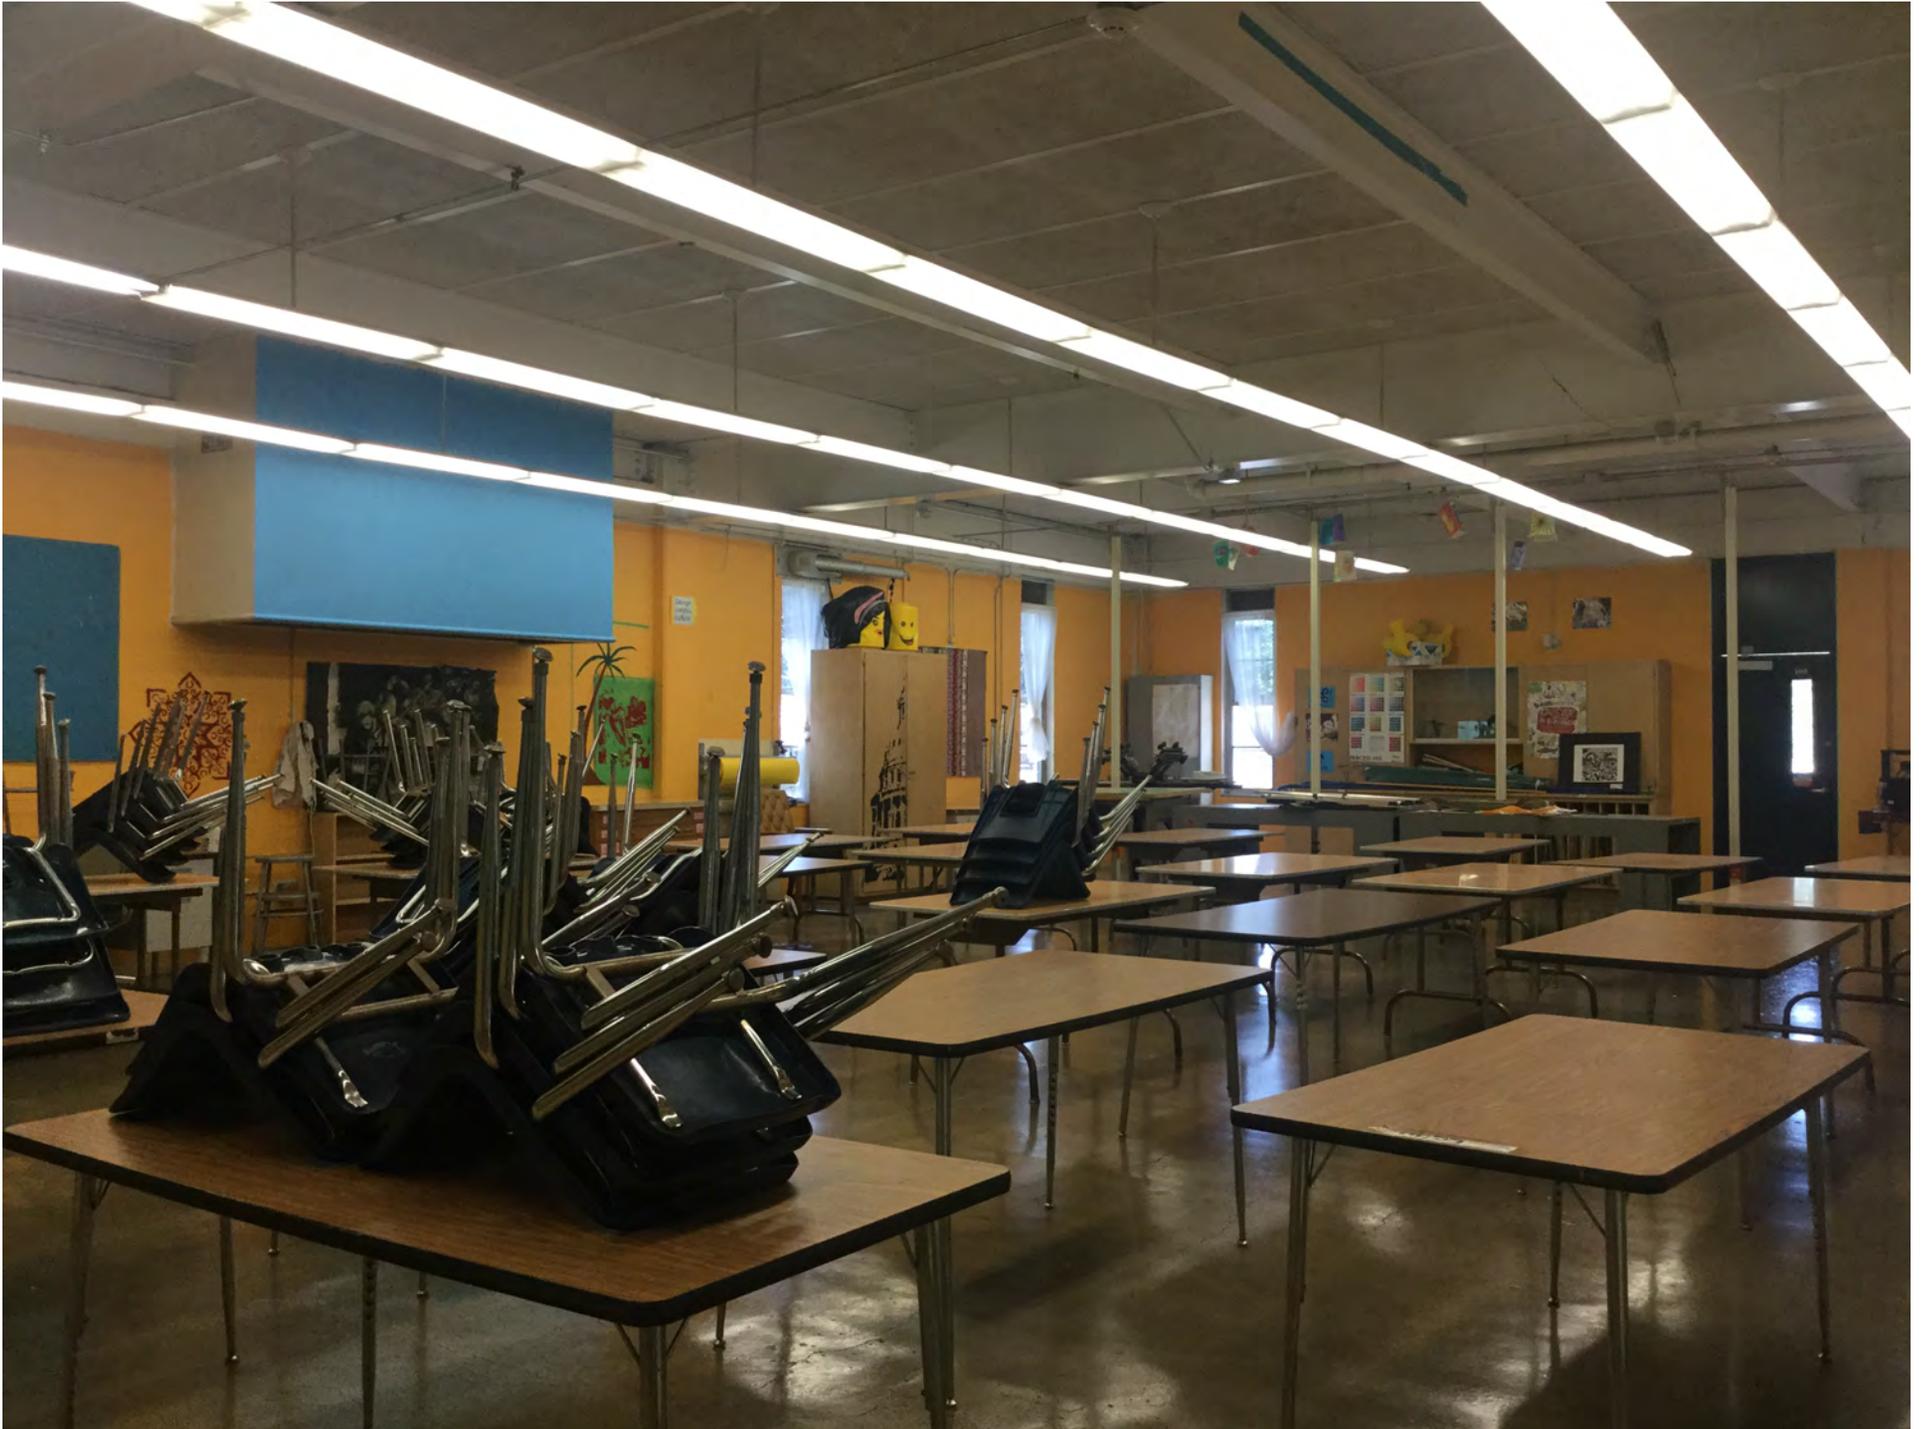
Photo 7. Art Room

1) Very unsatisfactory 2) Unsatisfactory 3) Average 4) Good 5) Very good N/A) Does not apply.								There are two art rooms with only one kiln connected to one of the rooms. One art room is sufficiently large, while the other one is too small.	See Image 7

3.11	Are Visual Arts support spaces appropriately configured per the ed spec?			3				Comments	1.00 3.00
1) Very unsatisfactory - Support spaces are disconnected from served spaces, too small, do not meet needs 2) Unsatisfactory - Support spaces are connected, but too small, inadequate for needs 3) Average - Connected, moderate size, but need some renovations or updates to function well 4) Good - Connected, good size/layout, meets needs/functions well 5) Very good - connected, generous size, nice condition, functions appropriately N/A) Does not apply.								Only one of the two art rooms have sufficient storage.

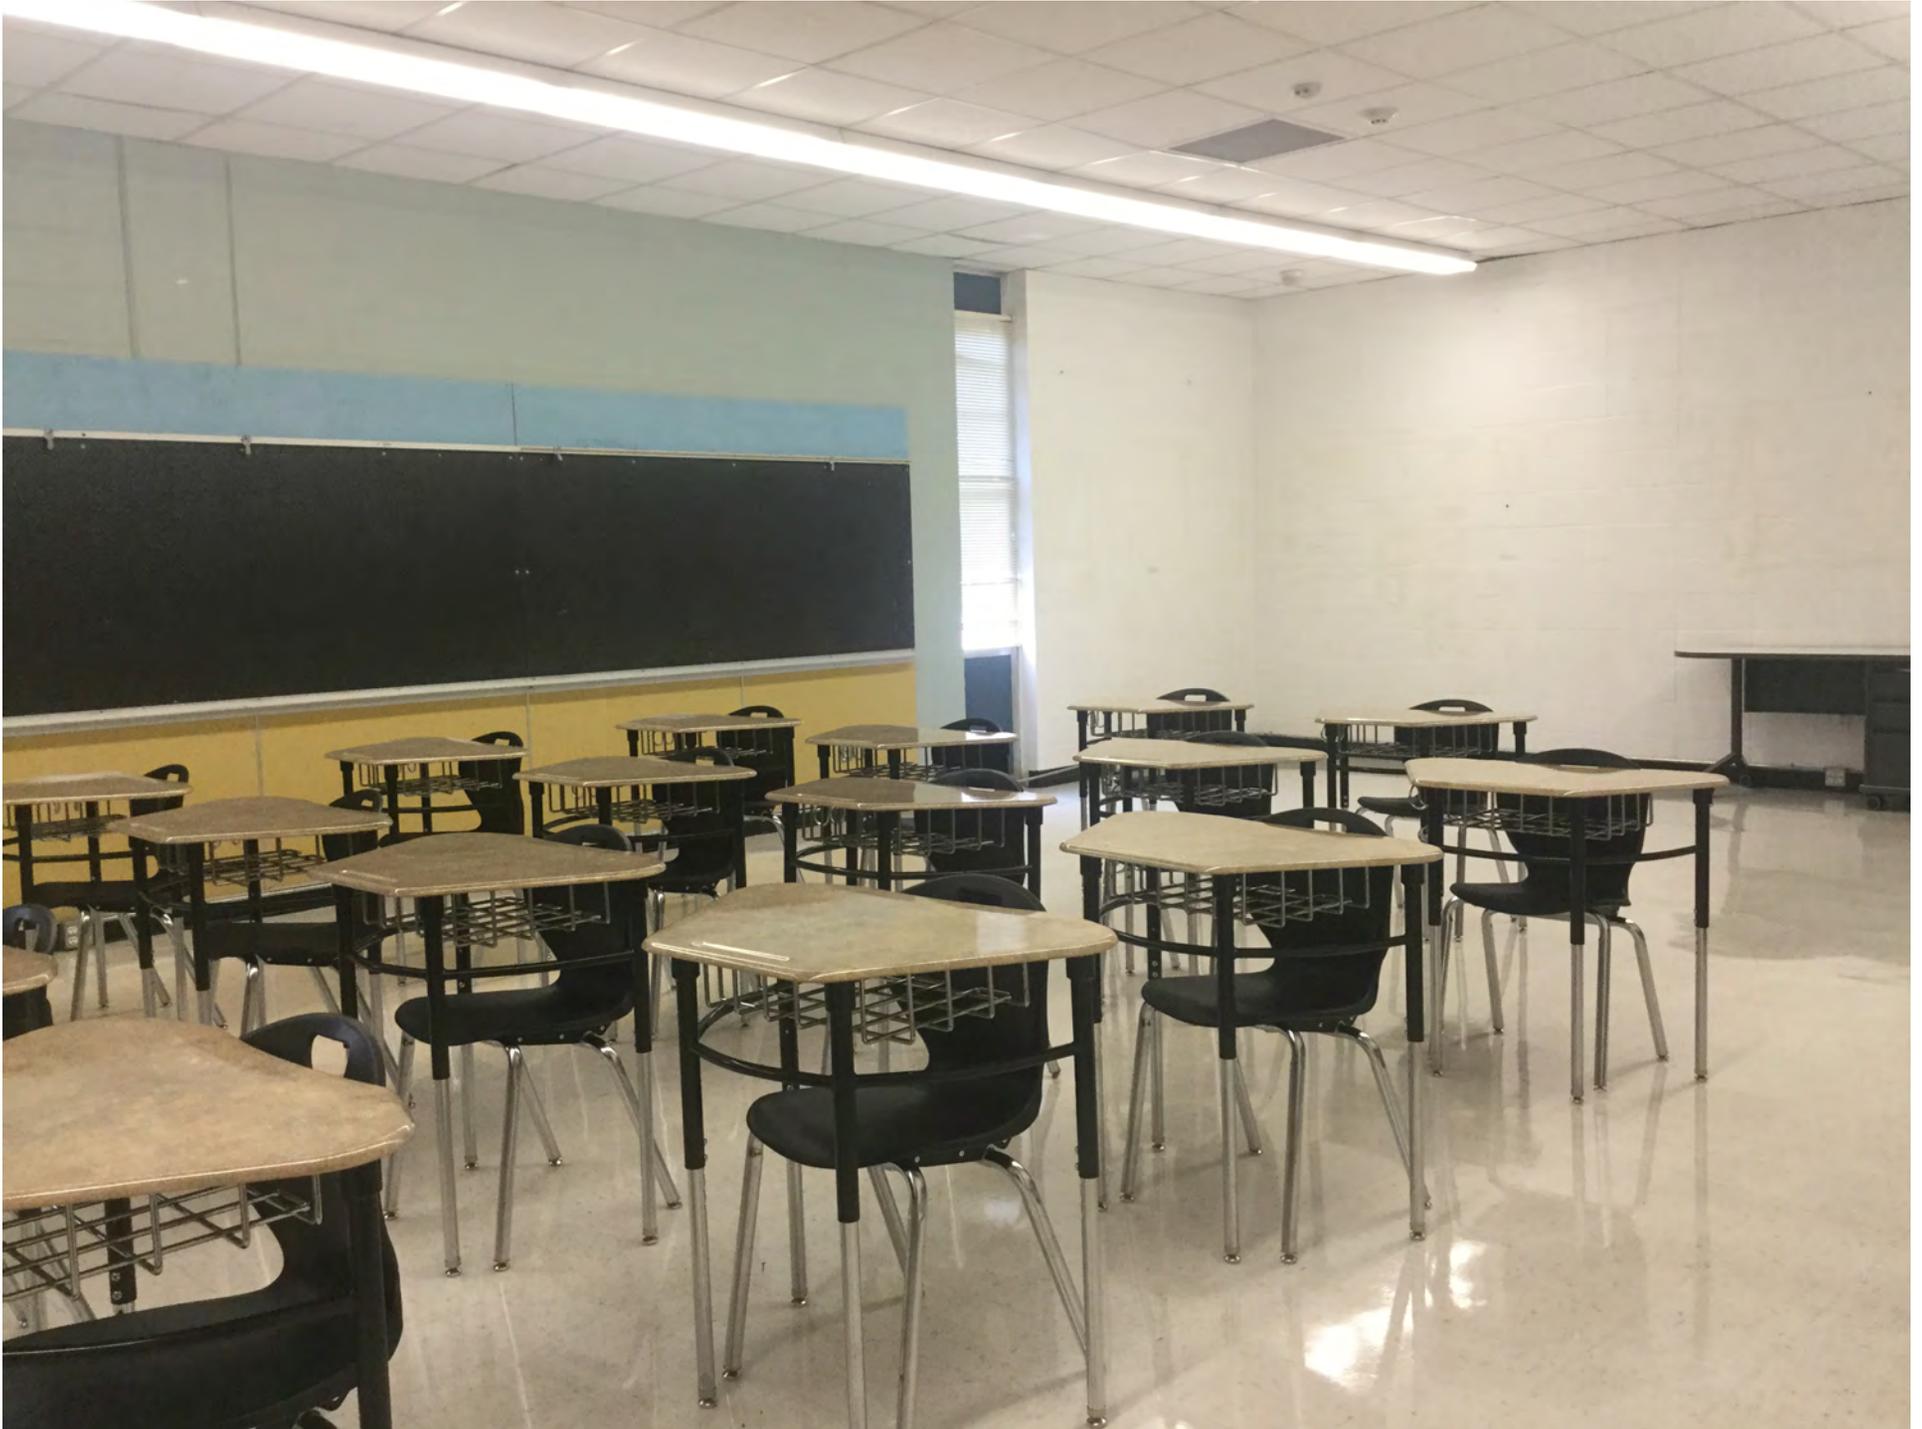
Photo 8. Classroom

1) Very unsatisfactory - No project space 2) Unsatisfactory - Non-dedicated, undersized or otherwise inadequate 3) Average - Limited dedicated spaces of moderate size and layout, equipment and furniture appropriate but need updates 4) Good - Dedicated spaces of adequate size and layout, most of the equipment and furniture is appropriate for program 5) Very good - Dedicated spaces of adequate size and layout, equipment and furniture appropriate for program N/A) Does not apply.								The facility has varying size of classrooms. Some of the larger rooms lend themselves to hands-on learning.		
See image 8

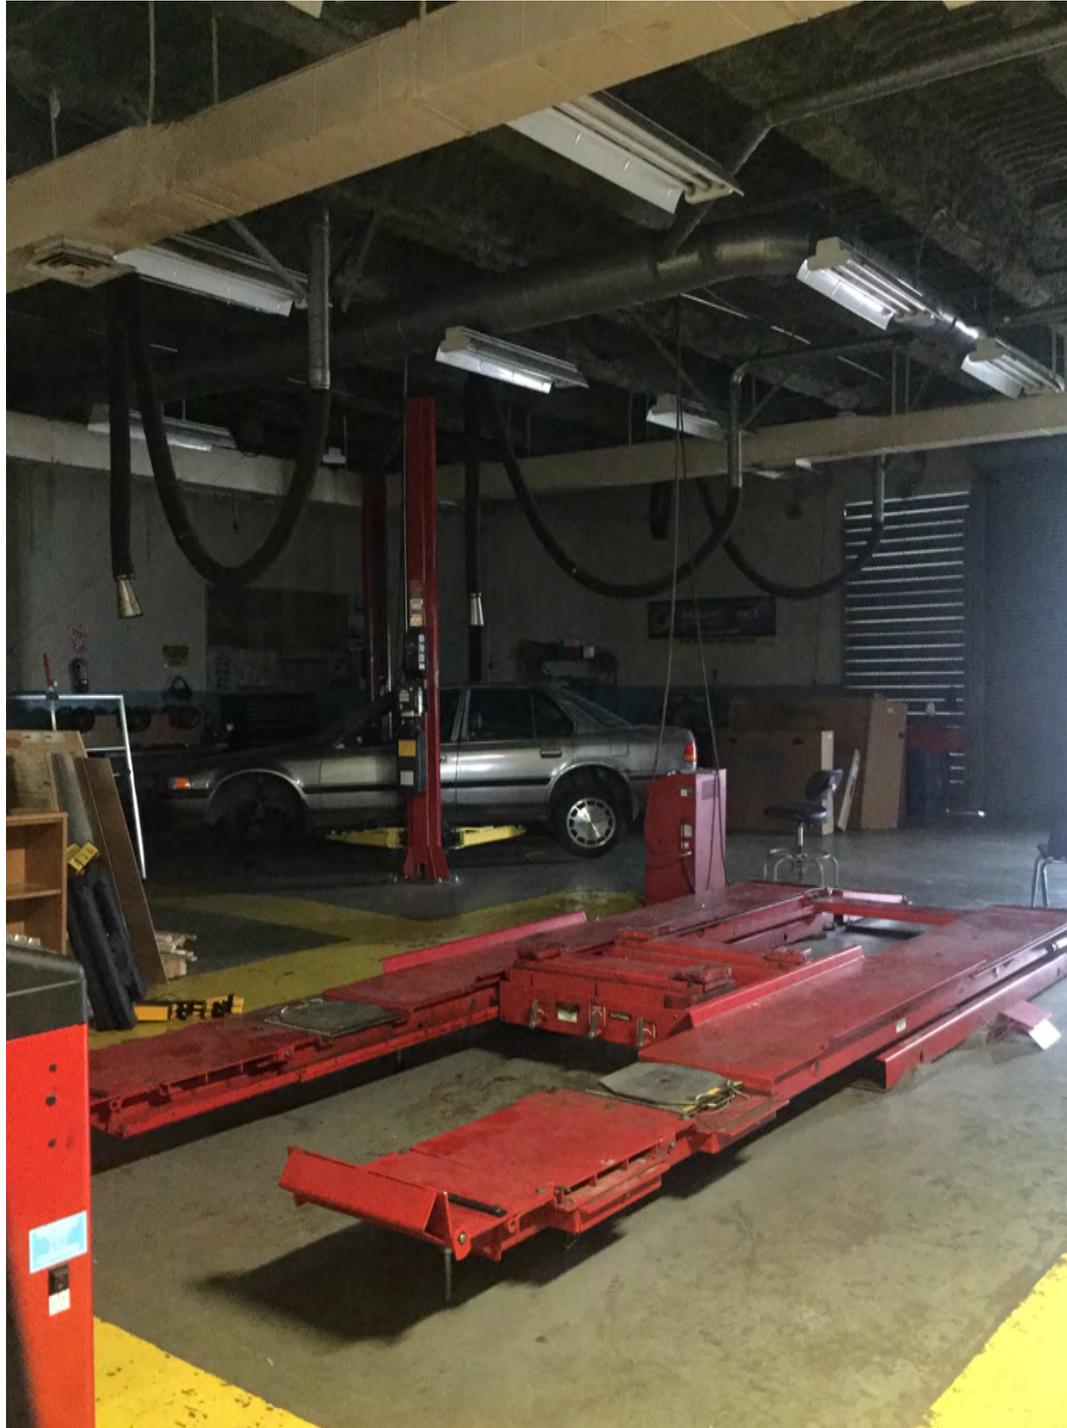
Photo 9. Auto Mechanic Shop

4.9	Do the career education spaces simulate real world or college environments? (High School Only)				4				Comments	1.00	4.00
1) Very unsatisfactory - No dedicated spaces, lack of necessary equipment 2) Unsatisfactory - Non-dedicated, undersized or otherwise inadequate 3) Average - A few dedicated spaces of moderate size/layout, equipment and furniture appropriate but need updates 4) Good - Dedicated spaces of adequate size and layout, most of the equipment and furniture is appropriate for program 5) Very good - Dedicated spaces of adequate size and layout, equipment and furniture appropriate for program N/A) Does not apply.		There is an auto mechanic shop and health science clinic space on campus.									
		See Image 9
