Educational Suitability Summary Report

Reagan High School

Date: 07/25/2016 (Rev 1 – 12/12/2016 - Survey Responses)

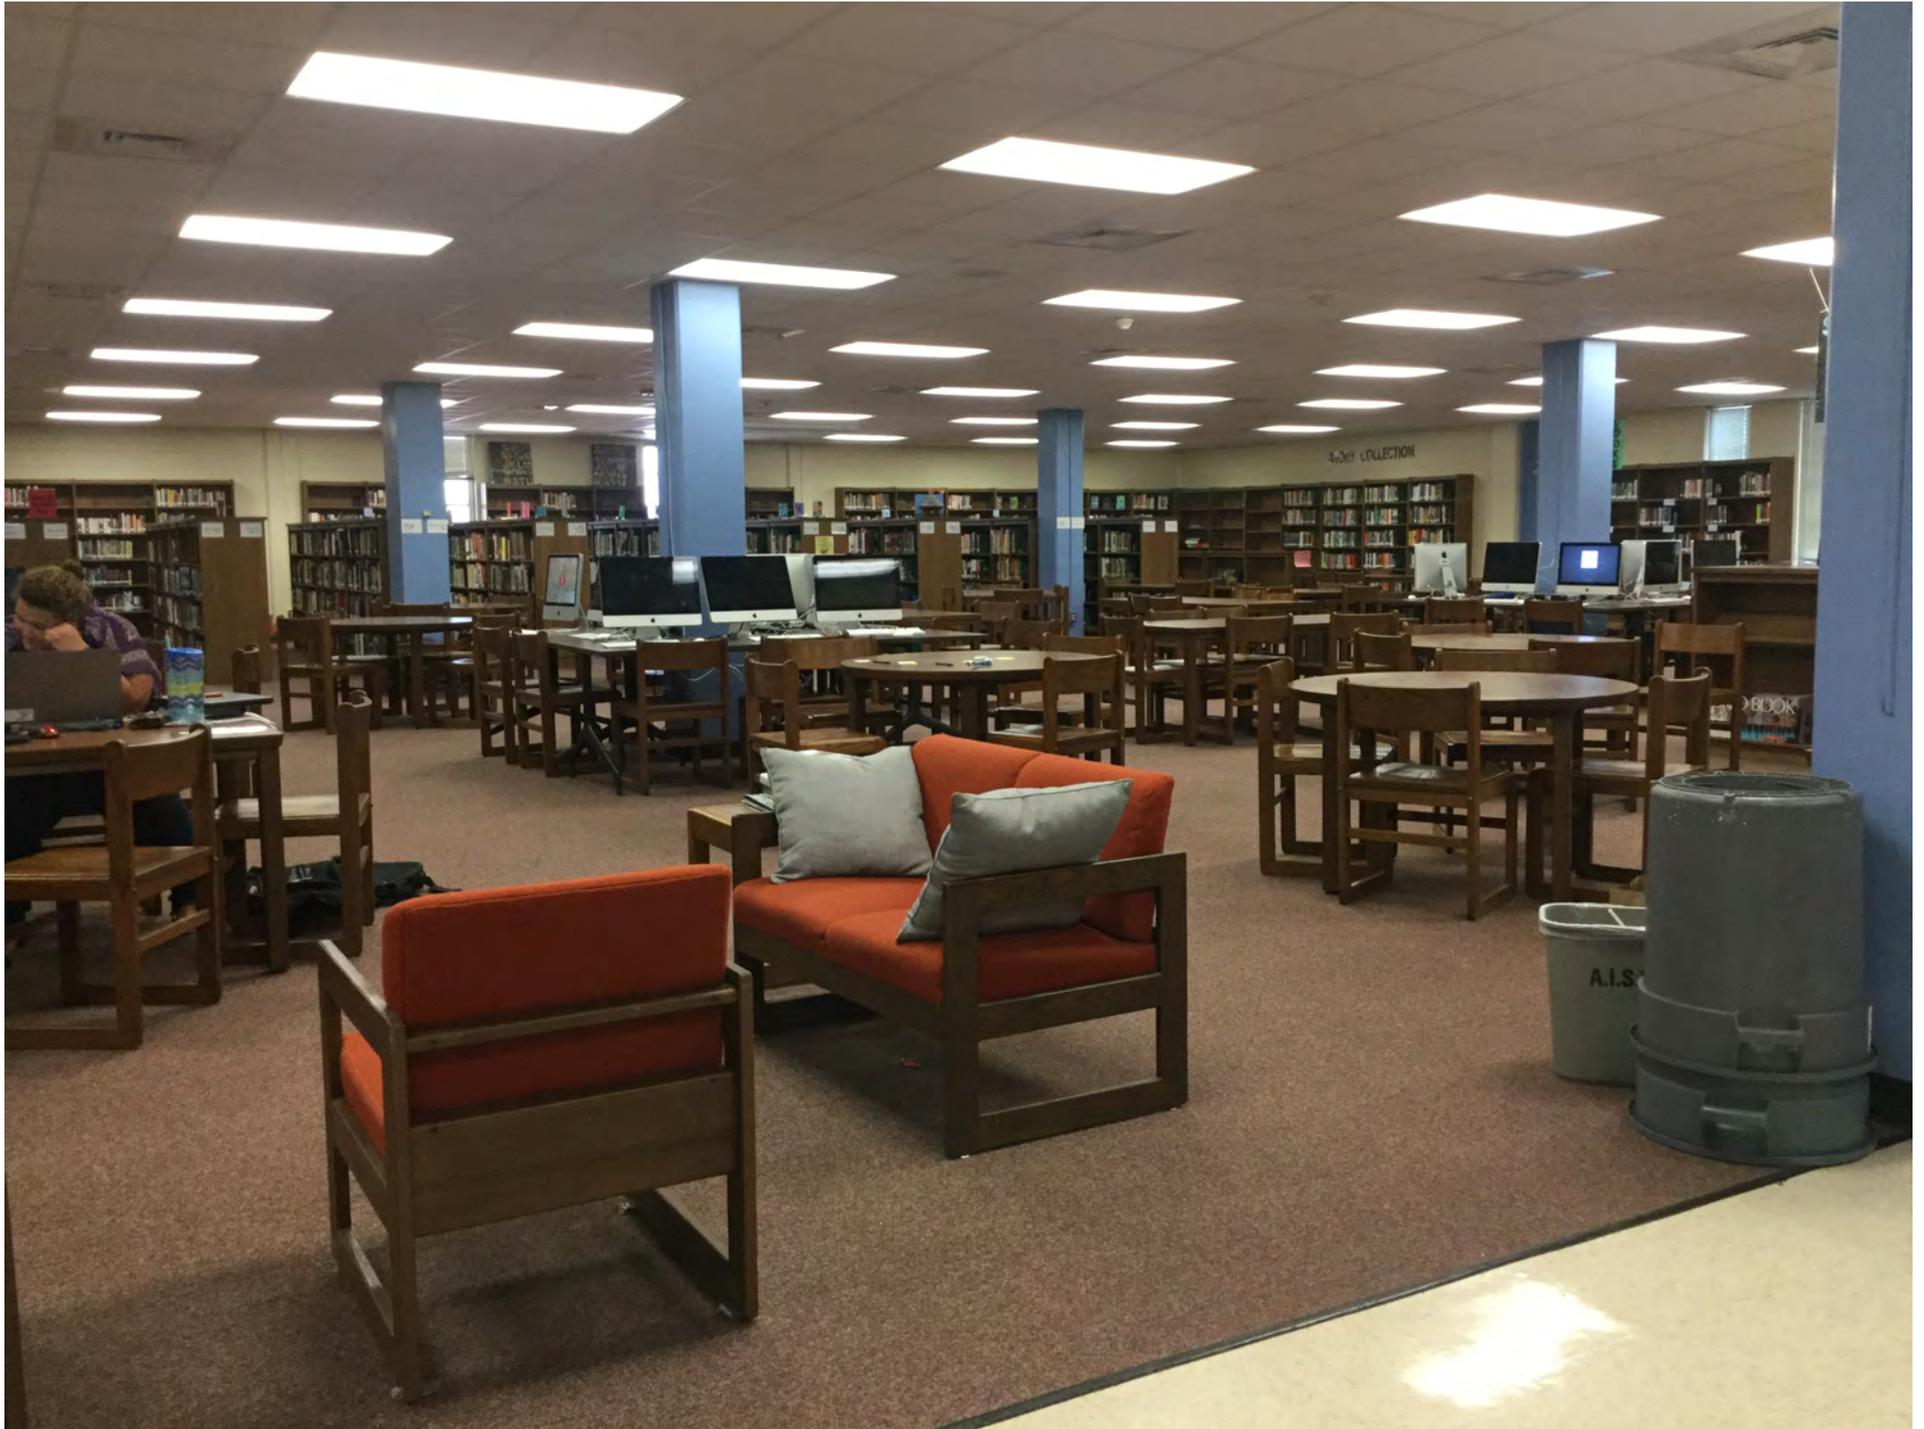
Photo 10. Library

5.3	How well does the Library/Media Center support social interaction?				4			1.00	4.00
1) Very unsatisfactory 2) Unsatisfactory 3) Average 4) Good 5) Very good N/A) Does not apply.		The library has appropriate furniture and an area for social interaction near the entry.							
		See Image 10
