Educational Suitability Summary Report

Travis High School – BLDG 007

Date: 05/16/2016 (REV1 – 12/12/2016 CAC comments)

Score 45% Unsatisfactory

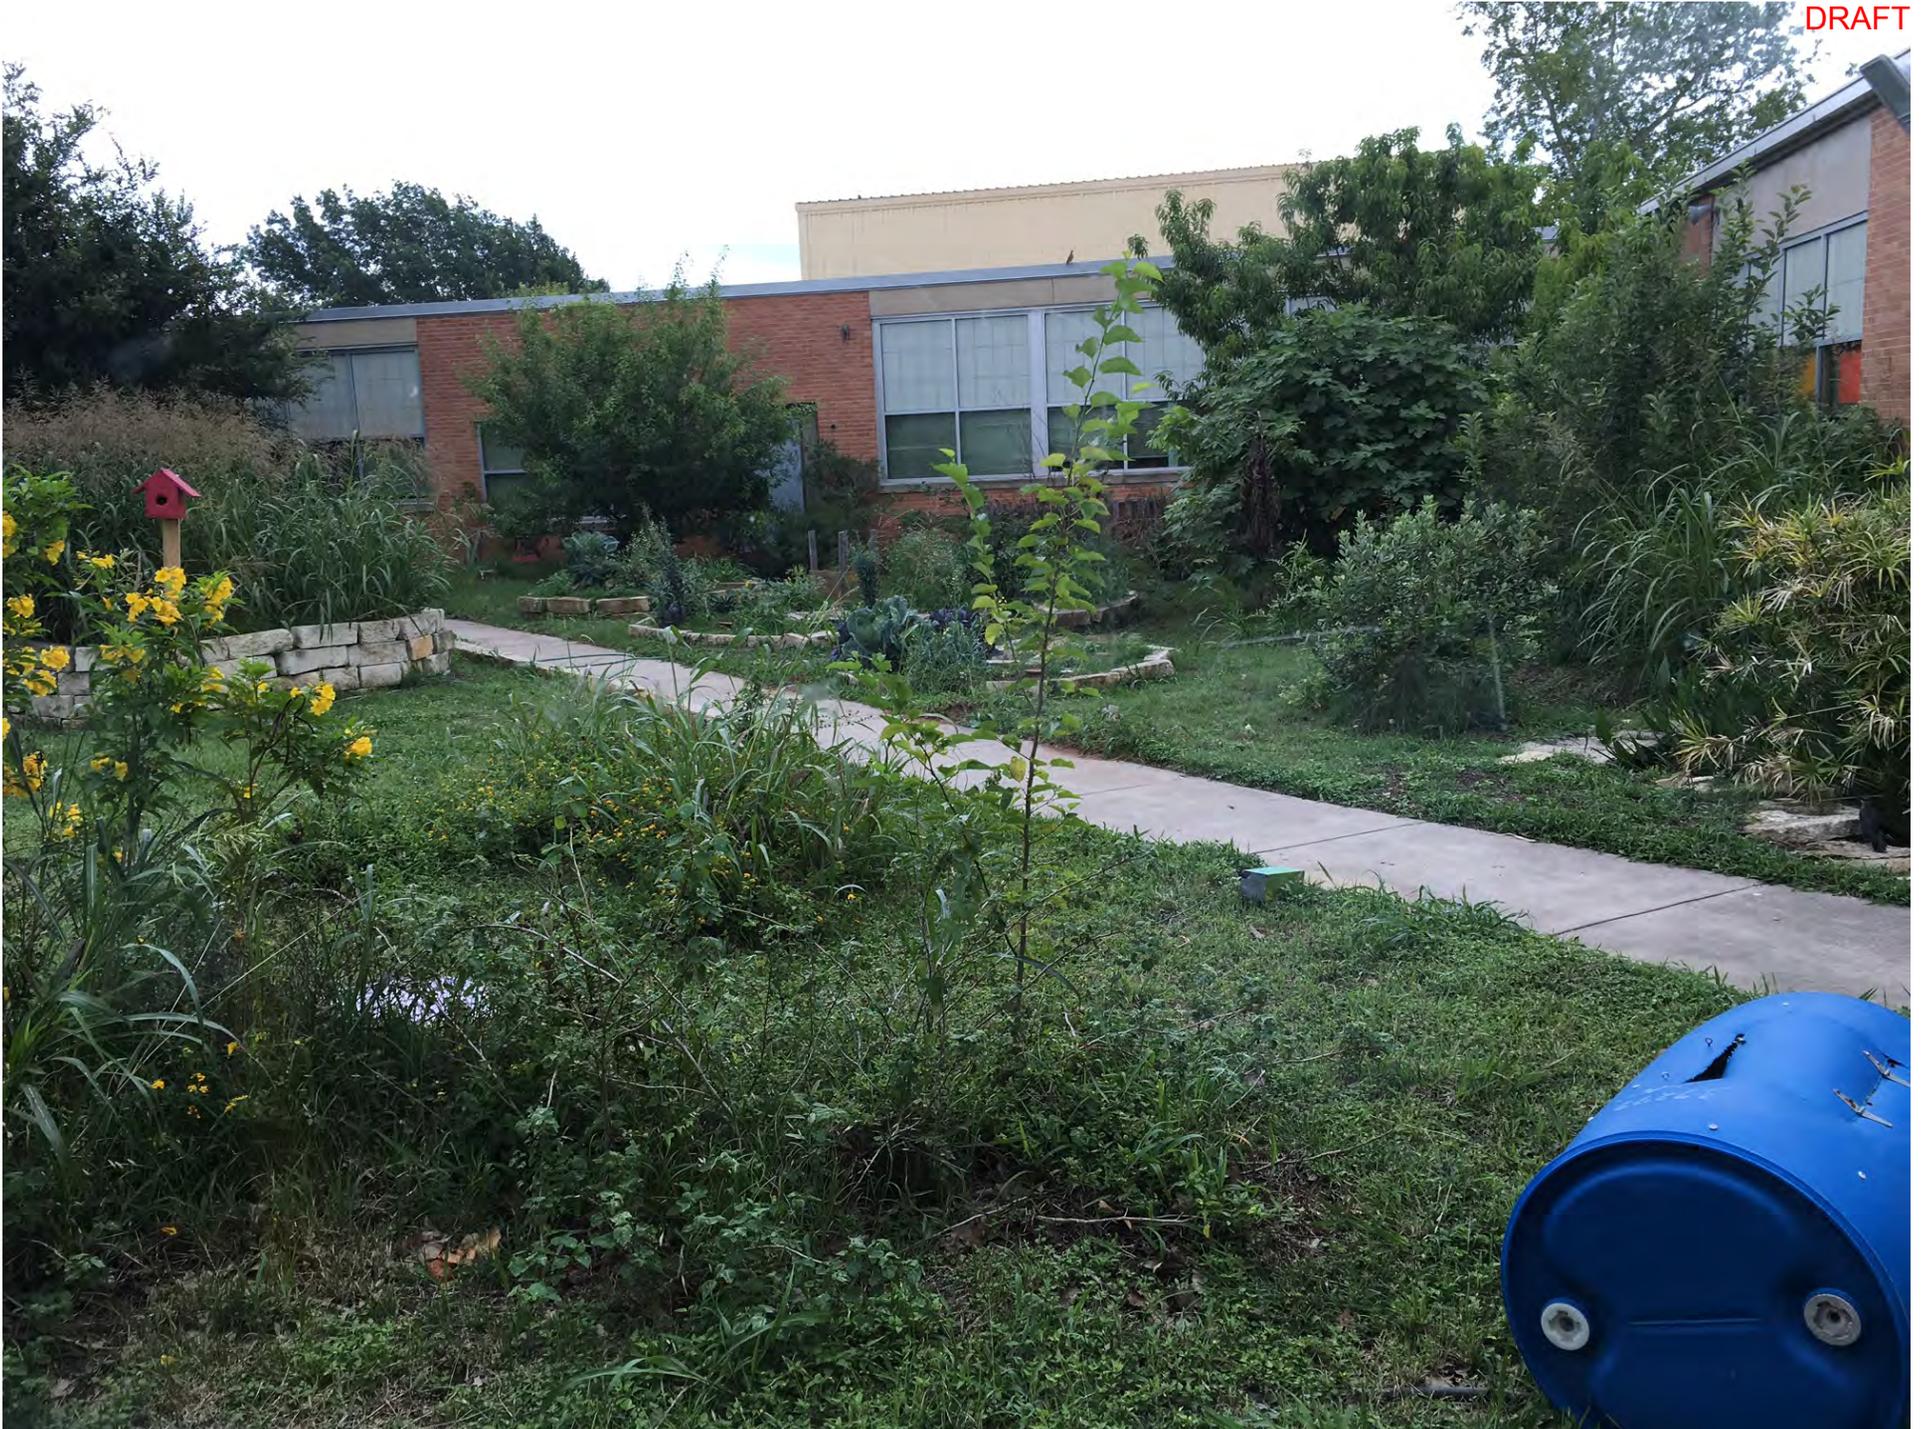
Photo 1. Courtyard Space

1.2	Are opportunities provided for outdoor learning (outdoor classrooms, gardens, etc.)?		2					Comments	1.00	2.00
	1) Outdoor space exists is not developed 2) Outdoor space for learning exists but not connected to classroom learning areas. 3. Outdoor learning spaces exist and are accessible but not in good condition. 4. Outdoor learning spaces need minor improvements to function well. 5. Outdoor learning spaces are in excellent condition. N/A) Does not apply.							The campus has some small courtyards. one hallway blocked access to the outdoor learning space. The courtyards need maintenance and direct access from classrooms to be effective. <i>CAC comment: Covered walkways needed during rain.</i>		
										See Photo 1 & 2

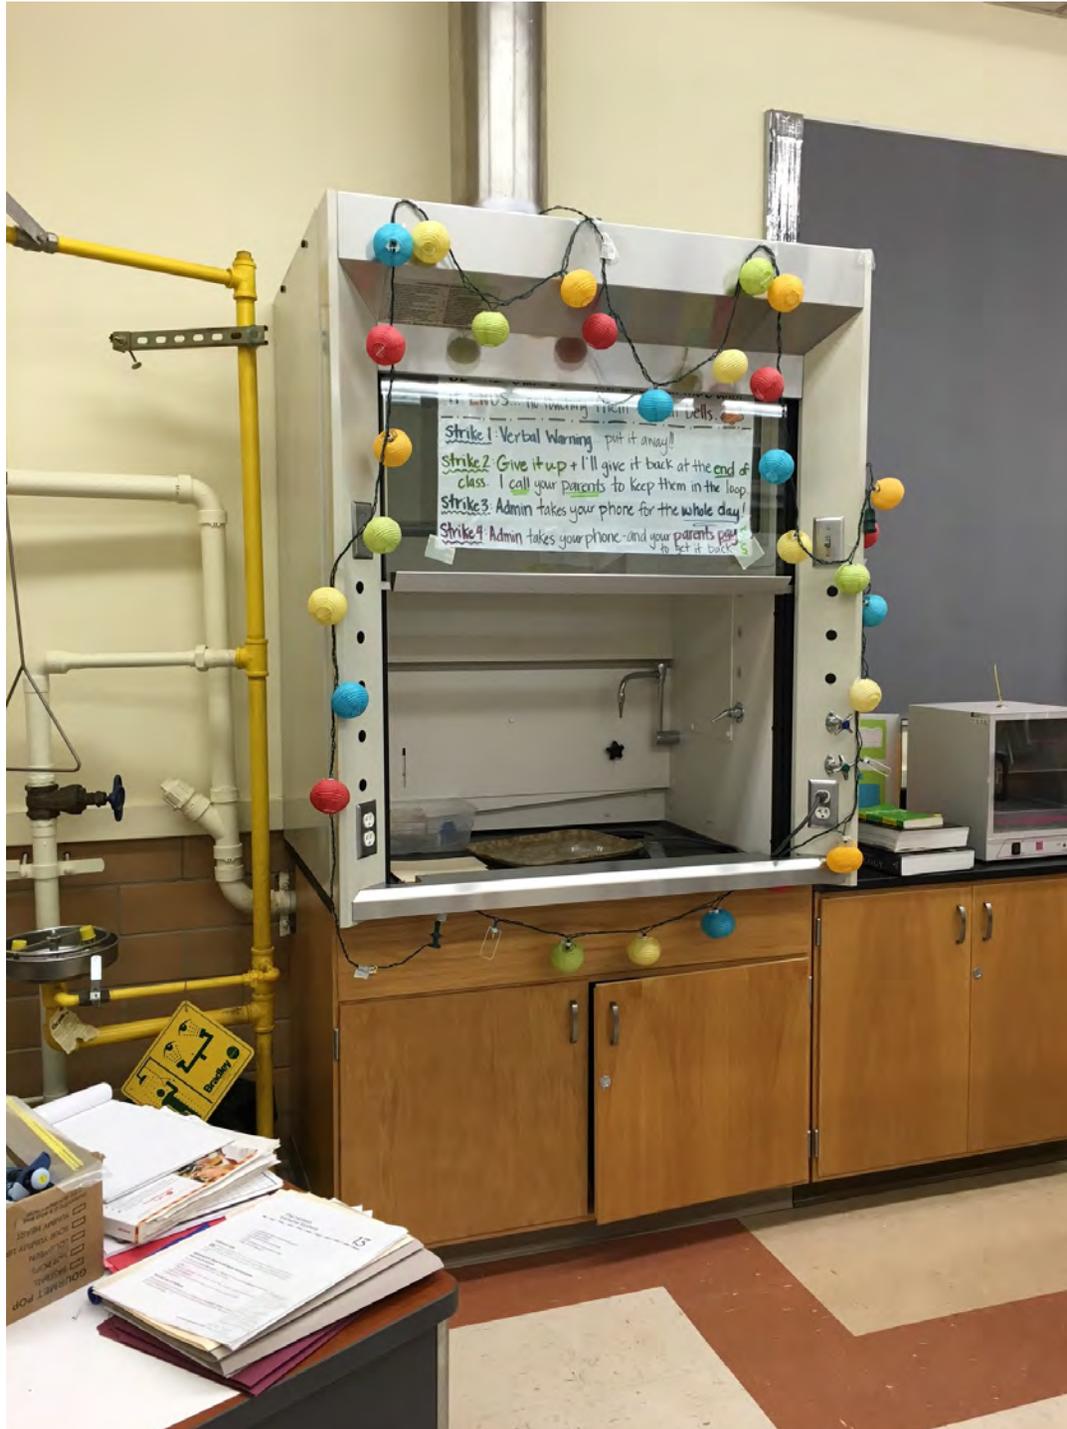
Photo 3. Science Vent Hood

3.5	Are Science Classrooms/Labs support areas appropriately configured per the ed spec?			3				Comments	1.00 3.00
1) Very unsatisfactory - Support spaces are disconnected from served spaces, too small, do not meet needs 2) Unsatisfactory - Support spaces are connected, but too small, do not meet needs 3) Average - Connected, moderate size, but need some renovations or updates 4) Good - Connected, good size, meets needs, functions well 5) Very good - connected, generous size, nice condition, functions appropriately N/A) Does not apply. (Elementary schools)		Prep room is not visible to classroom. Chemical storage room located in another classroom and not centrally located for all science staff.

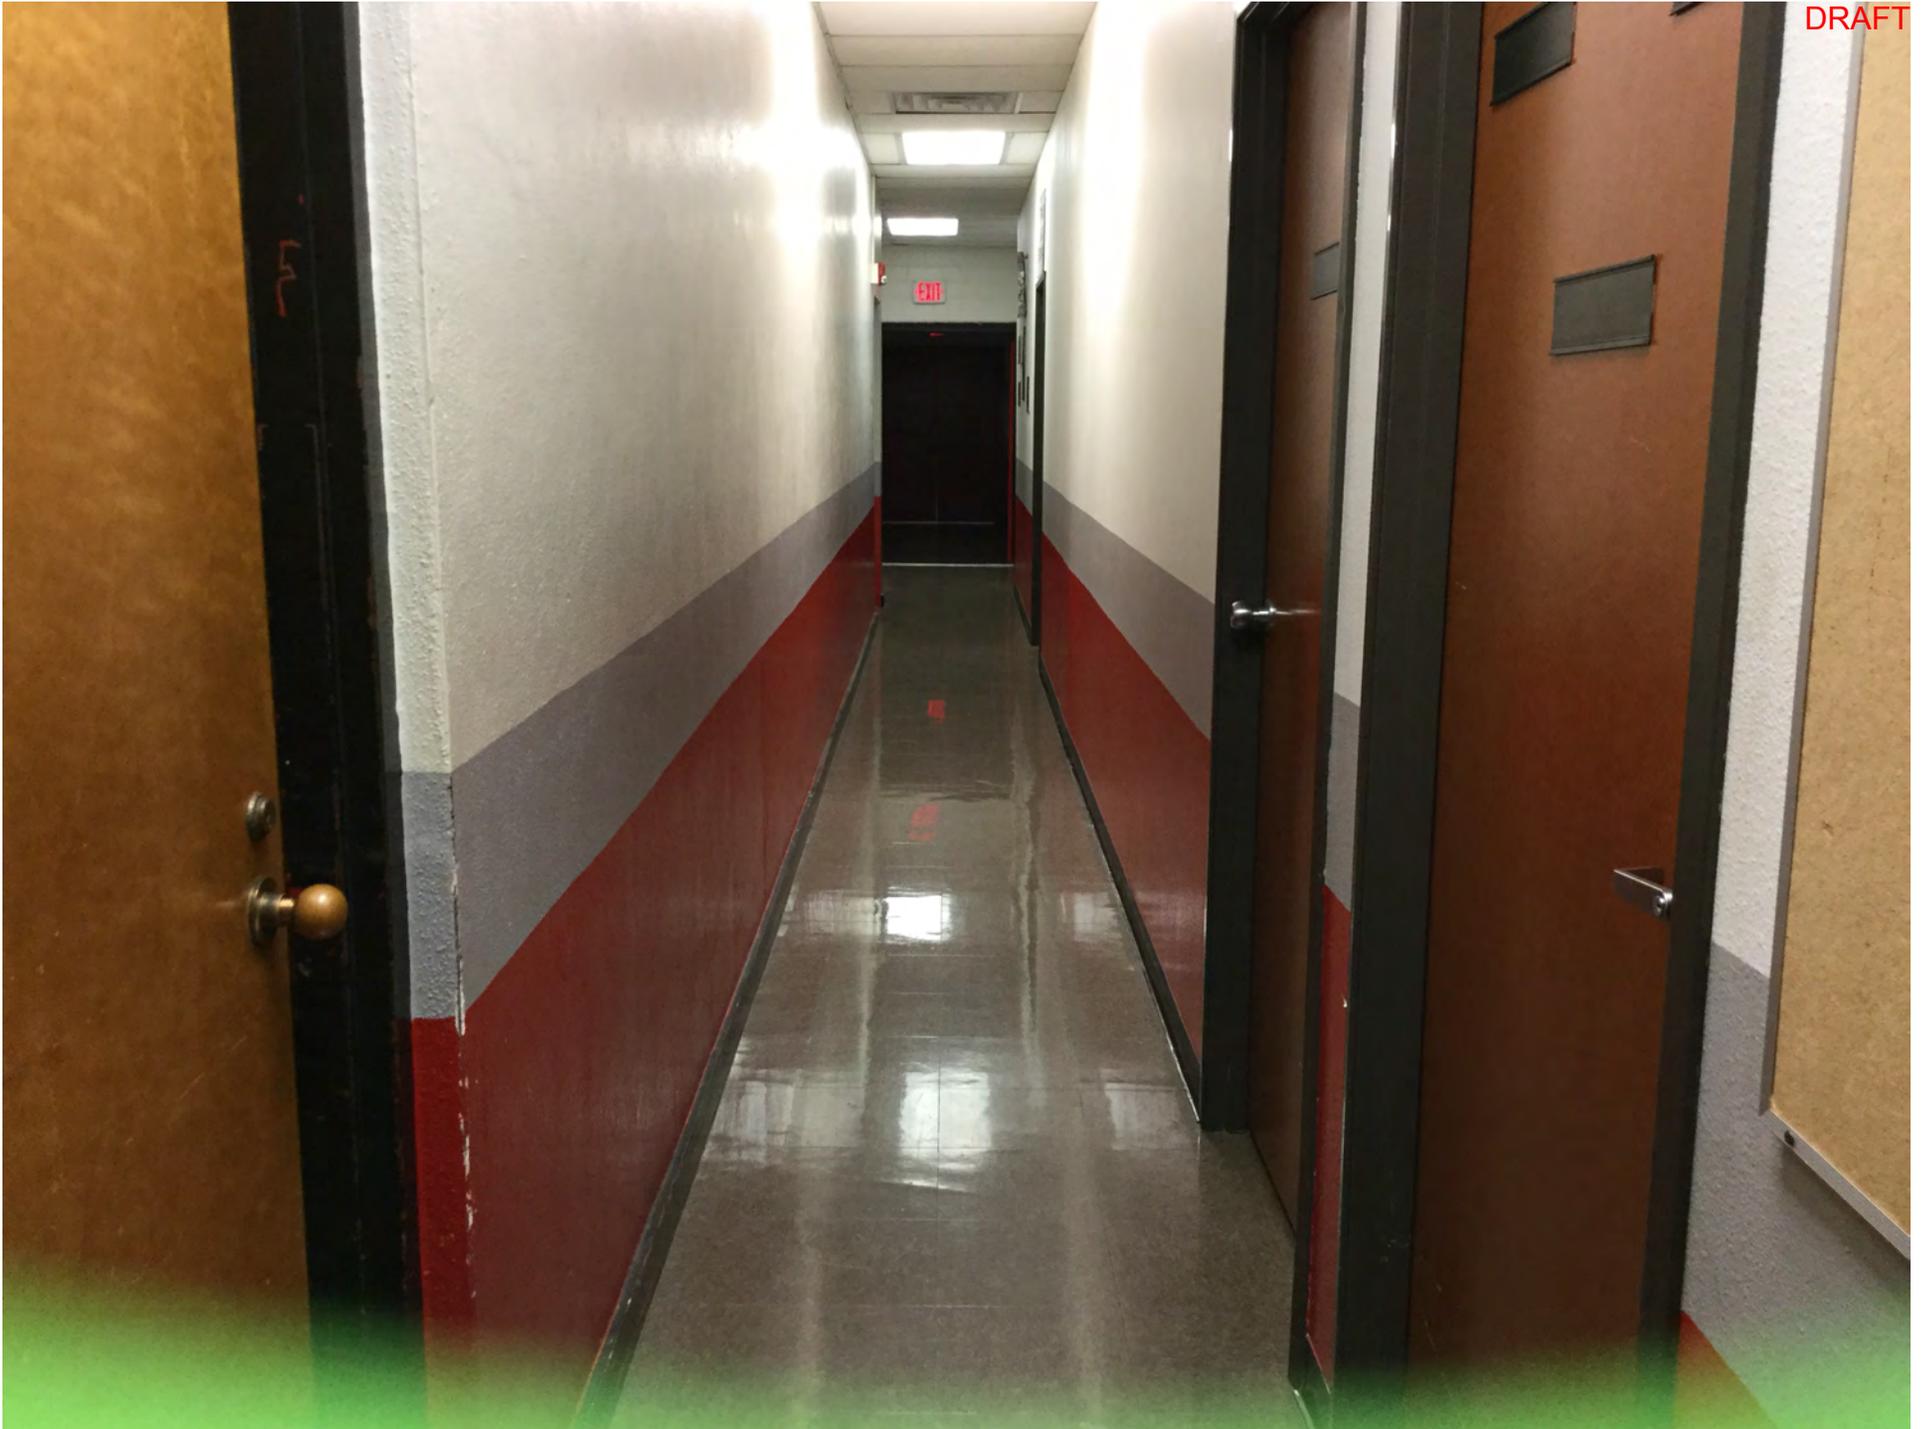
Photo 4. Gym corridor

1) Very unsatisfactory 2) Unsatisfactory 3) Average 4) Good 5) Very good N/A) Does not apply.								Circulation patterns in athletics are not direct. There are series of corridors that cross from locker rooms to showers to gym to fields. <i>CAC comment: Only 1 large gym.</i>		
See photo 4

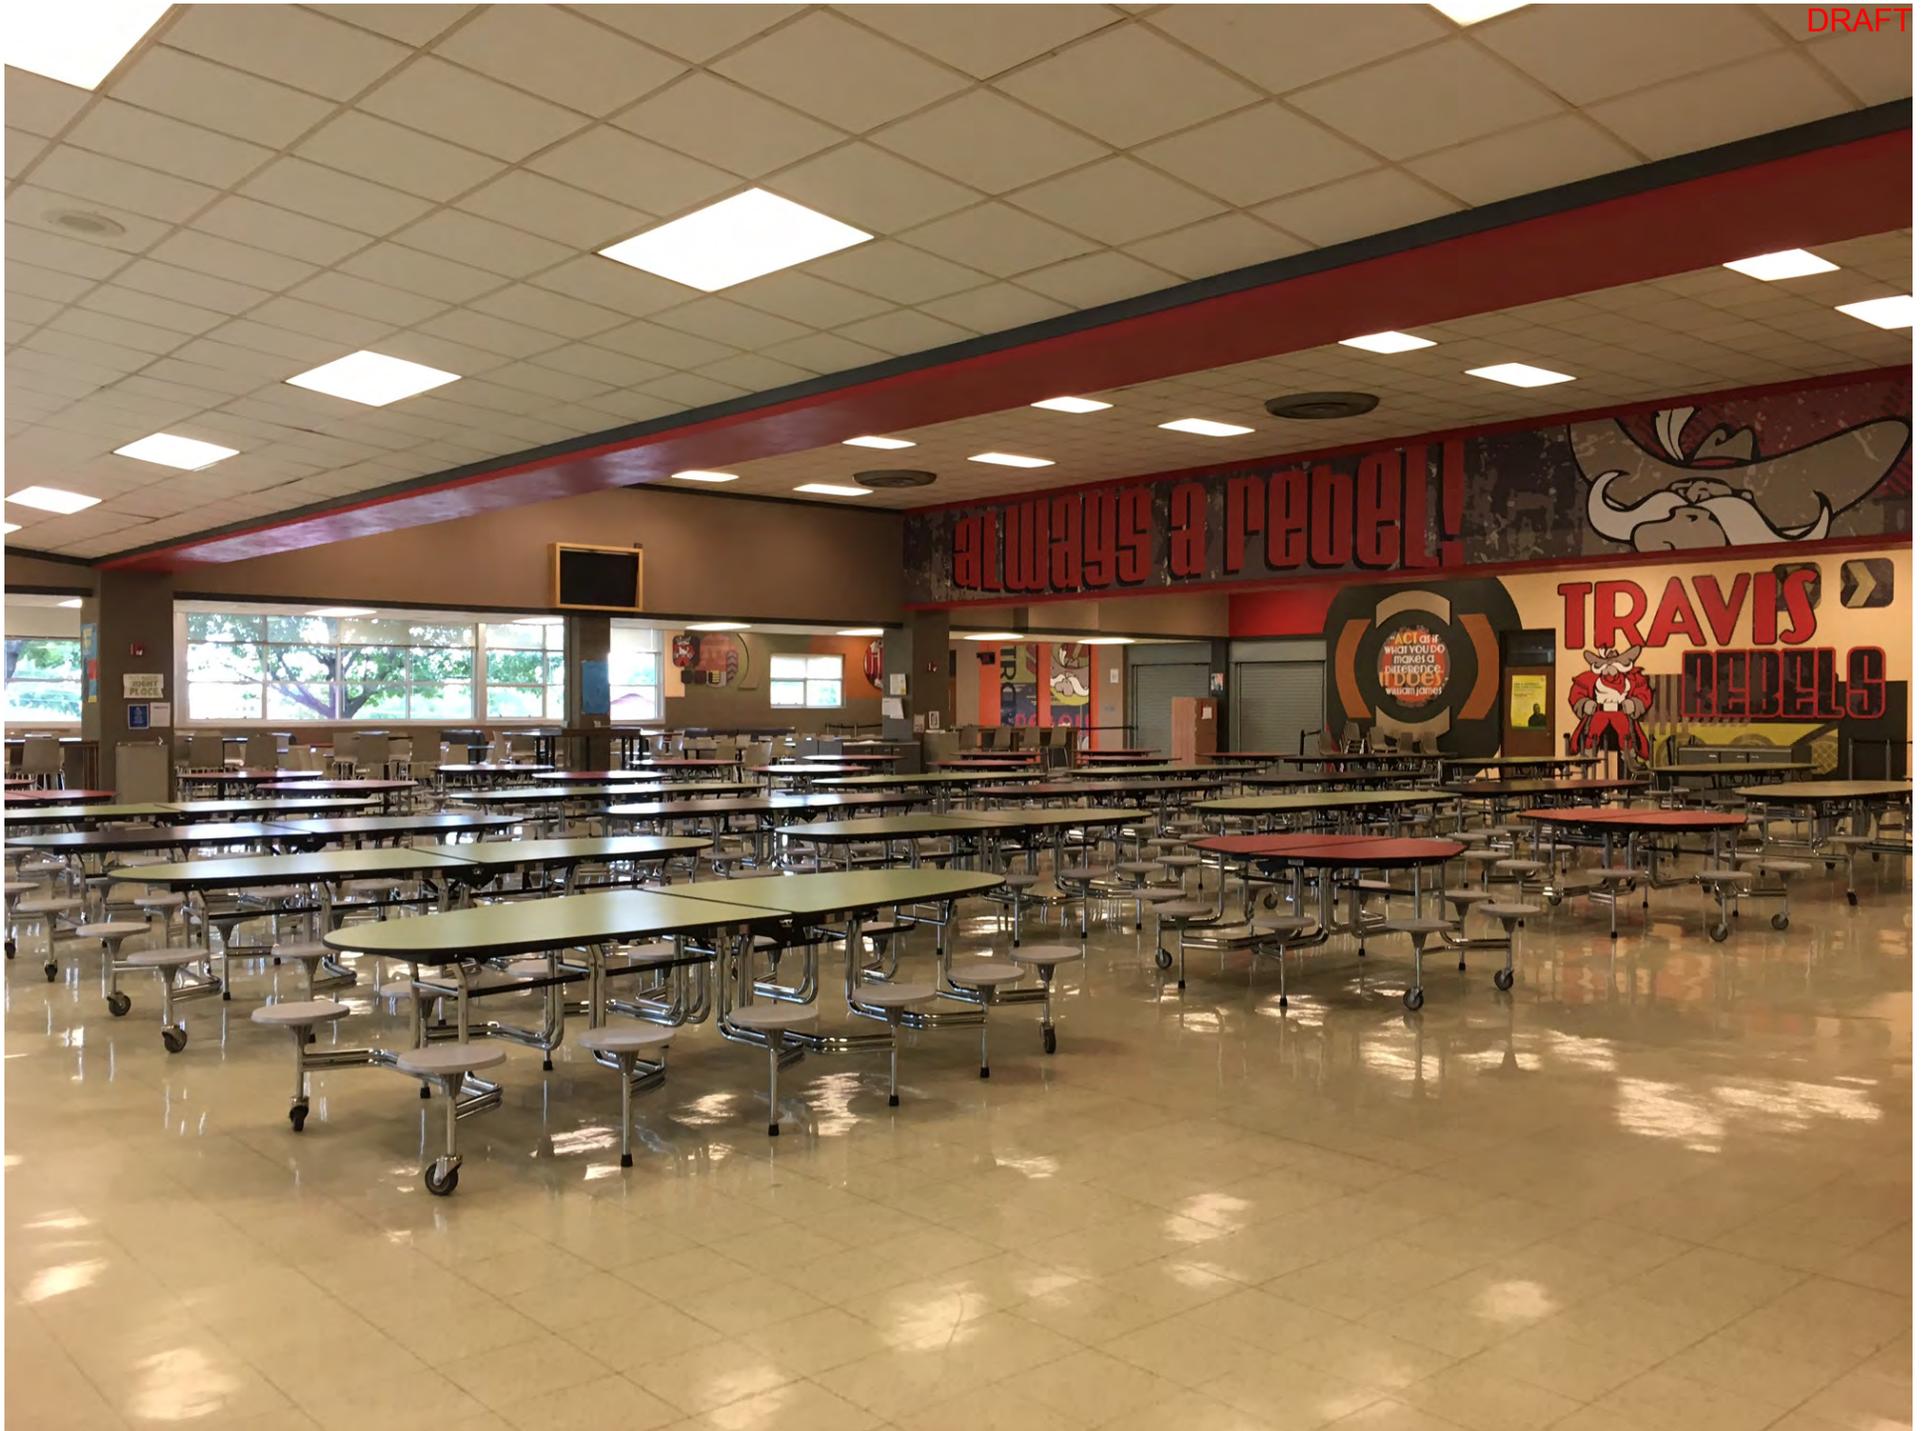
Photo 5. Cafeteria

3.16	Are the student dining facilities appropriately configured?					5		Comments	1.00	5.00
1) Very unsatisfactory - Too small, poor circulation, inflexible seating in poor condition 2) Unsatisfactory - Too small or inadequate circulation, seating in poor condition 3) Average - moderate size, with adequate circulation, seating in okay condition 4) Good - good size, adequate circulation, seating in good condition 5) Very good - good size, adequate circulation, seating in good condition, with more than one option for eating space (ex: connection to outdoor eating space) N/A) Does not apply.								There are new service lines and new furniture of various types. <i>CAC comment: Not all students can sit during our 1 lunch.</i>	See photo 5

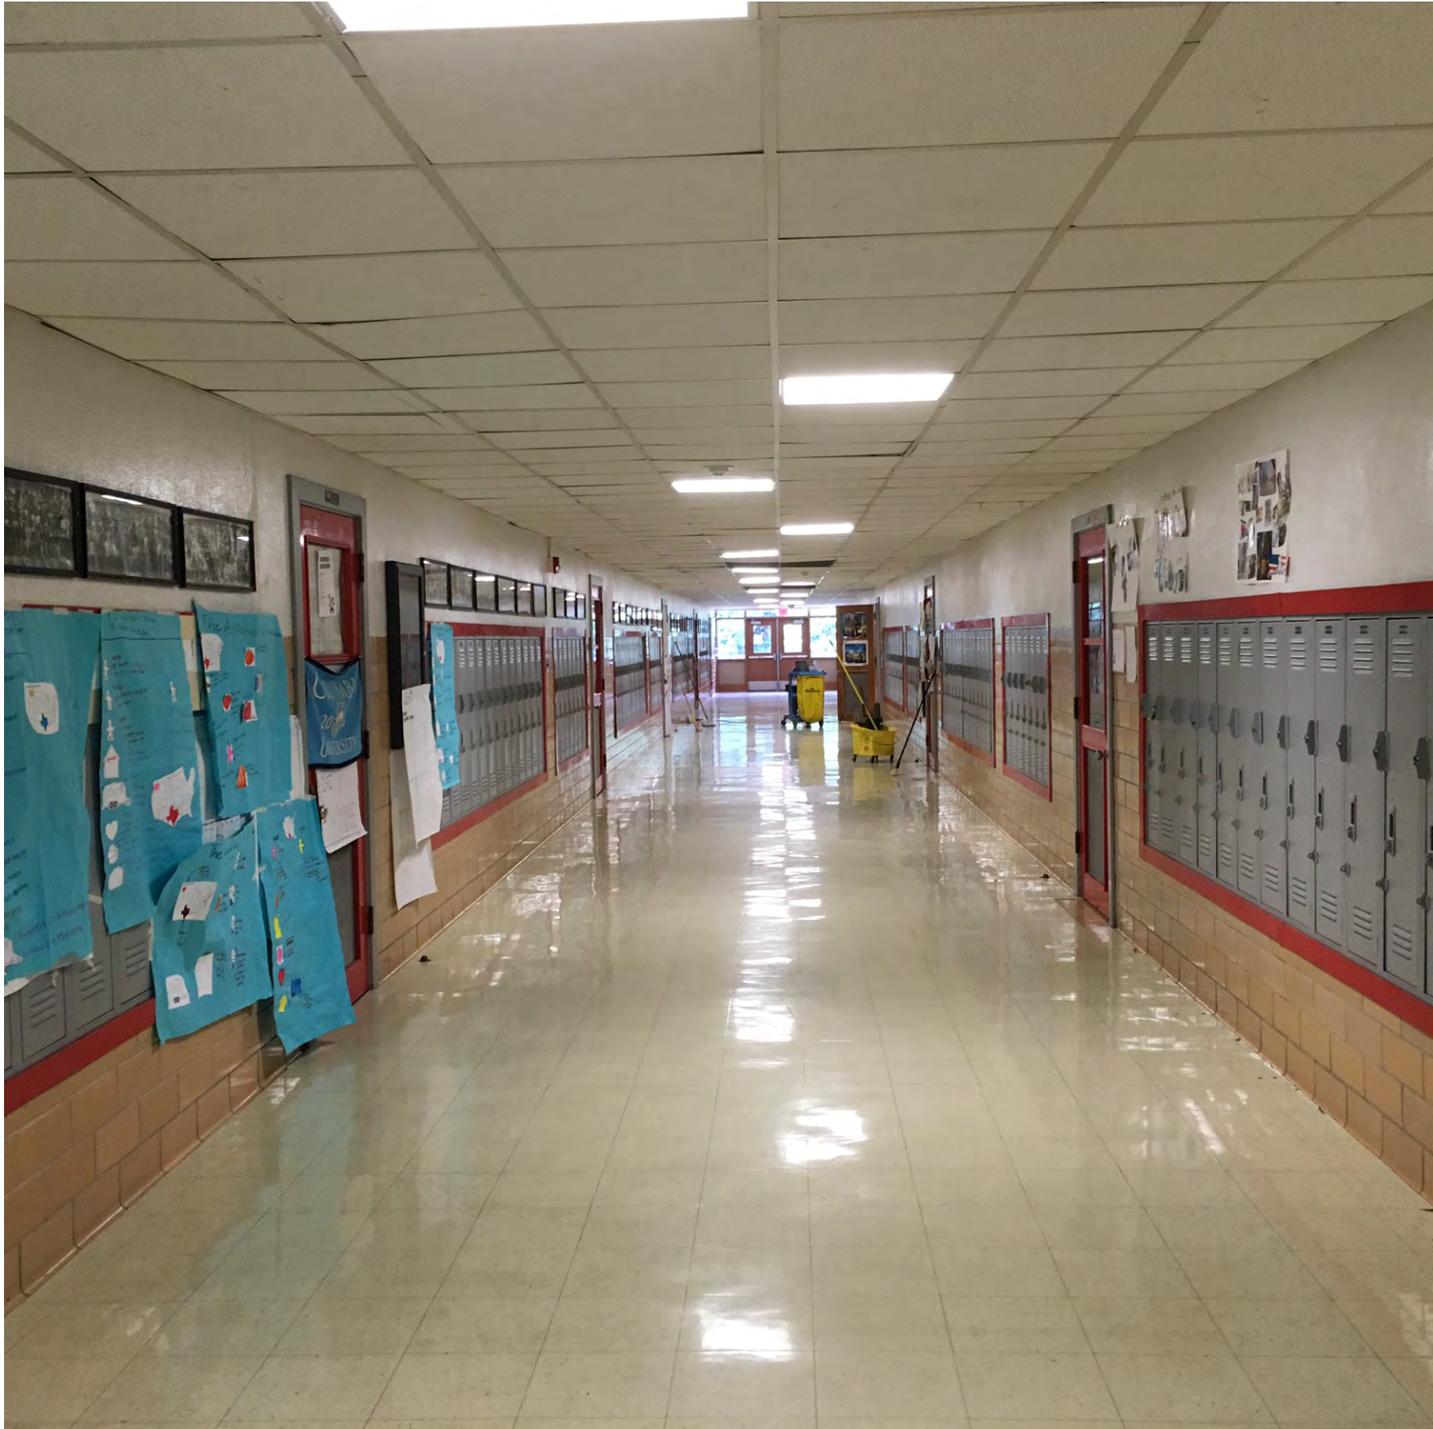
Photo 6. Wall display

4.4	Are there adequate places to display the evidence and artifacts of learning (both 2D and 3D)?		2					Comments	1.00	2.00
1) Very unsatisfactory - No display cases or wall space for display 2) Unsatisfactory - 1 wall in classrooms or very few spaces for display 3) Average - 2 walls in classrooms or some hallway spaces for display 4) Good - 3 walls in classrooms or multiple hallway spaces for display 5) Very good - ample classroom display space or many hallway spaces, including display cases N/A) Does not apply.				Few display cases, through out campus. The concrete block walls do not allow tacking. <i>CAC comment: Those we have are old.</i>

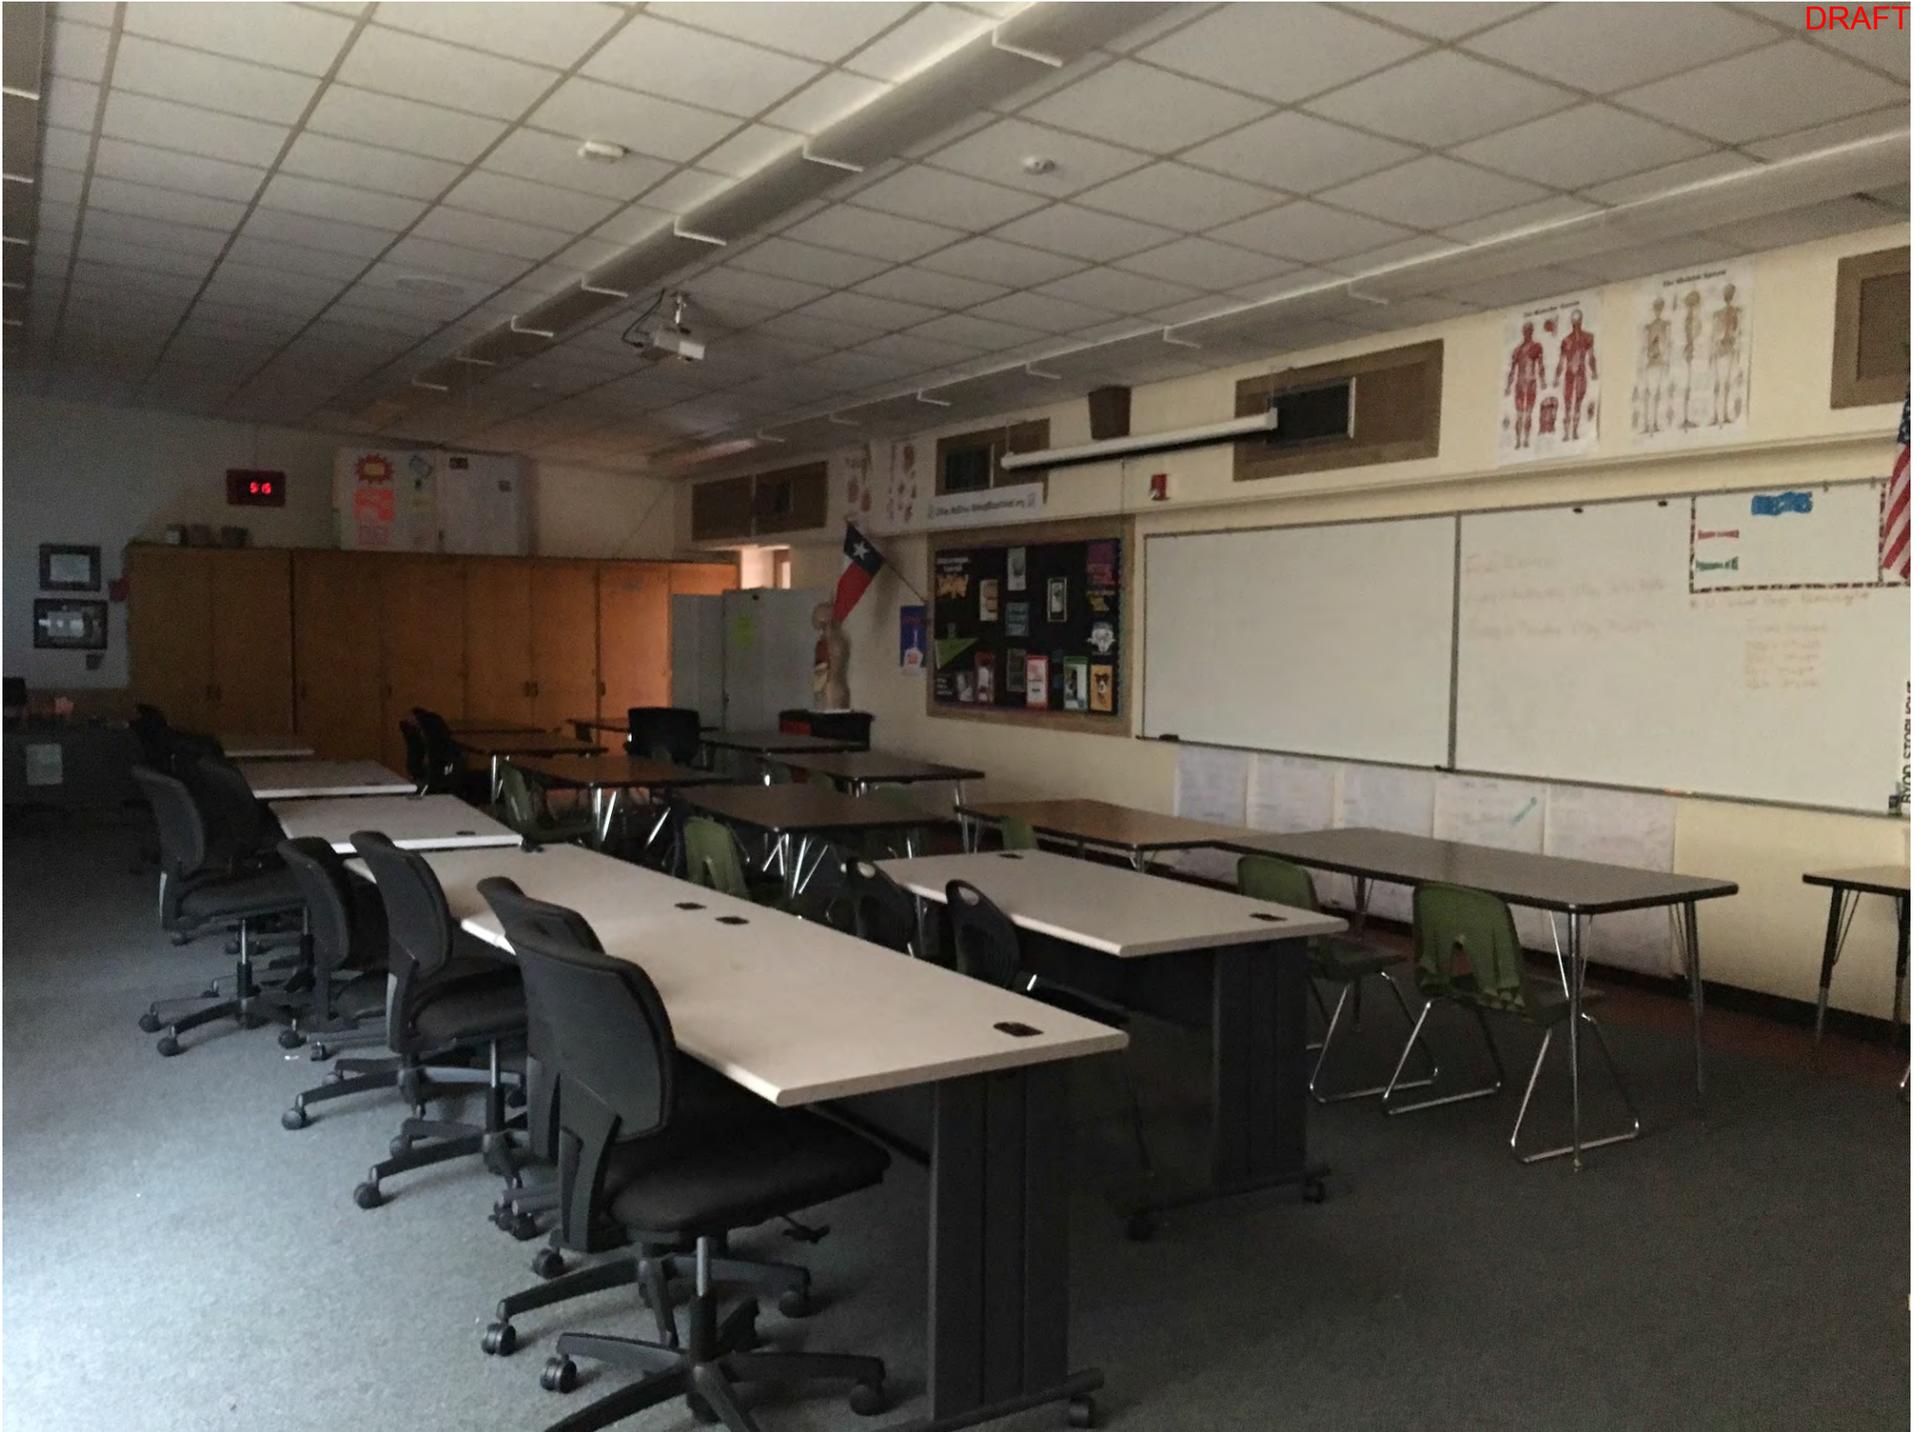
Photo 7. CTE room

4.9	Do the career education spaces simulate real world or college environments? (High School Only)		2						Comments	1.00	2.00
1) Very unsatisfactory - No dedicated spaces, lack of necessary equipment 2) Unsatisfactory - Non-dedicated, undersized or otherwise inadequate 3) Average - A few dedicated spaces of moderate size/layout, equipment and furniture appropriate but need updates 4) Good - Dedicated spaces of adequate size and layout, most of the equipment and furniture is appropriate for program 5) Very good - Dedicated spaces of adequate size and layout, equipment and furniture appropriate for program N/A) Does not apply.								Spaces are low quality. Equipment is adequate. Storage is poor.			
										See photo 7

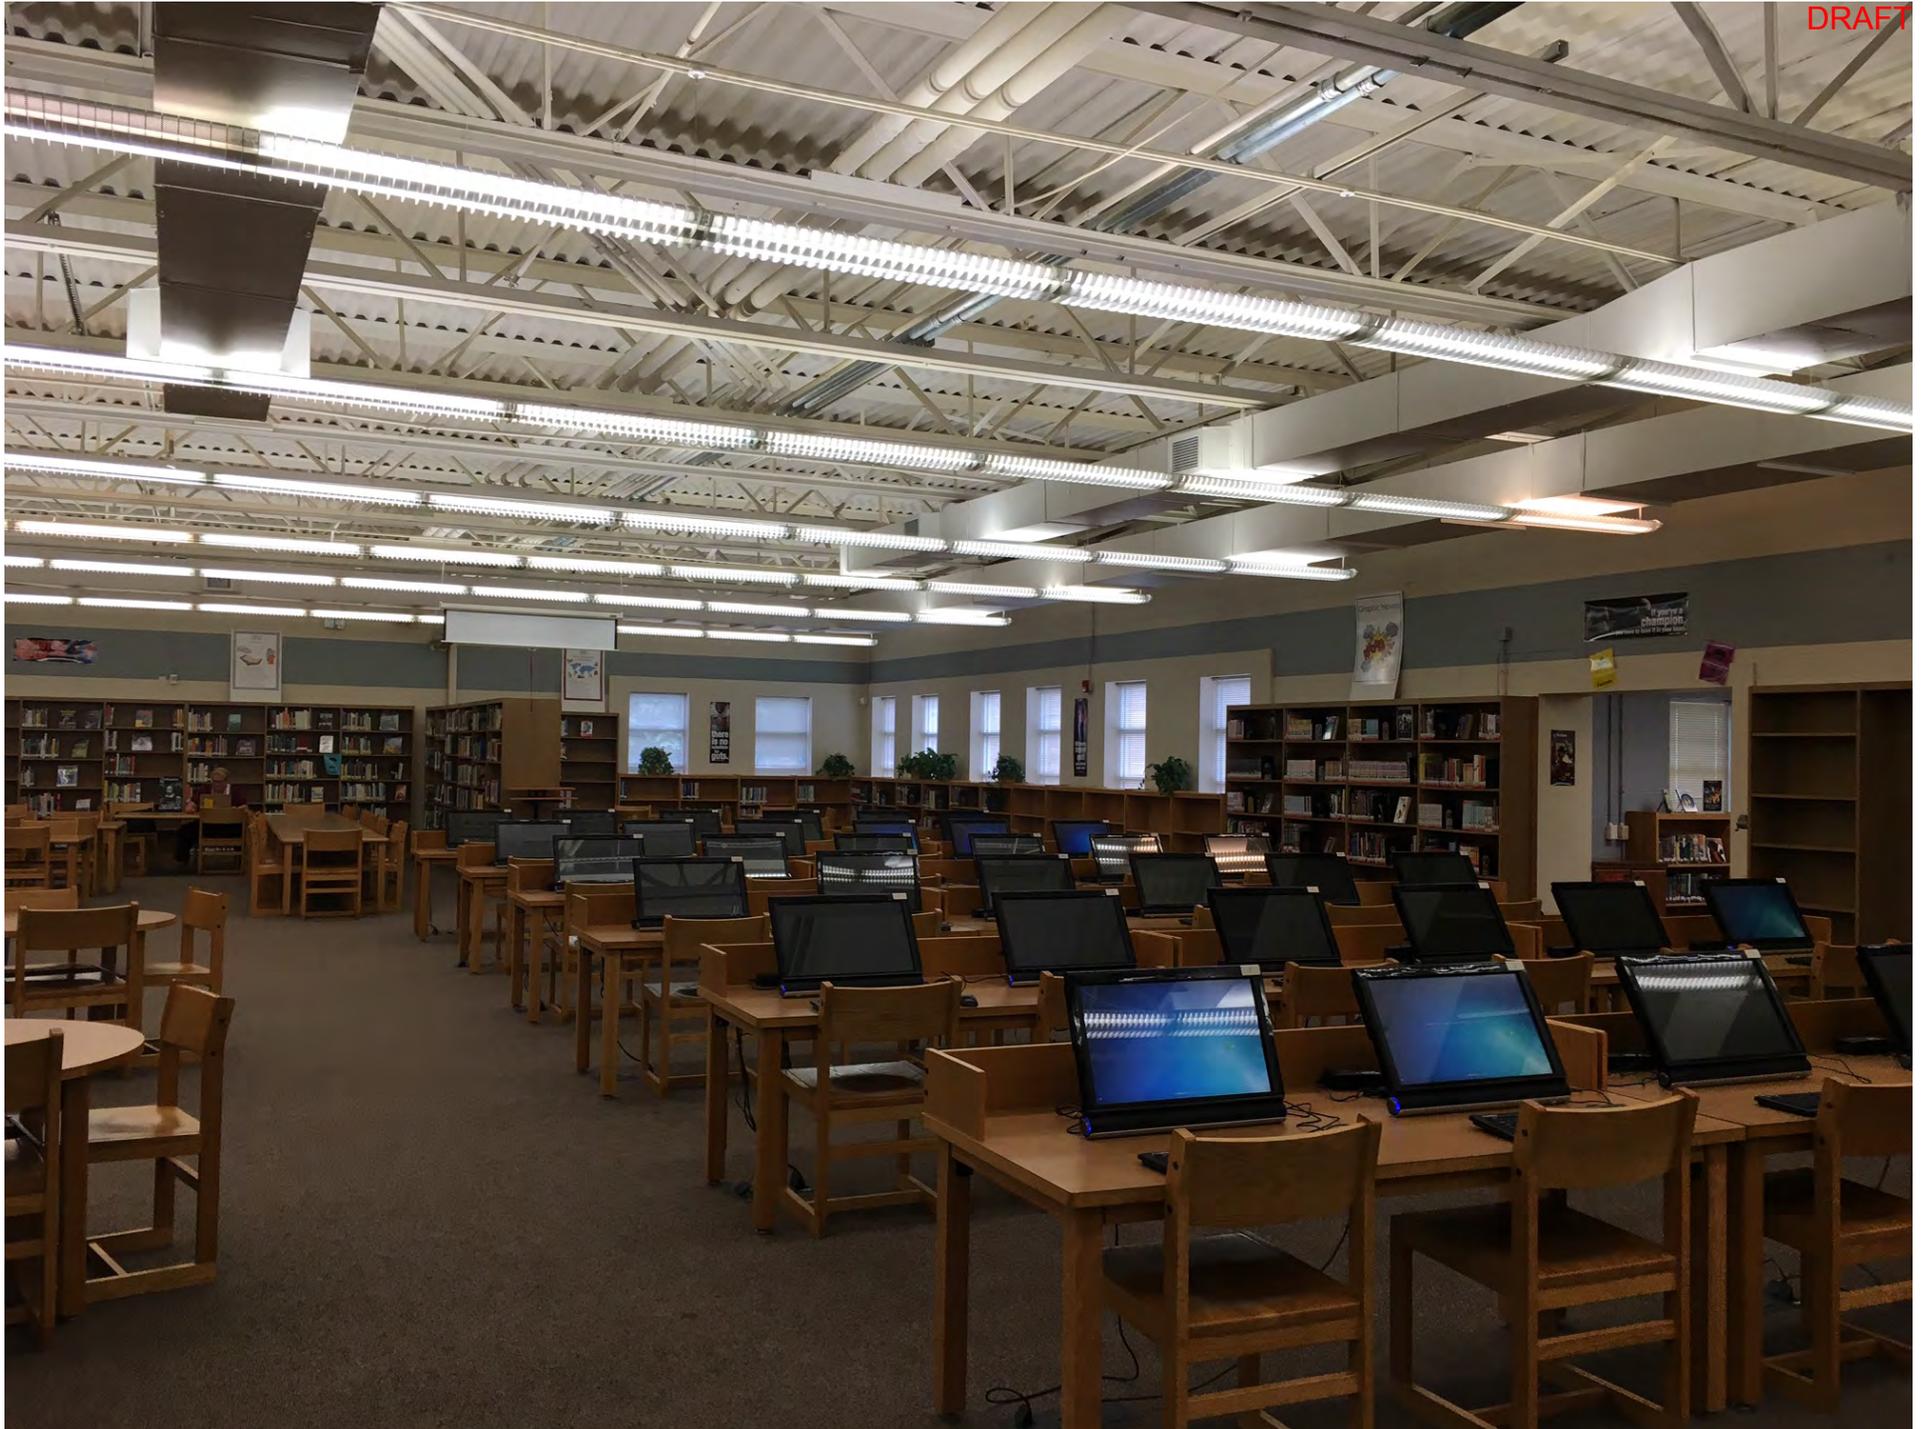
Photo 8. Library no acoustic ceiling

Library is close to the front entry, but the floor plans does not allow for secure for night access from rest of school. Library/Media Center acoustics do not support quiet study very well. Need for other casual seating to support social interaction and technology and projector to support small group areas.

5.2	How well does the Library/Media Center support quiet study?	1						Comments	1.00 1.00
1) Very unsatisfactory 2) Unsatisfactory 3) Average 4) Good 5) Very good N/A) Does not apply.								Acoustics are poor in the library. There are no individual work areas in the space.	
								See photo 8

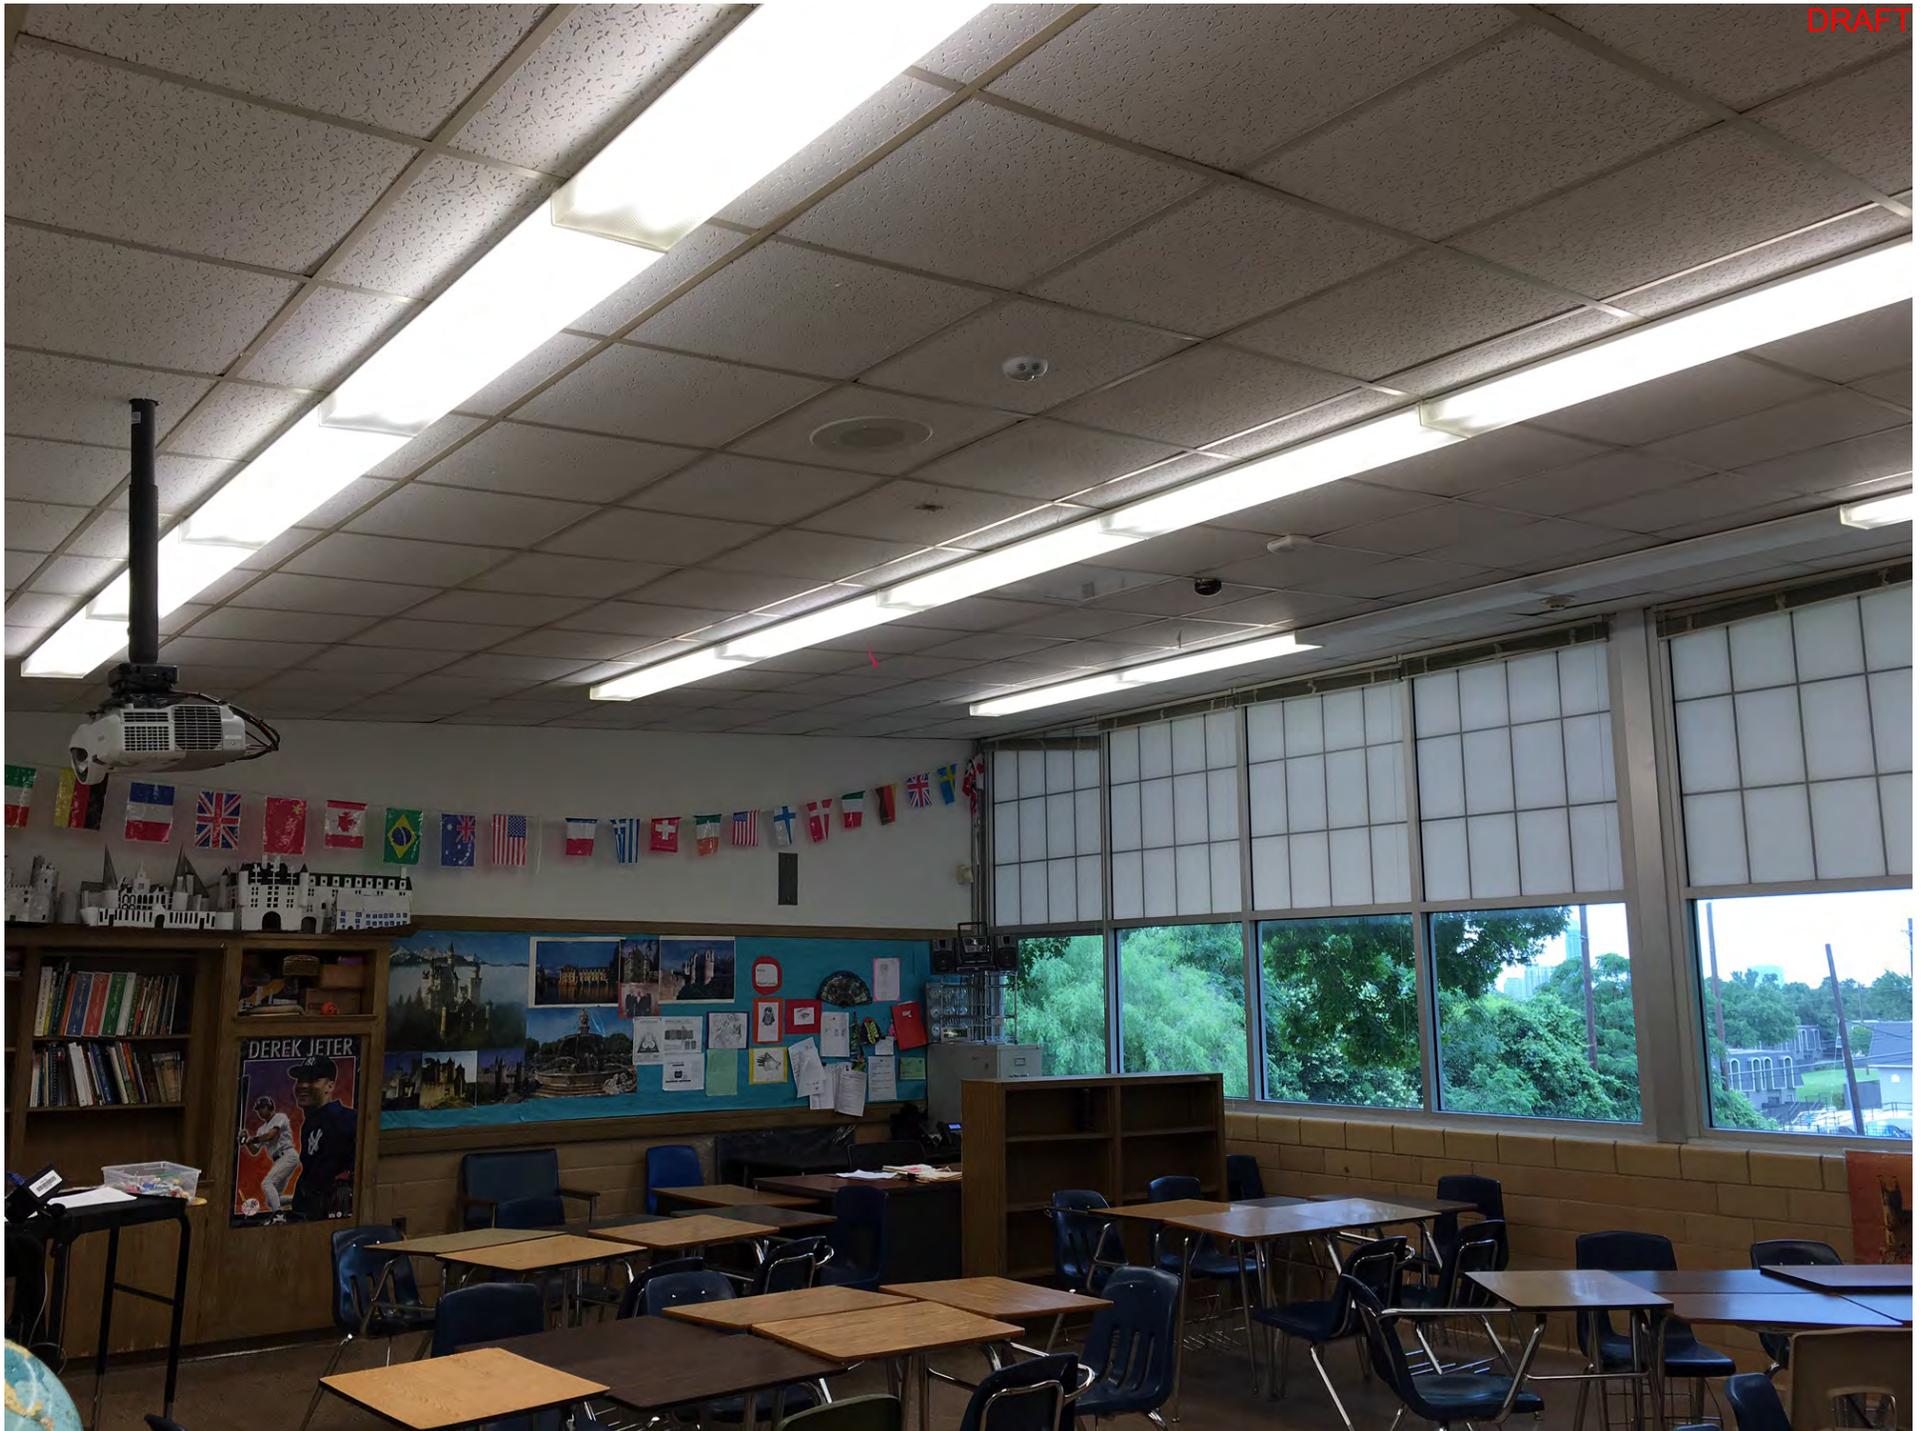
Photo 9. Classroom furniture & storage

Due to lack of storage closets, furniture is stored in a corridor near the science classrooms. Classroom casework is in poor condition and configuration. There is adequate student storage with lockers in corridors.

Most classrooms need updating with furniture. Furniture is dated and not as easily reconfigured for different learning groups. Career Tech classrooms have mixed tables of non-uniform and worn furniture. Furniture is dated, heavy, and is not easily reconfigured for different learning groups.

9 - Furniture, Fixtures & Equipment		1	2	3	4	5	N/A	4.75
9.1	What is the current condition of the furniture?	1						0.75 0.75
1) Very unsatisfactory - damaged/non-functioning 2) Unsatisfactory - torn, bent, wrong size 3) Average - scratched/dented/marked 4) Good - not new but sturdy and clean 5) Very good - new N/A) Does not apply.								Comments Most classroom furniture is not satisfactory. Cafeteria, library, and science are in good condition. CTE furniture is mismatched. <i>CAC comment: Mixed and matched.</i>
								See photo 8
