Educational Suitability Summary Report

Bailey Middle School

Date: 08/08/2016 (REV 11/4/16 – Survey Results)

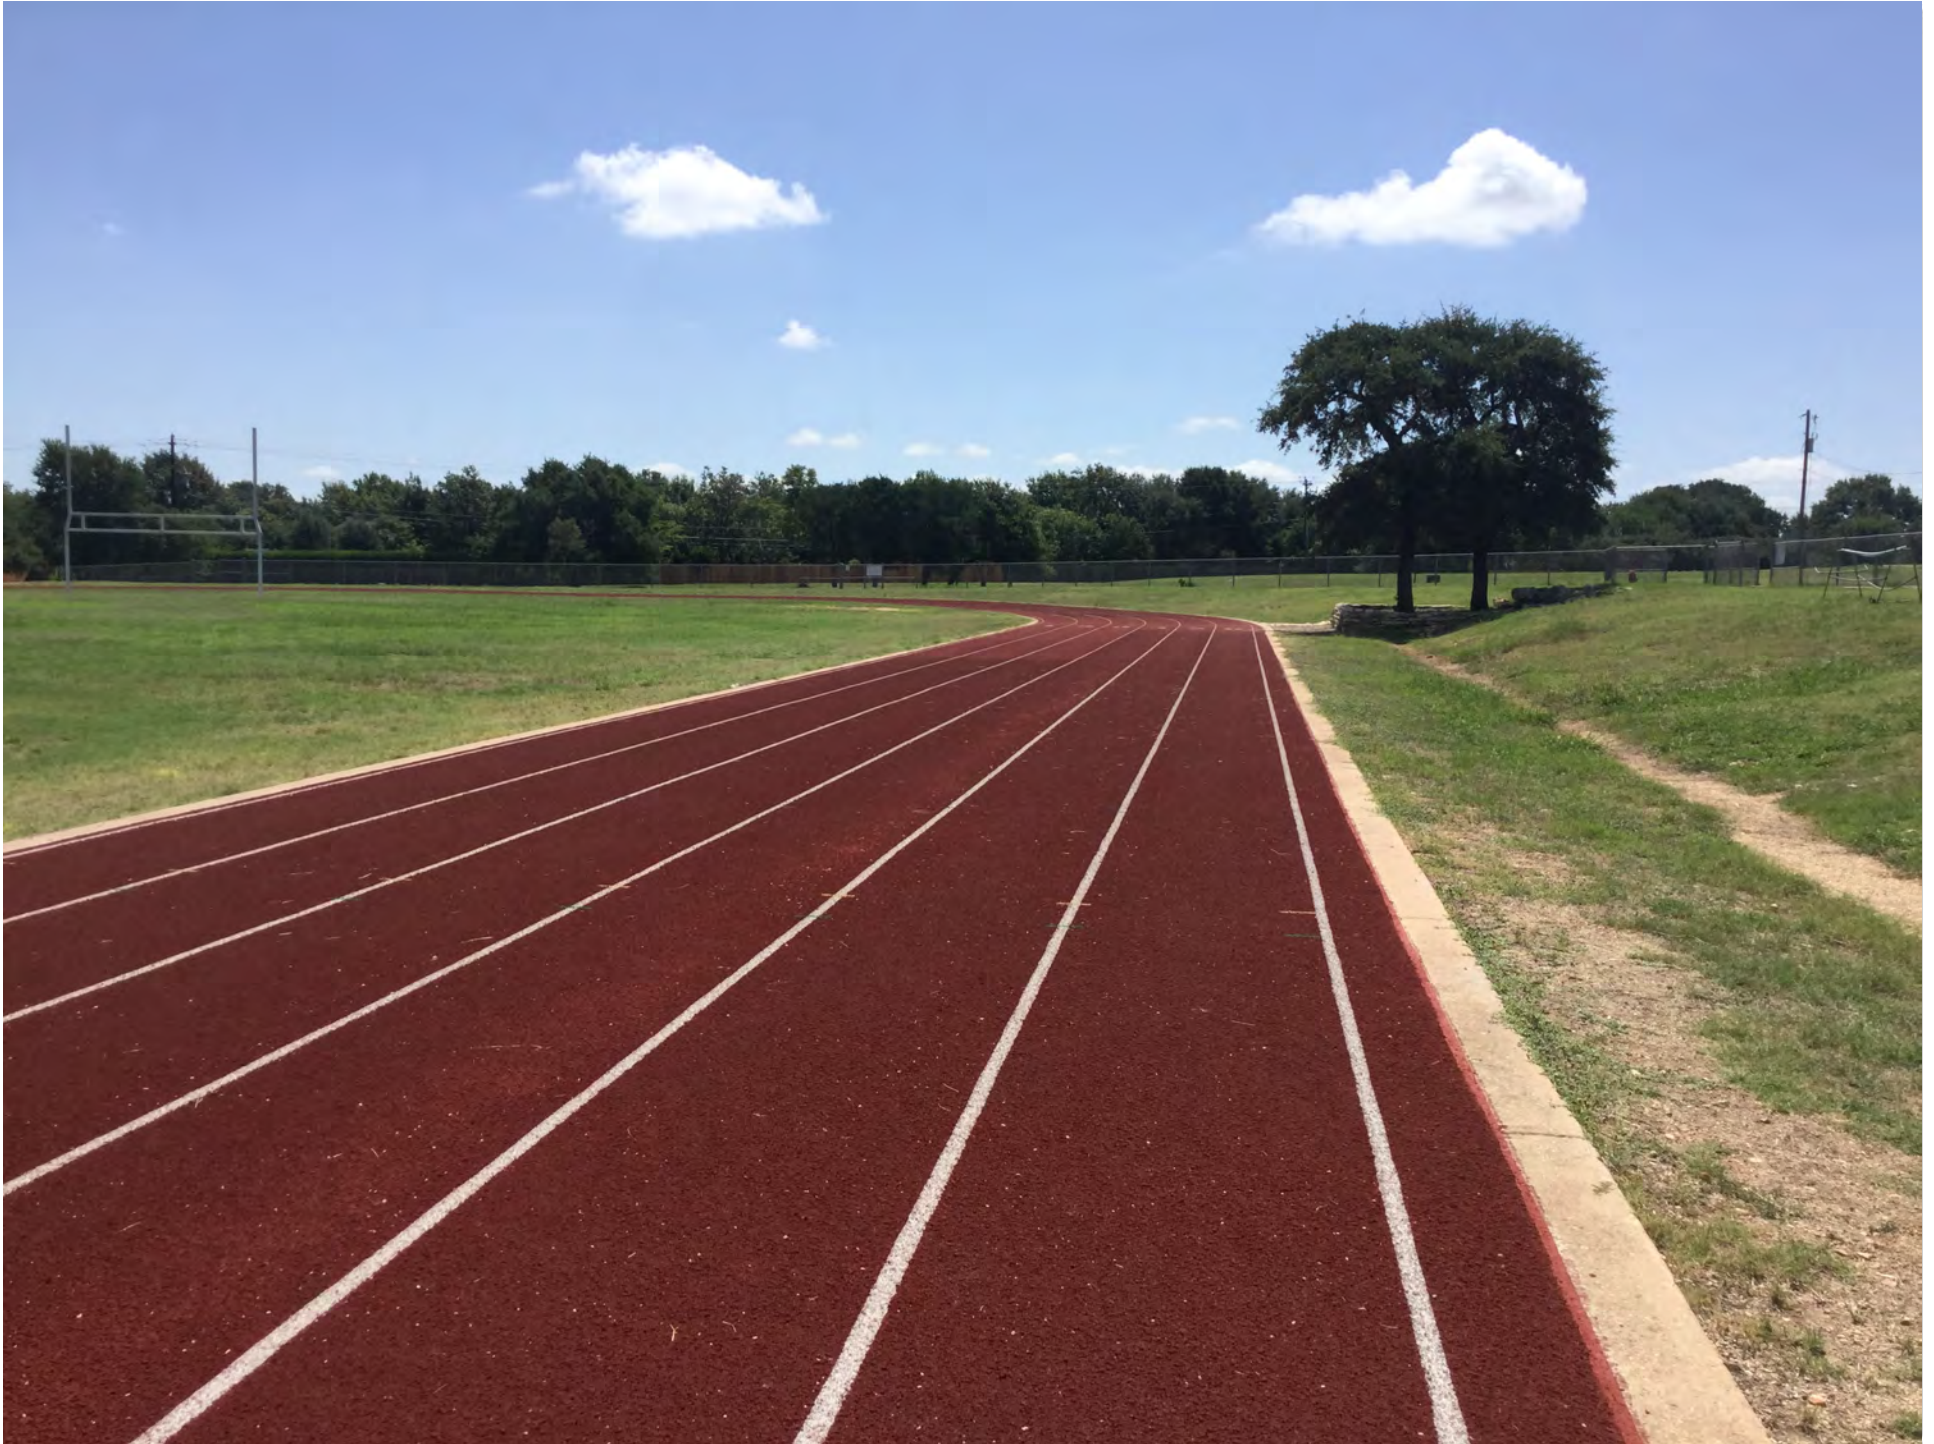
Photo 2. Track

The outdoor spaces need some improvements. The track was recently resurfaced, but it was done poorly and needs to be redone. There is a paved recess area that needs additional shade in the form of shade sails. The athletic facilities on campus are nice, but there is one locker-room off of the athletics

| 1 - Exterior | | 1 | 2 | 3 | 4 | 5 | N/A | 12.00 | |
|---|---|---|---|---|---|---|---|--|---|
| | 1) Outdoor play space exists, not developed 2) Outdoor play space exists but is not connected to gym or other athletic support areas or is too small. 3. Outdoor play spaces exist, are connected to other athletic areas, are the right size, but are not in good condition. 4. Outdoor play spaces need minor improvements to function well. 5. Outdoor play spaces are in excellent condition. N/A) Does not apply. | | | | | | | The track space is nice, but it needs refinishing. The surface is beginning to deteriorate despite being recently resurfaced. | |

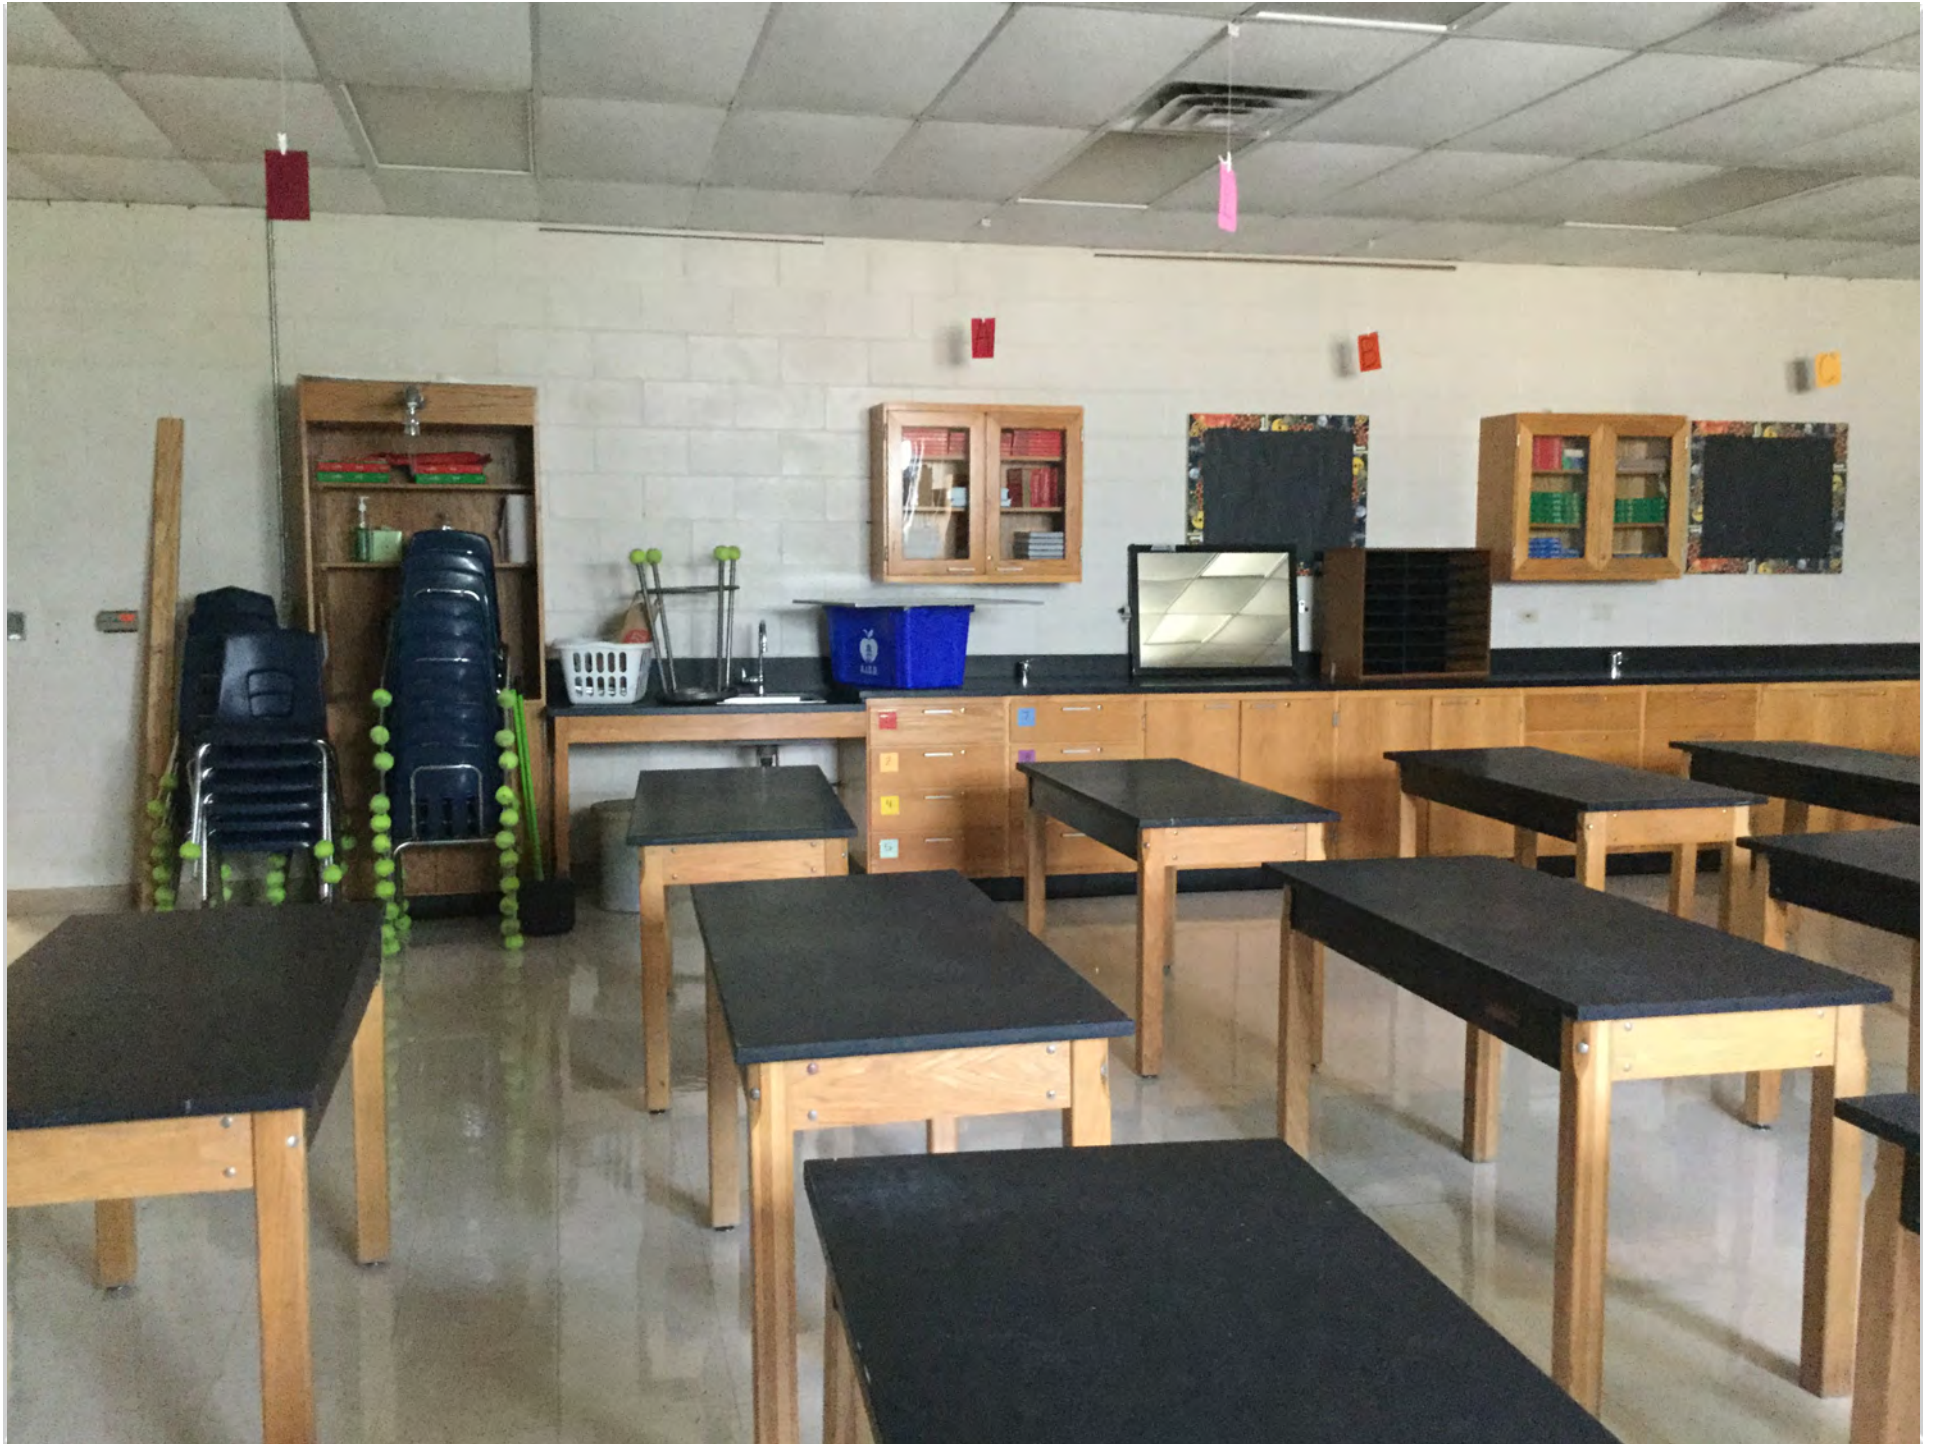
Photo 3. Science

| 3 - Academic & Co-Curricular Support | | 1 | 2 | 3 | 4 | 5 | N/A | 42.00 | |
|--|--|---|---|---|---|---|---|--|---|
| 1) Very unsatisfactory 2) Unsatisfactory 3) Neutral 4) Satisfactory 5) Very Satisfactory N/A) Does not apply. (Elementary schools) | | | | | | | | The science classrooms are good spaces with the appropriate solid surface tables and sinks. | |
| 1) Very unsatisfactory - Support spaces are disconnected from served spaces, too small, do not meet needs 2) Unsatisfactory - Support spaces are connected, but too small, do not meet needs 3) Average - Connected, moderate size, but need some renovations or updates 4) Good - Connected, good size, meets needs, functions well 5) Very good - connected, generous size, nice condition, functions appropriately N/A) Does not apply. (Elementary schools) | | | | | | | | There are a few science rooms that lack adequate storage and prep space. The eye wash stations need to be tested to be certain they are functioning appropriately. | |

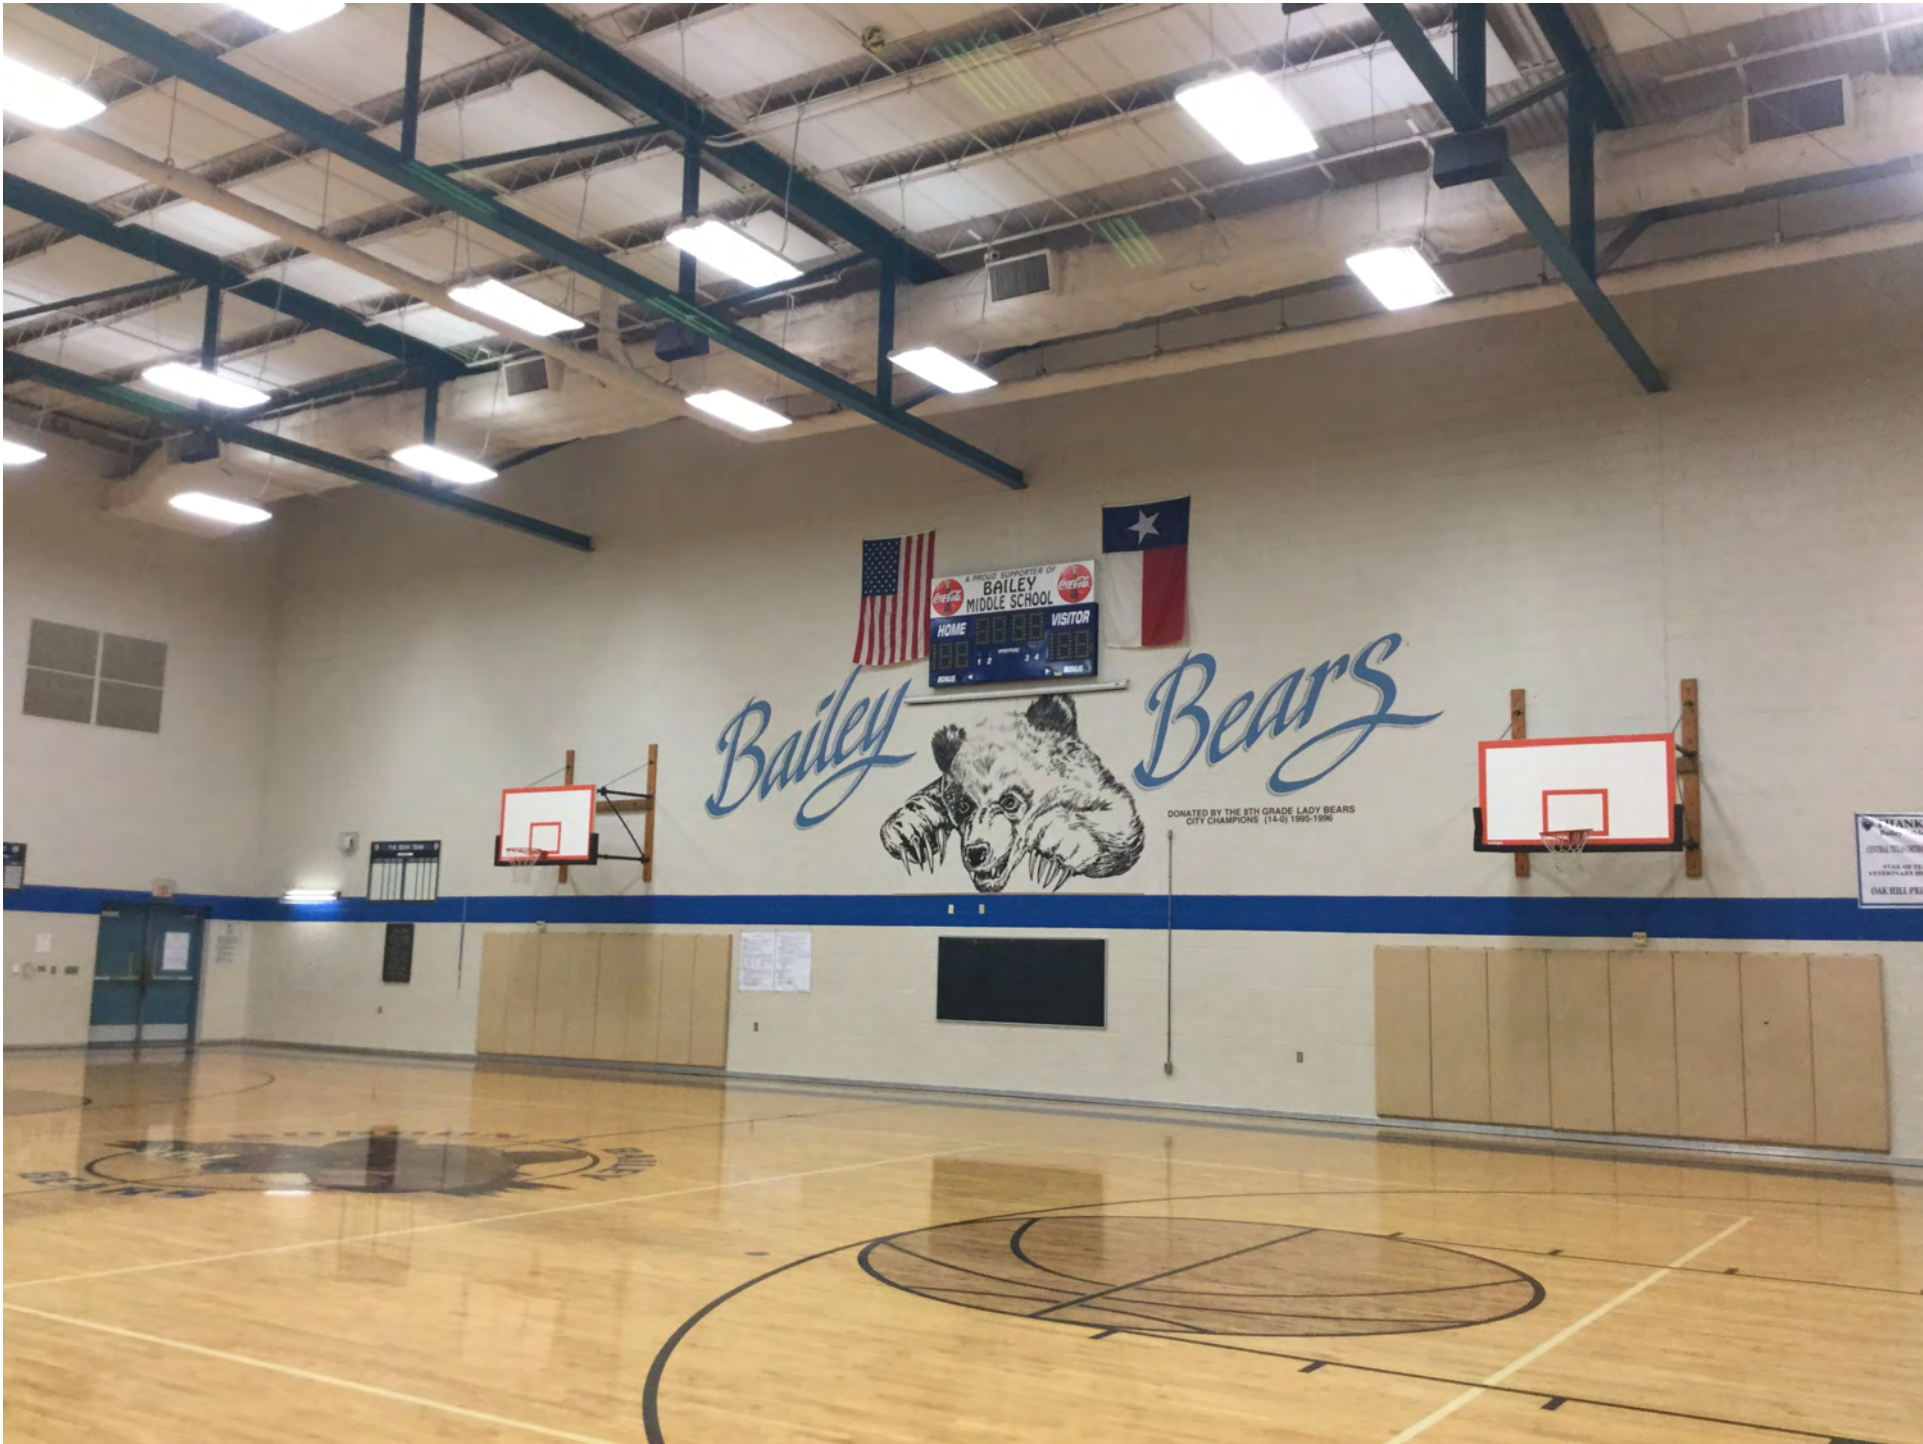
Photo 4.Gym

| 3 - Academic & Co-Curricular Support - Continued | | 1 | 2 | 3 | 4 | 5 | N/A | | |
|---|---|---|---|---|---|---|---|---|---|
| 1) Very unsatisfactory 2) Unsatisfactory 3) Average 4) Good 5) Very good N/A) Does not apply. | | | | | | | | The athletic spaces are excellent. The large gym just needs acoustic panels added to help with issues for assemblies. | |

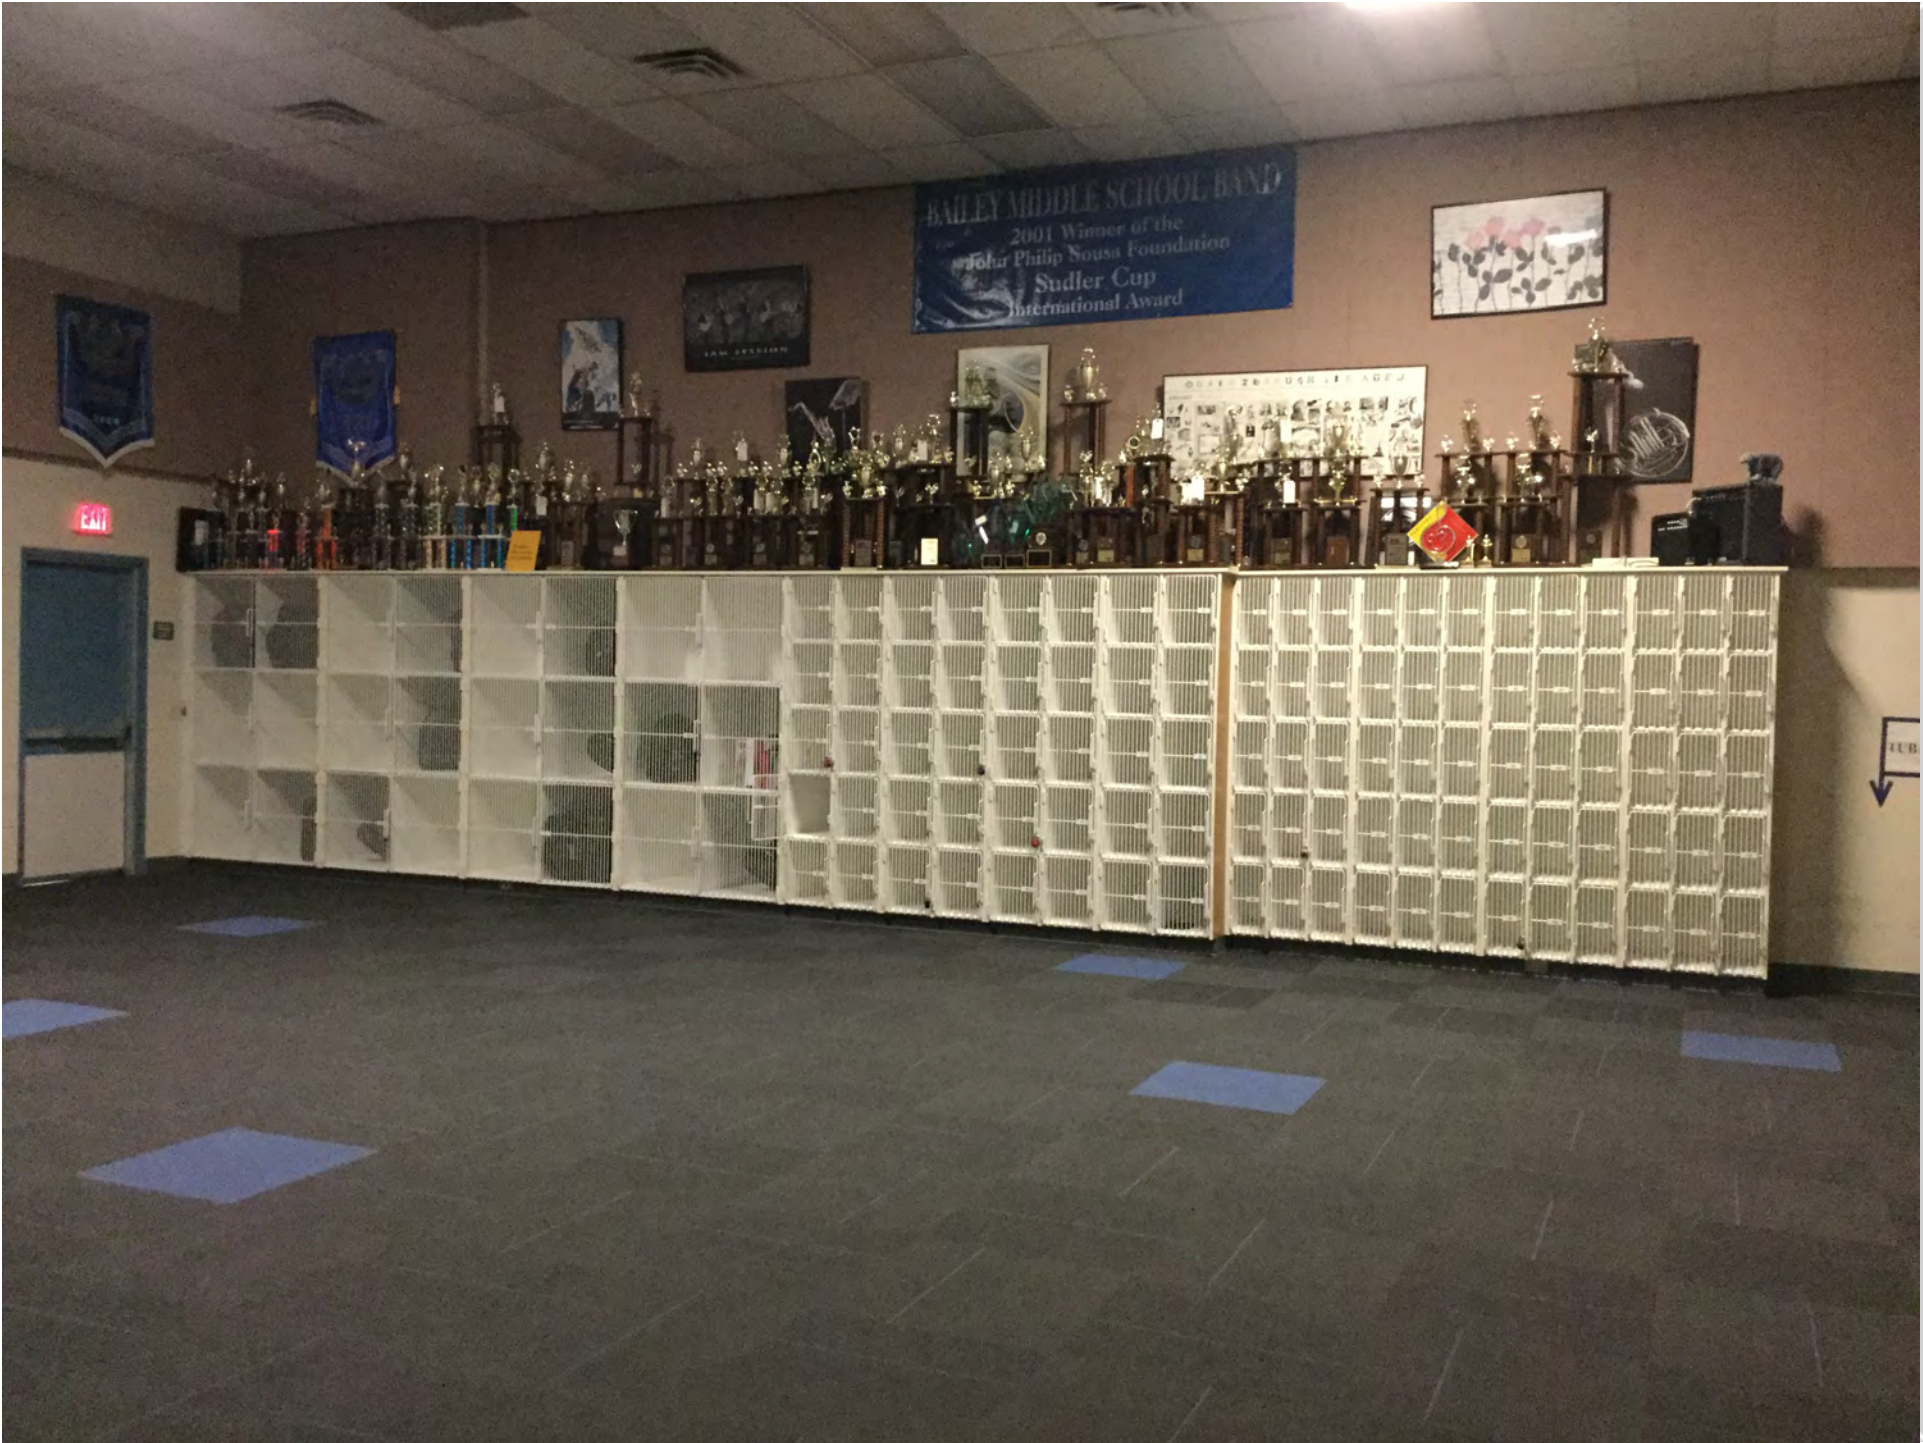
Photo 5. Band

| 3 - Academic & Co-Curricular Support - Continued | | 1 | 2 | 3 | 4 | 5 | N/A | | |
|---|---|---|---|---|---|---|---|---|---|
| 1) Very unsatisfactory 2) Unsatisfactory 3) Average 4) Good 5) Very good N/A) Does not apply. | | | | | | | | The band spaces are over capacity at the campus. They are having to split the band up into undersized spaces. The storage needs increasing. The theater and prop room needs to be larger. | |

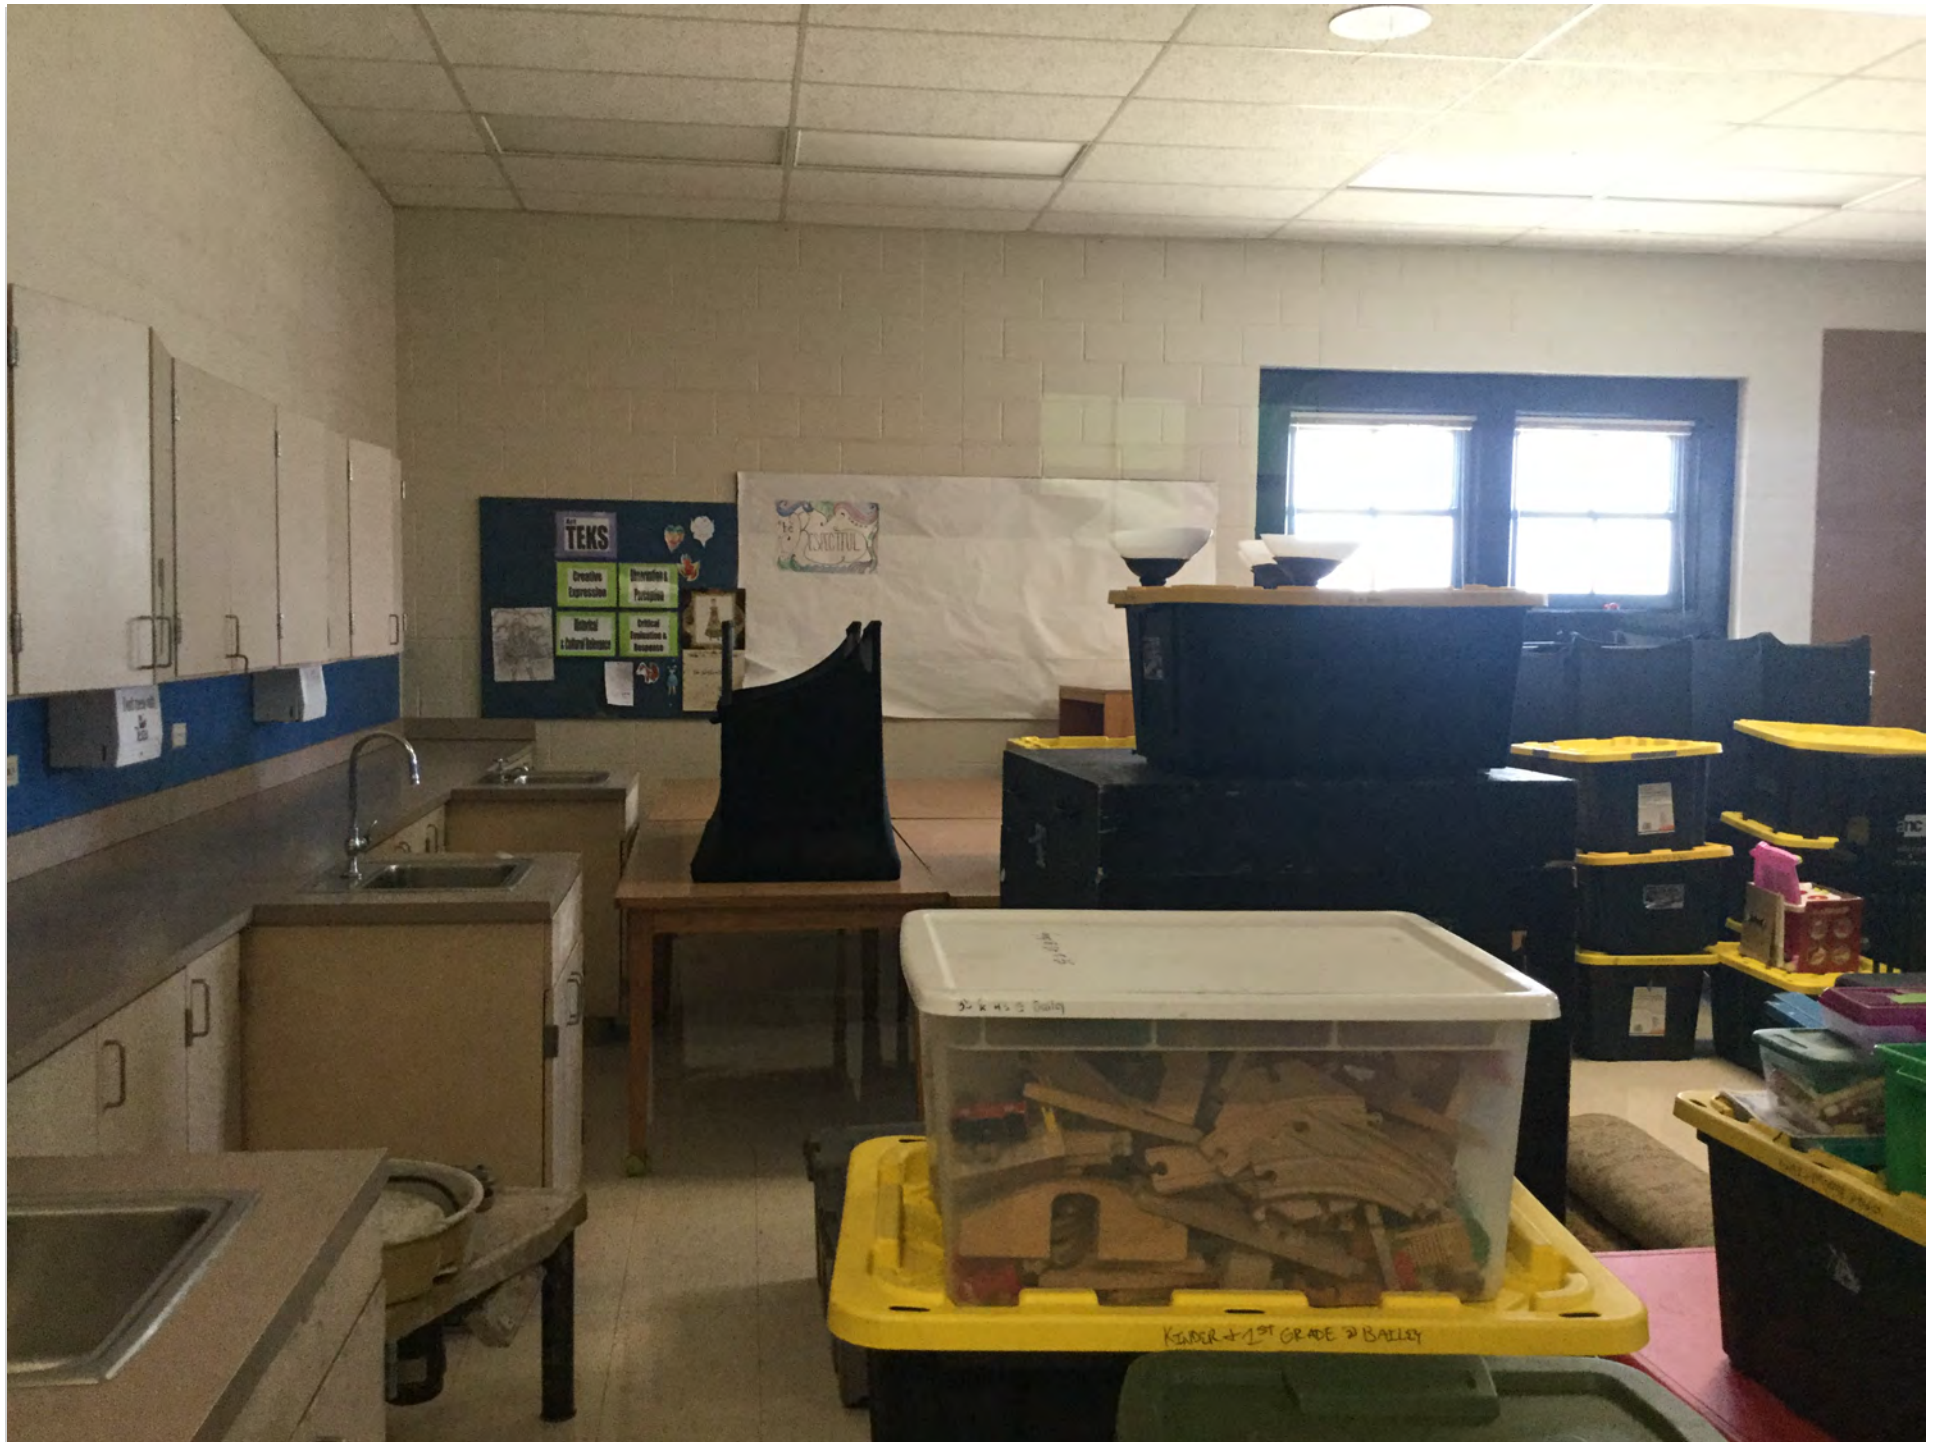
Photo 6. Art room

| 3 - Academic & Co-Curricular Support - Continued | | 1 | 2 | 3 | 4 | 5 | N/A | | |
|---|---|---|---|---|---|---|---|---|---|
| 1) Very unsatisfactory 2) Unsatisfactory 3) Average 4) Good 5) Very good N/A) Does not apply. | | | | | | | | The art room is an adequate size, with natural light. | |
| 1) Very unsatisfactory - Support spaces are disconnected from served spaces, too small, do not meet needs 2) Unsatisfactory - Support spaces are connected, but too small, inadequate for needs 3) Average - Connected, moderate size, but need some renovations or updates to function well 4) Good - Connected, good size/layout, meets needs/functions well 5) Very good - connected, generous size, nice condition, functions appropriately N/A) Does not apply. | | | | | | | | The casework in the art room needs updating. | |

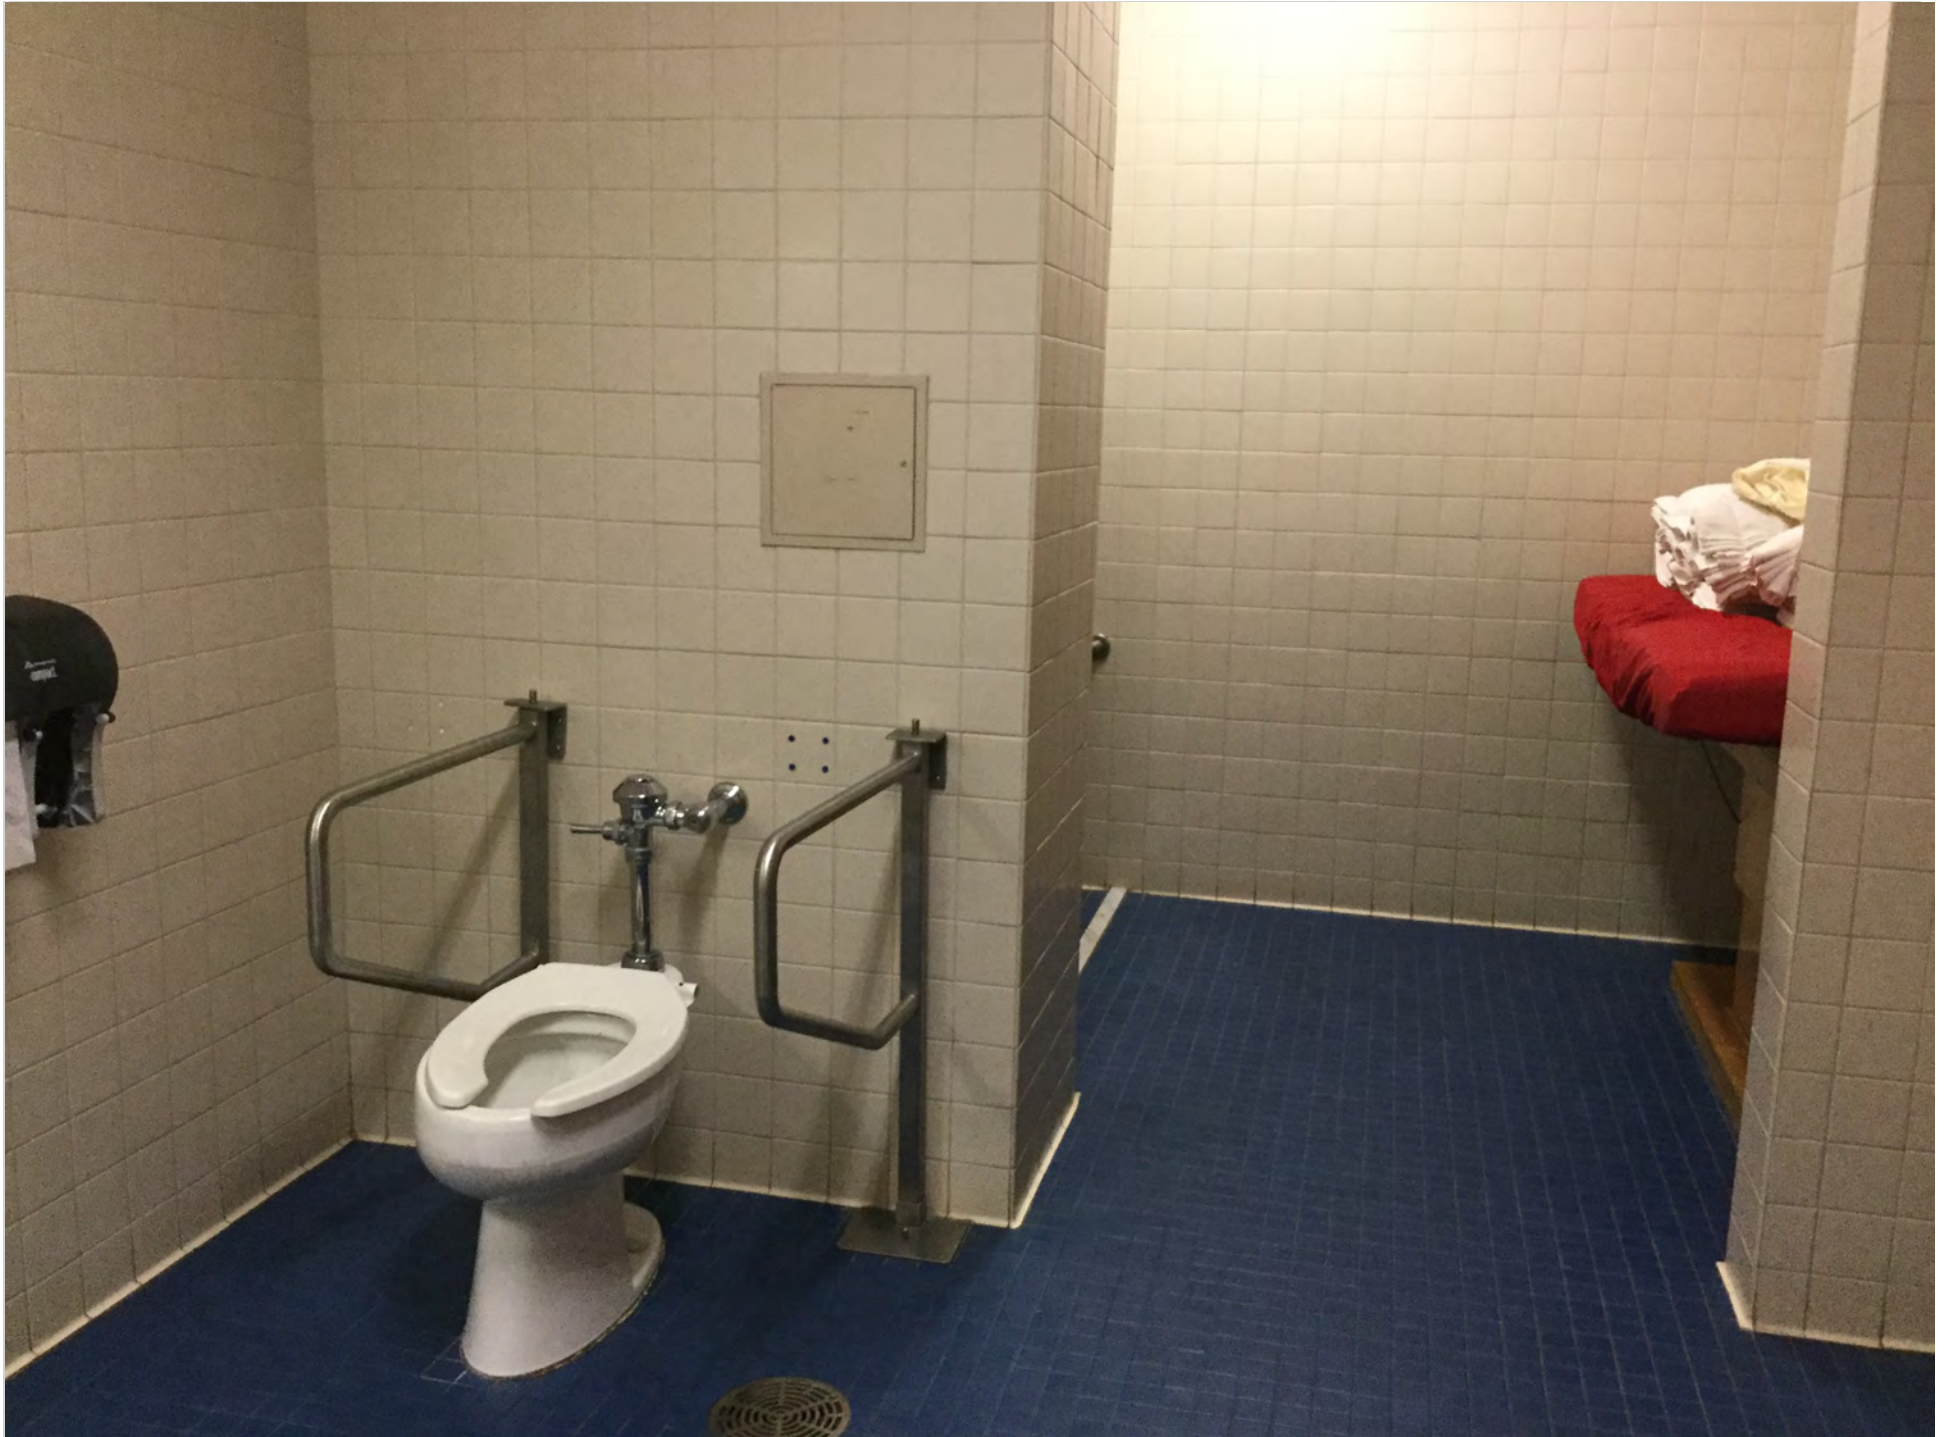
Photo 7. Special
Education Support

| 3 - Academic & Co-Curricular Support - Continued | | | | | | | 1 | 2 | 3 | 4 | 5 | N/A | | | |
|--|---|--|--|--|--|--|---|---|---|---|---|--|---|---|---|
| 1) Very unsatisfactory - Support spaces are disconnected from served spaces, too small, do not meet needs 2) Unsatisfactory - Support spaces are connected, but too small, inadequate for needs 3) Average - Connected, moderate size, but need some renovations or updates to function well 4) Good - Connected, good size/layout, meets needs/functions well 5) Very good - connected, generous size, nice condition, functions appropriately N/A) Does not apply. | | | | | | | | | | | | The restroom area is generous and has a shower and changing area as required. However, this space is somewhat dated. | | | |

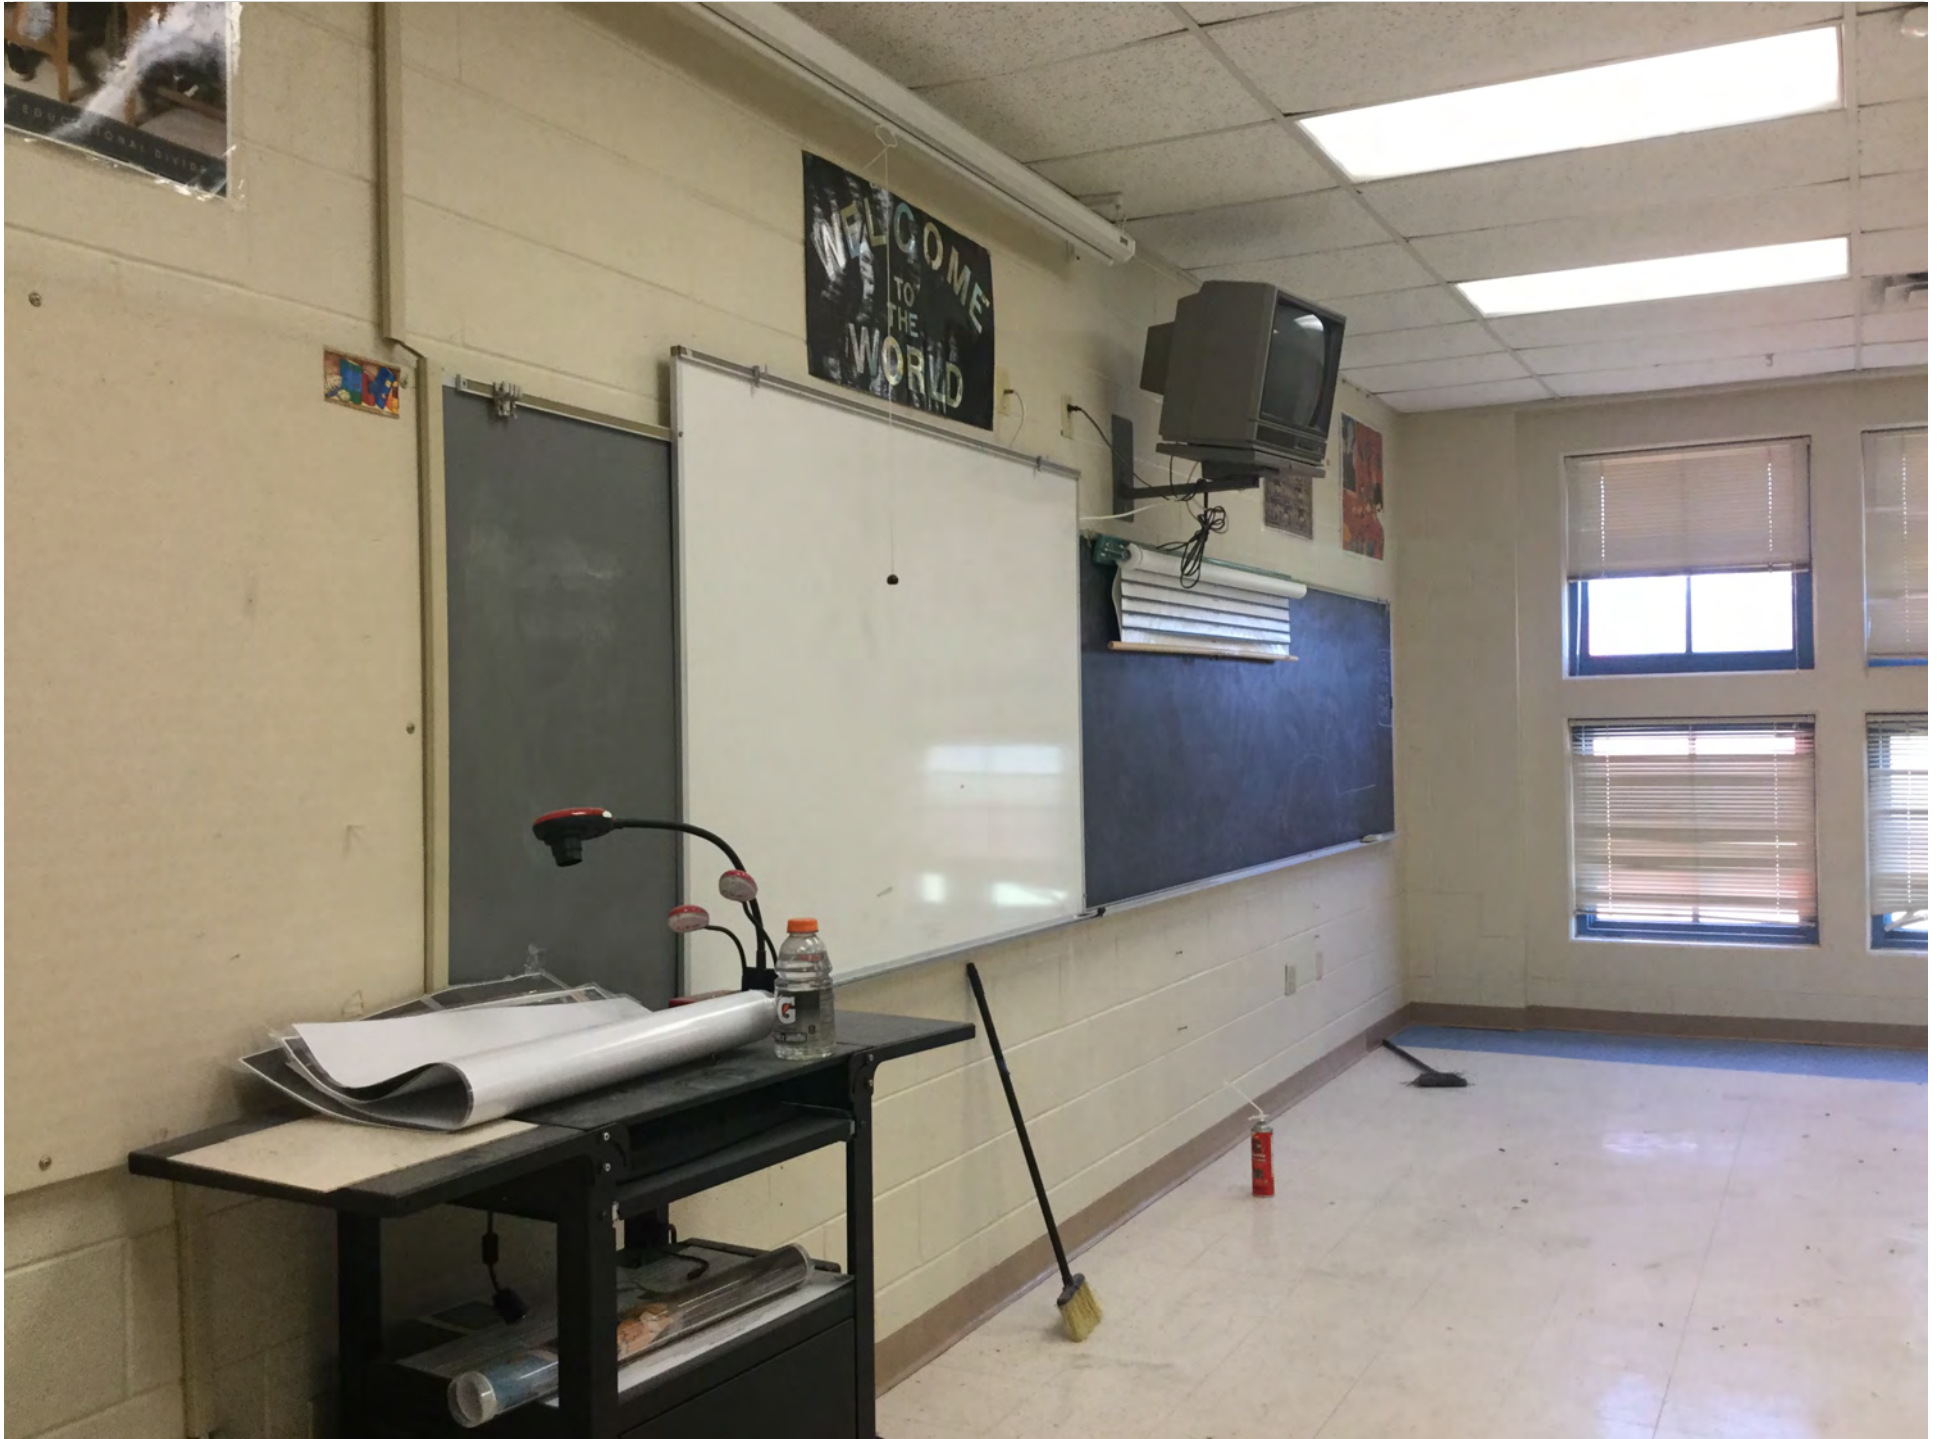
Photo 9. Visual CommTools

corridor that is not configured appropriately to block views from this corridor directly into the changing area. The visual communication tools such as the chalkboards and tack boards are outdated, and there is some older technology in the form of old television screens in the some classrooms.

The campus classrooms and support spaces are inadequate to accommodate hands-on project-based learning. The campus has one CTE workshop area, but otherwise lacks any common project spaces. The facility lacks consistent visual communication tools across the classrooms. There are some projectors but some of this technology is quite outdated. There are classrooms with outdated chalkboards as well.
