Educational Suitability Summary Report

Bailey Middle School

Date: 08/08/2016 (REV 11/4/16 – Survey Results)

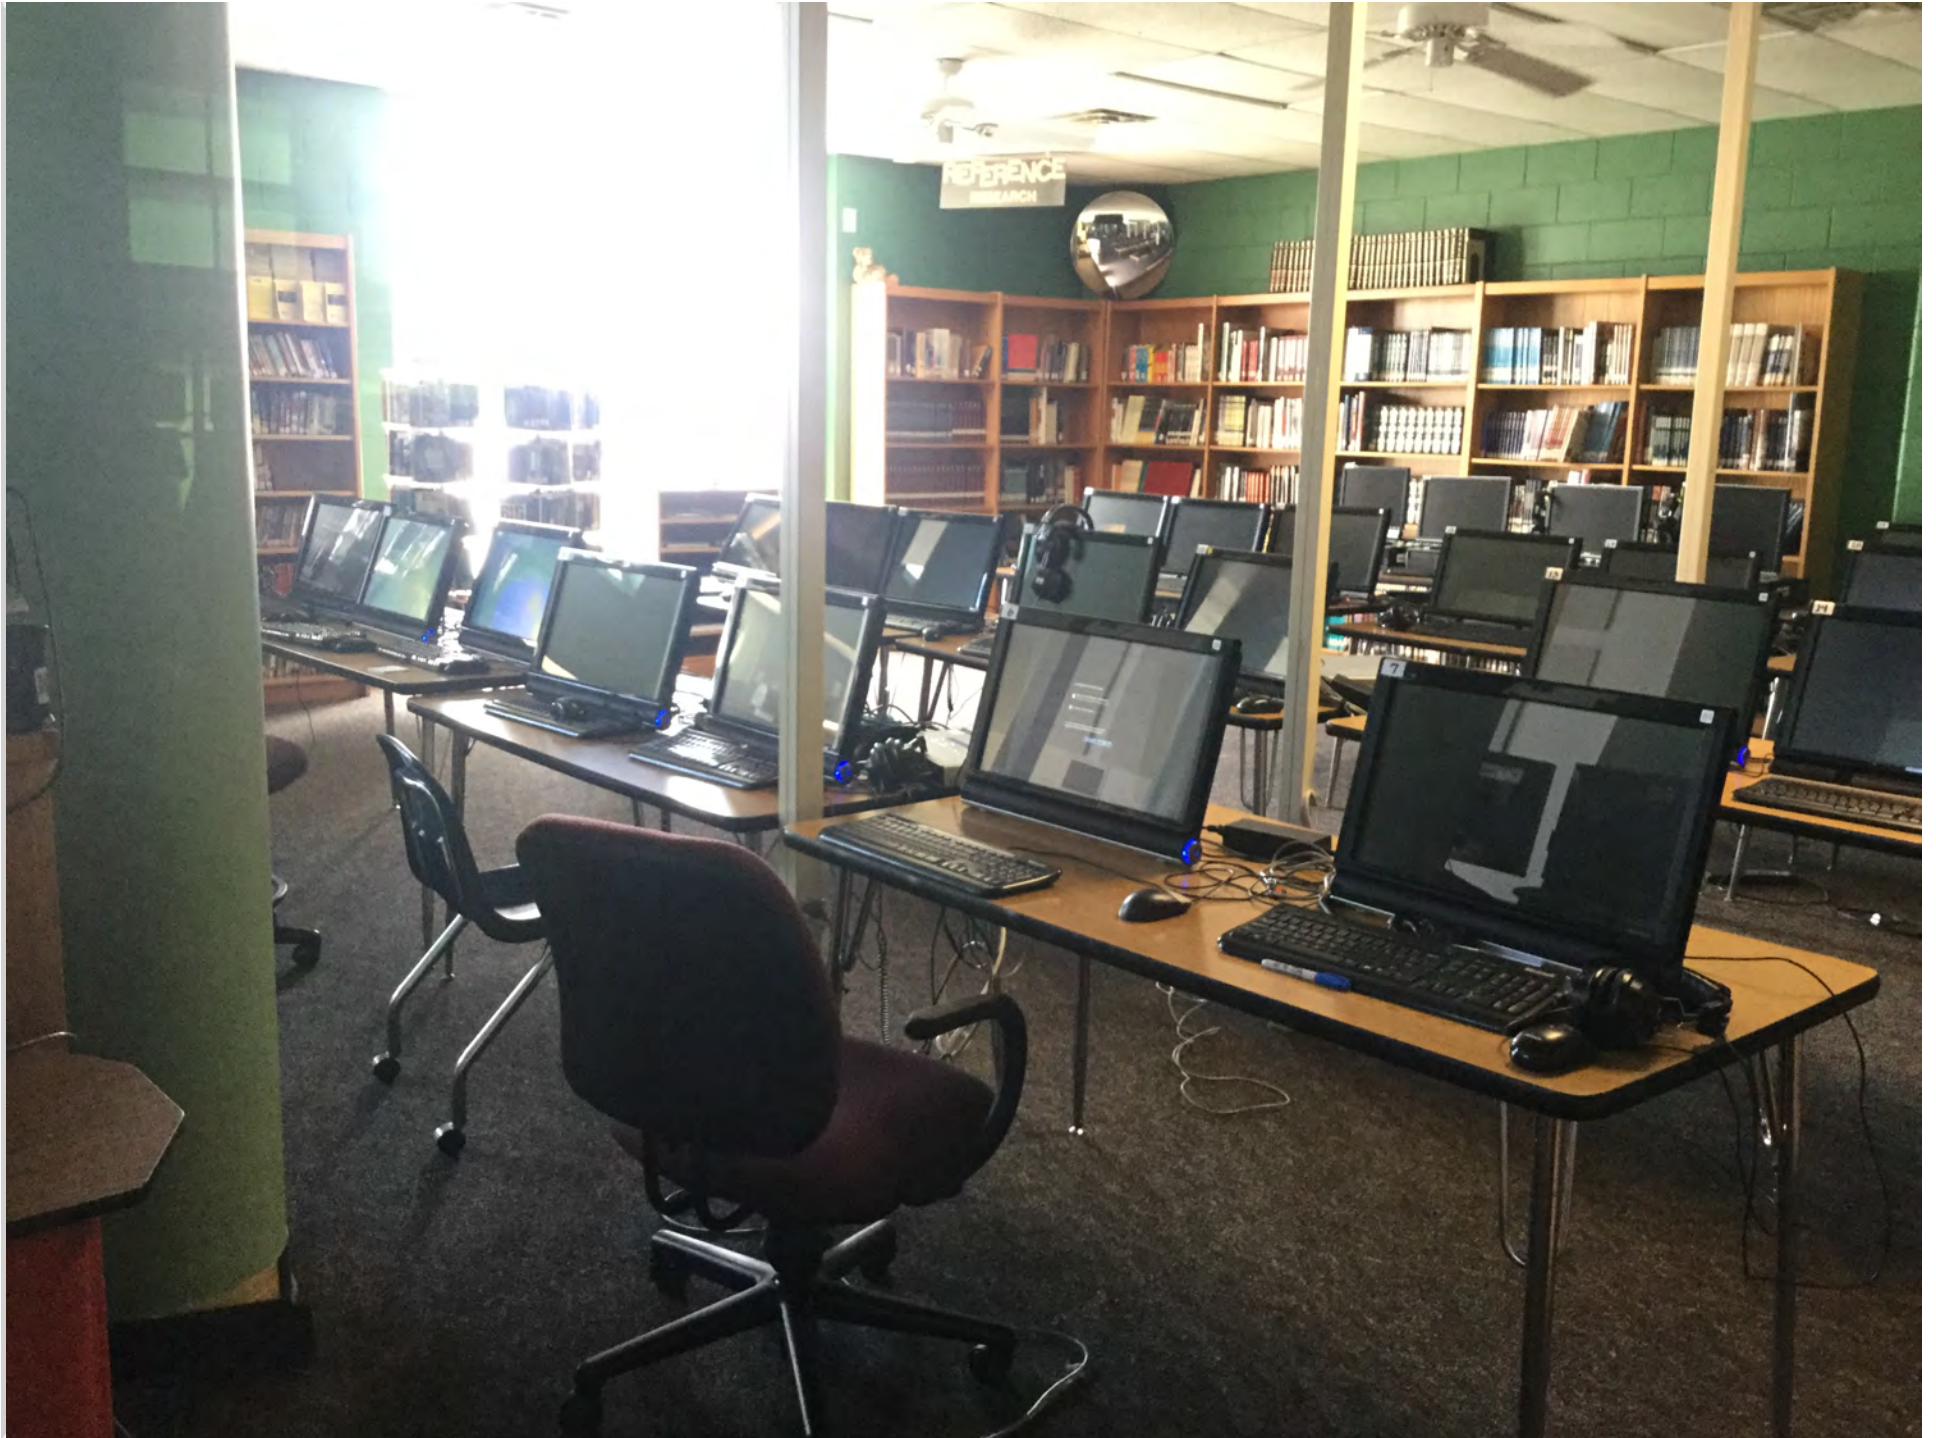
Photo 10. Library technology

| 5 - Library/Media Center - Continued | | 1 | 2 | 3 | 4 | 5 | N/A | | |
|---|---|---|---|---|---|---|---|--|---|
| 1) Very unsatisfactory - Very inadequate power outlets, no Wi-Fi capability, no computers, tablets, laptops, media carts or screens for use 2) Unsatisfactory - Some power, no Wi-Fi capability, outdated and inadequate technology available 3) Average - Some power outlets, network connectivity, technology available 4) Good - Adequate power outlets available, network connectivity, appropriate number of computers/tablets/laptops/media carts or screens available 5) Very good - Adequate power outlets available, good network connectivity, computers, tablets, laptops and media carts or screens available and adequate for number of students N/A) Does not apply. | | | | | | | | There are a lot of computers available in the library. The faculty expressed that the library is expected to become increasingly focused on technology access. | |
