Educational Suitability Summary Report

Burnet Middle School – BLDG 046

Date: 06/20/2016

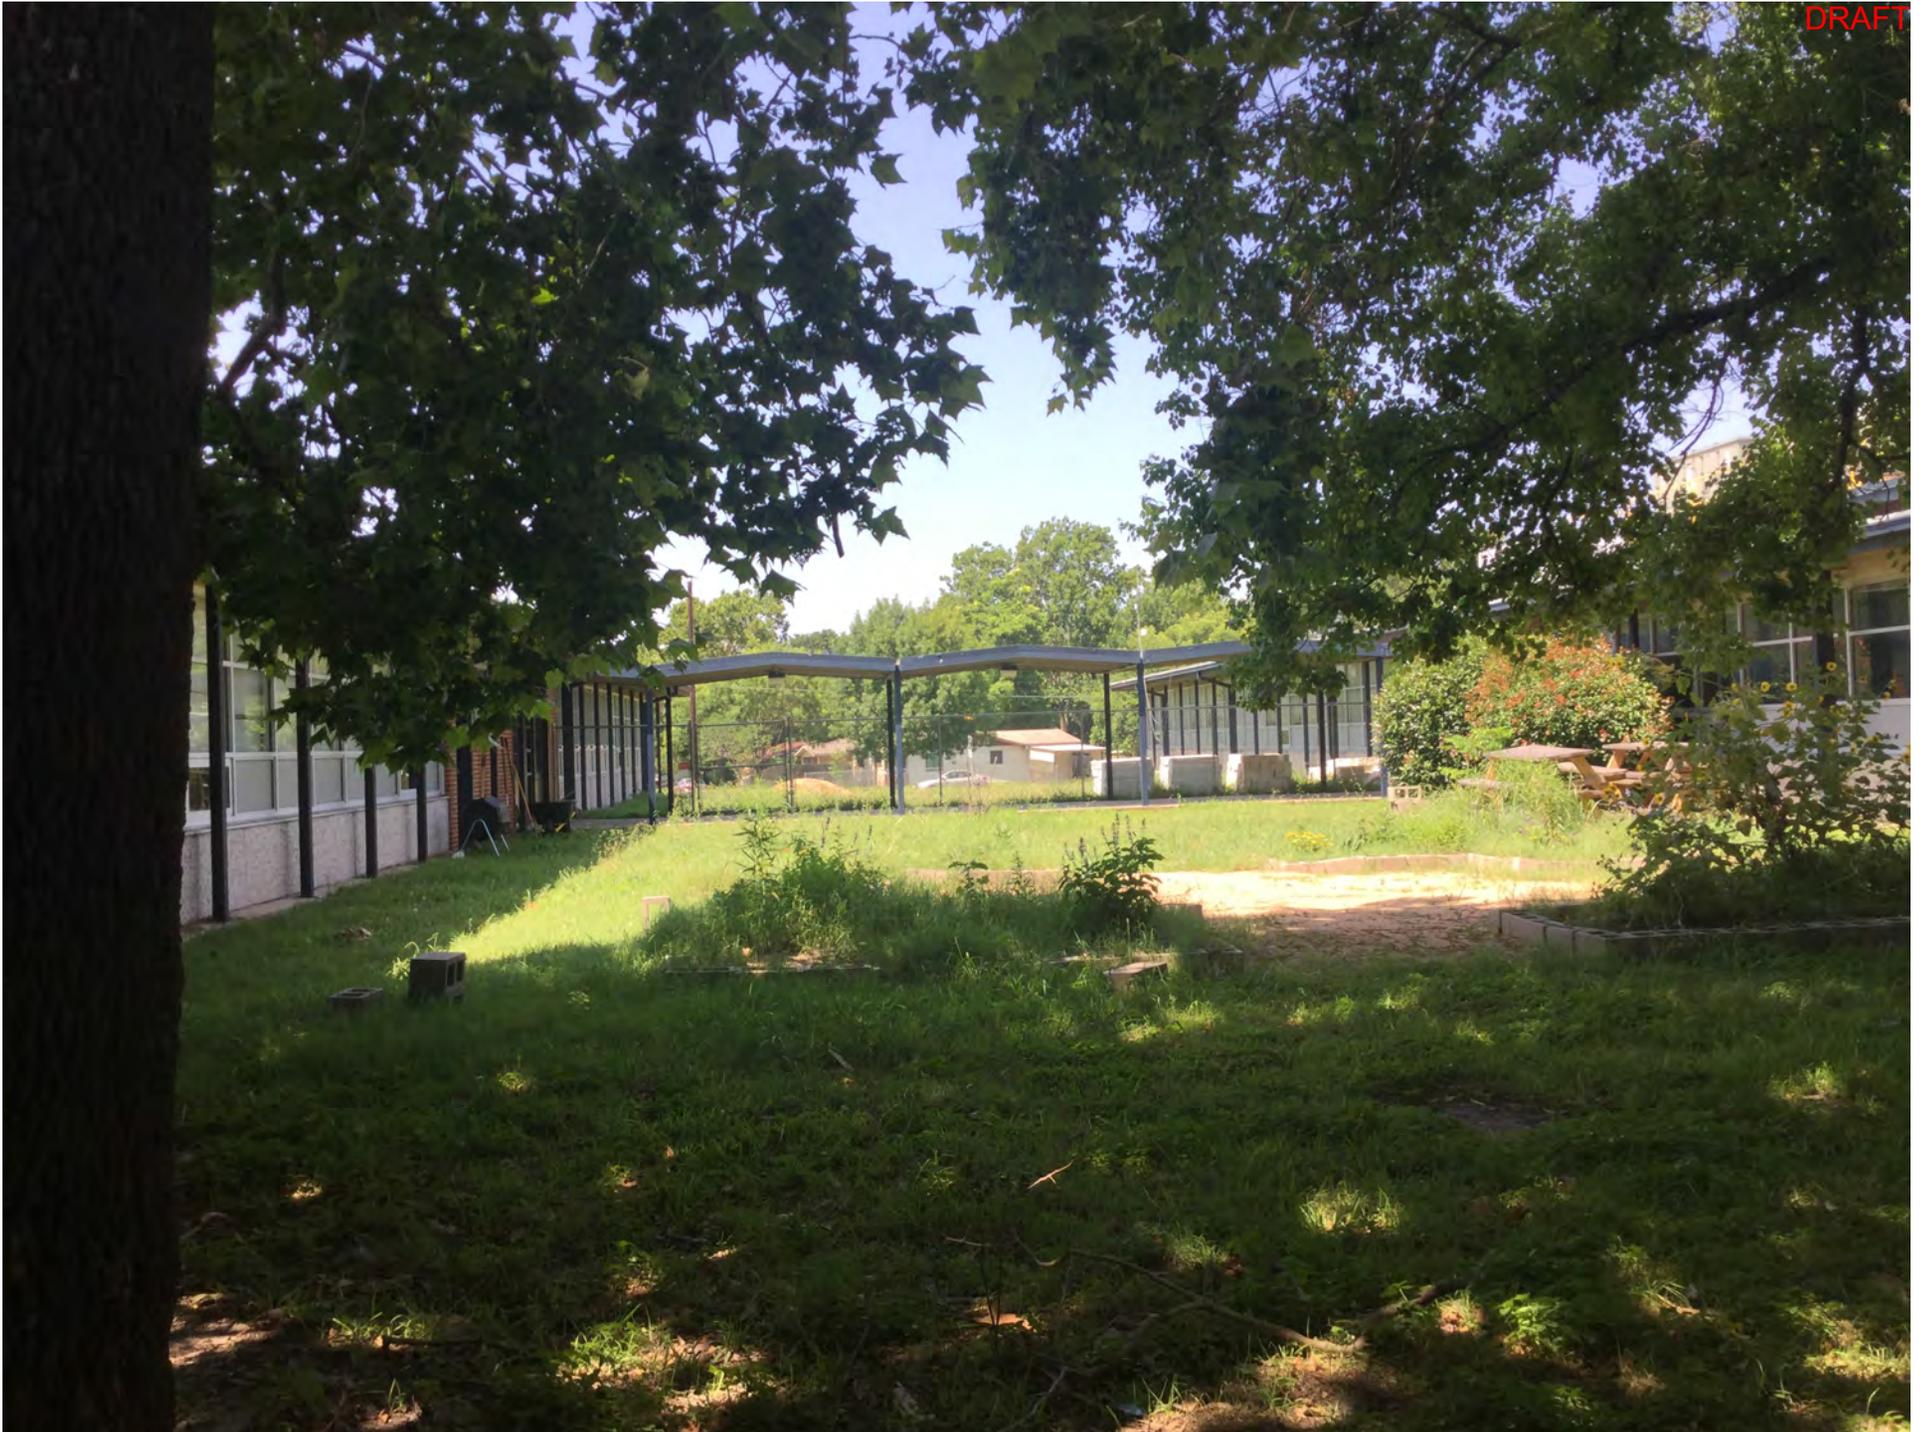
Photo 1. Courtyard.

1.2	Are opportunities provided for outdoor learning (outdoor classrooms, gardens, etc.)?			3				Comments	1.00	3.00
1) Outdoor space exists is not developed 2)Outdoor space for learning exists but not connected to classroom learning areas. 3. Outdoor learning spaces exist and are accessible but not in good condition. 4. Outdoor learning spaces need minor improvements to function well. 5. Outdoor learning spaces are in excellent condition. N/A) Does not apply.		The campus has a lot of outdoor courtyards that serve as outdoor space , but they need some development and maintenance. See Image 1

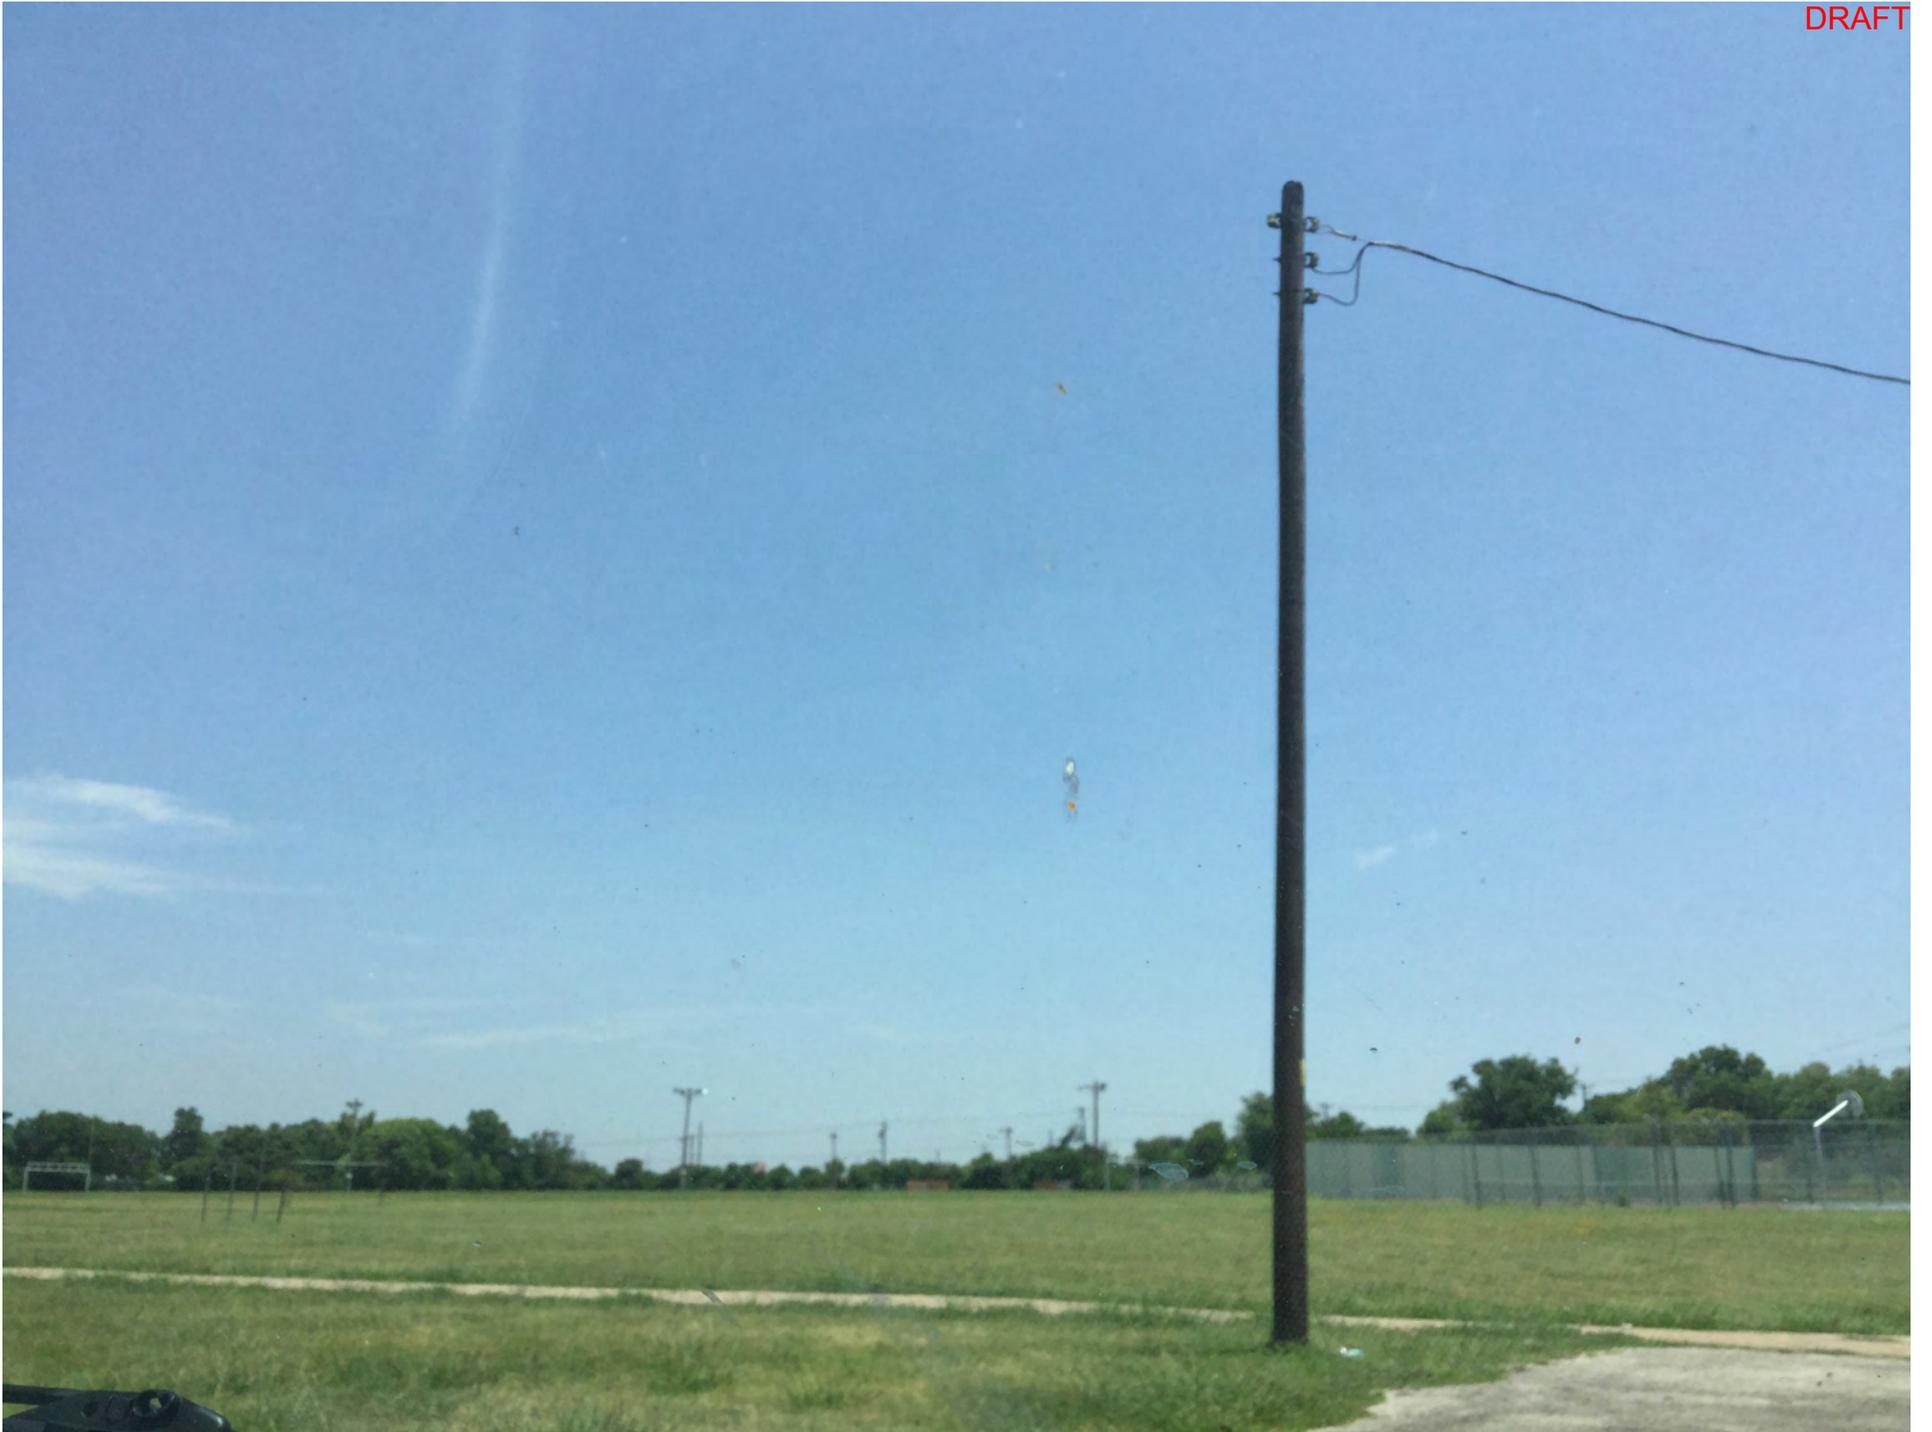
Photo 2. Playground

1.3	Are outdoor play spaces and playfields adequate in size and configuration?			3				Comments	1.00	3.00
1) Outdoor play space exists, not developed 2)Outdoor play space exists but is not connected to gym or other athletic support areas or is too small. 3. Outdoor play spaces exist, are connected to other athletic areas, are the right size, but are not in good condition. 4. Outdoor play spaces need minor improvements to function well. 5. Outdoor play spaces are in excellent condition. N/A) Does not apply.		The outdoor playfields need some major developments and improvements as well as needing an external concession stand for soccer field and track. The concession building needs to have concessions and restrooms. See Image 2

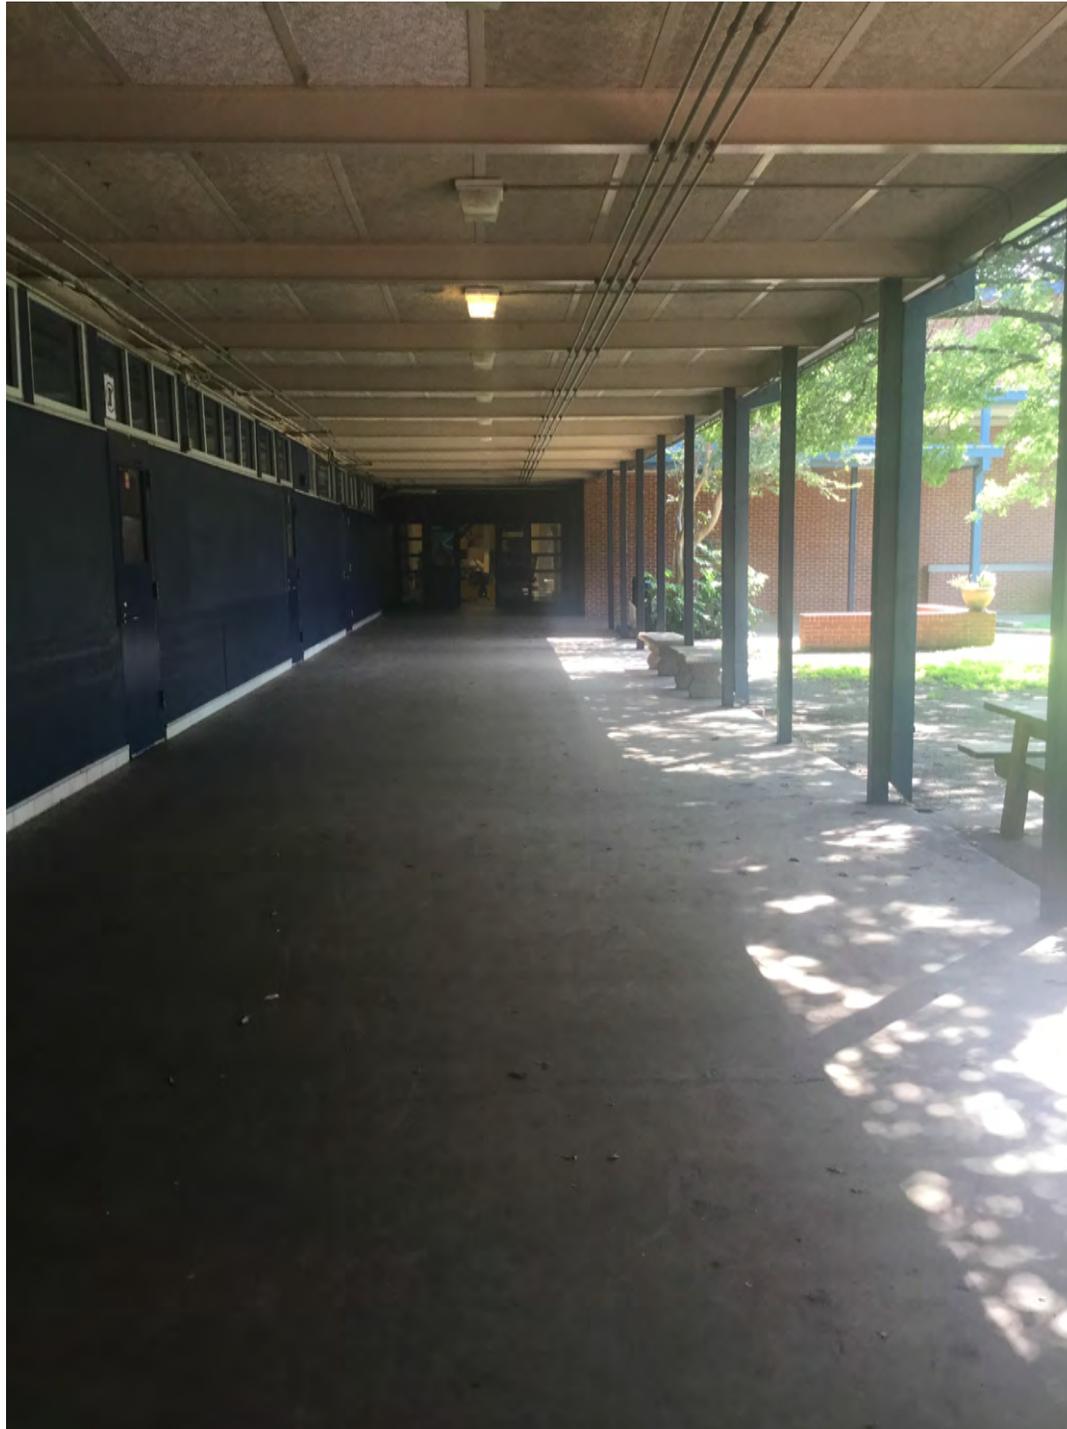
Photo 3. Open Corridor.

1) Primary circulation is 5'-0" to 6'-0" wide. 2) Primary circulation is 6'-0" to 7'-0" wide 3) Primary circulation is 7'-0" to 8'-0" wide 4) Primary circulation is 8'-0"-10'-0" wide 5) Primary circulation is 10'-0"+ wide N/A) Does not apply.								Some of its classroom wings have open corridors.	See image 3

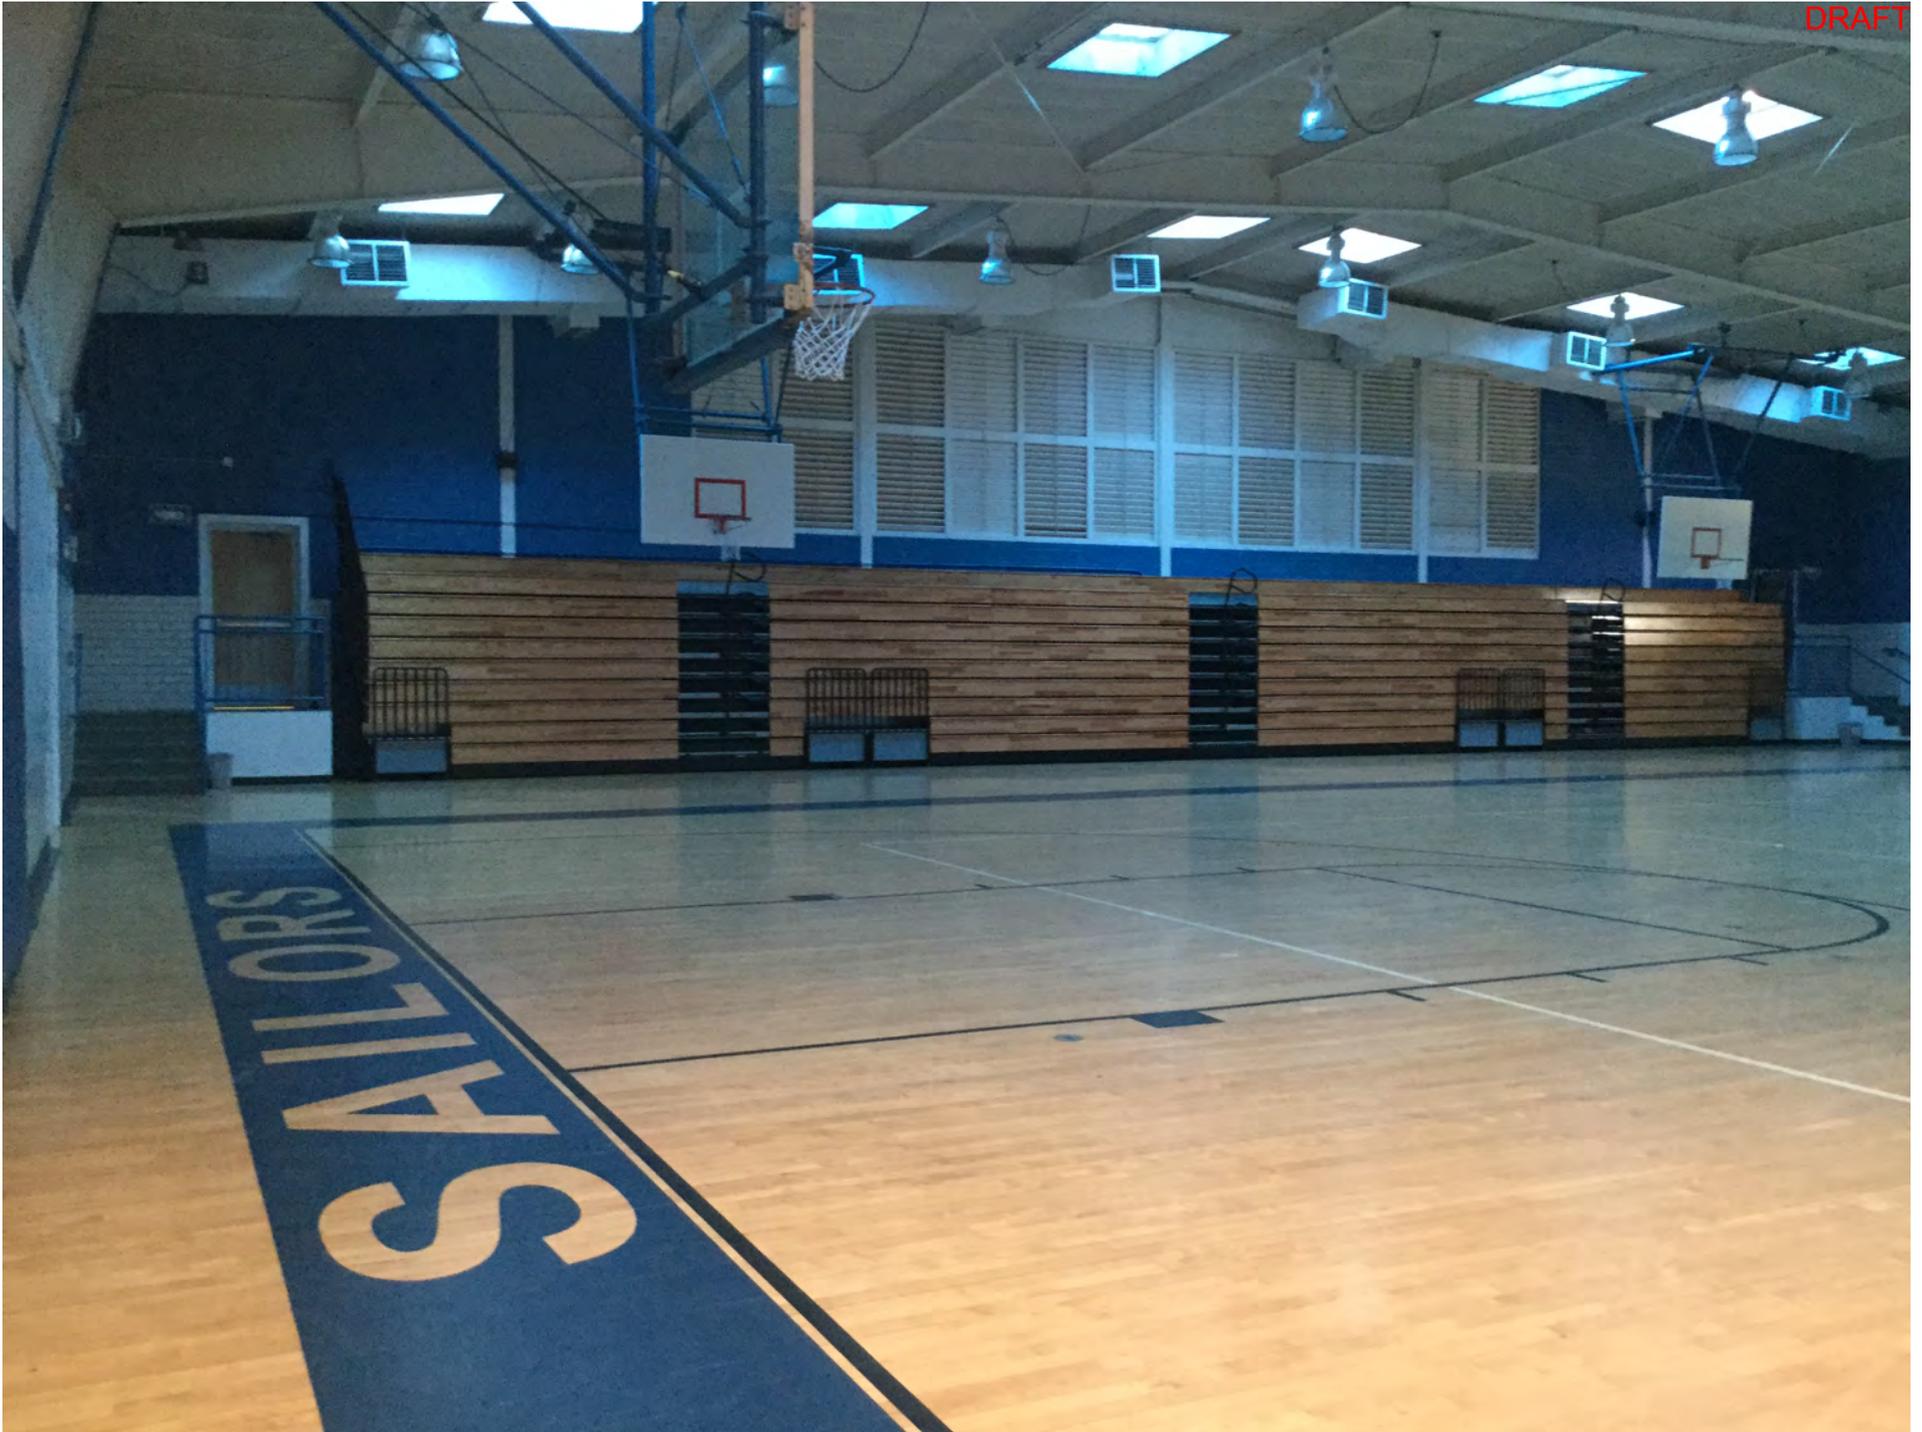
Photo 4. Gymnasium

1) Very unsatisfactory 2) Unsatisfactory 3) Average 4) Good 5) Very good N/A) Does not apply.		The gym area needs a full renovation. Bleachers for soccer are needed.								
		See image 4

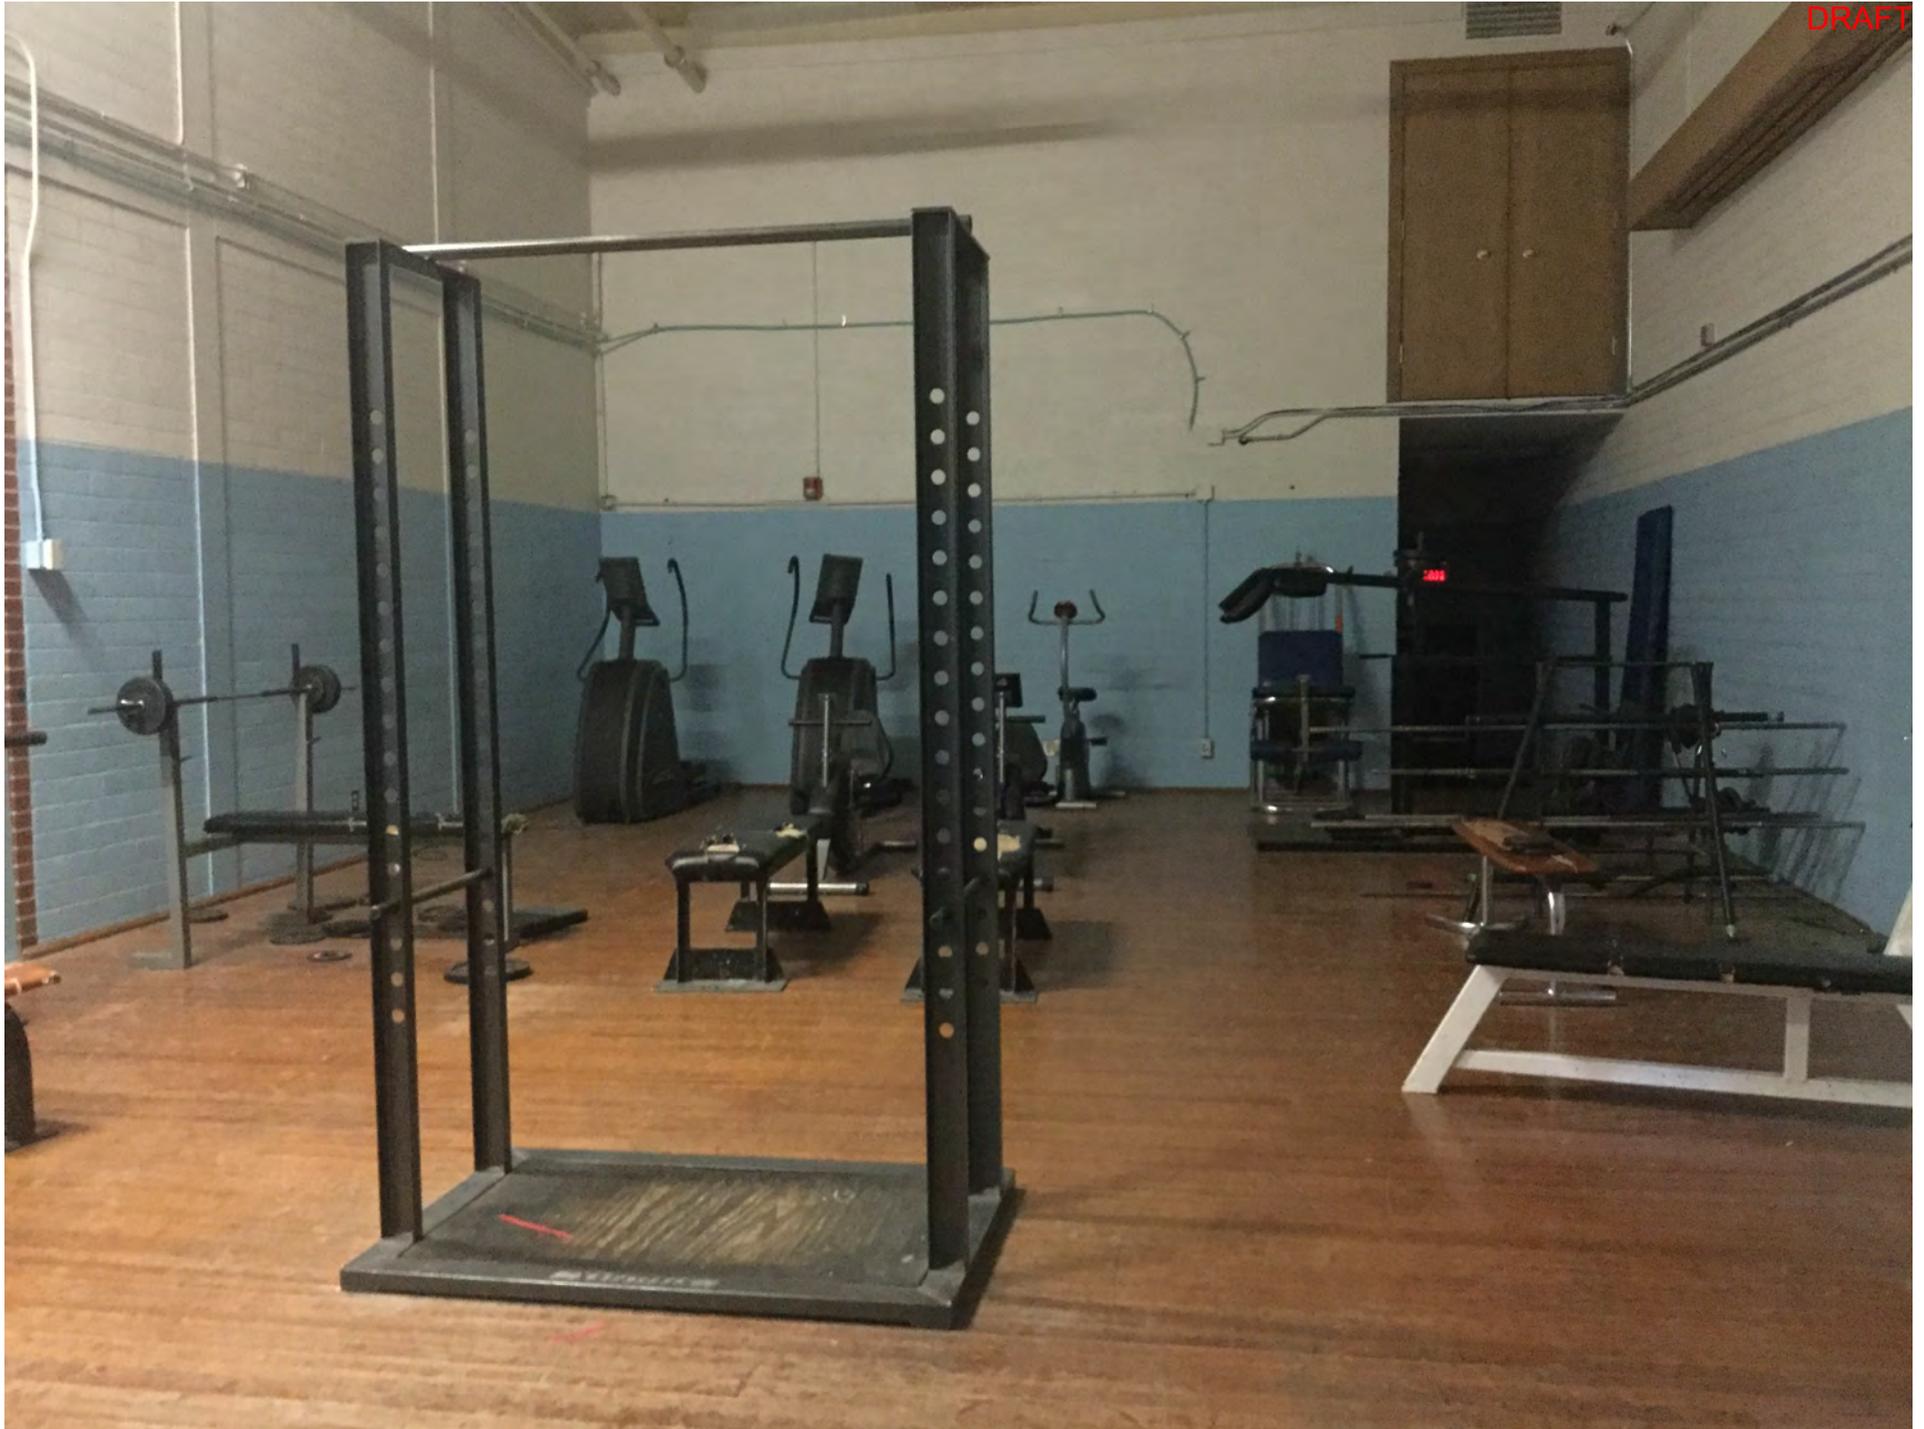
Photo 5. weight room

3.7	Are Physical Education and Athletic support spaces appropriately configured per the ed spec?		2					Comments	1.00	2.00
1) Very unsatisfactory - Support spaces are disconnected from served spaces, too small, do not meet needs 2) Unsatisfactory - Support spaces are connected, but too small, inadequate for needs 3) Average - Connected, moderate size, but need some renovations or updates to function well 4) Good - Connected, good size/layout, meets needs/functions well 5) Very good - connected, generous size, nice condition, functions appropriately N/A) Does not apply.		A dedicated space for a weight room is needed. It is currently on the stage.								
		See image 5

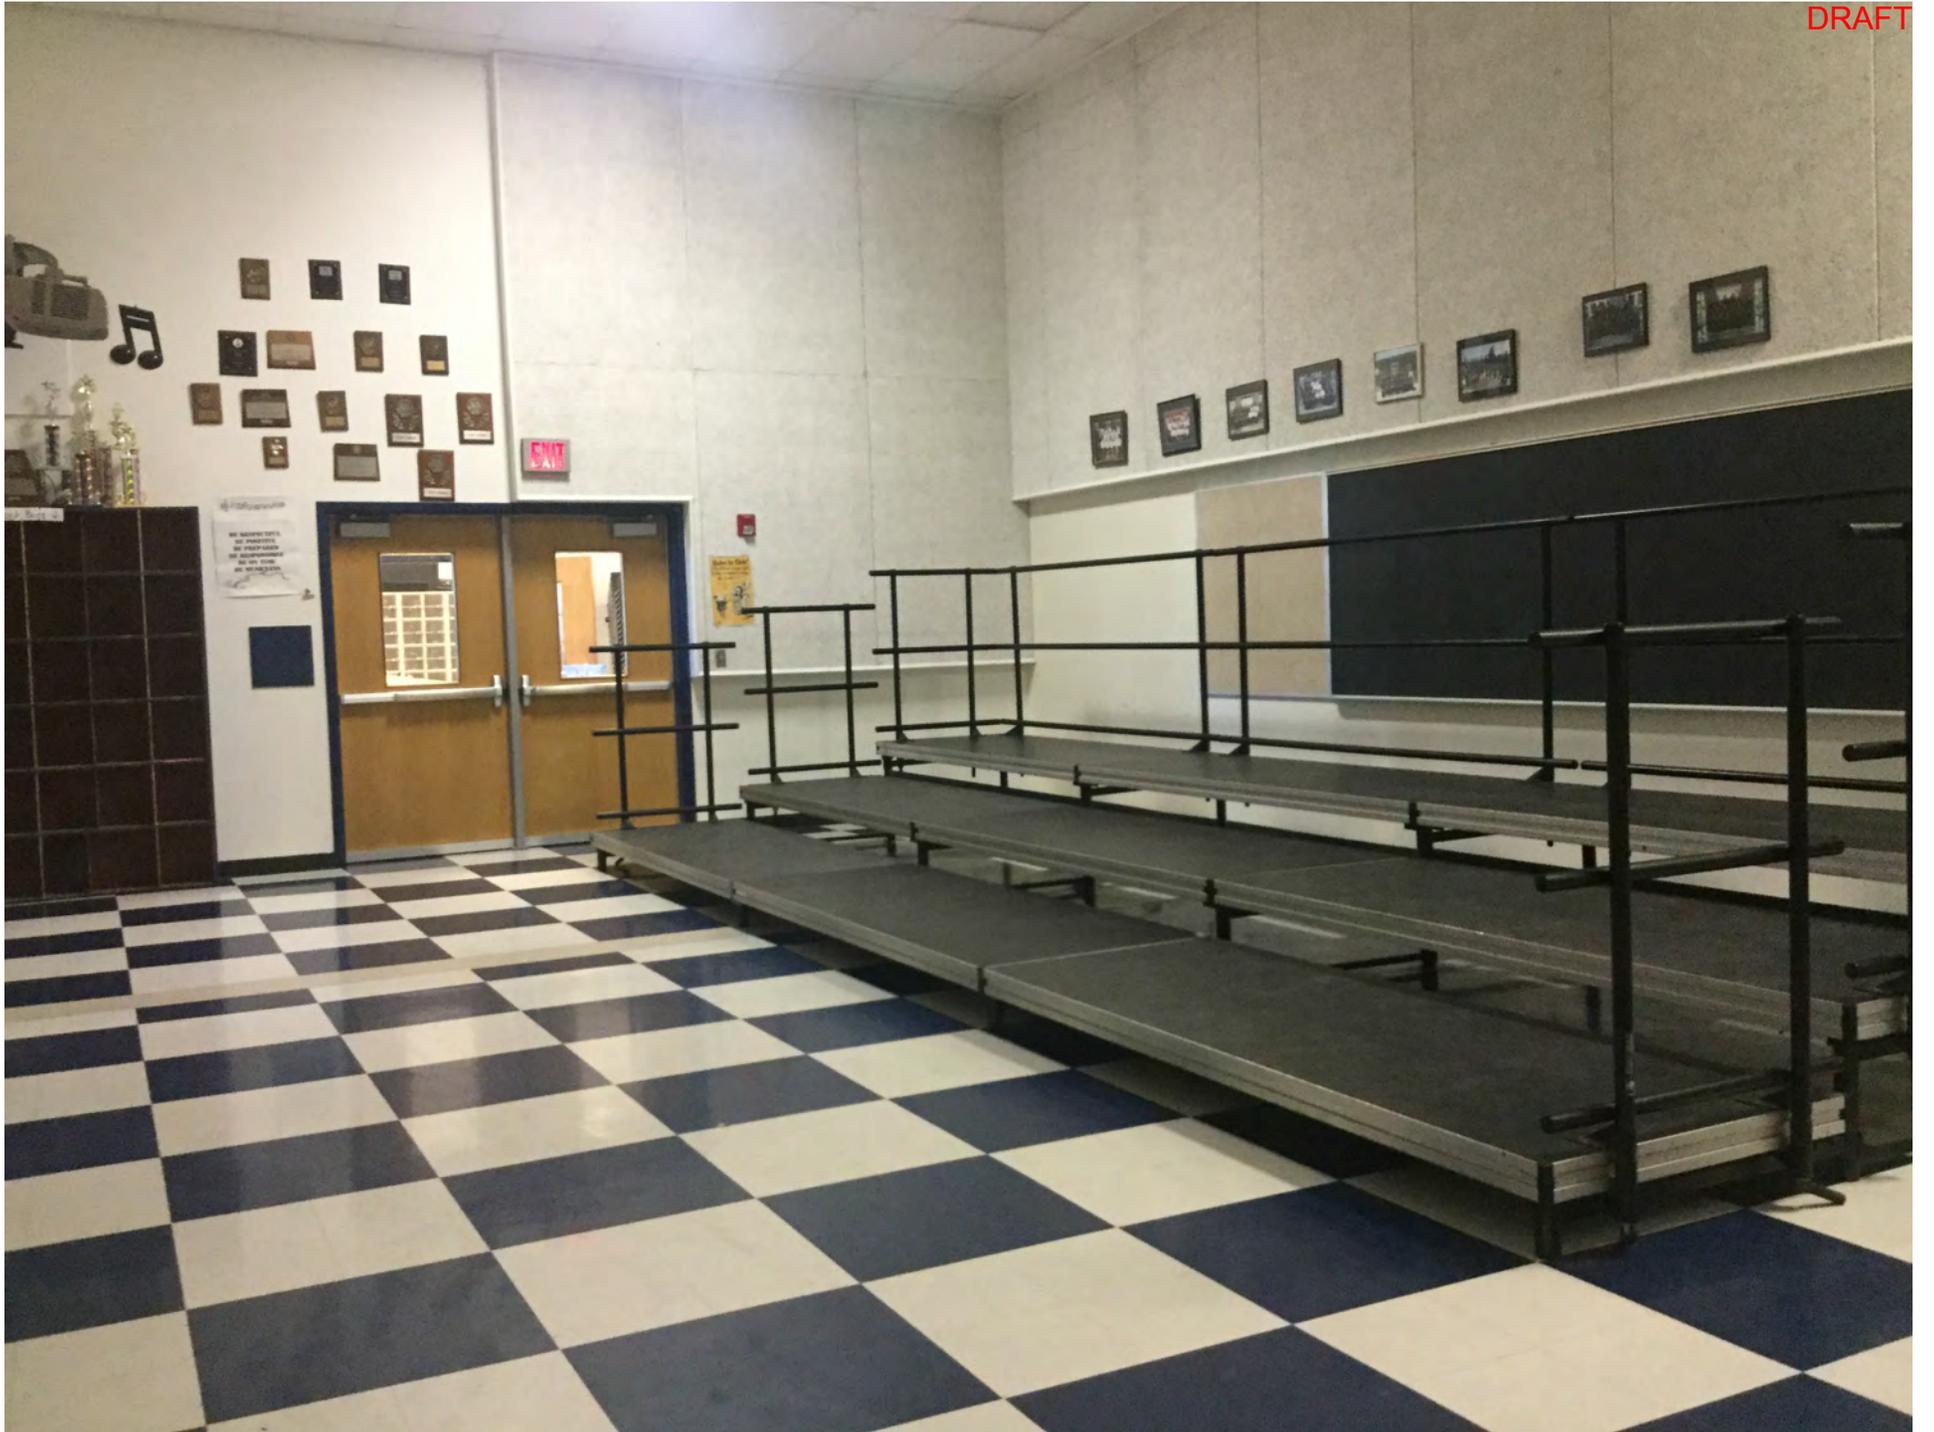
Photo 6. Music room

3.8	Are music, drama, or performance spaces appropriately configured per the ed spec?		2					Comments	1.00	2.00
1) Very unsatisfactory 2) Unsatisfactory 3) Average 4) Good 5) Very good N/A) Does not apply.		The music facility needs to be expanded. They have far more demand than space. There could be a band hall with some seating for performance.								
		See image 6

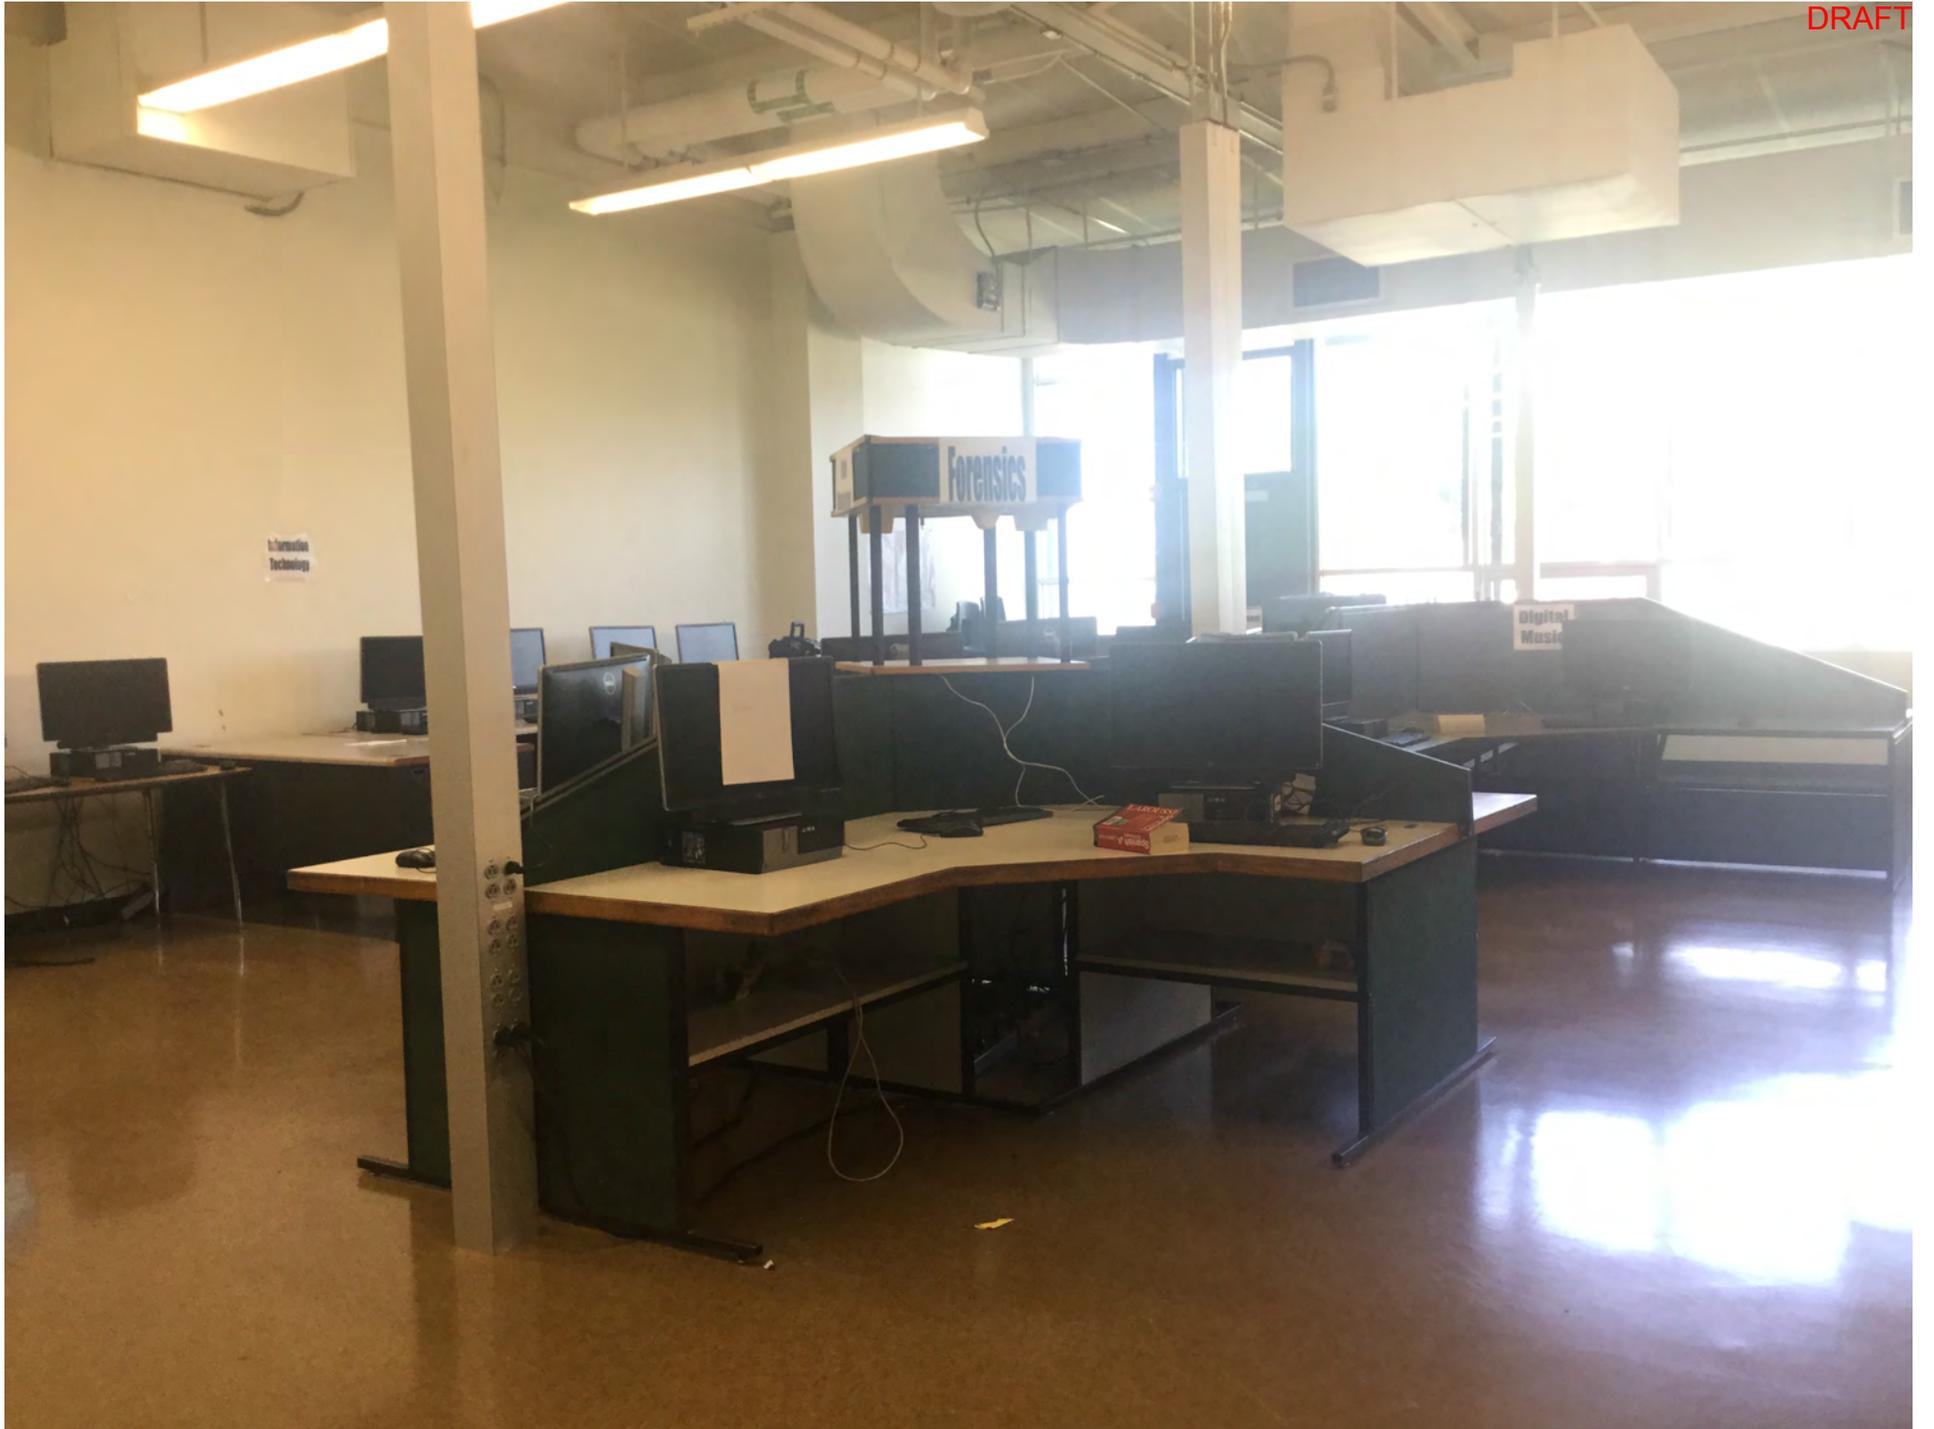
Photo 7. computer lab

3.12	Are computer lab spaces appropriately configured?	1							Comments	1.00	1.00
1) Very unsatisfactory 2) Unsatisfactory 3) Average 4) Good 5) Very good N/A) Does not apply.		At present there is only one computer lab for students in the school. One of the computer labs was removed to use equipment in the classrooms. A second computer lab is needed.									
See image 7

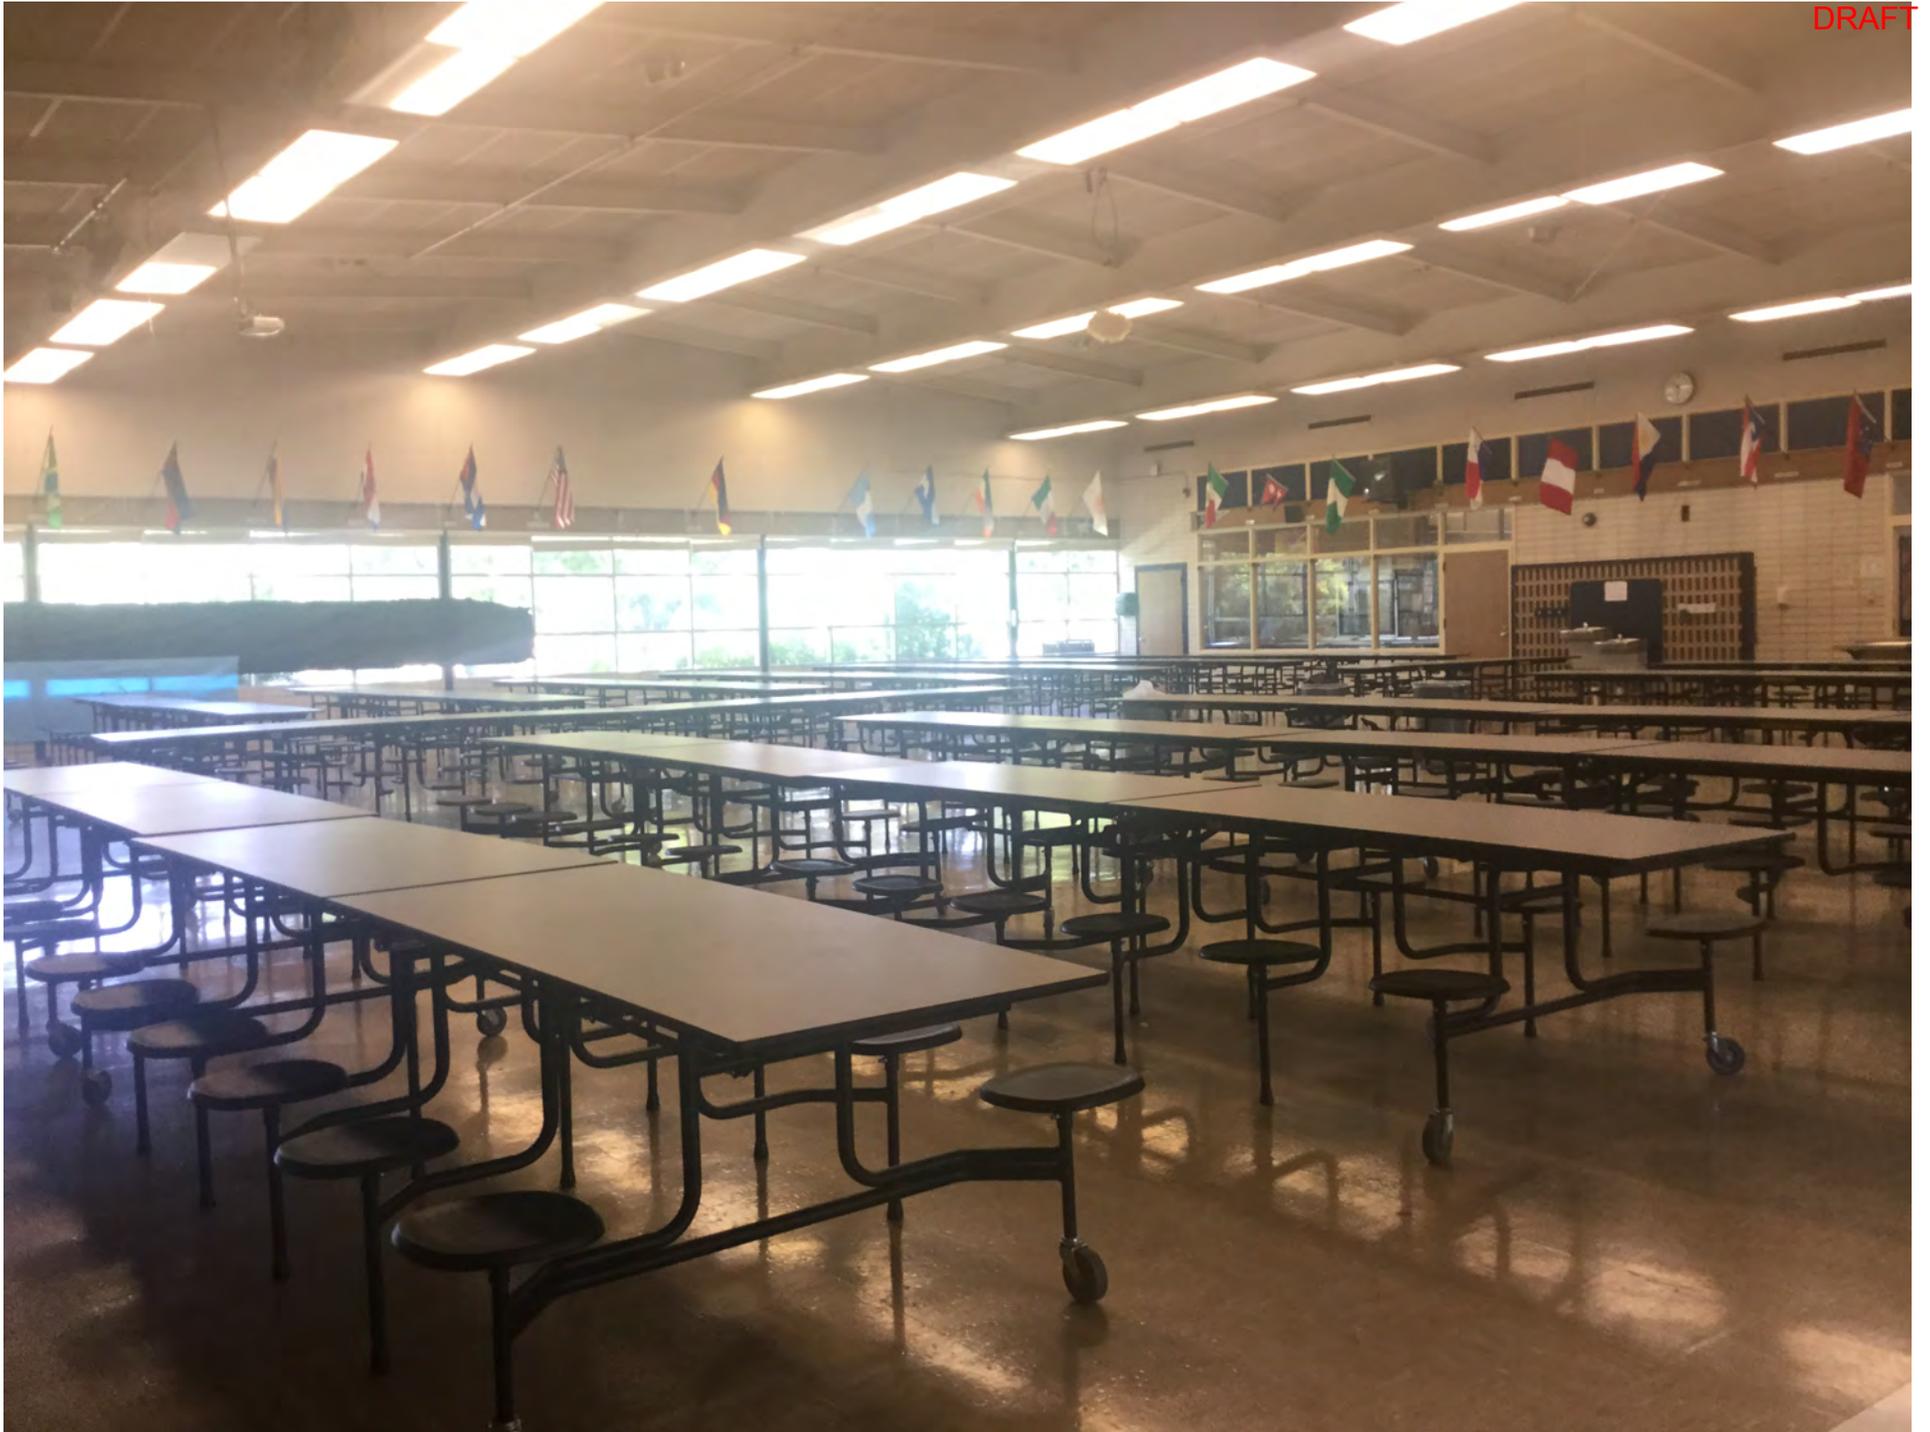
Photo 8. Cafeteria

3.16	Are the student dining facilities appropriately configured?			3				Comments	1.00 3.00
1) Very unsatisfactory - Too small, poor circulation, inflexible seating in poor condition 2) Unsatisfactory - Too small or inadequate circulation, seating in poor condition 3) Average - moderate size, with adequate circulation, seating in okay condition 4) Good - good size, adequate circulation, seating in good condition 5) Very good - good size, adequate circulation, seating in good condition, with more than one option for eating space (ex: connection to outdoor eating space) N/A) Does not apply.								The cafeteria is too small and cannot hold the full population (1200 students). Currently they are running three lunches. They are unable to hold enough students for the free breakfast (1000 students).	See Image 8
