Educational Suitability Summary Report

Burnet Middle School – BLDG 046

Date: 06/20/2016

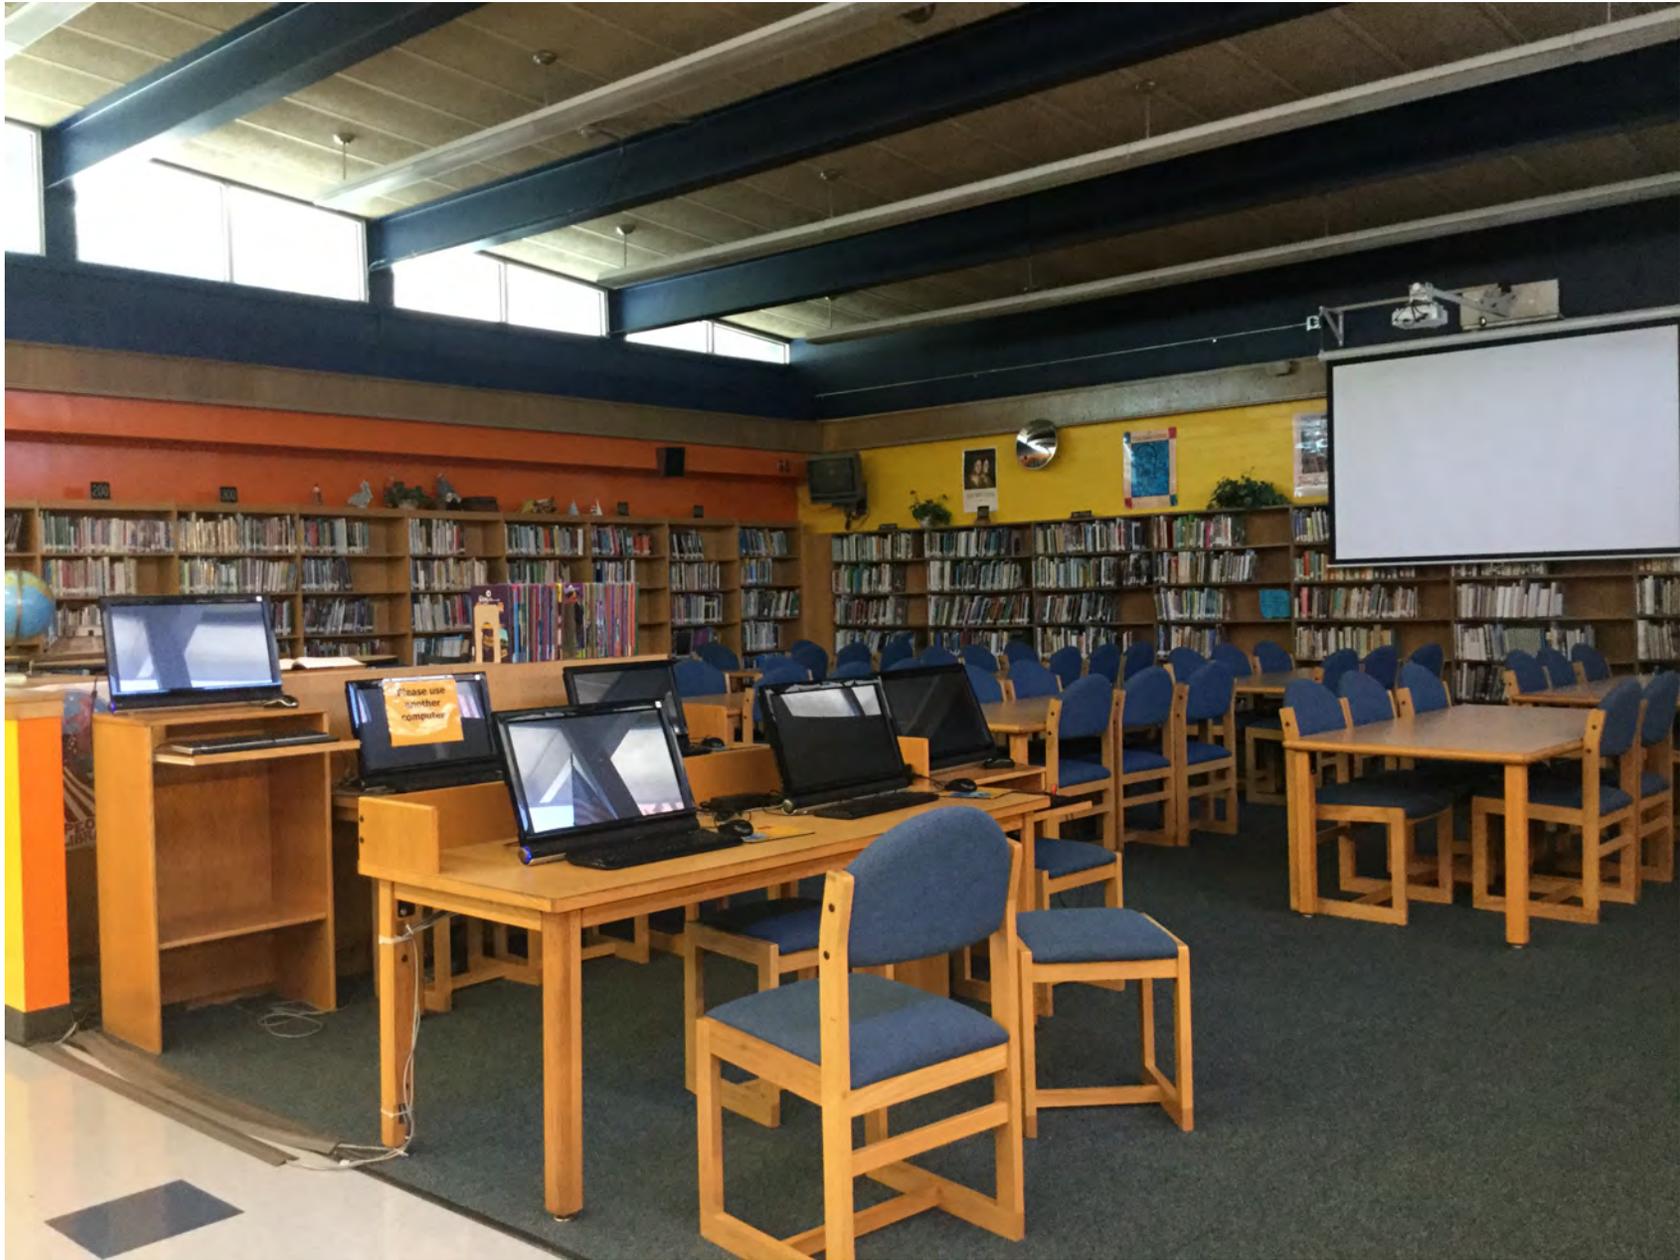
Photo 9. Library

1) Very unsatisfactory 2) Unsatisfactory 3) Average 4) Good 5) Very good N/A) Does not apply.										
		See Image 9								
5.3	How well does the Library/Media Center support social interaction?			3				Comments	1.00	3.00

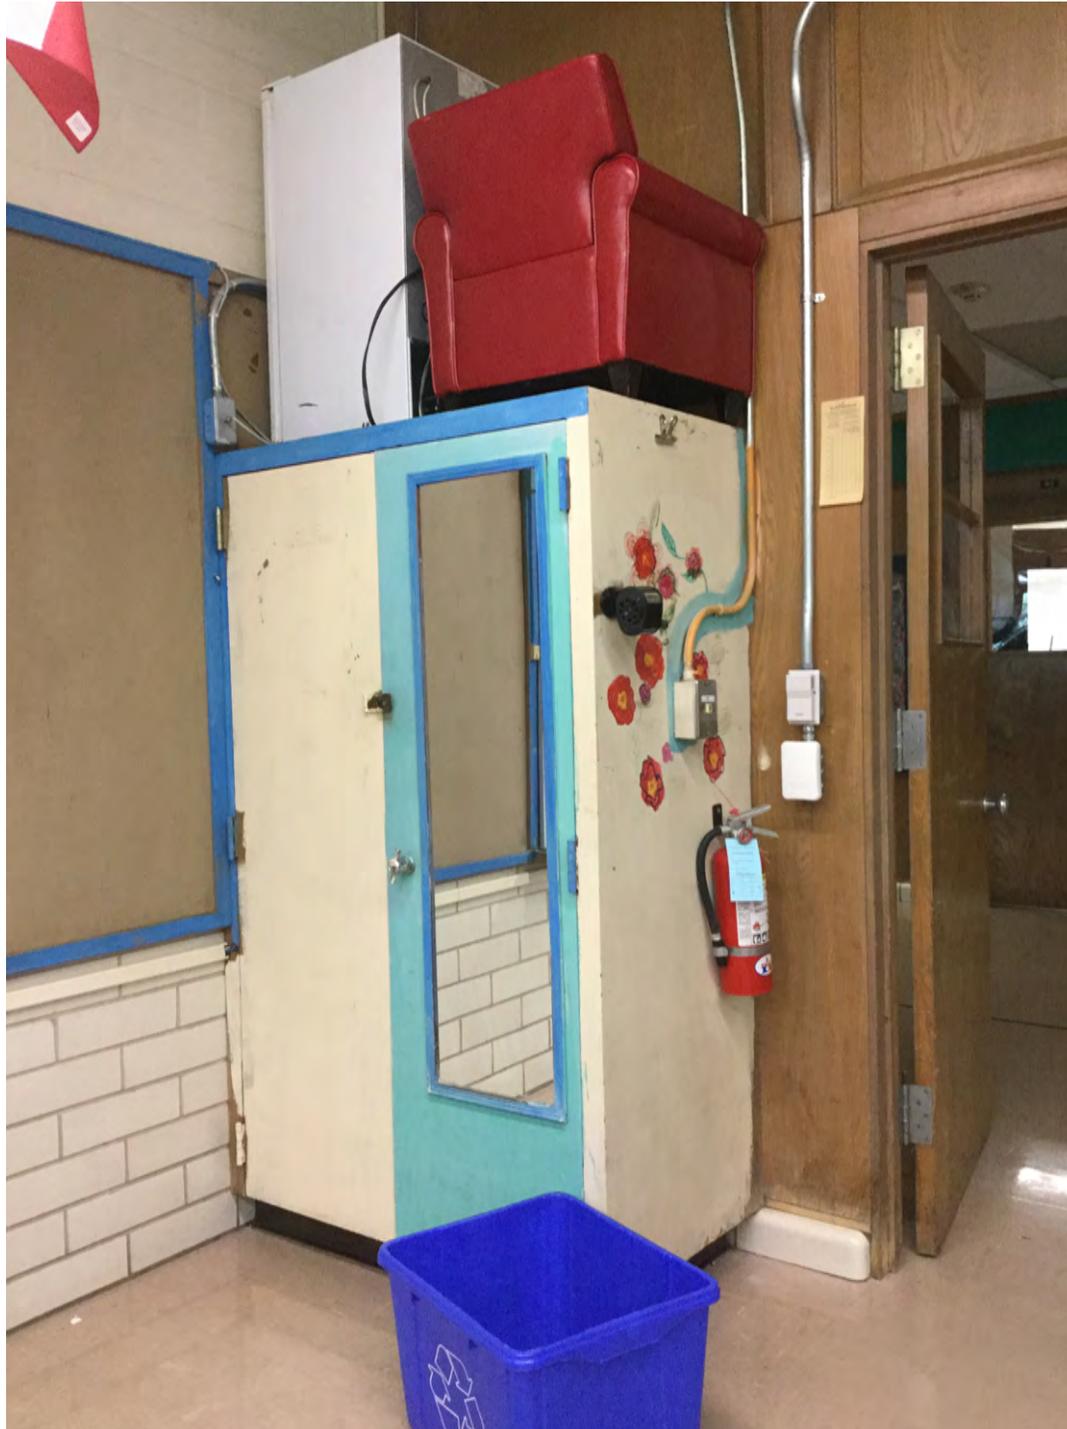
Photo 10. Storage

8 - Storage		1	2	3	4	5	N/A			8.00
8.1	Is there adequate general storage in the building?			3				Comments	1.00	3.00
1) Very unsatisfactory 2) Unsatisfactory 3) Average 4) Good 5) Very good N/A) Does not apply.								Overall, the campus needs more storage.		
										See Image 10
8.2	Is there adequate classroom storage?		2					Comments	1.00	2.00
1) Very unsatisfactory 2) Unsatisfactory 3) Average 4) Good 5) Very good N/A) Does not apply.										
8.3	Is there adequate student storage?			3				Comments	1.00	3.00
1) Very unsatisfactory 2) Unsatisfactory 3) Average 4) Good 5) Very good N/A) Does not apply.
