Educational Suitability Summary Report

Fulmore Middle School – BLDG 043

Date: 09/06/2016 (REV1 – 12/20/2016 – CAC comments)

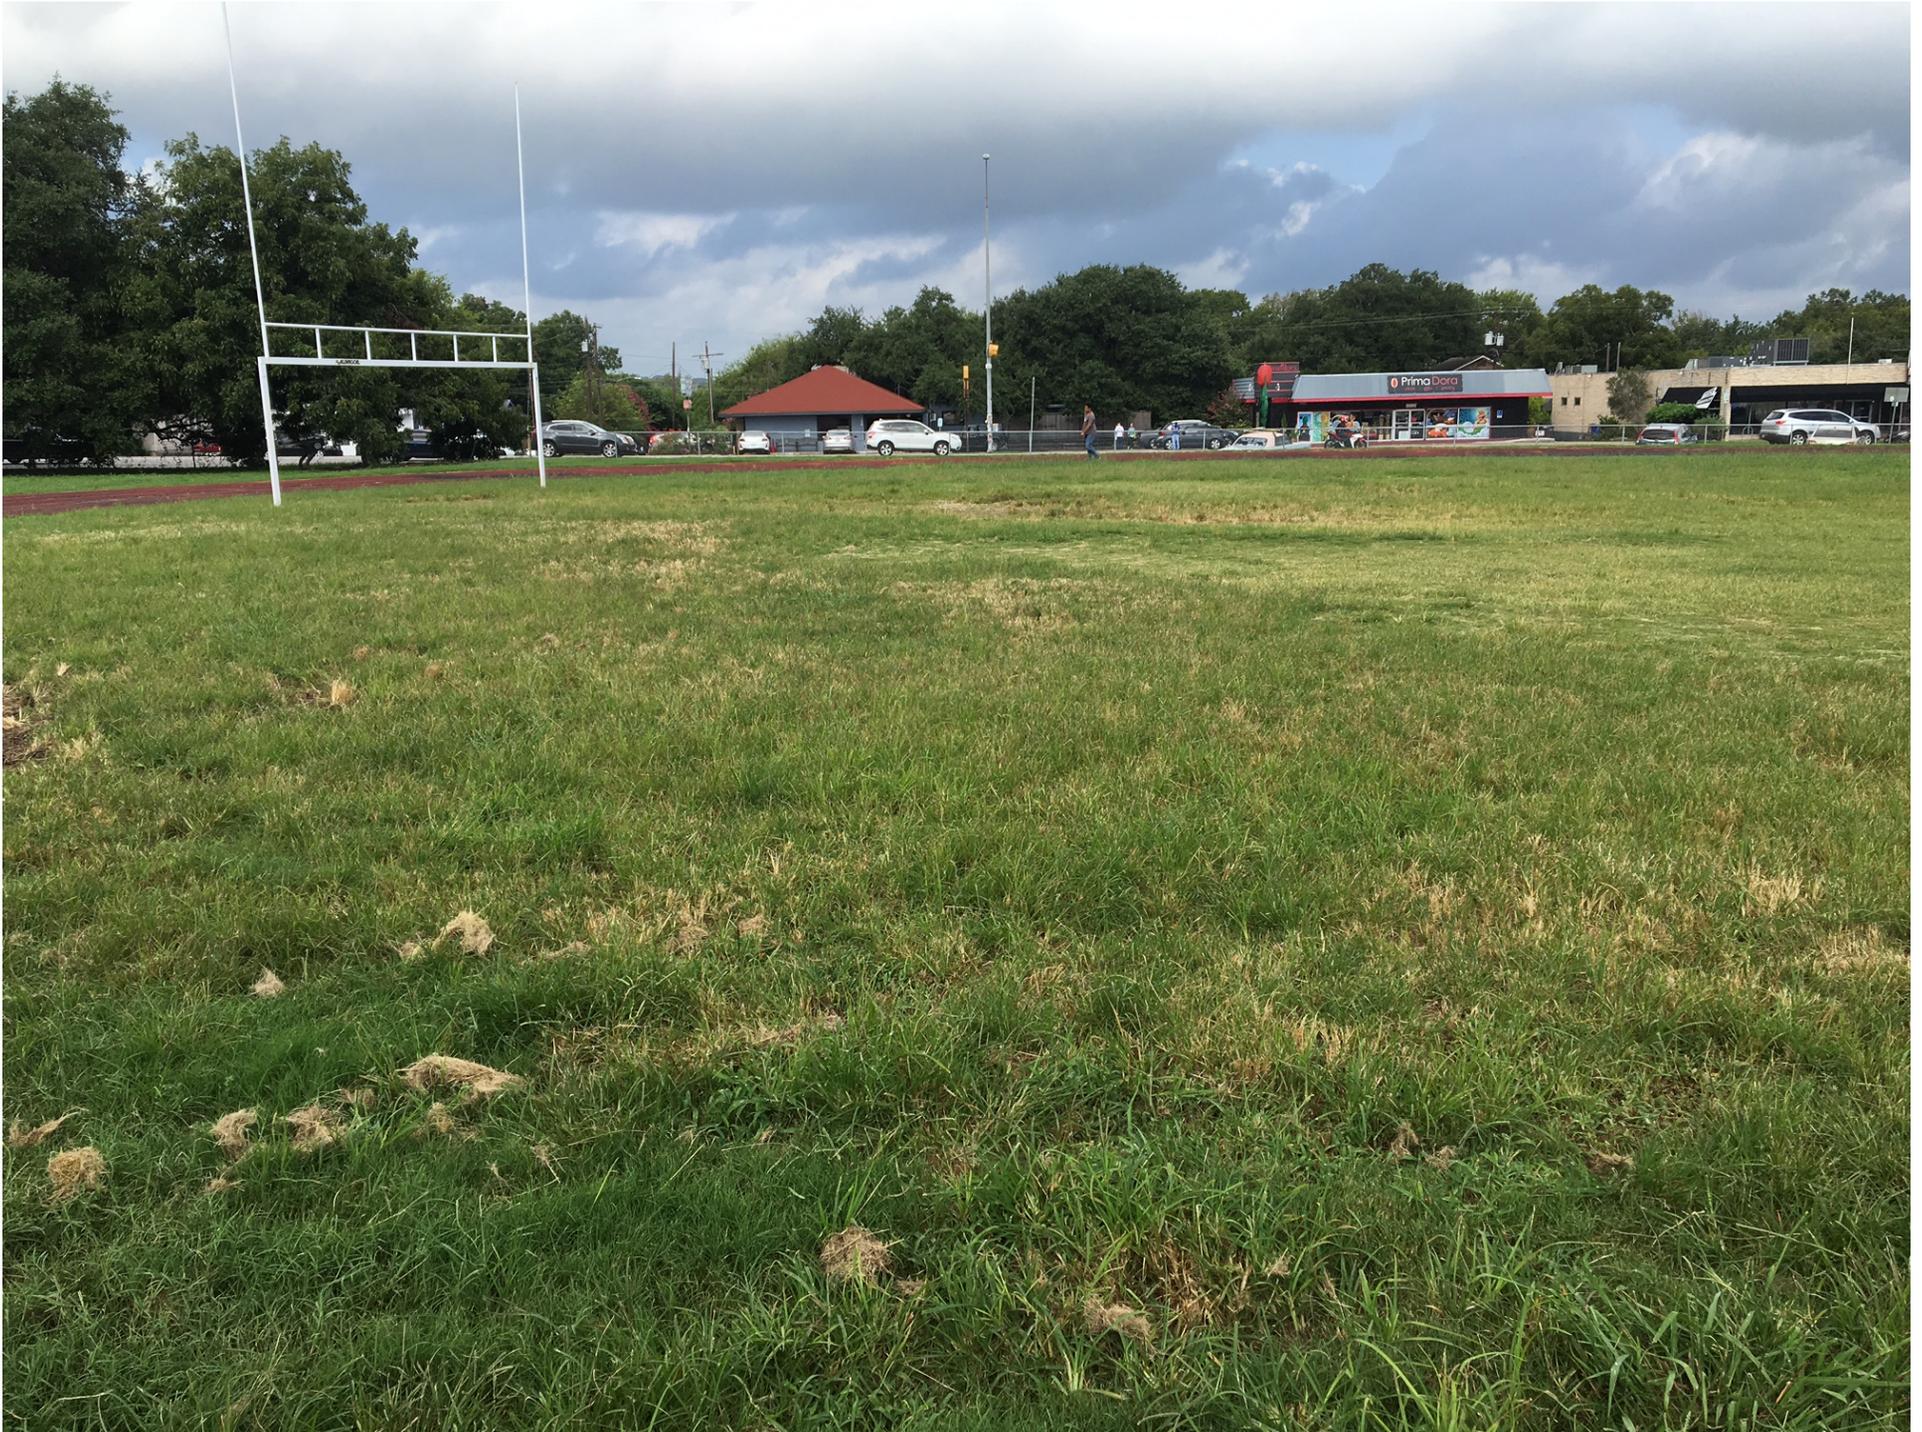
1.3	Are outdoor play spaces and playfields adequate in size and configuration?		2					Comments	1.00	2.00
	1) Outdoor play space exists, not developed 2) Outdoor play space exists but is not connected to gym or other athletic support areas or is too small. 3. Outdoor play spaces exist, are connected to other athletic areas, are the right size, but are not in good condition. 4. Outdoor play spaces need minor improvements to function well. 5. Outdoor play spaces are in excellent condition. N/A) Does not apply.							The play field and track are in poor condition. Rocks and dirt are in the field, so they are unable to practice in the field. The track has multiple areas that are in disrepair.

1.3 Poor Condition Field

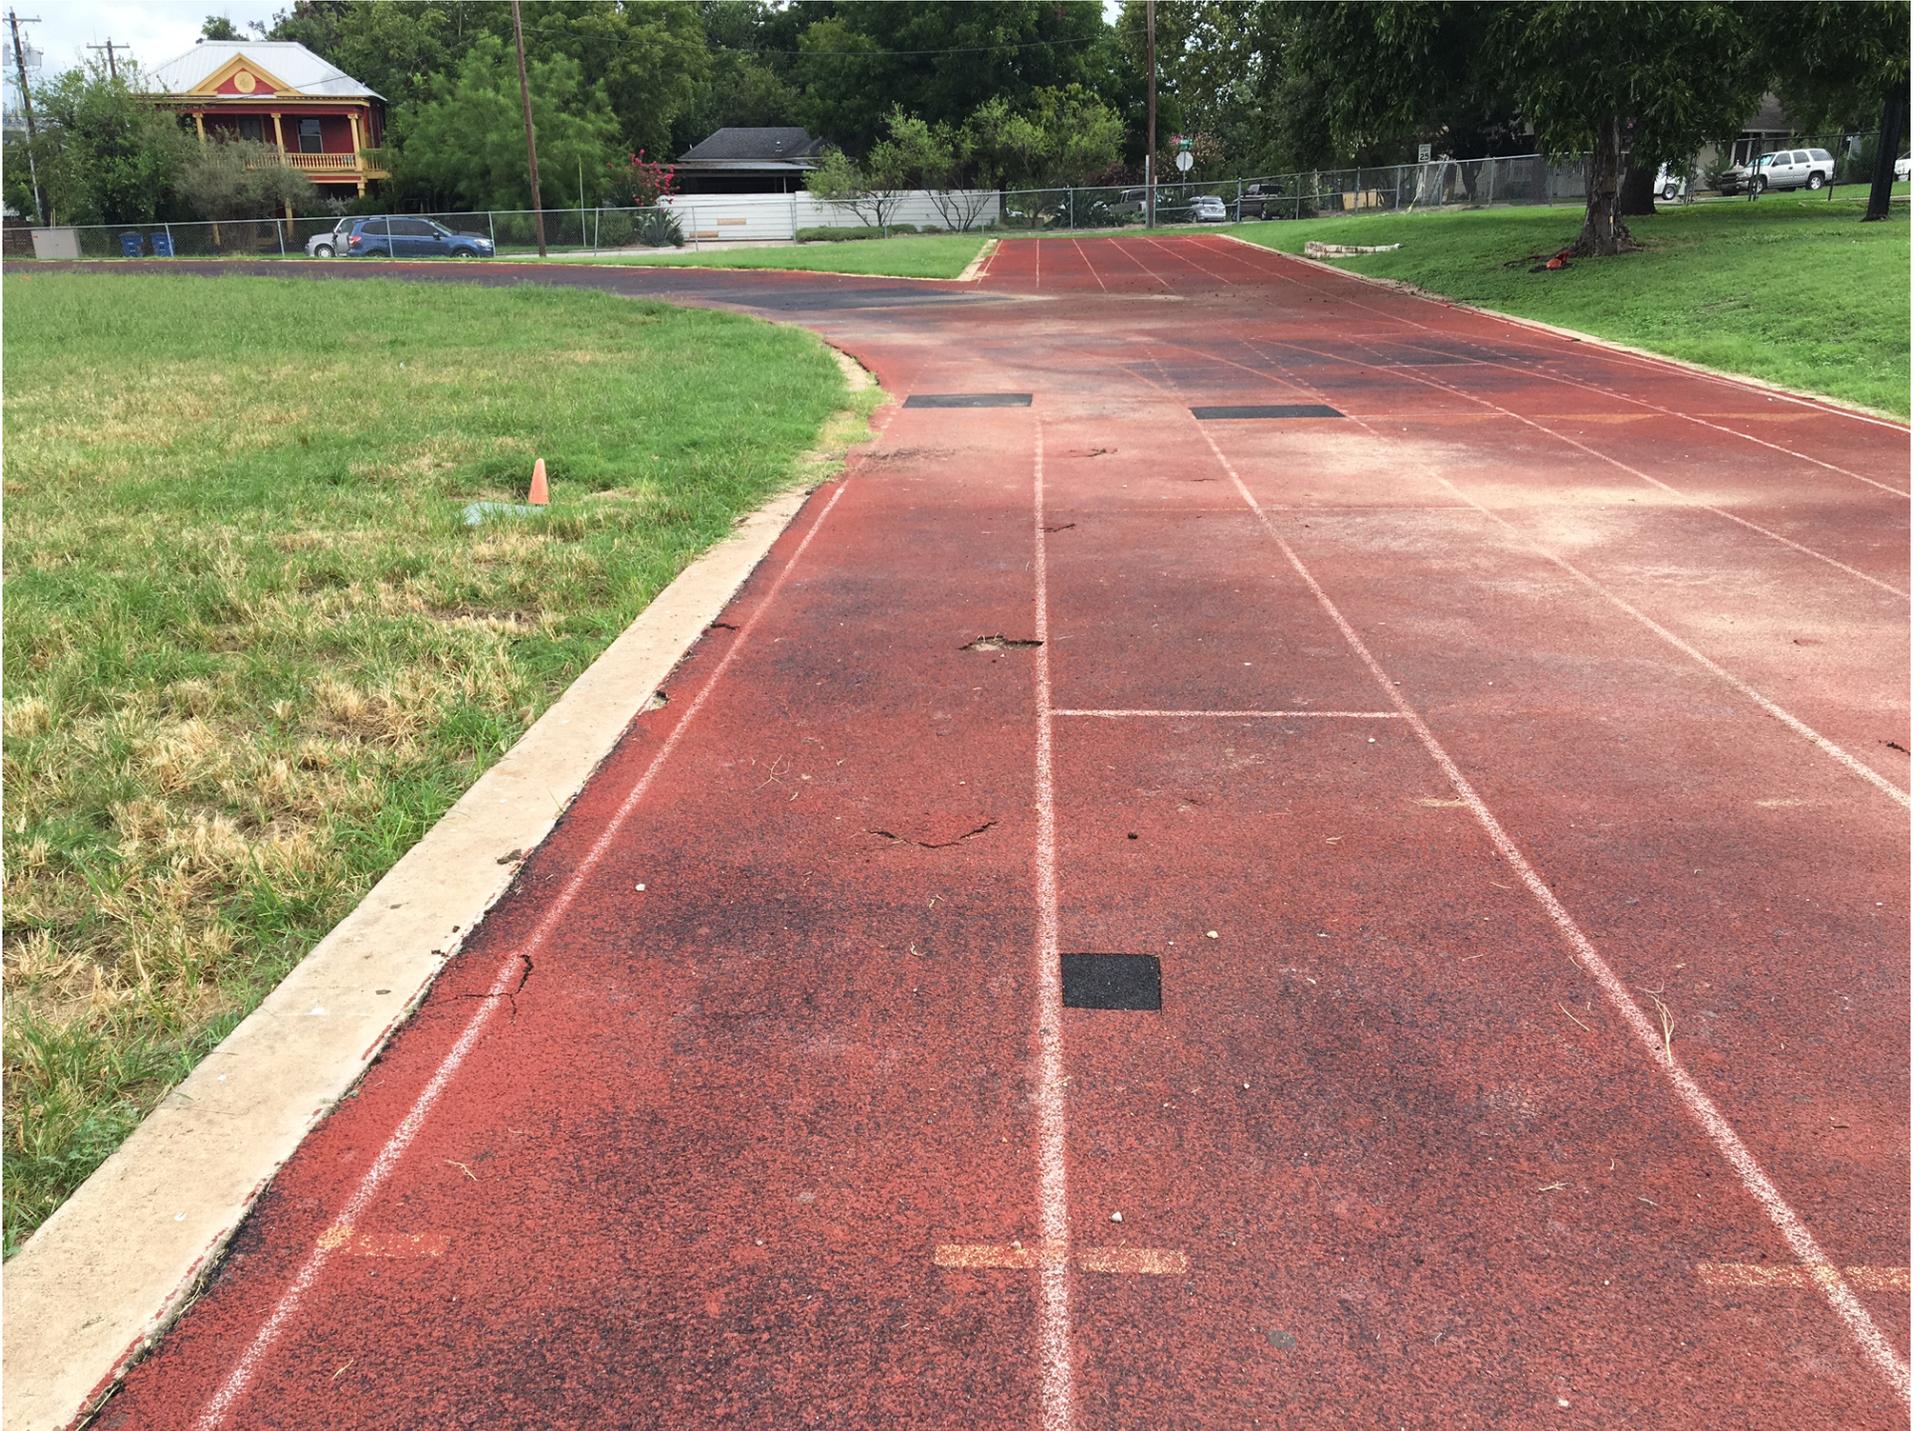
1.3 Poor Condition Track

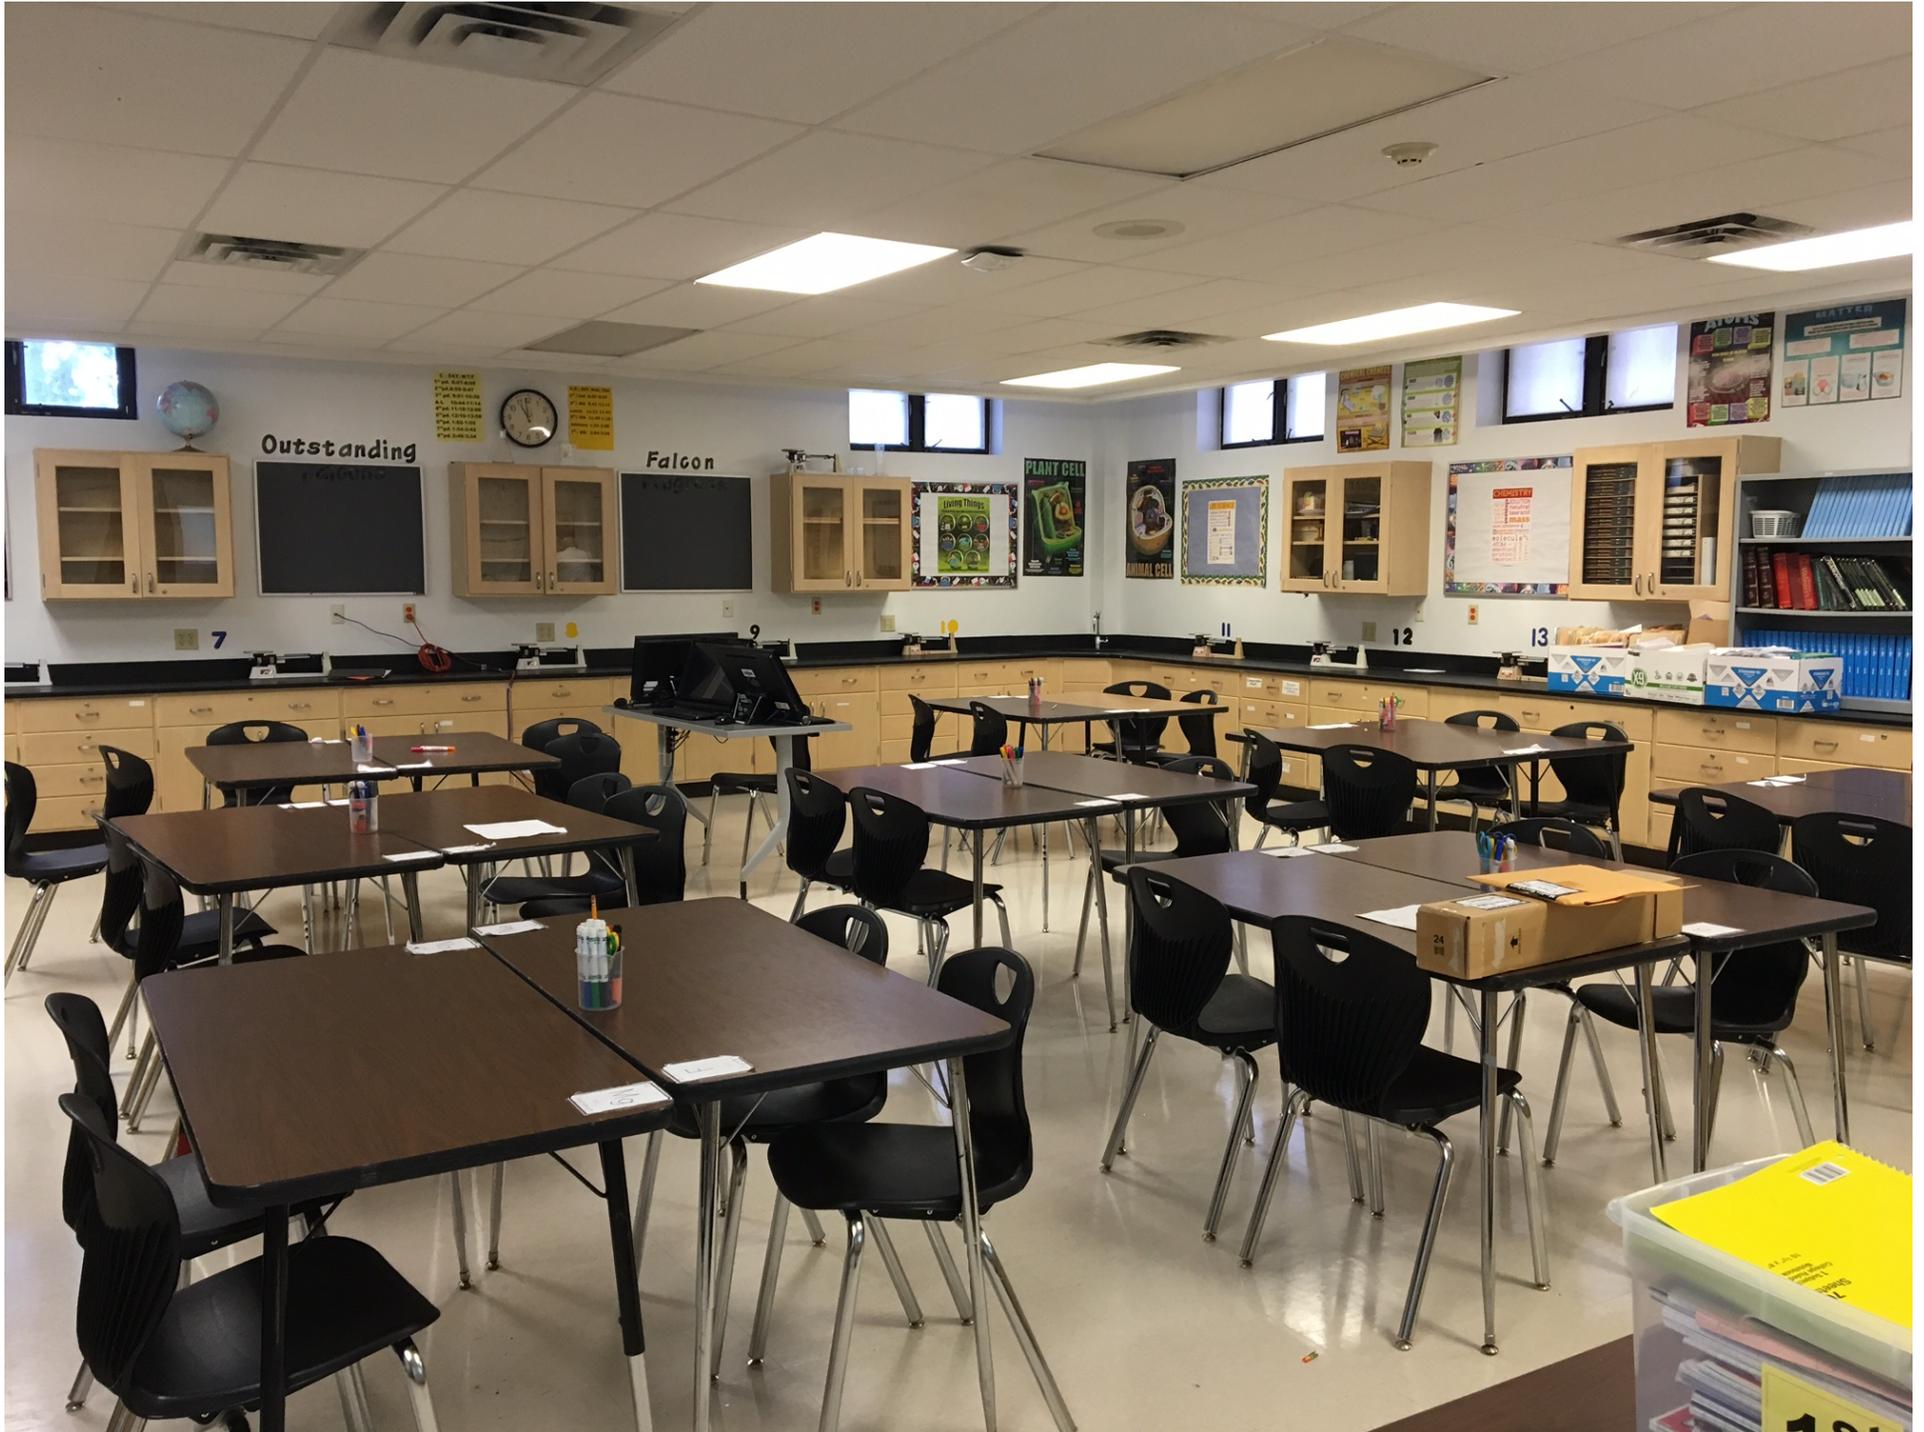
3.4	Are Science Classrooms/Labs appropriately configured per the ed spec?			3				Comments	1.00	3.00
1) Very unsatisfactory 2) Unsatisfactory 3) Neutral 4) Satisfactory 5) Very Satisfactory N/A) Does not apply. (Elementary schools)		Newer building has larger science classrooms, but they have been subjected to occasional flooding. The older science rooms are too small. Two of the science rooms are being used as a math class and the other as an English Language Arts.

3.4 Science Lab Inadequate Furniture

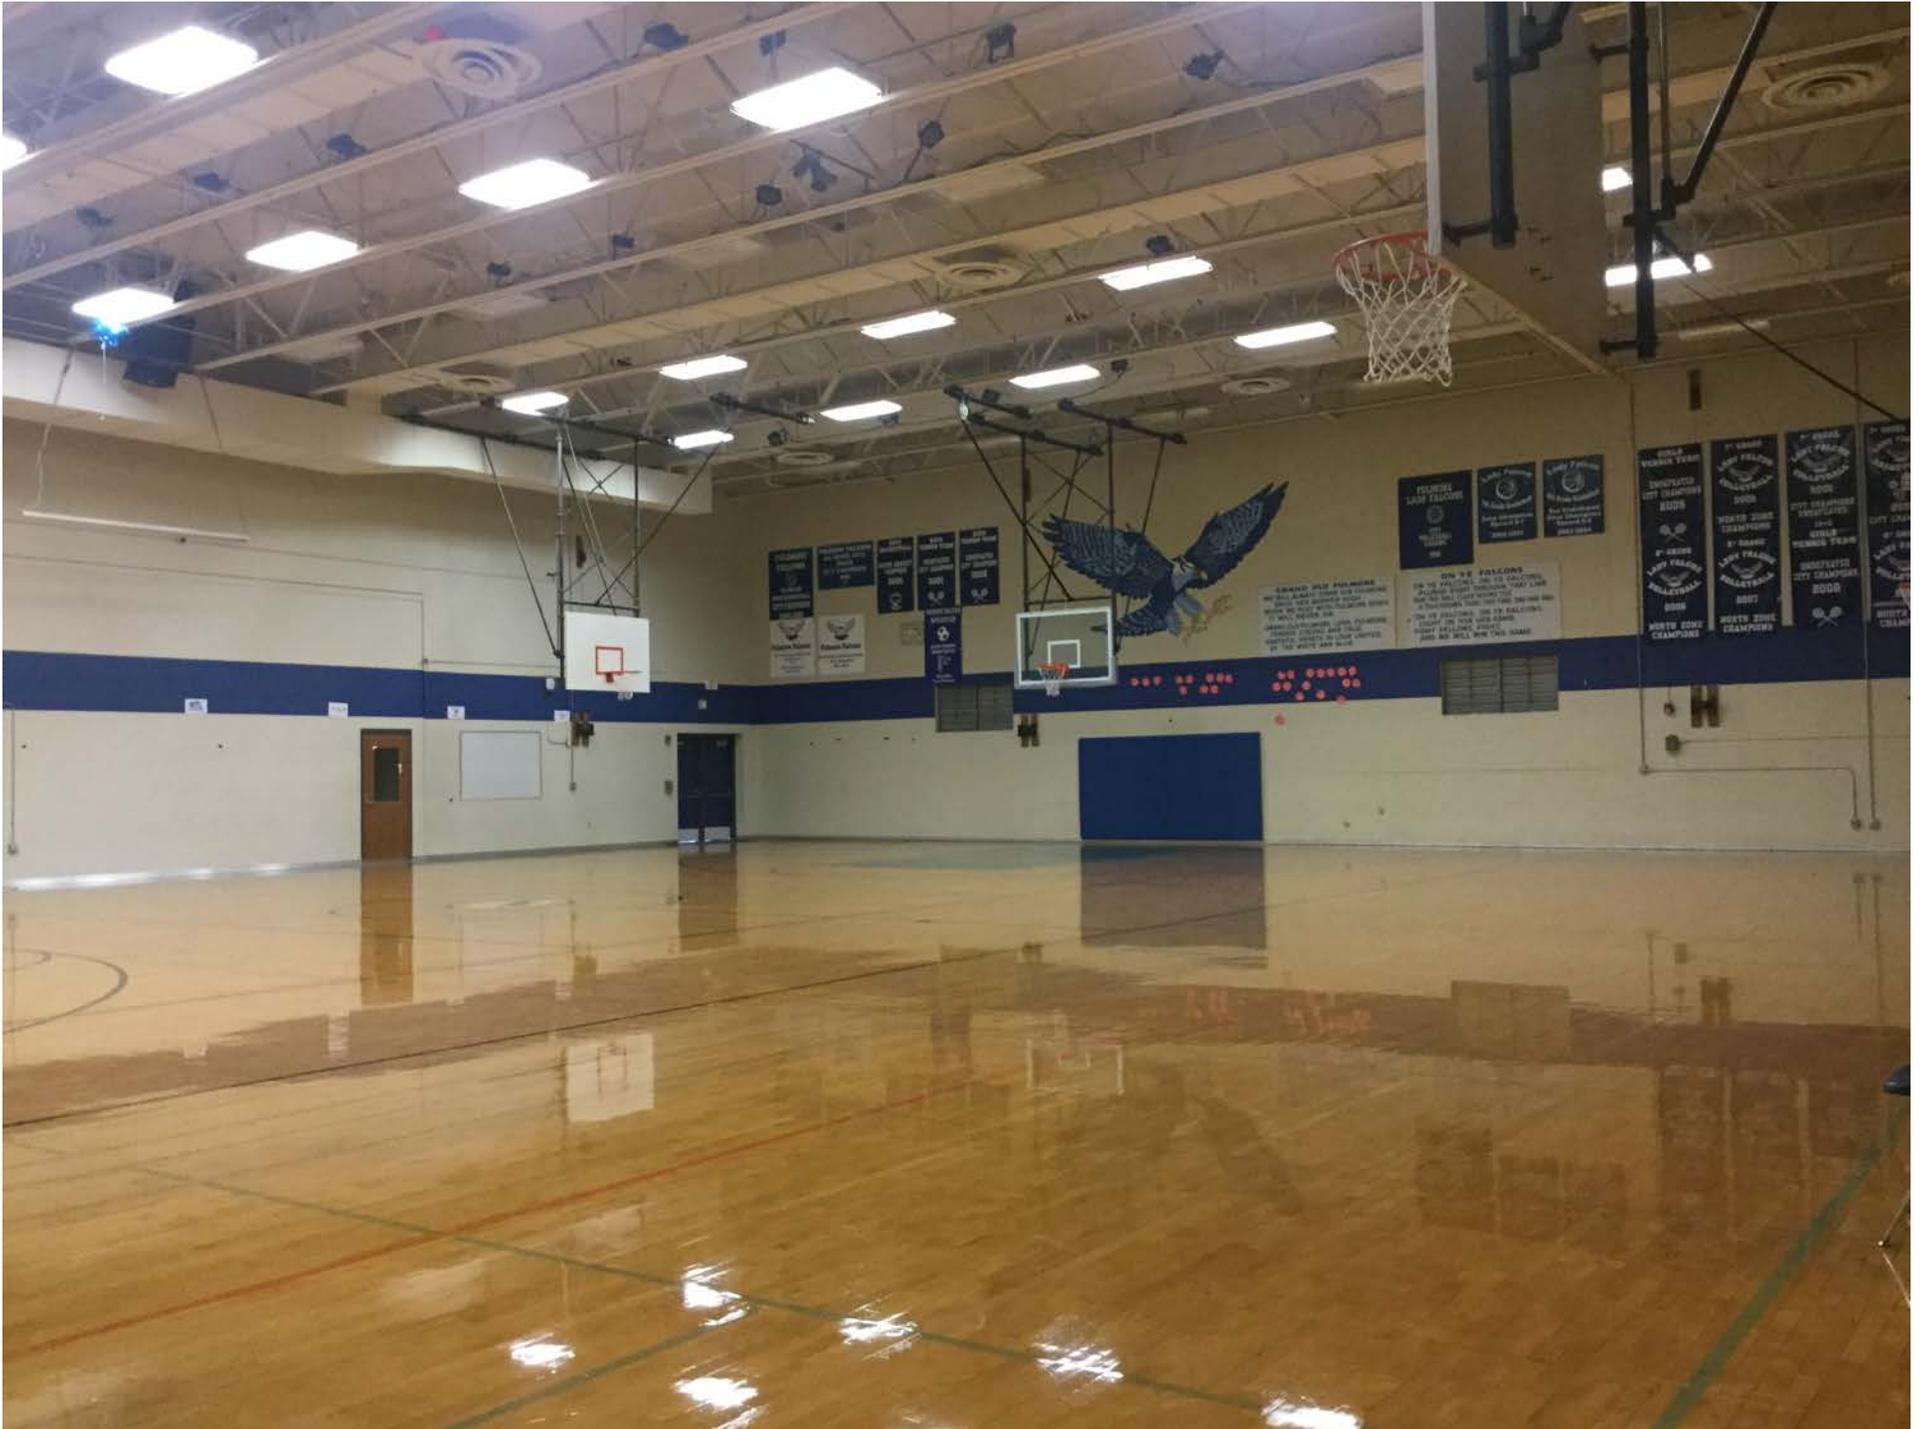
1) Very unsatisfactory 2) Unsatisfactory 3) Average 4) Good 5) Very good N/A) Does not apply.	Arrangement is appropriately configured, but outdated and the ceiling vent in the gym needs to be replaced. Existing conditions of locker rooms is a concern by staff members.

3.6 Gym

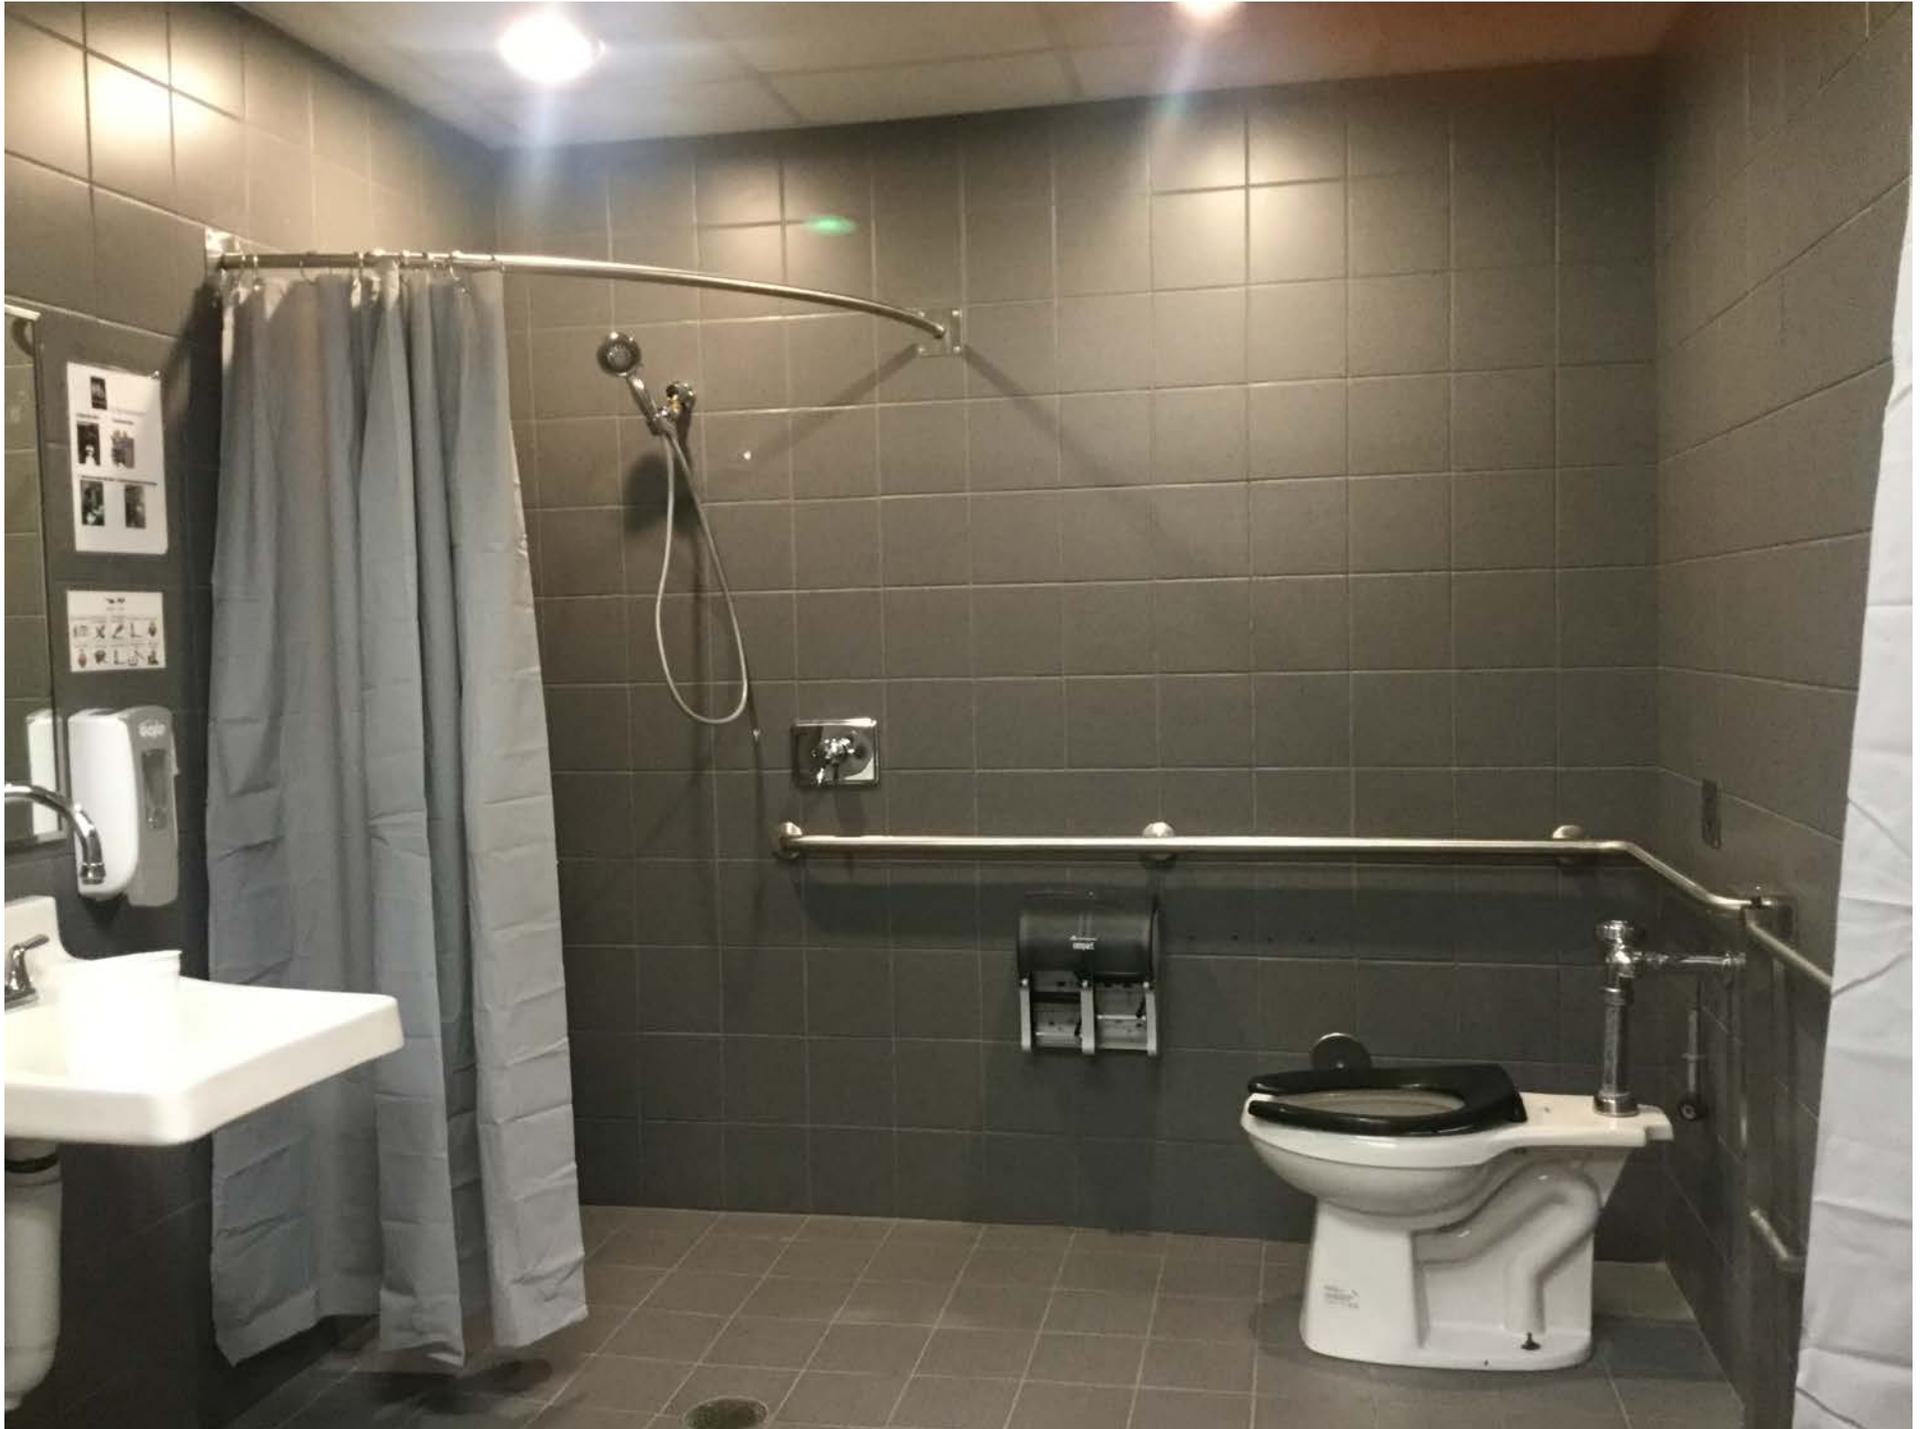
3.15	Are Special Education support spaces appropriately configured per the ed spec?			3				Comments	1.00 3.00
<p>1) Very unsatisfactory - Support spaces are disconnected from served spaces, too small, do not meet needs</p> <p>2) Unsatisfactory - Support spaces are connected, but too small, inadequate for needs</p> <p>3) Average - Connected, moderate size, but need some renovations or updates to function well</p> <p>4) Good - Connected, good size/layout, meets needs/functions well</p> <p>5) Very good - connected, generous size, nice condition, functions appropriately</p> <p>N/A) Does not apply.</p>								<p>Some classrooms do not have connected restroom and others are in a portable. A storage room is being converted into quiet/cool down room. <i>SPED Dept Comments: No direct access to restrooms for SBS and SCORES kids in portables. No "cool down" areas for SCORES/SBS kids.</i></p>

3.15 Life Skills Shower

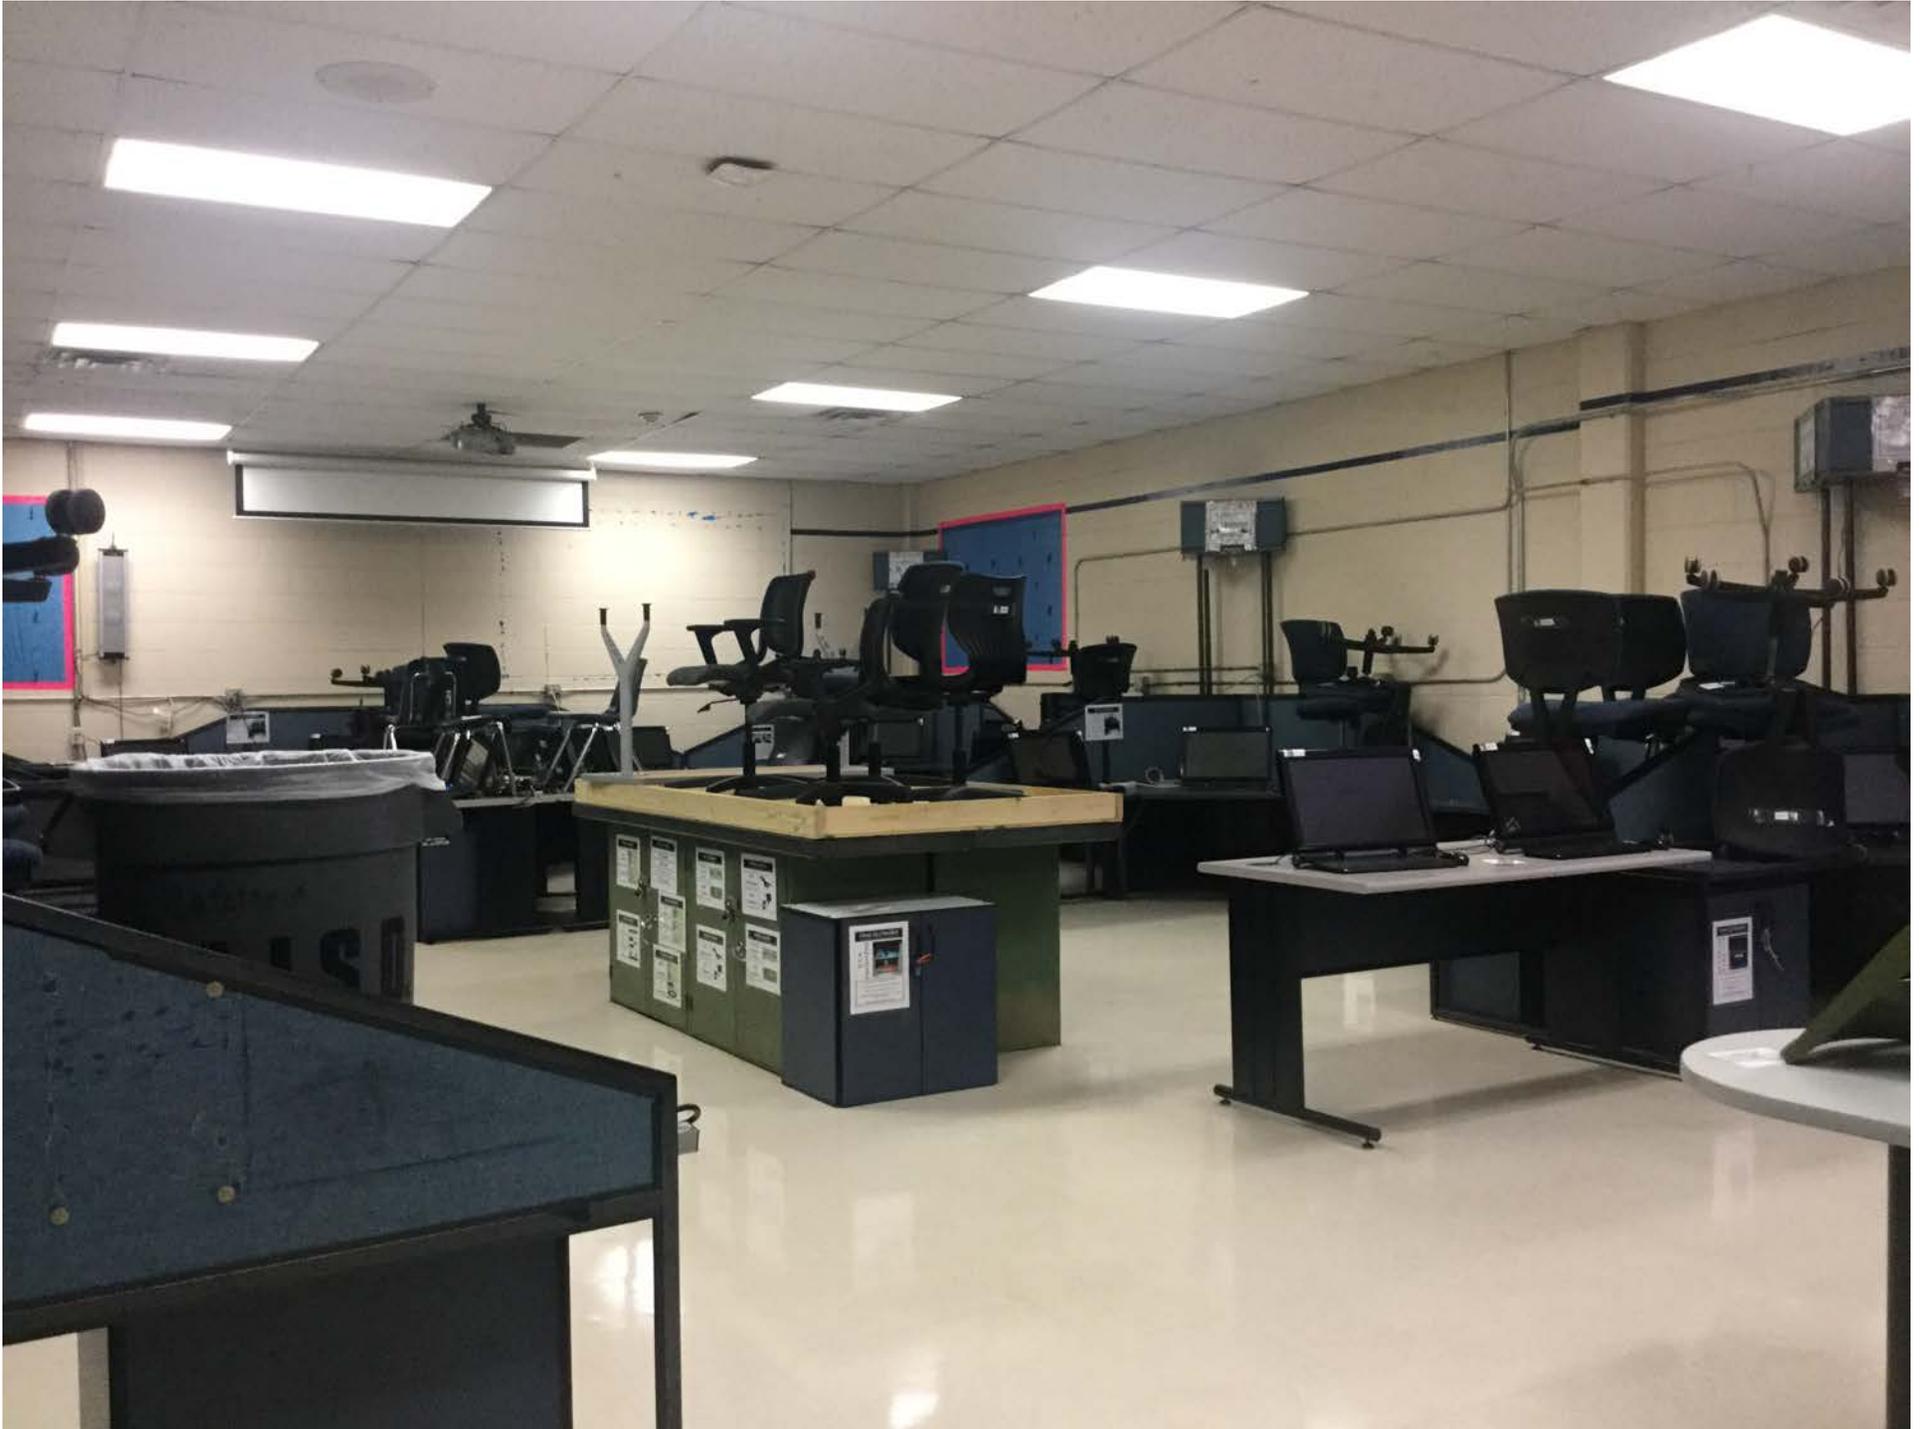
1) Very unsatisfactory - No project space 2) Unsatisfactory - Non-dedicated, undersized or otherwise inadequate 3) Average - Limited dedicated spaces of moderate size and layout, equipment and furniture appropriate but need updates 4) Good - Dedicated spaces of adequate size and layout, most of the equipment and furniture is appropriate for program 5) Very good - Dedicated spaces of adequate size and layout, equipment and furniture appropriate for program N/A) Does not apply.		The robotics classroom is the only dedicated room. More space is needed for demonstrations. The campus would desire a culinary program. If that program were to existing, they would need a culinary kitchen and dining facility.

4.1 Robotics Lab

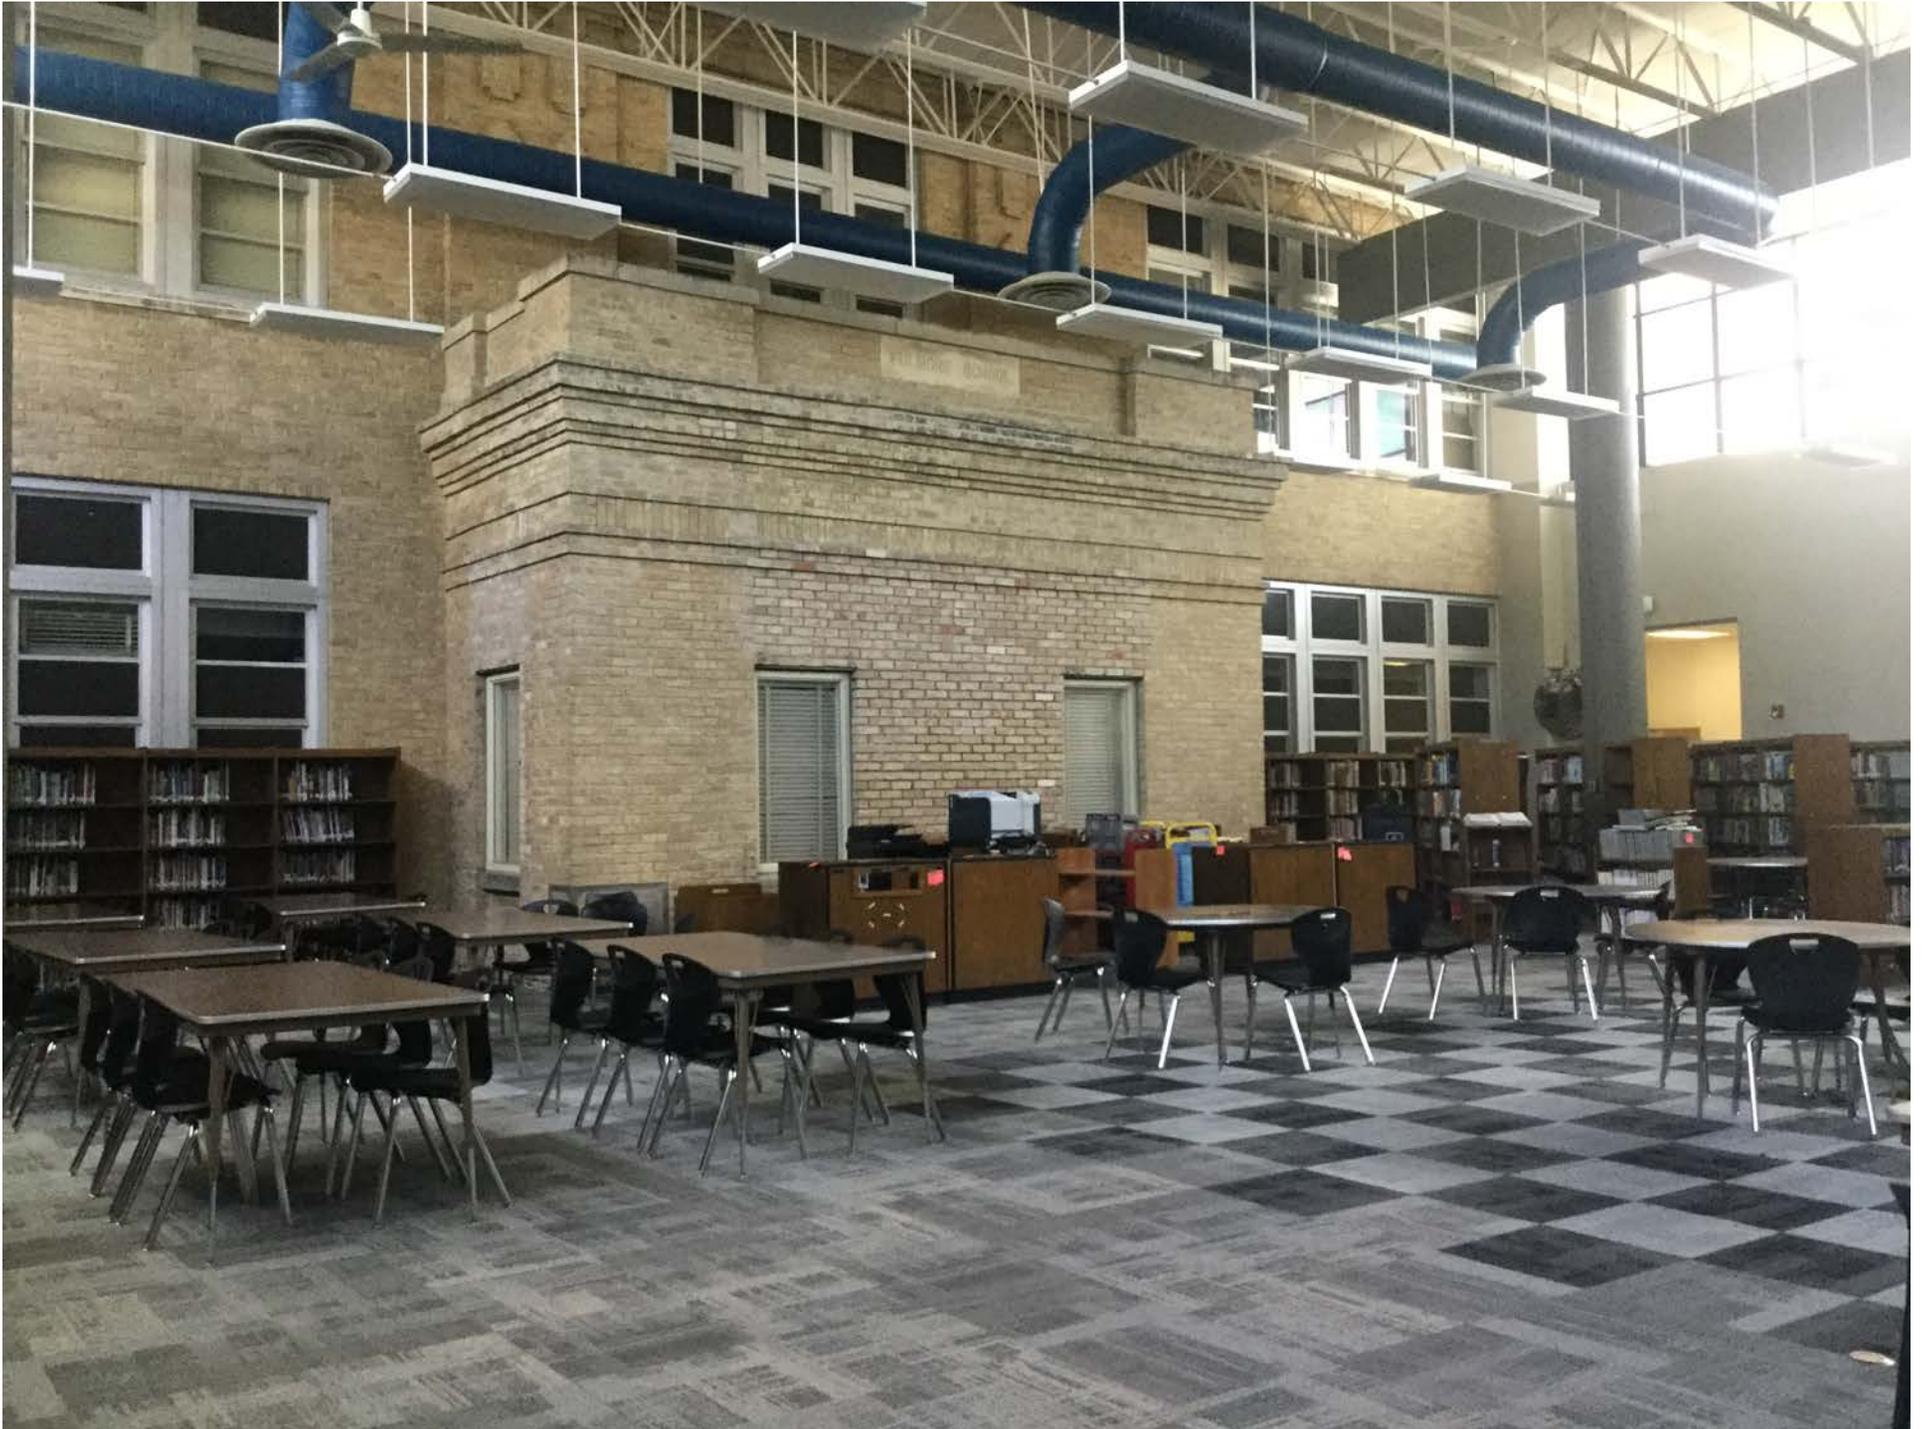
1) Very unsatisfactory 2) Unsatisfactory 3) Average 4) Good 5) Very good N/A) Does not apply.								Supports larger groups with the spacious library and layout with more centralized seating.

5.5 Library

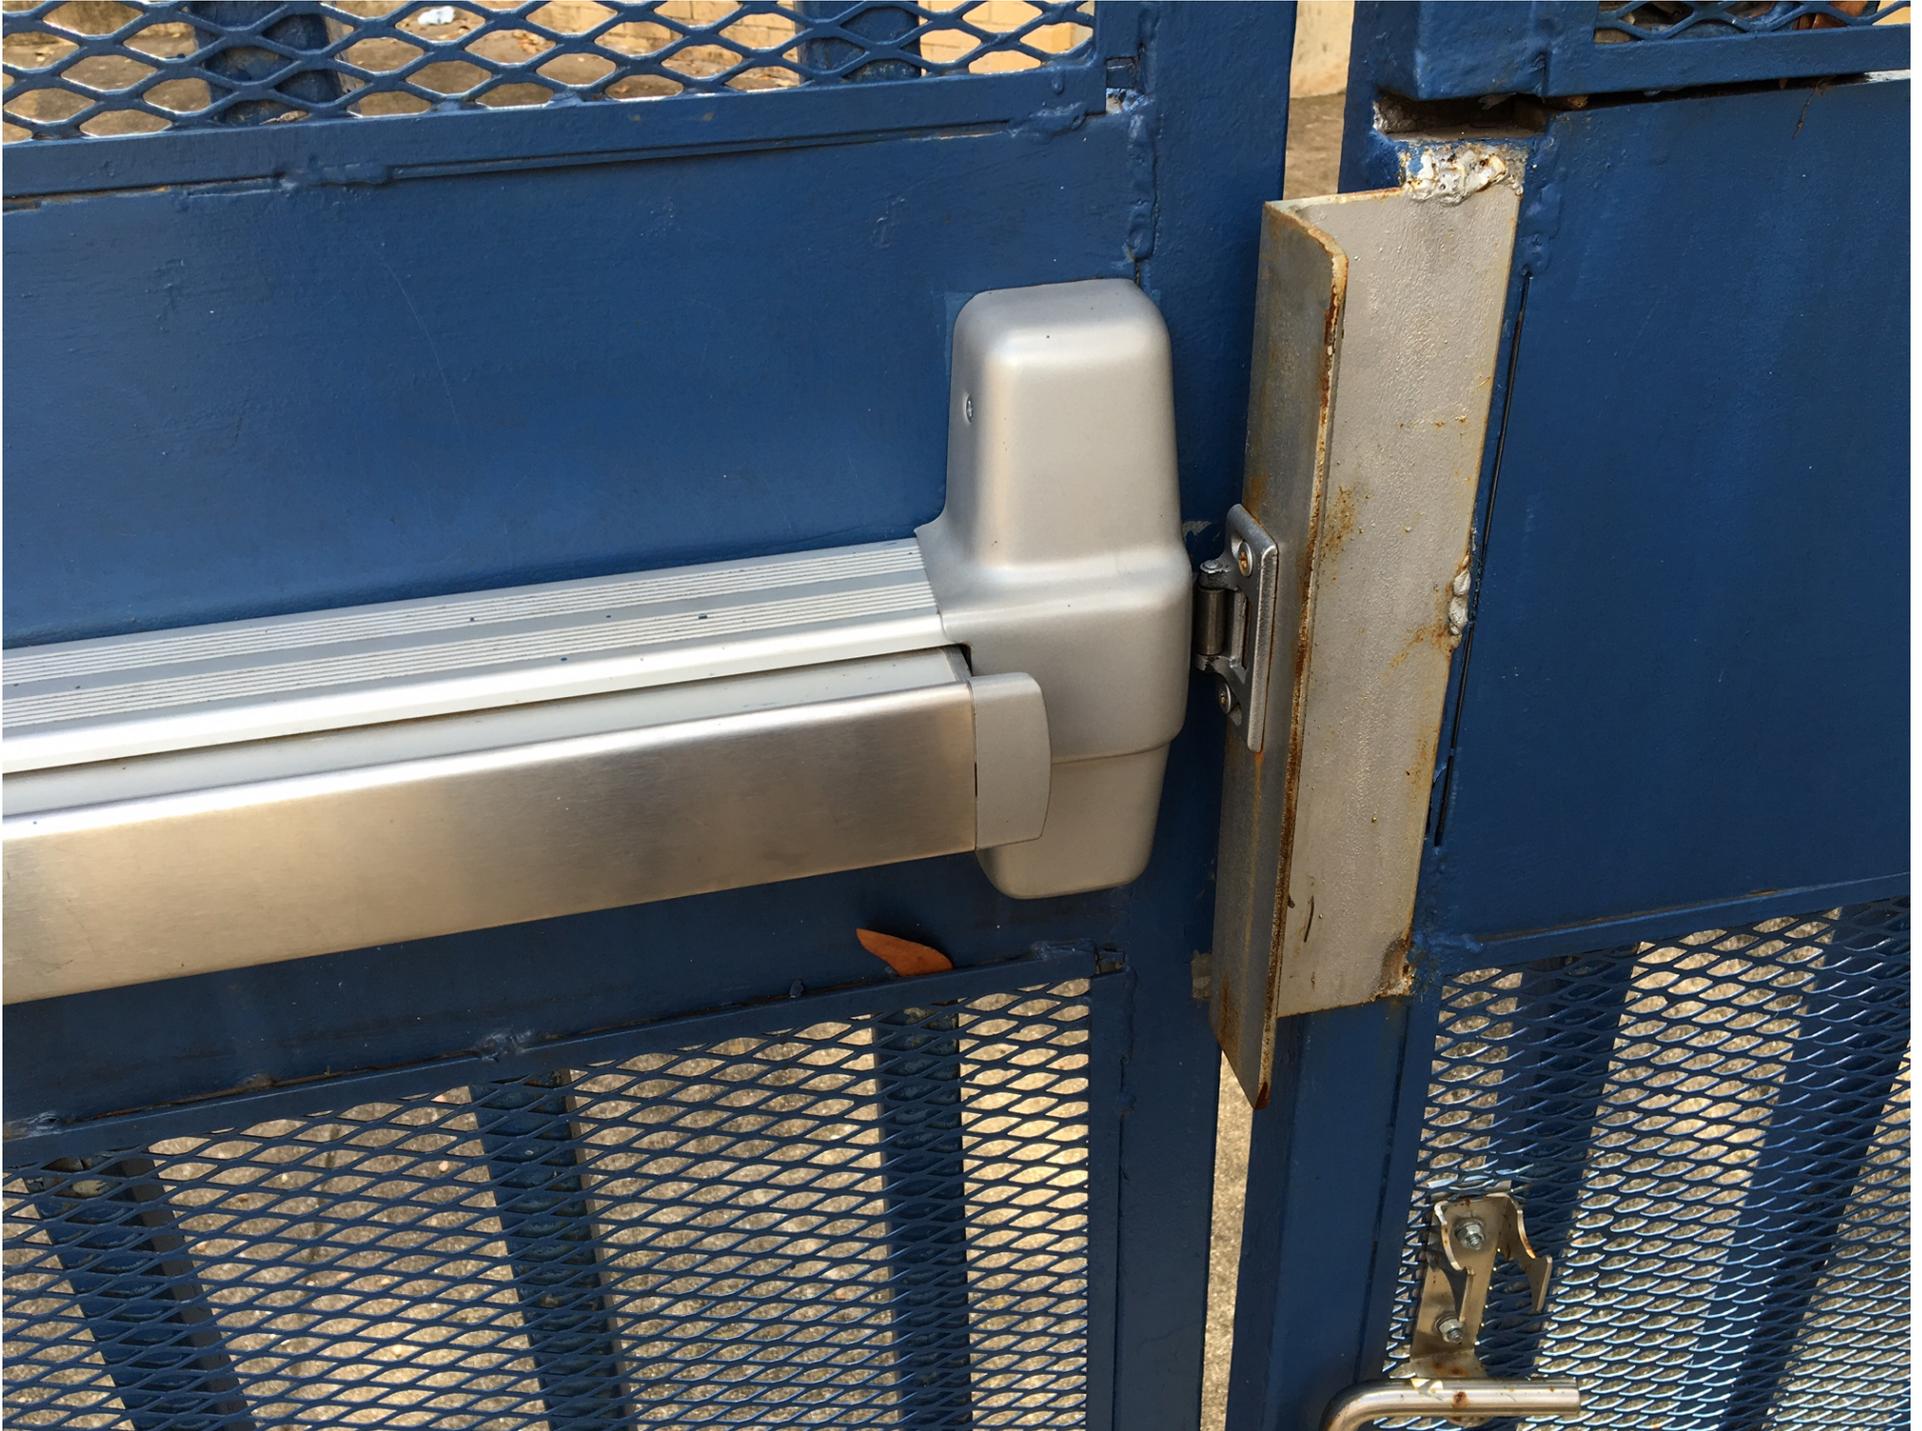
6.2	How adequate is site lighting and security for the campus overall?		2					1.00	2.00
1) No exterior lighting, no secure perimeter 2) Lighting is limited to front entry only, parking lot lighting poor, security is minimal 3) Lighting at all night-use entries and parking lot, but poor condition. Security is moderate 4) Lighting at all night-use entries and parking lots, good condition, signage less visible. Perimeter is well secured, but needs updates. 5) Signage, parking lots, and entries are well lit, visible and easy to use. Perimeter is very secure. N/A) Does not apply.		Comments The parking lots need lighting, and the campus needs more security cameras.

6.2 Security Gate
