## Educational Suitability Summary Report

Garcia Young Men's Leadership Academy – BLDG 064

Date: 06/08/2016 (Rev 1 – 12/20/16 – Updated Survey Responses)

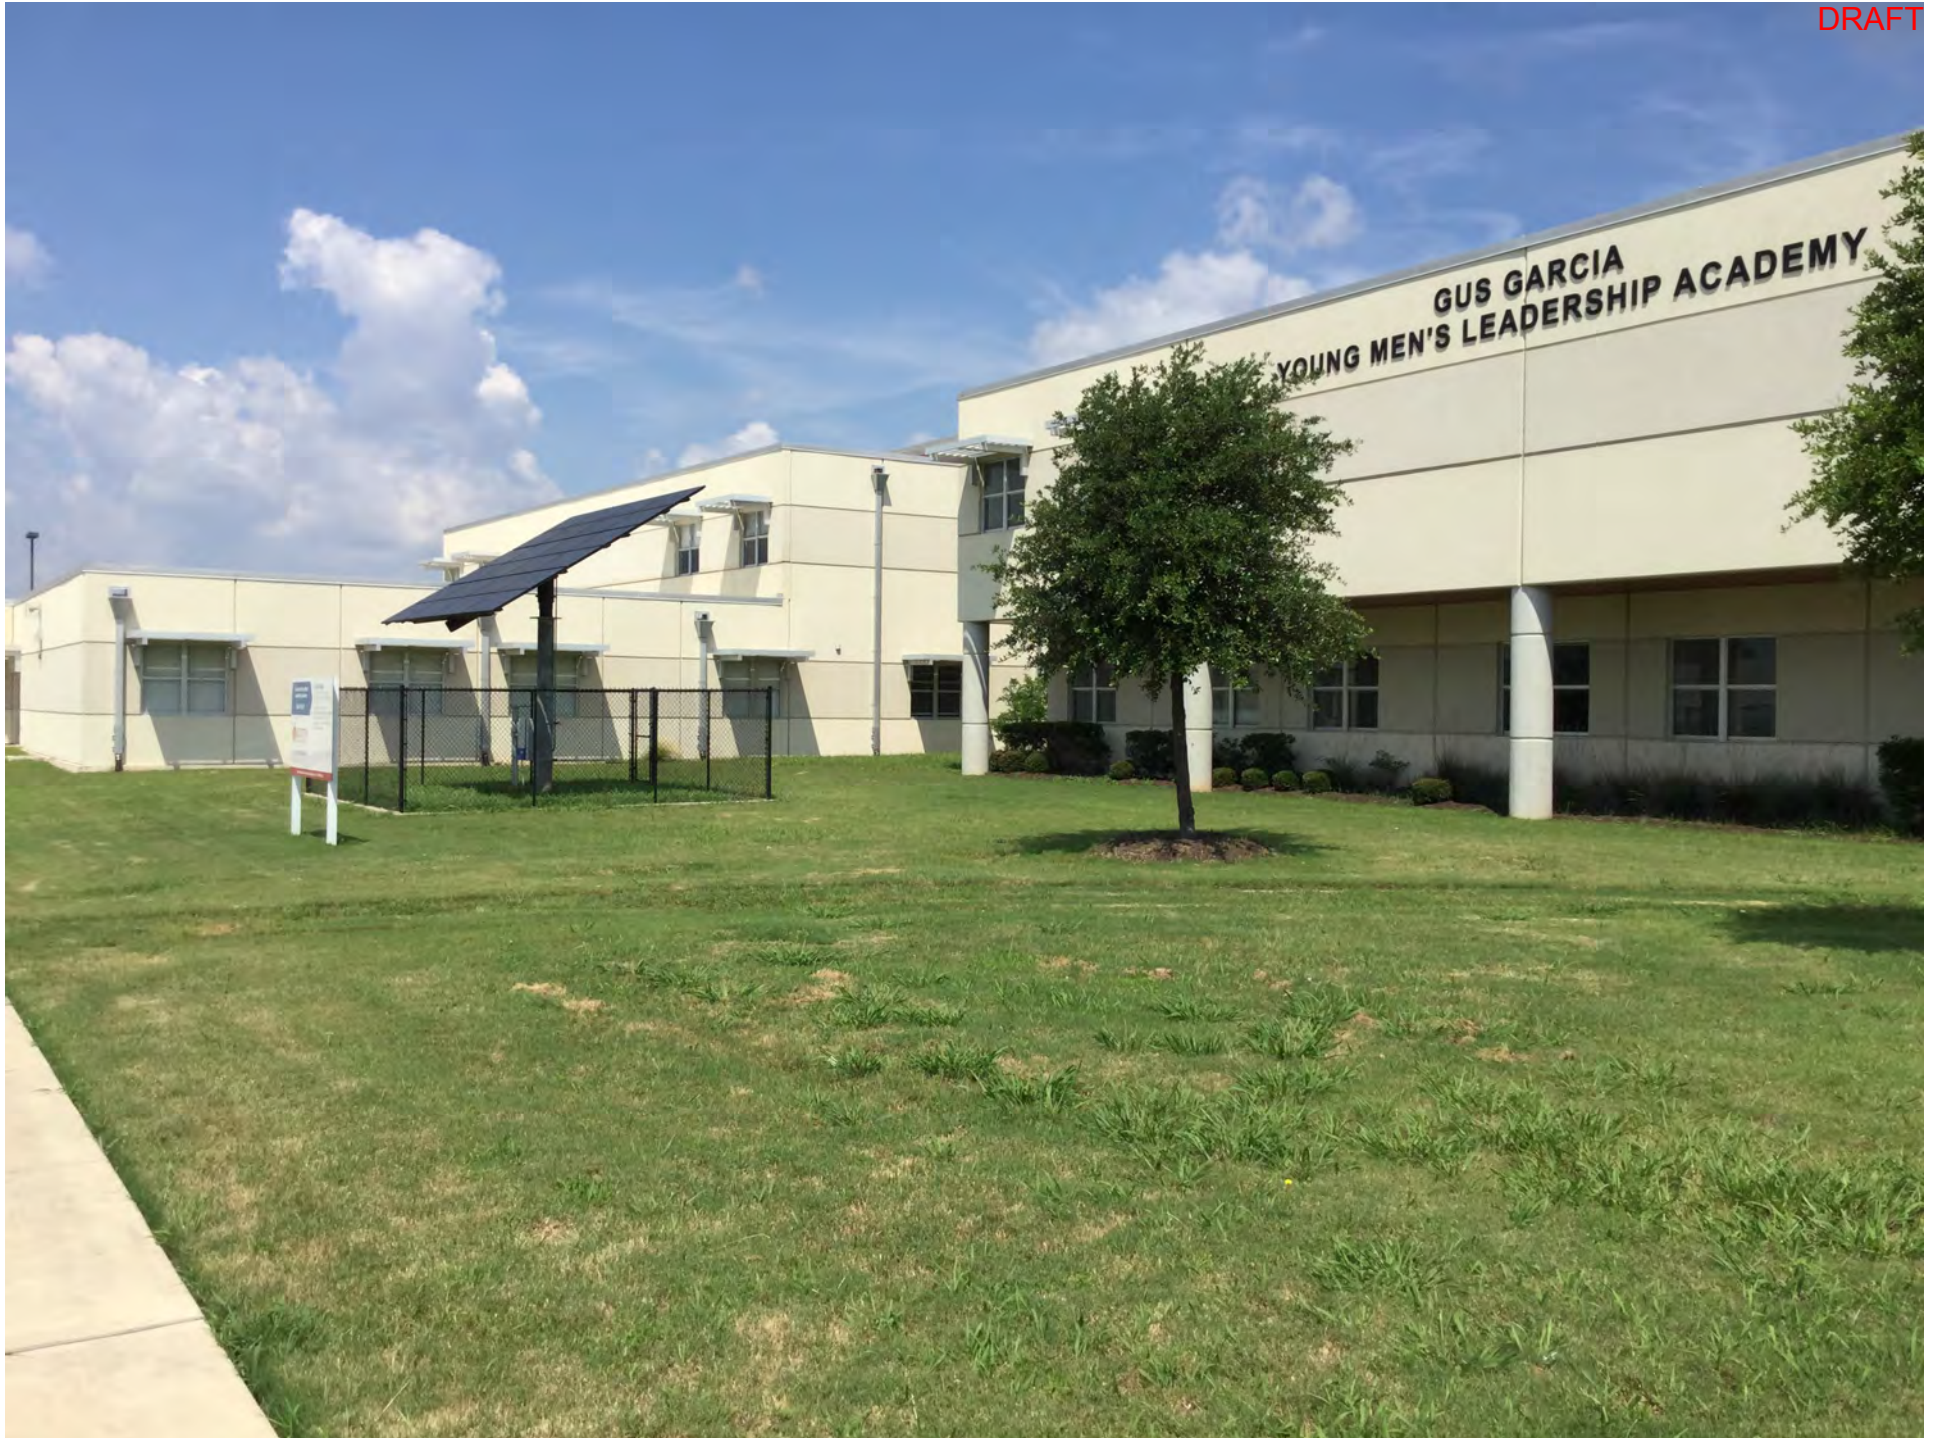
Photo 1. Appearance

2.3	Does the general appearance of the school evoke pride for the students and community?					5		Comments	0.25 1.25
	1) General appearance is poor. 2) General appearance is aged but ok. 3) General appearance is good. 4) General appearance shows pride in campus and student works. 5) General appearance shows pride in campus and student works and is welcoming to the community. N/A) Does not apply.							In general the appearance of the school is very nice and new.	see photo 1

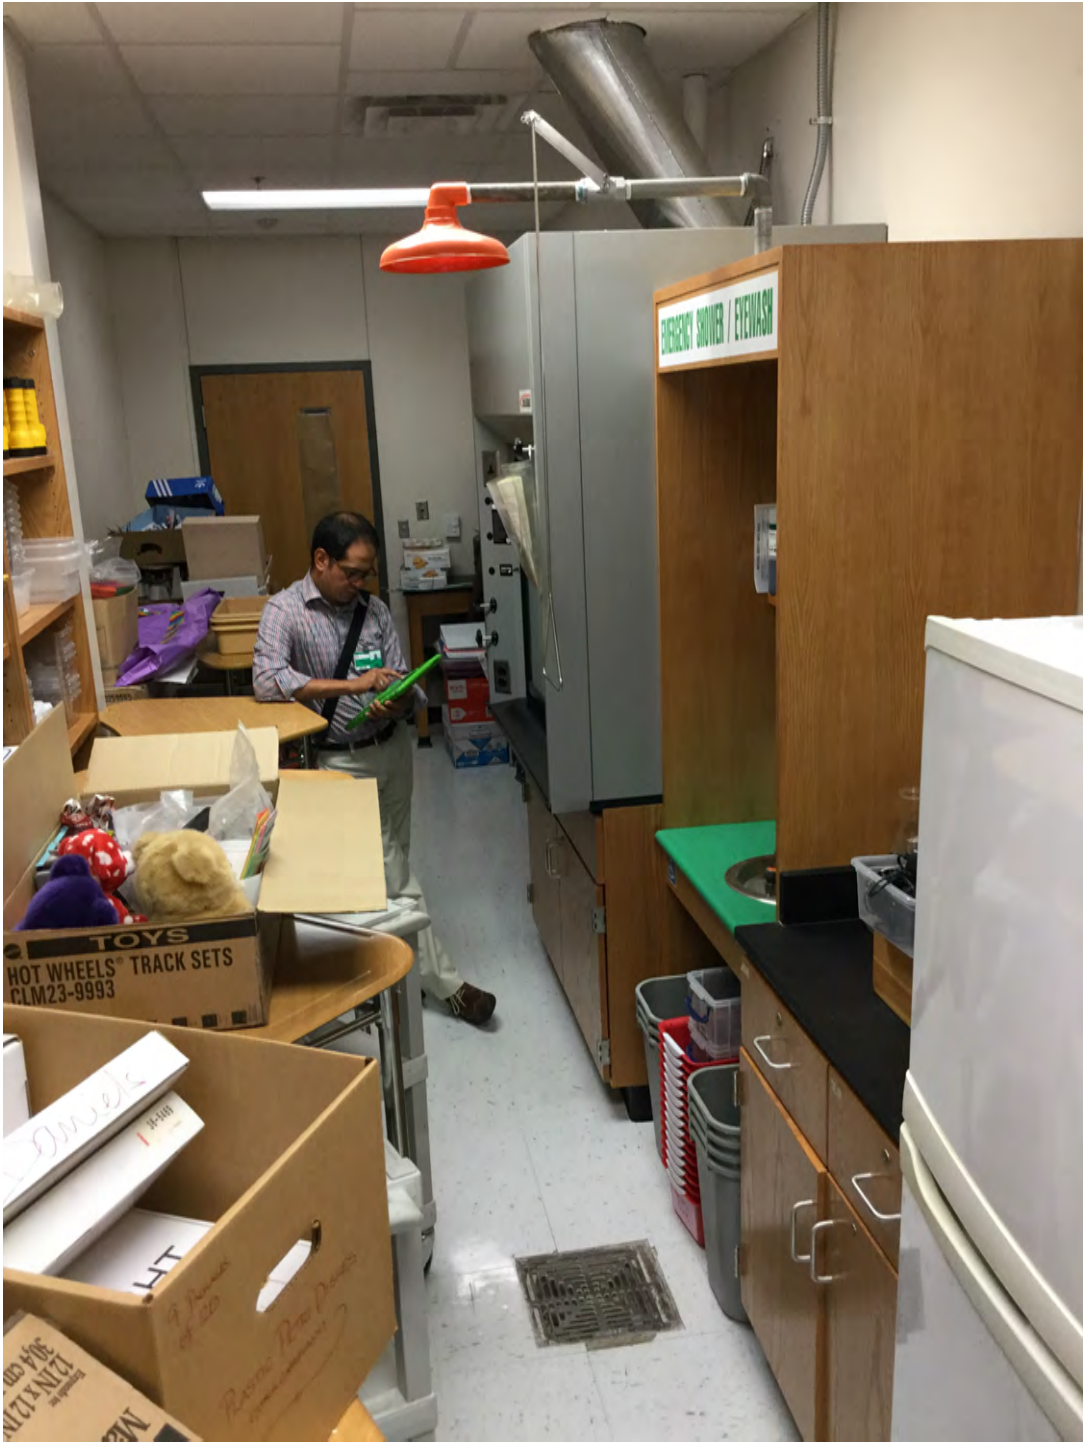
Photo 2. Science Support

3.4	Are Science Classrooms/Labs appropriately configured per the ed spec?					5		Comments	1.00 5.00
1) Very unsatisfactory 2) Unsatisfactory 3) Neutral 4) Satisfactory 5) Very Satisfactory N/A) Does not apply. (Elementary schools)									see photo 2

3.5	Are Science Classrooms/Labs <b>support</b> areas appropriately configured per the ed spec?		2					Comments	1.00 2.00
1) Very unsatisfactory - Support spaces are disconnected from served spaces, too small, do not meet needs 2) Unsatisfactory - Support spaces are connected, but too small, do not meet needs 3) Average - Connected, moderate size, but need some renovations or updates 4) Good - Connected, good size, meets needs, functions well 5) Very good - connected, generous size, nice condition, functions appropriately N/A) Does not apply. (Elementary schools)									Prep room is very narrow. The demonstration and hood are in the prep room but this would not function for a demo. Eye wash is also located in the prep room and difficult to access.

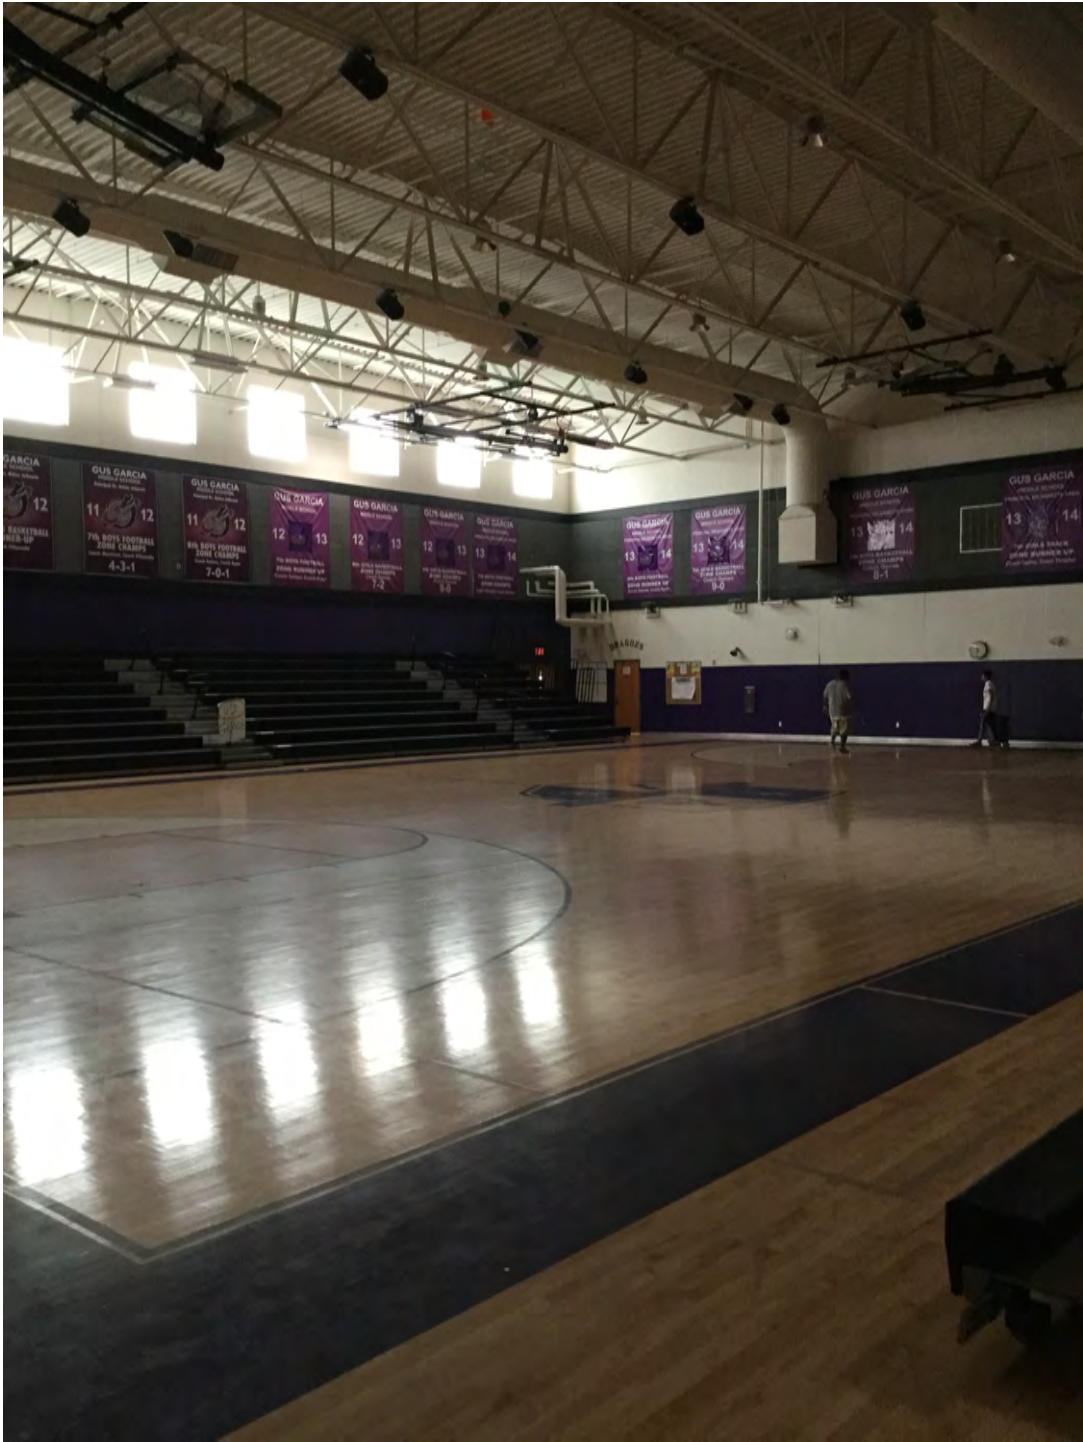
Photo 3. Gym Facility

1) Very unsatisfactory 2) Unsatisfactory 3) Average 4) Good 5) Very good N/A) Does not apply.								Gym facility is extremely nice. Two separate court areas with bleachers and nice flooring.	see photo 3

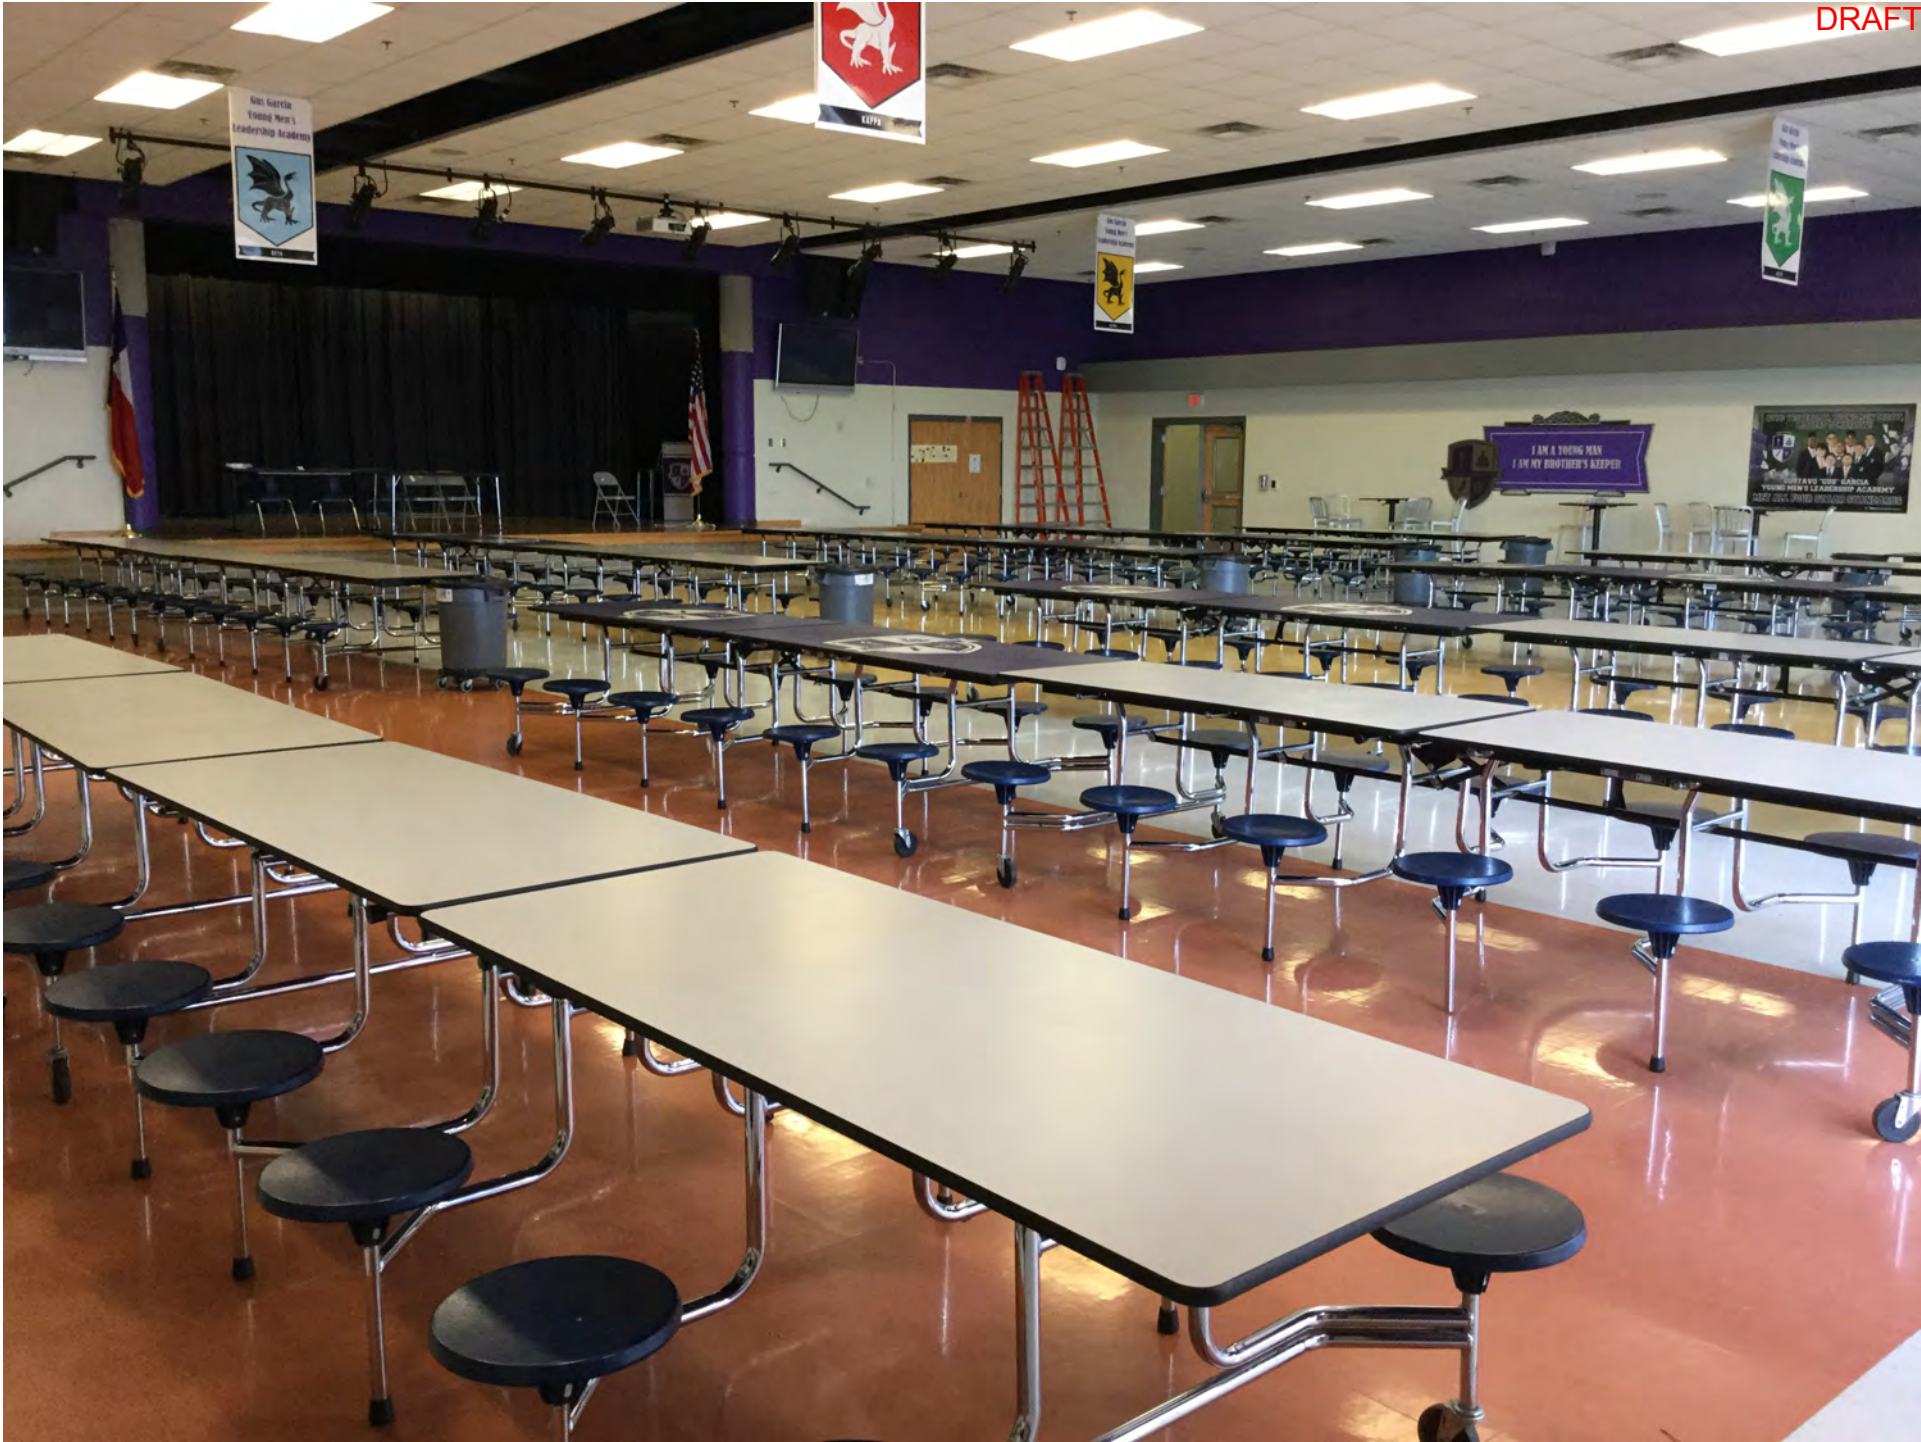
Photo 4. Dining Facility

3.16	Are the student dining facilities appropriately configured?										5		Comments	1.00	5.00
1) Very unsatisfactory - Too small, poor circulation, inflexible seating in poor condition 2) Unsatisfactory - Too small or inadequate circulation, seating in poor condition 3) Average - moderate size, with adequate circulation, seating in okay condition 4) Good - good size, adequate circulation, seating in good condition 5) Very good - good size, adequate circulation, seating in good condition, with more than one option for eating space (ex: connection to outdoor eating space) N/A) Does not apply.												see photo 4

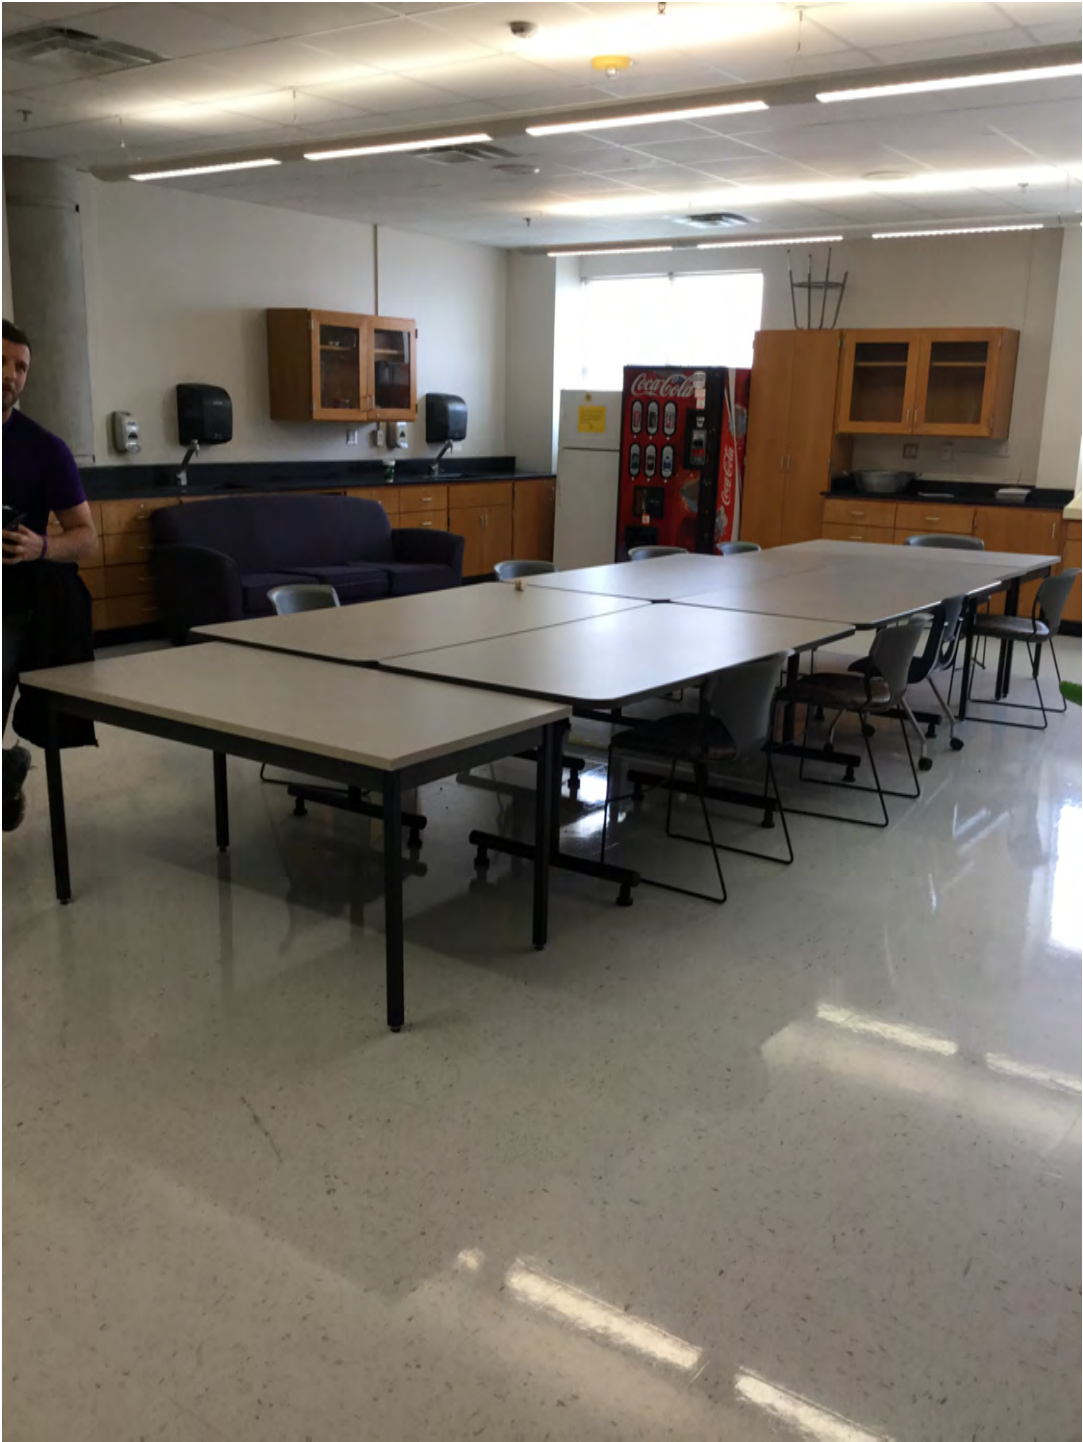
Photo 5.  
Collaborative Spaces

1) Very unsatisfactory - no common spaces or meeting rooms or in very poor condition 2) Unsatisfactory - a few common spaces or meeting rooms in unsatisfactory condition 3) Average - a few common spaces and meeting areas needing updates 4) Good - multiple common spaces and meeting rooms in good condition 5) Very good - adequate common spaces and meeting rooms of excellent quality N/A) Does not apply.								The only break-out space for teacher/student collaboration is mainly in the library space. Lacking meeting spaces.	see photo 5

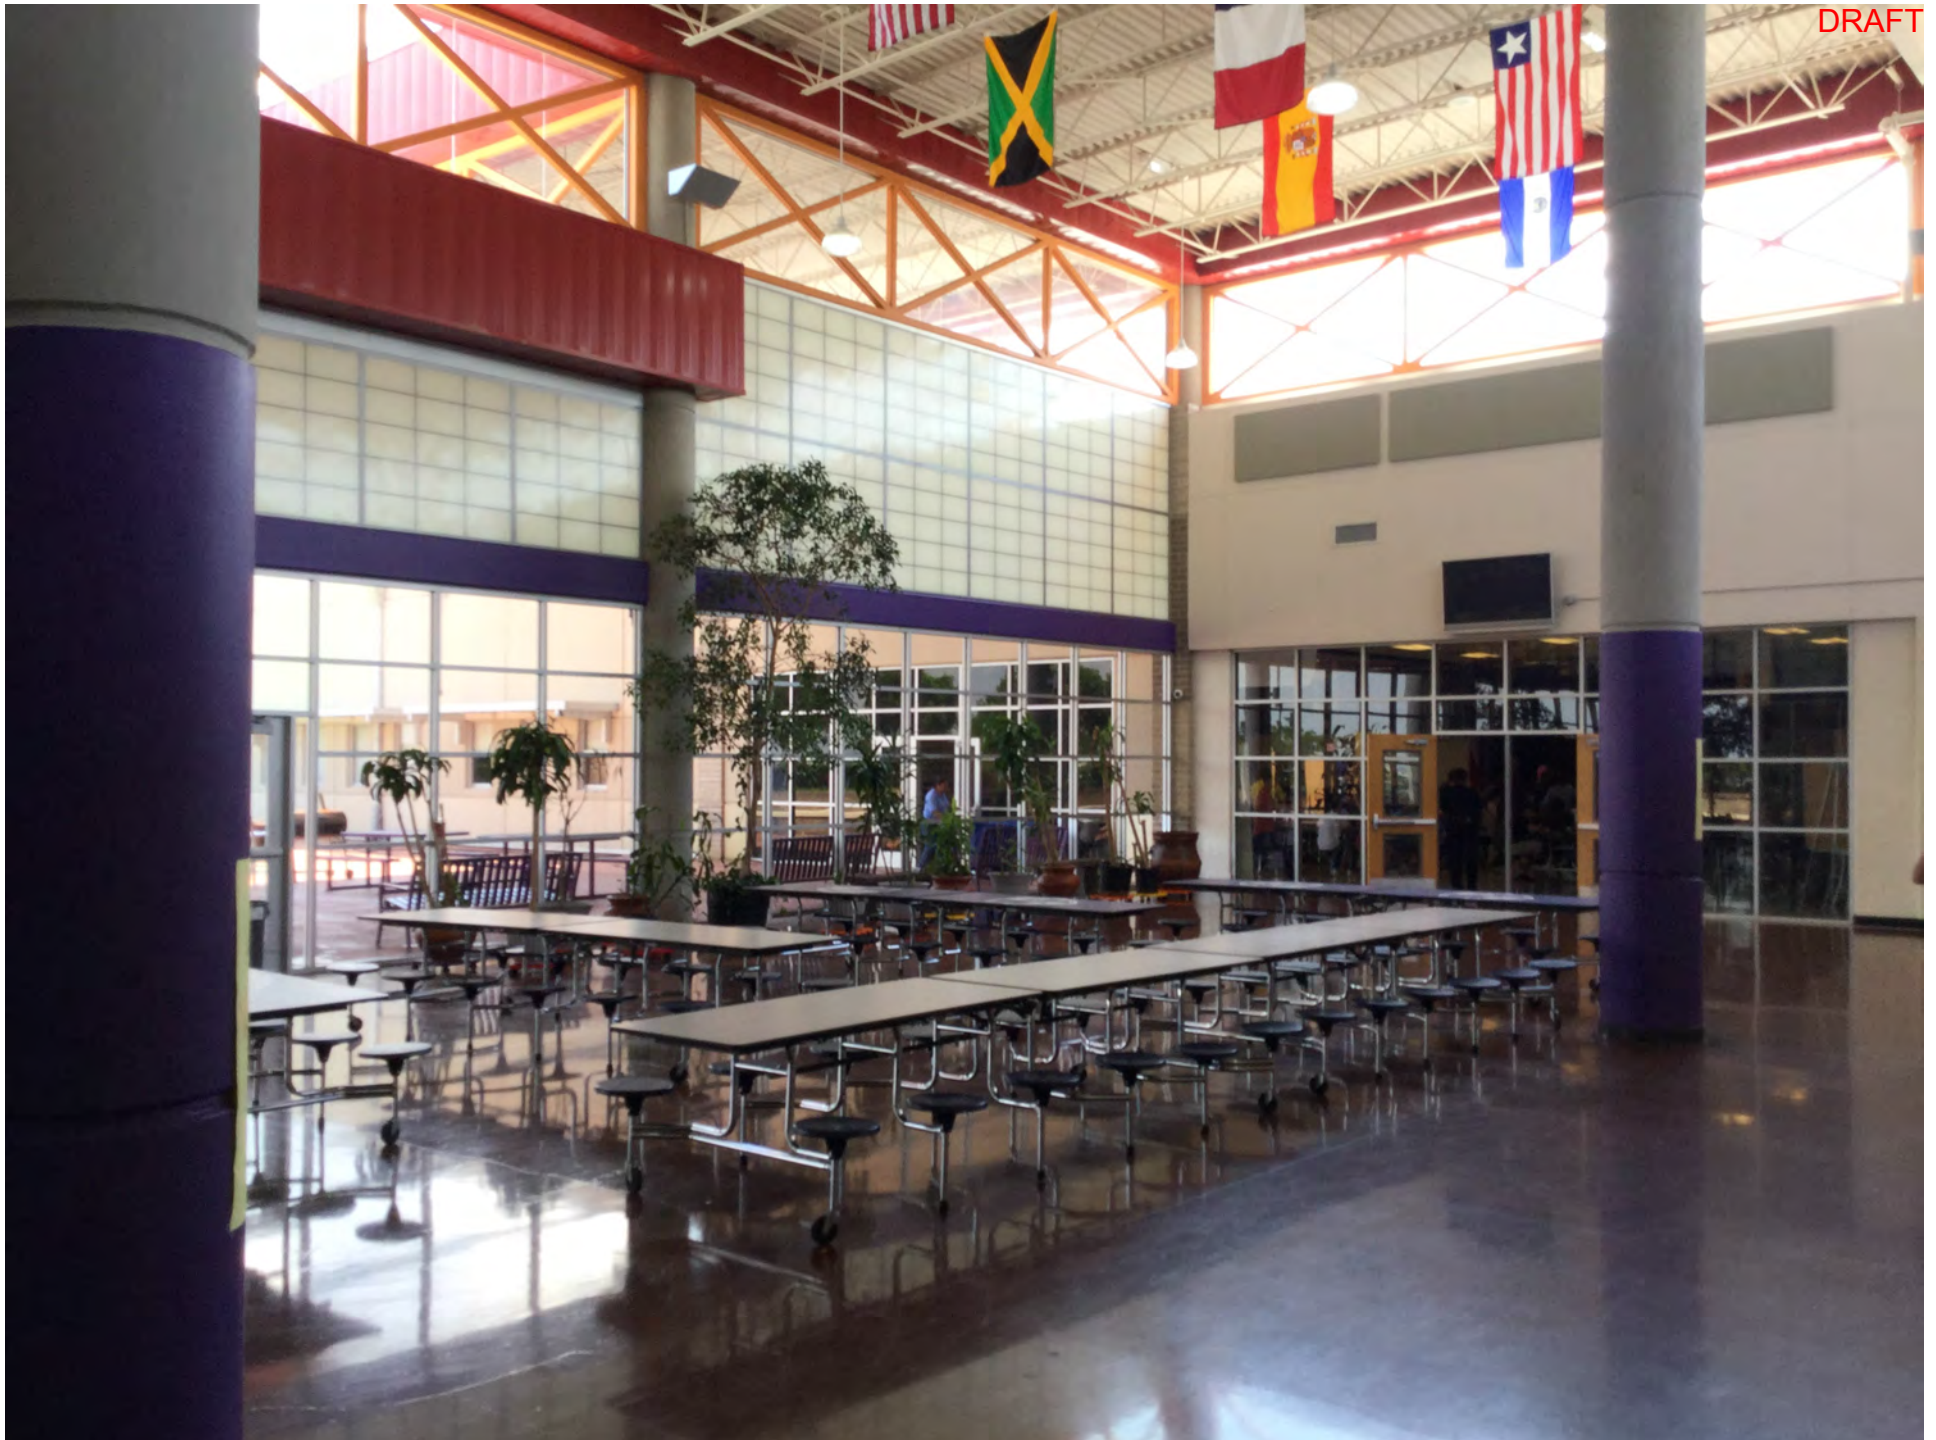
Photo 6. Informal  
Interactive Space

4.6	Does the building provide opportunities for informal interaction?					5		Comments	1.00 5.00
1) Very unsatisfactory - no gathering areas or areas in very poor condition 2) Unsatisfactory - one exterior or interior common space with no seating or unsatisfactory condition 3) Average - one exterior or interior common space with seating needing updates 4) Good - 2 exterior or interior common spaces with appropriate seating/good condition 5) Very good - multiple exterior and interior commons spaces with appropriate seating in excellent condition N/A) Does not apply.								There is a generous common space atrium with an outdoor patio for informal interactions. The front plaza is large and shaded as well.	see photo 6

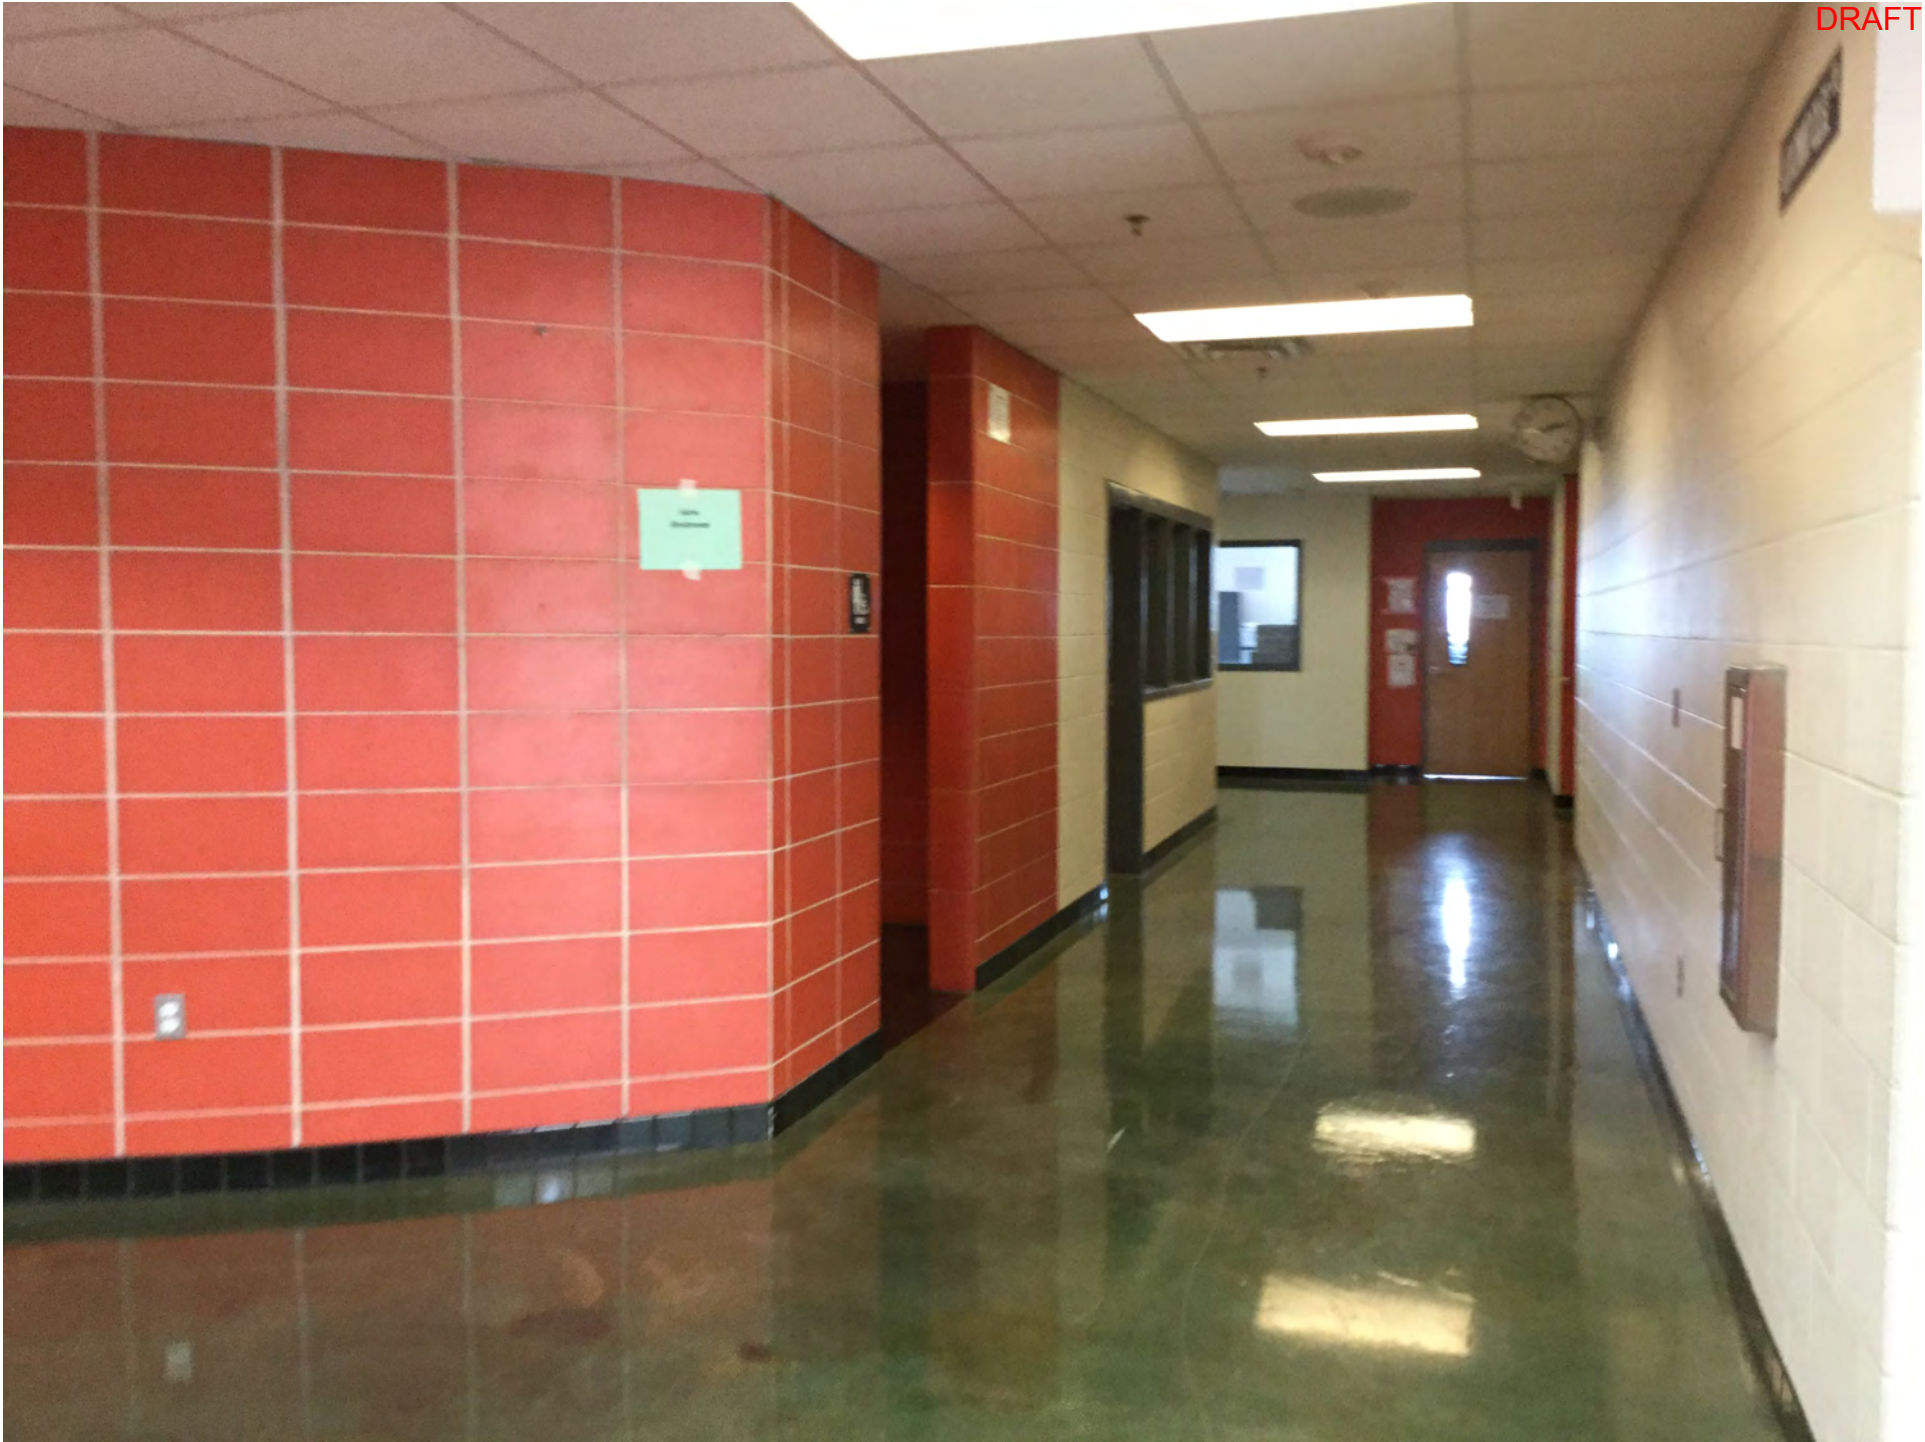
Photo 7. Security

6.4	Is there enough interior transparency for faculty to affectively supervise students who are not in classrooms?				4			Comments	1.00	4.00
1) Very unsatisfactory 2) Unsatisfactory 3) Average 4) Good 5) Very good N/A) Does not apply.								Faculty complained of the visibility issue in the "pod" layout of the school. There is a corridor that is a blind-spot for faculty supervision.		
see photo 7

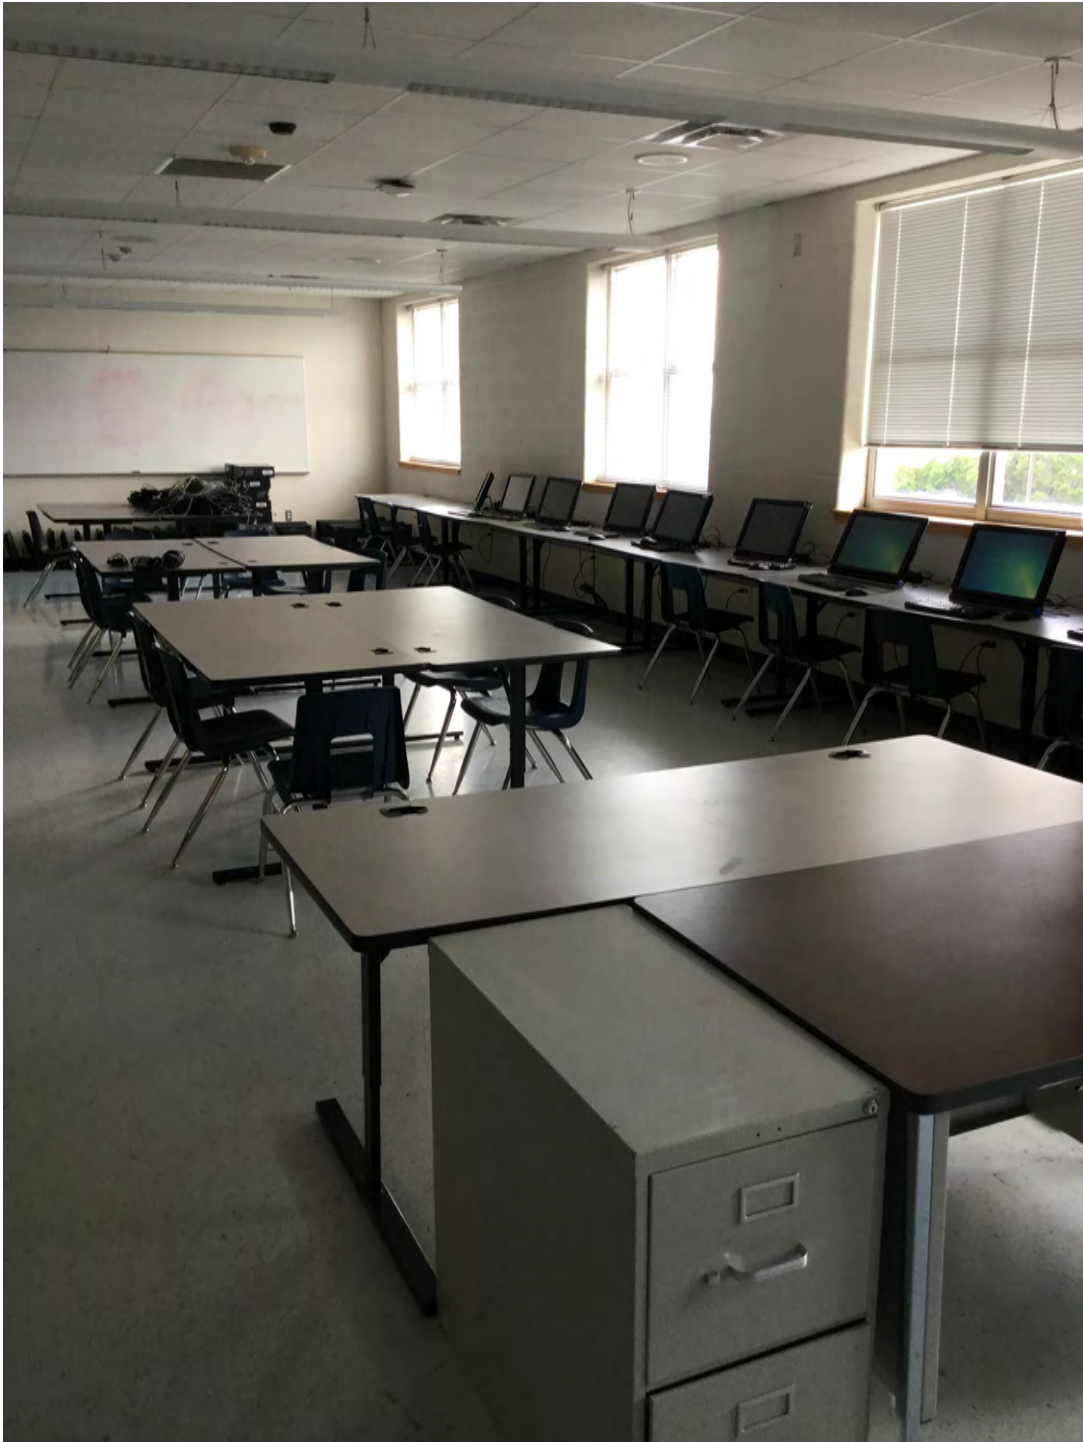
Photo 8. Technology

7 - Technology		1	2	3	4	5	N/A	9.00	
7.1	How well equipped are the facilities with instructional technology?				4			Comments	1.00 4.00
1) Very unsatisfactory - very few or no available computers or devices. Old/outdated technology 2) Unsatisfactory- few computers/devices. Some outdated technology 3) Average- A few computers/devices. A mix of new and outdated technology 4) Good - multiple computers or devices per room. Mostly new technology. 5) Very good - multiple computers and devices and new technology. N/A) Does not apply.								Some classrooms are missing technology that is present in the standard classrooms.	
								see photo 8

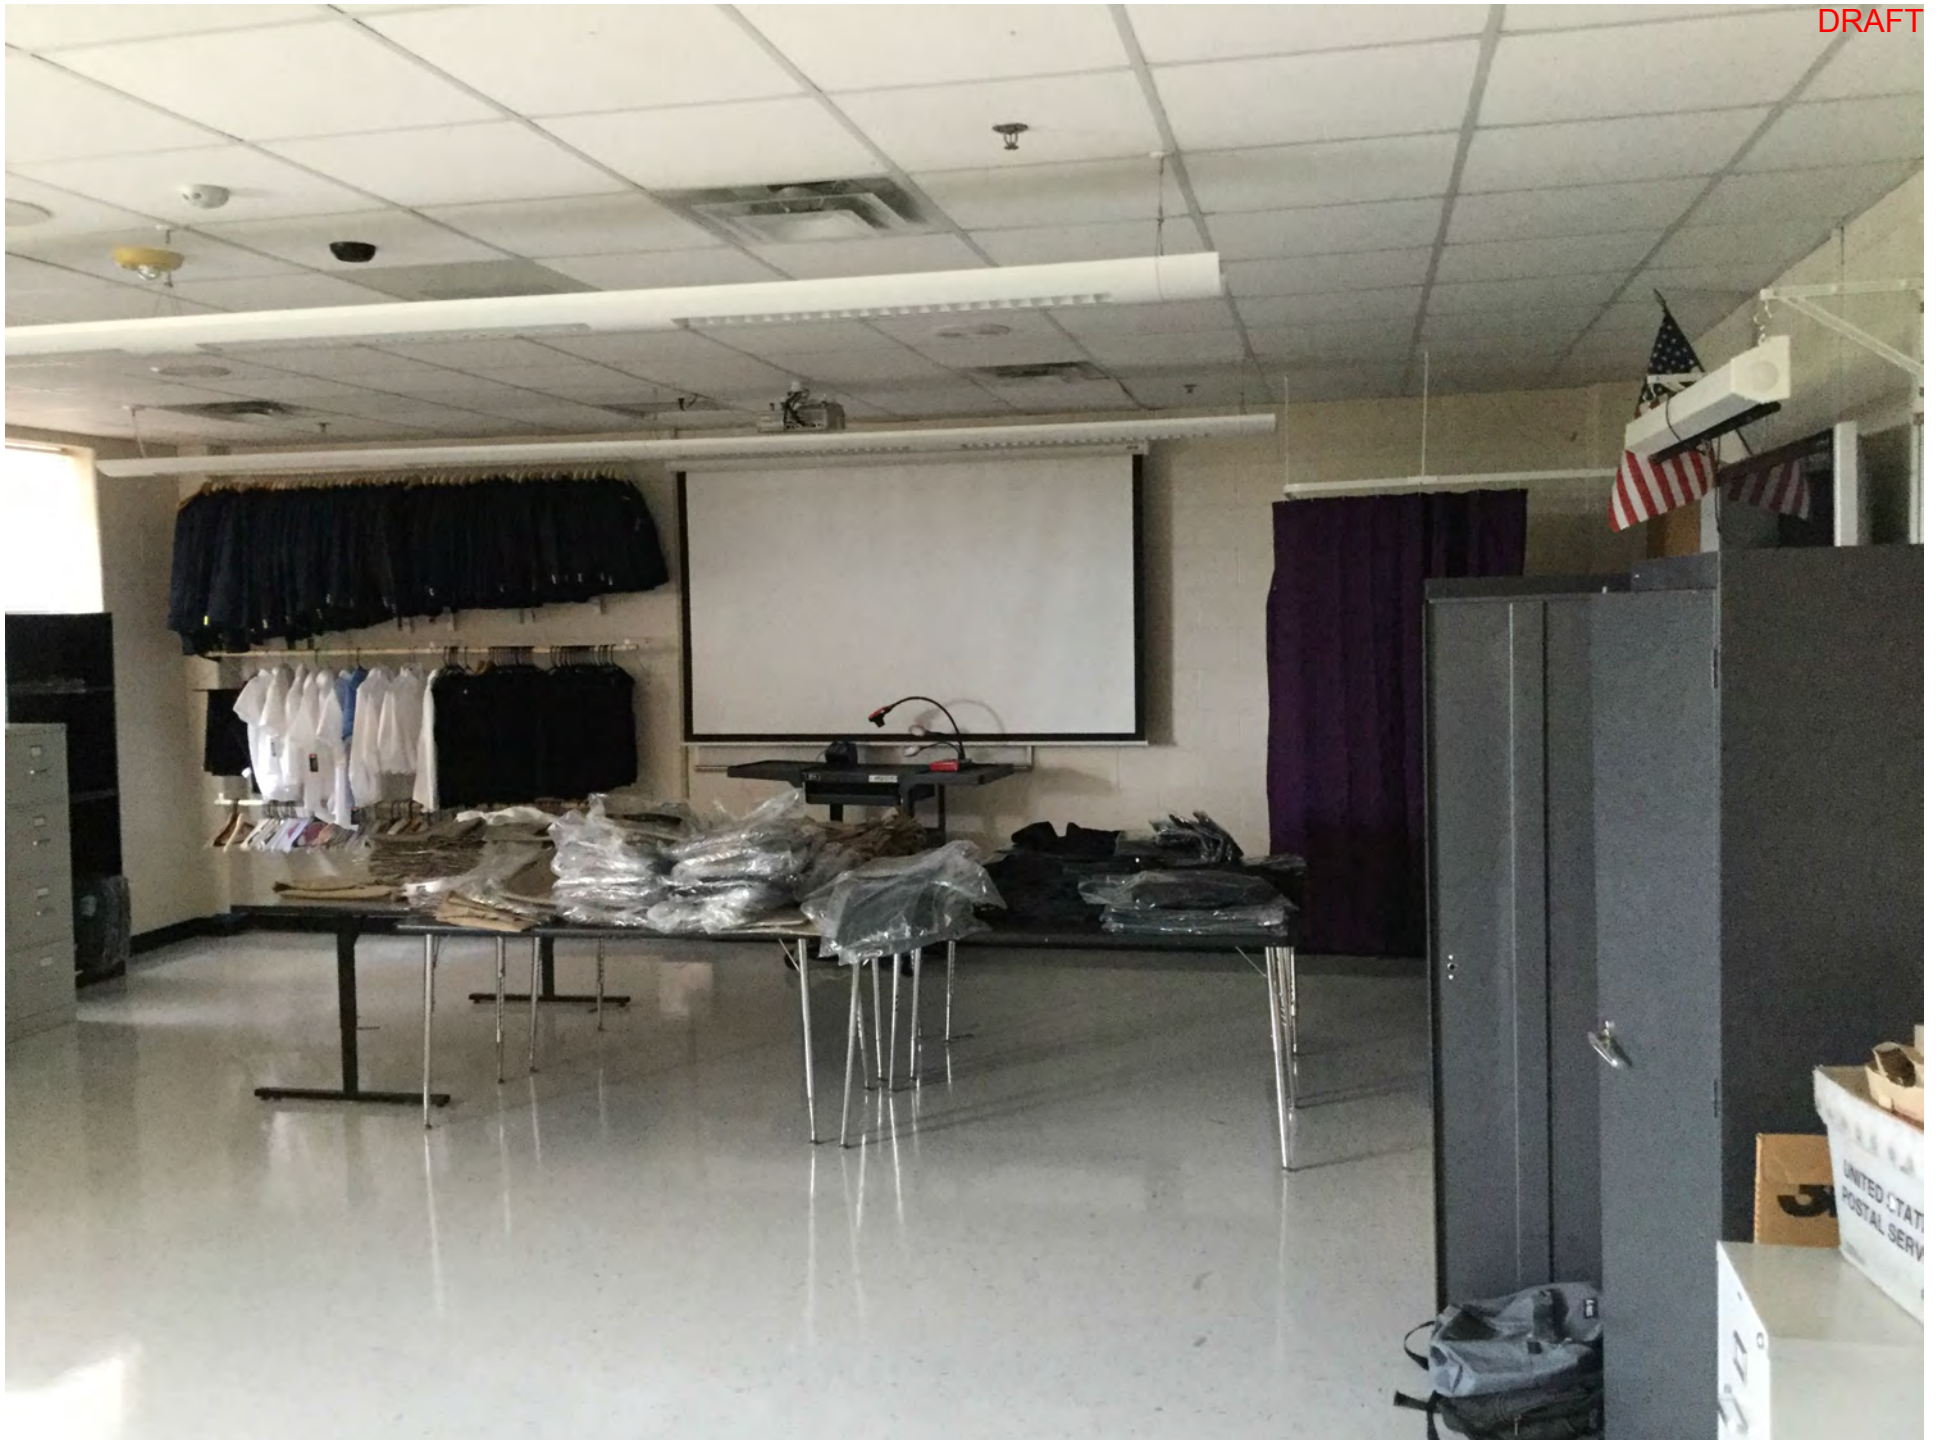
Photo 9. Storage

General building storage is inadequate. Some classrooms have been repurposed as storage rooms for school uniforms, student records, or furniture. Additionally, classrooms lack built-in storage. Playing fields lack storage, and currently equipment is stored in a storage container.

8 - Storage		1	2	3	4	5	N/A	7.00	
8.1	Is there adequate general storage in the building?	1						Comments	1.00 1.00
1) Very unsatisfactory 2) Unsatisfactory 3) Average 4) Good 5) Very good N/A) Does not apply.								There is not enough school storage. Currently there are a few classrooms that have been converted into storage for uniforms, a teacher workroom, and storage for furniture. There is also insufficient storage for the athletic fields.	see photo 9
