Educational Suitability Summary Report

Kealing Middle School

Date: 07/11/2016

(REV 1 –11/15/2016 - AISD CONSTRUCTION DEPARTMENT)

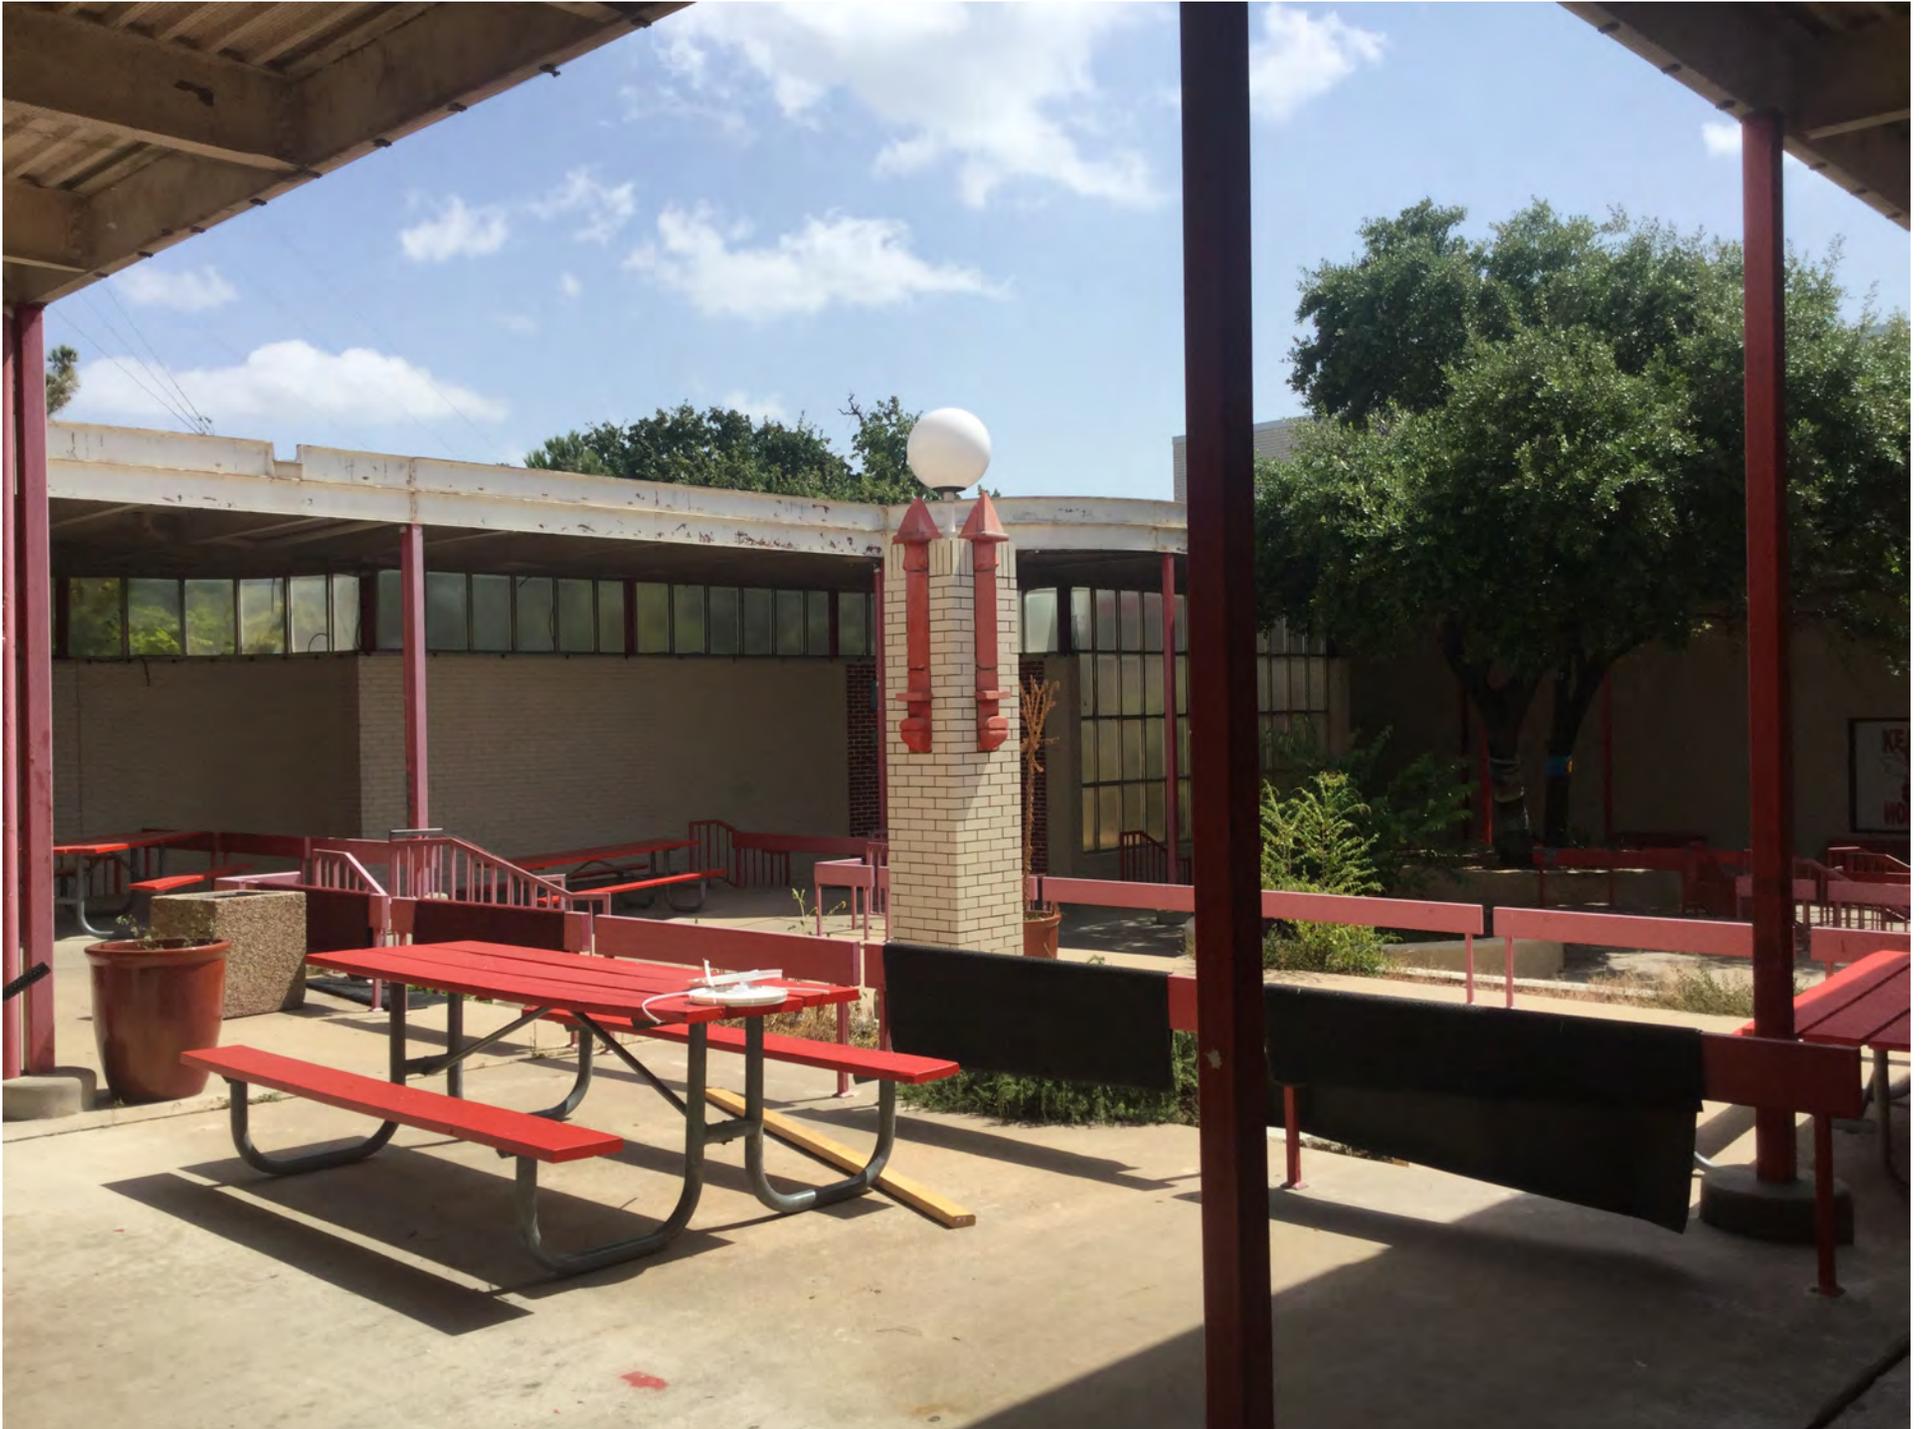
Photo 1.
1.2 Outdoor Learning Space

1.2	Are opportunities provided for outdoor learning (outdoor classrooms, gardens, etc.)?			3				Comments	1.00	3.00
1) Outdoor space exists is not developed 2)Outdoor space for learning exists but not connected to classroom learning areas. 3. Outdoor learning spaces exist and are accessible but not in good condition. 4. Outdoor learning spaces need minor improvements to function well. 5. Outdoor learning spaces are in excellent condition. N/A) Does not apply.									see photo 1

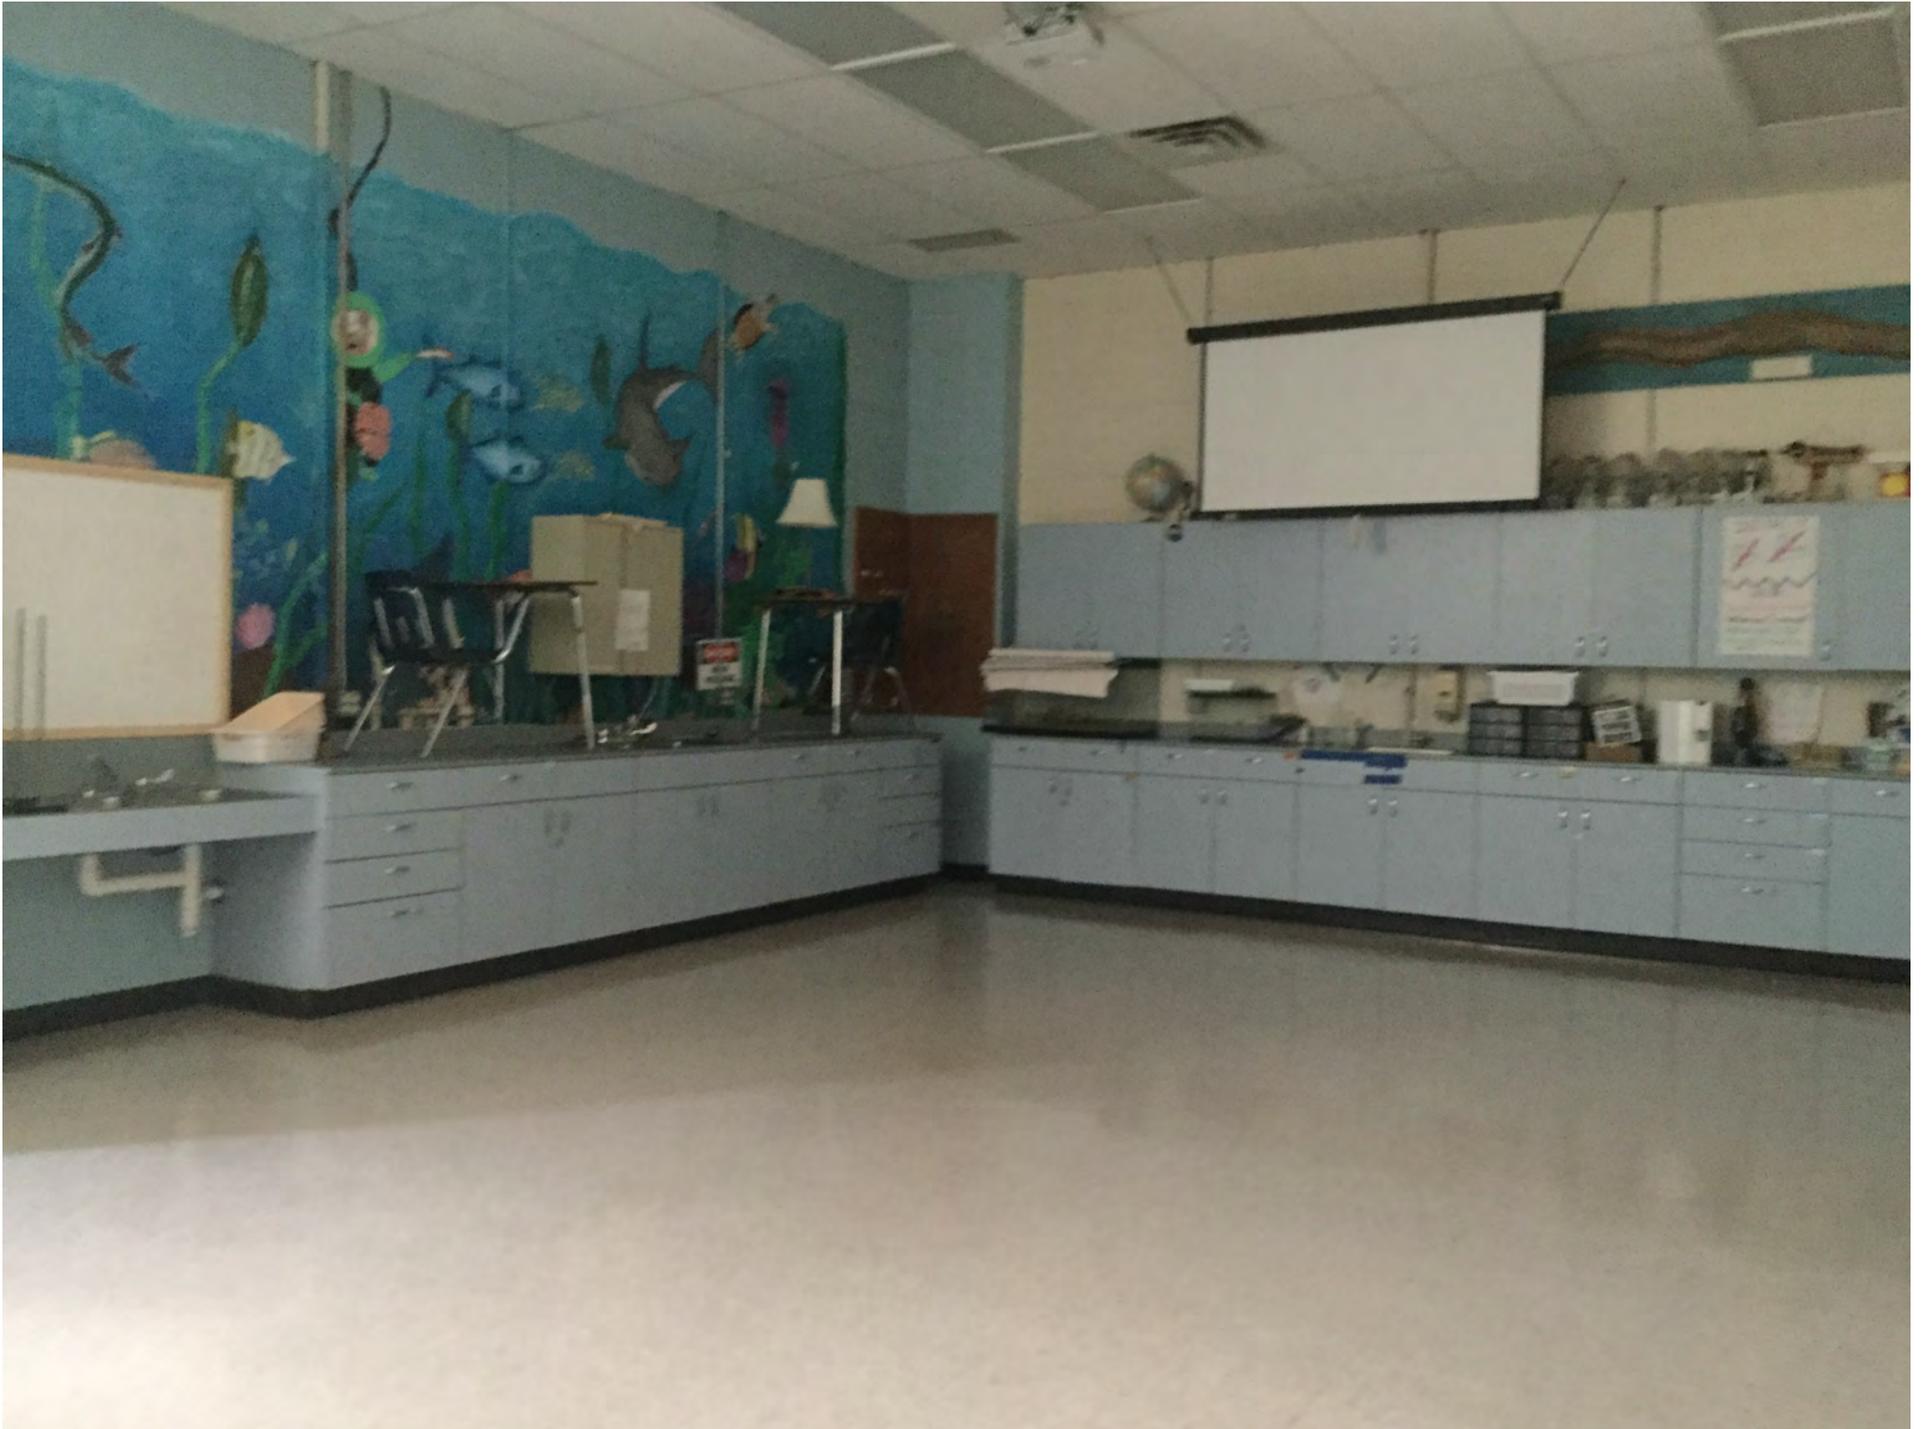
Photo 2.
3.4 Science Classrooms

3.4	Are Science Classrooms/Labs appropriately configured per the ed spec?			3				Comments	1.00	3.00
1) Very unsatisfactory 2) Unsatisfactory 3) Neutral 4) Satisfactory 5) Very Satisfactory N/A) Does not apply. (Elementary schools)		There is a mix of well equipped classrooms and inadequate classrooms. The standard classrooms without plumbing are also being appropriated as science classrooms.								
		see photo 2

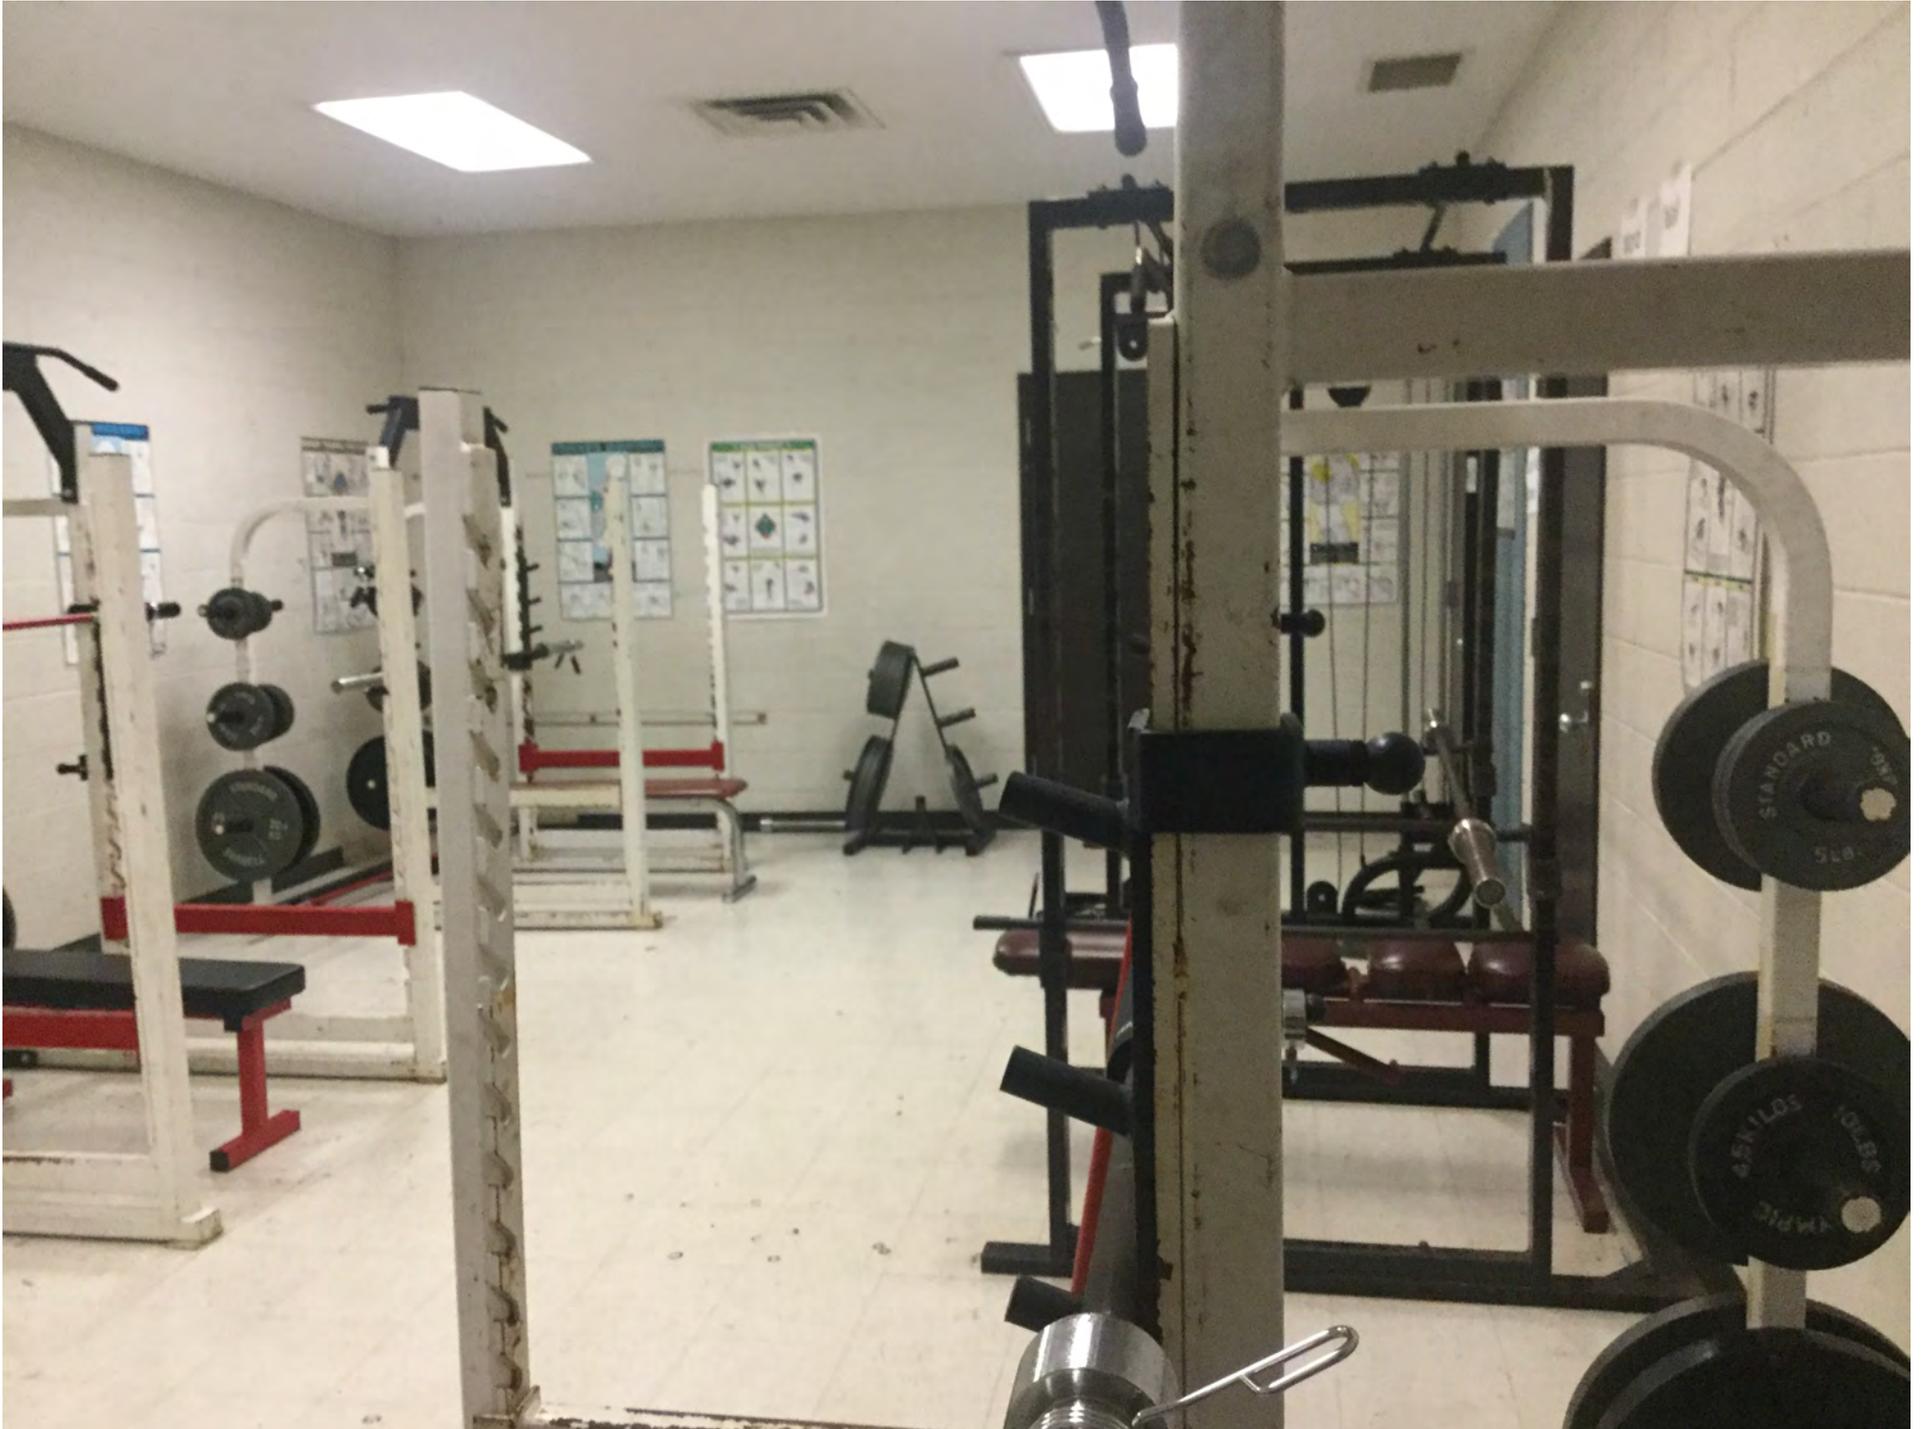
Photo 3.
3.7 Weight Room

3.7	Are Physical Education and Athletic support spaces appropriately configured per the ed spec?		2					Comments	1.00 2.00
1) Very unsatisfactory - Support spaces are disconnected from served spaces, too small, do not meet needs 2) Unsatisfactory - Support spaces are connected, but too small, inadequate for needs 3) Average - Connected, moderate size, but need some renovations or updates to function well 4) Good - Connected, good size/layout, meets needs/functions well 5) Very good - connected, generous size, nice condition, functions appropriately N/A) Does not apply.		The weight room and storage are inadequate.							
		see photo 3

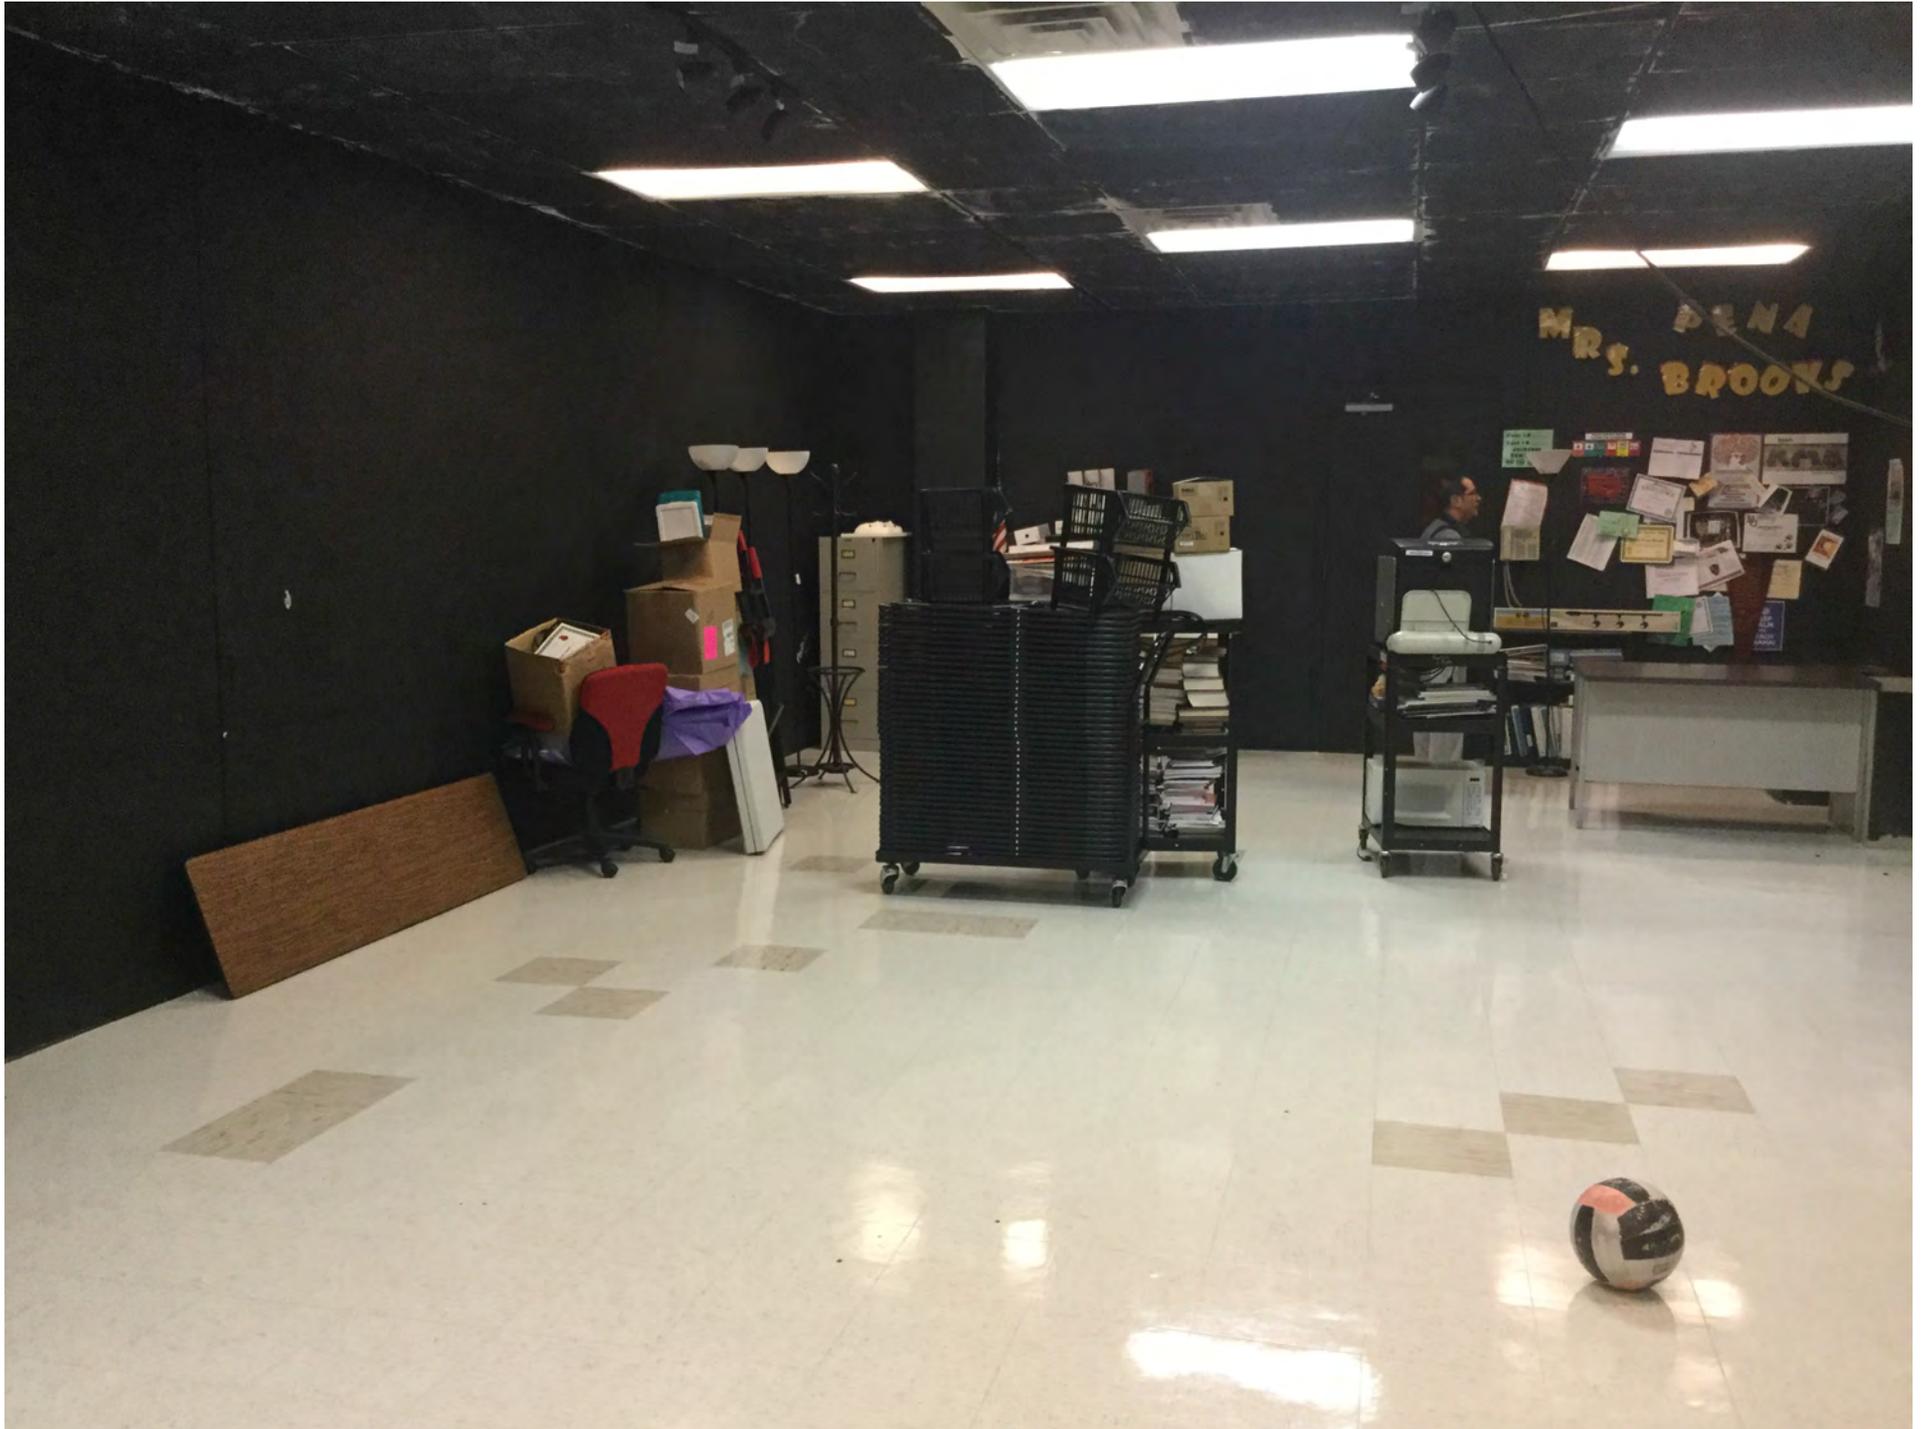
Photo 4.
3.8 Black Box Theater

3.8	Are music, drama, or performance spaces appropriately configured per the ed spec?			3				Comments	1.00 3.00
1) Very unsatisfactory 2) Unsatisfactory 3) Average 4) Good 5) Very good N/A) Does not apply.		The choir room is small. The black box theater is just a standard classroom with walls painted black. The orchestra room is too small and is not flexible with permanent risers.							
		see photo 4

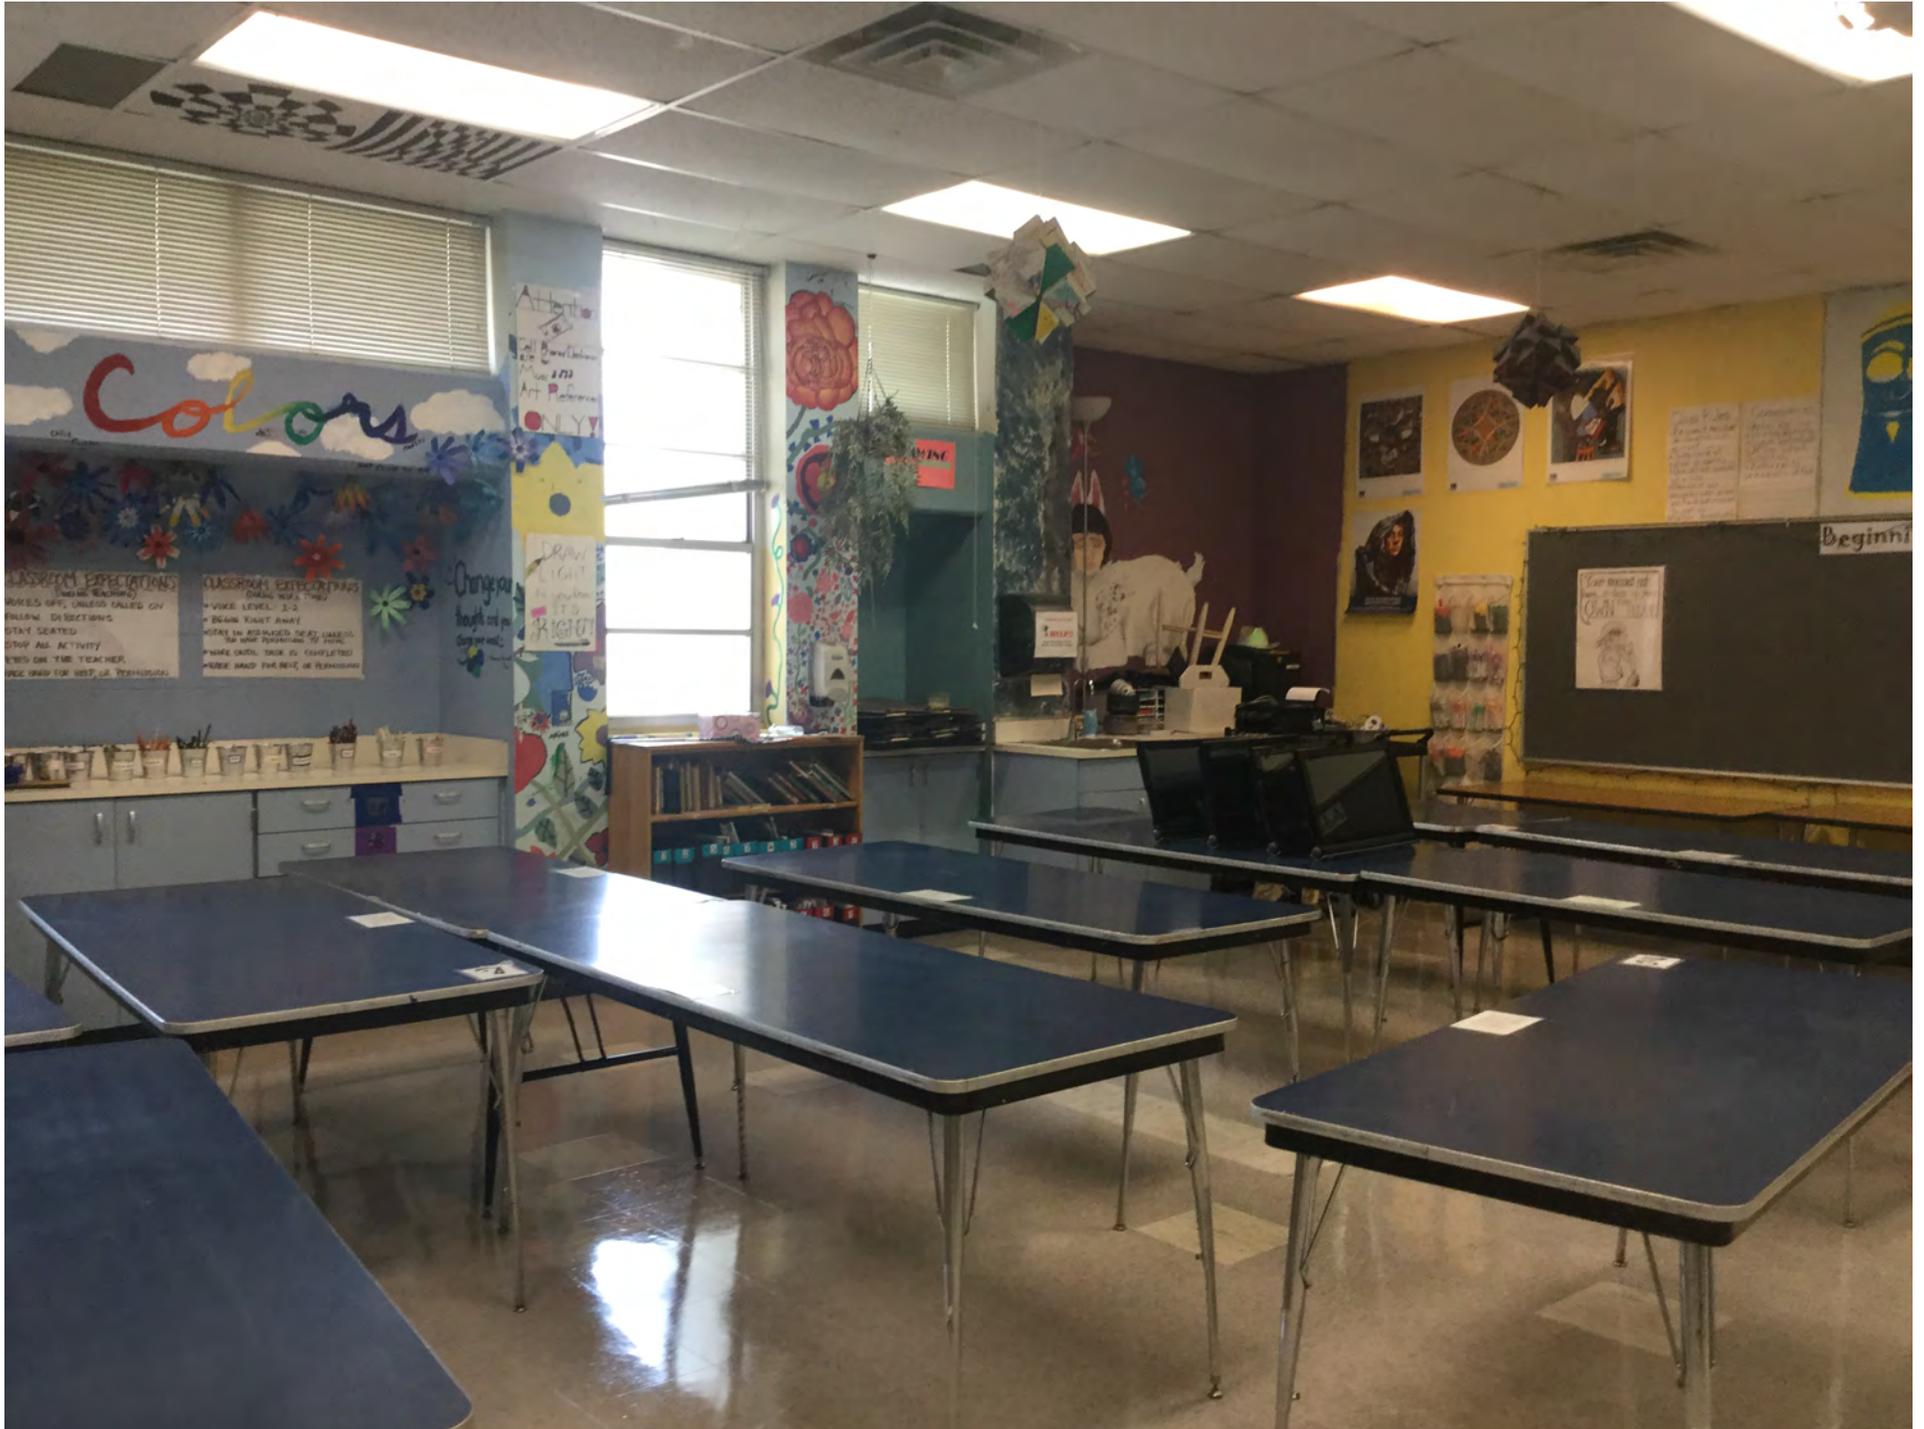
Photo 5.
3.10 Art Room

1) Very unsatisfactory 2) Unsatisfactory 3) Average 4) Good 5) Very good N/A) Does not apply.								The art room space is moderately sized with available technology, but is missing necessary equipment such as sinks and storage.			see photo 5

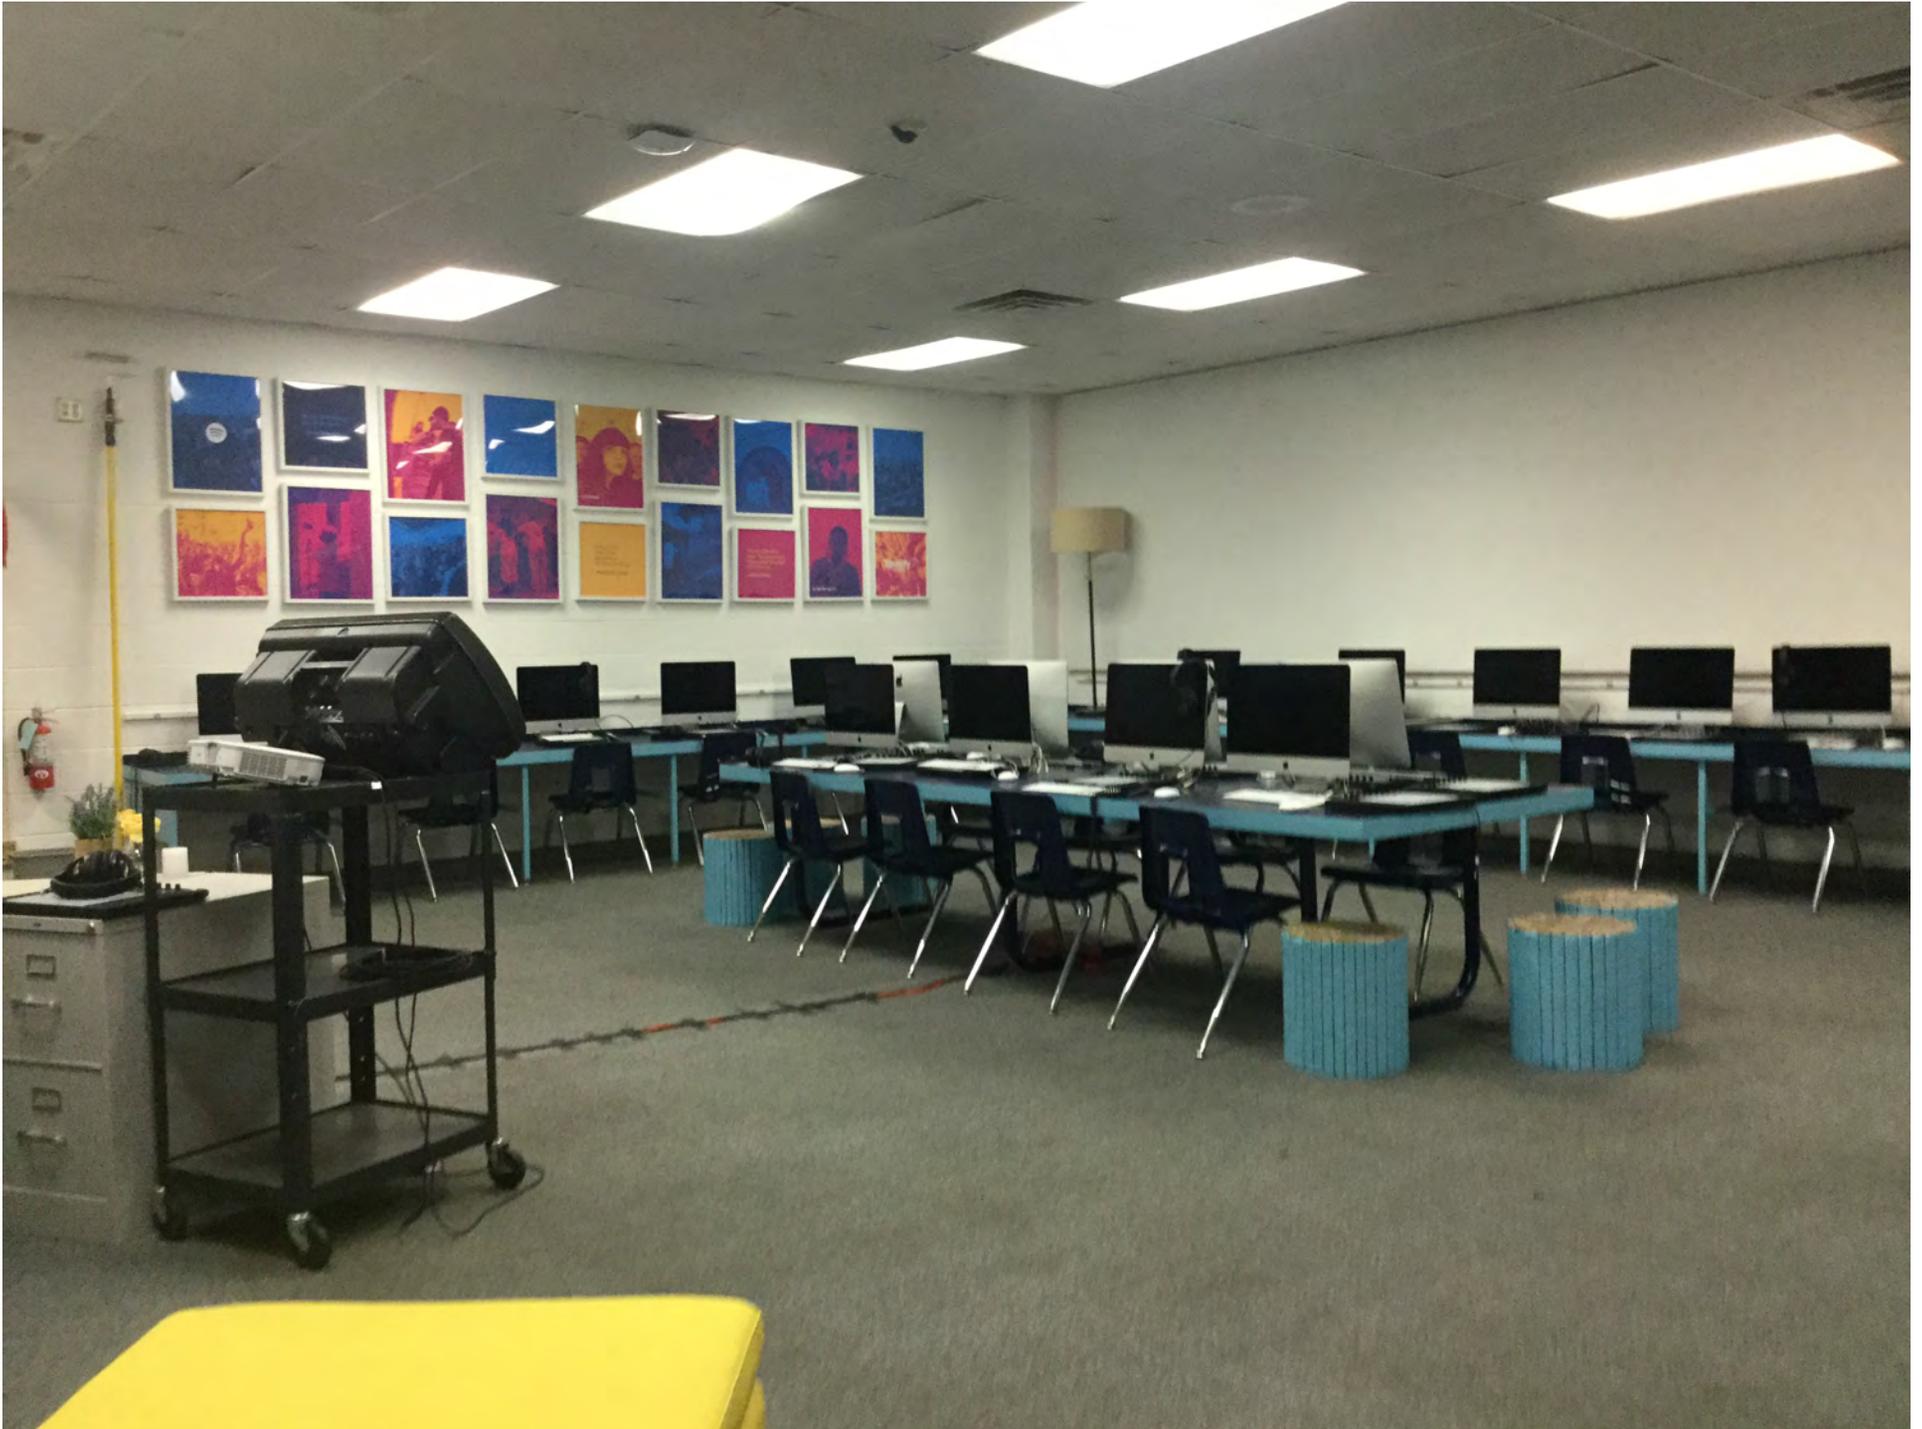
Photo 6.
3.13 Computer Lab

3.13	Are computer lab support spaces appropriately configured?				4				Comments	1.00	4.00
1) Very unsatisfactory - Support spaces are disconnected from served spaces, too small, do not meet needs 2) Unsatisfactory - Support spaces are connected, but too small, inadequate for needs 3) Average - Connected, moderate size, but need some renovations or updates to function well 4) Good - Connected, good size/layout, meets needs/functions well 5) Very good - connected, generous size, nice condition, functions appropriately N/A) Does not apply.											see photo 6

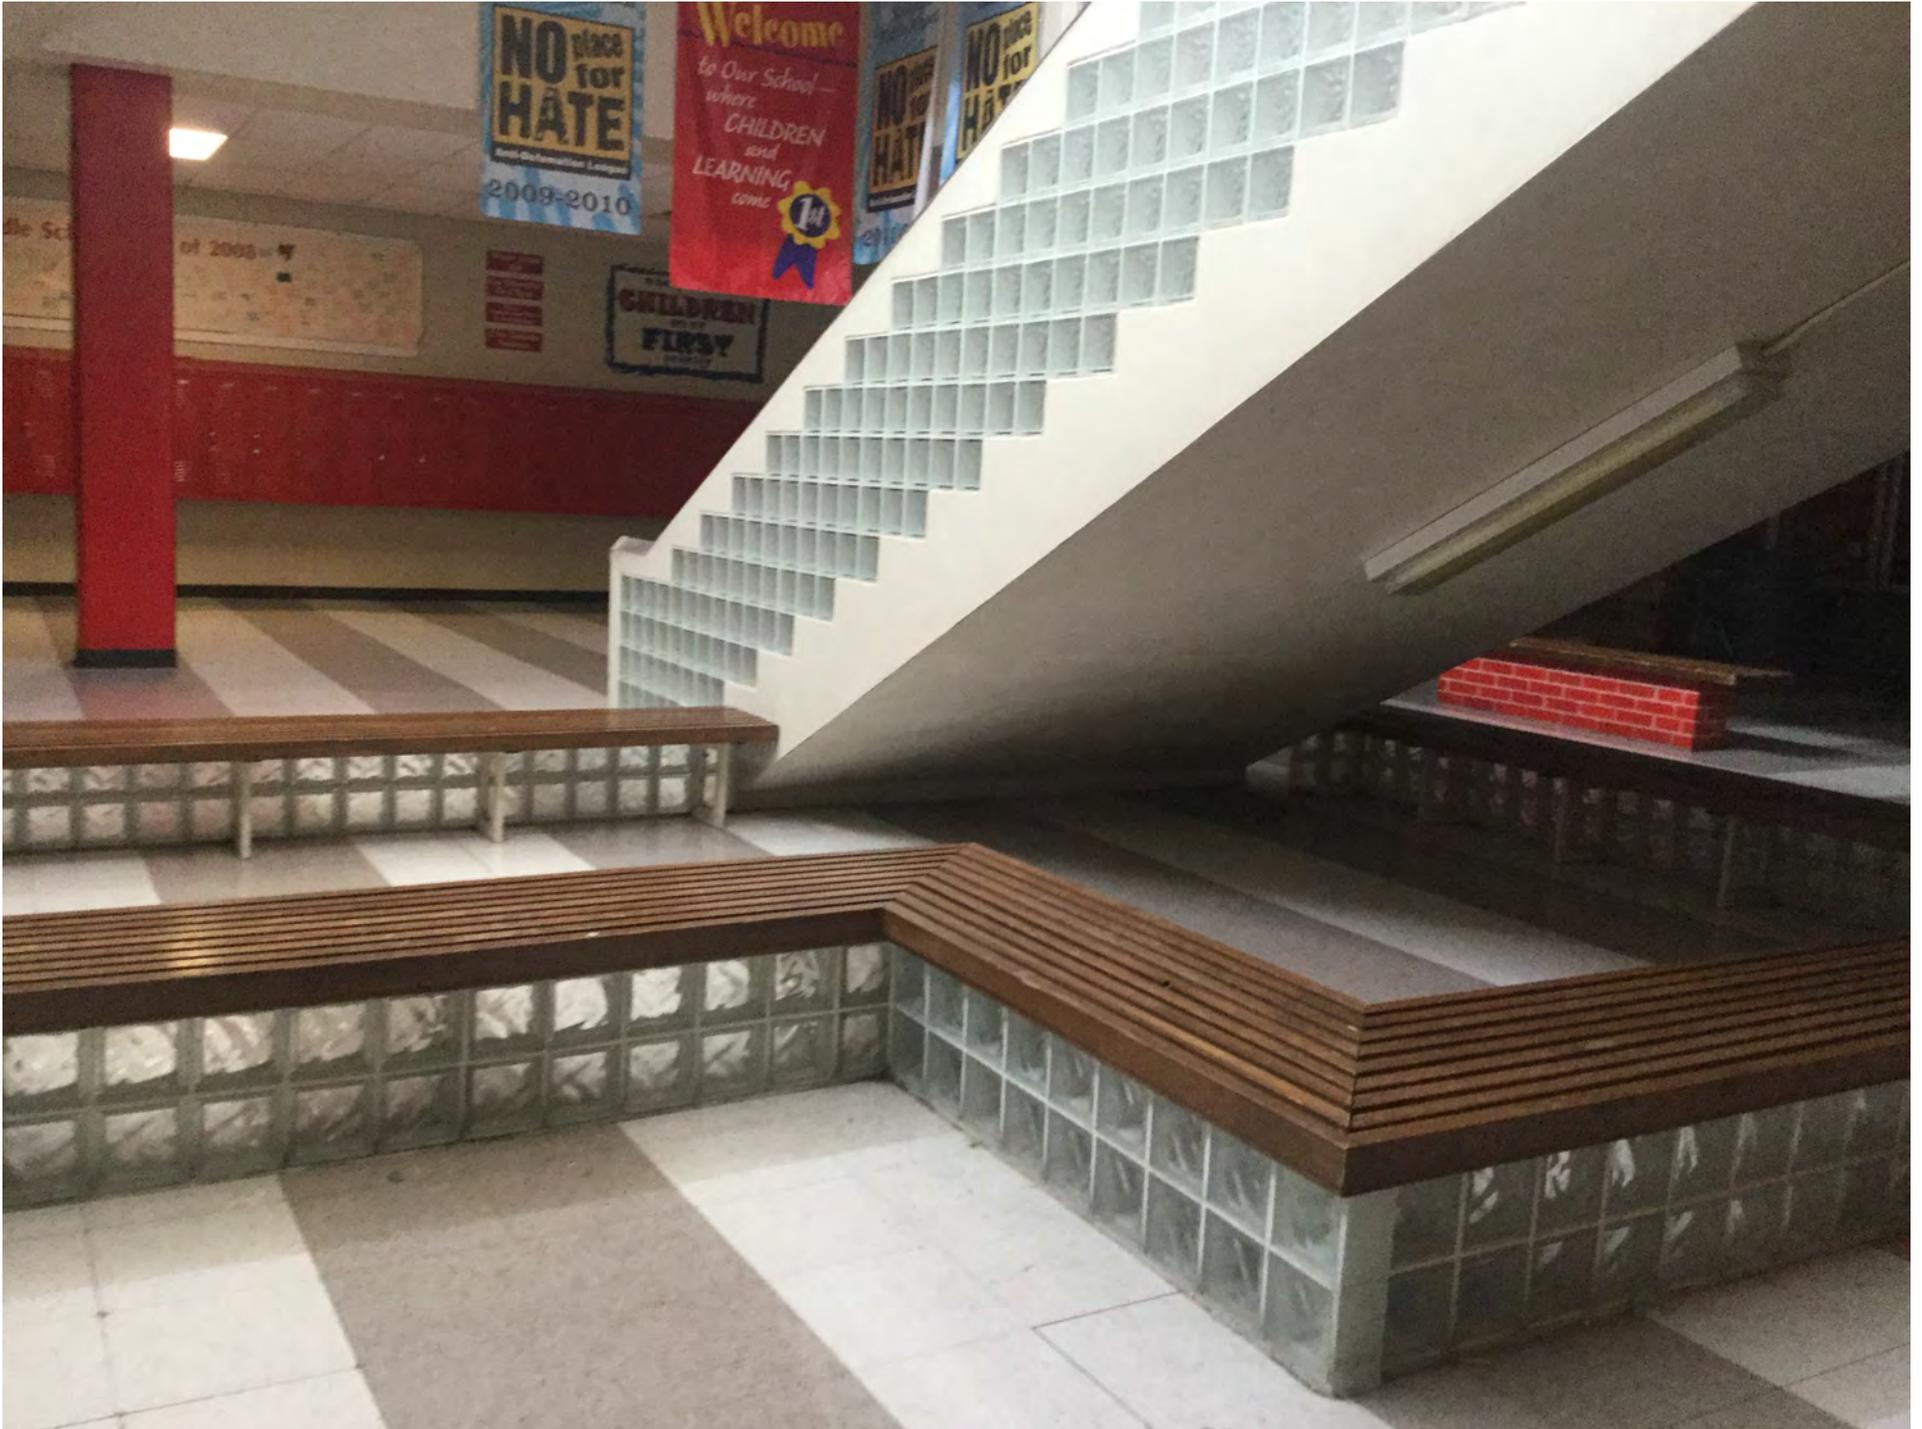
Photo 8.
4.6 Informal Interaction

4.6	Does the building provide opportunities for informal interaction?				4			Comments	1.00	4.00
1) Very unsatisfactory - no gathering areas or areas in very poor condition 2) Unsatisfactory - one exterior or interior common space with no seating or unsatisfactory condition 3) Average - one exterior or interior common space with seating needing updates 4) Good - 2 exterior or interior common spaces with appropriate seating/good condition 5) Very good - multiple exterior and interior commons spaces with appropriate seating in excellent condition N/A) Does not apply.										
		see photo 8

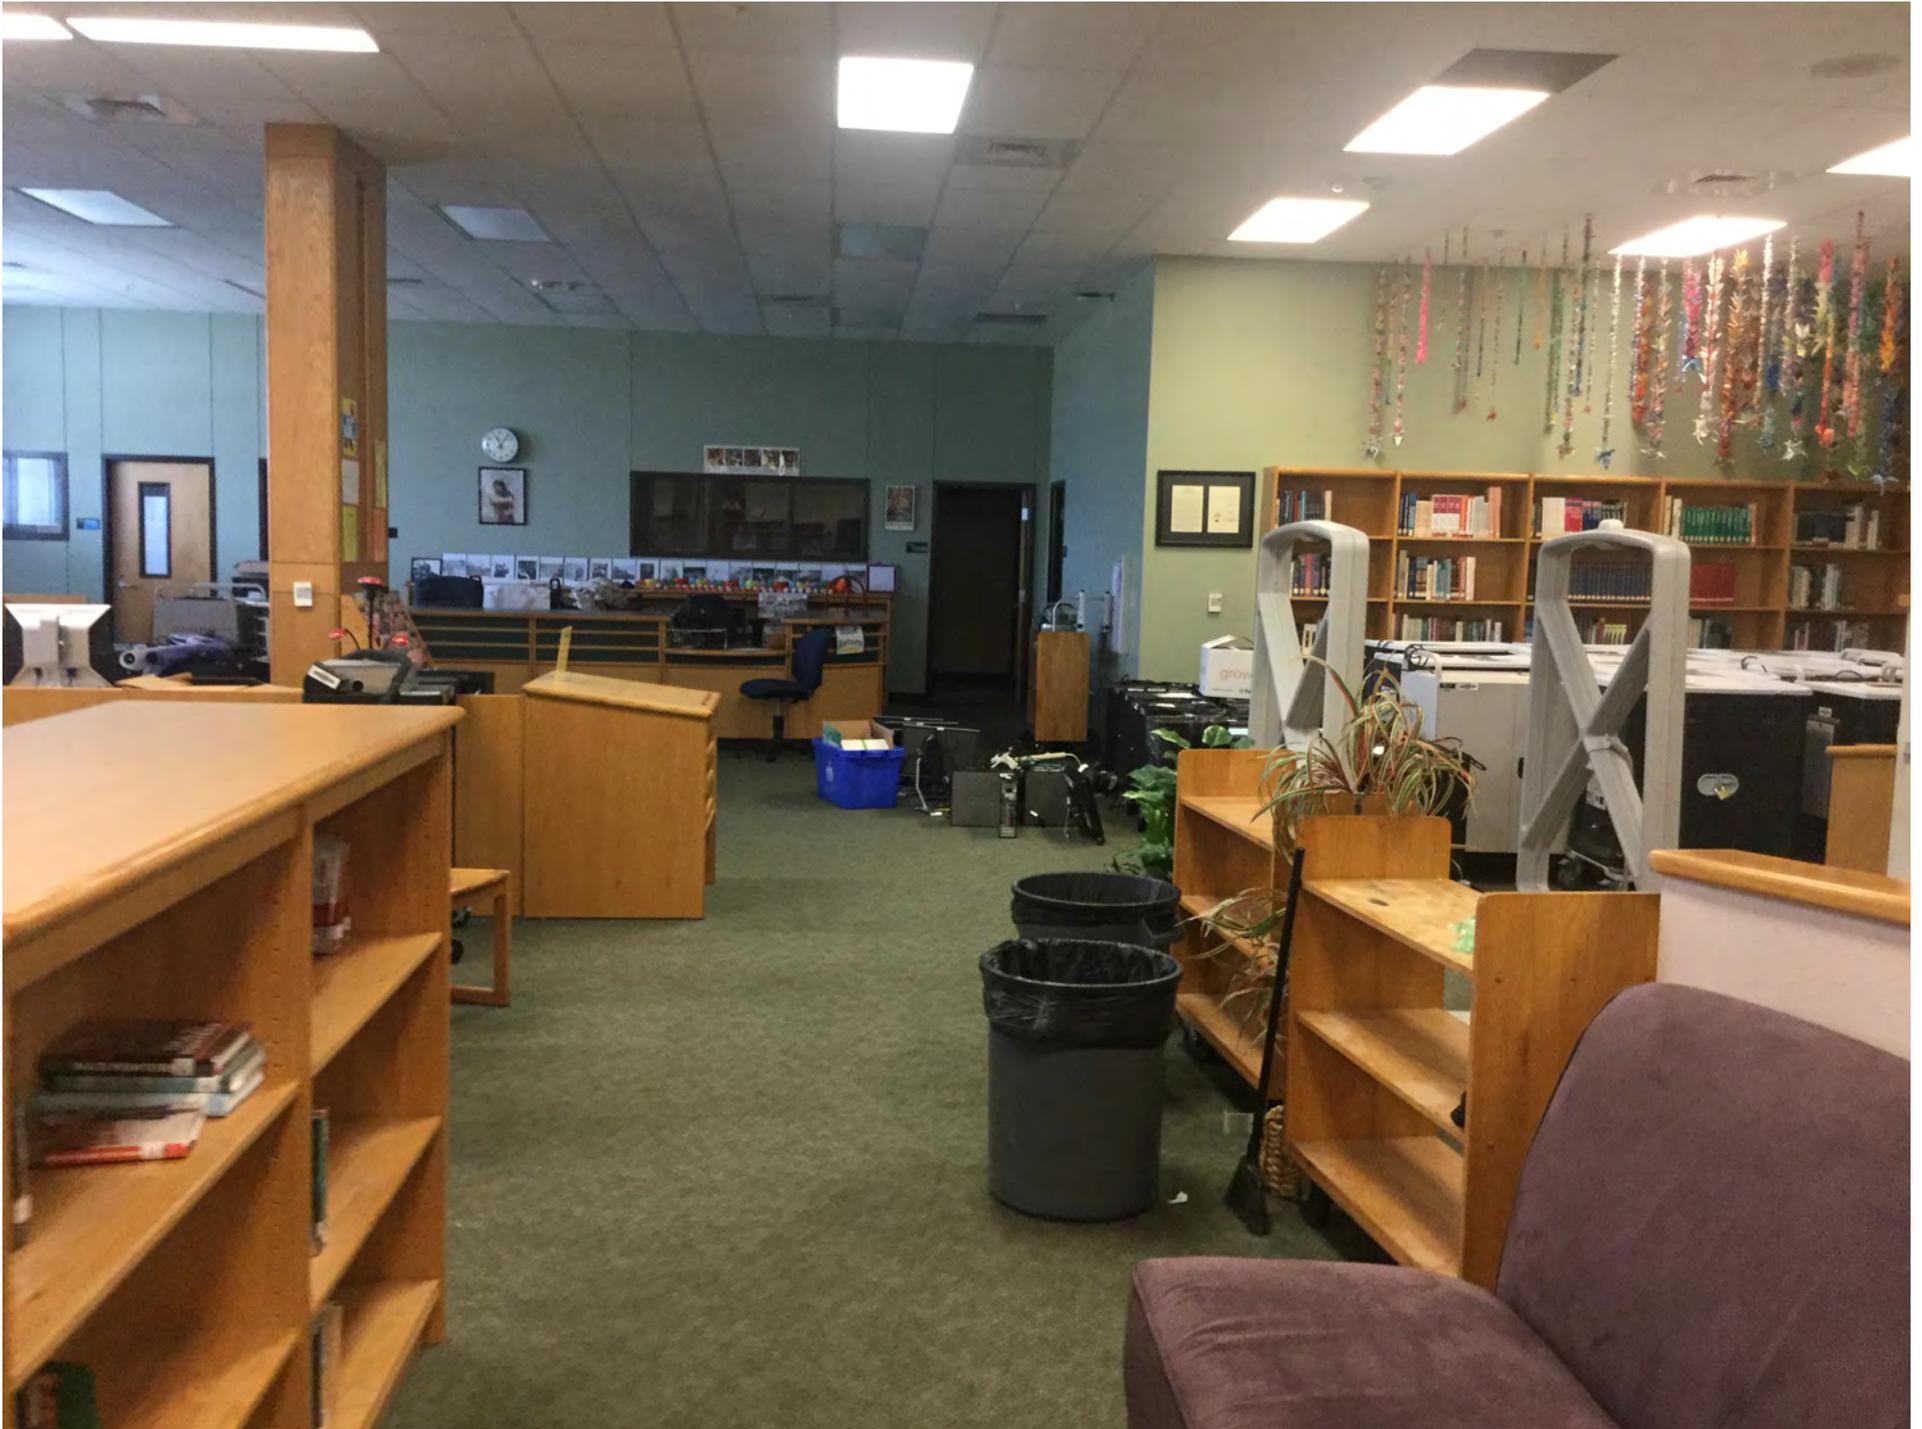
Photo 9.
5.3 Library

5.3	How well does the Library/Media Center support social interaction?				4			Comments	1.00	4.00
1) Very unsatisfactory 2) Unsatisfactory 3) Average 4) Good 5) Very good N/A) Does not apply.		The library is spacious with plenty of seating, but there is no specialized area for social interaction.								
		see photo 9
