## Educational Suitability Summary Report

Martin Middle School

Date: 08/15/2016

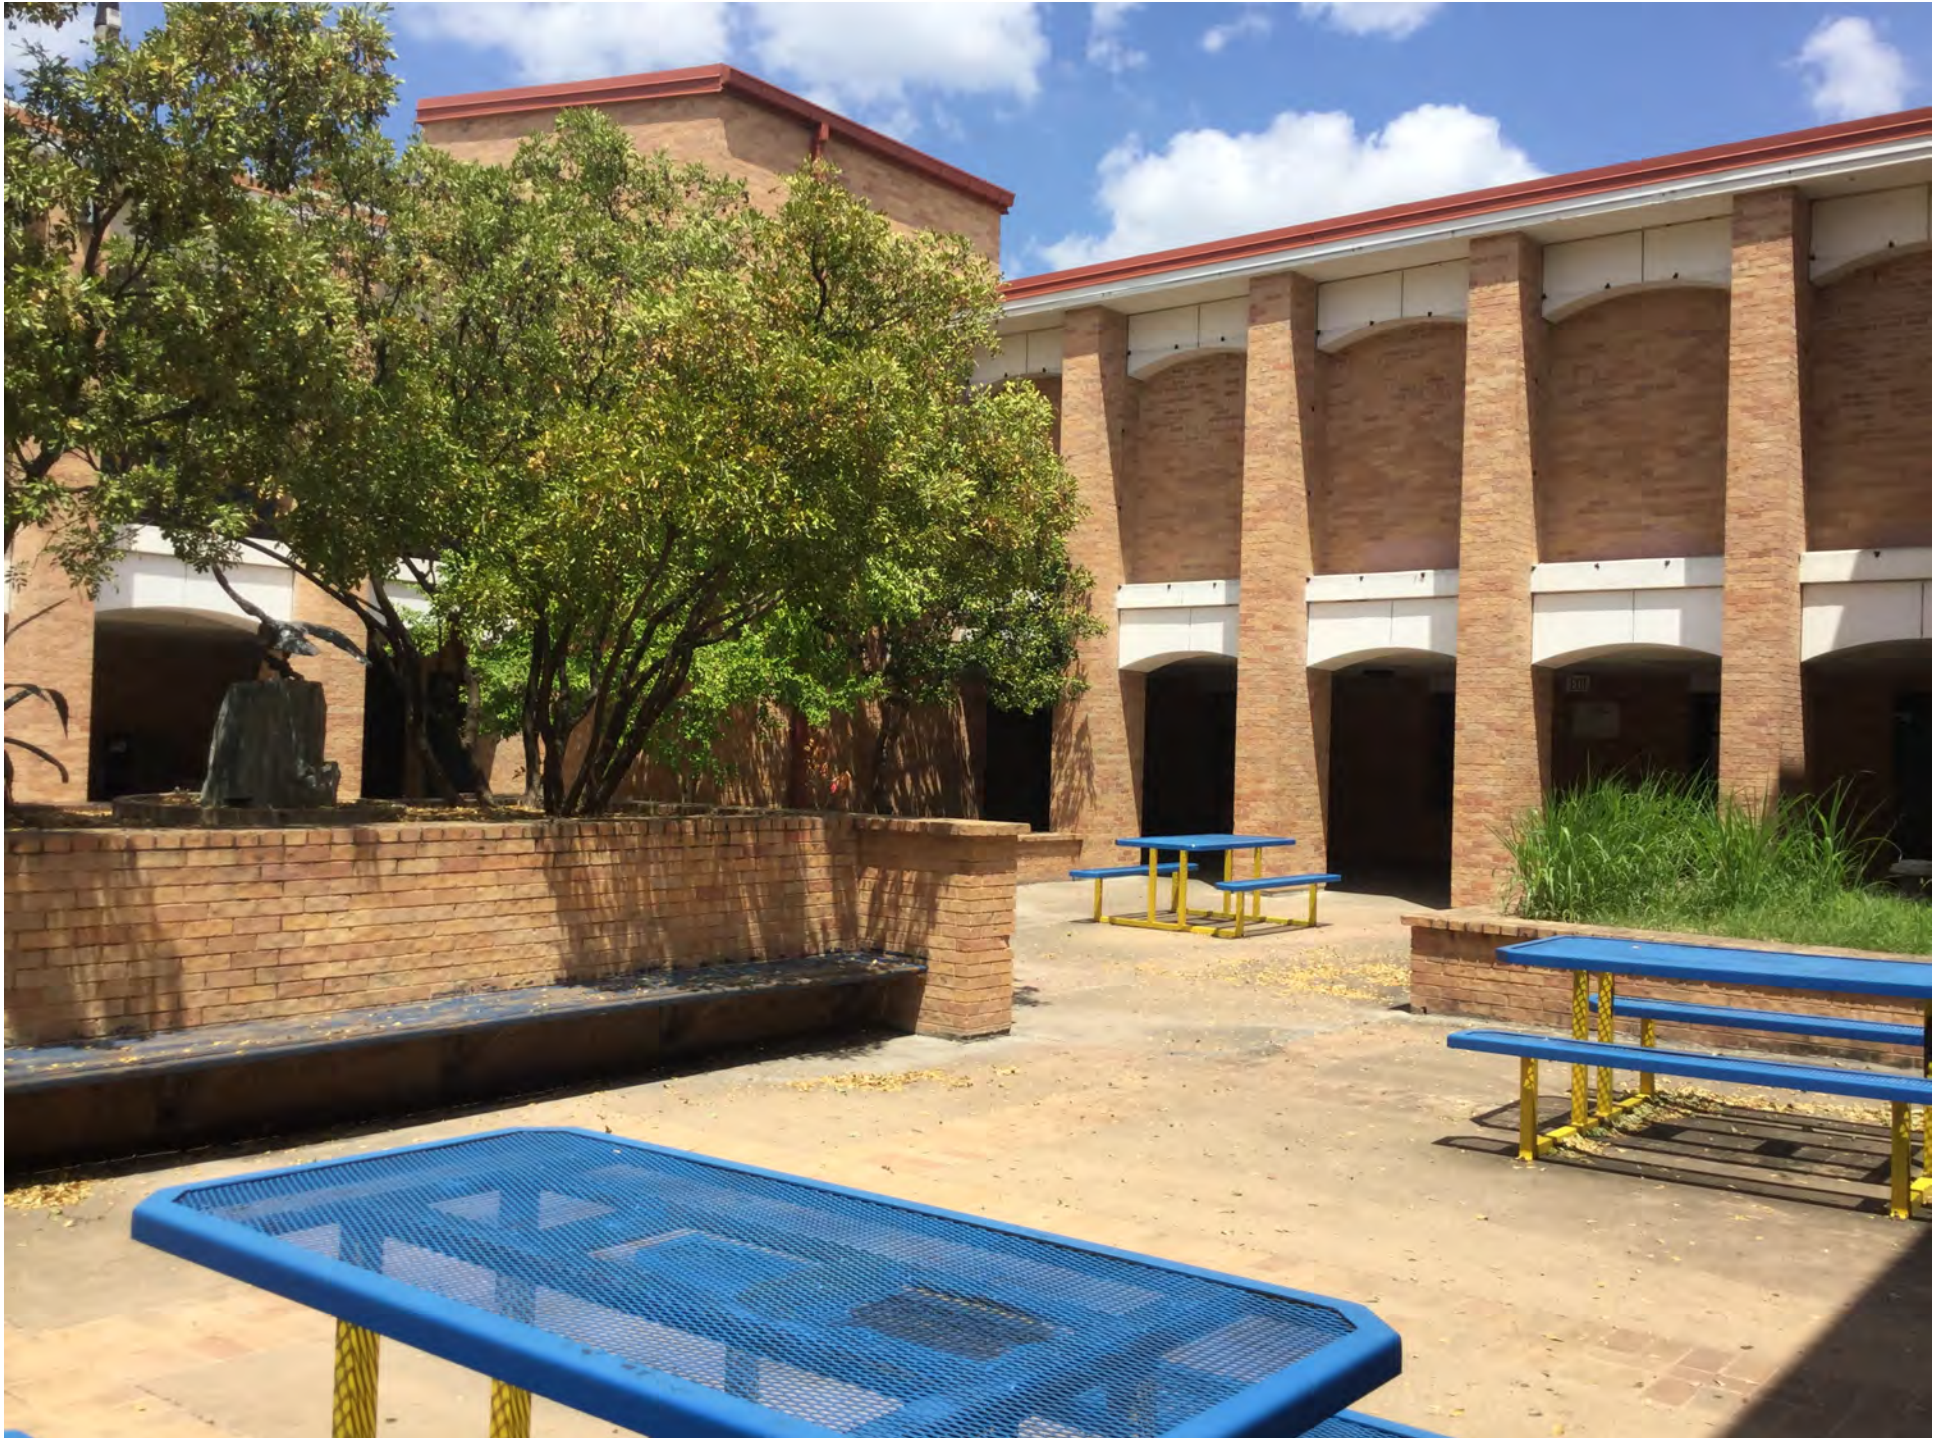
Photo 1. Courtyard

4.6	Does the building provide opportunities for informal interaction?			3				Comments	1.00 3.00
1) Very unsatisfactory - no gathering areas or areas in very poor condition 2) Unsatisfactory - one exterior or interior common space with no seating or unsatisfactory condition 3) Average - one exterior or interior common space with seating needing updates 4) Good - 2 exterior or interior common spaces with appropriate seating/good condition 5) Very good - multiple exterior and interior commons spaces with appropriate seating in excellent condition N/A) Does not apply.								The courtyard area is appropriate for informal interaction.

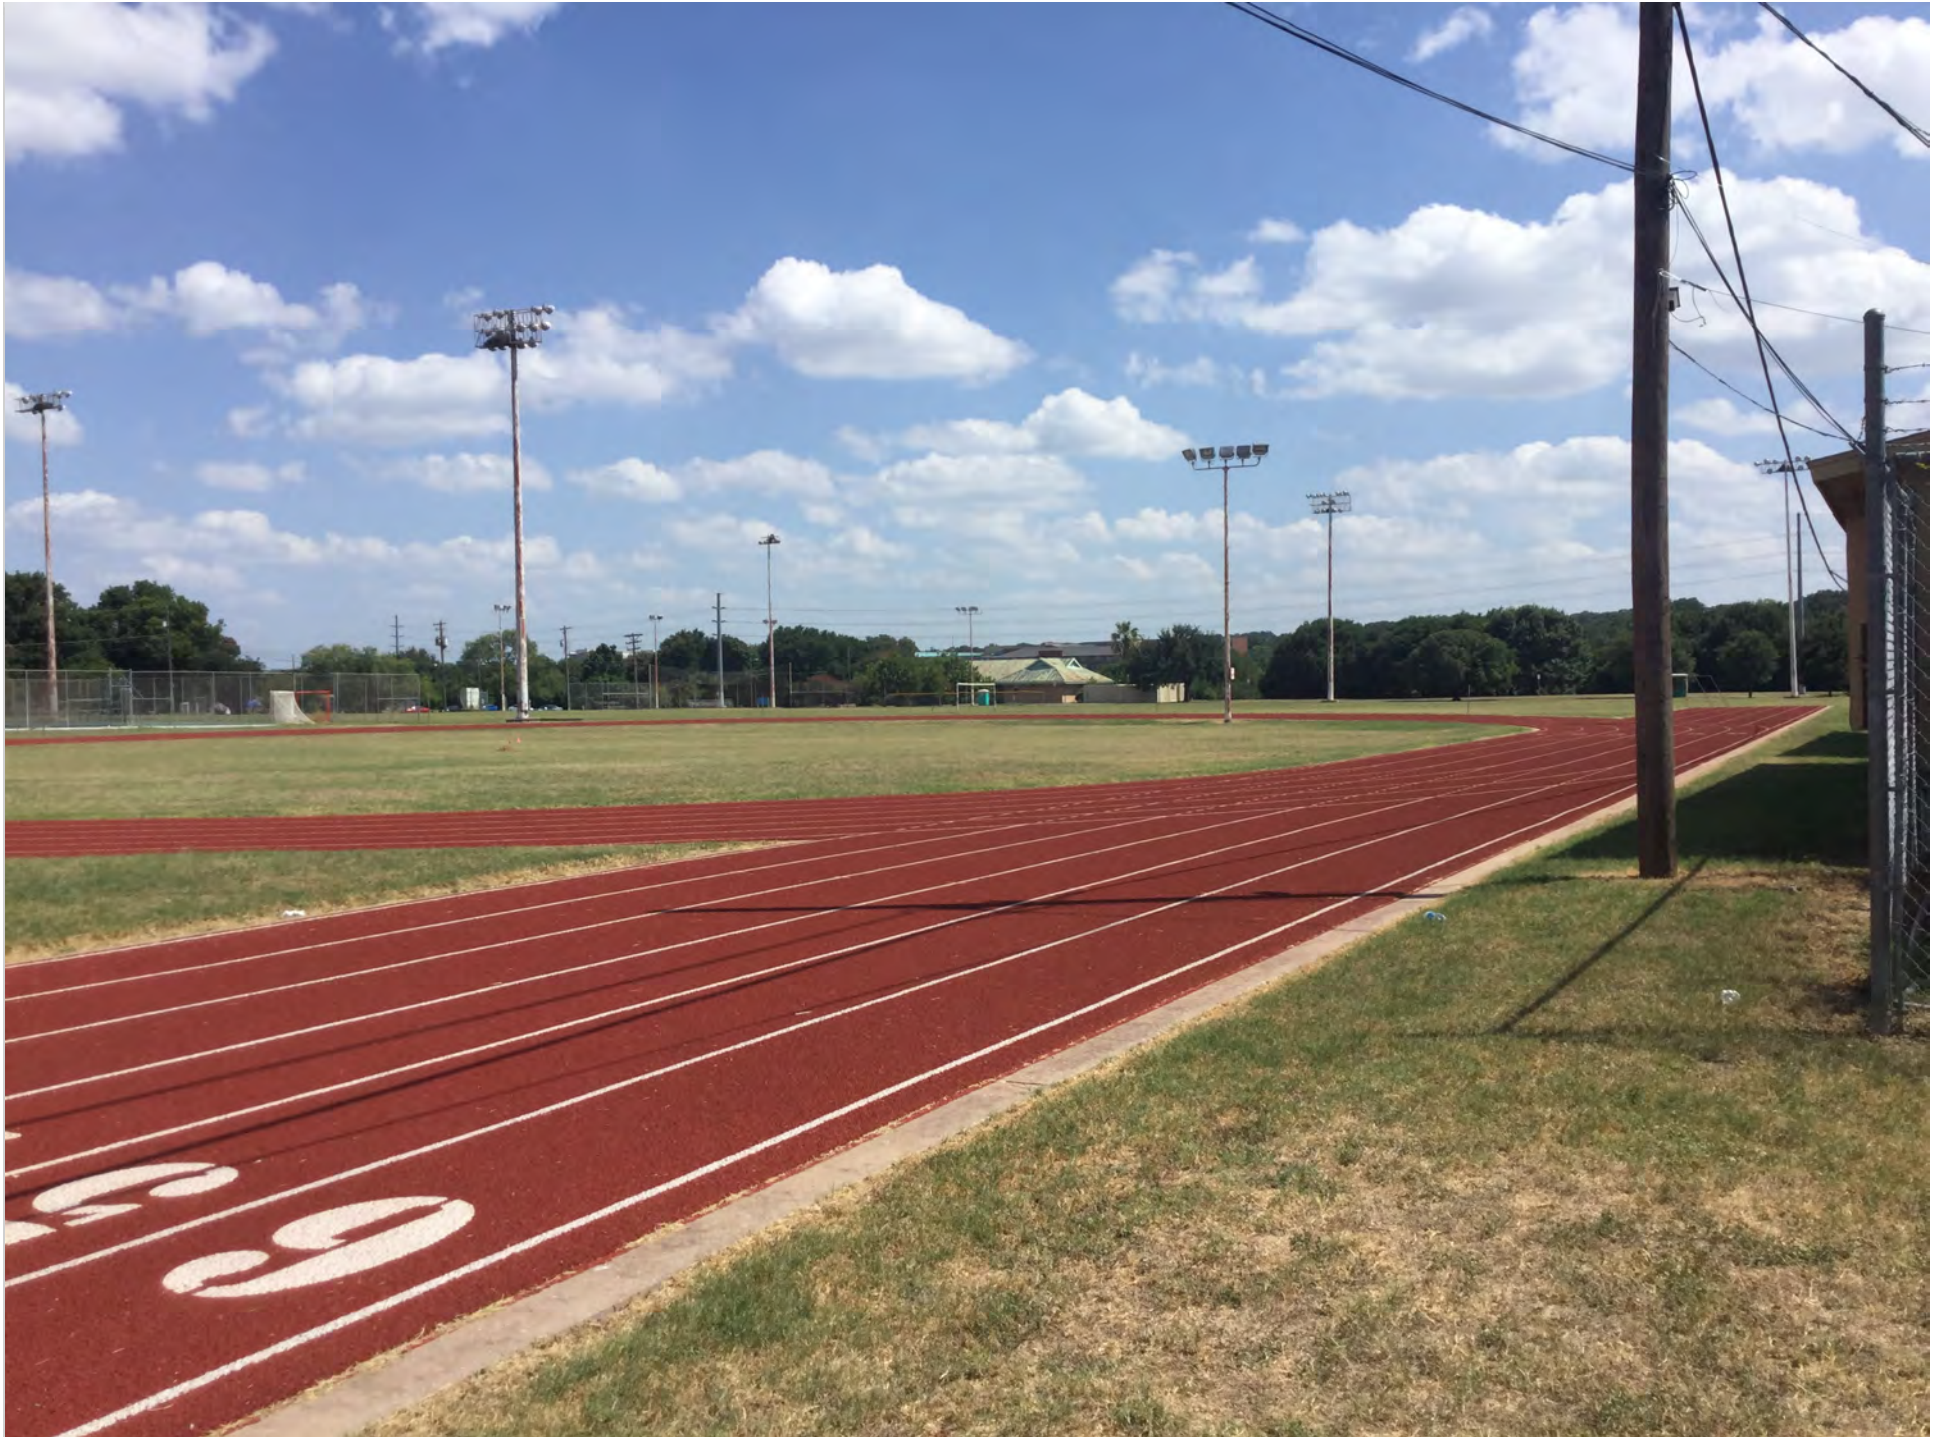
Photo 2. Track

1.3	Are outdoor play spaces and playfields adequate in size and configuration?				4			Comments	1.00 4.00
	1) Outdoor play space exists, not developed 2)Outdoor play space exists but is not connected to gym or other athletic support areas or is too small. 3. Outdoor play spaces exist, are connected to other athletic areas, are the right size, but are not in good condition. 4. Outdoor play spaces need minor improvements to function well. 5. Outdoor play spaces are in excellent condition. N/A) Does not apply.

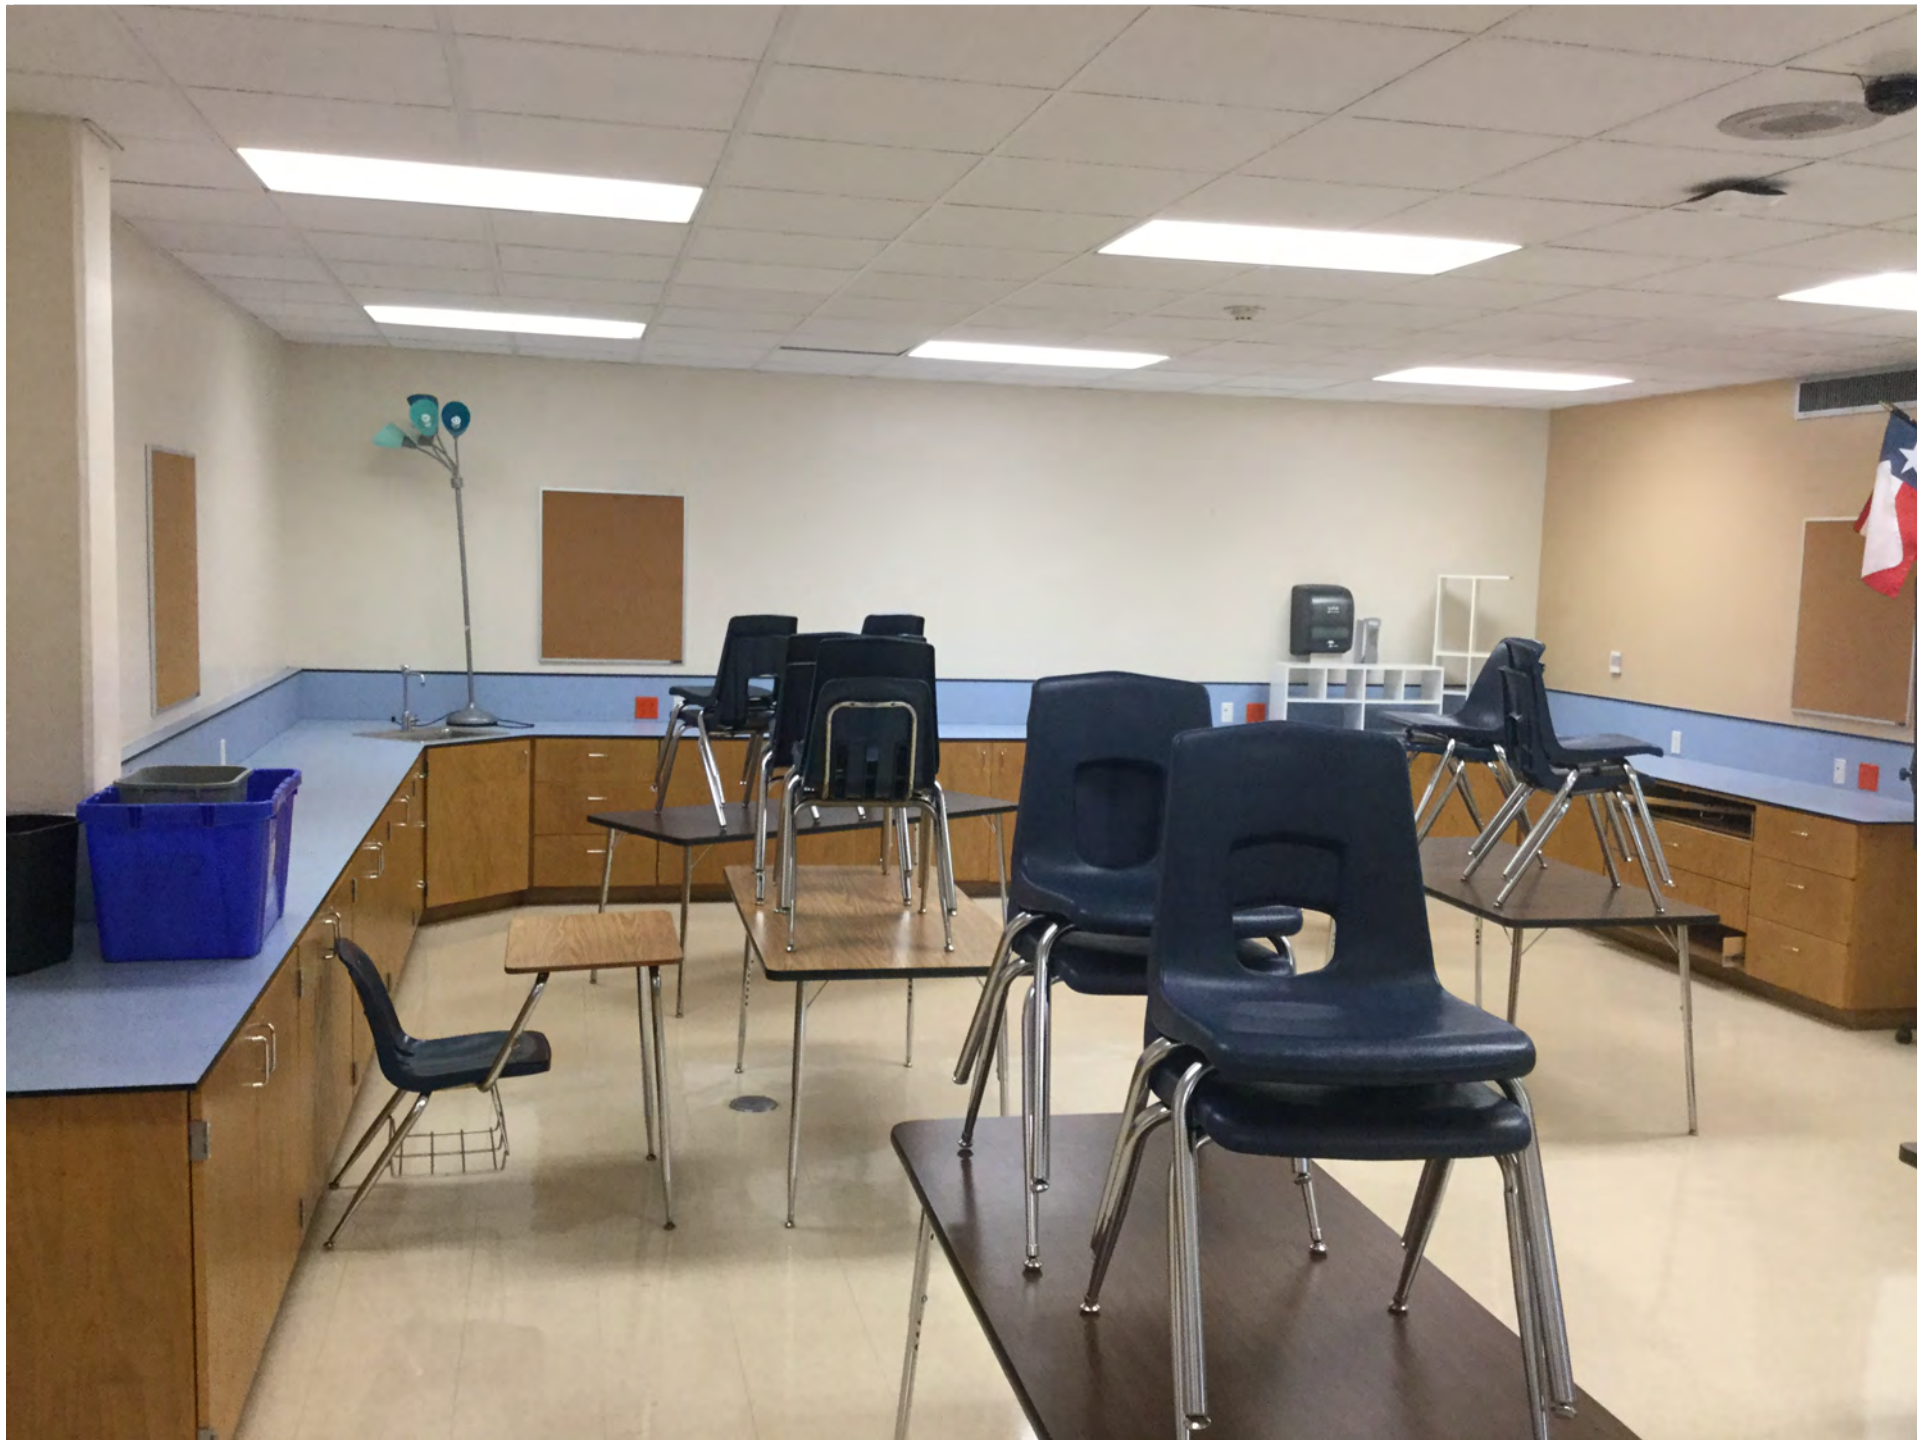
Photo 3. Science

3.4	Are Science Classrooms/Labs appropriately configured per the ed spec?	1						Comments	1.00 1.00
	1) Very unsatisfactory 2) Unsatisfactory 3) Neutral 4) Satisfactory 5) Very Satisfactory N/A) Does not apply. (Elementary schools)							The furniture and casework is inadequate and inappropriate for the needs of the lab. The sinks are not accessible. The space is not large enough or flexible.

3.5	Are Science Classrooms/Labs <b>support</b> areas appropriately configured per the ed spec?	1						Comments	1.00 1.00
	1) Very unsatisfactory - Support spaces are disconnected from served spaces, too small, do not meet needs 2) Unsatisfactory - Support spaces are connected, but too small, do not meet needs 3) Average - Connected, moderate size, but need some renovations or updates 4) Good - Connected, good size, meets needs, functions well 5) Very good - connected, generous size, nice condition, functions appropriately N/A) Does not apply. (Elementary schools)							The storage is inadequate and there is a lack of equipment. There is no proper venting.

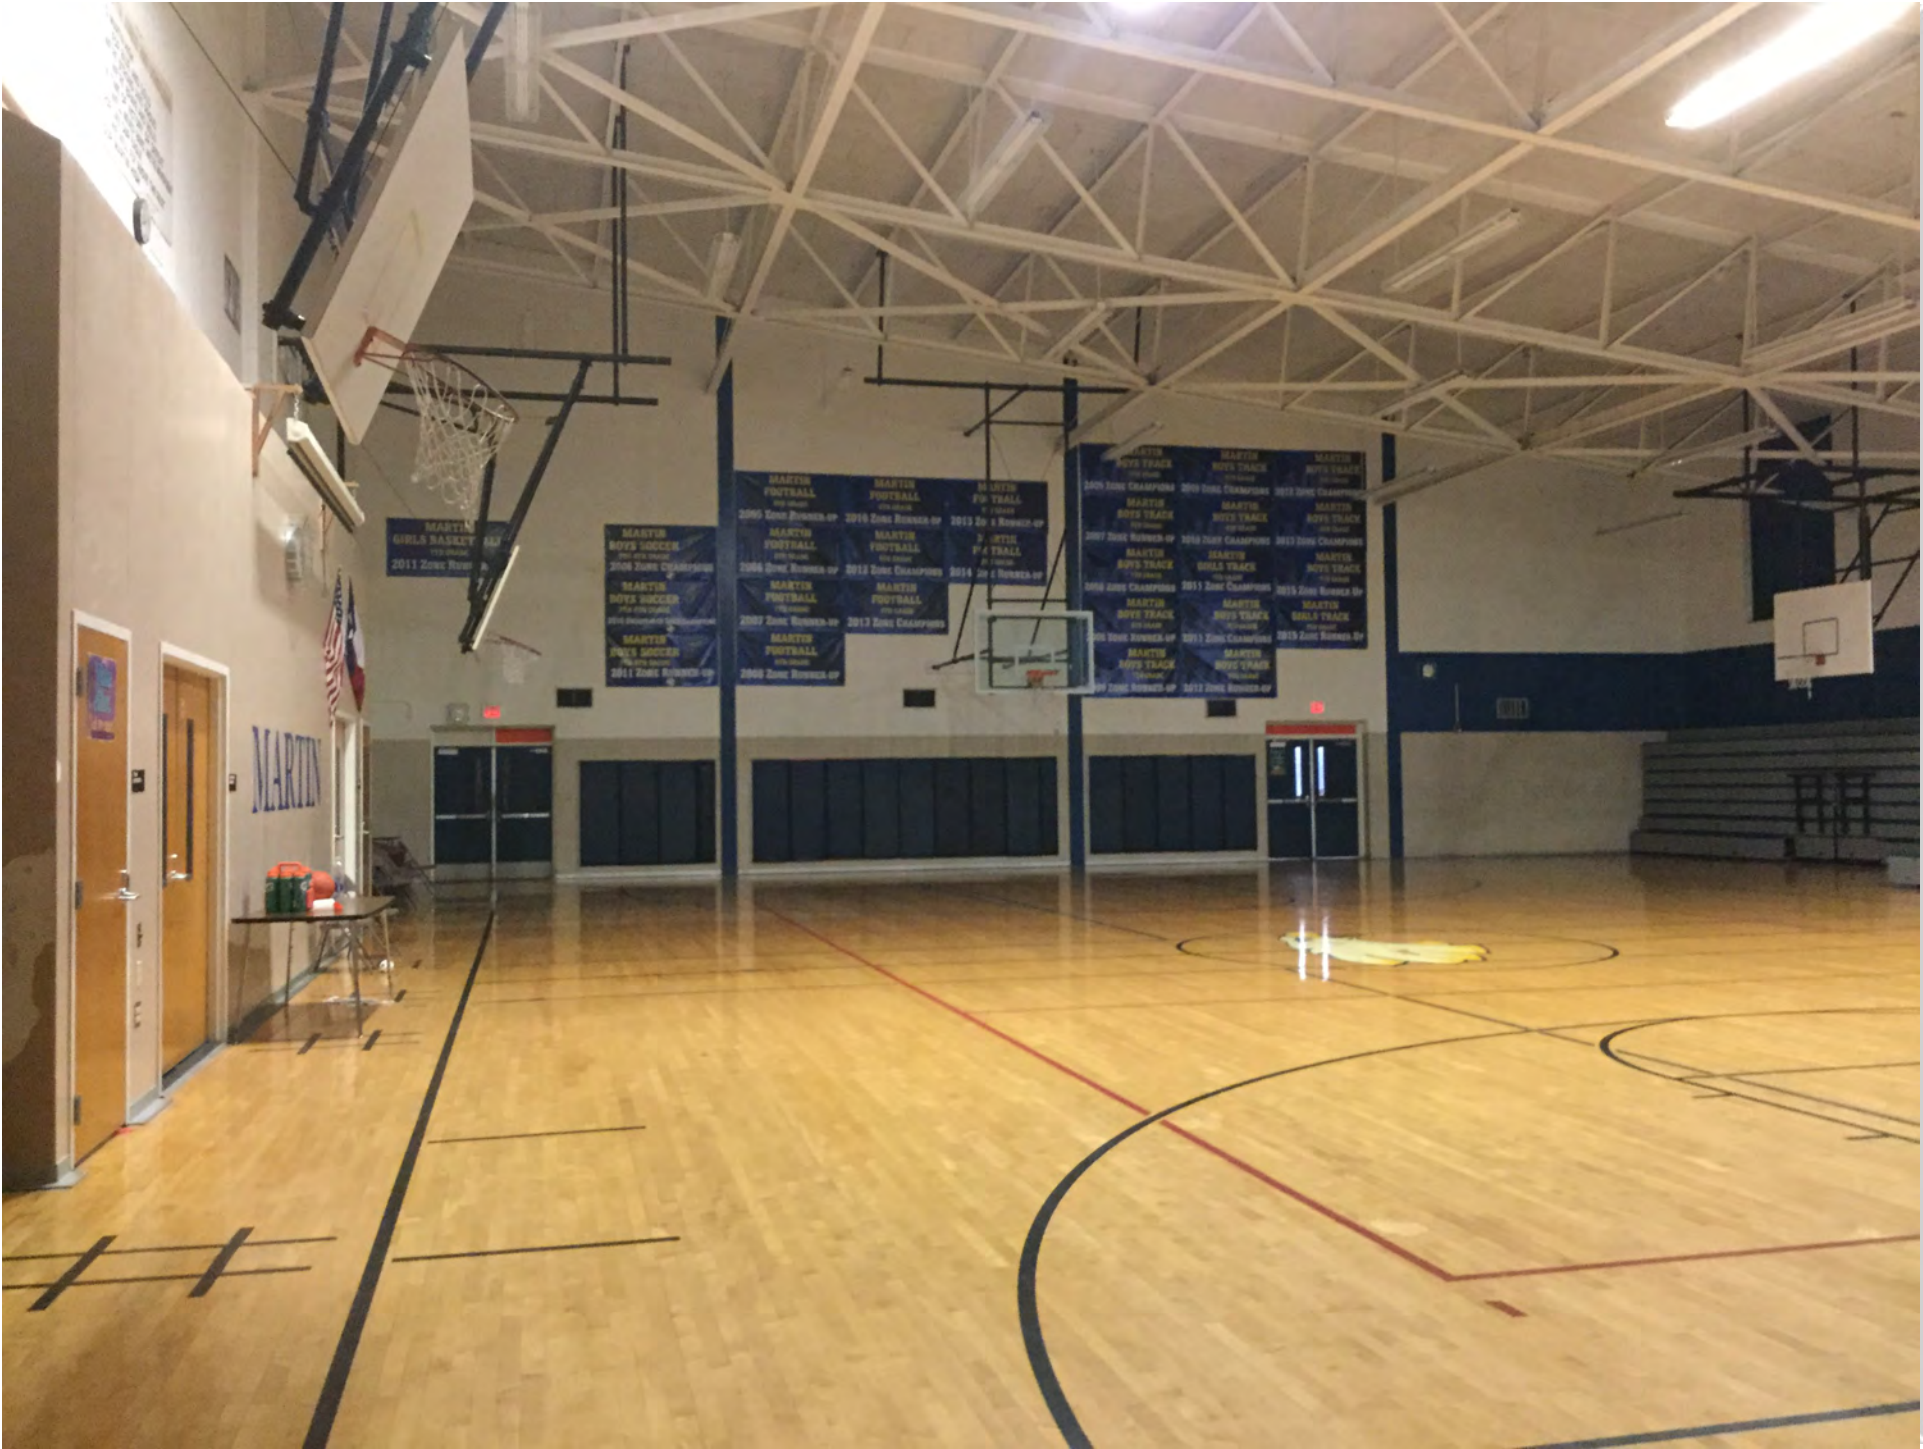
Photo 4. Gym

1) Very unsatisfactory - Support spaces are disconnected from served spaces, too small, do not meet needs 2) Unsatisfactory - Support spaces are connected, but too small, inadequate for needs 3) Average - Connected, moderate size, but need some renovations or updates to function well 4) Good - Connected, good size/layout, meets needs/functions well 5) Very good - connected, generous size, nice condition, functions appropriately N/A) Does not apply.								The locker rooms are in moderate condition. The weight room needs updated equipment. The bleachers are in poor condition and cause student injuries.

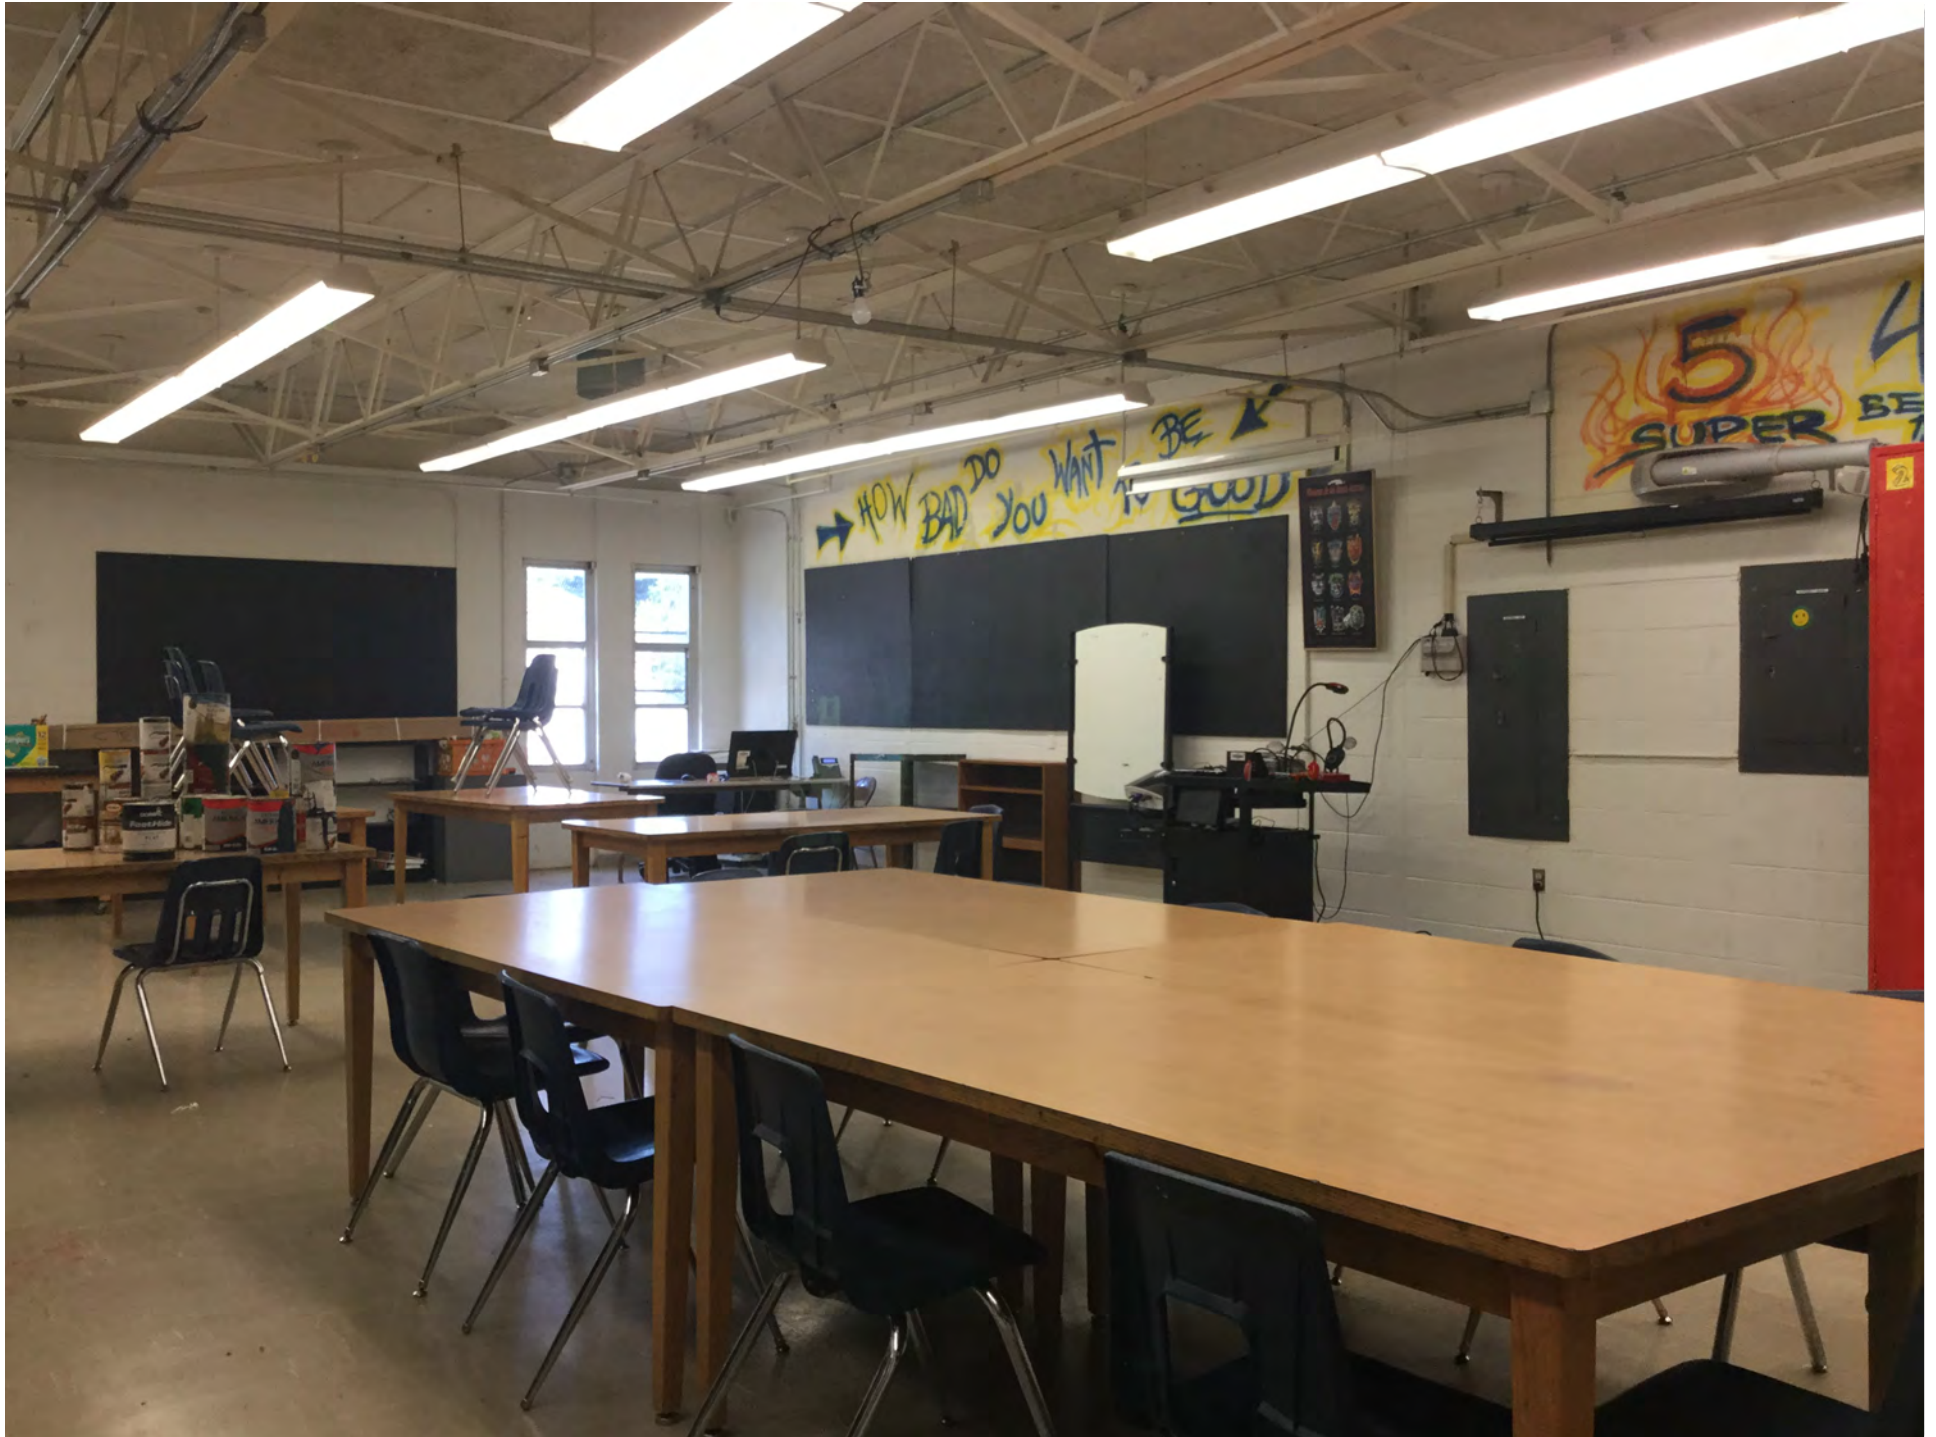
Photo 5. Art

1) Very unsatisfactory 2) Unsatisfactory 3) Average 4) Good 5) Very good N/A) Does not apply.										There is one lassroom with limited natural light. The configuration is average.

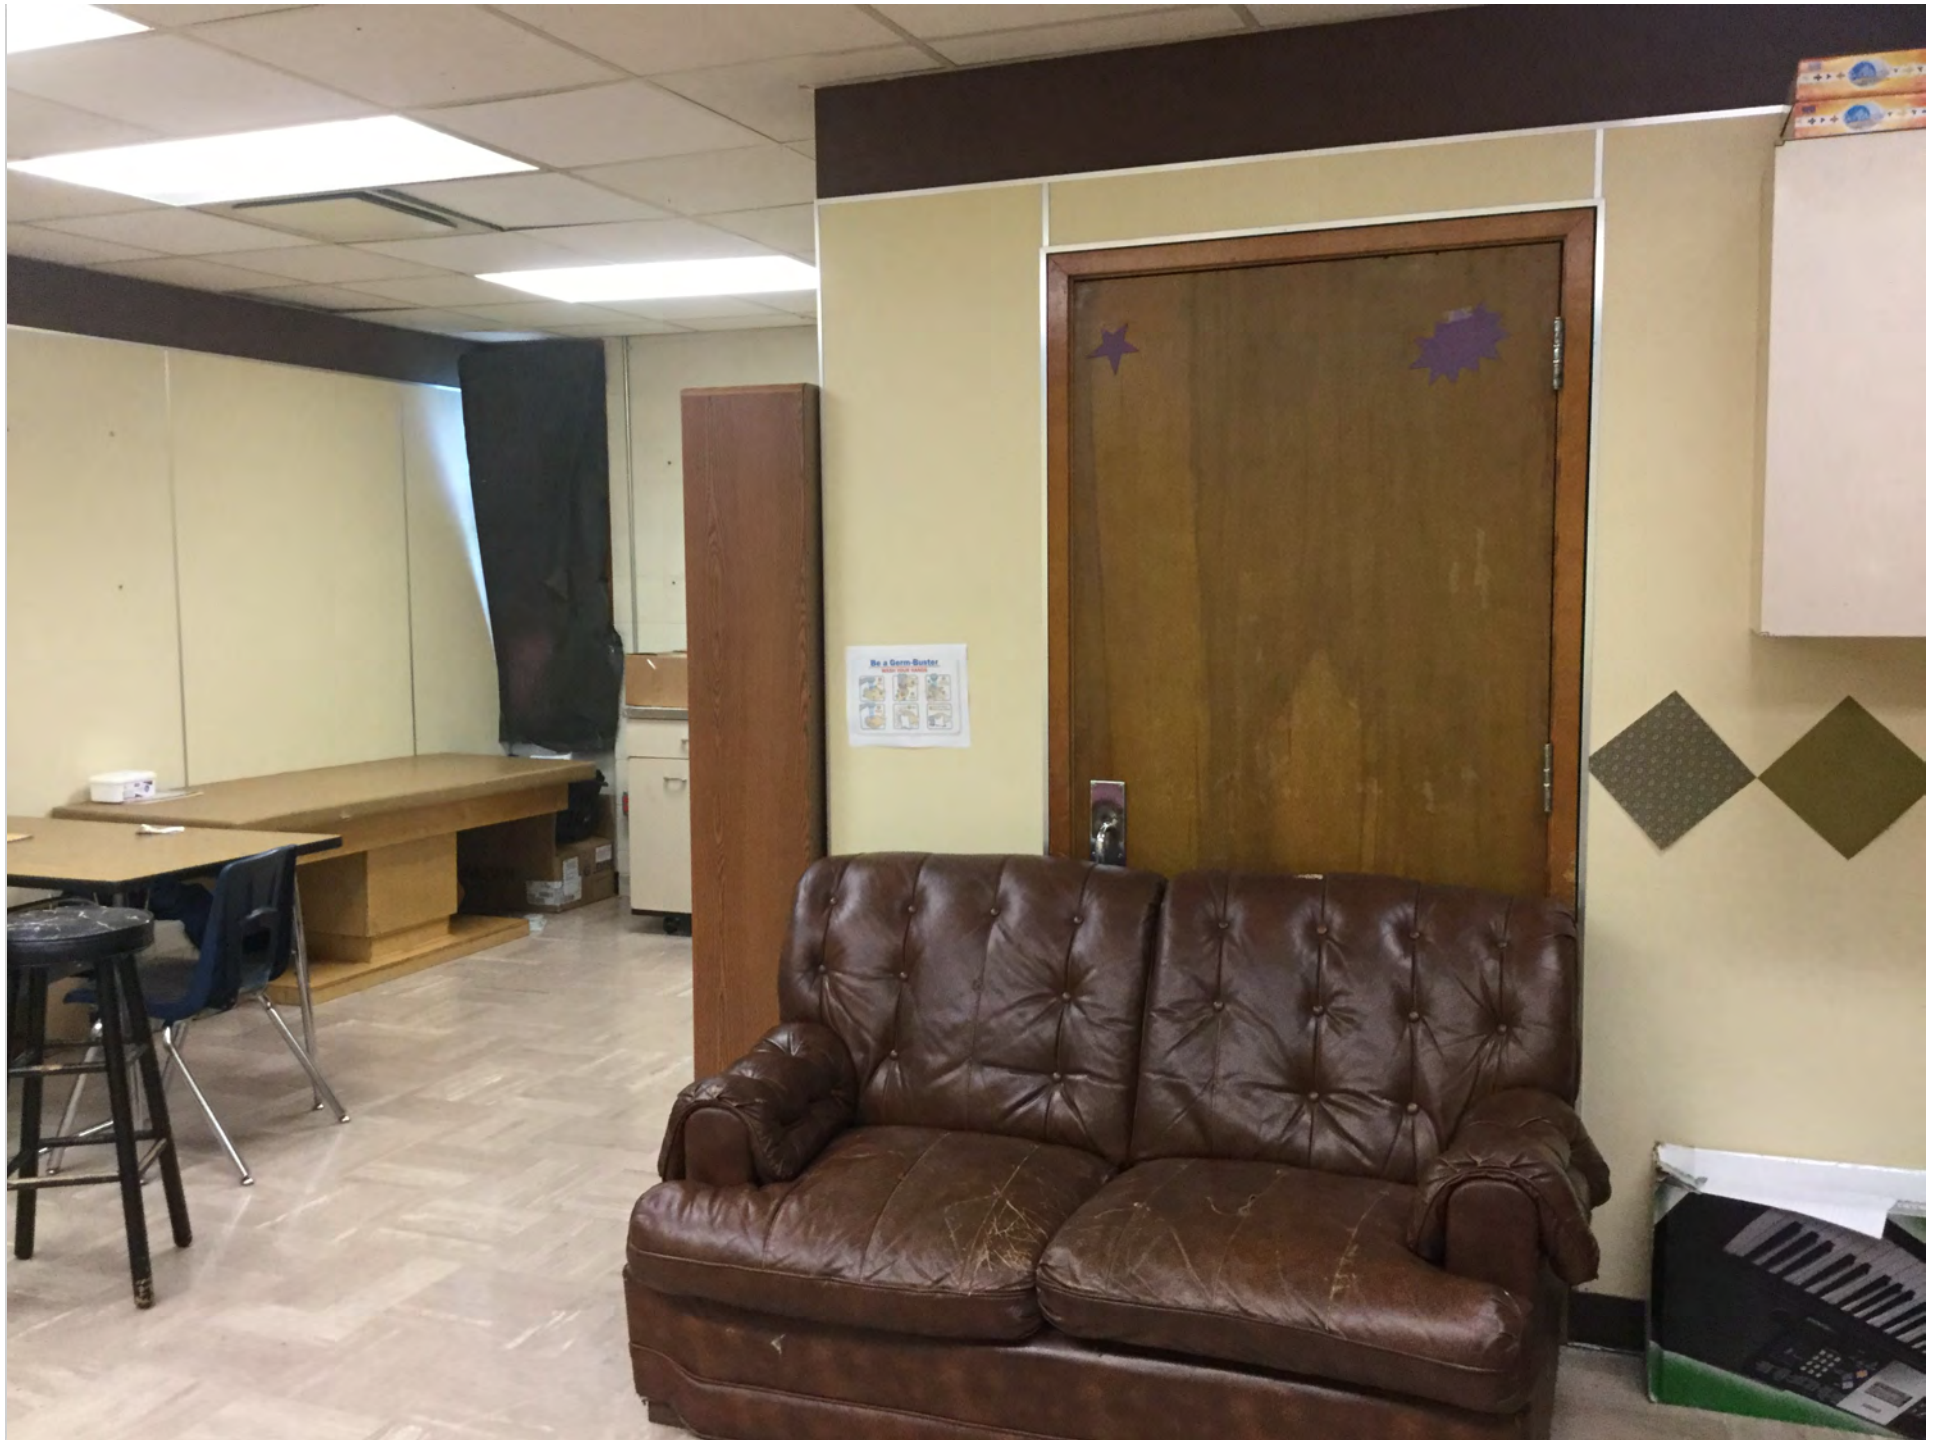
Photo 6. Special  
Education Support

3.15	Are Special Education <b>support</b> spaces appropriately configured per the ed spec?						1							Comments	1.00	1.00
1) Very unsatisfactory - Support spaces are disconnected from served spaces, too small, do not meet needs 2) Unsatisfactory - Support spaces are connected, but too small, inadequate for needs 3) Average - Connected, moderate size, but need some renovations or updates to function well 4) Good - Connected, good size/layout, meets needs/functions well 5) Very good - connected, generous size, nice condition, functions appropriately N/A) Does not apply.													The restrooms are not appropriate, and they lack the proper equipment. The furniture is in poor, damaged condition. The changing area for one room is within the classroom without appropriate privacy.

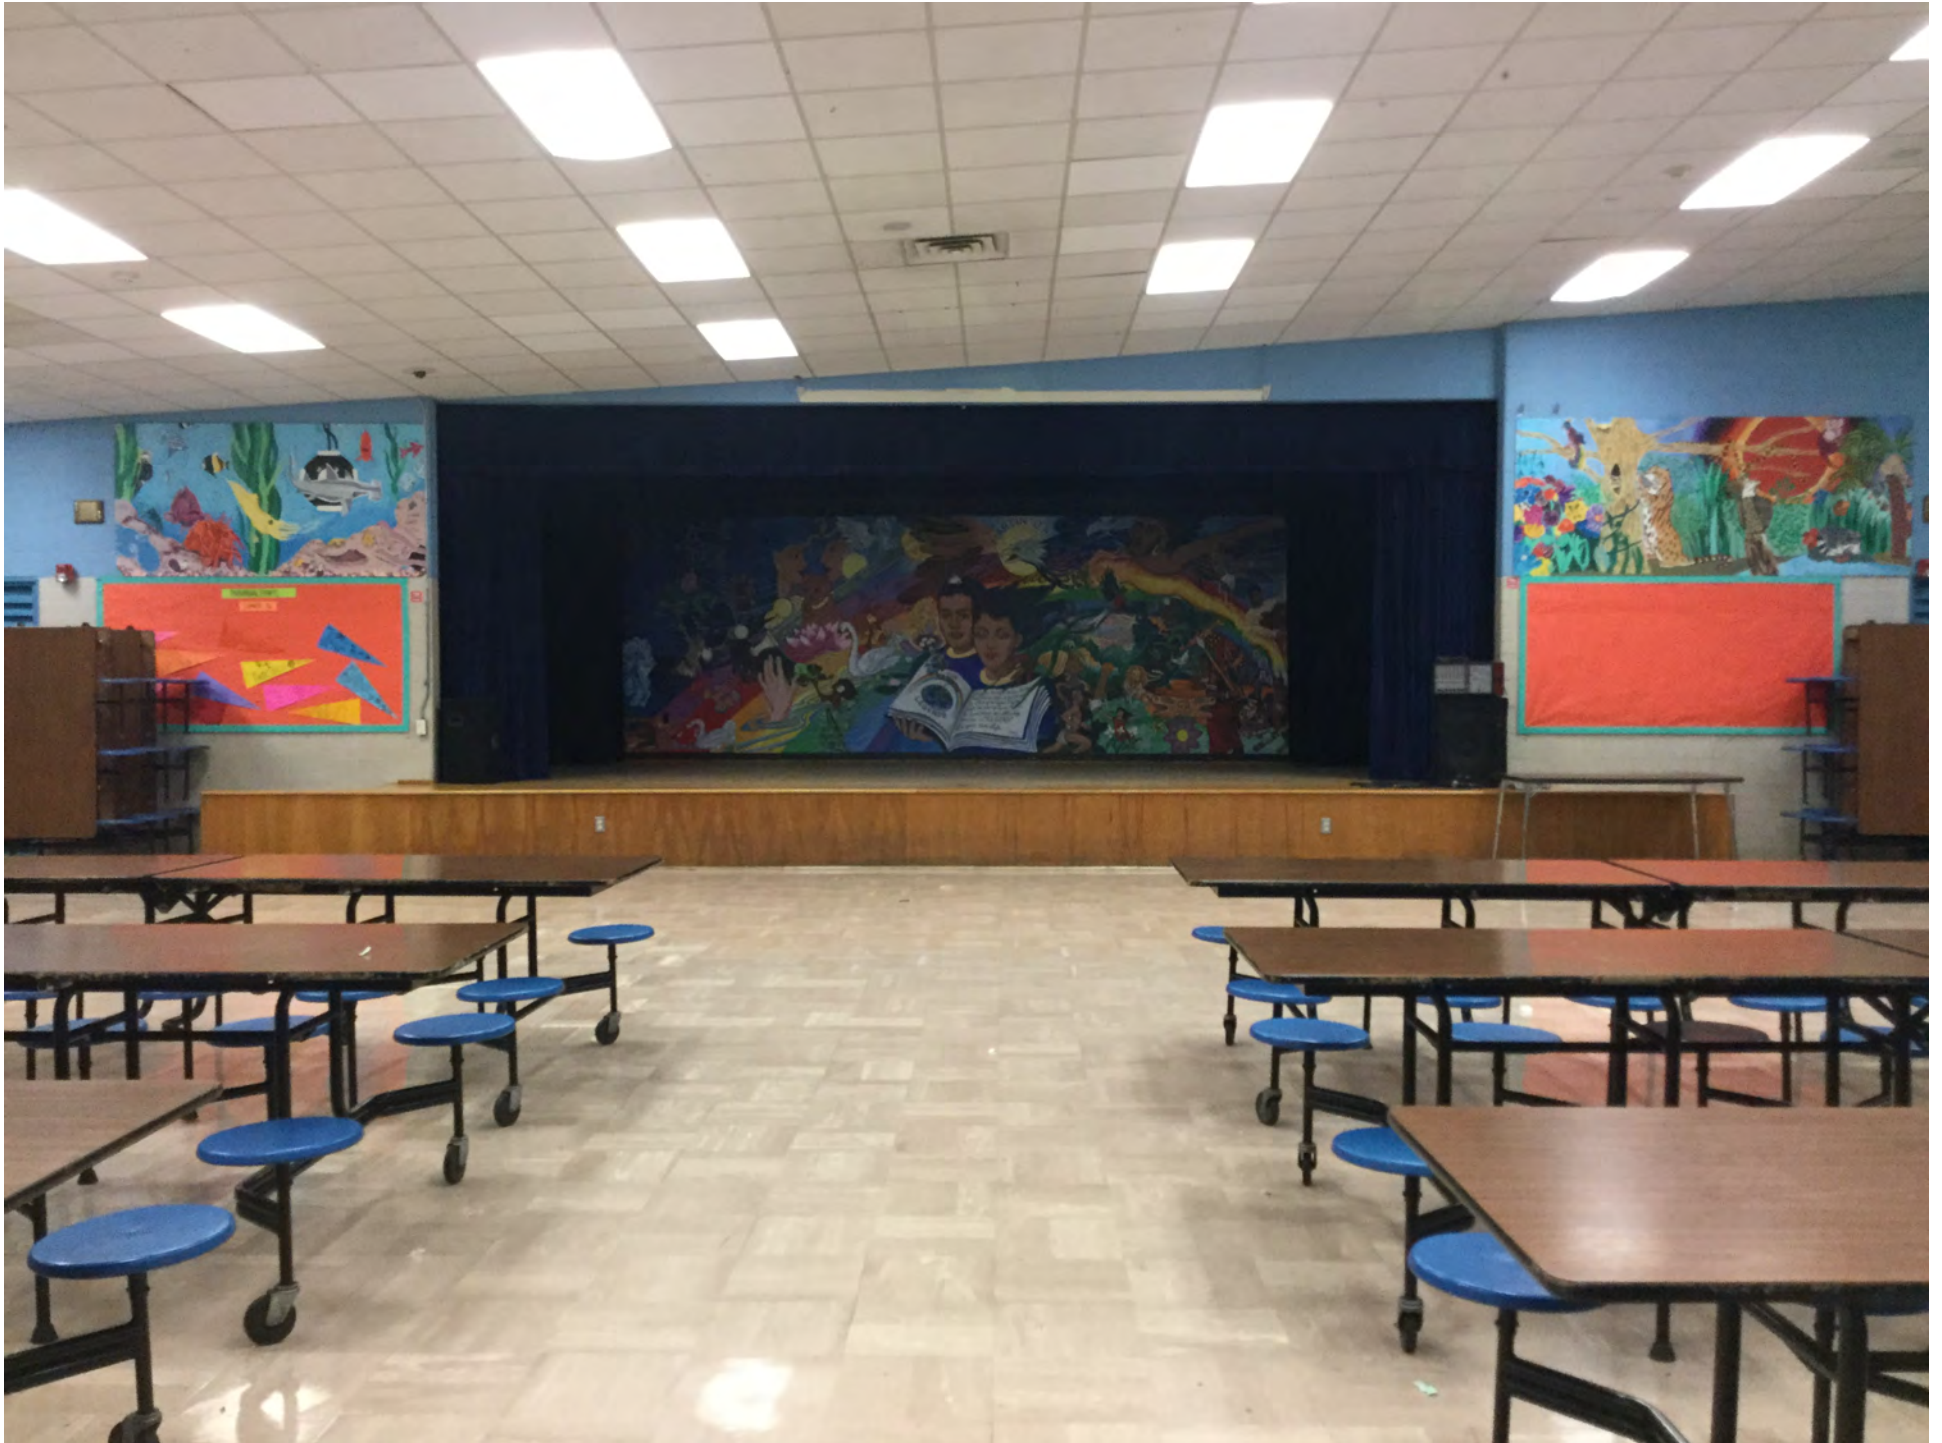
Photo 7. Cafeteria

3.16	Are the student dining facilities appropriately configured?								3					Comments	1.00	3.00
1) Very unsatisfactory - Too small, poor circulation, inflexible seating in poor condition 2) Unsatisfactory - Too small or inadequate circulation, seating in poor condition 3) Average - moderate size, with adequate circulation, seating in okay condition 4) Good - good size, adequate circulation, seating in good condition 5) Very good - good size, adequate circulation, seating in good condition, with more than one option for eating space (ex: connection to outdoor eating space) N/A) Does not apply.
