## Educational Suitability Summary Report

Martin Middle School

Date: 08/15/2016

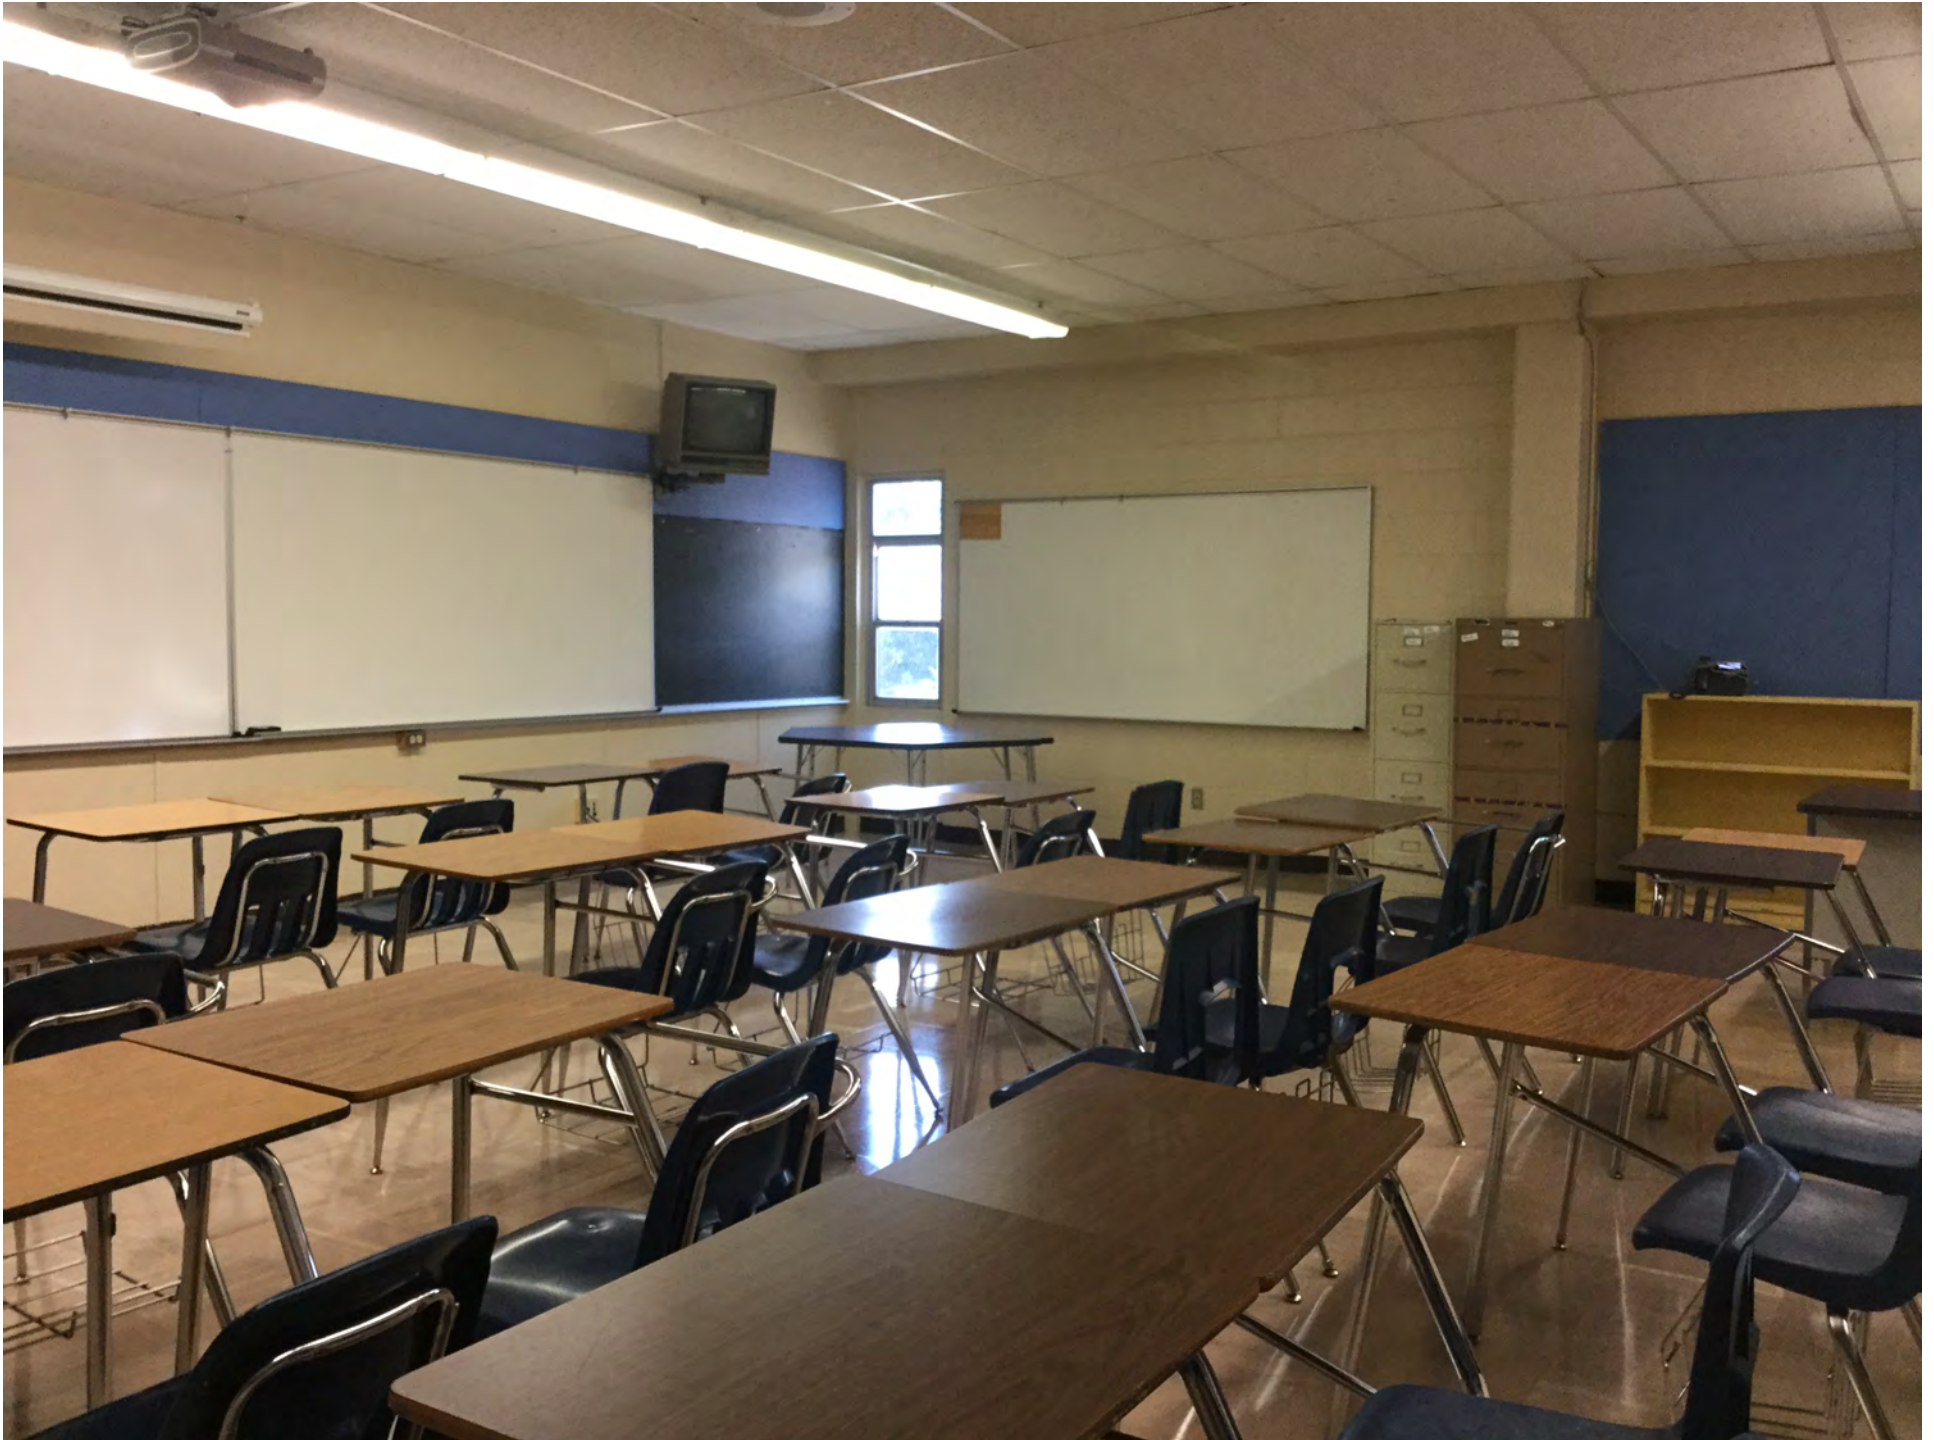
Photo 8. Classroom

The campus has outdated furniture that is in poor condition. The furniture is inconsistent throughout the classrooms and is not easily reconfigurable for different group sizes. Many classrooms have attached desk and chair combinations that are not easily rearranged.
