Educational Suitability Summary Report

Murchison Middle School – BLDG 052

Date: 08/18/2016 (REV1 – 12/19/2016 CAC/Revised Score)

Score 42% Unsatisfactory

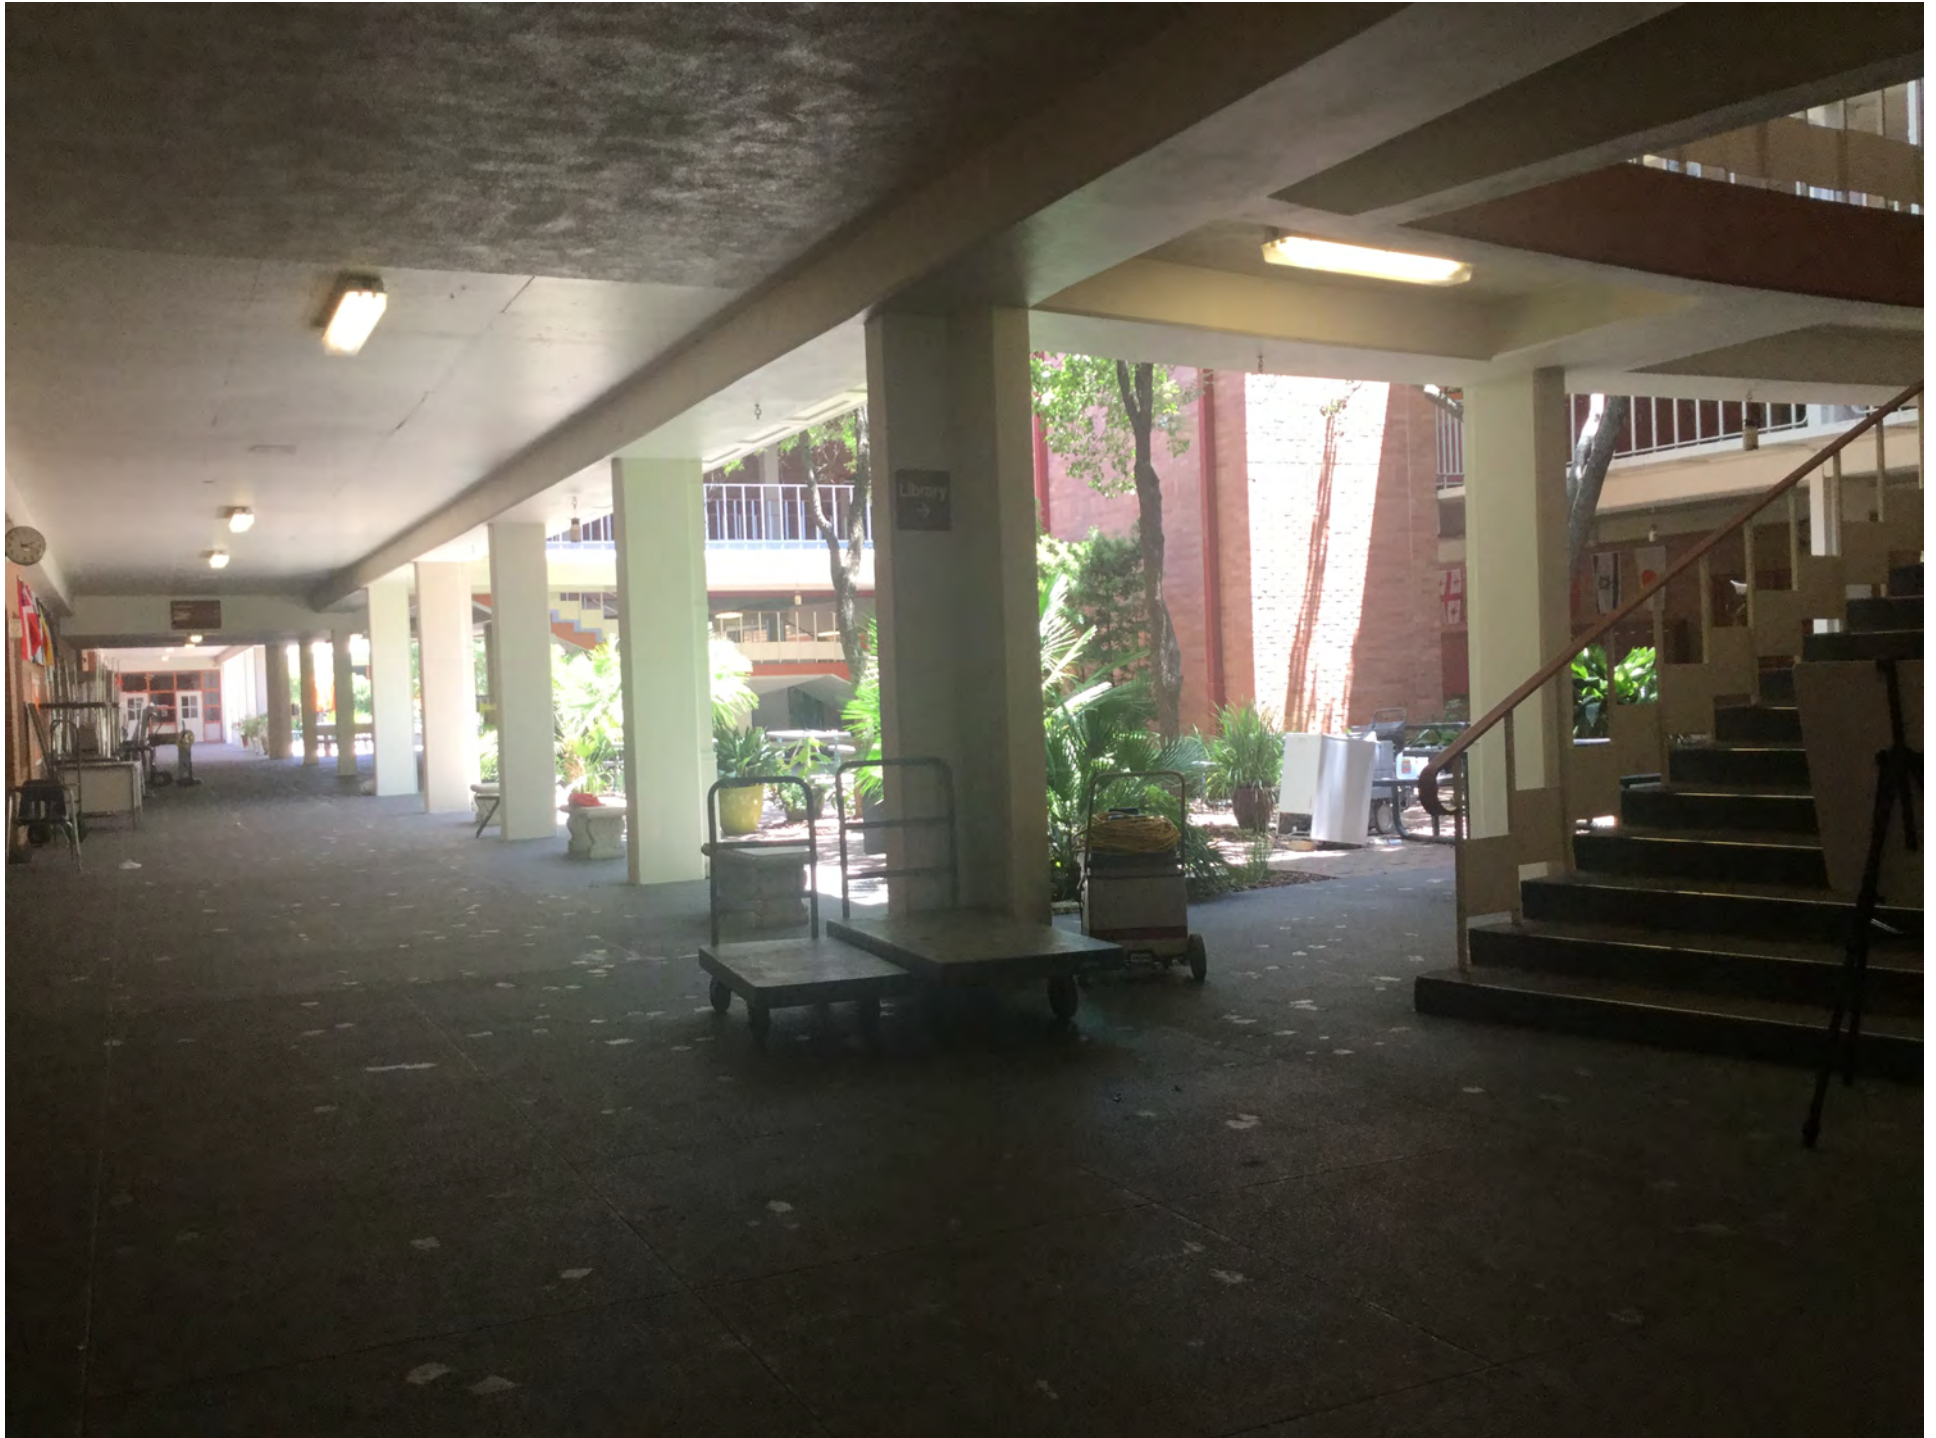
Photo 1. Outdoor Space

1.2	Are opportunities provided for outdoor learning (outdoor classrooms, gardens, etc.)?			3				Comments	1.00 3.00
	1) Outdoor space exists is not developed 2) Outdoor space for learning exists but not connected to classroom learning areas. 3. Outdoor learning spaces exist and are accessible but not in good condition. 4. Outdoor learning spaces need minor improvements to function well. 5. Outdoor learning spaces are in excellent condition. N/A) Does not apply.							The exterior spaces are used frequently by necessity due to the number of students on campus. The interior courtyard space is used and has furniture located through out.	
								See Photo 1

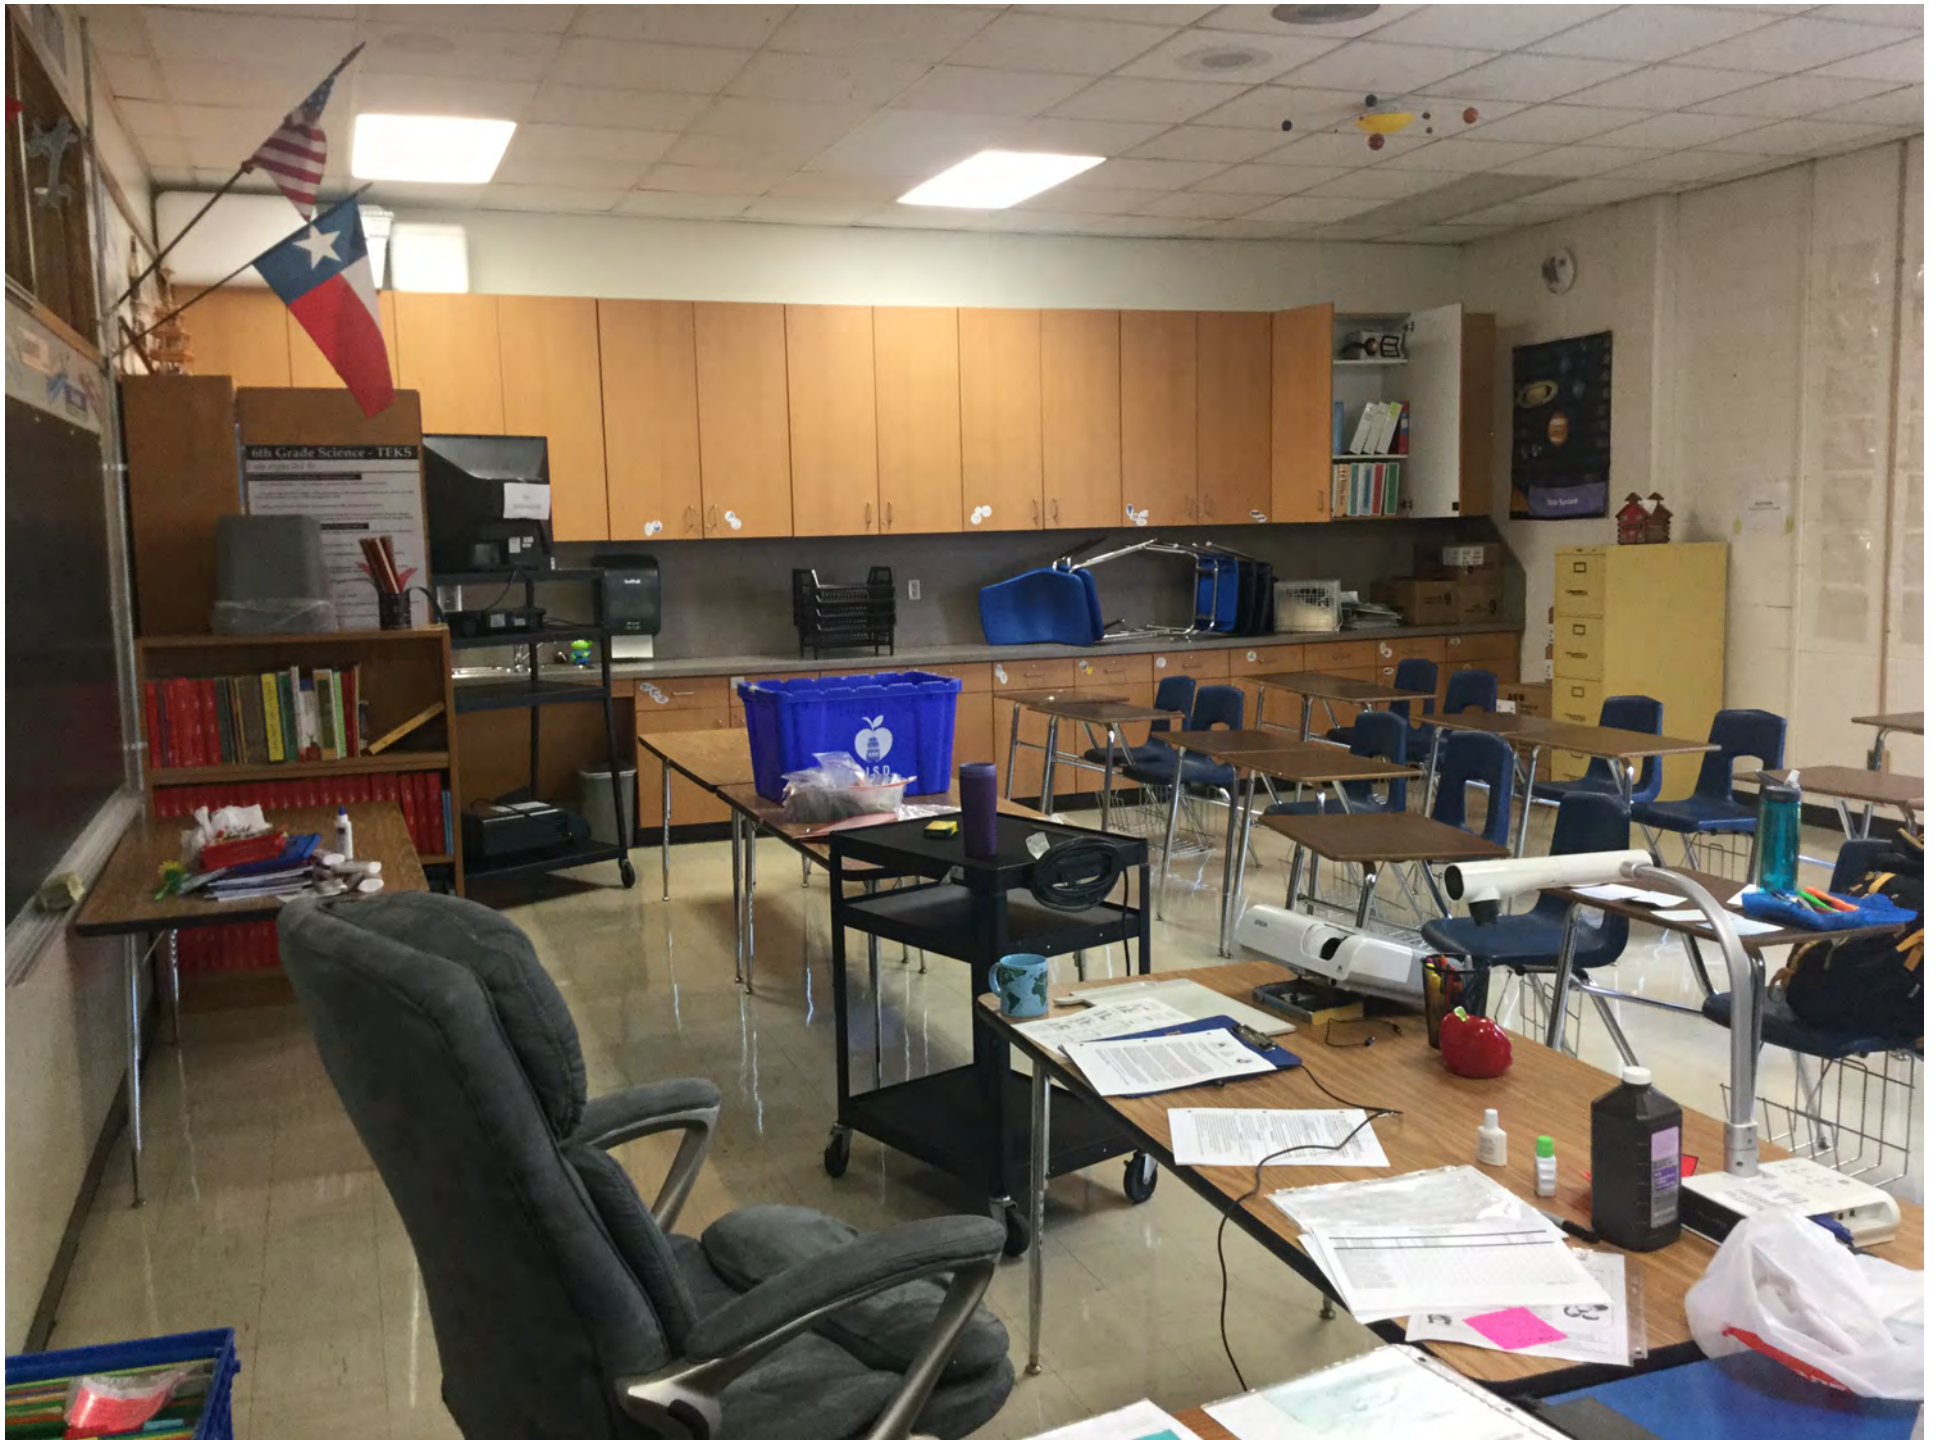
Photo 2. Science Room

3.4	Are Science Classrooms/Labs appropriately configured per the ed spec?	1						Comments	1.00 1.00
1) Very unsatisfactory 2) Unsatisfactory 3) Neutral 4) Satisfactory 5) Very Satisfactory N/A) Does not apply. (Elementary schools)									Most science labs do not have lab tables. Some science classrooms have desks and tables with chairs and some have fixed desk and chair combinations. Not all of the rooms have an accessible sink. Science labs are small. <i>CAC comments: Science classrooms are too small to ensure student safety during labs. CAC recommends a score of 1.</i>
									See Photos 3-5

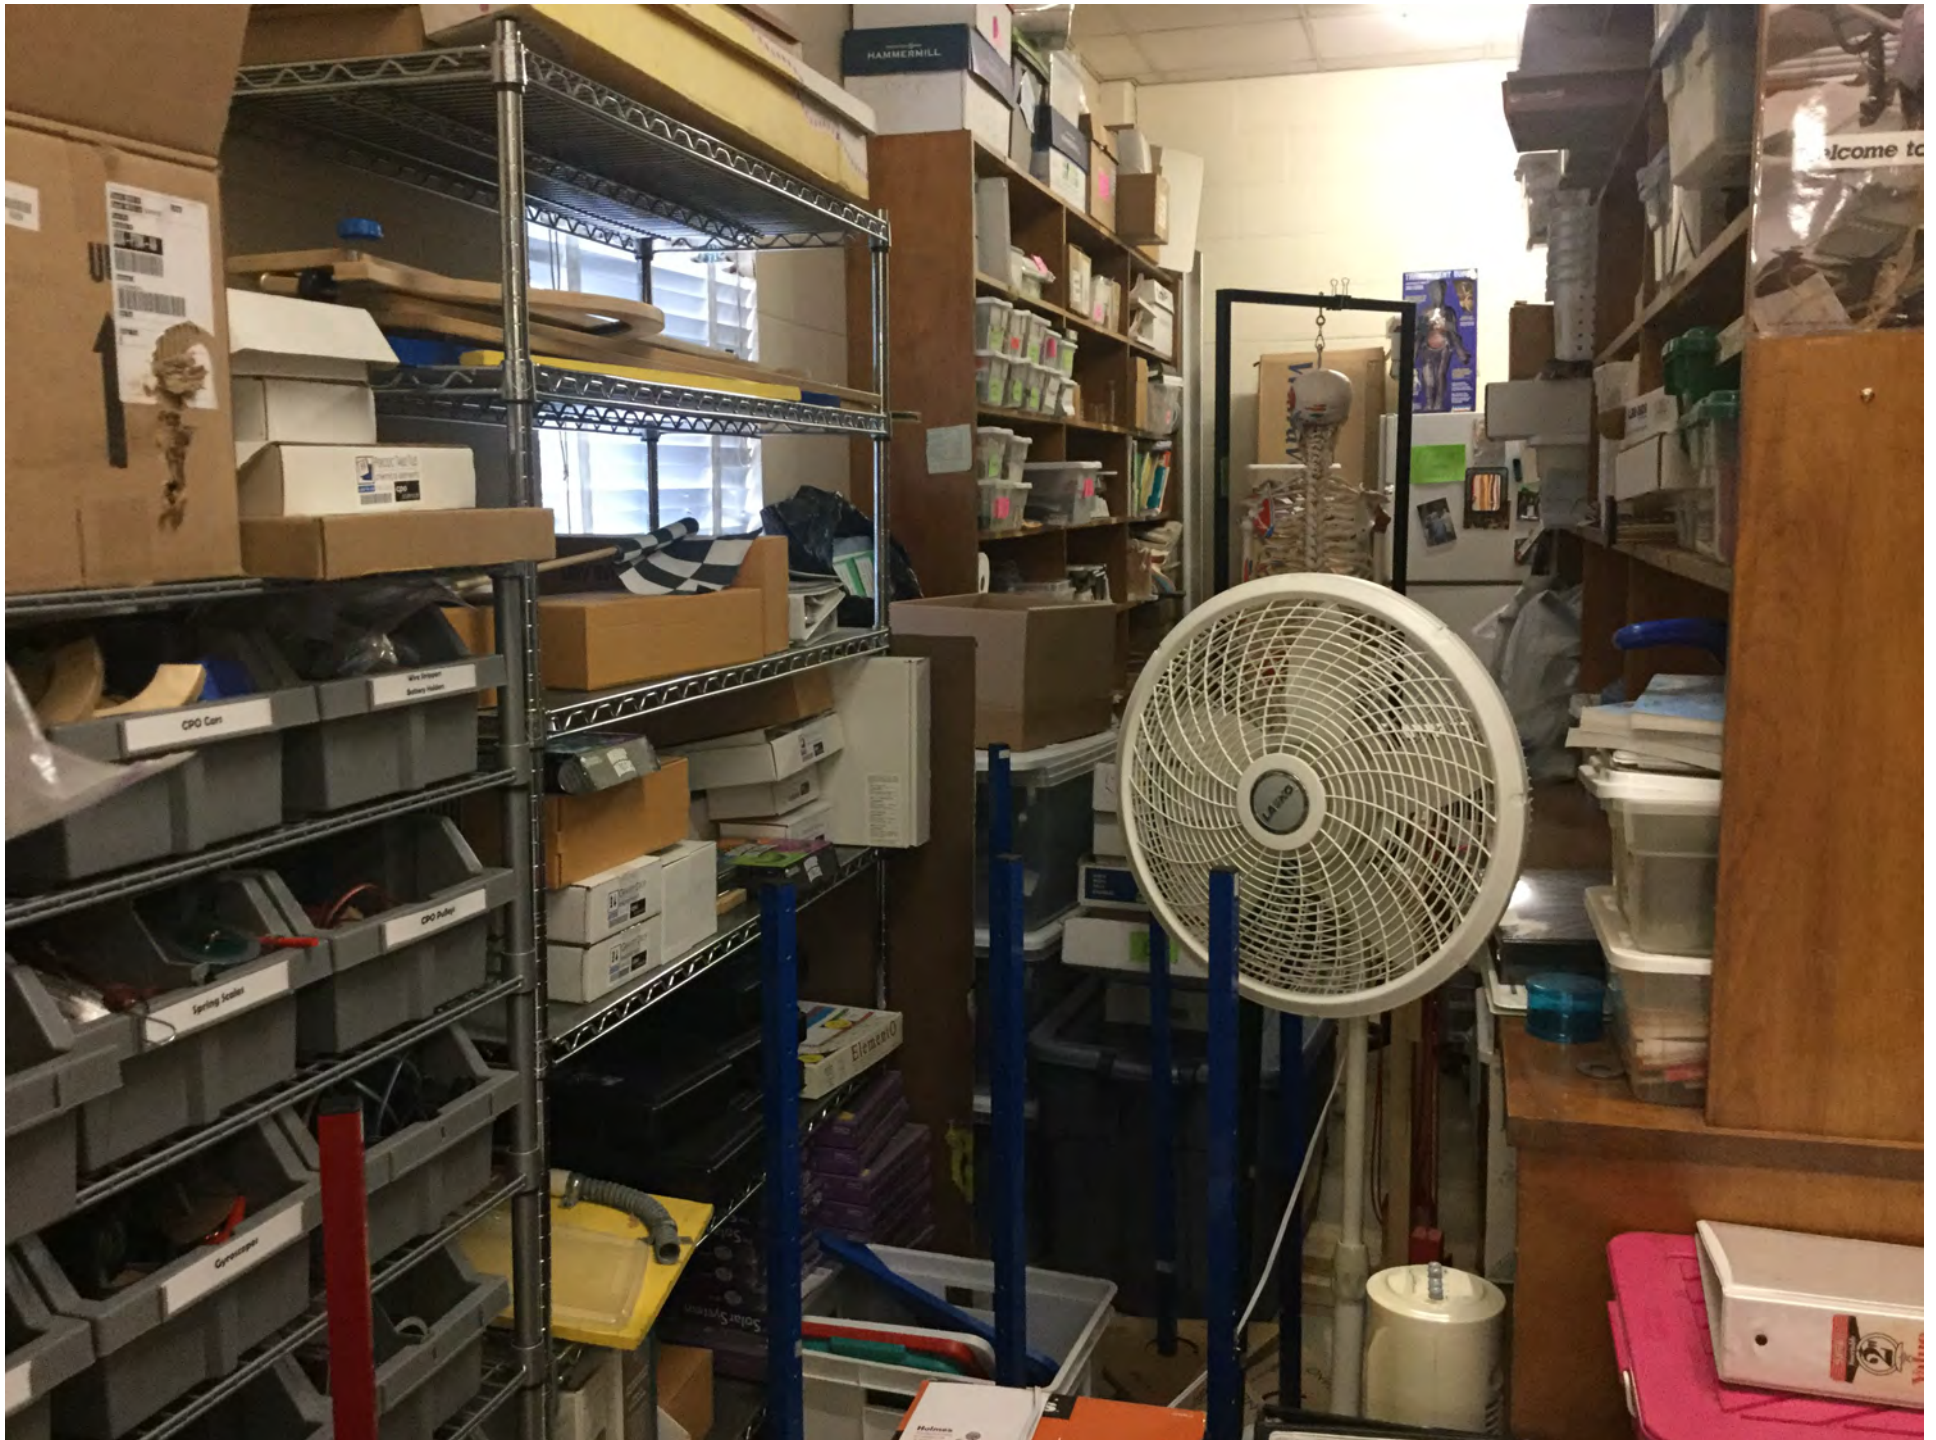
Photo 5. Science Storage

3.5	Are Science Classrooms/Labs support areas appropriately configured per the ed spec?		2					Comments	1.00 2.00
1) Very unsatisfactory - Support spaces are disconnected from served spaces, too small, do not meet needs 2) Unsatisfactory - Support spaces are connected, but too small, do not meet needs 3) Average - Connected, moderate size, but need some renovations or updates 4) Good - Connected, good size, meets needs, functions well 5) Very good - connected, generous size, nice condition, functions appropriately N/A) Does not apply. (Elementary schools)									Not all of the science labs have sufficient storage or a connected prep/storage room.

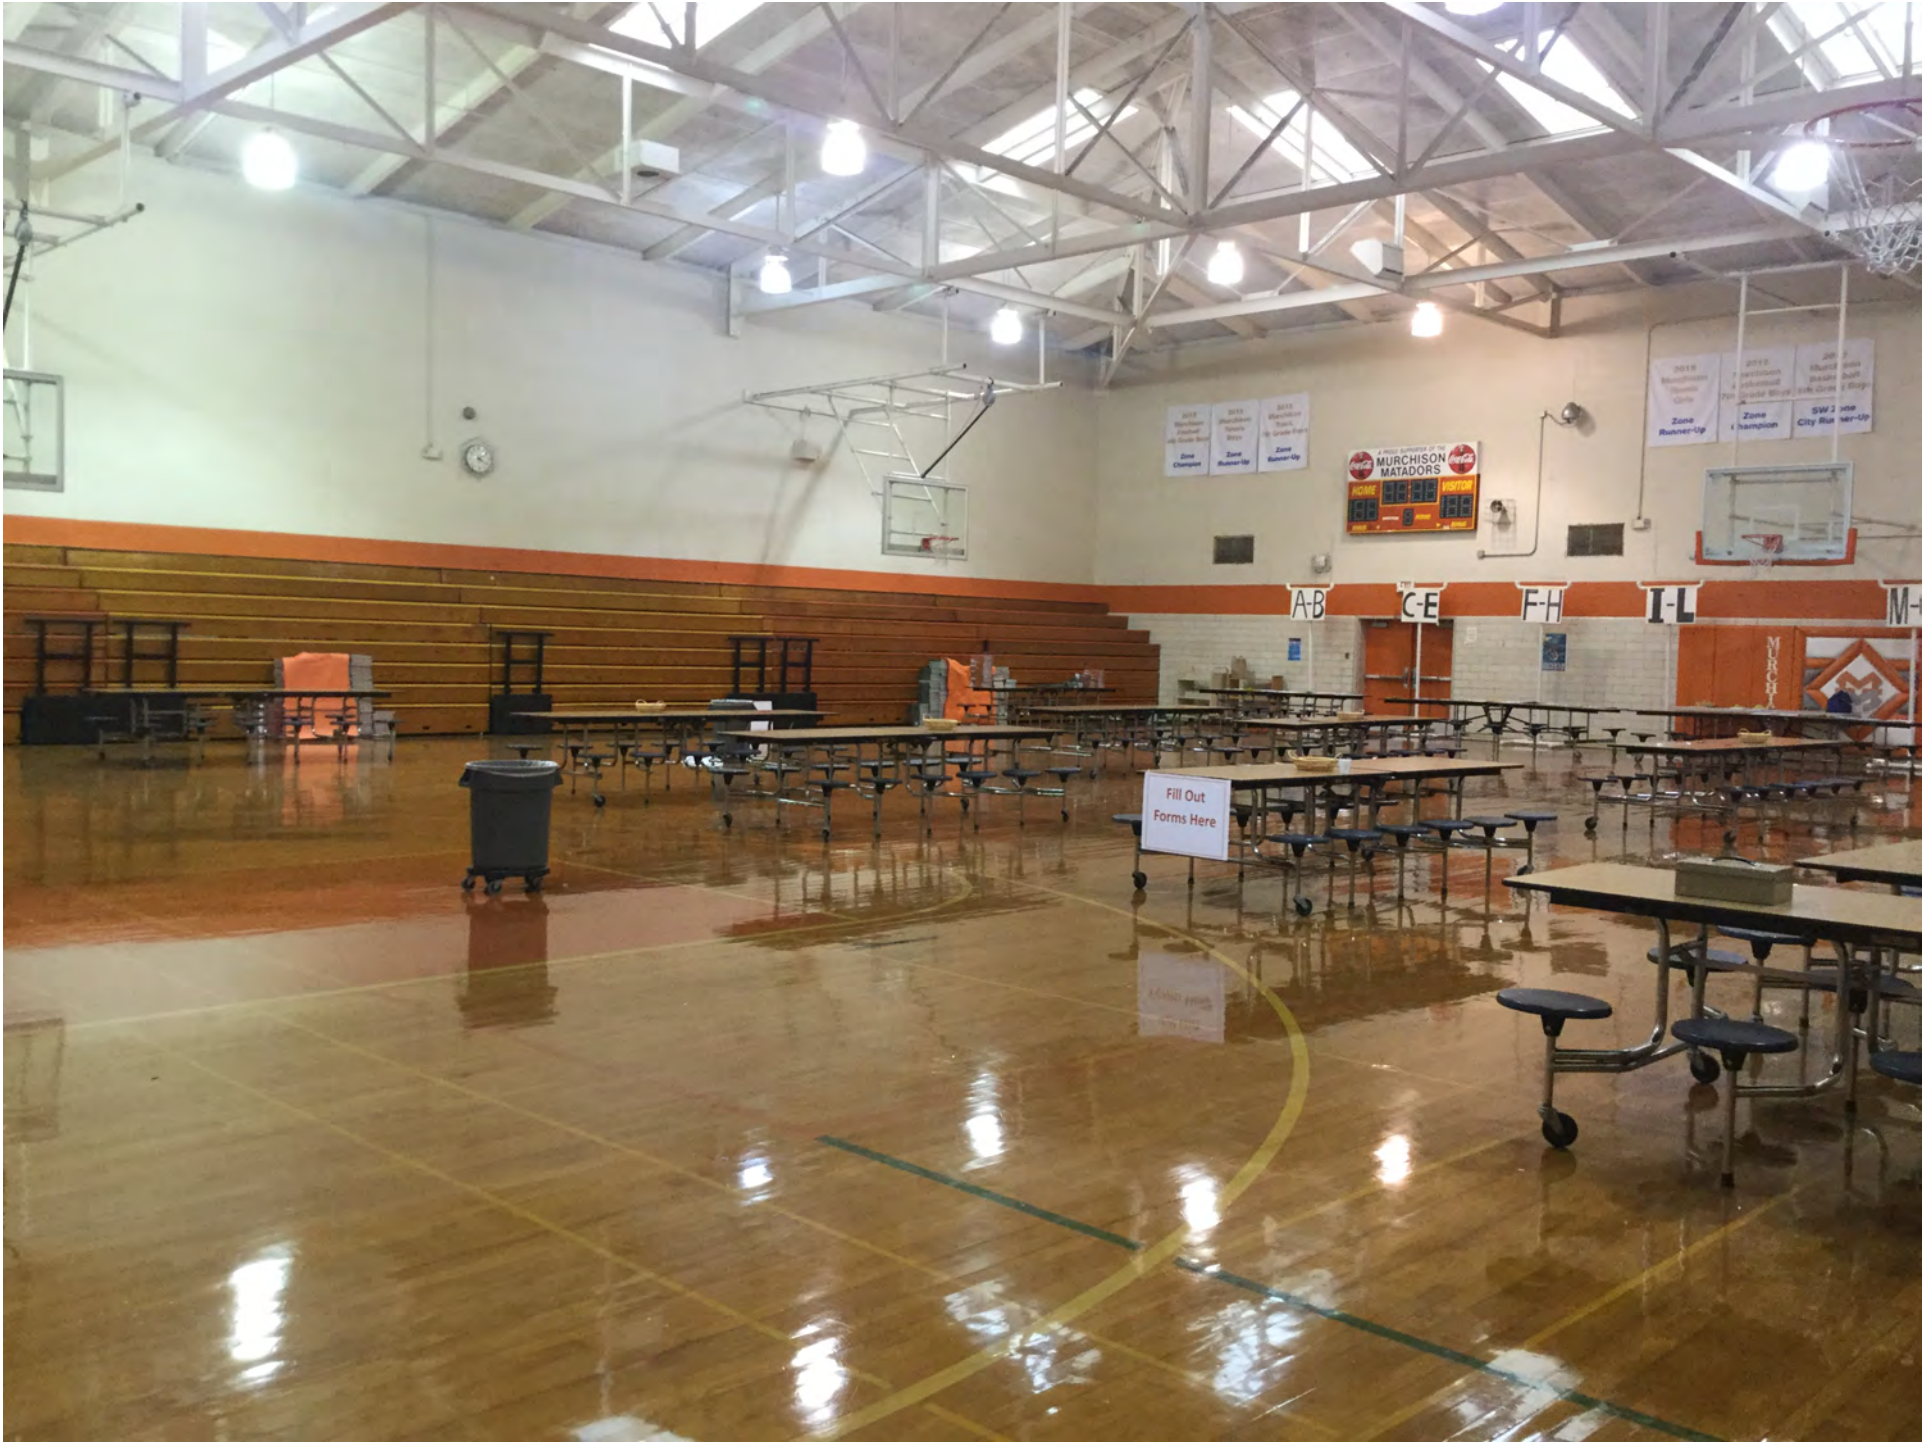
Photo 6. Gym

1) Very unsatisfactory 2) Unsatisfactory 3) Average 4) Good 5) Very good N/A) Does not apply.	The gym has dated equipment and the original 1967 flooring is beginning to buckle. The bleachers are old and do not function well. The basketball goals do not function to swing up. The layout meets current ED Spec. <i>CAC comments: 1 Large gym and 1 small gym is not enough space to accommodate # of seats in PE and Athletics. Classes meet in the foyer. CAC requests a score of 1.</i>											See Photo 6 -7

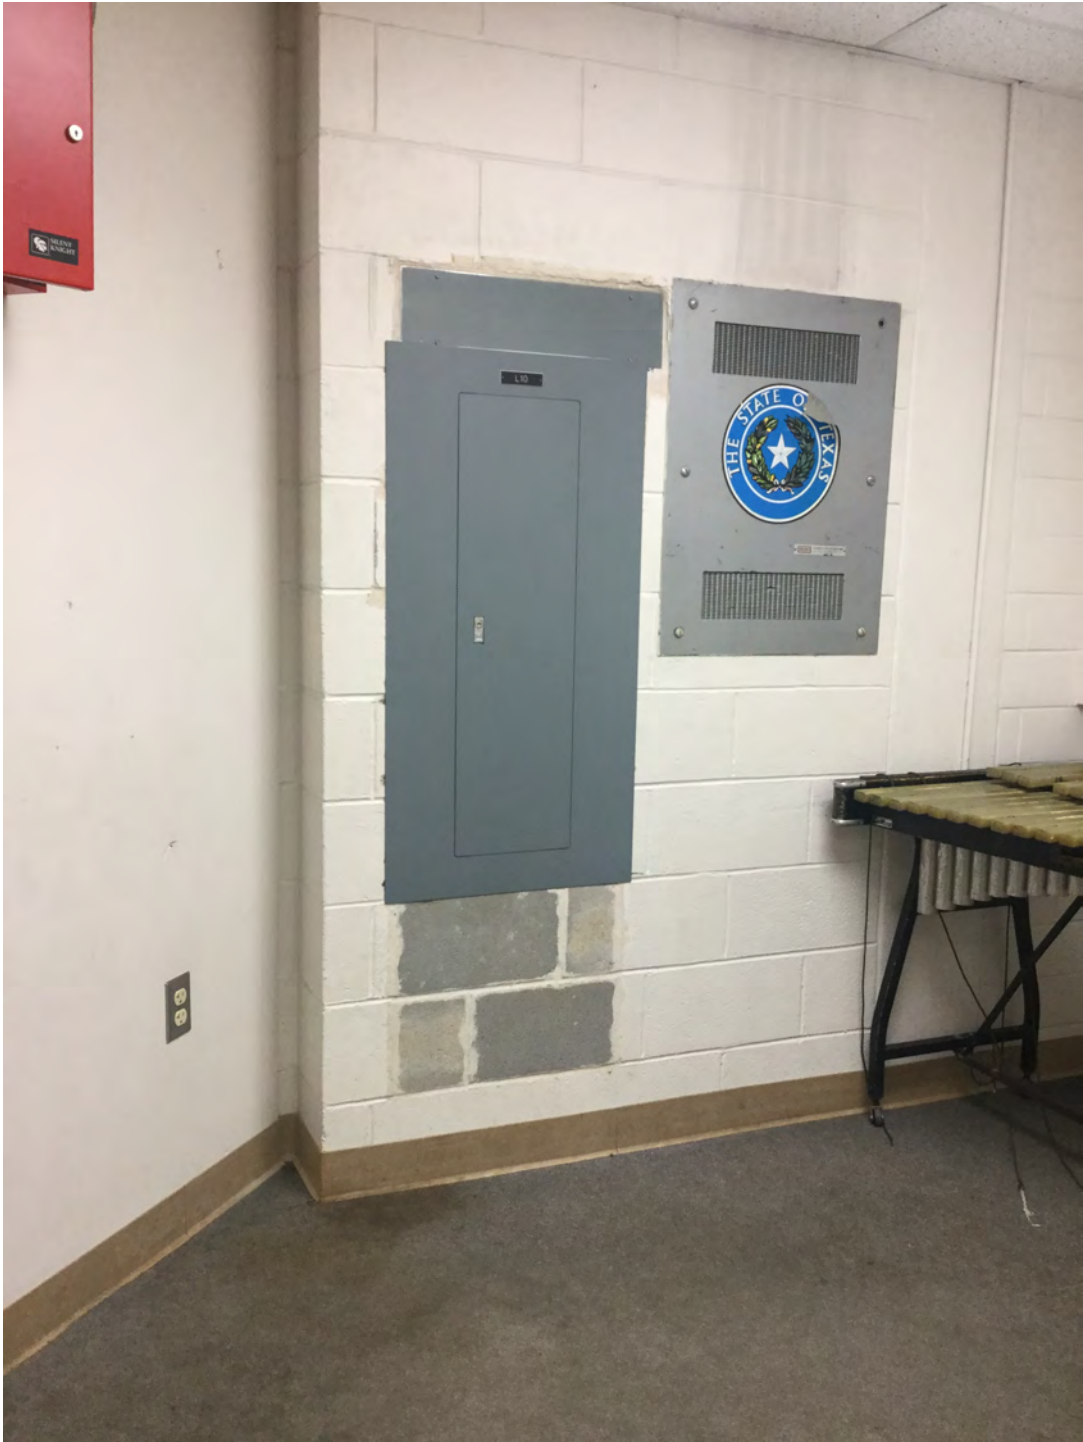
Photo 9. Practice Room

3.9	Are music, drama, or performance support spaces appropriately configured per the ed spec?	1											Comments	1.00 1.00
	1) Very unsatisfactory - Support spaces are disconnected from served spaces, too small, do not meet needs 2) Unsatisfactory - Support spaces are connected, but too small, inadequate for needs 3) Average - Connected, moderate size, but need some renovations or updates to function well 4) Good - Connected, good size/layout, meets needs/functions well 5) Very good - connected, generous size, nice condition, functions appropriately N/A) Does not apply.	There are no connected locker or dressing rooms for dance. The storage space is inadequate and serves as sectional rehearsal space for band and orchestra. Part of orchestra is conducted in a portable. The offices are used for chair testing and rehearsal/practice space. The practice room has electrical panels that create a humming sound. The storage is not secure for instruments. Layout meets current ED Spec, but due to enrollment, the departments is struggling with space. <i>CAC comments: Orchestra, Band and Choir are in portables. Choir office is also private practice space. No functional performance space. New A/C in gym makes it unable to hear musical performances.</i>											See Photo 9

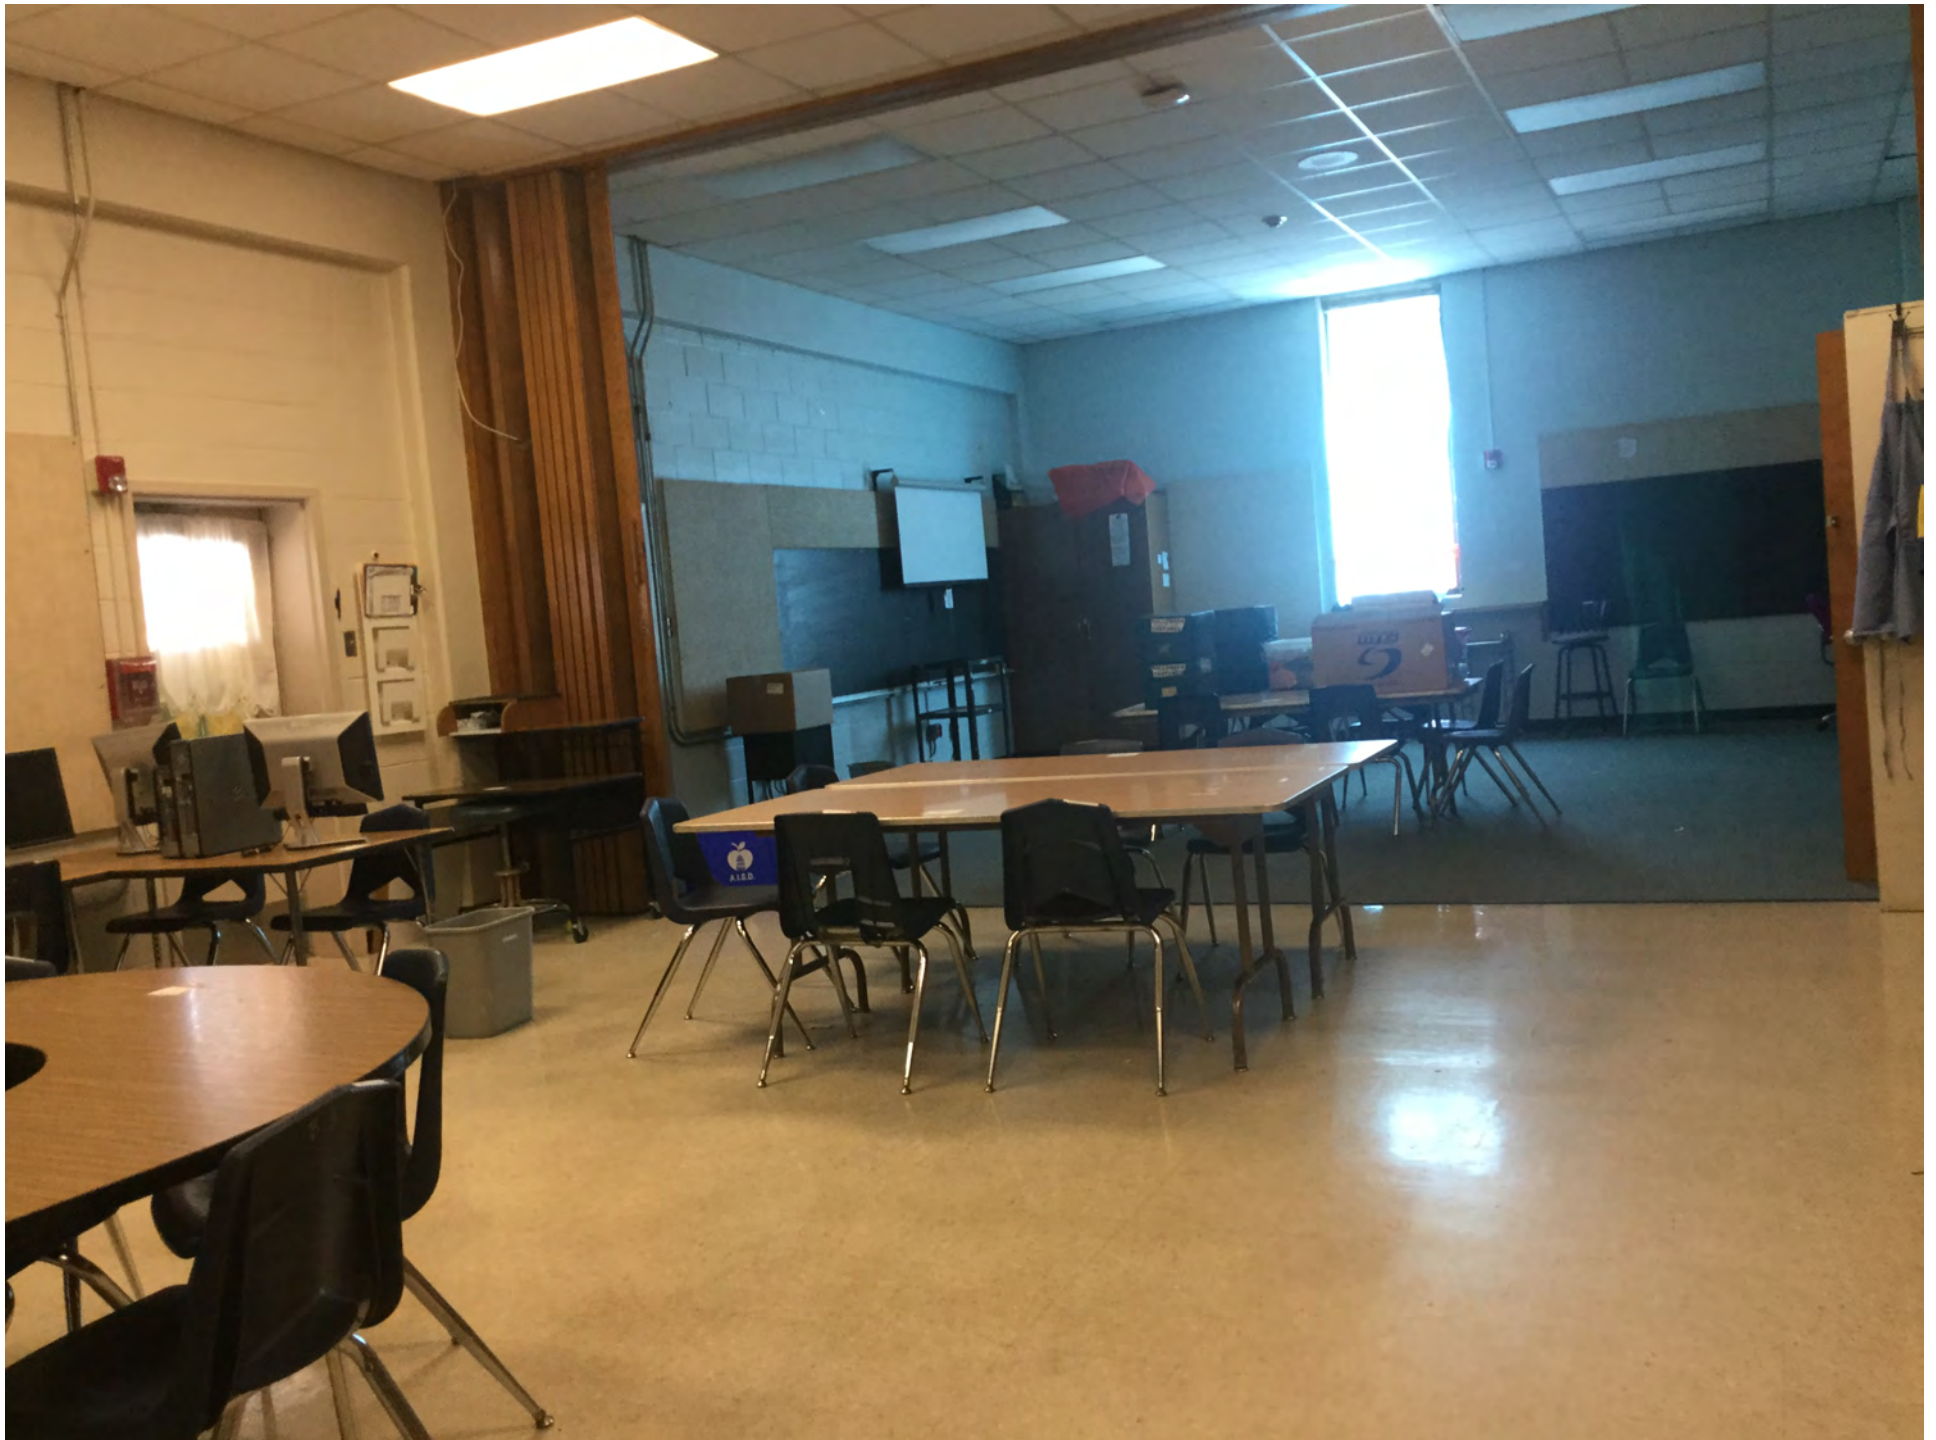
Photo 10. Special Education

1) Very unsatisfactory 2) Unsatisfactory 3) Average 4) Good 5) Very good N/A) Does not apply.								The space is large, with two classrooms dedicated to space. The space lacks a quiet/cool down corner. A makeshift cool-down corner is in a small repurposed office down the hall. <i>CAC comments: Special behavior support programs in Autistic support programs lack space and significant supports. Currently in portables. SPED comments: SBS & SCORES are in separate rooms in portable with restroom.</i>	See Photo 10

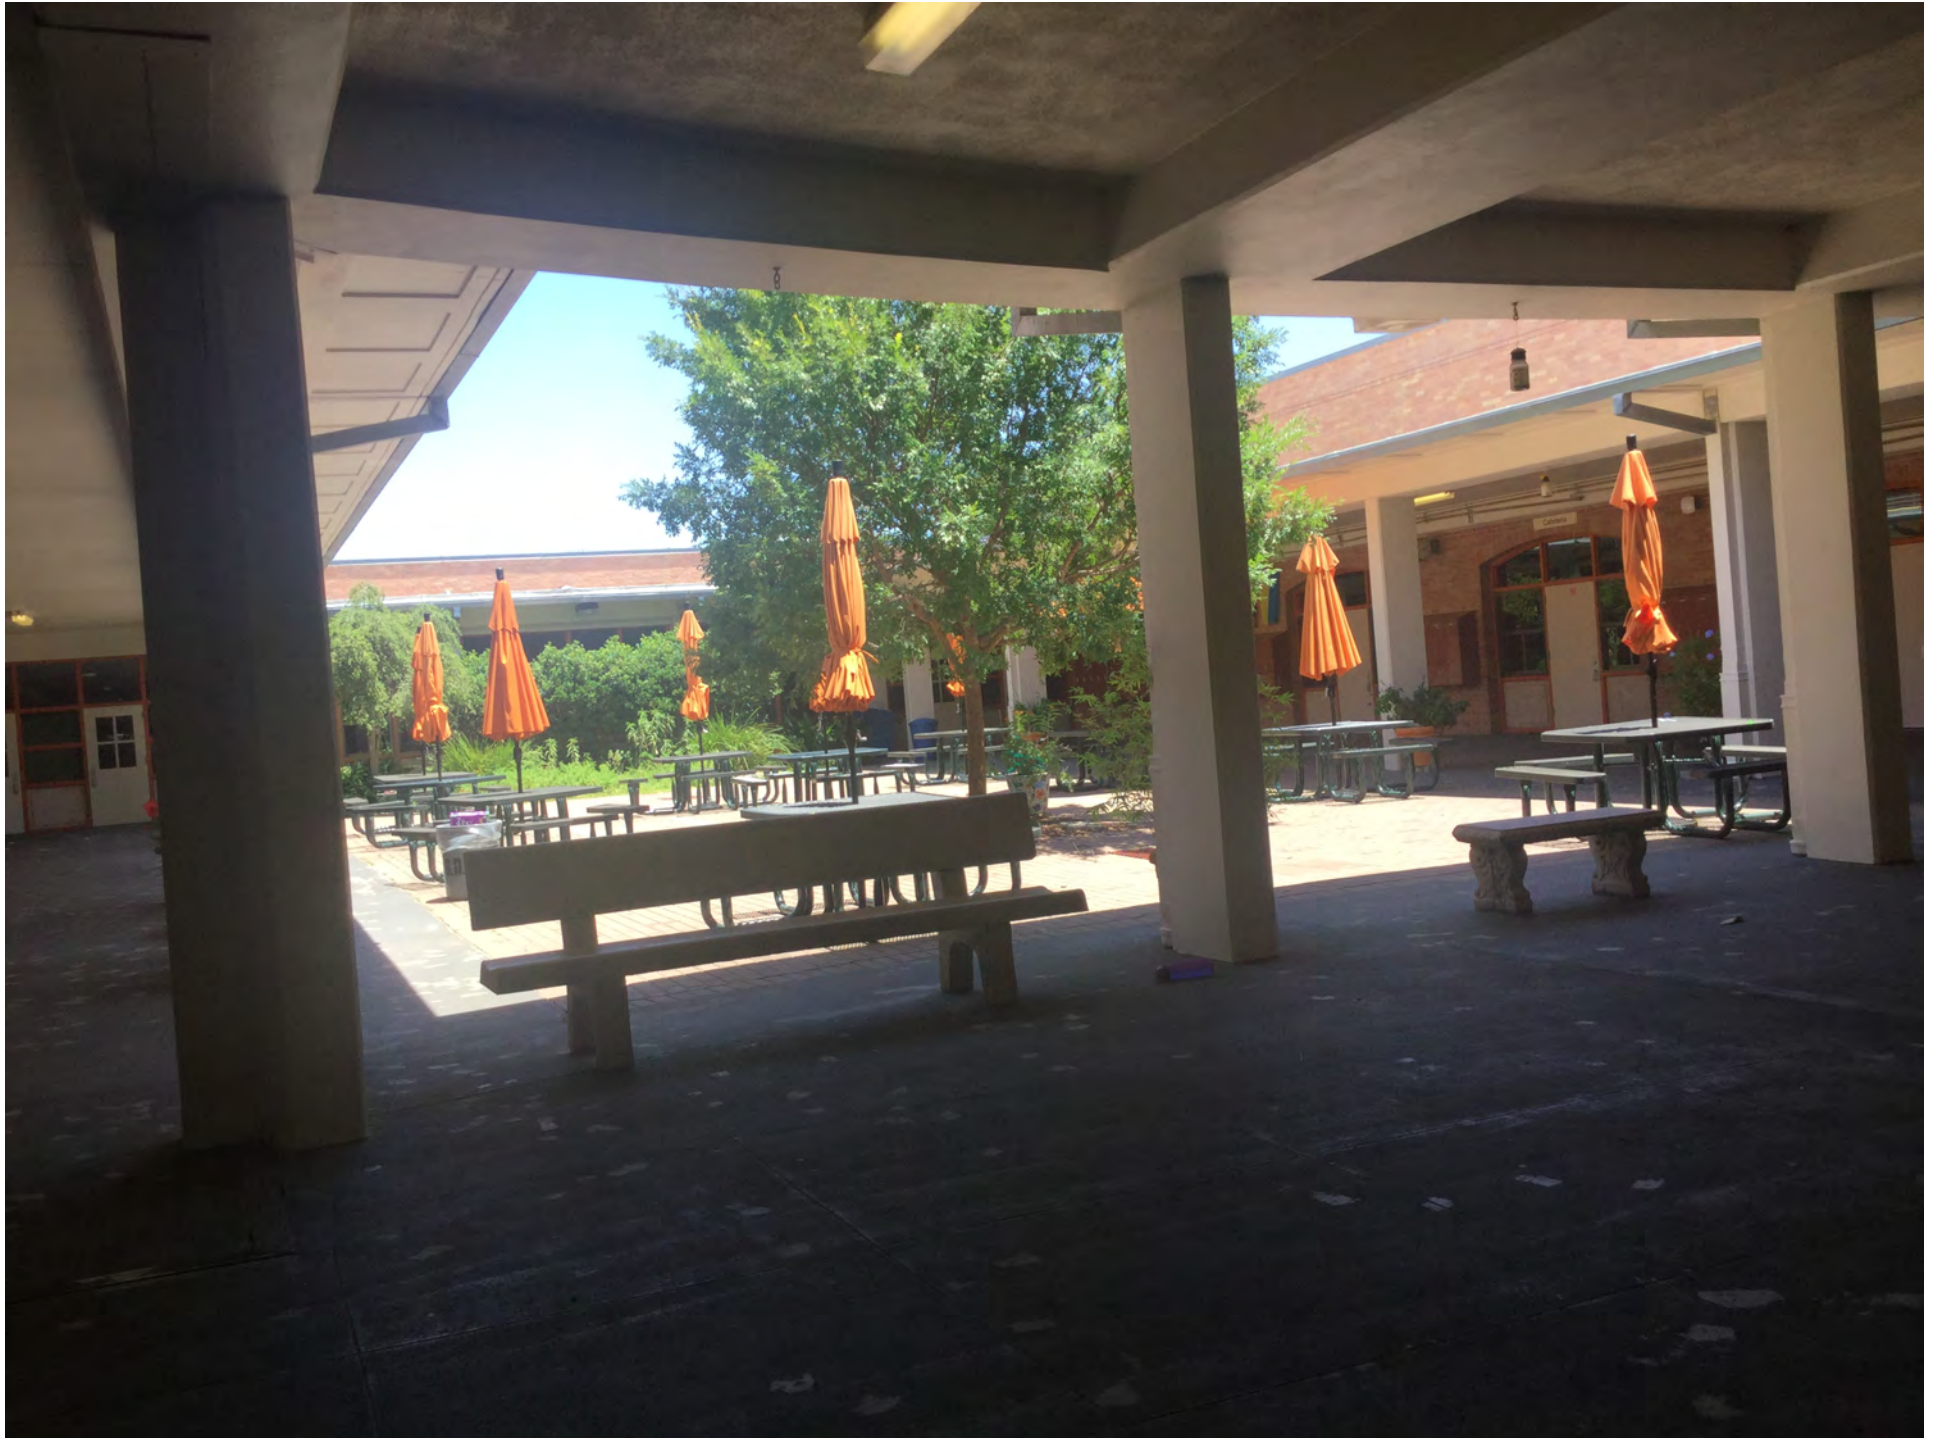
Photo 11. Outdoor dining

3.16	Are the student dining facilities appropriately configured?		2					Comments	1.00 2.00
1) Very unsatisfactory - Too small, poor circulation, inflexible seating in poor condition 2) Unsatisfactory - Too small or inadequate circulation, seating in poor condition 3) Average - moderate size, with adequate circulation, seating in okay condition 4) Good - good size, adequate circulation, seating in good condition 5) Very good - good size, adequate circulation, seating in good condition, with more than one option for eating space (ex: connection to outdoor eating space) N/A) Does not apply.								The recent expansion of the cafeteria has fallen short of expectations to seat 100 more students. The area appears to be too small of an expansion to accommodate number of students or handle circulation widths to comfortably allow ADA clearances. The outdoor seating is a necessity to accommodate the number of students with only 3 lunch periods. <i>CAC comments: Inflexible seating. Space used as theater for presentations. Acoustics are inaudible. CAC recommends a score of 1.</i>	See Photo 11

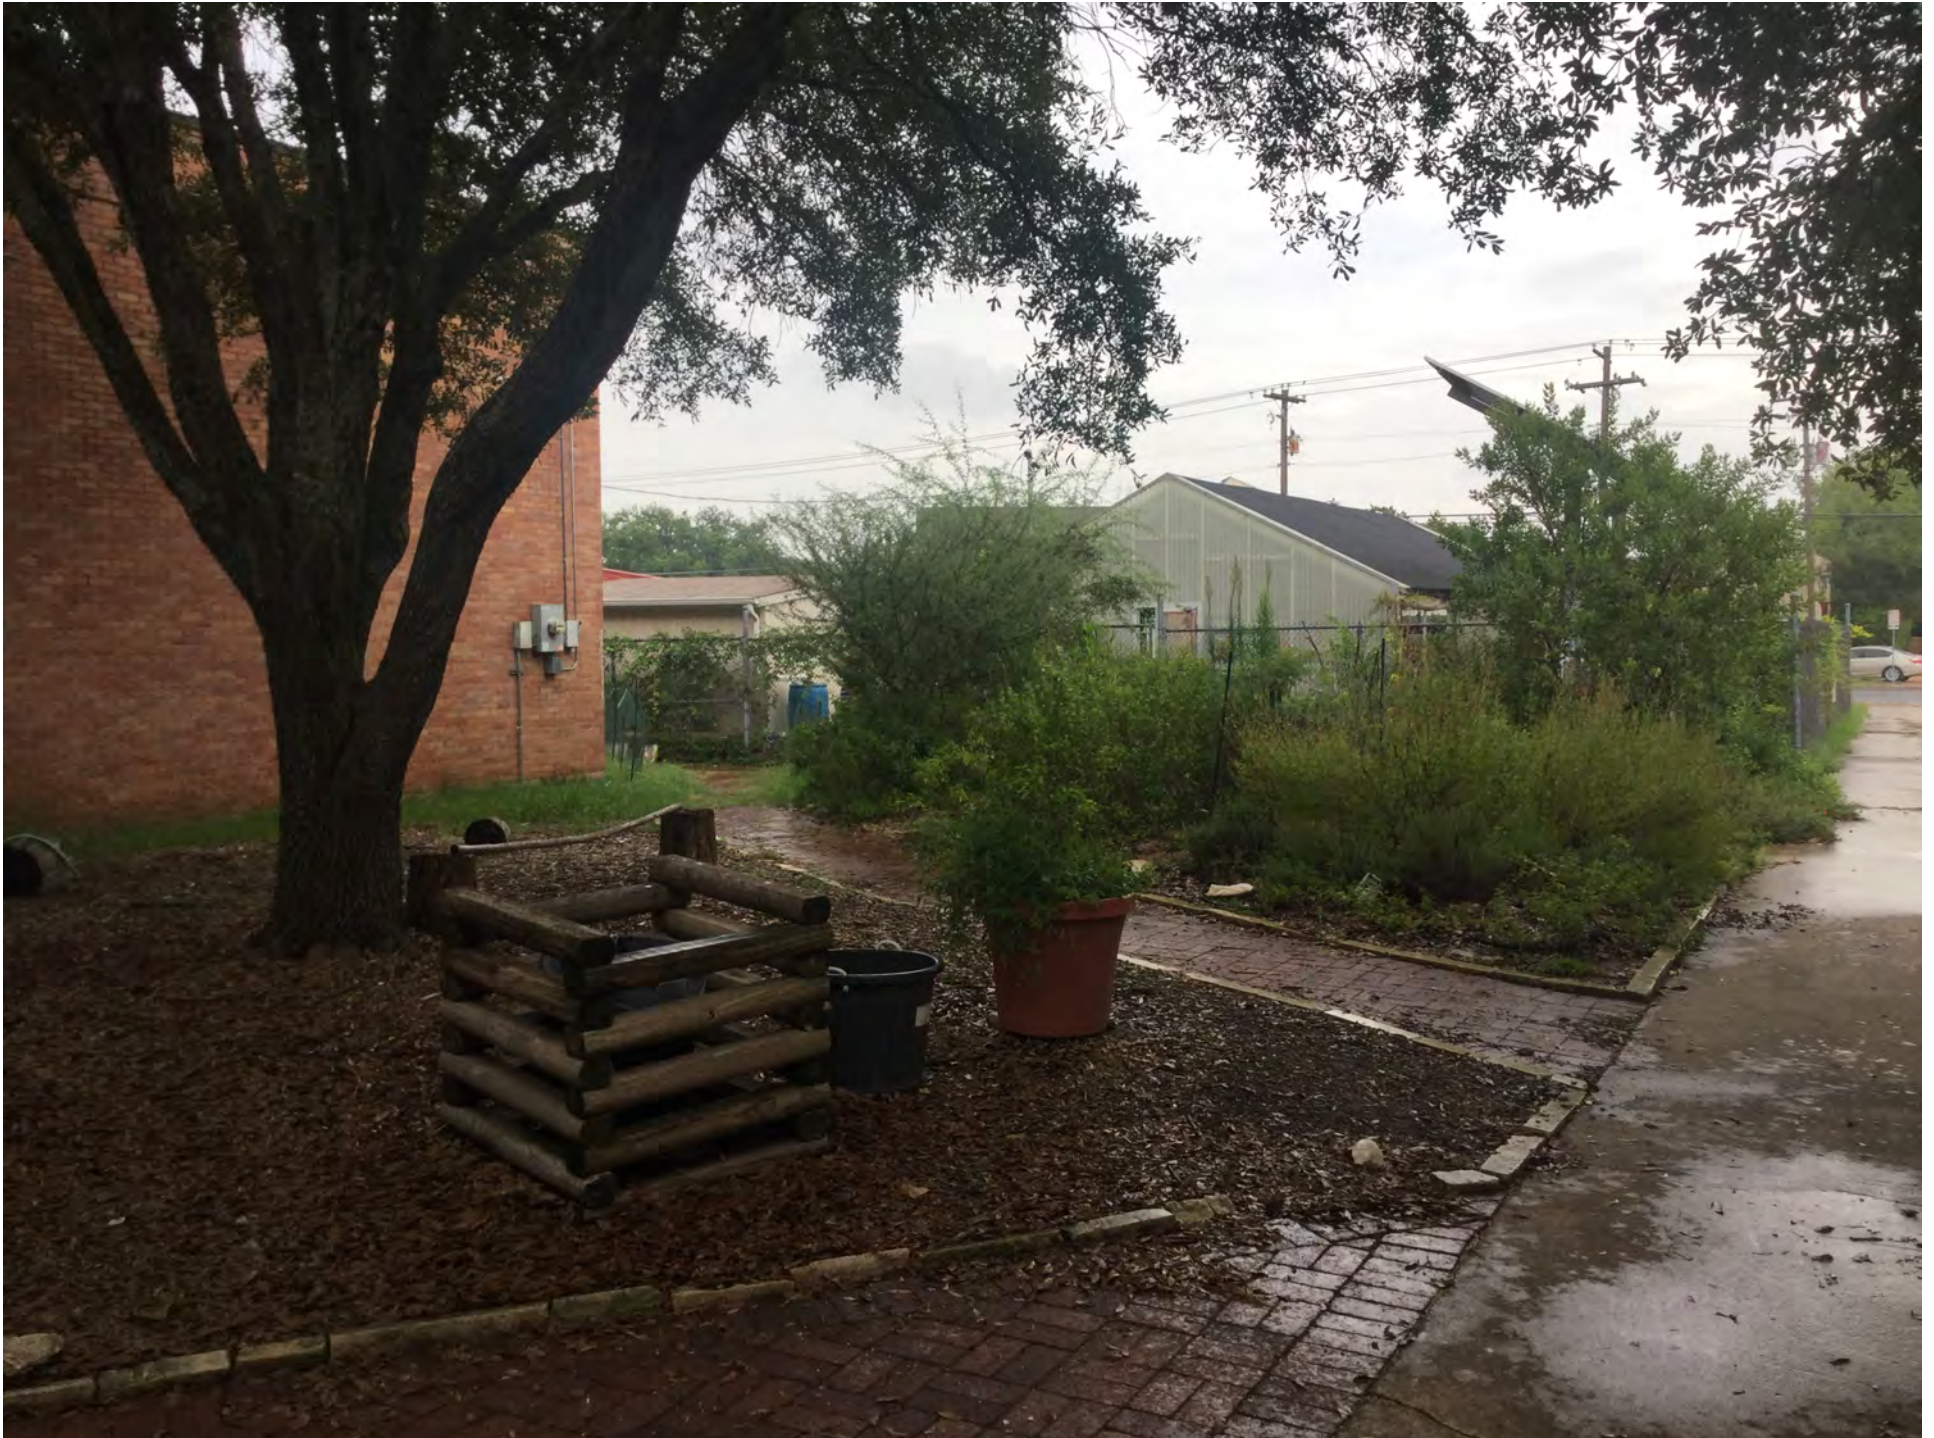
Photo 12. Greenhouse

1) Very unsatisfactory - No project space 2) Unsatisfactory - Non-dedicated, undersized or otherwise inadequate 3) Average - Limited dedicated spaces of moderate size and layout, equipment and furniture appropriate but need updates 4) Good - Dedicated spaces of adequate size and layout, most of the equipment and furniture is appropriate for program 5) Very good - Dedicated spaces of adequate size and layout, equipment and furniture appropriate for program N/A) Does not apply.								There are limited spaces. There is a woodshop and greenhouse space.	See Photo 12
