Educational Suitability Summary Report

Murchison Middle School – BLDG 052

Date: 08/18/2016 (REV1 – 12/19/2016 CAC/Revised Score)

Score 42% Unsatisfactory

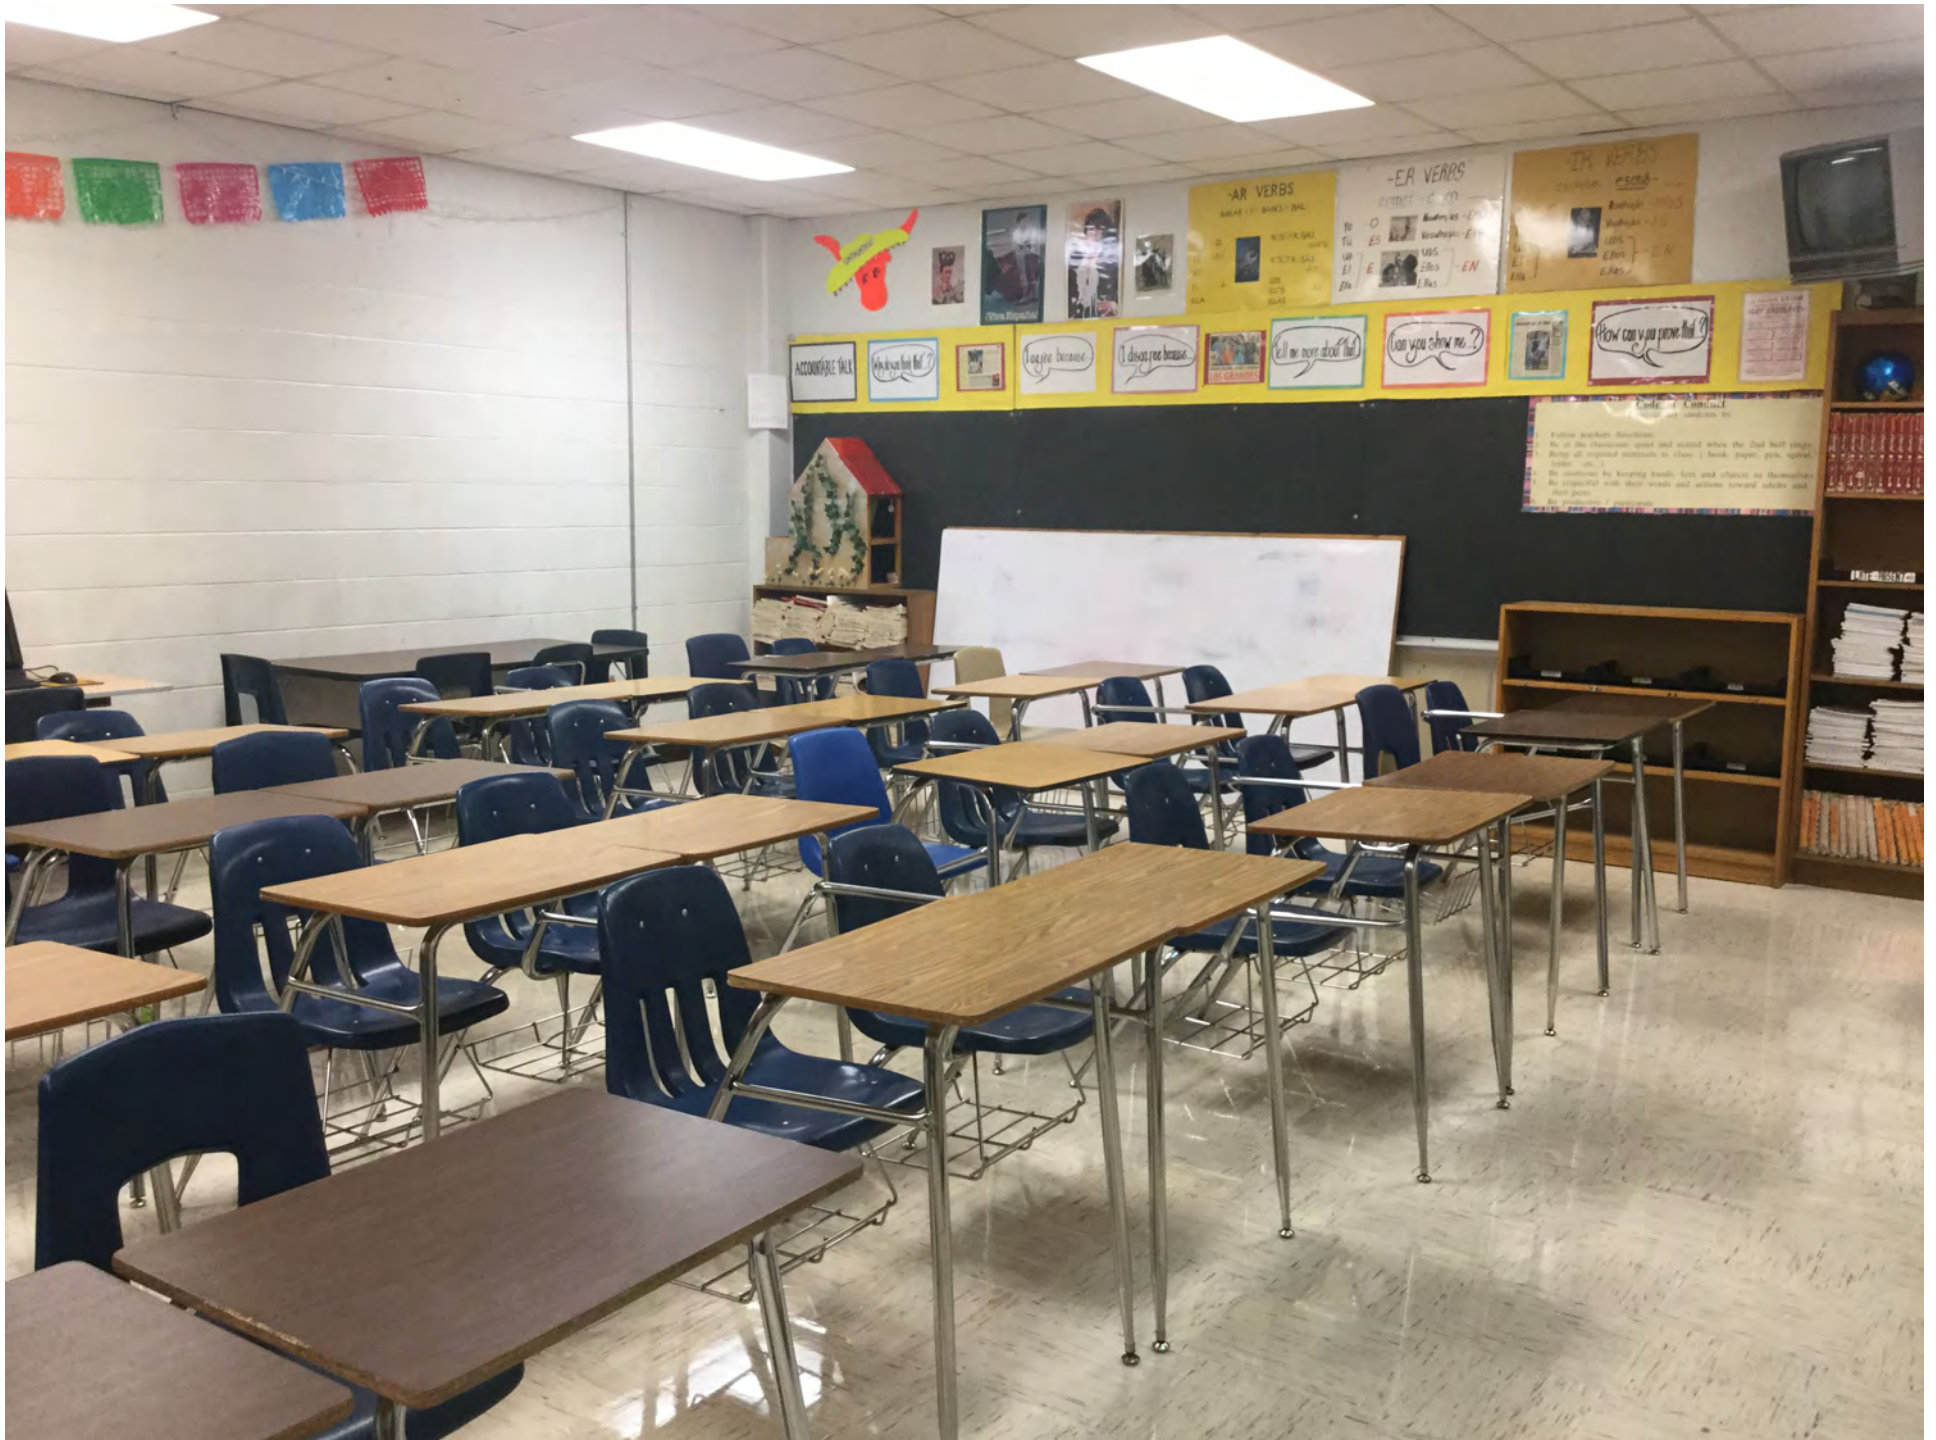
Photo 13. Typical Classroom Furniture

9 - Furniture, Fixtures & Equipment		1	2	3	4	5	N/A	4.50	
9.1	What is the current condition of the furniture?		2					Comments	0.75 1.50
1) Very unsatisfactory - damaged/non-functioning 2) Unsatisfactory - torn, bent, wrong size 3) Average - scratched/dented/marked 4) Good - not new but sturdy and clean 5) Very good - new N/A) Does not apply.								See Photo 13
