Educational Suitability Summary Report

O. Henry Middle School BLDG-047

Date: 8/17/2016 (REV1 – 11/3/2016 – Re-interview & Survey updated) **Score 63 % Average**

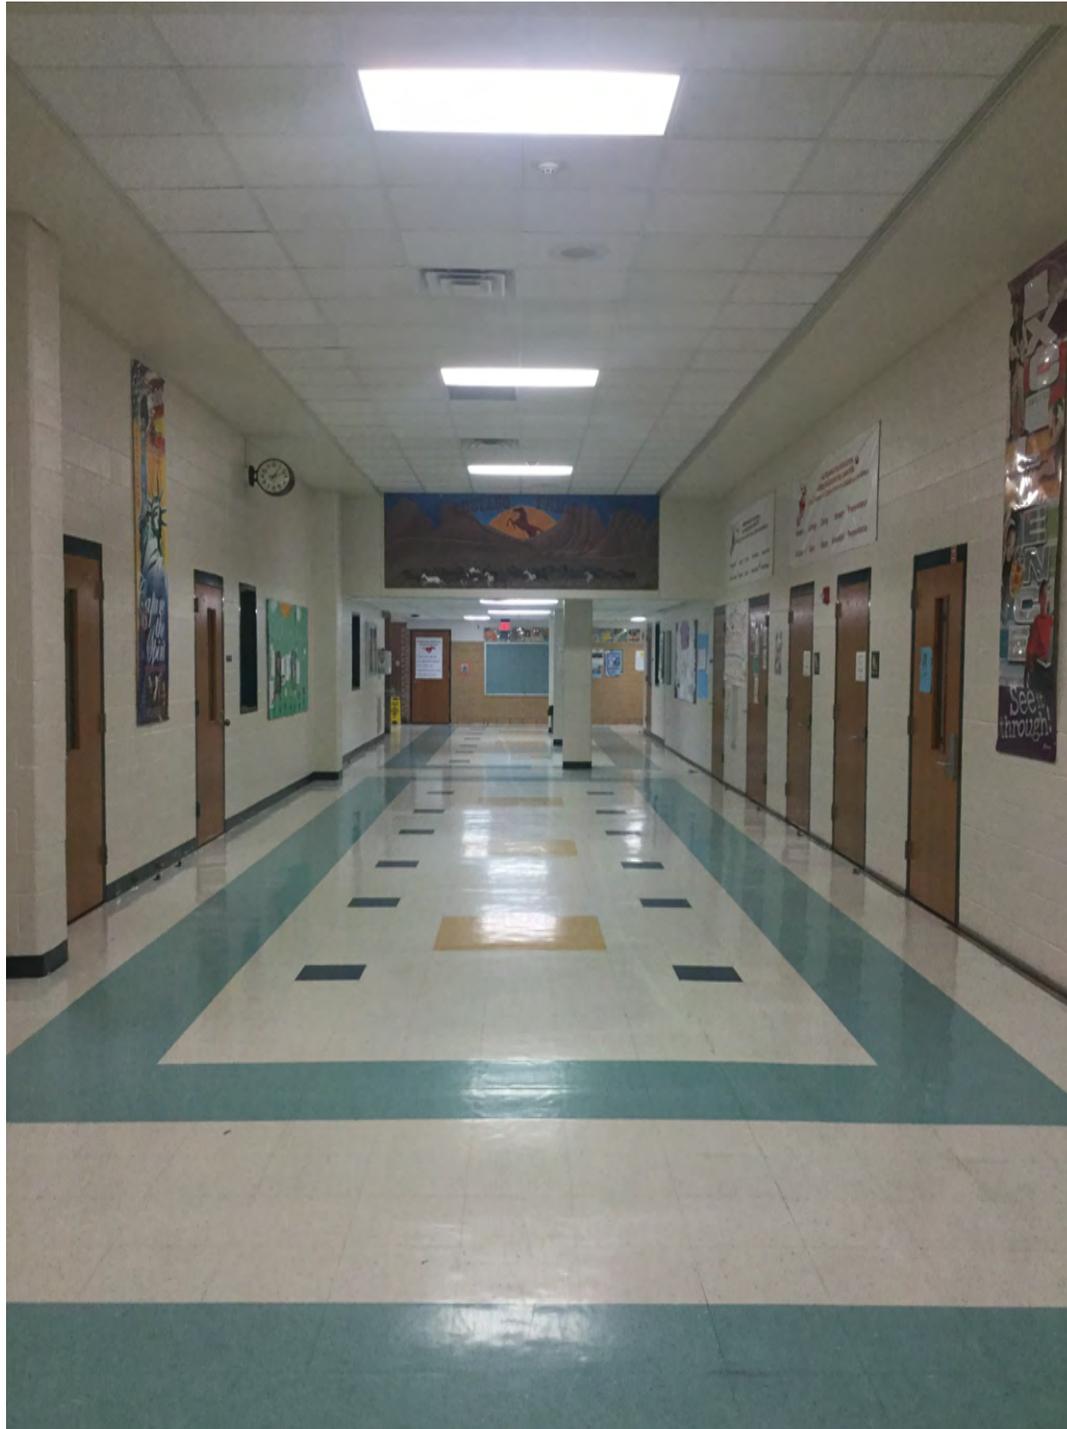
2.1 Corridor

1) Primary circulation is 5'-0" to 6'-0" wide. 2) Primary circulation is 6'-0" to 7'-0" wide 3) Primary circulation is 7'-0" to 8'-0" wide 4) Primary circulation is 8'-0"-10'-0" wide 5) Primary circulation is 10'-0"+ wide N/A) Does not apply.		Comments

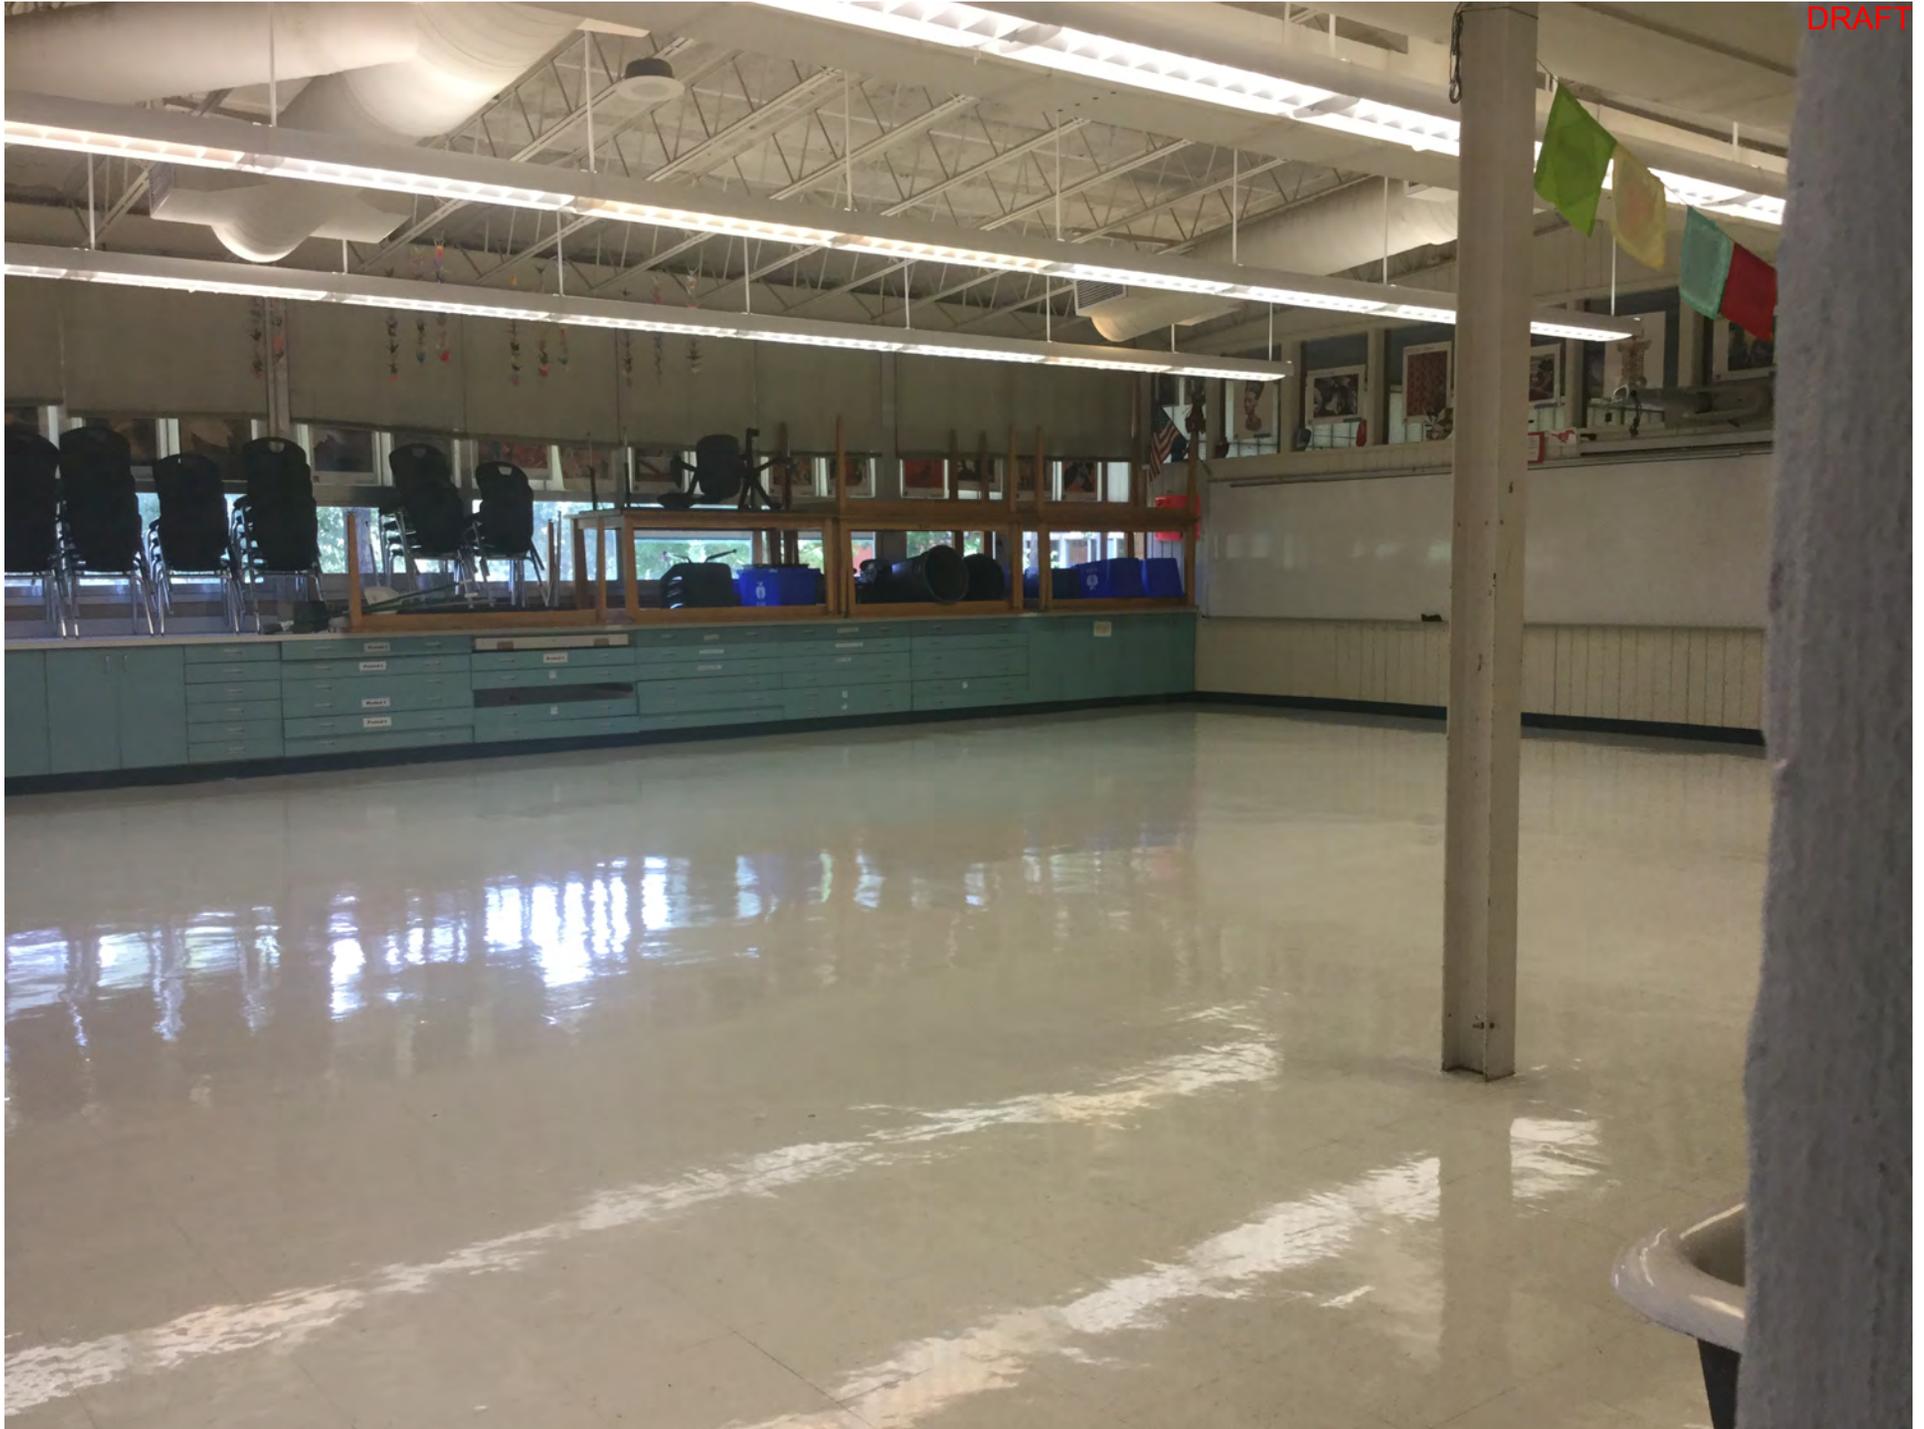
3.10 Visual Arts

3 - Academic & Co-Curricular Support - Continued		1	2	3	4	5	N/A		
3.10	Are Visual Arts spaces appropriately configured per the ed spec?				4				
<p>1) Very unsatisfactory</p> <p>2) Unsatisfactory</p> <p>3) Average</p> <p>4) Good</p> <p>5) Very good</p> <p>N/A) Does not apply.</p>								Comments	1.00 4.00
								Due to enrollment, another art room is needed. The existing art space has adequate storage and a kiln.
