## Educational Suitability Summary Report

Webb Middle School and Primary Center

Date: 08/04/2016

**Score 43% Unsatisfactory**

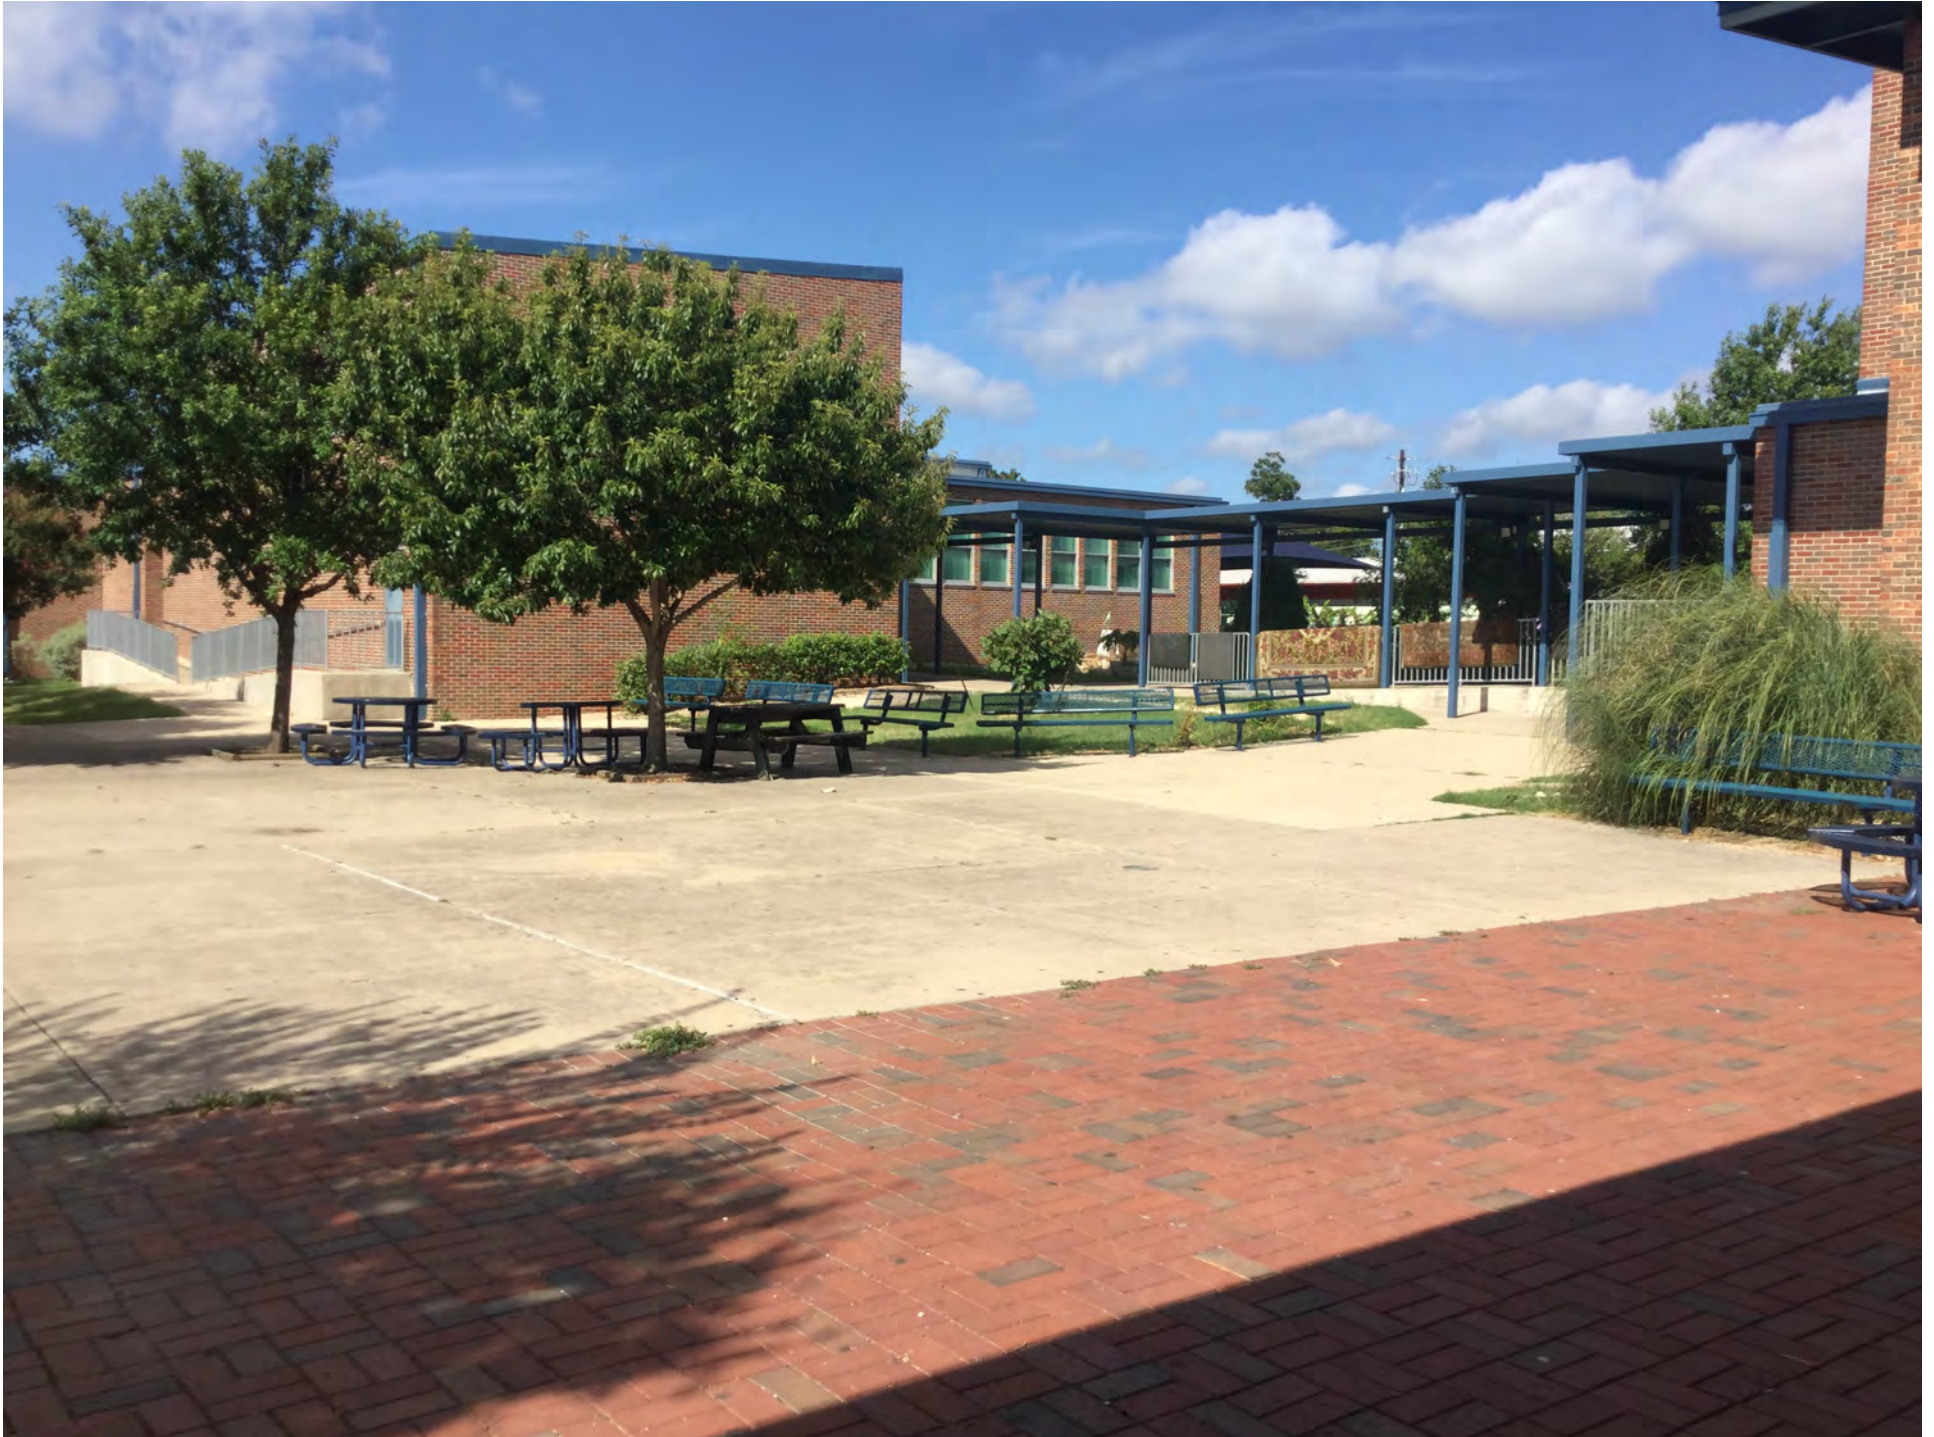
Photo 1. Outdoor Space

1.2	Are opportunities provided for outdoor learning (outdoor classrooms, gardens, etc.)?		2					Comments	1.00 2.00
	1) Outdoor space exists is not developed 2) Outdoor space for learning exists but not connected to classroom learning areas. 3. Outdoor learning spaces exist and are accessible but not in good condition. 4. Outdoor learning spaces need minor improvements to function well. 5. Outdoor learning spaces are in excellent condition. N/A) Does not apply.							There is only one common outdoor space with some furniture.	
									See Image 1

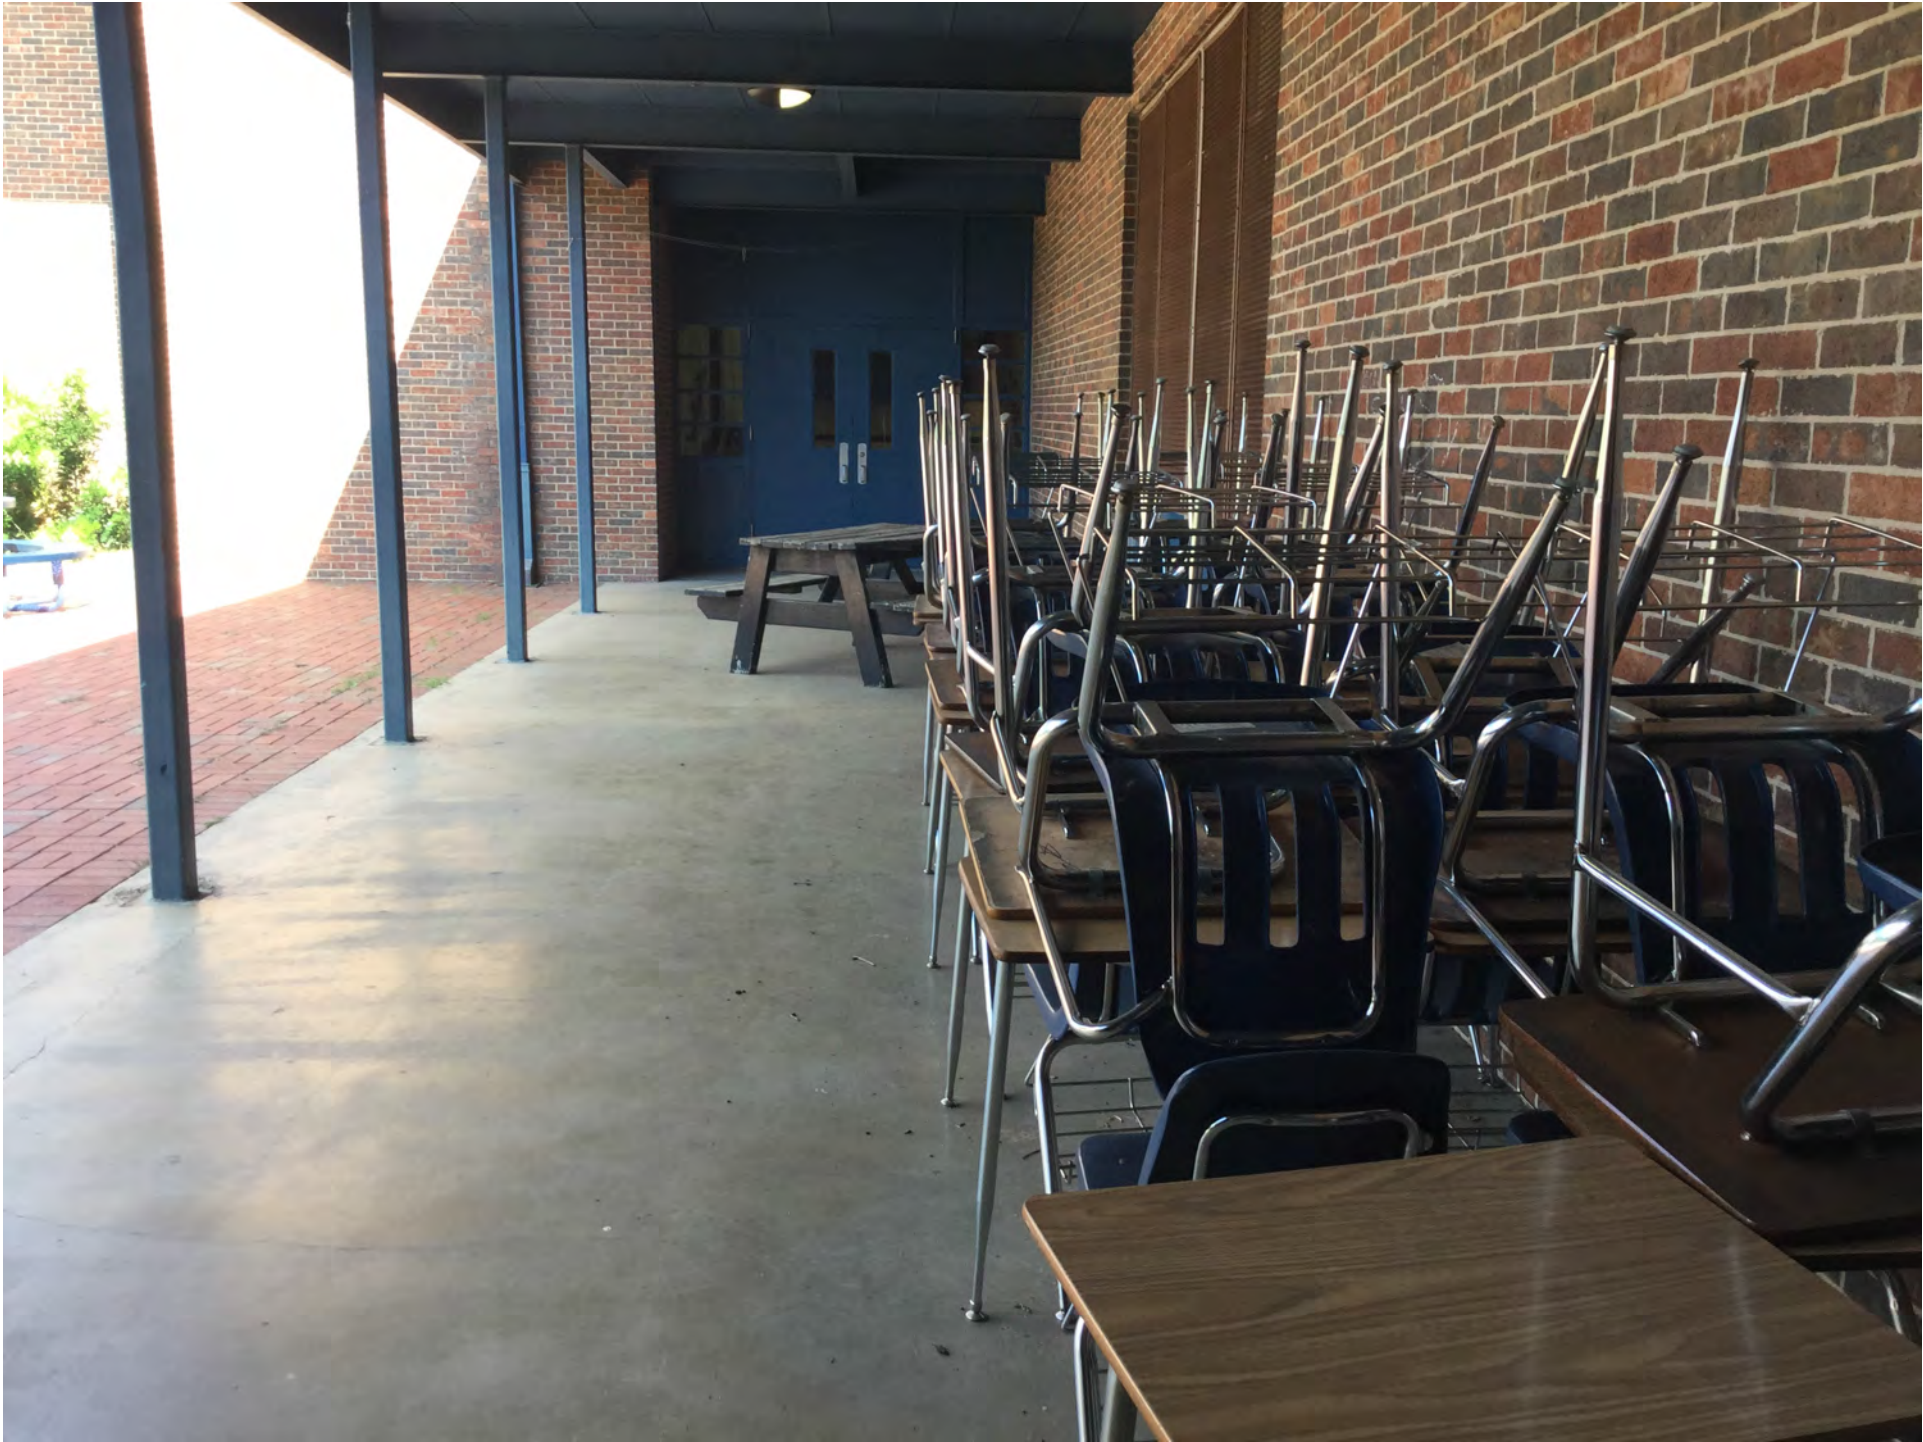
Photo 2. Hallway

2 - General Building		1	2	3	4	5	N/A		3.25
2.1	Are interior circulation routes wide enough to safely and effectively accommodate student movement?				4			Comments	0.50 2.00
								There are lockers in the corridor.

1) Primary circulation is 5'-0" to 6'-0" wide. 2) Primary circulation is 6'-0" to 7'-0" wide 3) Primary circulation is 7'-0" to 8'-0" wide 4) Primary circulation is 8'-0"-10'-0" wide 5) Primary circulation is 10'-0"+ wide  N/A) Does not apply.									See Image 2

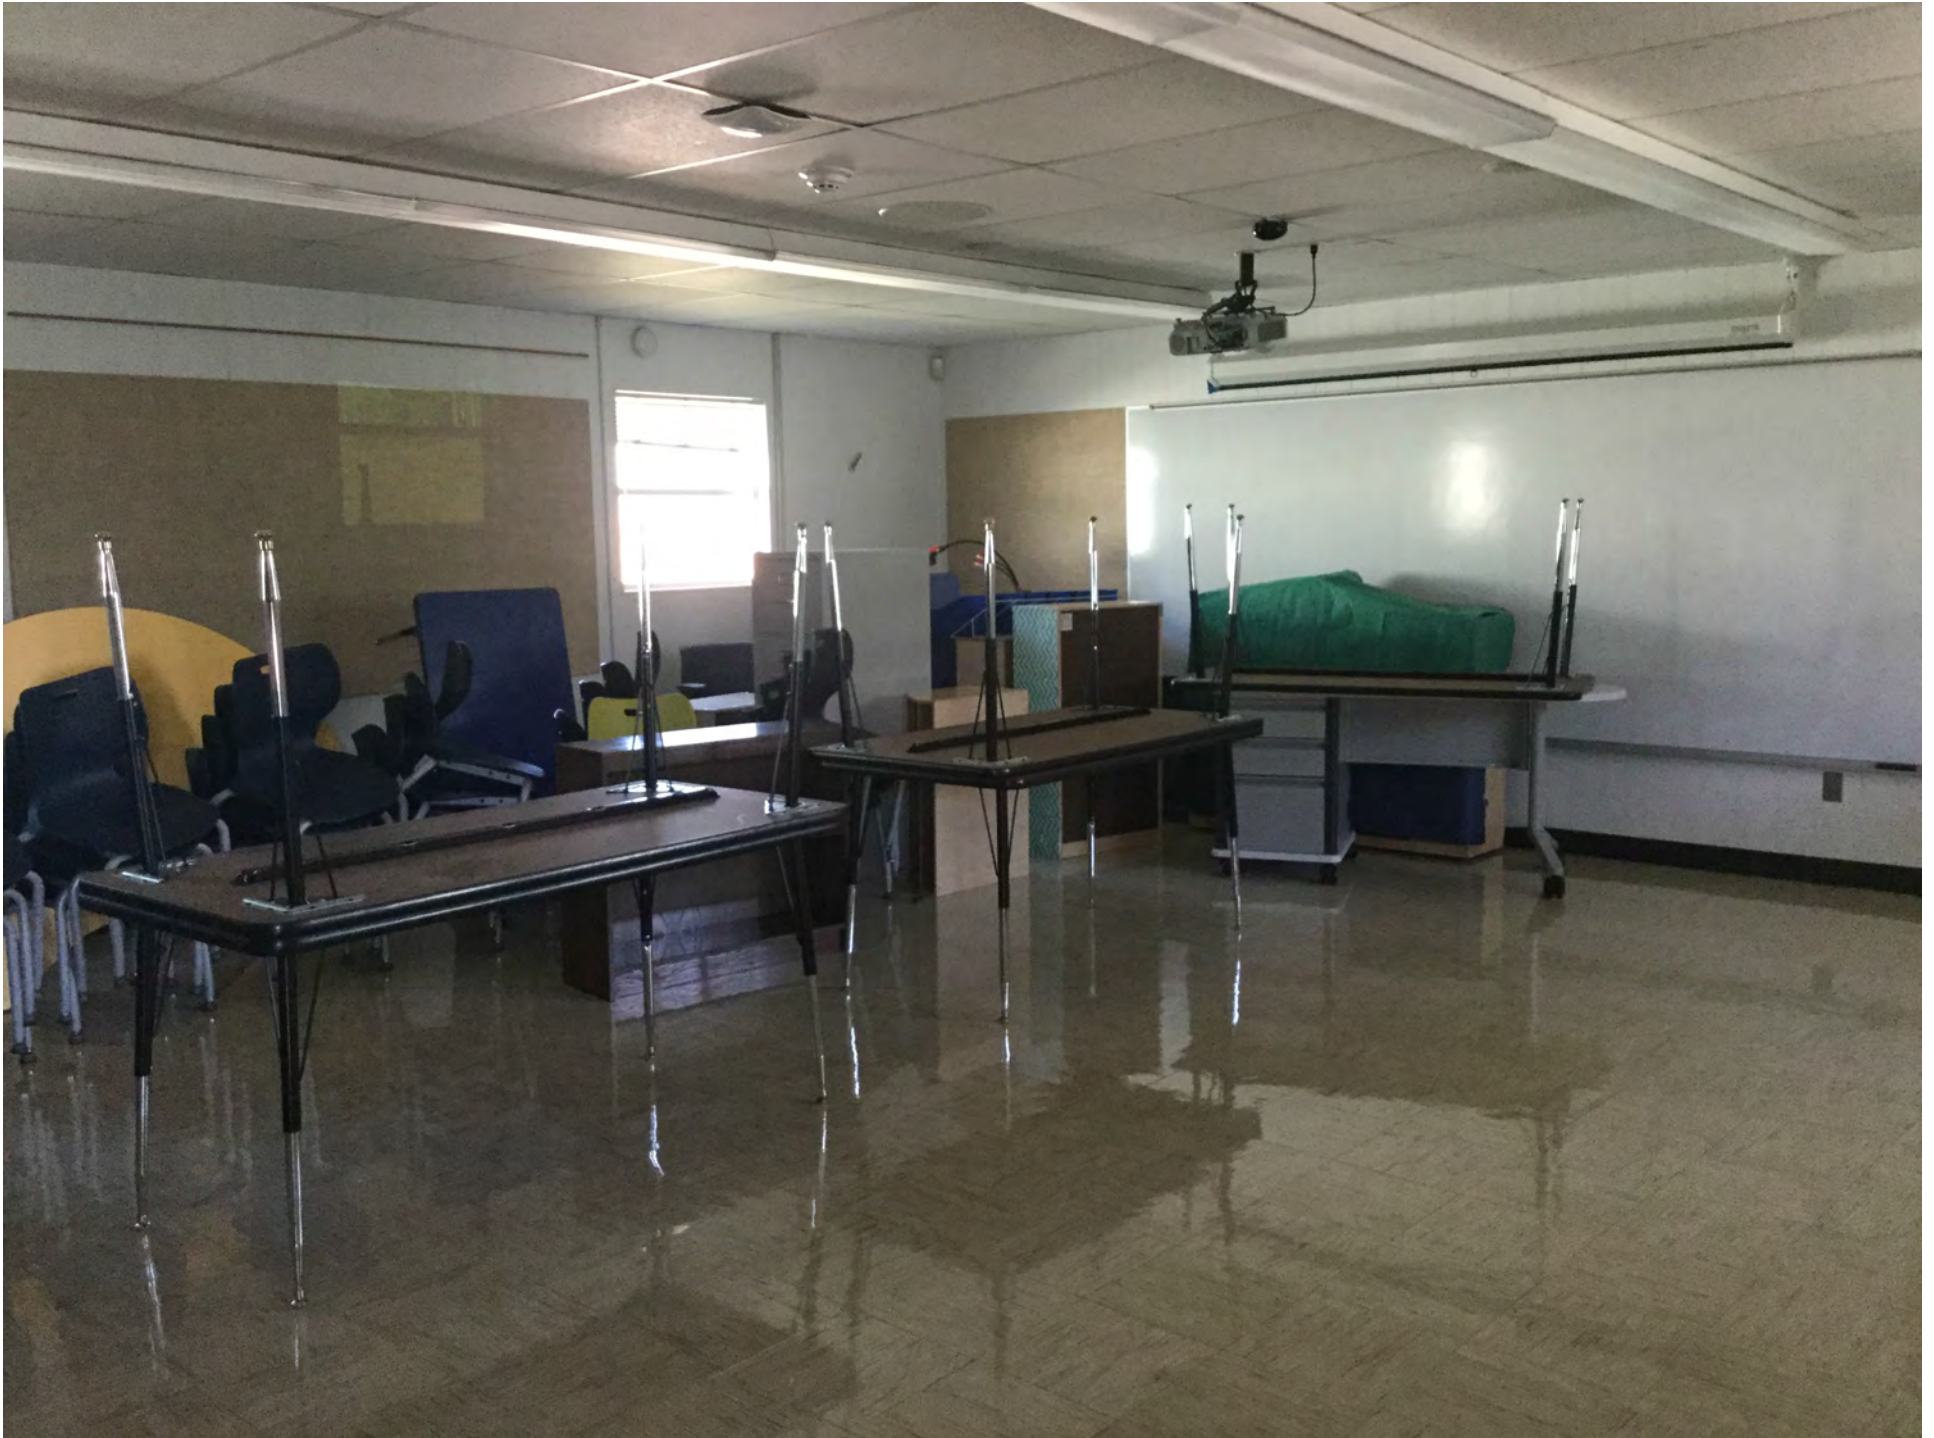
Photo 3. Kinder Class

3 - Academic & Co-Curricular Support		1	2	3	4	5	N/A	36.00	
3.2	Are Pre-K and Kinder classrooms appropriately configured per the ed spec? (elementary school only)	1						Comments	1.00 1.00

1) Very unsatisfactory - Too small, awkward layout, does not meet needs 2) Unsatisfactory - Too small, only one area for all teaching methods, limited flexibility 3) Neutral - Moderate size, two areas for different teaching methods, some flexibility, access to student storage/casework 4) Satisfactory - Good size, at least two zones for different teaching methods, flexibility and student storage, not new 5) Very Satisfactory - Good size, two zones for different teaching methods, flexibility and student storage/casework, adequate display area and visual teaching tools N/A) Does not apply.								The Kinder spaces are very limited. The entire K-4th grade classrooms, gym space, cafeteria, and resource spaces are housed in portables.	See Image 3

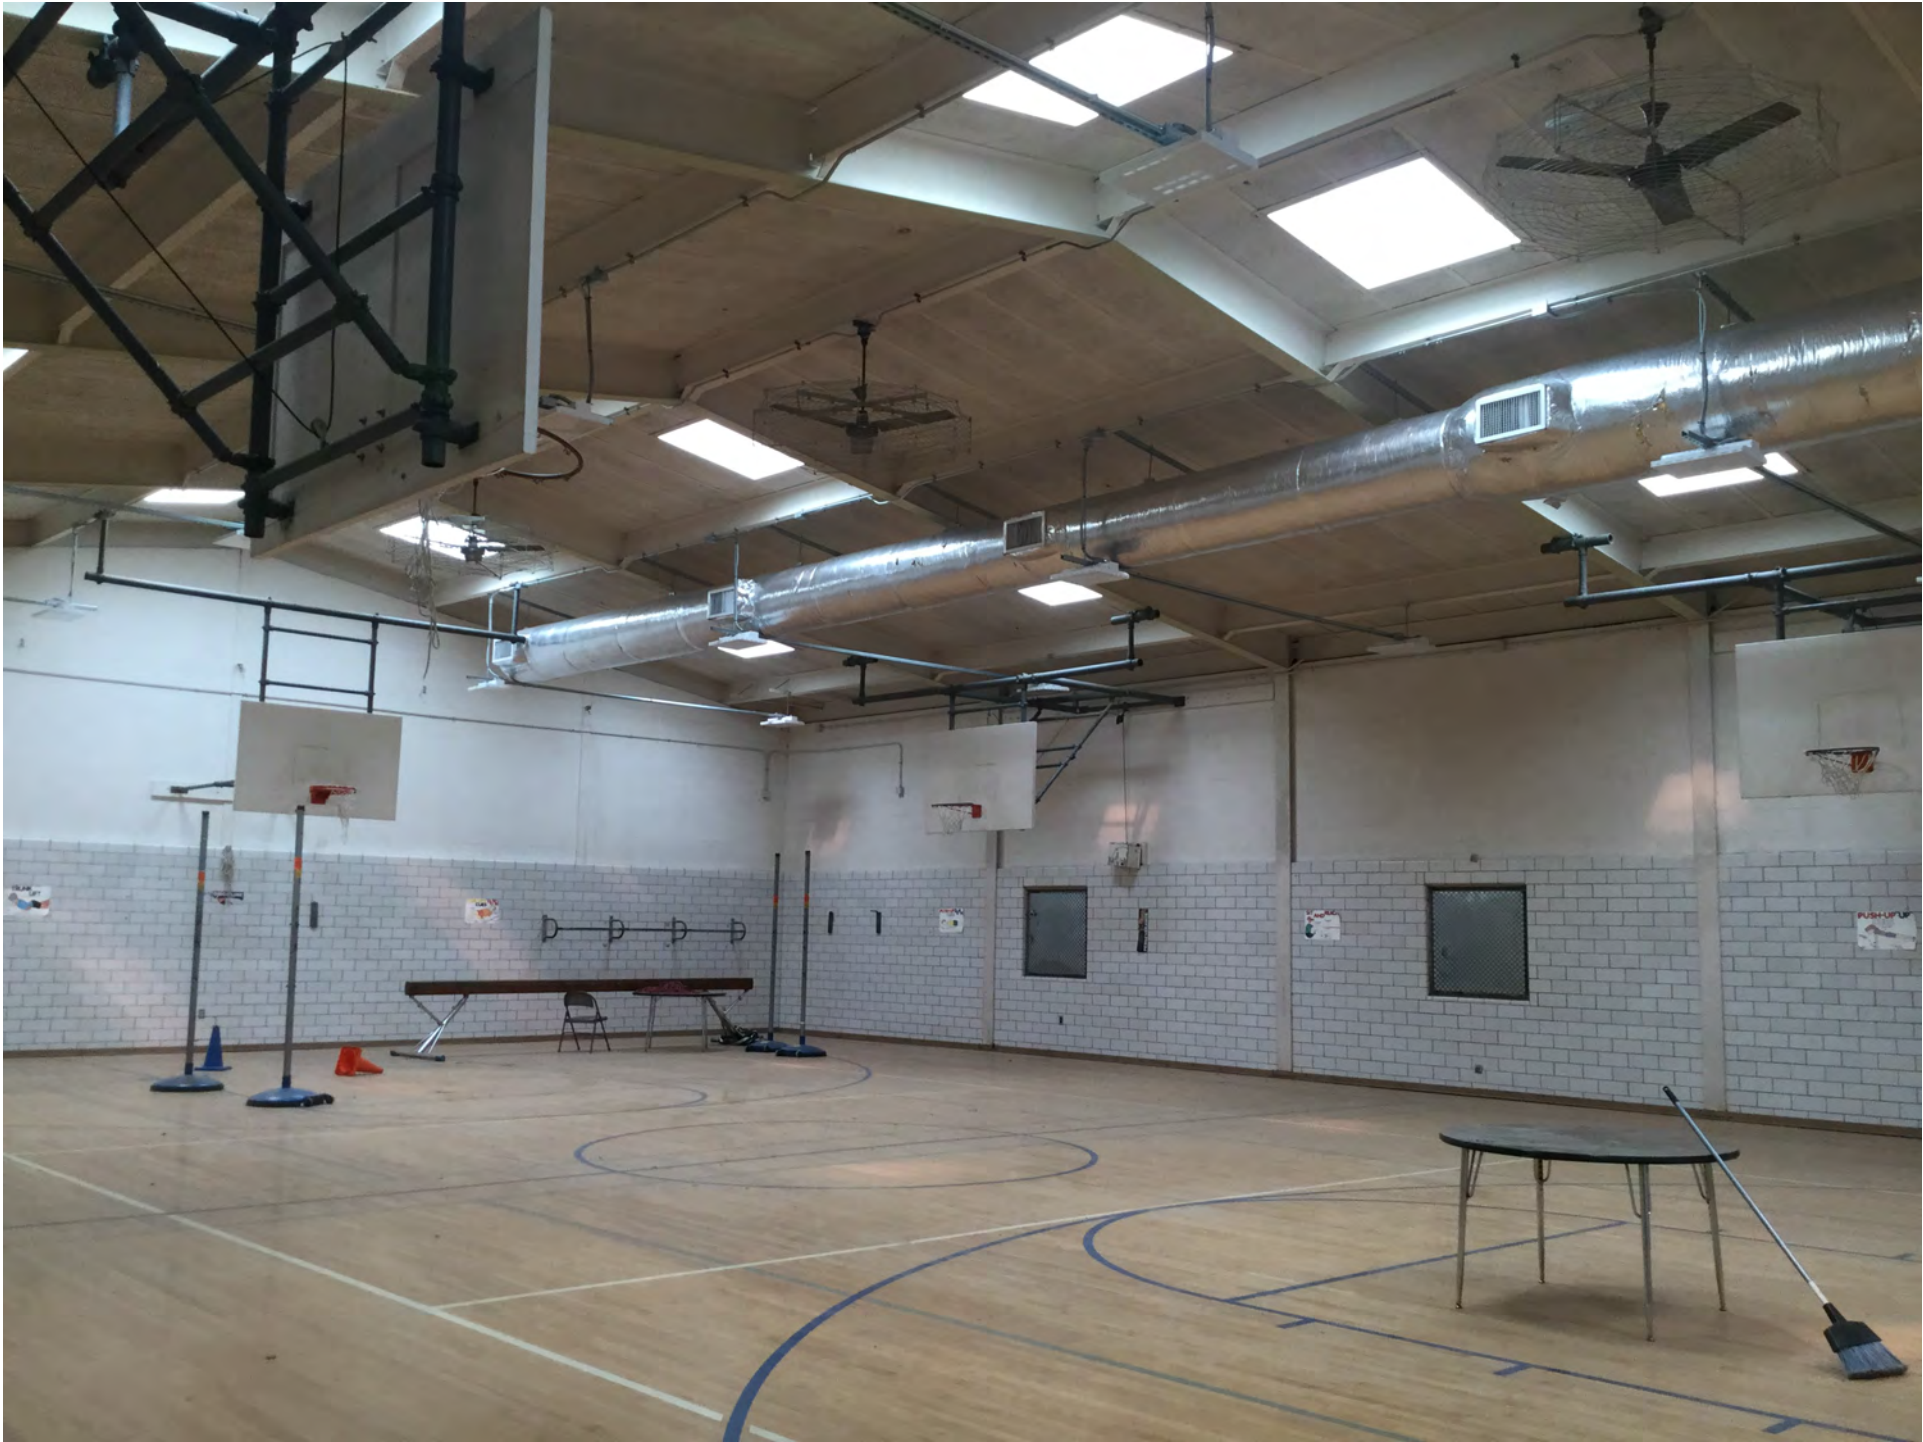
Photo 4. Gym

3 - Academic & Co-Curricular Support - Continued		1	2	3	4	5	N/A		
3.6	Are Physical Education and Athletic spaces appropriately configured per the ed spec?		2					Comments	1.002.00

1) Very unsatisfactory 2) Unsatisfactory 3) Average 4) Good 5) Very good N/A) Does not apply.								The gym is undersized for the student body. The Primary Center portion of the building is using a portable for a gym which is very unsatisfactory.	See Image 4 & 5

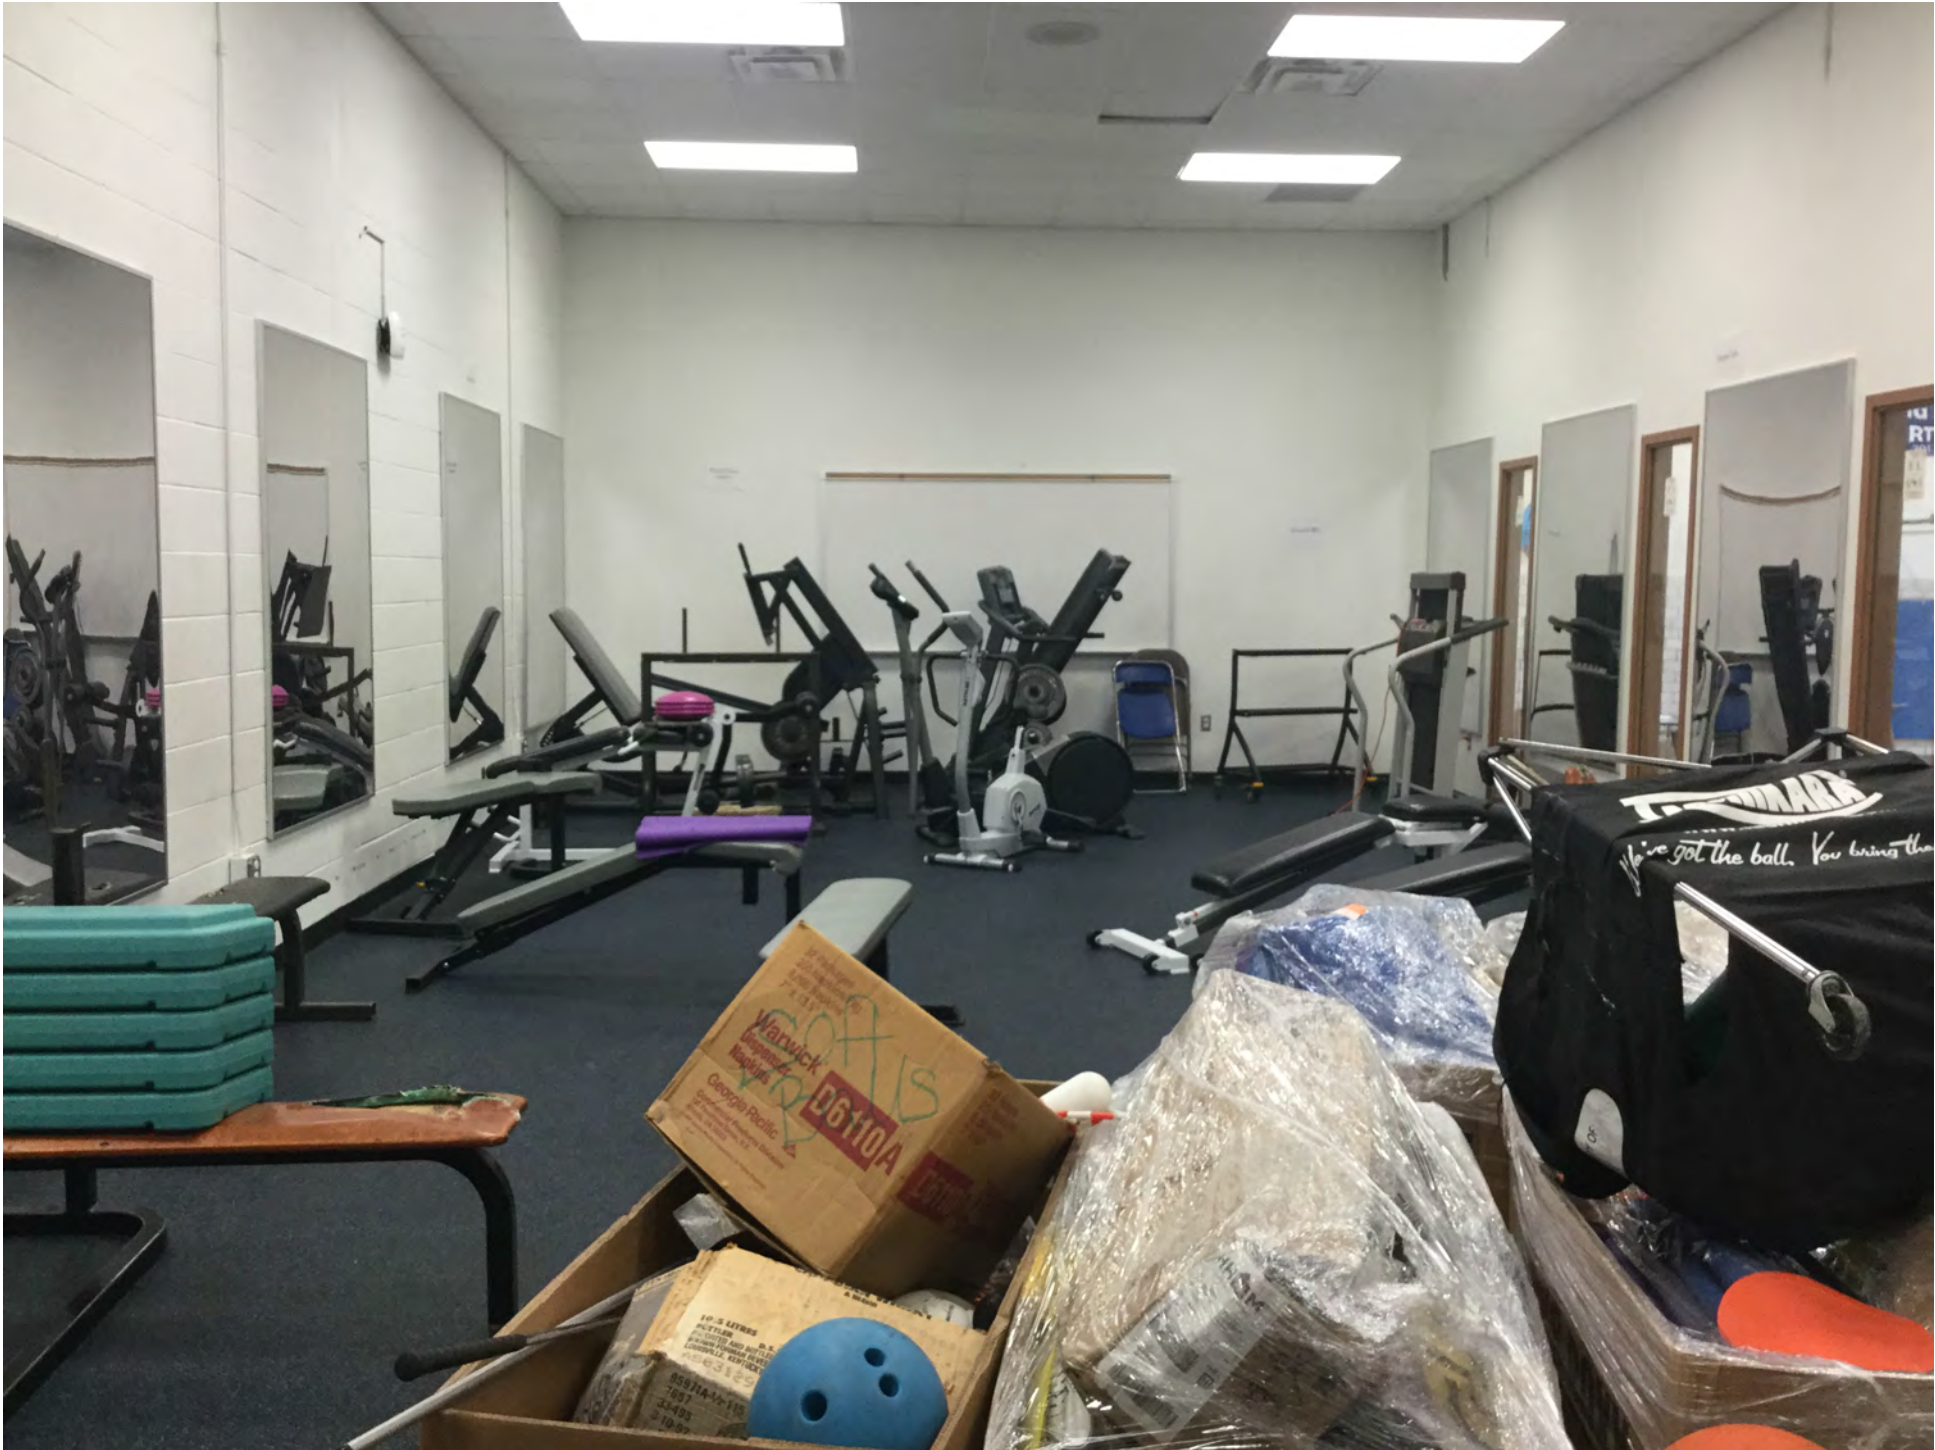
Photo 6. Gym Support

3.7	Are Physical Education and Athletic <b>support</b> spaces appropriately configured per the ed spec?		2					Comments	1.002.00
1) Very unsatisfactory - Support spaces are disconnected from served spaces, too small, do not meet needs 2) Unsatisfactory - Support spaces are connected, but too small, inadequate for needs 3) Average - Connected, moderate size, but need some renovations or updates to function well 4) Good - Connected, good size/layout, meets needs/functions well 5) Very good - connected, generous size, nice condition, functions appropriately N/A) Does not apply.								The weight room needs new equipment and ventilation. The locker room needs some upgrades. Portions of the shower area have been repurposed for storage. The bleachers are undersized for the school. The primary center is using a portable for a gym. This has unacceptable support space.	See Image 6

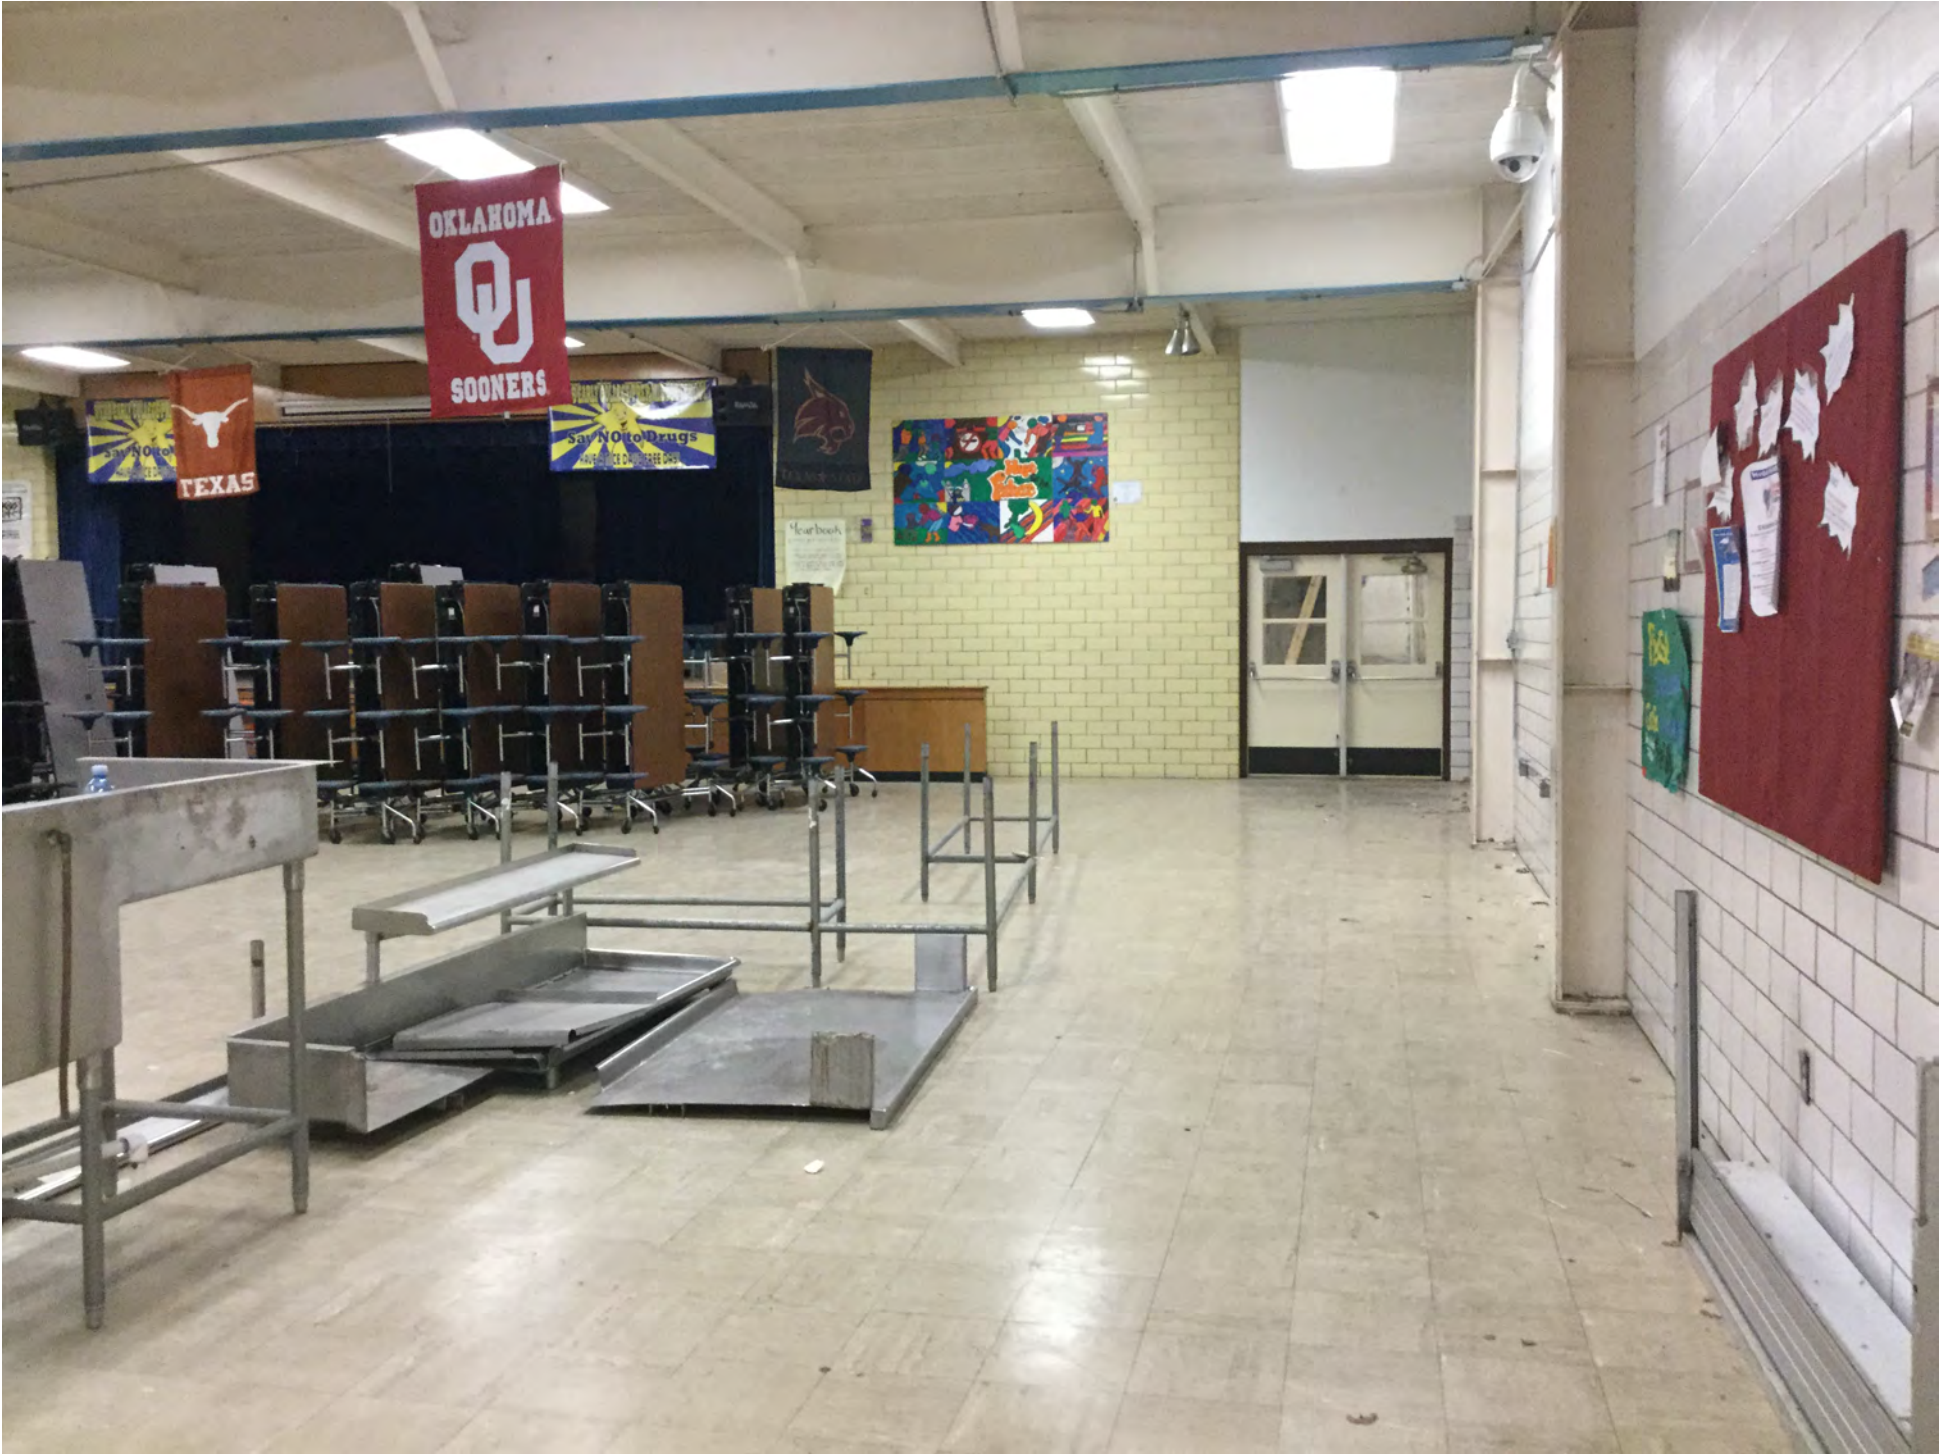
Photo 7. Cafetorium

3.16	Are the student dining facilities appropriately configured?								3					Comments	1.00	3.00
1) Very unsatisfactory - Too small, poor circulation, inflexible seating in poor condition 2) Unsatisfactory - Too small or inadequate circulation, seating in poor condition 3) Average - moderate size, with adequate circulation, seating in okay condition 4) Good - good size, adequate circulation, seating in good condition 5) Very good - good size, adequate circulation, seating in good condition, with more than one option for eating space (ex: connection to outdoor eating space) N/A) Does not apply.													See Image 7

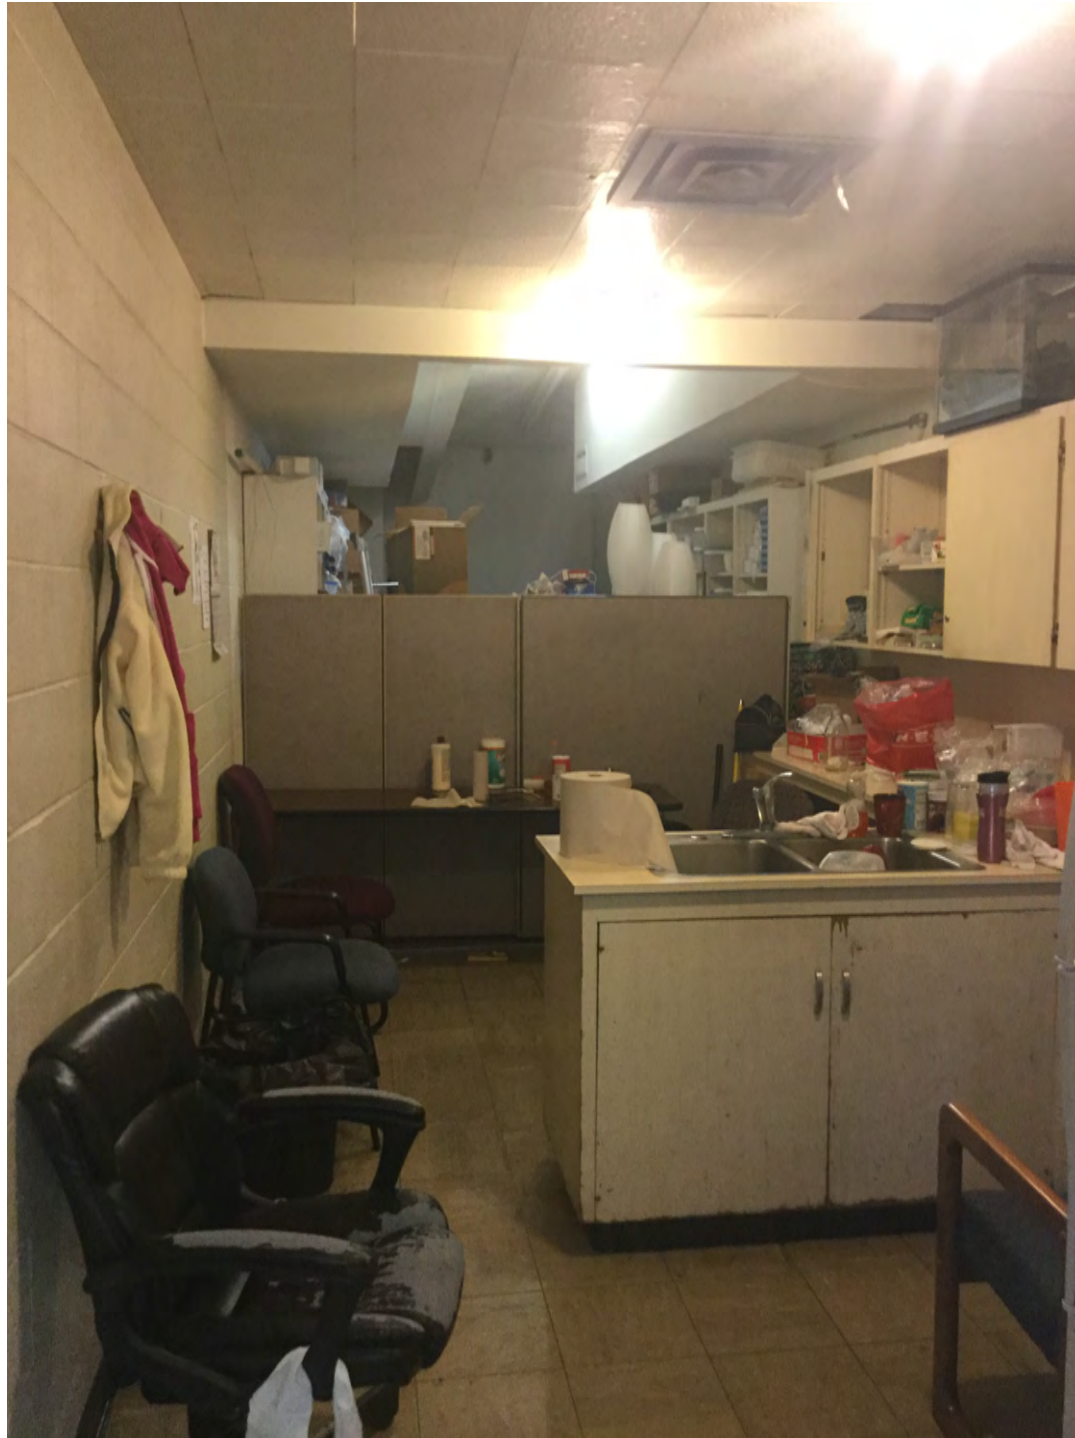
Photo 8. Storage/Office

4.3	Is there adequate storage and or support space to support project-based learning?	1						Comments	1.00 1.00
	1) Very unsatisfactory - none 2) Unsatisfactory-minimal casework/storage 3) Average - moderately sized casework 4) Good - large casework/cabinets/support 5) Very good - walk-in storage/ample support space N/A) Does not apply.							Storage throughout the facility has been repurposed into office or learning space.	
								See Image 8

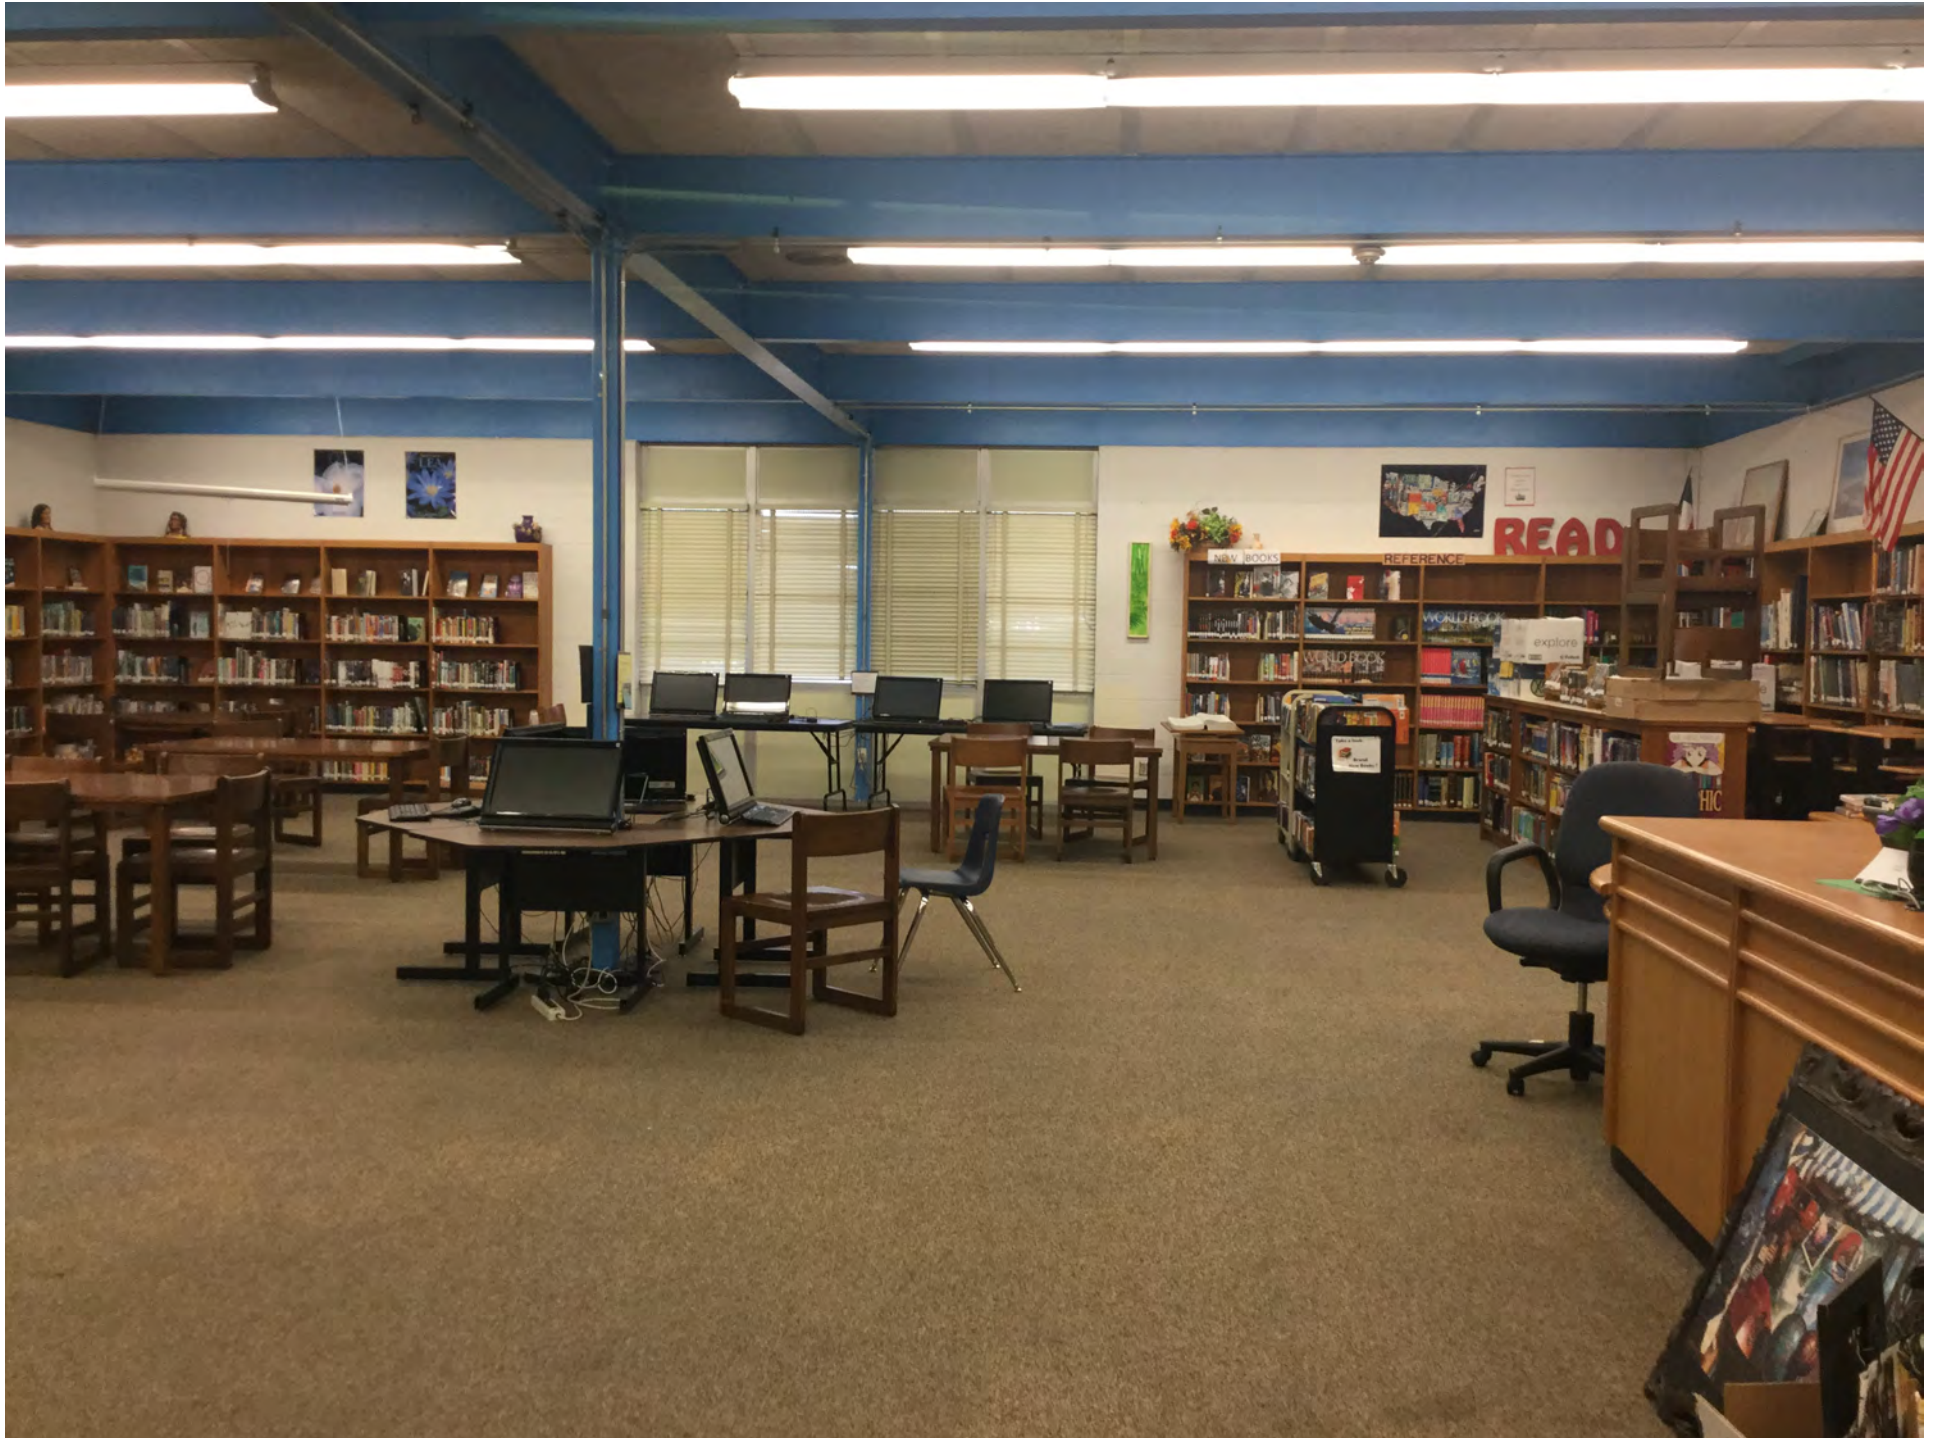
Photo 9. Library

5 - Library/Media Center		1	2	3	4	5	N/A	16.00	
5.1	Is the Library/Media Center easily accessible for the occupants and visitors to the school?		2					Comments	0.50 1.00

1) Very unsatisfactory 2) Unsatisfactory 3) Average 4) Good 5) Very good N/A) Does not apply.							The library cannot be locked off from rest of campus and has very low natural lighting. The library for K - 4th grade is in a portable with very limited space and natural light.		
See Image 9
