Educational Suitability Summary Report

Anderson High School

Date: 01/07/2021

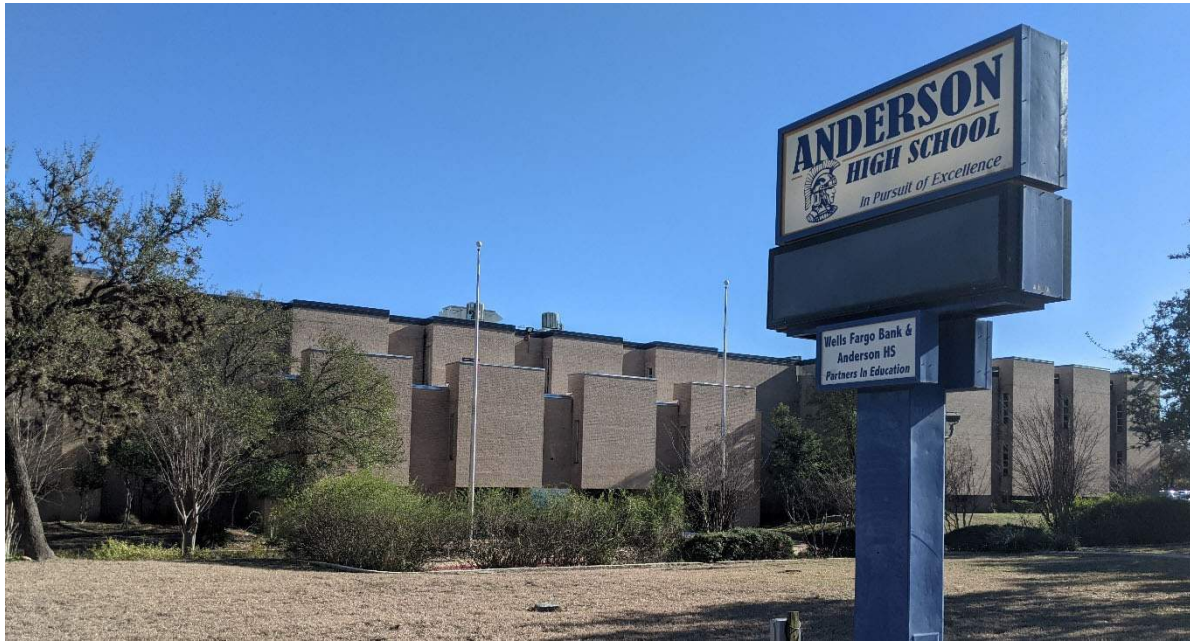
Monument sign at main drop-off. No entry canopy or building signage.

The school has two digital monument signs. The one on Mesa Drive has not worked in over 10 years and needs to be removed. The one at the corner of Steck and Mesa is over 10 years old and needs to be refurbished.* There are no entry canopies to assist with wayfinding. Buses and vehicles function well at drop-off but mix for pickup. Buses heading south stack in the south parking lot. Special education buses use the student lot on the east side of campus. There is no canopy for the special education students waiting for the bus.

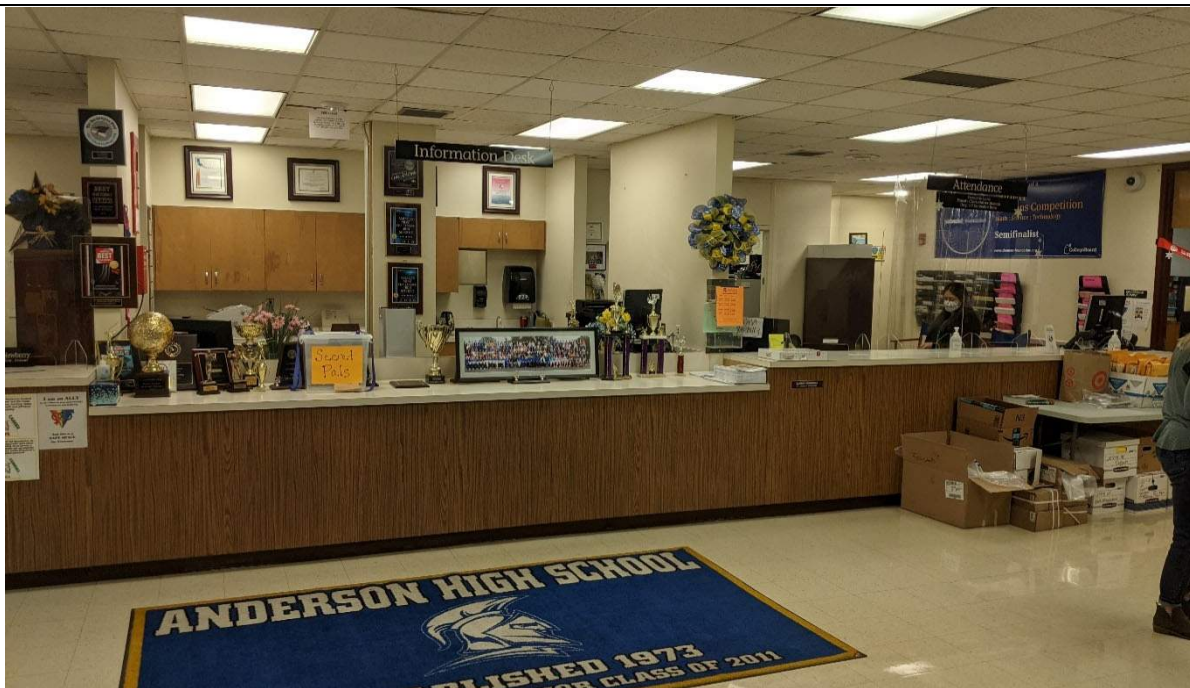
Administration: Large reception, but finishes are dated and does not feel welcoming.

[Redacted] The administration space is large, but the furniture and finishes feel dated and do not create a welcoming environment. The Formica countertops are worn through to the Masonite underneath.

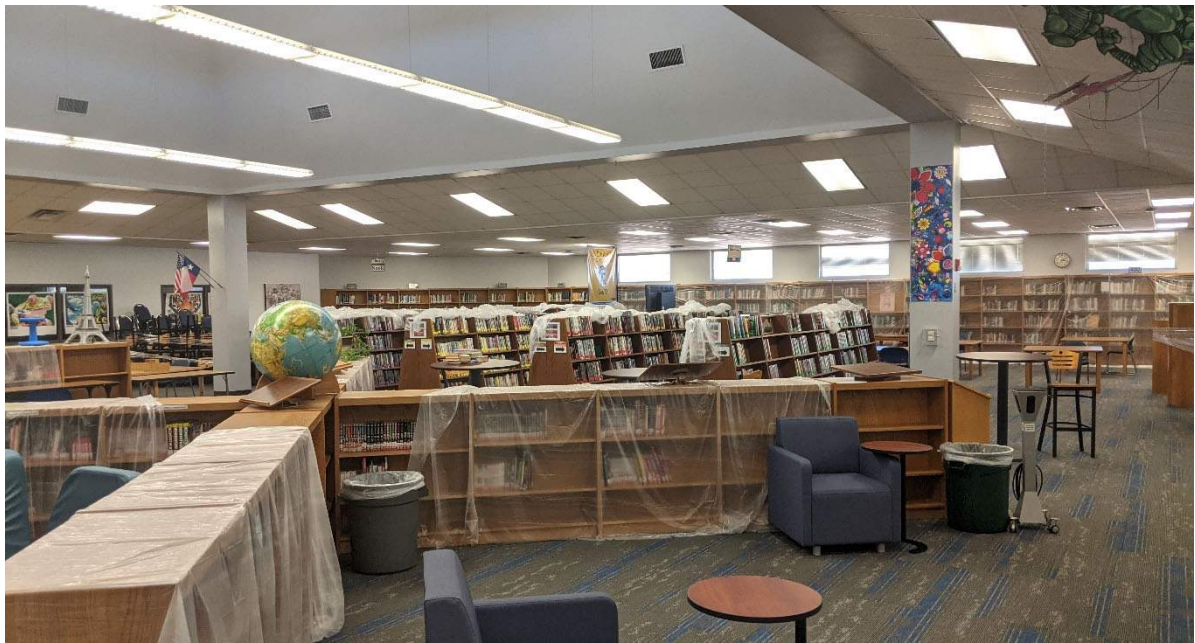
Media Center: Library has skylights, and some informal seating is present.

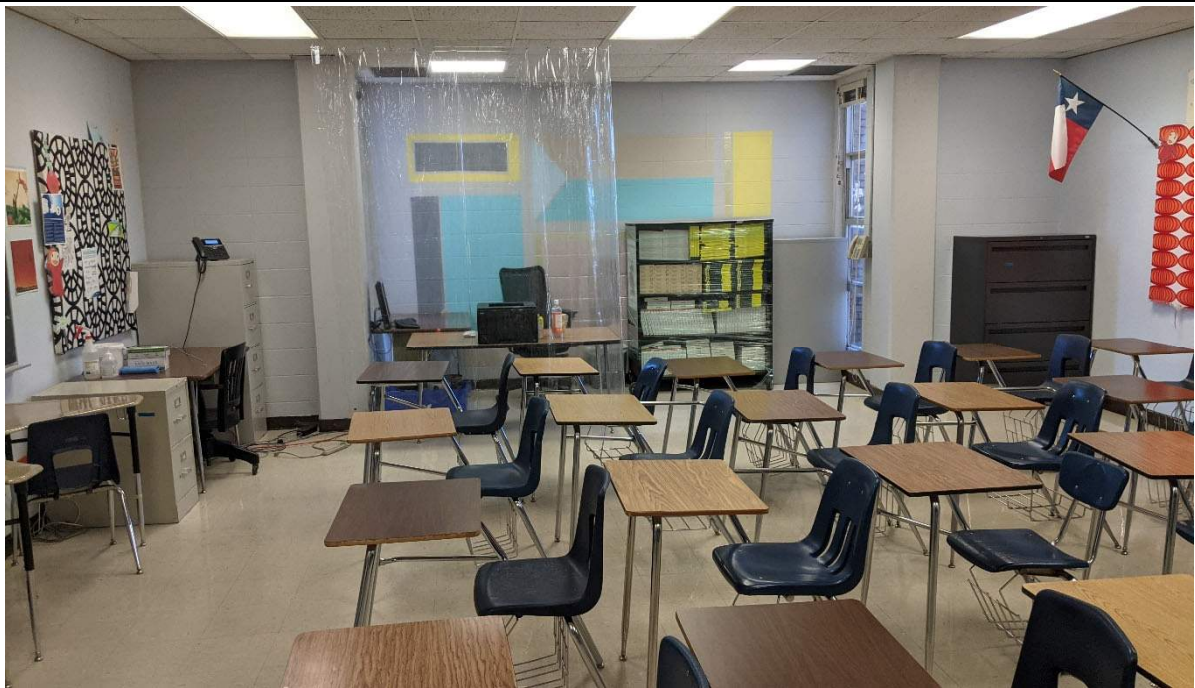
Academics & Learning: Typical studio has limited natural light and no views. Furniture is a mixture of connected desk / chair combinations and loose table and chairs.

Typical studios are 800 square feet and consist of a single space for teaching. There is no transparency to the corridor or designated breakout areas, meaning teachers cannot divide classes into different group sizes. In some learning neighborhoods, small conference rooms are available, but not always for student use. There are three special education spaces, but only two have an accessible

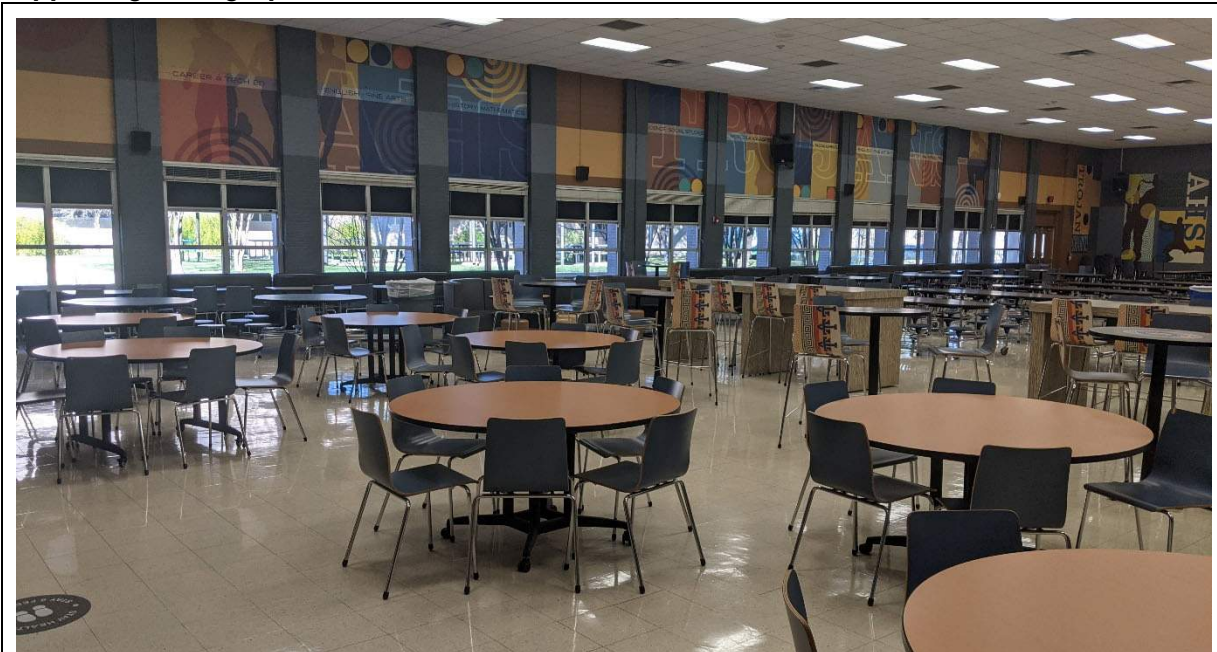
Food Services: Cafeteria is undersized but has a variety of furniture and natural light.

The cafeteria is undersized by about 5,000 SF for student capacity (~2,200 students). The school has only one lunch period, and students are allowed to eat anywhere on campus. The courtyards near the cafeteria have a good mix of covered and uncovered seating areas.

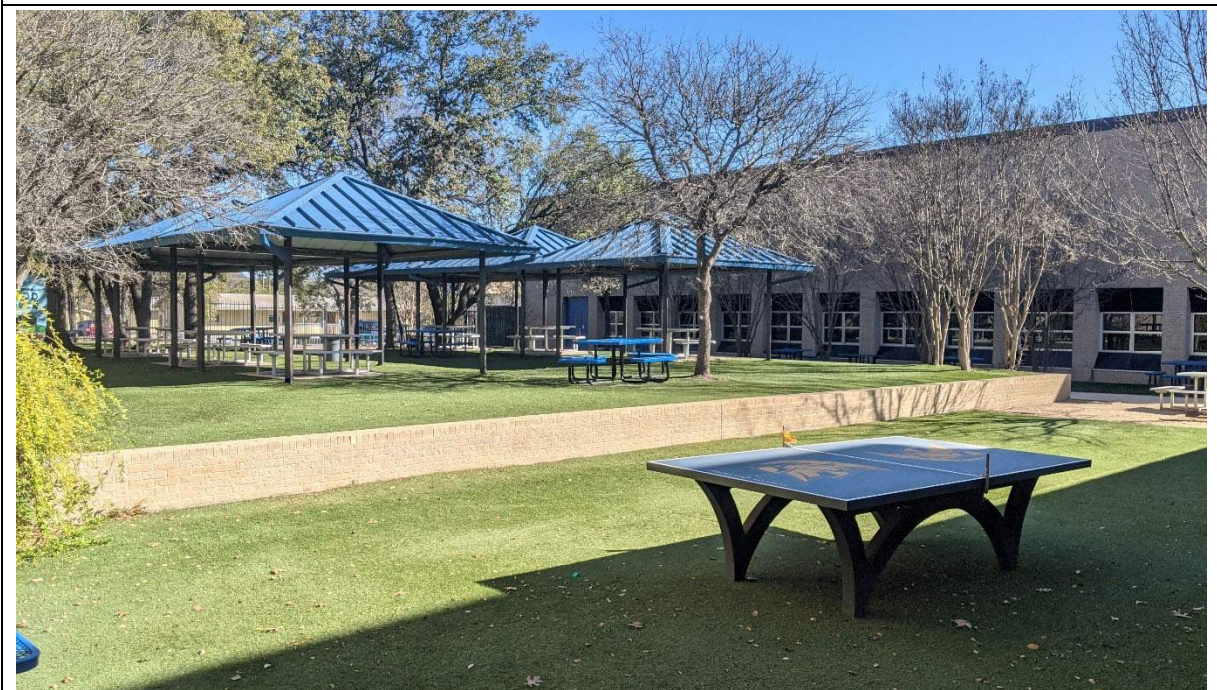
Outdoor Learning: Turfed outdoor area with covered pavilions and multiple eating areas. Artificial turf was completed through a private donation and is about 10 years old. This area is critical to the school to function for overflow space for cafeteria and outdoor classrooms.

Outdoor learning takes place on the turf courtyard near the cafeteria. The area has some cover but little support for a true learning space; no power or screens are provided, and seating is not ideal for learning. The learning garden is small and in poor condition. No rain garden, rain collection cisterns, or nature trails are present on the campus.

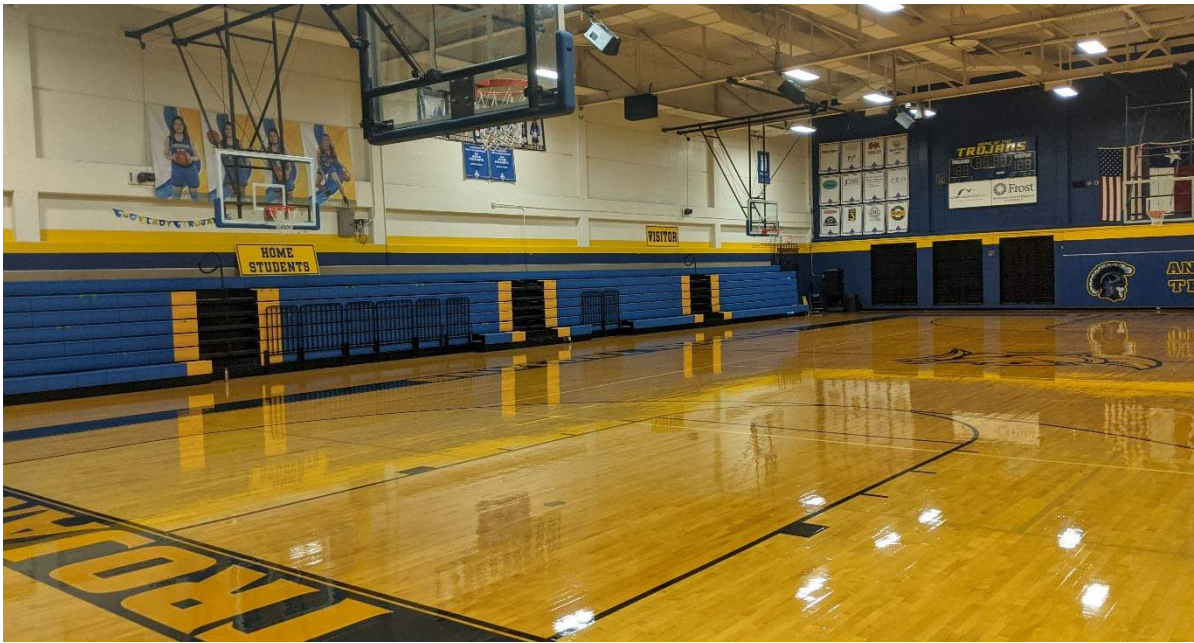
Athletics and Wellness: Gym does not meet current Ed Spec but is in good condition. It is significantly smaller at 10,100 SF than the 16,400 SF per Ed Spec.

Physical education spaces do not meet the Ed Spec. The main gym is undersized and cannot accommodate all spectators. The secondary gym is small with no natural light, but the dance gym is in good condition. There is only one weight room provided on campus and the room has ventilation and sanitation issues. The school has a full-size track, and the turf field is in very good condition. The baseball field is undergoing improvements and can host games.

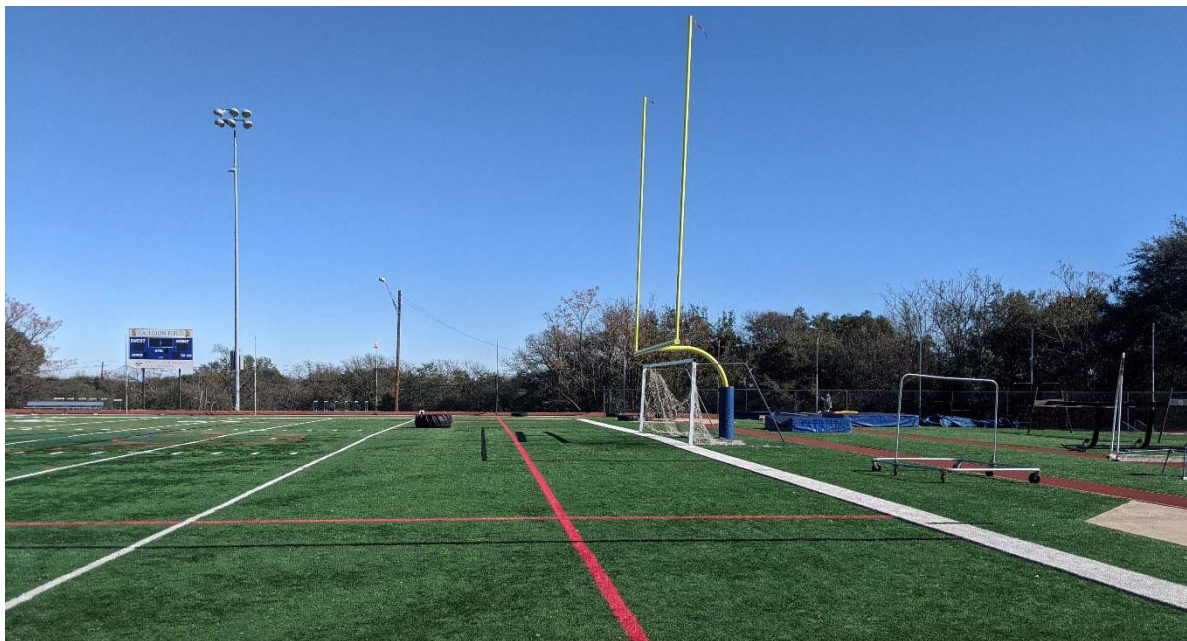
Athletics and Wellness: Turf field is in good condition and striped for a wide variety of sports.

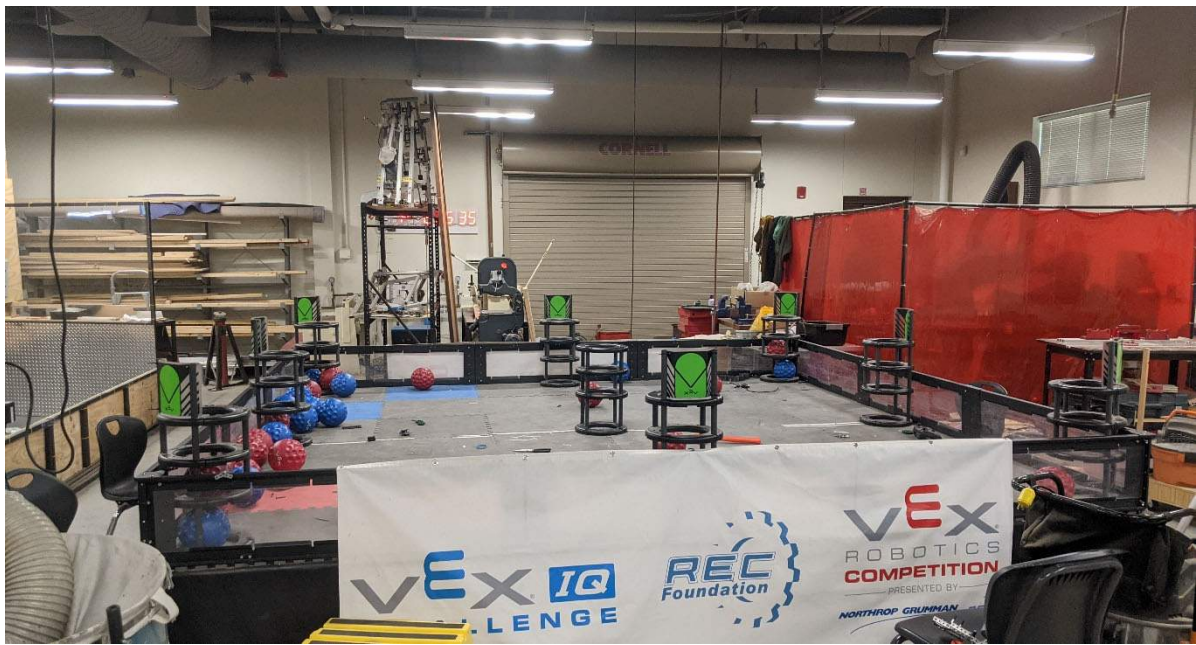
CTE: Robotics competition space is next to manufacturing and wood shop.

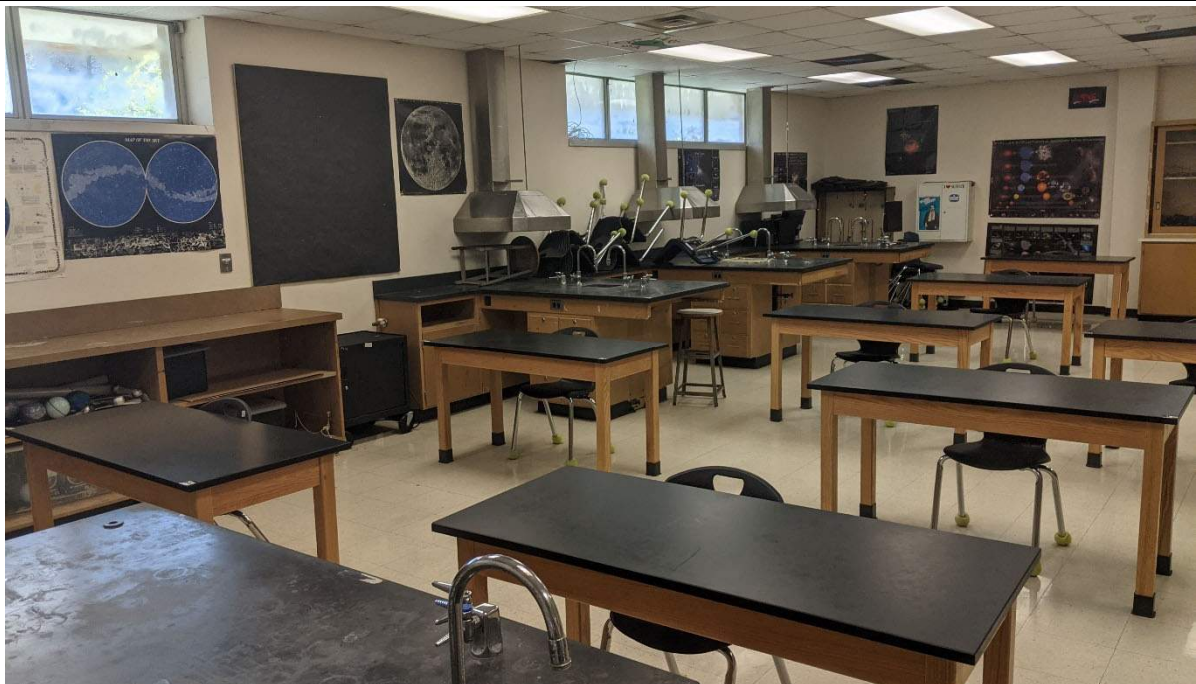
Academics & Learning: Science lab with small clerestory windows. Furniture is dated but in adequate condition. It was noted by the District Project Manager that in many locations the casework is in poor condition and should be replaced.

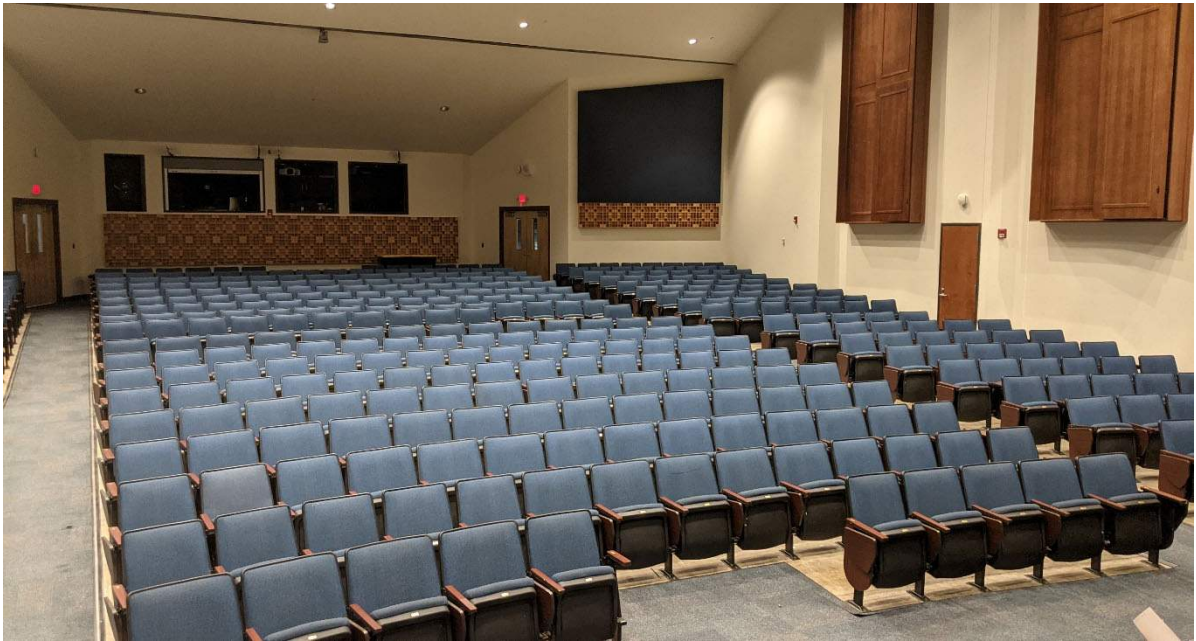
Visual and Performing Arts: Theater seating for over 400. Wall treatments have been added over the years to improve acoustics.

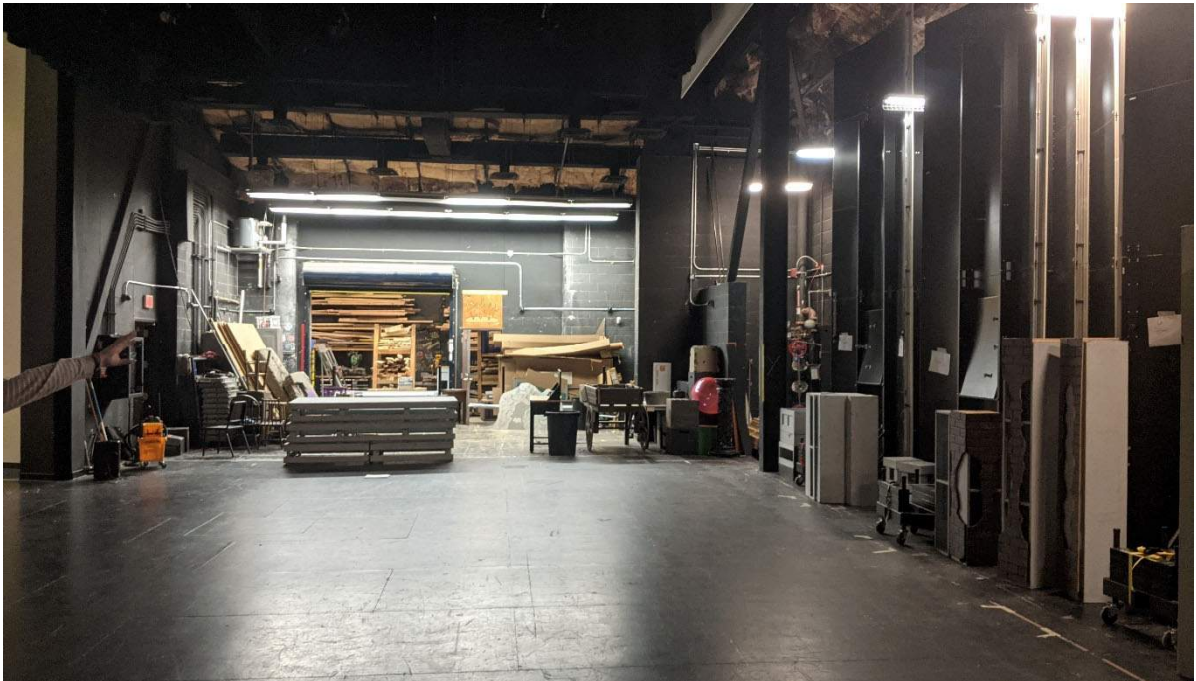
Visual and Performing Arts: Theater stage with attached scene shop. The theater has recently undergone electrical upgrades via private donation. The stage and wing space are undersized per Ed Spec. It was also noted by Fine Arts Director that the proscenium is not wide enough for a modern theatrical production.

10.6	Are theater and support spaces appropriately configured per the ed spec?		2					Comments	1.00 2.00	
1	Very unsatisfactory - Too small, missing program spaces								According to Arts Director, for a modern production, the proscenium is not wide enough. (Per Ed Spec, the stage and wing space is undersized by approximately 1,000 SF.) Black box theater is in an ad hoc space. Not proper black box. There is no theater/drama studio. Stage has a scene shop.	
2	Unsatisfactory - Too small, poor condition									
3	Neutral - Adequate size, adequate condition, needs updates or renovations to function well.									
4	Satisfactory - Good size, good condition									
5	Very Satisfactory - Generous size, excellent condition									
N/A	Does not apply
