Educational Suitability Summary Report

Ann Richards School for Young Women Leaders

Date: 01/28/2021

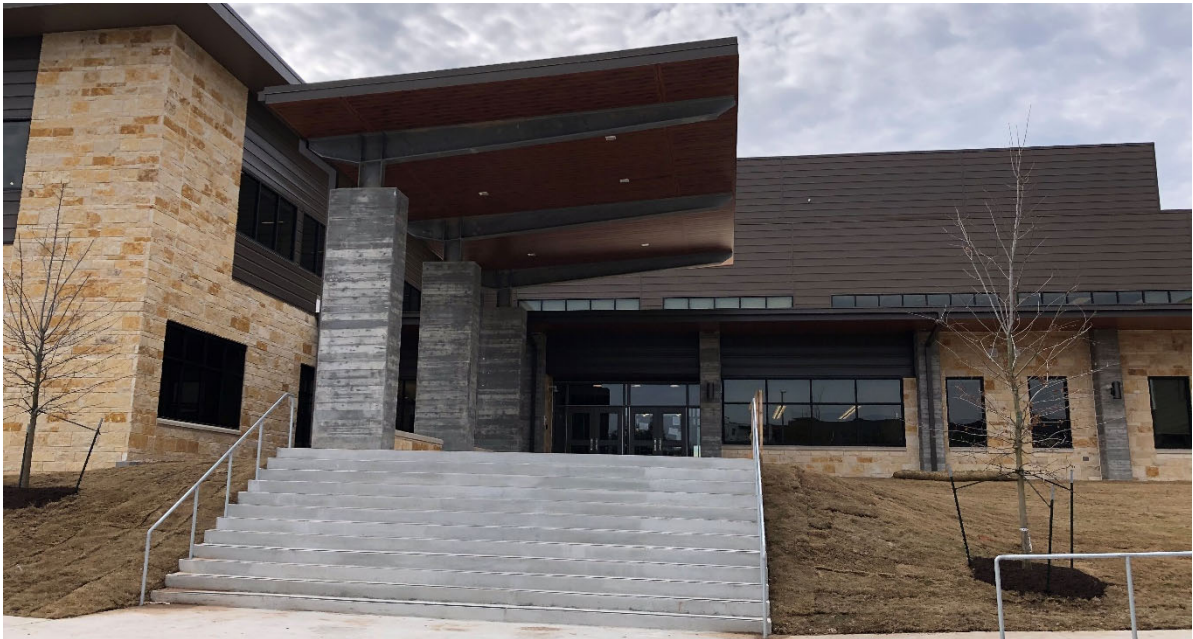
Main school entry off Panther Trail has a large canopy to provide protection from weather .

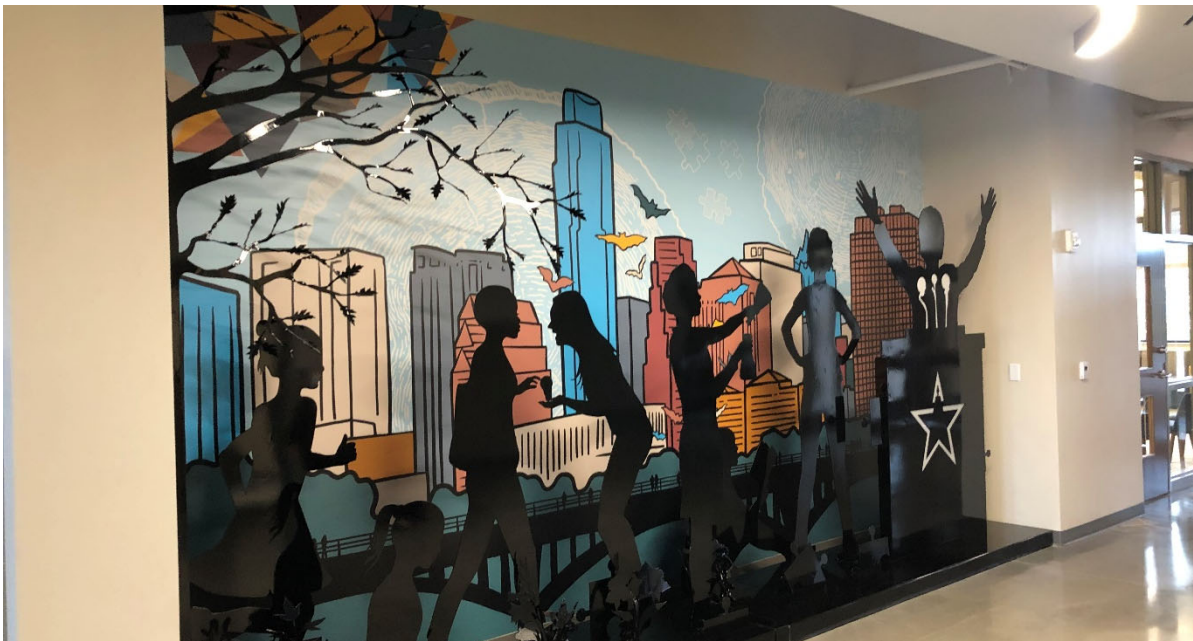
The building has unique murals/graphics. This one is at the entry of the school. In general, there are limited places for 2D and 3D display throughout the school.

8.7	Are there adequate places to display the evidence and artifacts of learning (both 2D and 3D)?			3				Comments	1.00 3.00	
1	Very unsatisfactory - No dedicated space							Ample 2D display space provided but limited display area for 3D art.		
2	Unsatisfactory - Too small, non-dedicated, poor condition									
3	Average - Adequate size, adequate condition, needs updates or renovations to function well									
4	Satisfactory - Good size, good condition									
5	Very Satisfactory - Generous size, excellent condition									
N/A	Does not apply

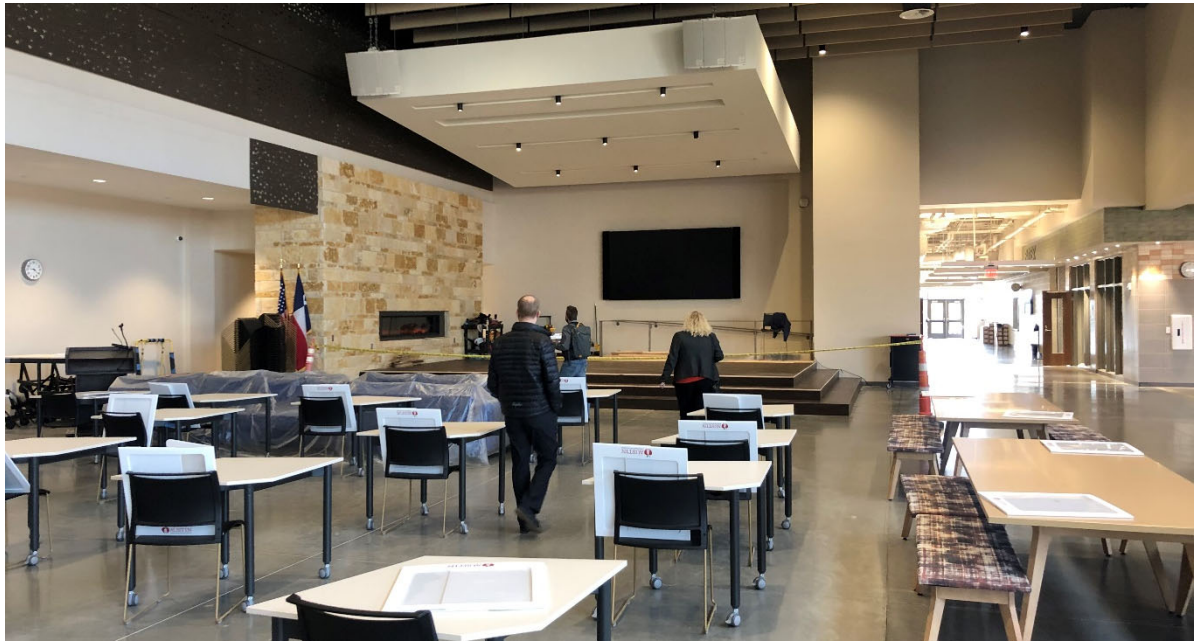
Cafeteria has a stage but is not set-up for formal productions. There is a variety of seating within the space.

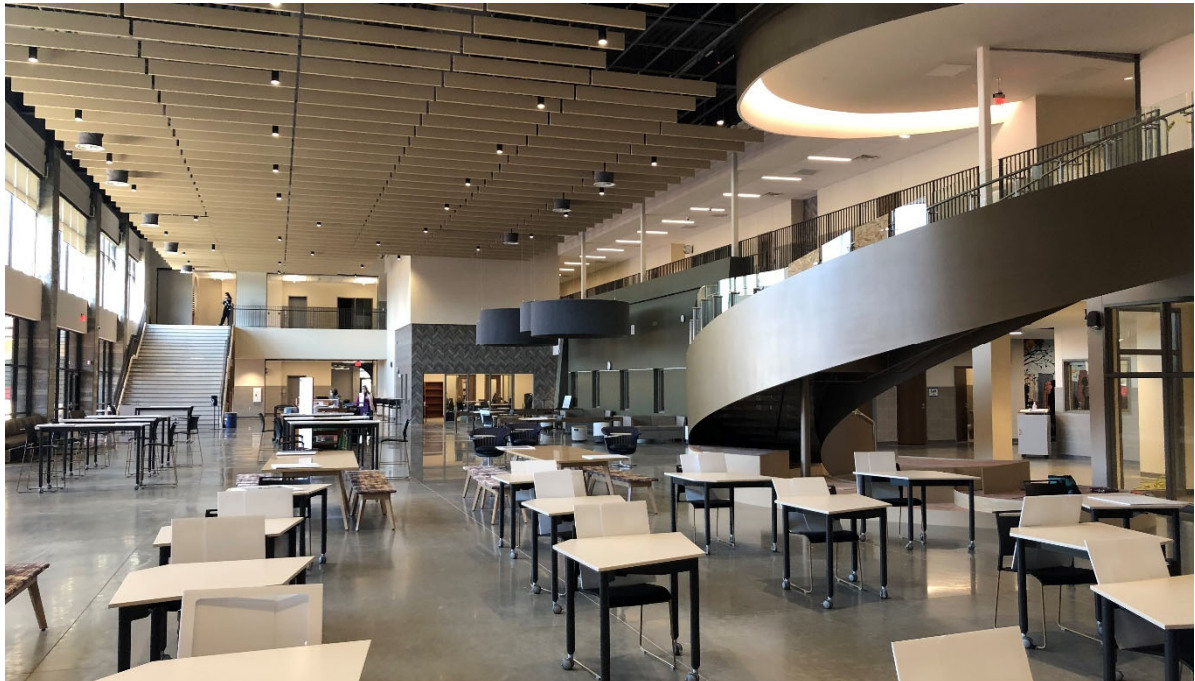
Two-story multipurpose space serves as a cafeteria and a large meeting space that opens to outdoor courtyard/seating.

12 - Food Services										10.00	100%	
12.1	Is the Dining Commons appropriately configured per the ed spec?					5				Comments	1.00	5.00
1	Very unsatisfactory - Too small, missing program spaces	Large open area with a variety of seating options and good connection to the outdoors,										
2	Unsatisfactory - Too small, poor condition, only one option for eating space provided, inadequate circulation											
3	Average - Adequate size and condition, needs updates or renovations to function well											
4	Satisfactory - Good size and condition, good circulation, multiple options for eating space (ex: connection to outdoor eating space)											
5	Very Satisfactory - Generous size, excellent condition and circulation, multiple options for eating space (ex: connection to outdoor eating space)											
N/A	Does not apply

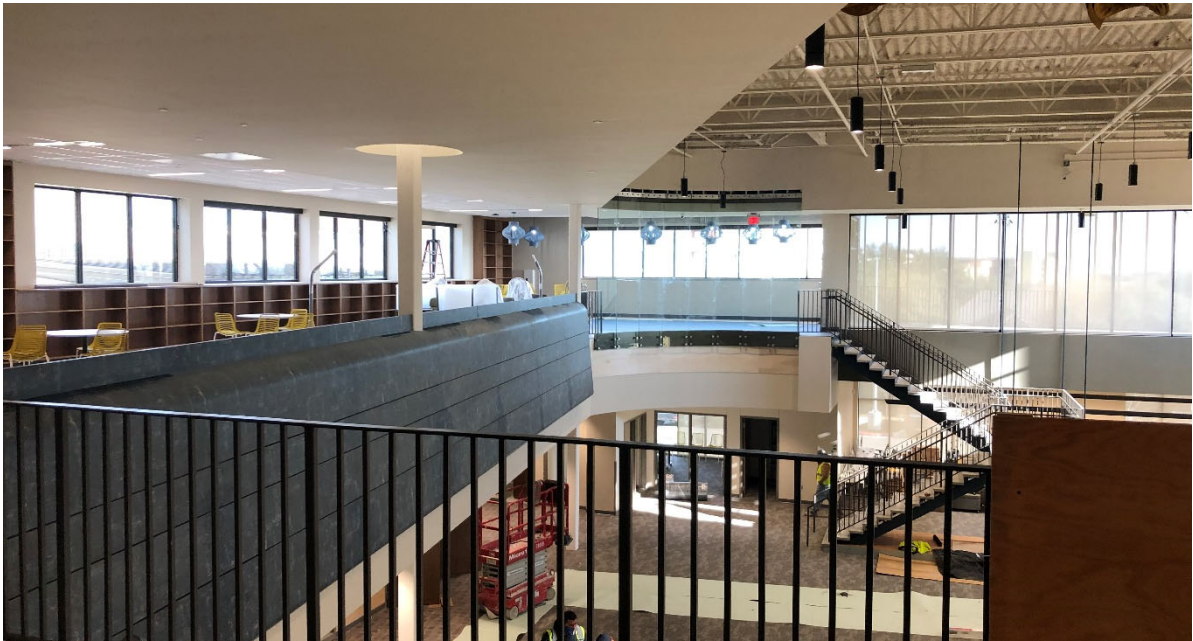
Media Center: Two-story space with a variety of seating types, a collaboration stair, and a second-floor porch for additional outdoor space.

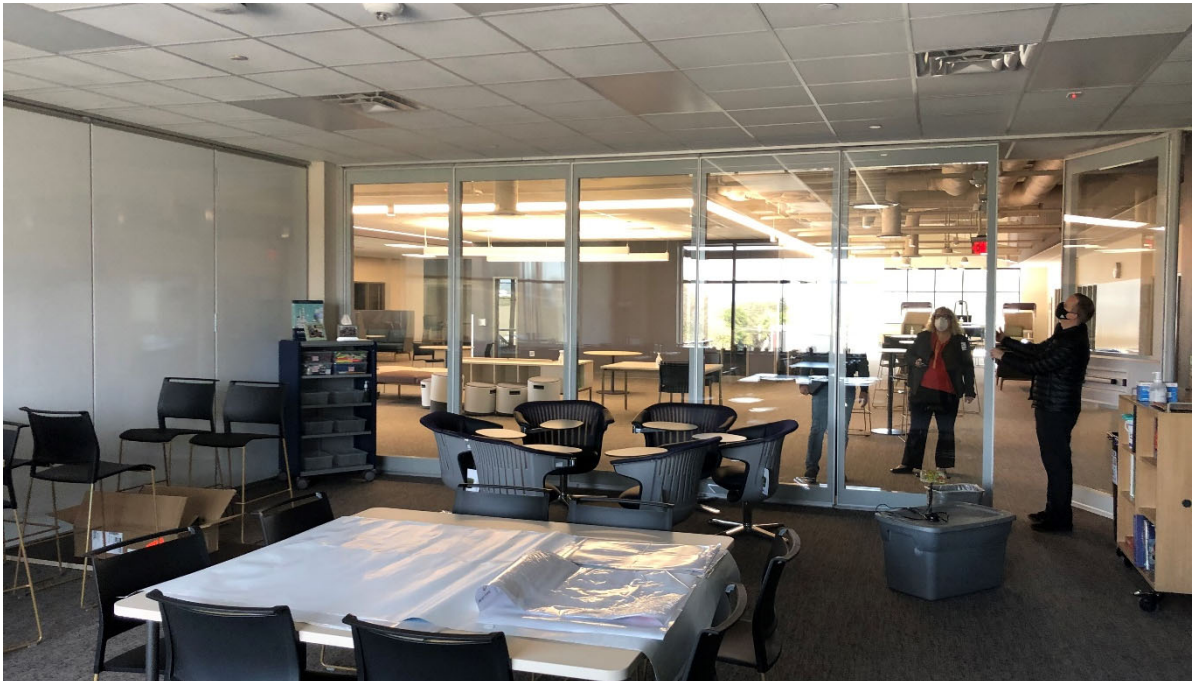
Typical studio has a variety of furniture. Some studios have movable partitions to open to collaboration space and adjacent studio.

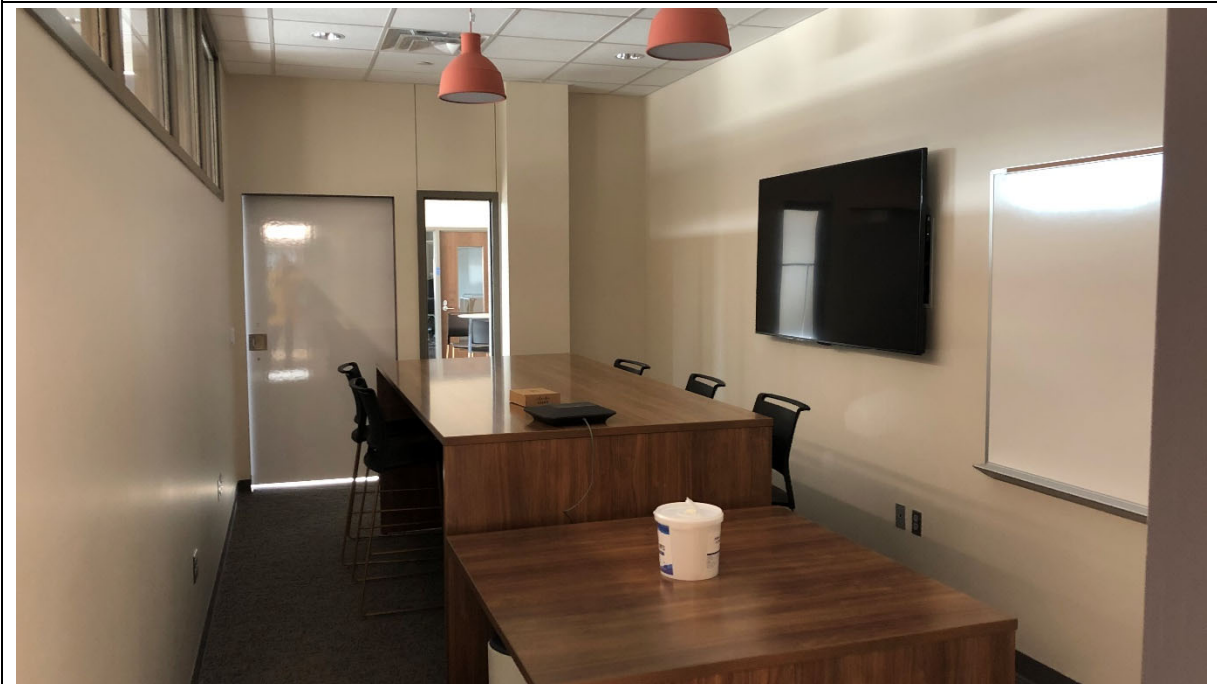
Small group rooms with technology and whiteboards are in each of the learning neighborhoods.

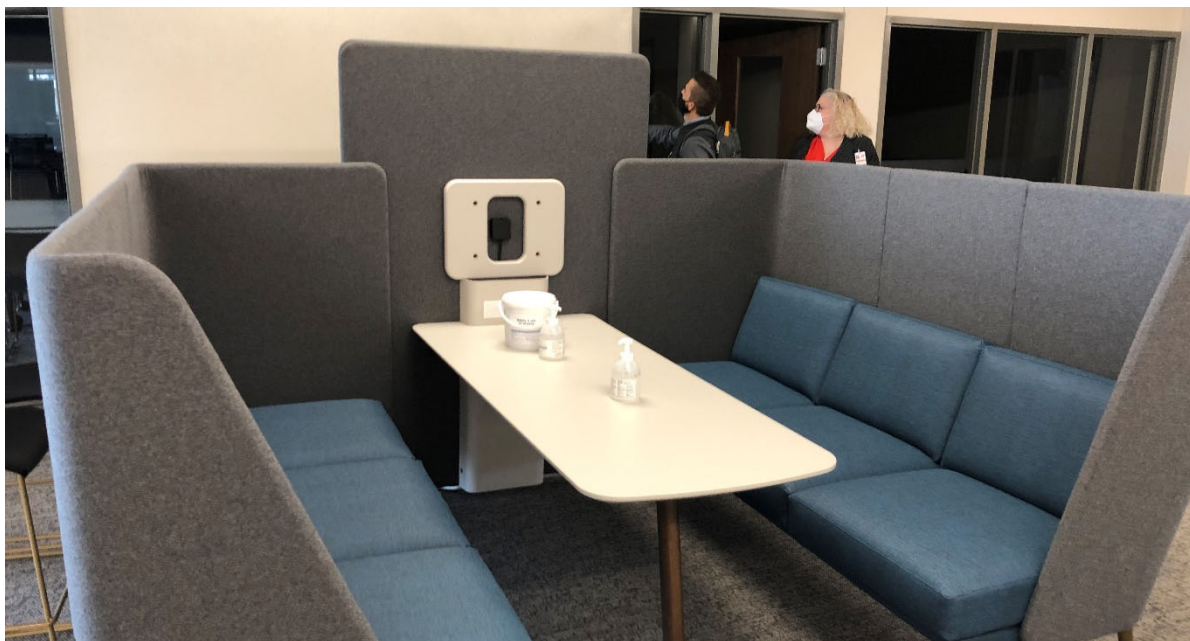
Furniture provides variety for individualized study and group work and supports charging/technology needs.

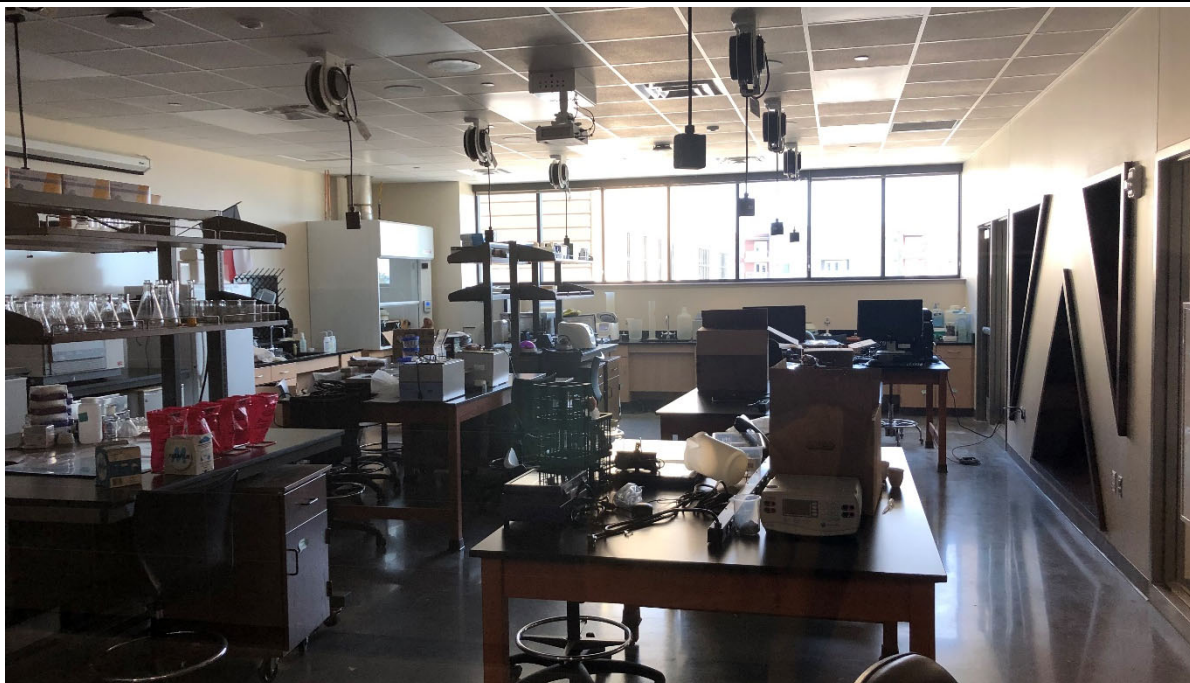
Science lab with overhead power and prep room between two lab spaces.

N/A	Does not apply									
8.4	Are Science Labs and support spaces appropriately configured per the ed spec?					5		Comments	1.00 5.00	
1	Very unsatisfactory - No dedicated science room									
2	Unsatisfactory - Too small, poor condition, no connected support space									
3	Average - Adequate size, adequate condition, needs some renovations or updates to function well									
4	Satisfactory - Good size, good condition, connected support spaces									
5	Very Satisfactory - Generous size, excellent condition, connected support spaces									
N/A	Does not apply

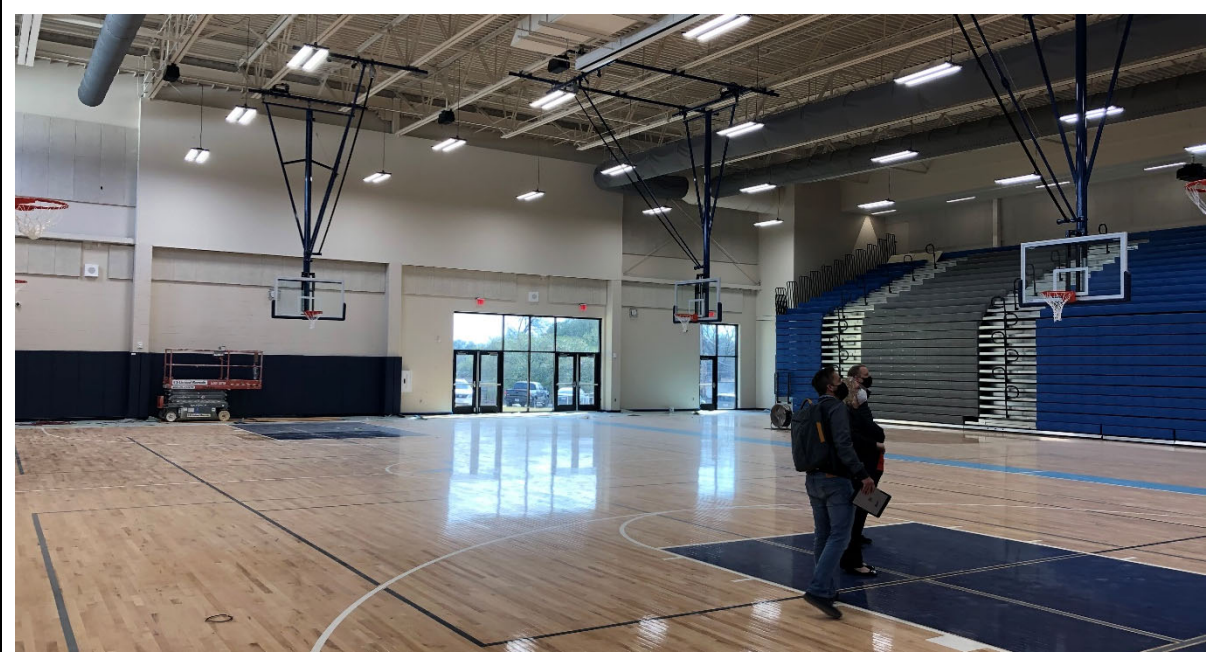
Main gym is adequately sized with bleachers along one side of the gym. The projection screen and projector are sized adequately for the large space.

14.4	Is there adequate AV for presentations spaces – cafeteria, gym, aux gym?					5		Comments	1.00	5.00	
1	Very unsatisfactory - AV not present in one or more space							Large motorized drop-down screen and ceiling-mounted projector in both gym and cafeteria.			
2	Unsatisfactory - AV undersized for room. Poor condition										
3	Average - AV adequately sized / poor condition OR AV undersized / average condition										
4	Satisfactory - AV adequately sized for room. Average Condition.										
5	Very Satisfactory - AV adequately sized for room. Excellent condition.										
N/A	Does not apply

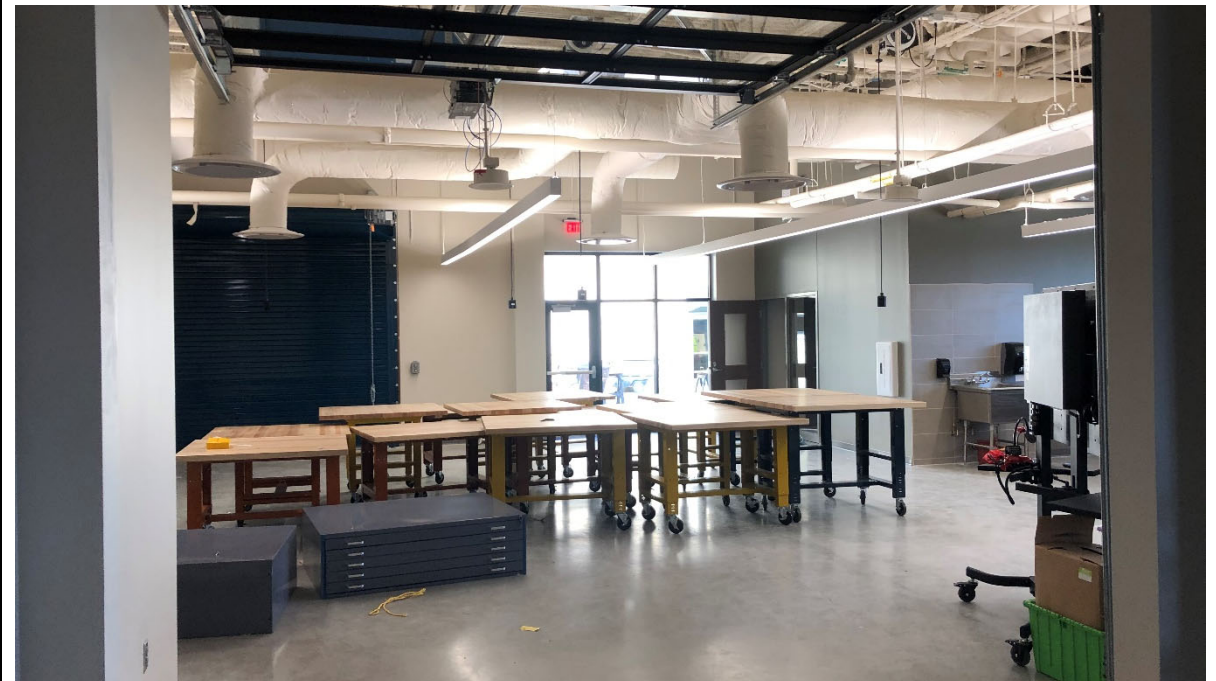
Art studios are flexible spaces with movable worktables and overhead doors between the two art rooms as well as one to the outdoors. They are next to engineering studios and a maker space.

10.7	Are visual arts and support spaces appropriately configured per the ed spec?					5		Comments	1.00 5.00
	1 Very unsatisfactory - Too small, missing program spaces 2 Unsatisfactory - Too small, poor condition 3 Neutral - Adequate size, adequate condition, needs updates or renovations to function well. 4 Satisfactory - Good size, good condition 5 Very Satisfactory - Generous size, excellent condition N/A Does not apply	Both high school and middle school art rooms are generously sized. Have access to outdoor art courtyard.
