## **Educational Suitability Summary Report**

Austin High School

Date: 10/26/2020

**Score 59% Average**

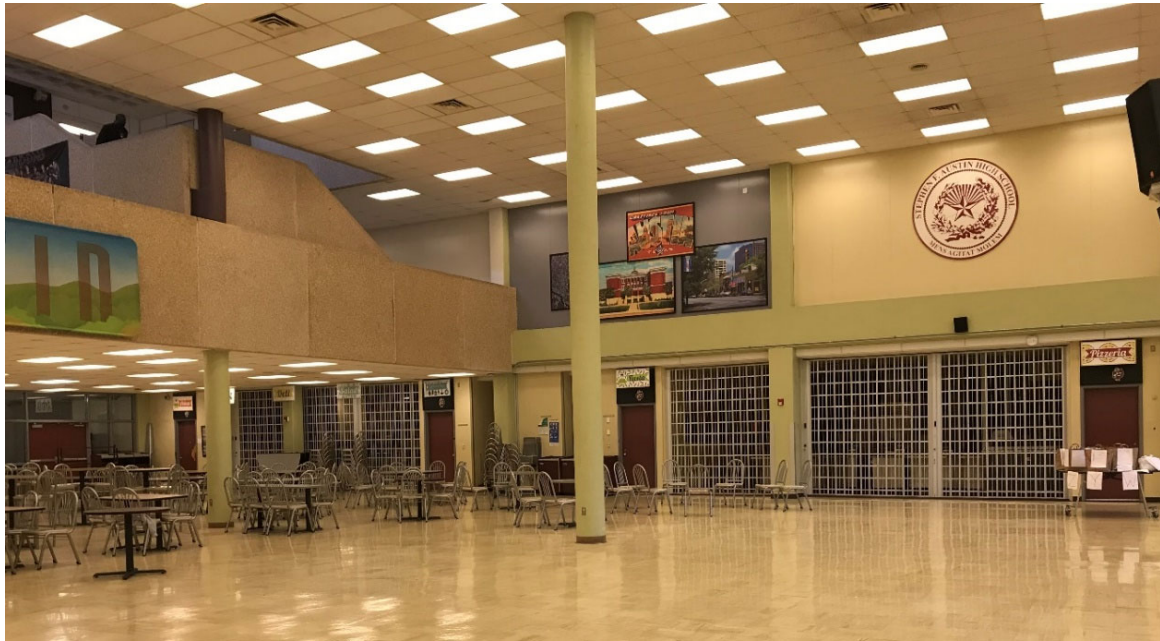
*Cafeteria is undersized for campus capacity and cannot hold events such as banquets for student groups. Fluorescent lighting throughout the school is dated and not controllable.*

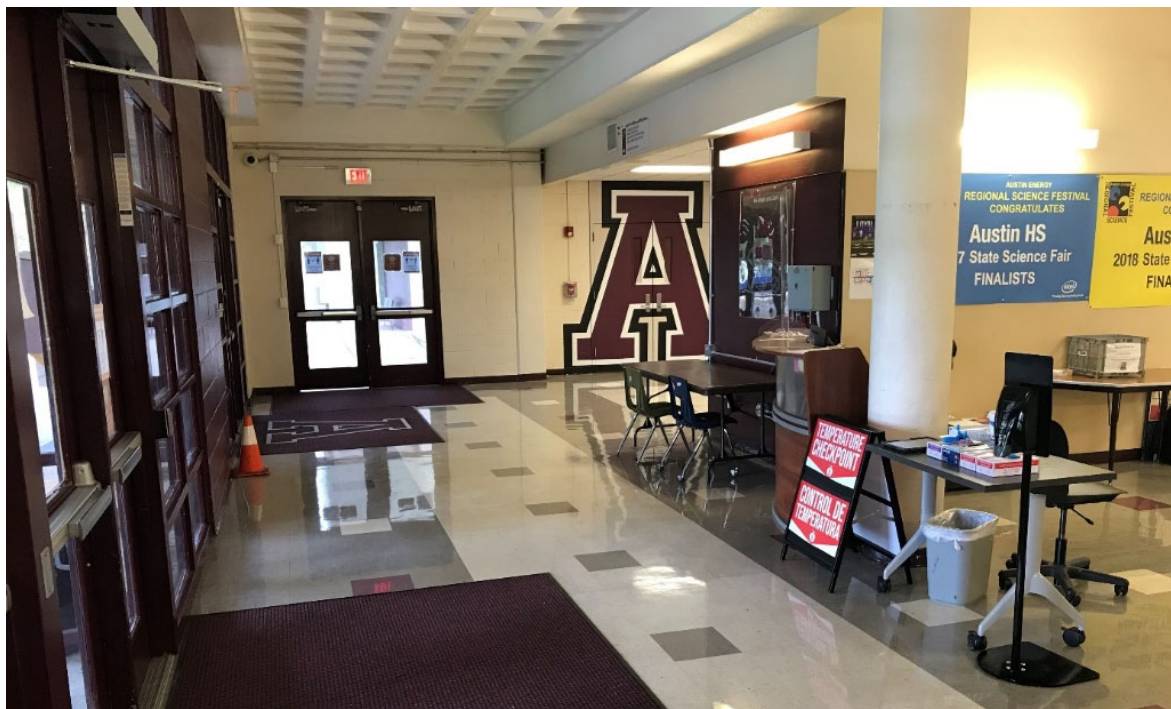
*Main entry is large with displays and murals that make the space feel welcoming.*

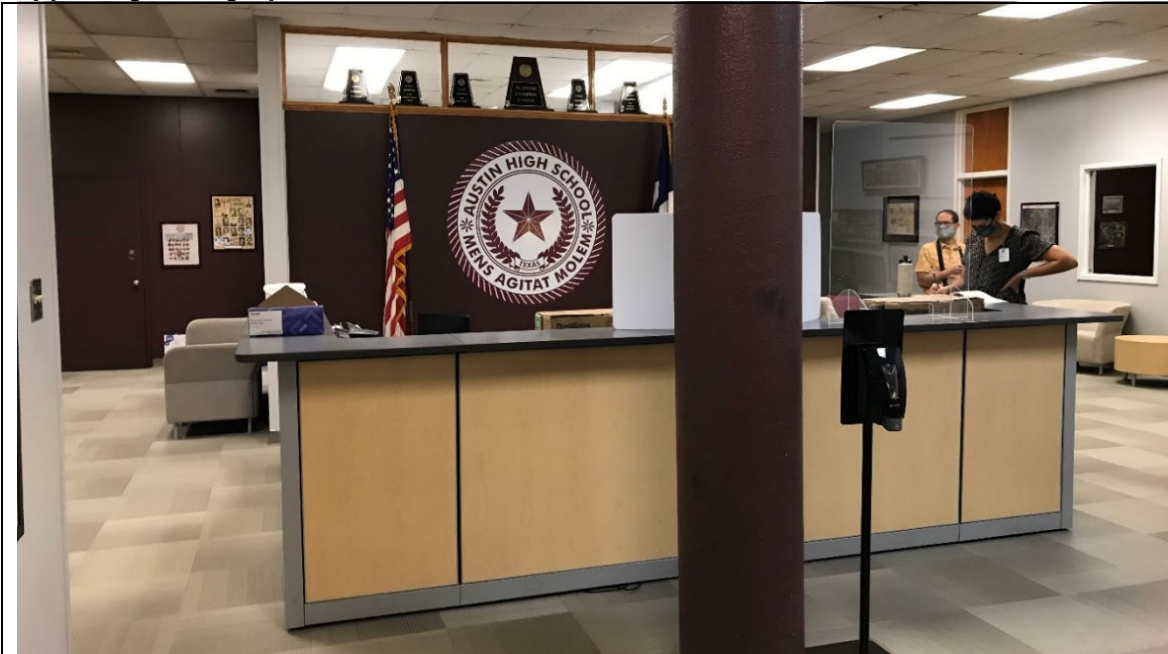
Administration space is located on the second floor.

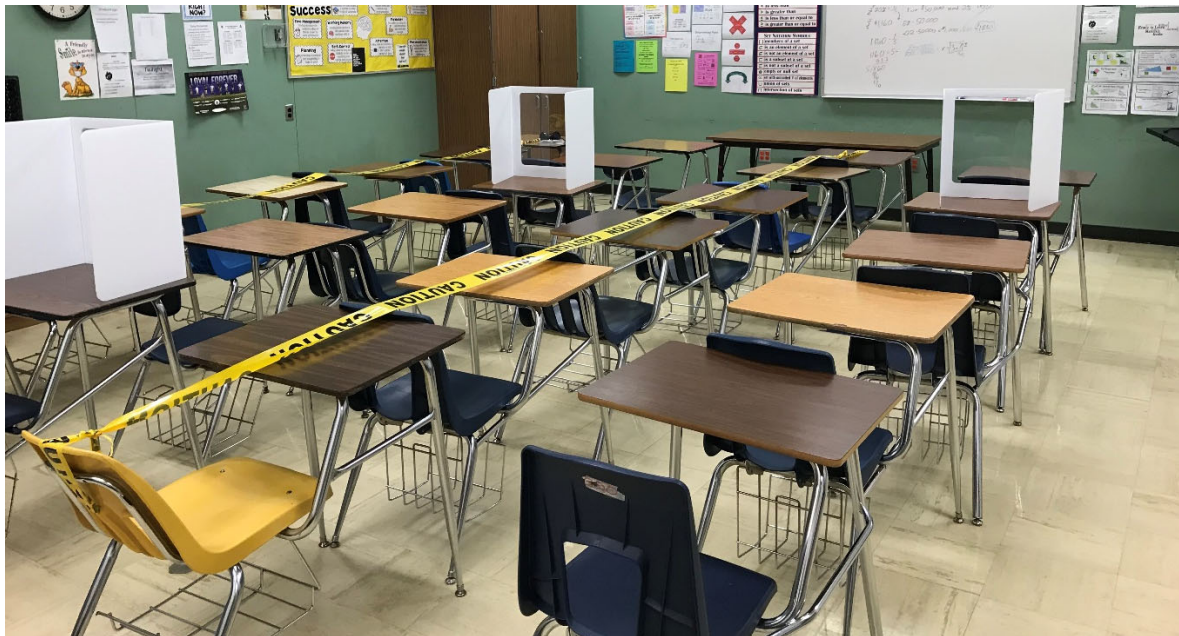
Many studios have limited to no natural lighting/views. The furniture is also not flexible in many studios with attached chair / desk combinations. Furniture arrangement in this photo is not typical and is in reaction to COVID restrictions.

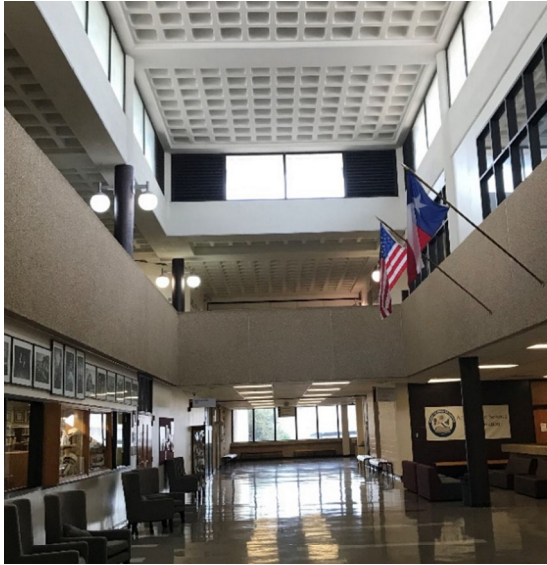
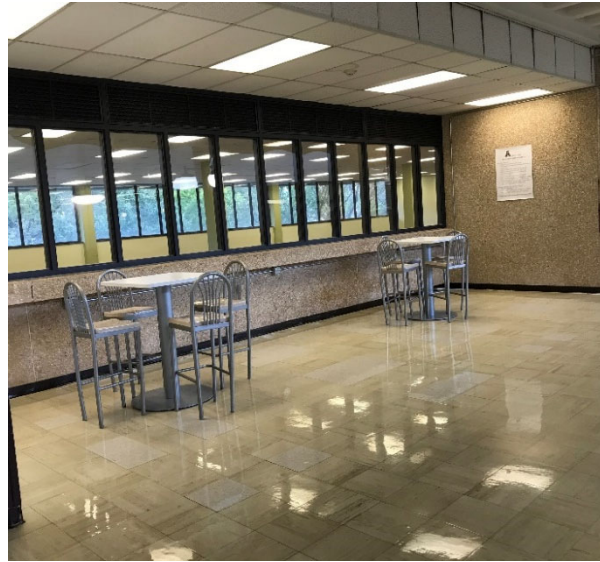
*Open, daylit central circulation with ample breakout spaces suitable for student learning. Furniture placement is sparse and there are not enough charging locations.*

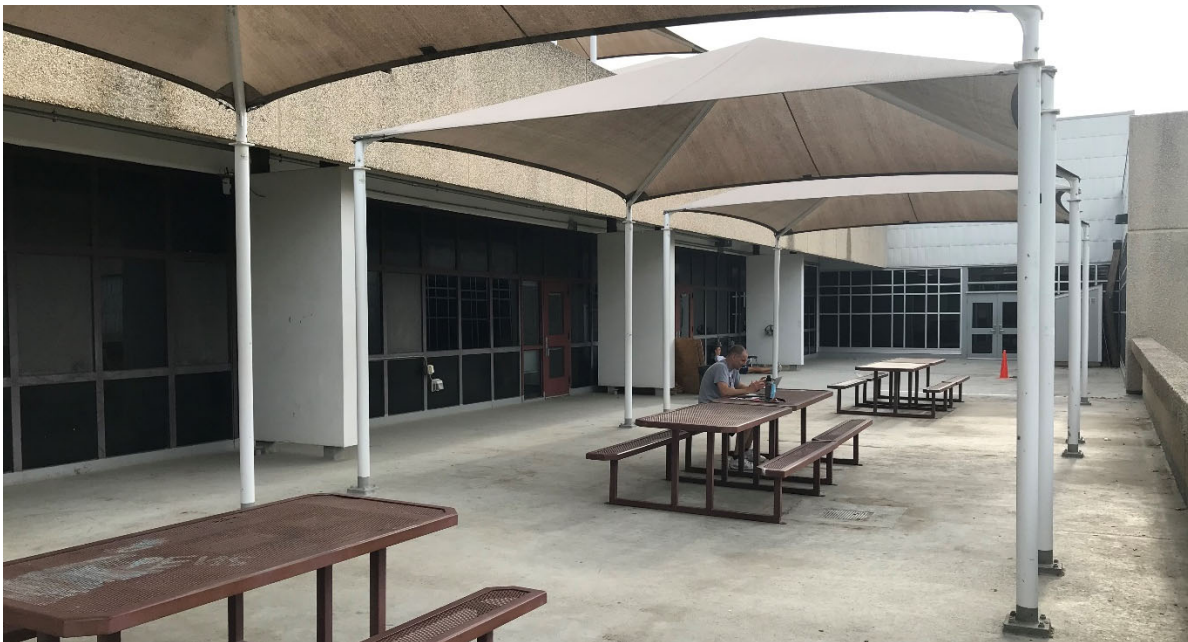
*Two tiers of rooftop patios provide shaded outdoor learning opportunities. Additional infrastructure, such as charging stations, is needed. These patios function as outdoor maker spaces and storage container is seen in the background for supplies.*

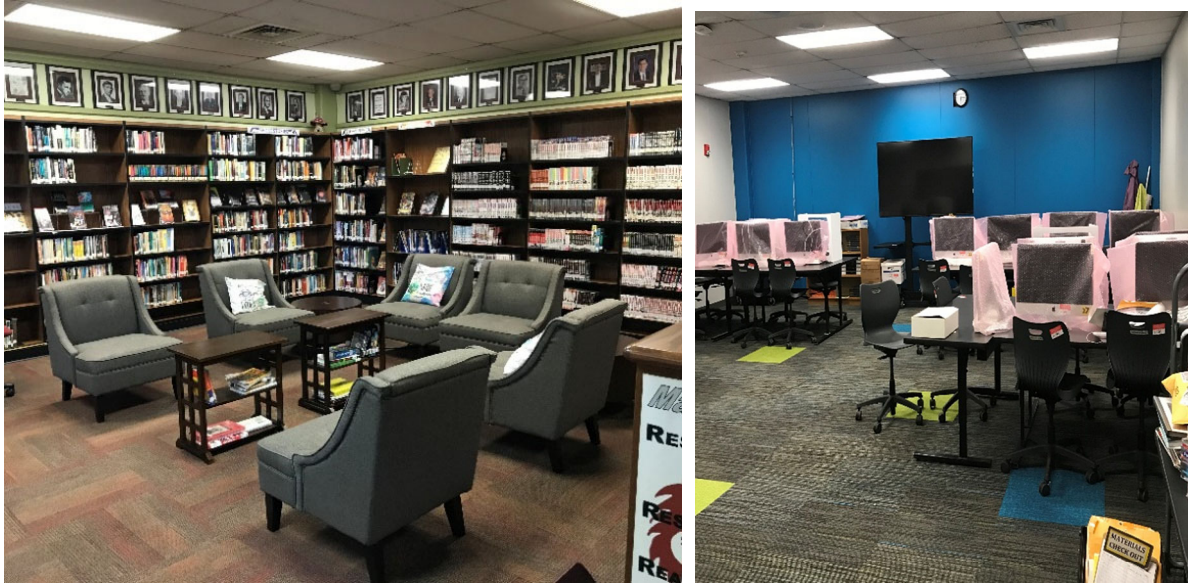
*Library has a wide variety of spaces for large, medium and small group learning but has limited transparency to the main corridor and a mixture of new and old furniture. An Innovation Lab off the library has flexible furniture / new technology.*

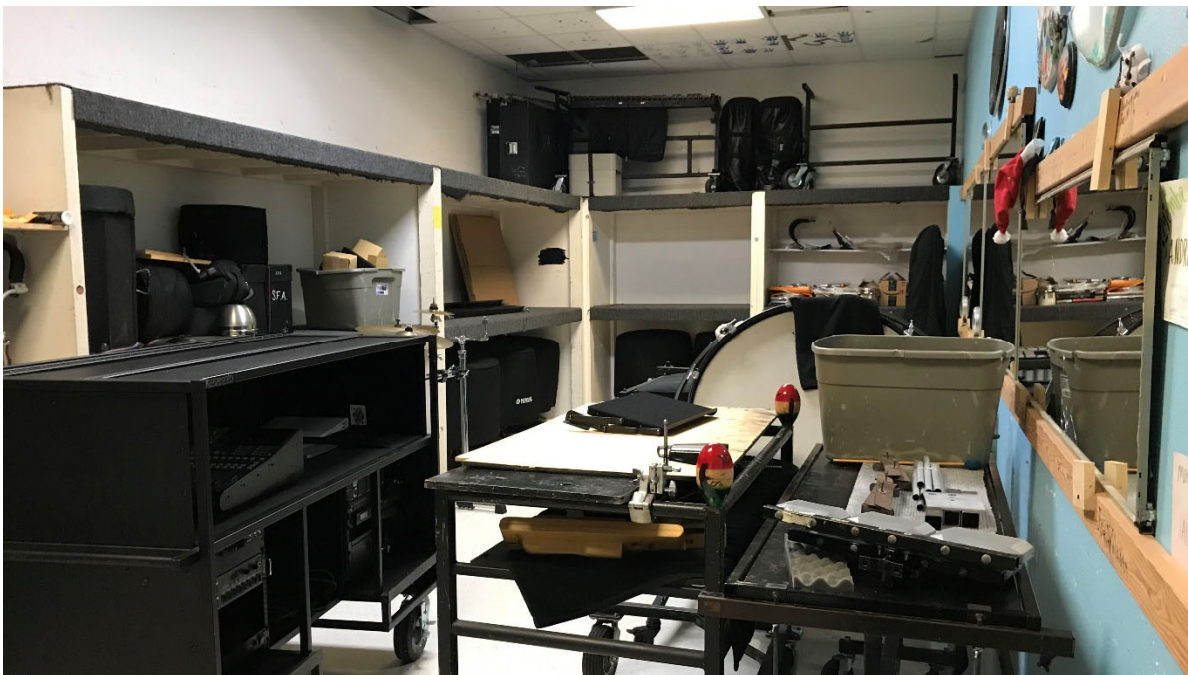
*Throughout the school there is a shortage of storage. Many storage areas are cramped and difficult to navigate.*
