Educational Suitability Summary Report

Covington Middle School

Date: 1/18/2021

Score 62% Average

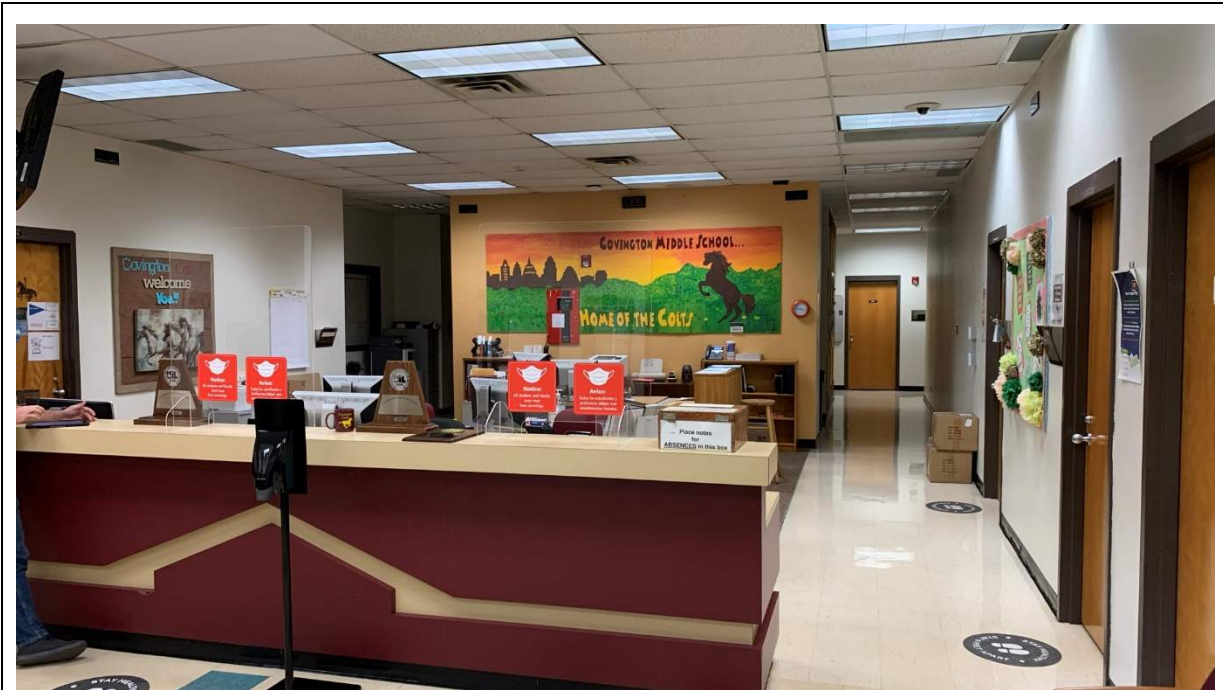
Reception is large, open, and welcoming. It is located near the main entrance but lacks good transparency into the entry lobby.

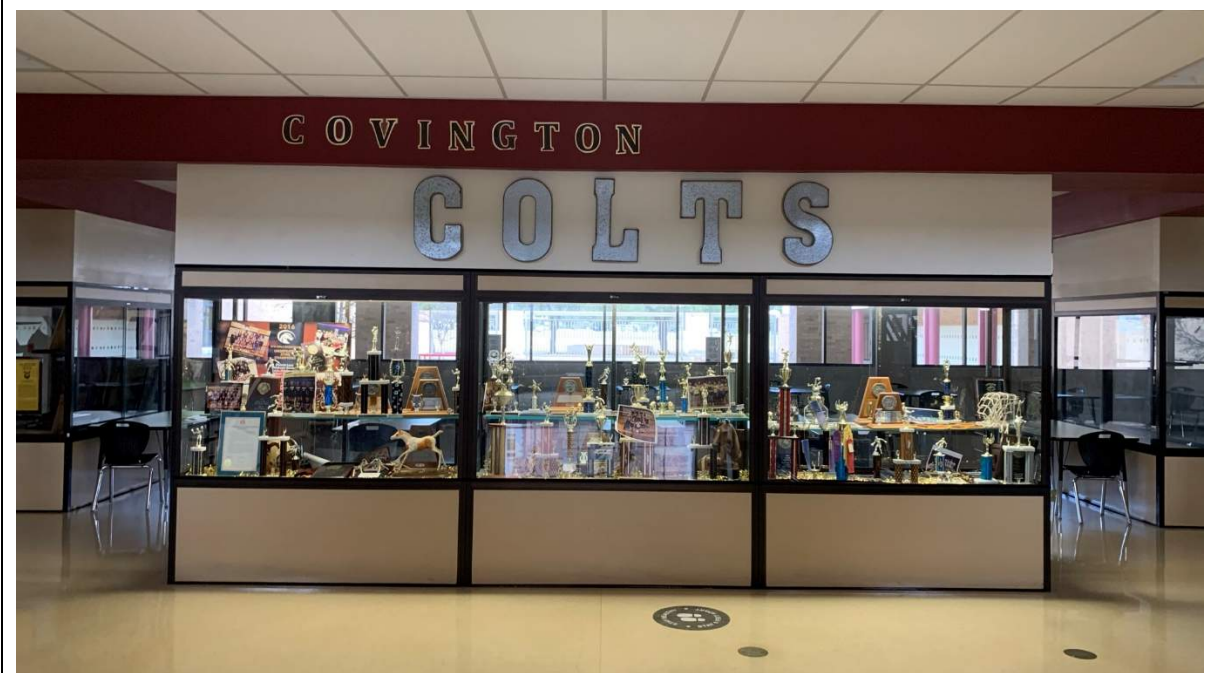
There are many areas for 3D display throughout the campus. There are fewer opportunities for 2D display, as most corridors are lined with lockers and only a tackstrip is provided above.

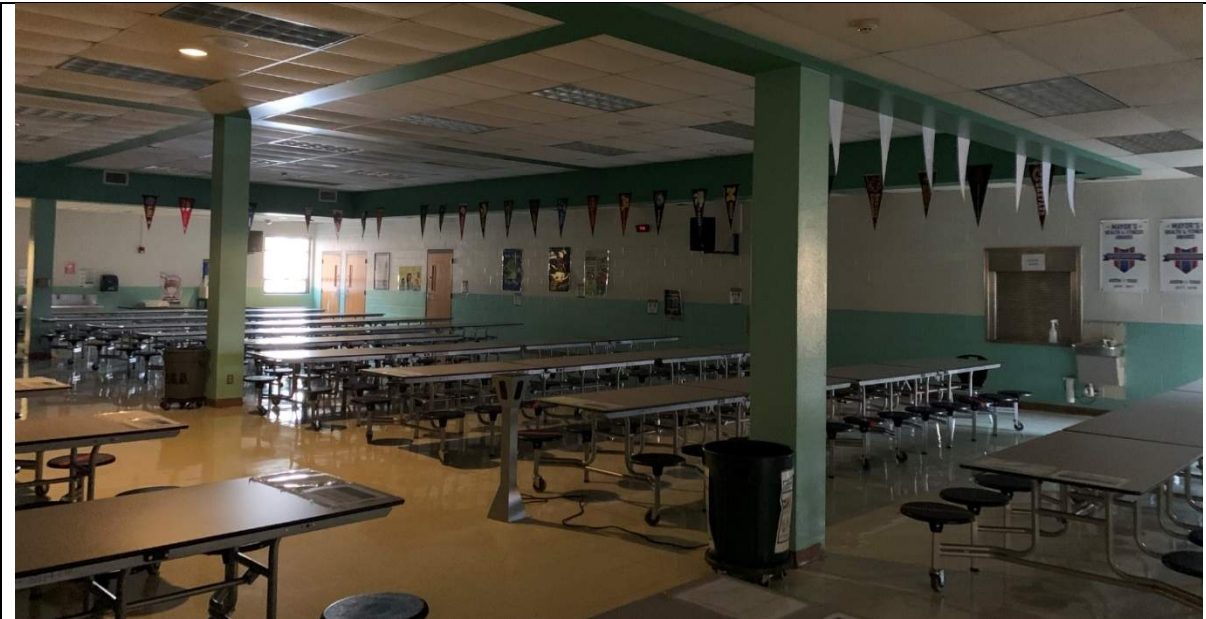
The cafeteria is very undersized per the Education Specifications and does not have adequate technology, nor can it be access securely for after-hours use.

12 - Food Services										10.00	40%	
12.1	Is the Dining Commons appropriately configured per the ed spec?		2							Comments	1.00	2.00
1	Very unsatisfactory - Too small, missing program spaces	Cafeteria is 2000 sq ft undersized. Almost no natural light into cafeteria. Only one seating option, one large open space. Needs updating										
2	Unsatisfactory - Too small, poor condition, only one option for eating space provided, inadequate circulation											
3	Average - Adequate size and condition, needs updates or renovations to function well											
4	Satisfactory - Good size and condition, good circulation, multiple options for eating space (ex: connection to outdoor eating space)											
5	Very Satisfactory - Generous size, excellent condition and circulation, multiple options for eating space (ex: connection to outdoor eating space)											
N/A	Does not apply

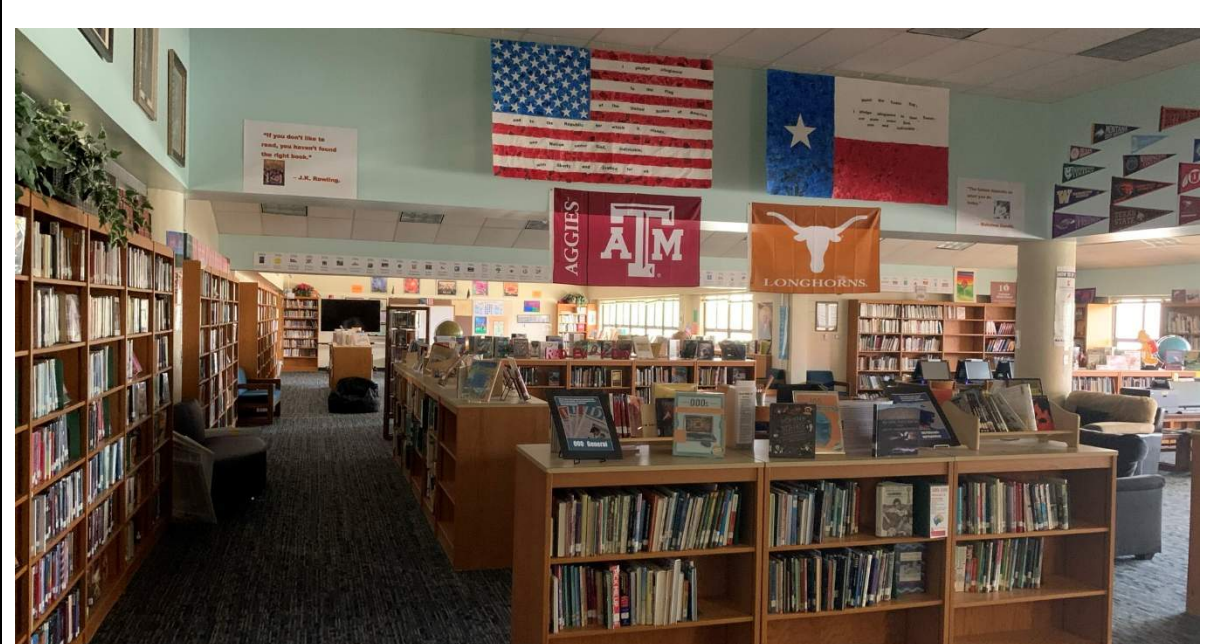
The library is undersized per the Education Specifications but has designated zones for different group sizes or teaching needs. Most of the furniture is dated and cumbersome to move.

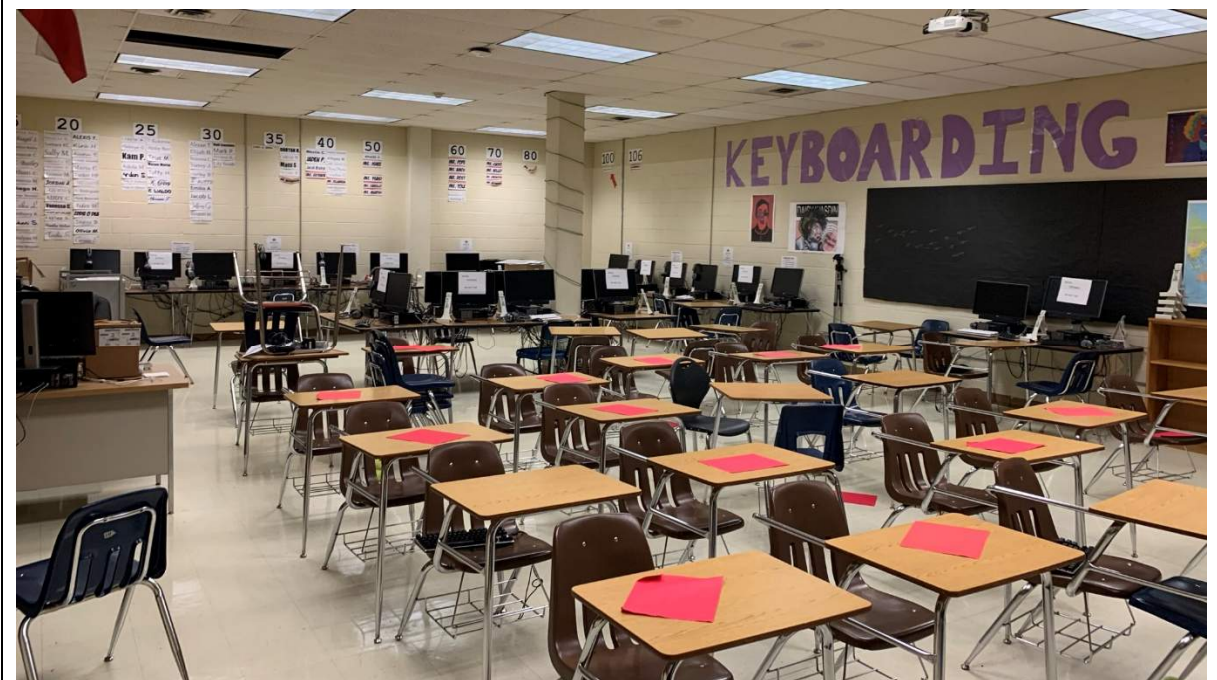
There are multiple computer lab studios throughout campus that support the CTE pathways offered at the school. The furniture is not adequate to support the functional needs of this space.

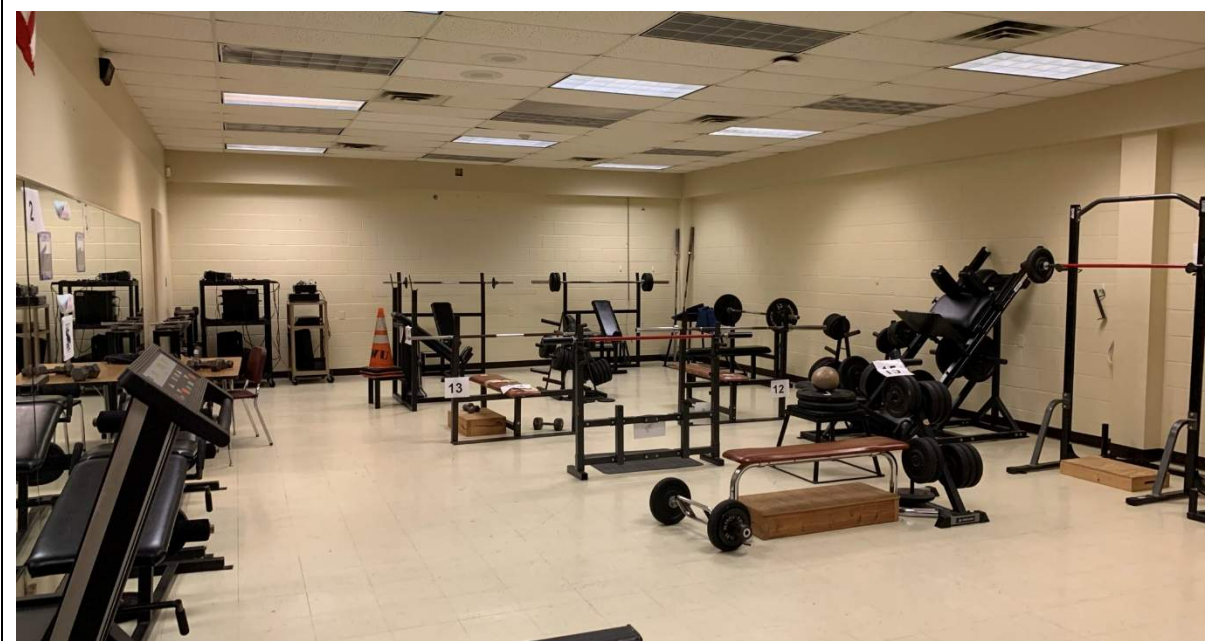
The weight room equipment is dated and damaged. The room is disconnected from the gym in, what appears to be, a former studio space. Per the school, this issue will be resolved once the scheduled Fine Arts renovations are completed.

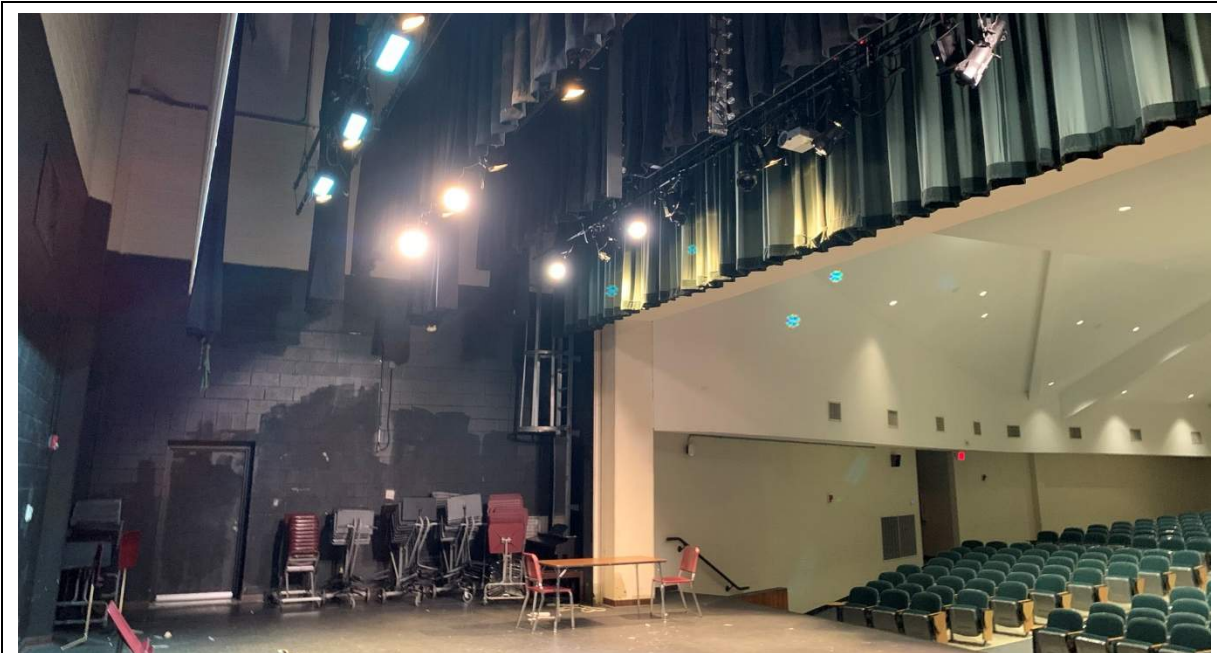
Auditorium and stage are in good condition and an adequate size. Stage wings are small and the only entry to the stage is through a band studio.

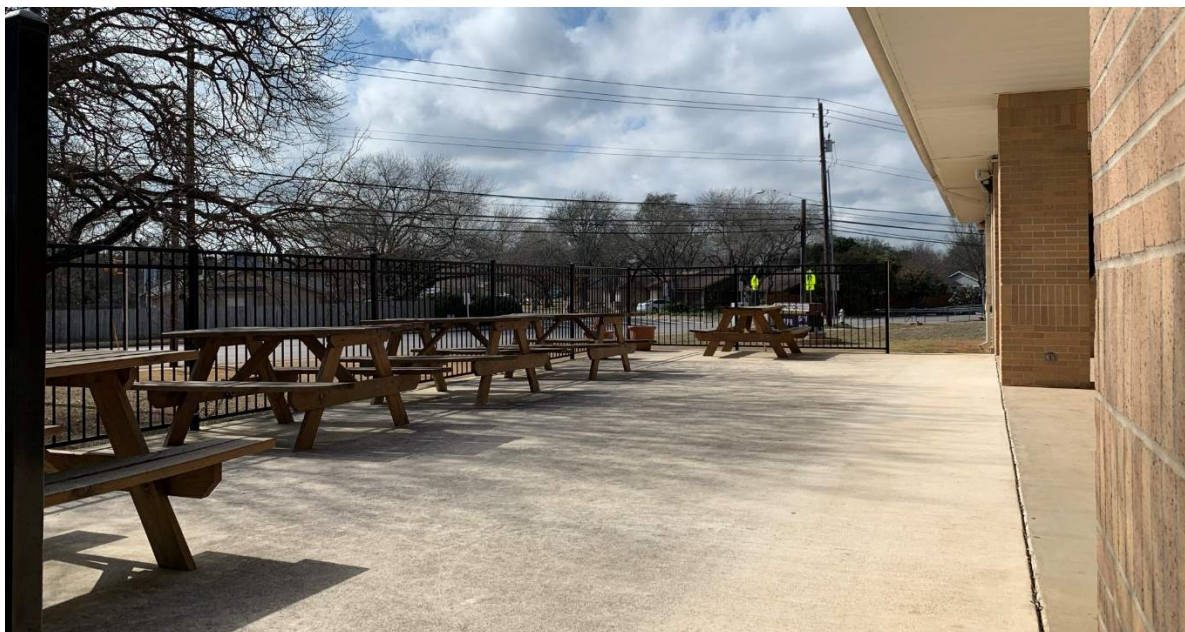
The visual arts studio has an outdoor learning space. It appears to be the only dedicated outdoor studio on campus that is easily accessible.
