Educational Suitability Summary Report

Gorzycki Middle School

Date: 12/14/2020

Score 73% Satisfactory

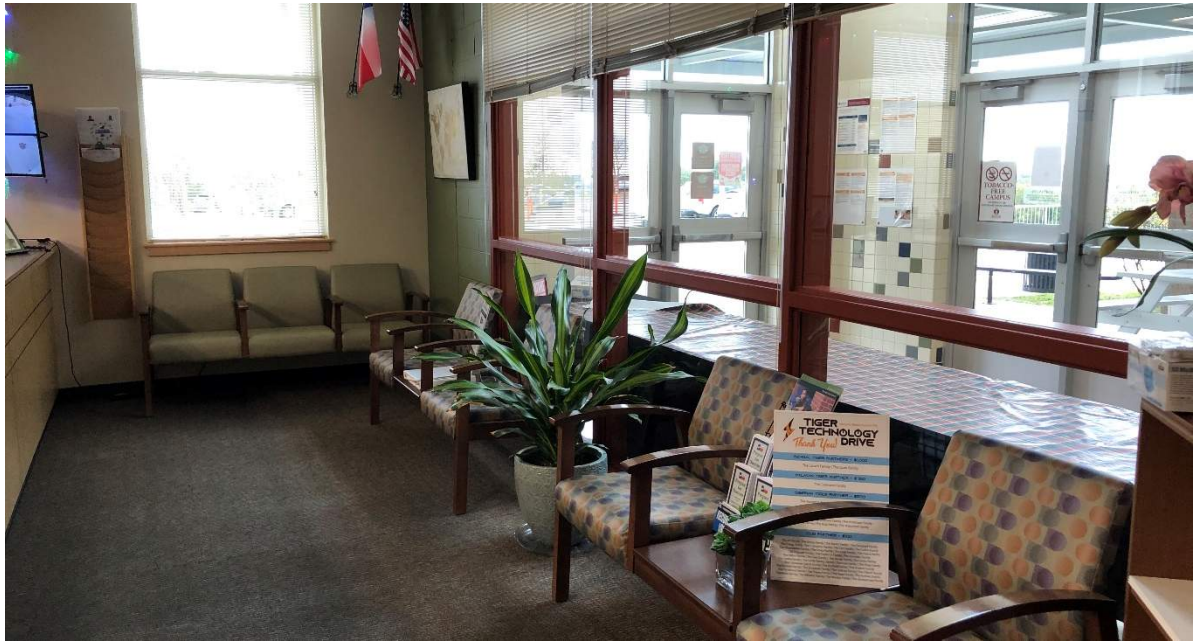
Administration Spaces: Front office seating area with sufficient transparency to front door and secure vestibule.

The reception area includes a secure vestibule and is welcoming with lots of light and transparency, as well as informal seating. Access to conference rooms requires some navigating and they are not public facing.

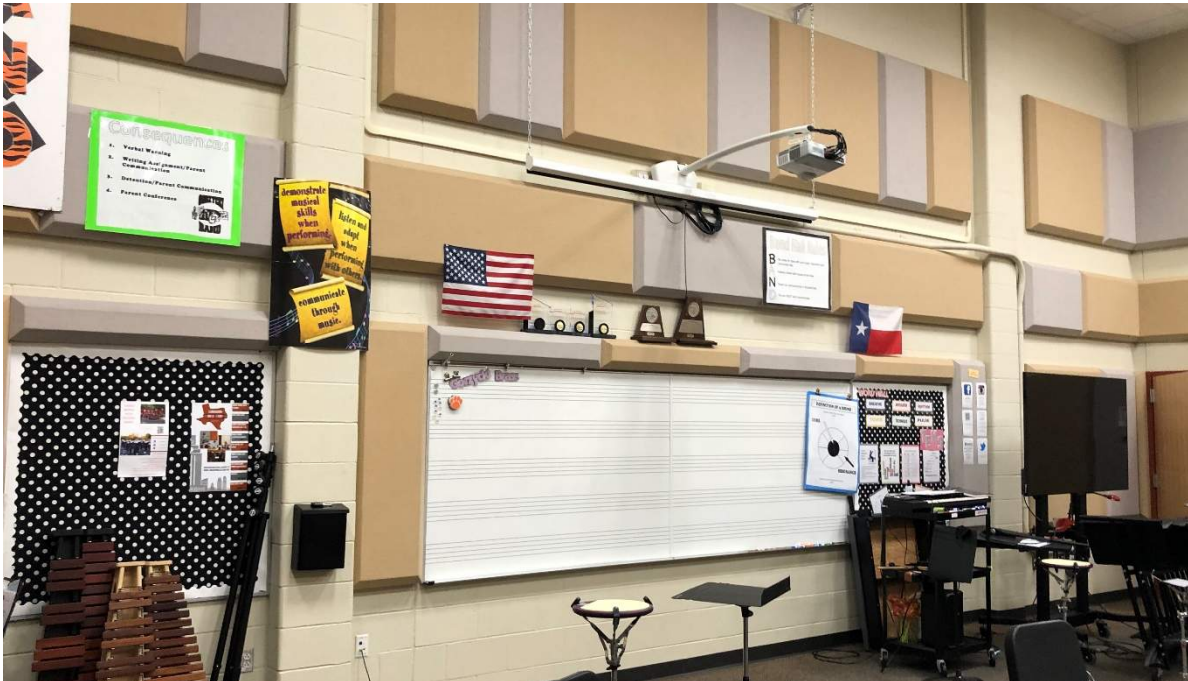
Band room is well-sized and in good condition with technology to function well.

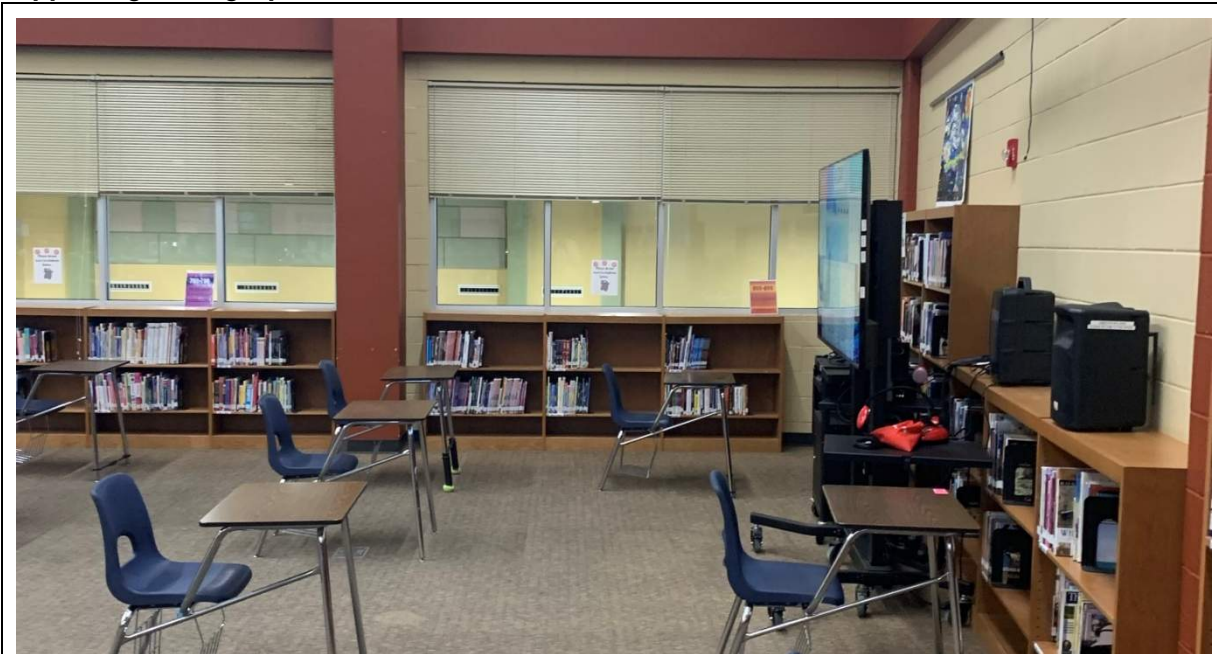
Media Center: Library is in good condition, but most furniture is not reconfigurable or easily movable.

The library is a large, double-height space with enough room to separate into smaller groups, but there are no dedicated quiet study spaces. The furniture is cumbersome to move and does not allow for much flexibility or variety in seating types.

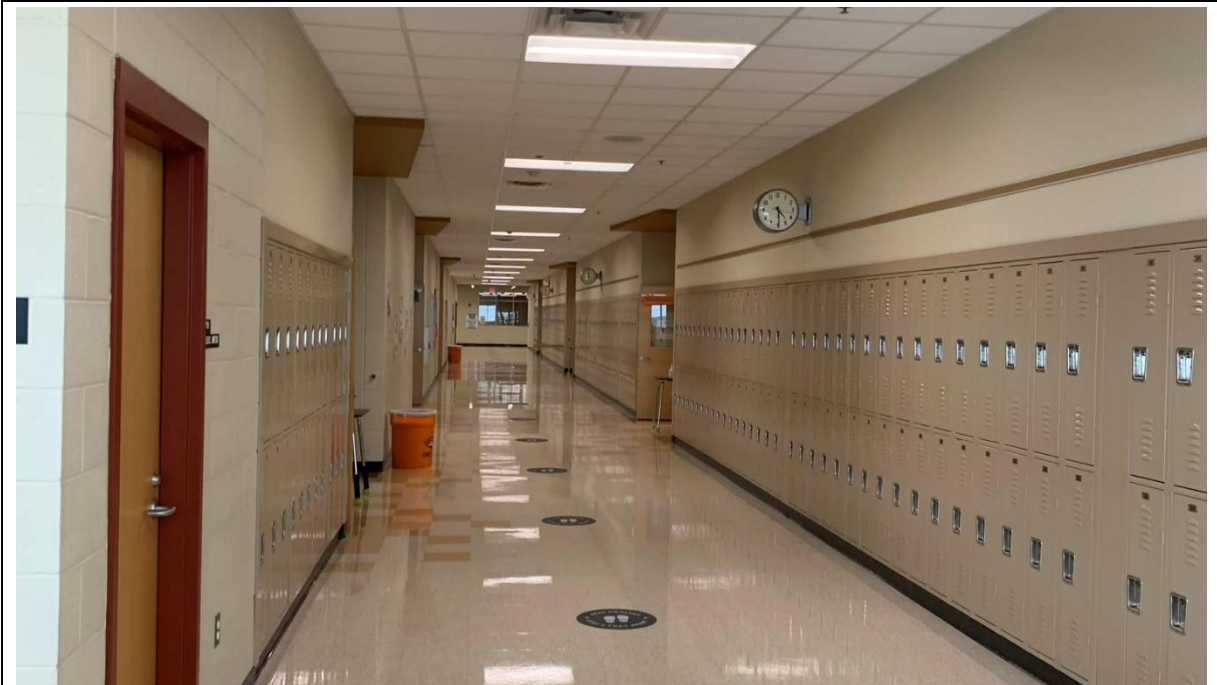
Typical corridor at learning neighborhoods is sufficiently wide enough for safe and effective circulation, but there is a lack of dedicated collaboration spaces.

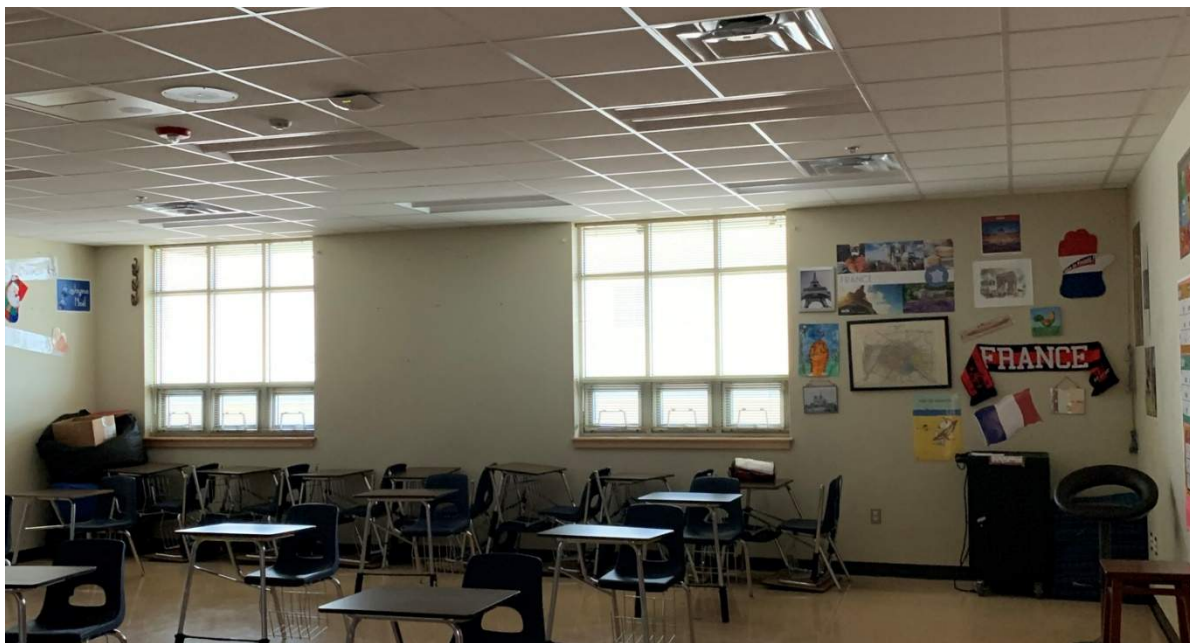
Typical studio furniture with connected chairs and desks is not flexible and easily reconfigured. Studios have good access to natural light and views to exterior.

Most studios have fixed chairs with desks. There is aged furniture throughout campus with lack of variety and flexibility to reconfigure easily.

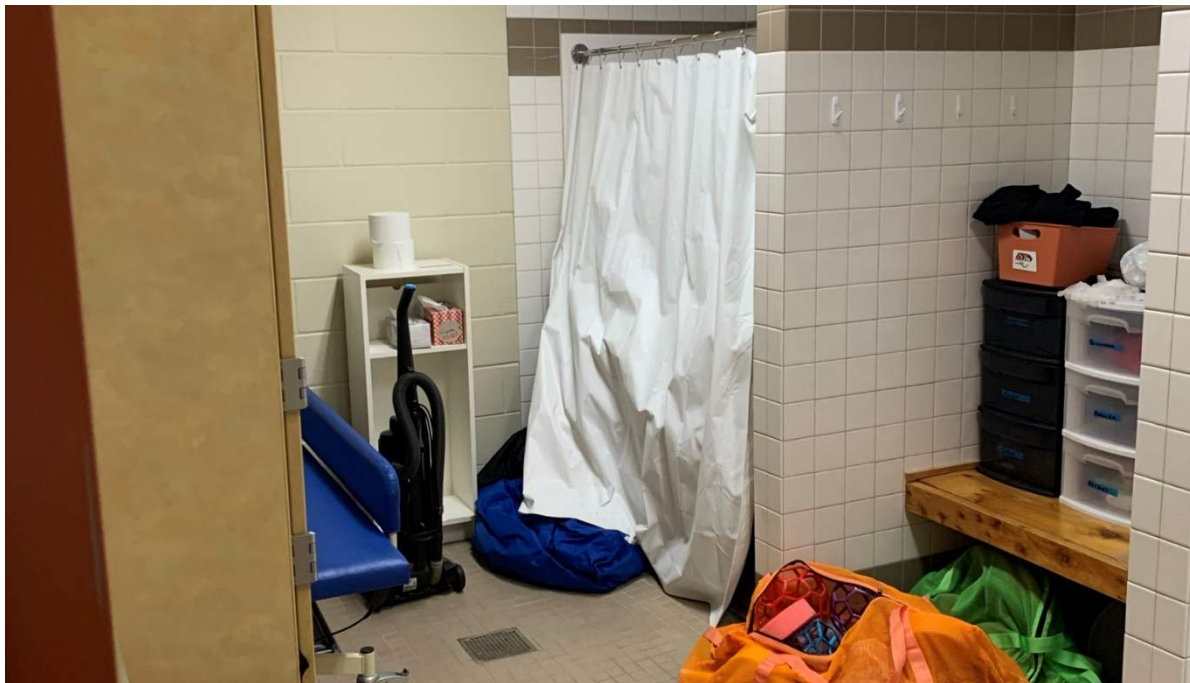
Special education restroom is well-connected to special education studio with ample space but partly used as storage.

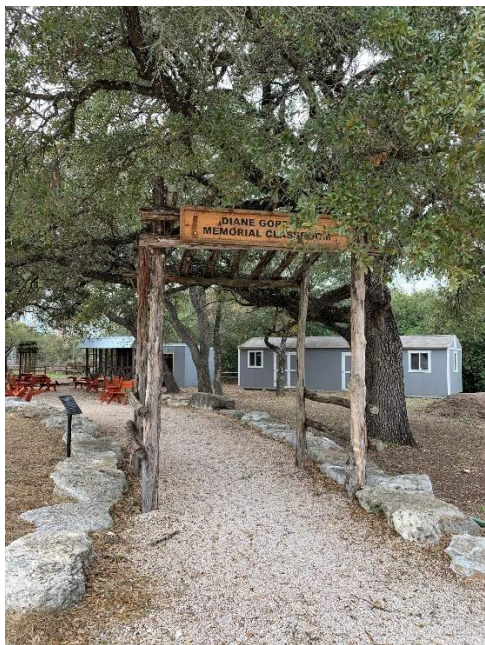
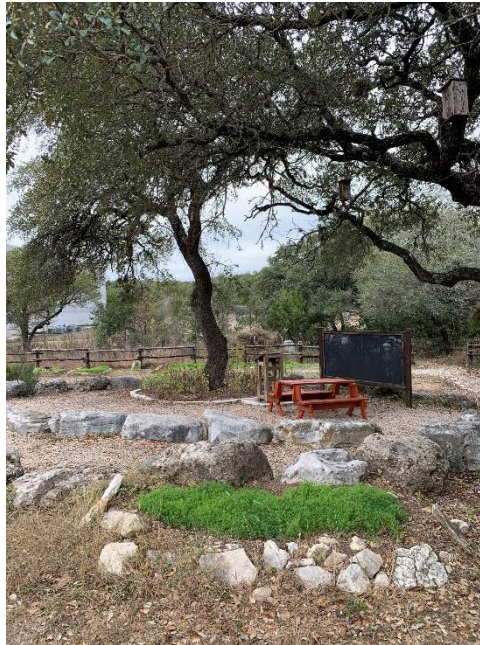
Exterior learning garden with furniture, storage shed and chicken coop.

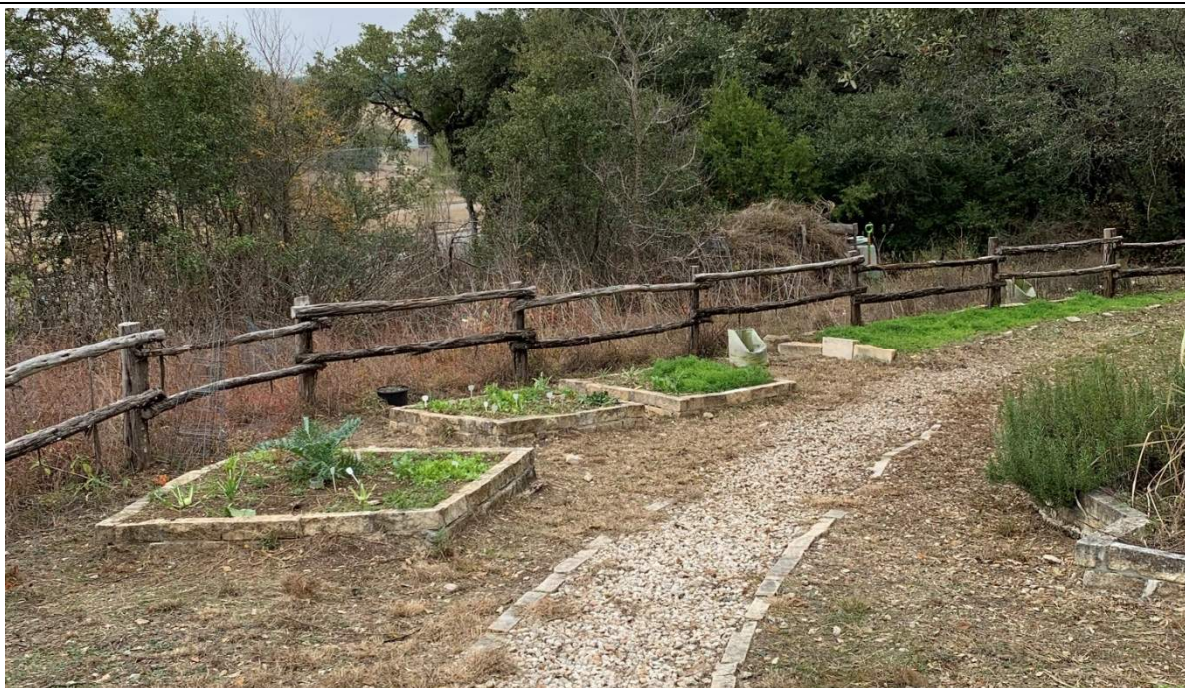
Campus gardens are well-located by outdoor learning area and water access.

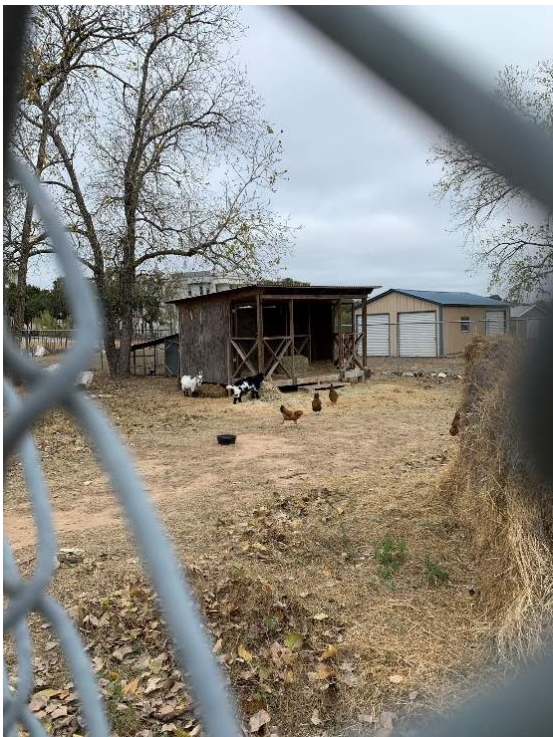
Outdoor learning space with goat raising and more chickens.

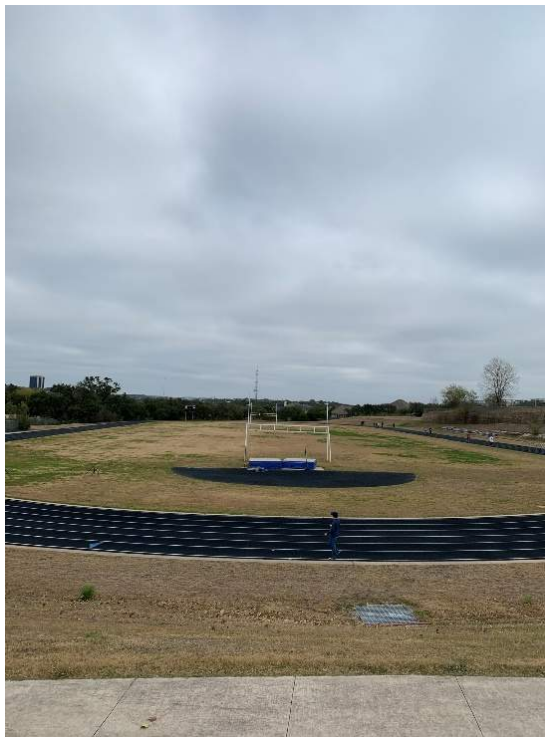
Play field and track are in good condition.
