## **Educational Suitability Summary Report**

Kealing Middle School

Date: 01/11/2021

**Score 57% Average**

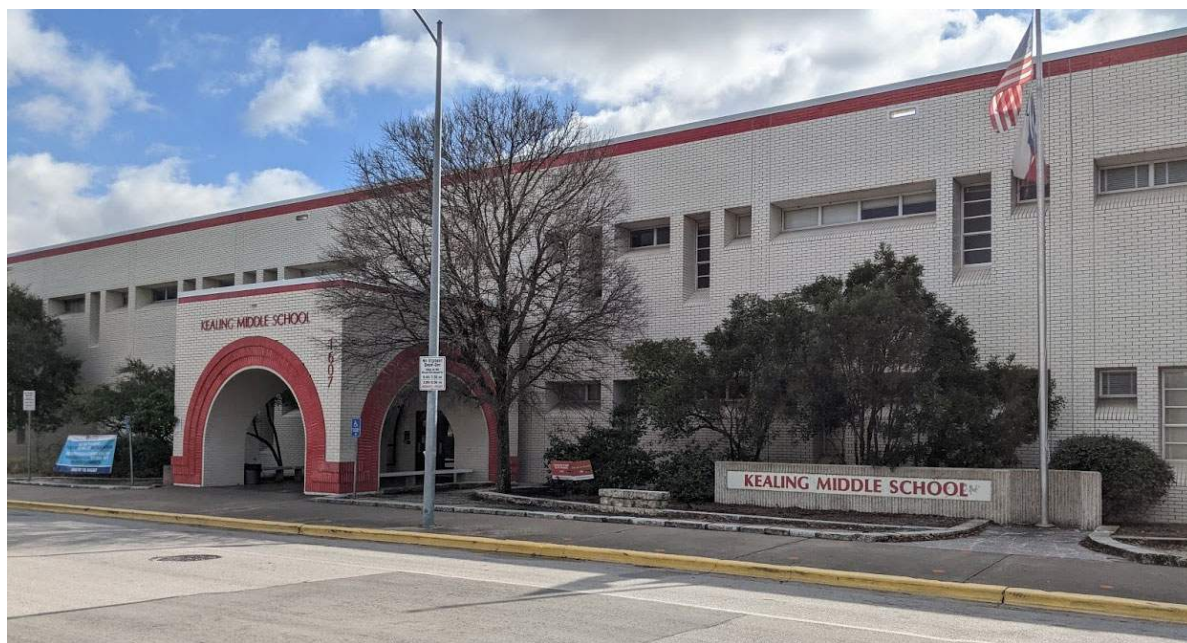
*Main building entry and drop-off on Pennsylvania Avenue.*

The building has separate drop-off areas for parents and the majority of buses. The special education buses pick up in the parent parking lot in the rear of the school.

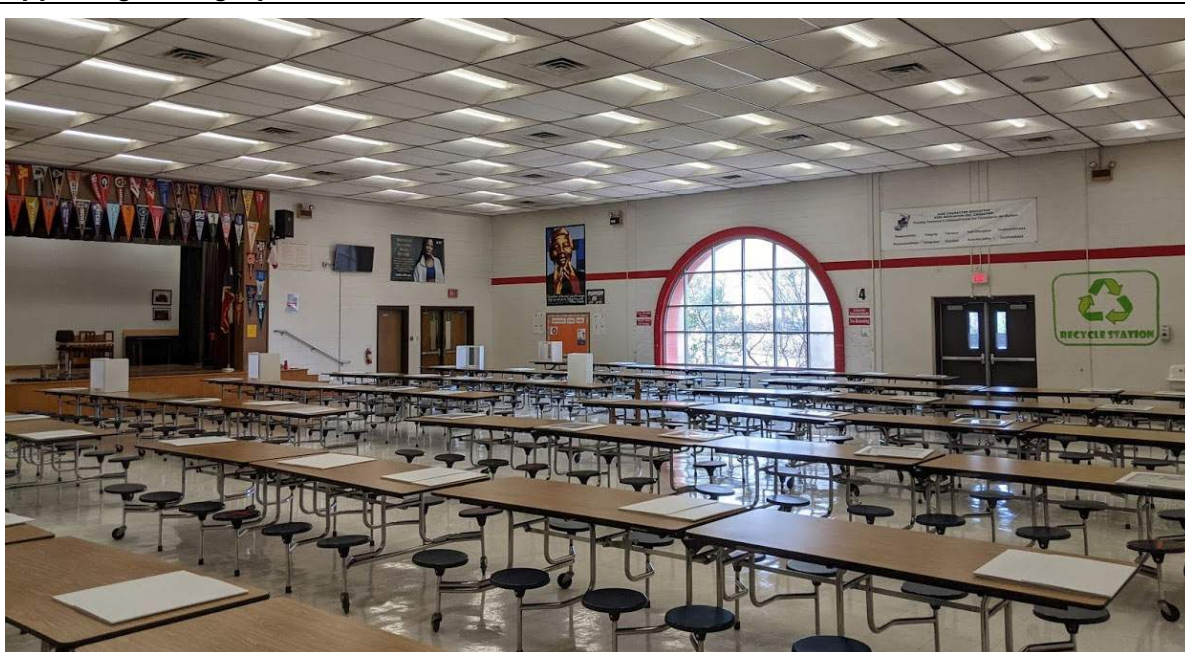
*Cafeteria is undersized but in generally good condition.*

The cafeteria is too small for the number of students at Kealing, requiring the school to have five lunch periods. A large, outdoor dining area with additional seating is next to the cafeteria.

12 - Food Services										10.00	60%	
12.1	Is the Dining Commons appropriately configured per the ed spec?		2							Comments	1.00	2.00
1	Very unsatisfactory - Too small, missing program spaces	Operating on 5 lunch shifts due to number of students. Cafeteria is 4,300 SF. Per Ed Spec to accommodate 1,300 students, cafeteria should be ~7,300 SF. General appearance of the cafeteria is okay.										
2	Unsatisfactory - Too small, poor condition, only one option for eating space provided, inadequate circulation											
3	Average - Adequate size and condition, needs updates or renovations to function well											
4	Satisfactory - Good size and condition, good circulation, multiple options for eating space (ex: connection to outdoor eating space)											
5	Very Satisfactory - Generous size, excellent condition and circulation, multiple options for eating space (ex: connection to outdoor eating space)

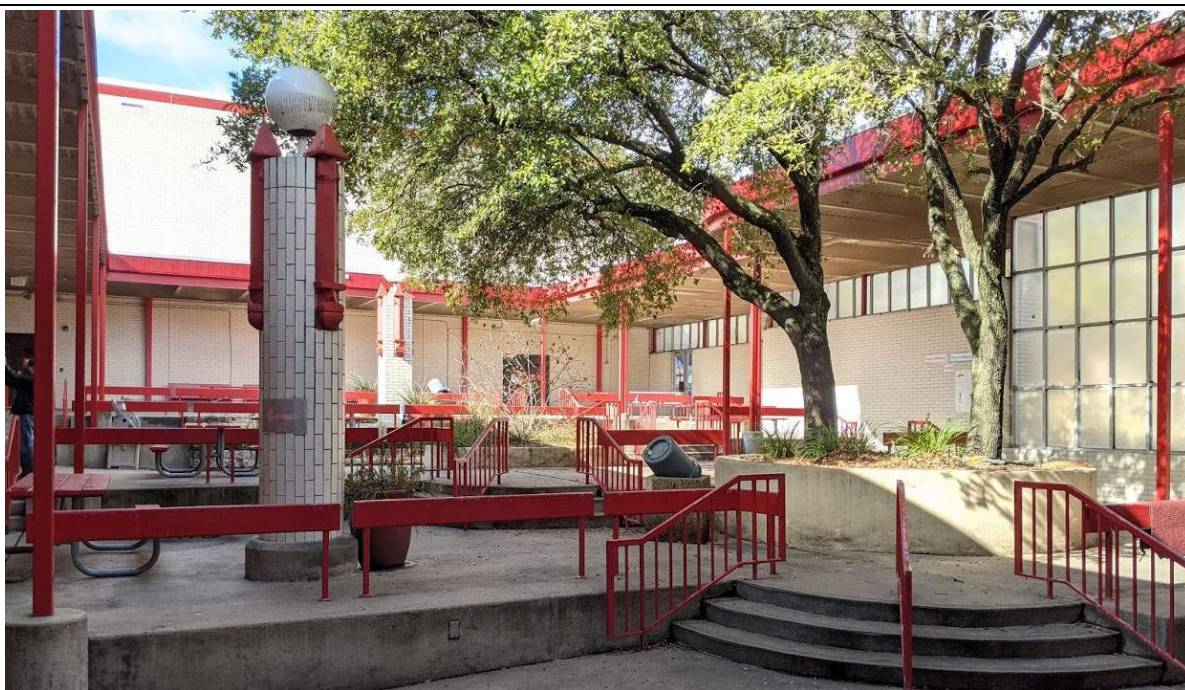
*Large courtyard near cafeteria. Variety of seating and some shade provided.*

Outdoor learning at Kealing takes place in a variety of spaces. The courtyard between the main building and the cafeteria is popular, but some of the furniture is rusting and needs to be updated. A shaded, outdoor studio is dedicated to PE and other teachers have requested additional covered studios. The learning garden is in good condition, but additional seating would be helpful to host more students.

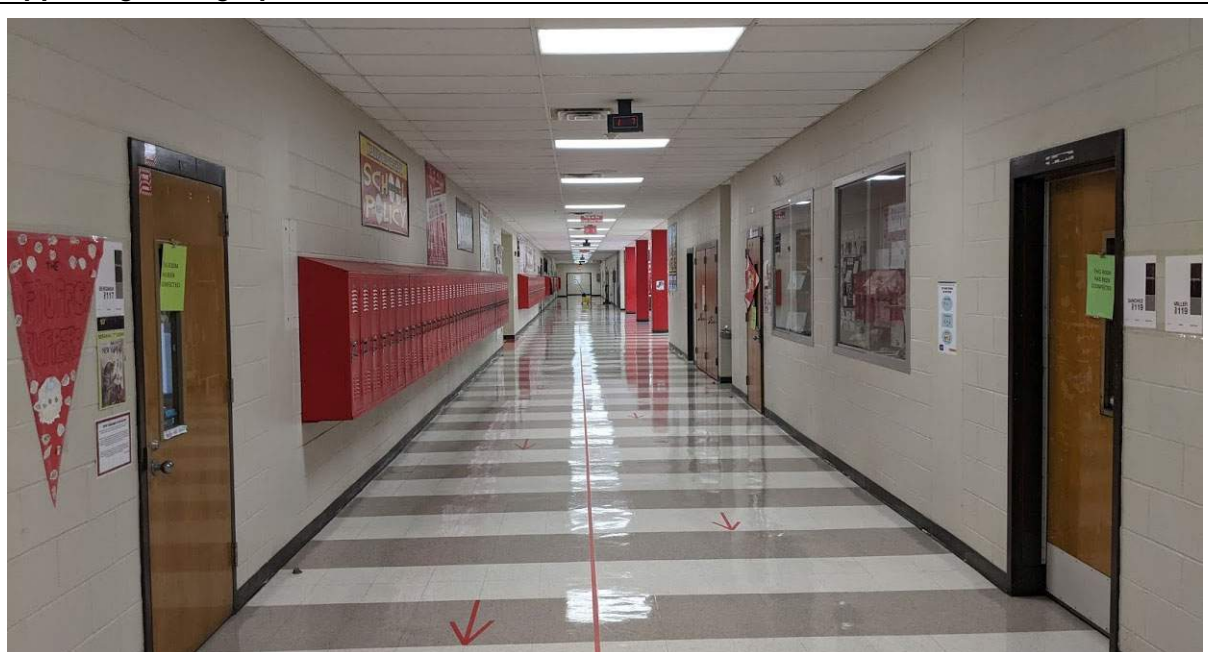
*Typical corridors are wide but have limited breakout space and transparency.*

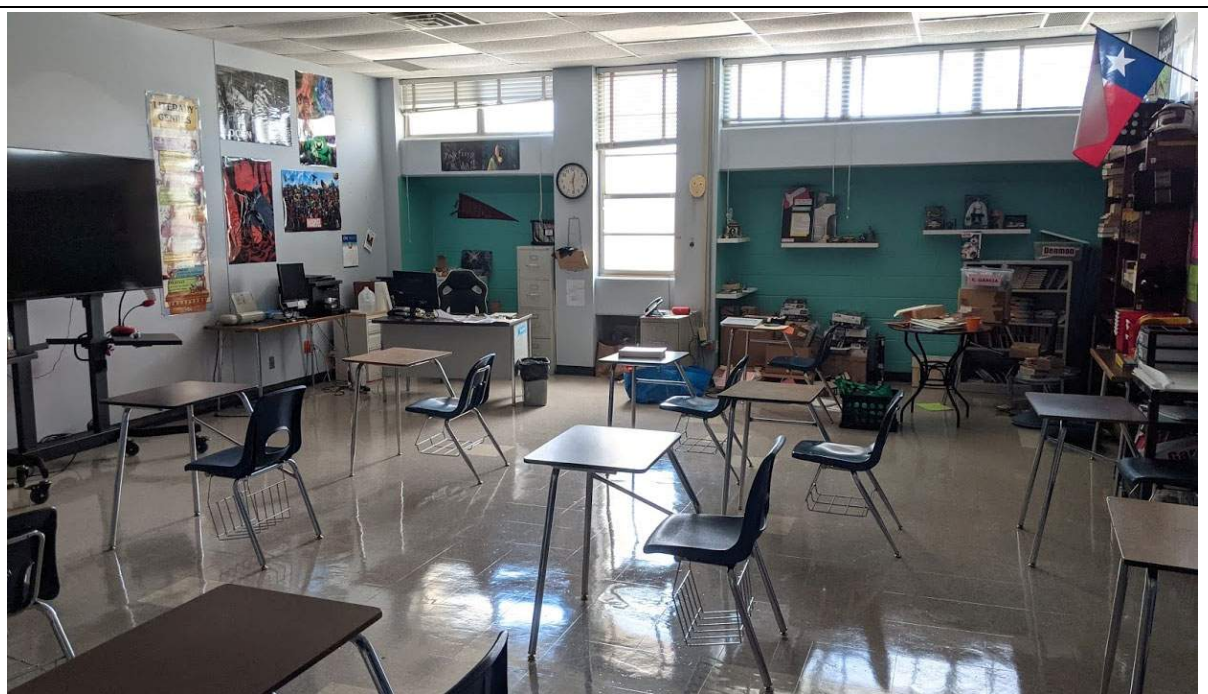
*Typical studio with clerestory lighting and no storage. Furniture is dated and some studios still have attached chair/desk combination.*

Most studios have access to some natural light, but much of it is through clerestory windows that limit views. The two building wings are positioned so closely together that some studios only have a view of the wall of the adjacent wing.

Furniture varies widely from one studio to the next. Some areas have older configurations with chairs and attached desks, while others have loose chairs and bulky tables. Common spaces have little variety in seating options, although the library does have a small amount of mixed informal seating.

7.4	Is the furniture ergonomic and size appropriate for grade level?			3				Comments	1.00 <b>3.00</b>
	1 Very unsatisfactory - Desk with attached chair combinations too small for grade level 2 Unsatisfactory - Desk with attached chair combinations 3 Average - Mix of studios with tables/loose chairs and desks with fixed seats 4 Very satisfactory - Tables with loose chairs 5 Very satisfactory - Tables with loose chairs that allow students to be active N/A Does not apply	Some studios with attached chair/desk combination.

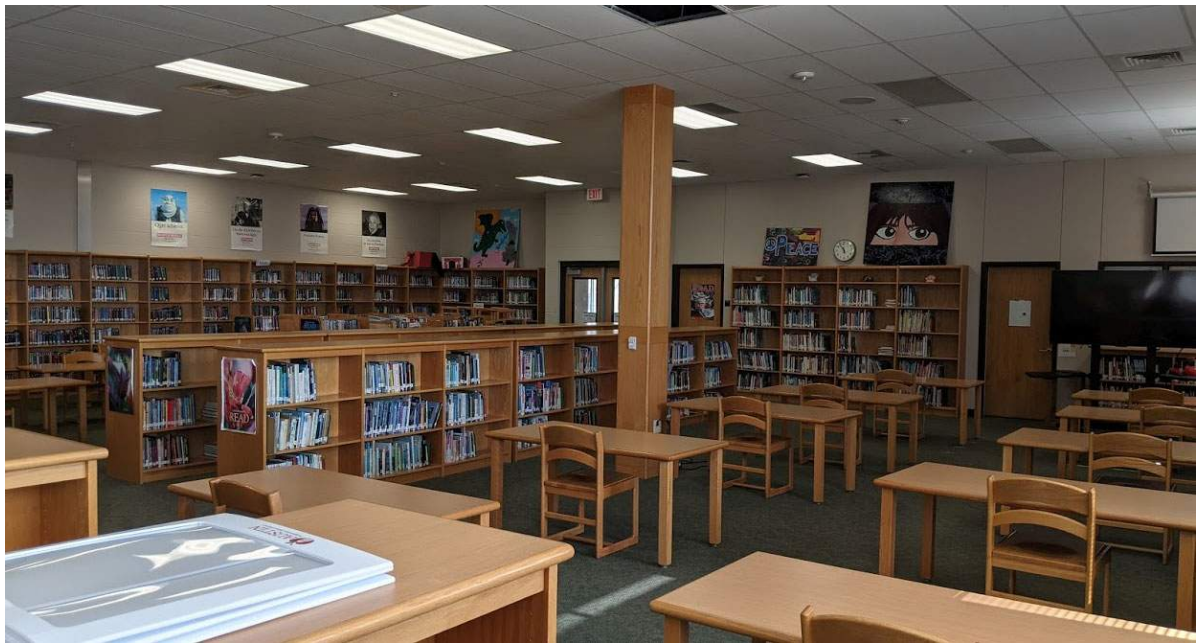
*Media Resources: Library lacks flexibility due to bulky furniture and immobile bookcases.*

Per Ed Spec, the library is well-sized, but fixed bookshelves and bulky furniture make it difficult to accommodate different group sizes. Some informal seating is present, and the layout might be reduced due to COVID-19 concerns. Several small rooms are connected to the library, but currently none are being used as breakout spaces for small groups or individual learning. Technology in the library is limited to a very small projector screen and a TV on mobile cart.

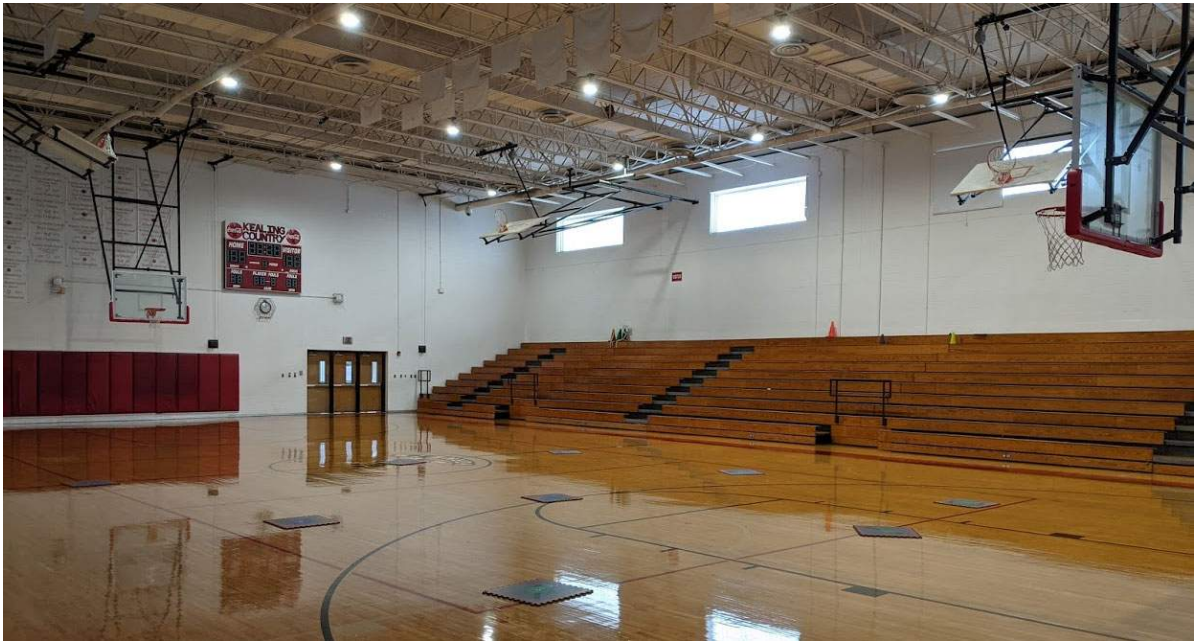
*Gym bleachers are stuck in the out position, limiting flexibility of space.*

The school's main gym is well-sized and in generally good condition. The bleachers are permanently stuck in the out position, which limits flexibility of the space. Lighting and climate control are issues in the gymnasium. The track and field is 2/3 the size of a regulation field, meaning the school cannot host several key sports. The school's three tennis courts are in adequate condition.

11 - Athletics and Wellness							18.75	57%	
11.1	Does the campus meet ed spec standard for physical education program spaces?			3			Comments	1.00	3.00
	1 Very unsatisfactory - Too small, missing program spaces						Bleachers are currently stuck and cannot be retracted.		
	2 Unsatisfactory - Too small, poor condition								
	3 Average - Adequate size, adequate condition, needs some renovations or updates to function well								
	4 Satisfactory - Good size, good condition								
	5 Very Satisfactory - Generous size, excellent condition								
	N/A Does not apply

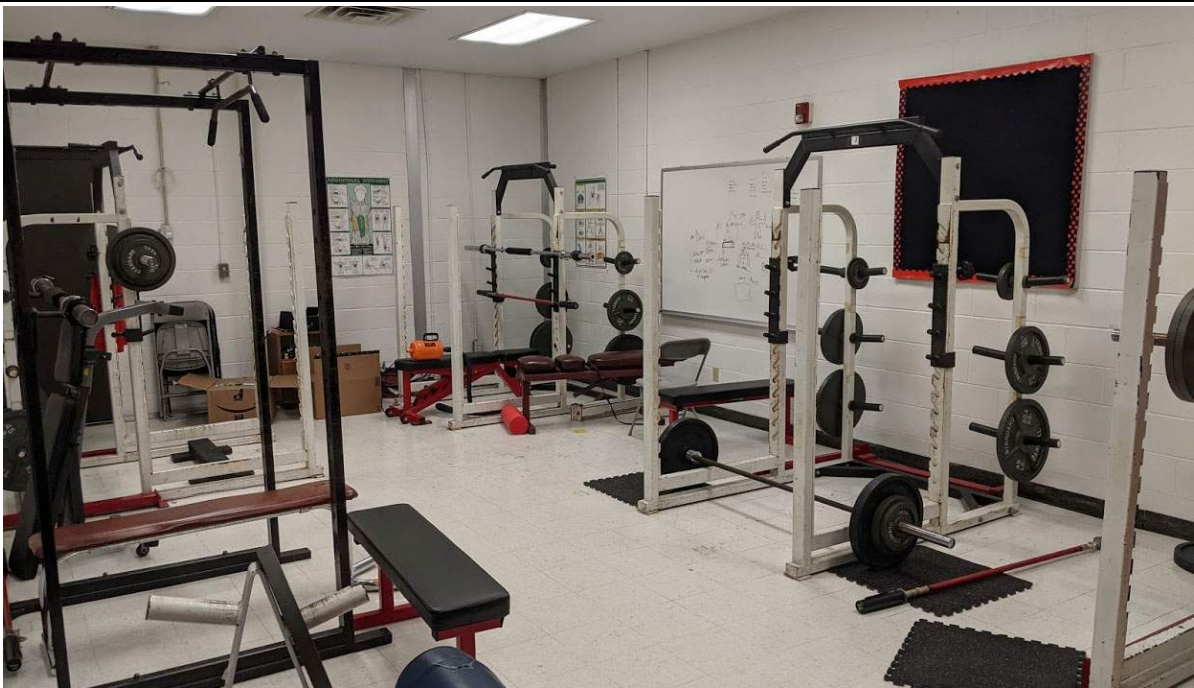
*Small weight room lacks safe spacing of equipment.*

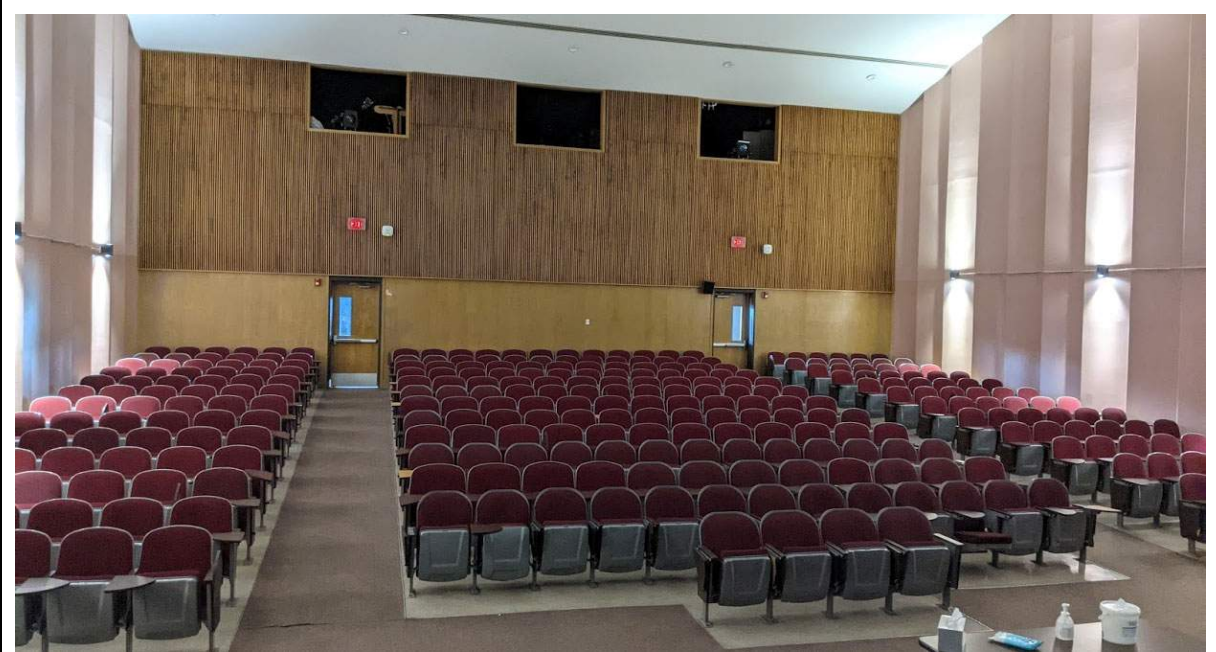
*Theater has 200 seats and requires grade-level assemblies to be split into two groups.*

The discussion with Kealing Academy Director Timothy Estes covered what is working well and what could be improved at Kealing Middle School. In general, the school lacks areas for students to collaborate in larger groups. It was noted that the library is too small, and its current configuration only allows about 15-20 students at a time. (From the assessment walk, this appears to be an outcome of the number of bookshelves as well as single-use desks for COVID-19 protocols.) The cafeteria is sized for an elementary school. Five lunch periods are needed to serve all students. The theater houses 200, requiring grade-level assemblies to be split into two groups.

10.6	Are theater and support spaces appropriately configured per the ed spec?			3				Comments	1.00 <b>3.00</b>	
1	Very unsatisfactory - Too small, missing program spaces							Stage in good condition, but lacks storage and seating is limited for size of campus population.		
2	Unsatisfactory - Too small, poor condition									
3	Neutral - Adequate size, adequate condition, needs updates or renovations to function well.									
4	Satisfactory - Good size, good condition									
5	Very Satisfactory - Generous size, excellent condition									
N/A	Does not apply

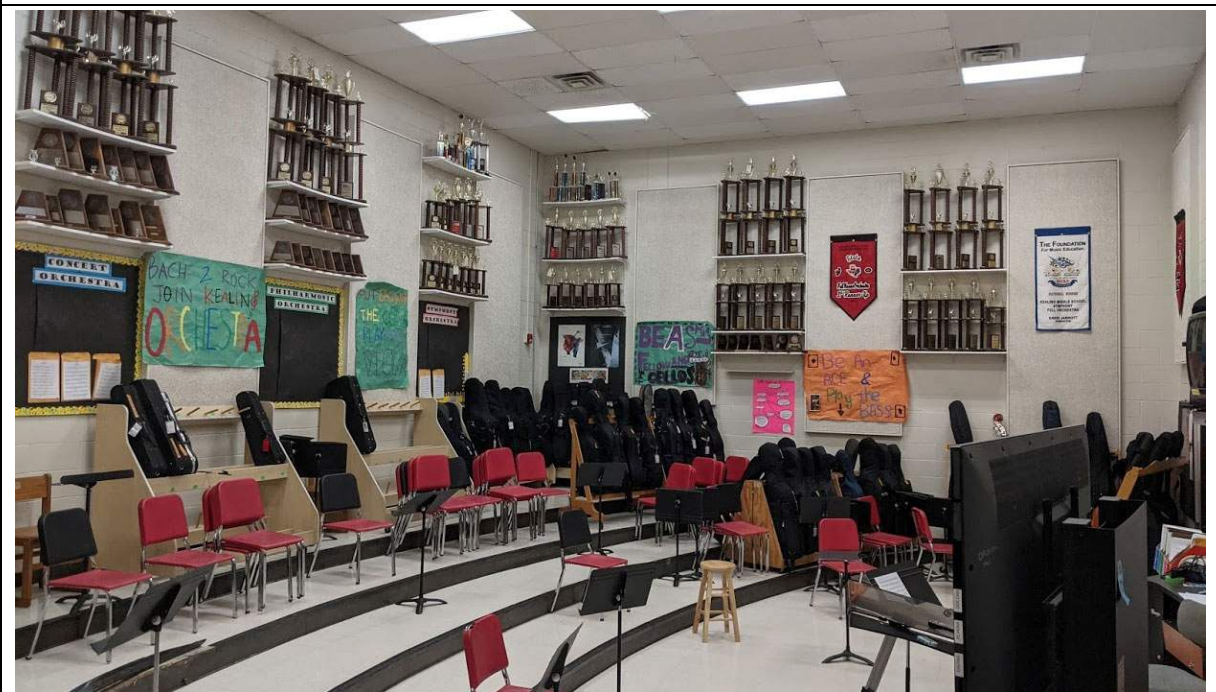
*Orchestra room lacks storage for instruments.*

10.3	Are orchestra and support spaces appropriately configured per the ed spec?			3				Comments	1.00 <b>3.00</b>
1 Very unsatisfactory - Too small, missing program spaces 2 Unsatisfactory - Too small, poor condition 3 Neutral - Adequate size, adequate condition, needs updates or renovations to function well. 4 Satisfactory - Good size, good condition 5 Very Satisfactory - Generous size, excellent condition N/A Does not apply		More storage needed. Short corridor being used as storage space within orchestra room.

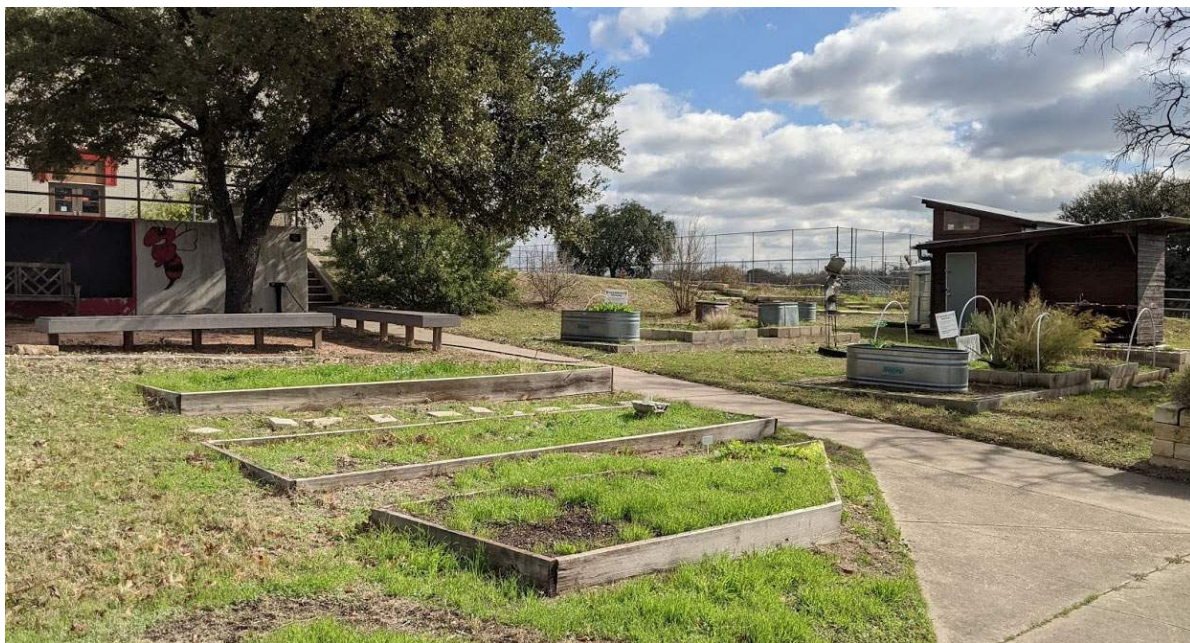
*Learning garden and supply shed.*

another small outdoor studio has photovoltaics contributed by Austin Energy. The learning garden is in good condition but is disconnected from the learning spaces. A small shed provides storage and infrastructure for the garden. A rain collection cistern is provided.

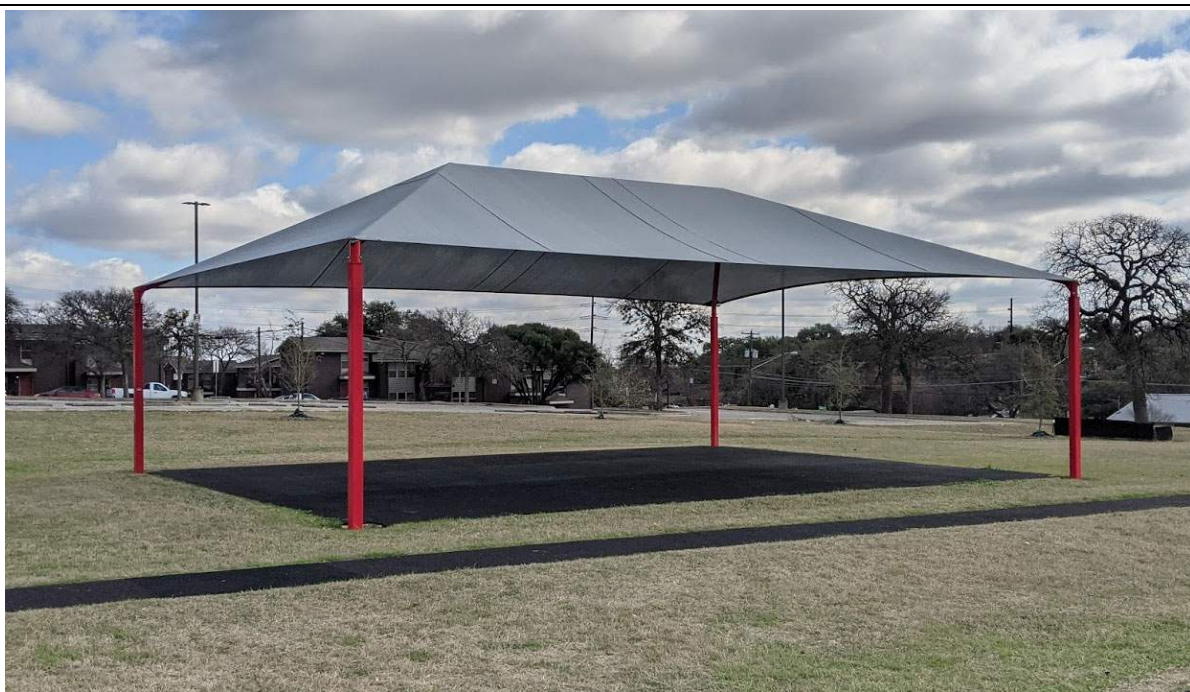
*Shaded outdoor space used mainly by PE.*

Two dedicated outdoor learning studios are on the grounds: one shaded structure is for PE only, and

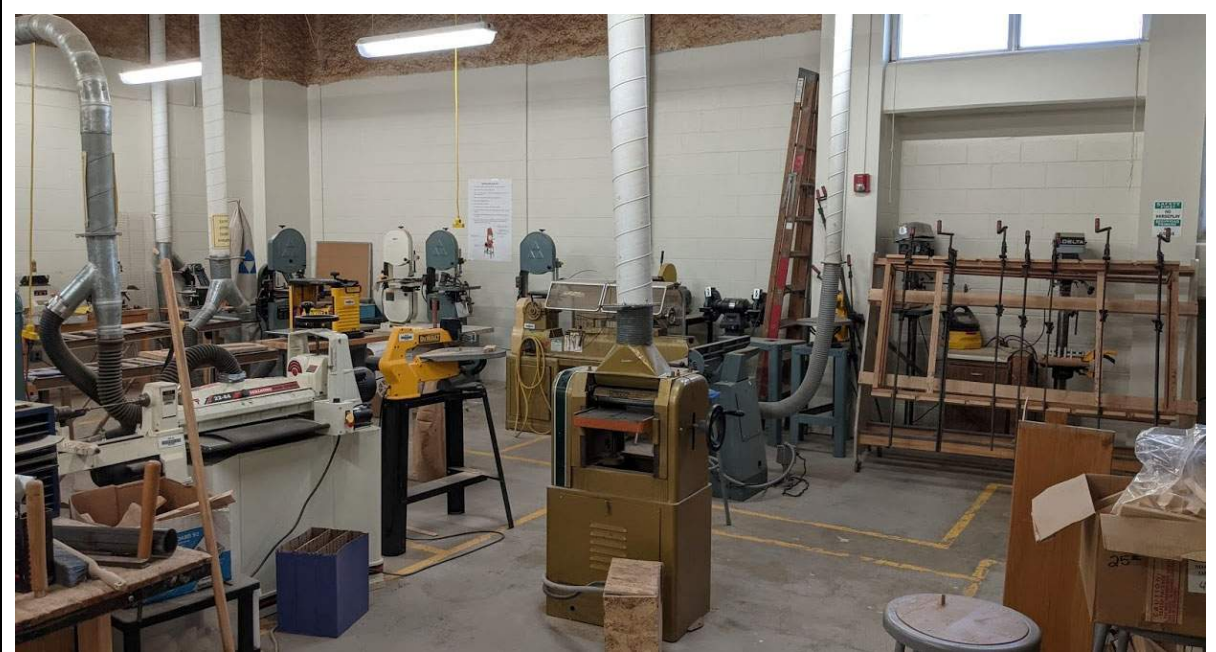
*CTE and Career Connected Learning: Large machine and wood shop with attached fabrication lab.*

Kealing has a wide variety of CTE programs, offering more than 80 electives to students. Some of these are housed in purpose-built areas such as the machinery and wood shop or the A/V program. Many other programs are in typical retrofitted studios.
