## **Educational Suitability Summary Report**

Future Liberal Arts and Science Academy at Current Eastside Campus

Date: 01/26/2021

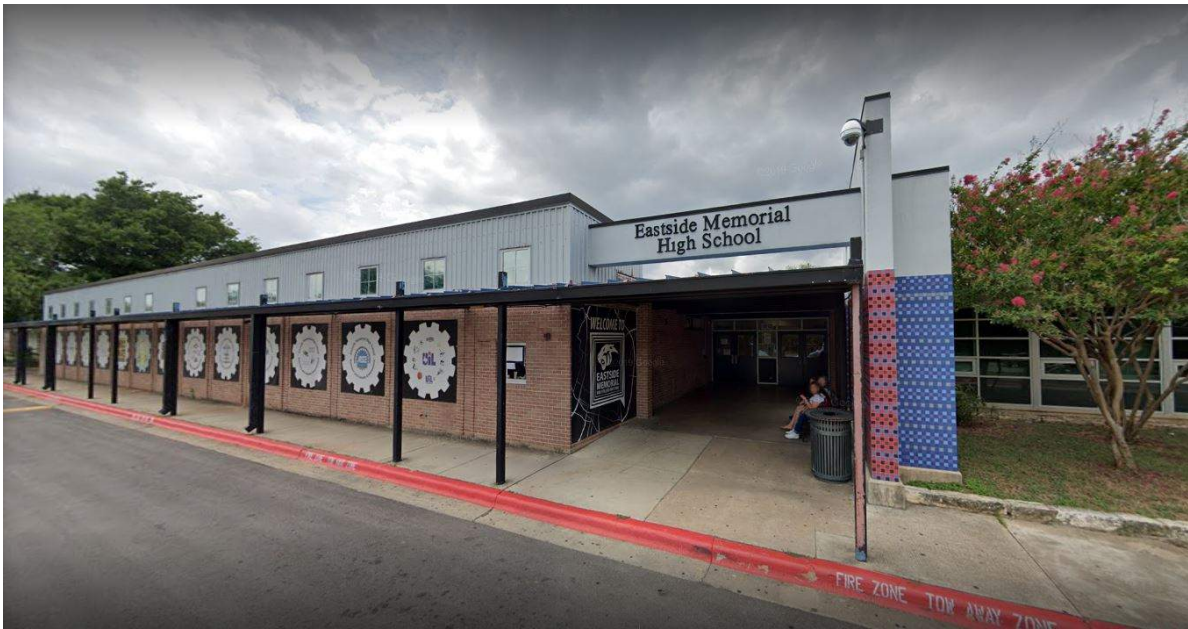
Improvements are planned for summer of 2021.

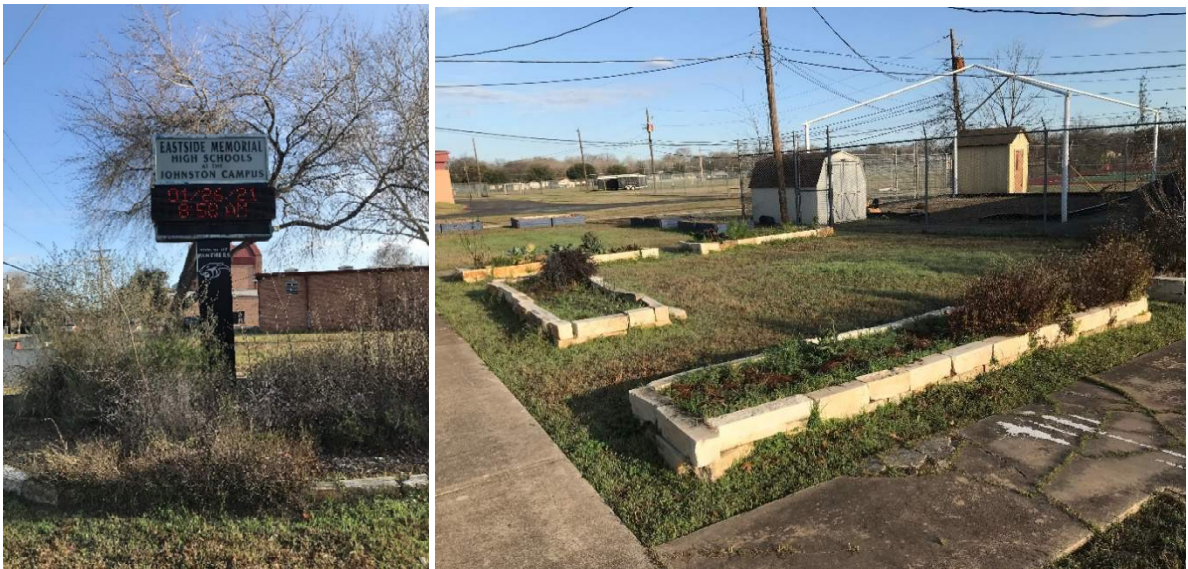
The marquee sign is far from the main entry and is overgrown with weeds (left). School gardens are present, but the unraised beds and cracked walkways are not ADA compliant (right).

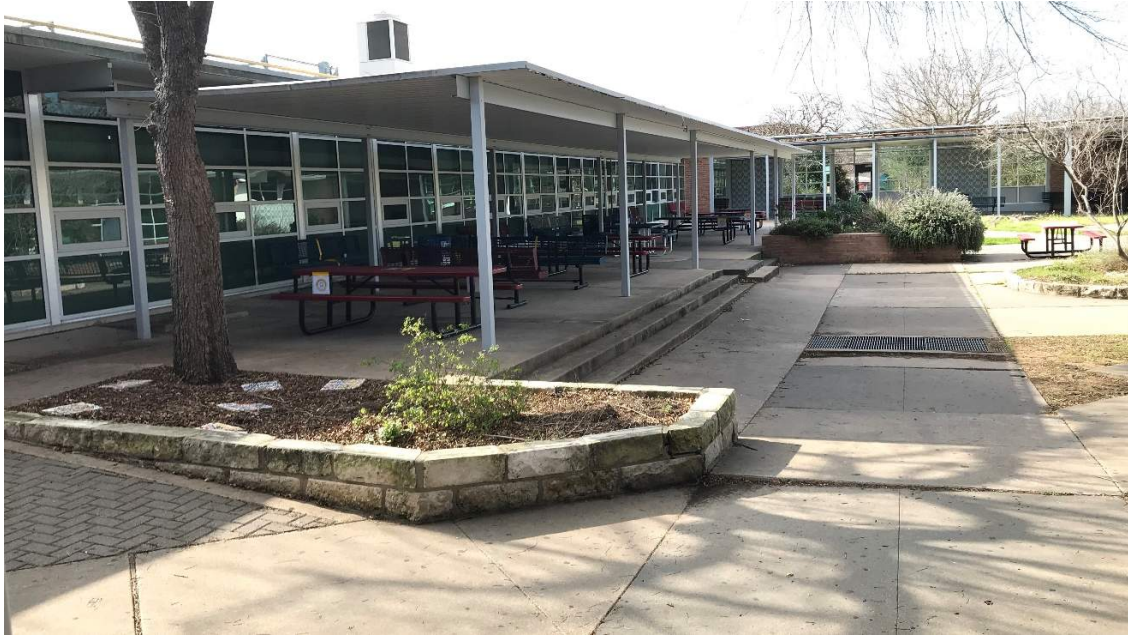
*The campus has plenty of courtyards that bring in natural light and provide opportunities for outdoor learning and dining. Renovations are needed to bring some of the courtyards into ADA compliance.*

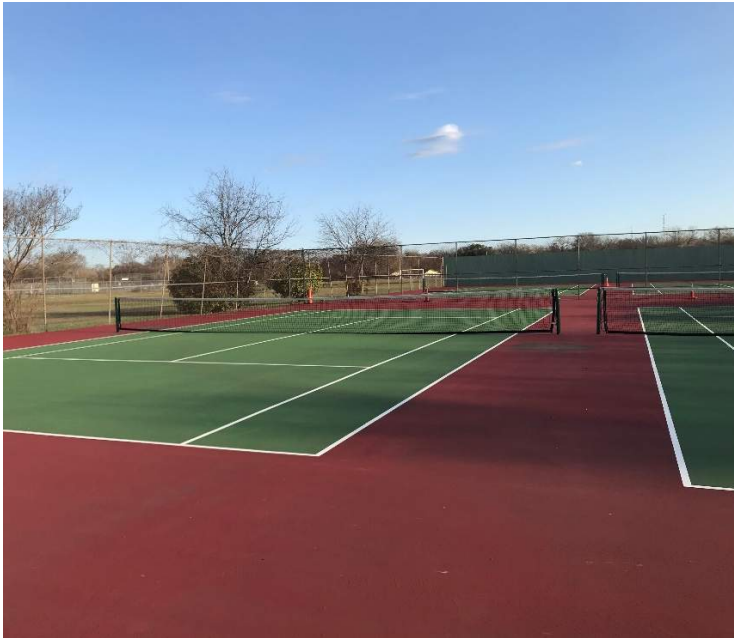
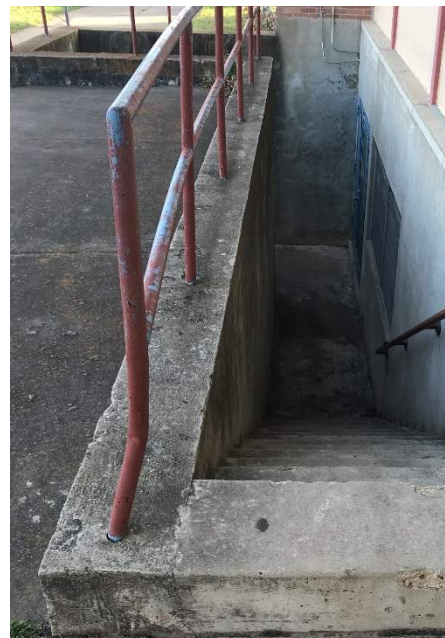
*Tennis courts appear to be new and/or in good condition (left). Exterior handrailing is bent with peeling paint and stairs pose a trip hazard (right).*

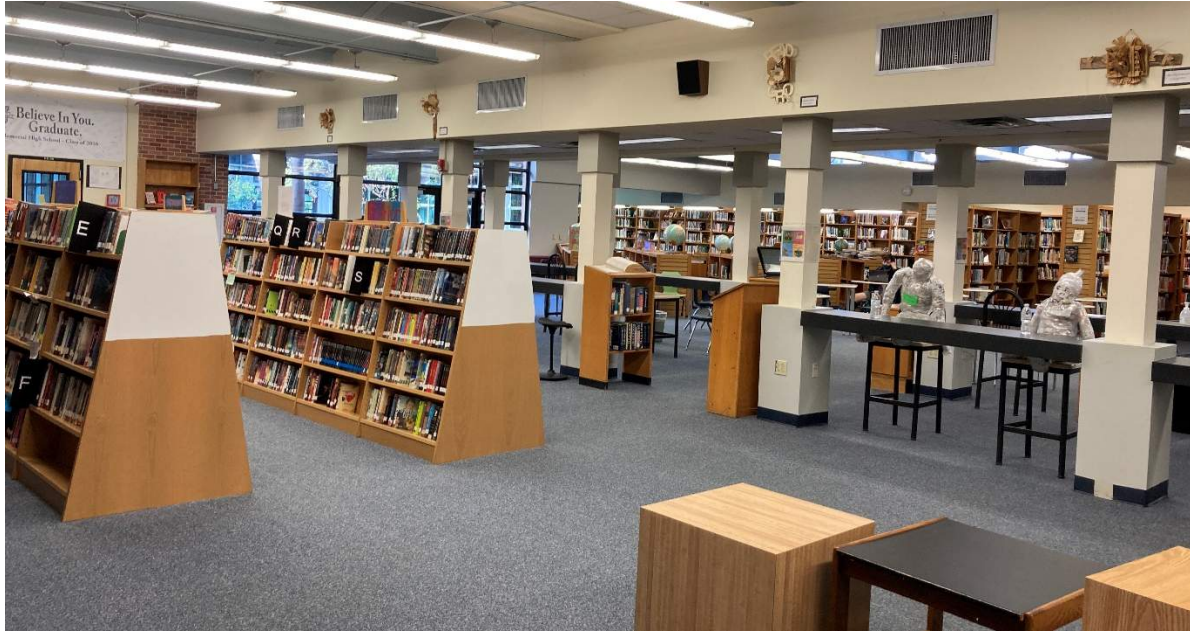
*Media Center: The library is in good condition but needs mobile furniture and technology updates.*

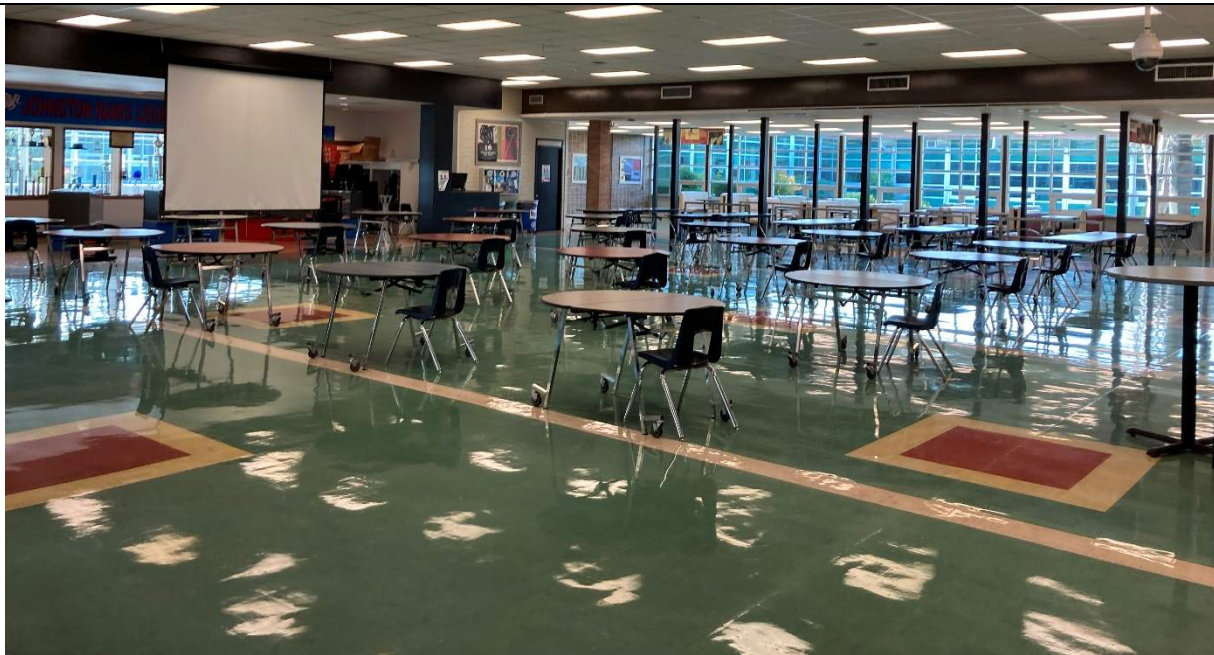
*The furniture in the cafeteria is not mobile and there is no projector.*

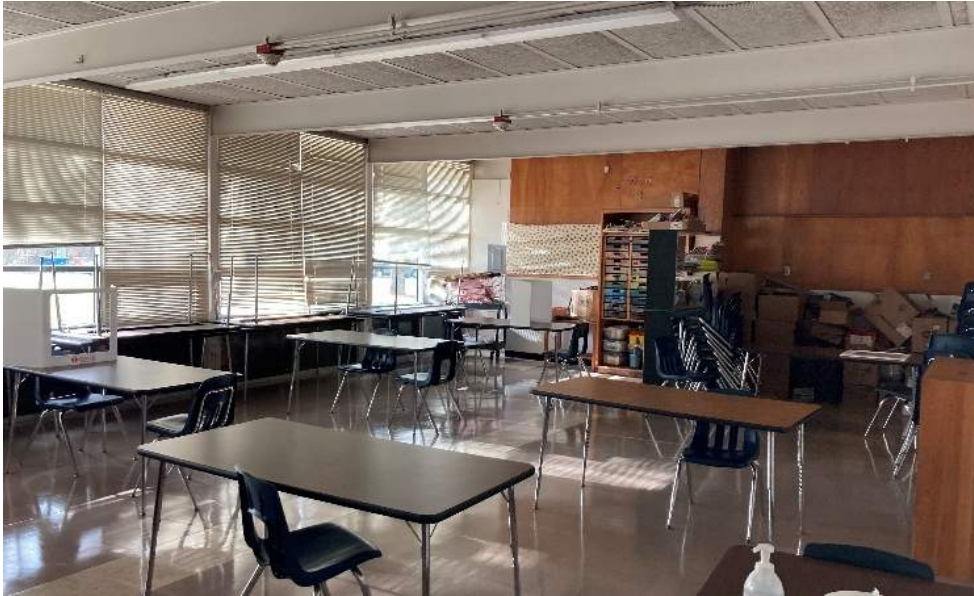
*Typical studios have plenty of daylight but need mobile furniture and movable partitions to fully support project-based learning.*

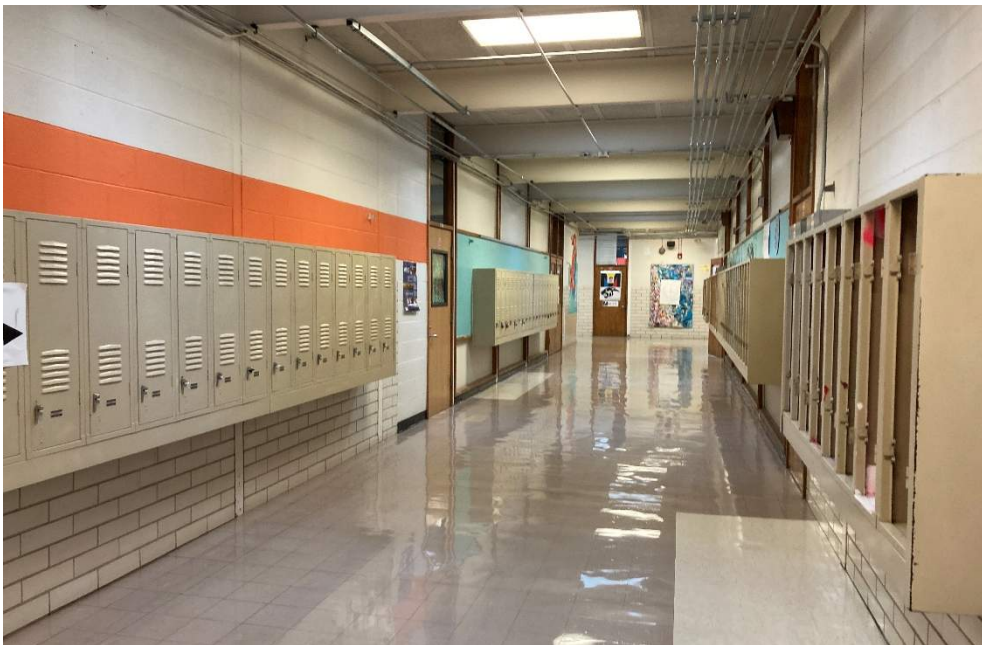
*Typical corridors have no transparency into the studios and some lockers appear to be damaged/broken.*

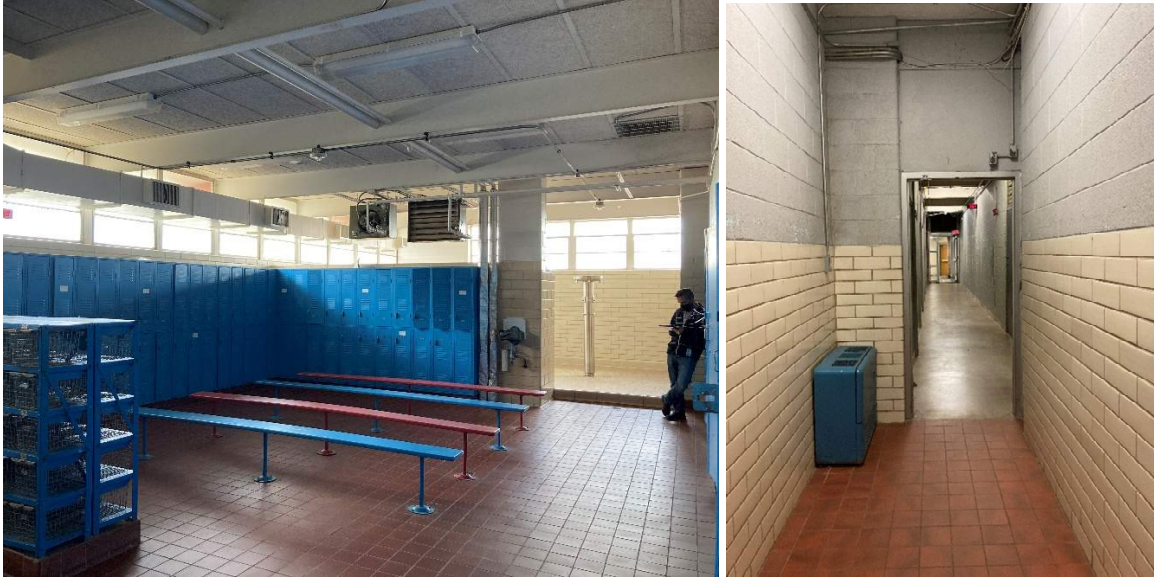
*Locker rooms have plenty of natural light (left). Athletic corridors are very narrow, dark and difficult to navigate (right).*

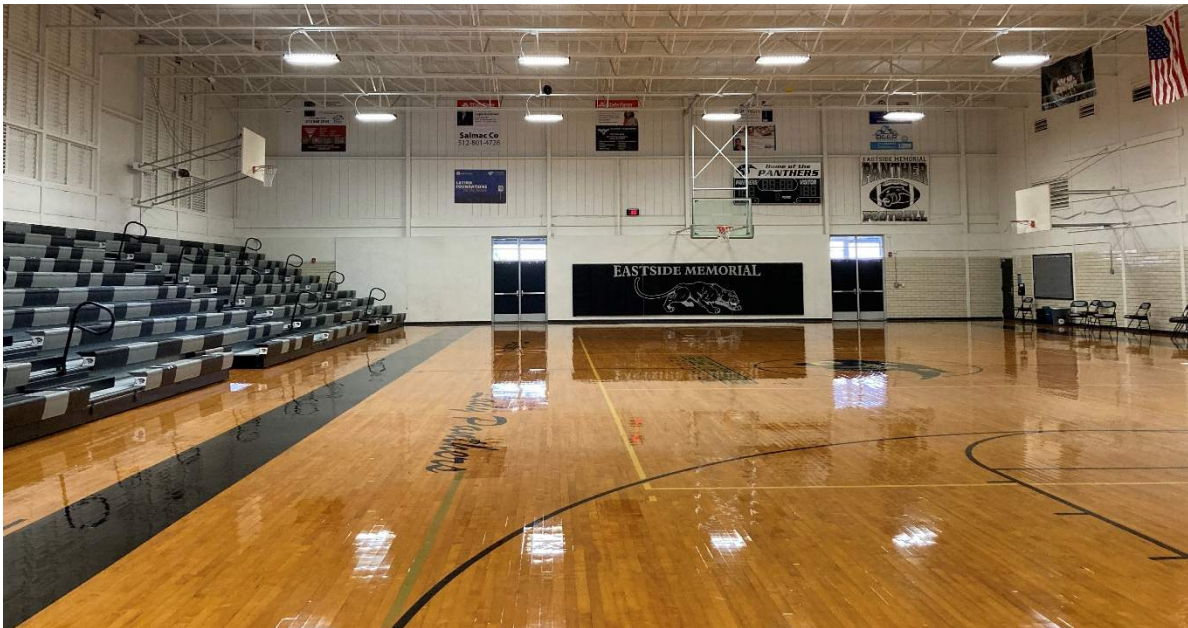
*The main gym is too small to support bleachers on either side of the playing area and lacks dedicated restrooms.*
