Educational Suitability Summary Report

Sadler Means Young Women's Leadership Academy

Date: 12/11/2020

Score 56% Average

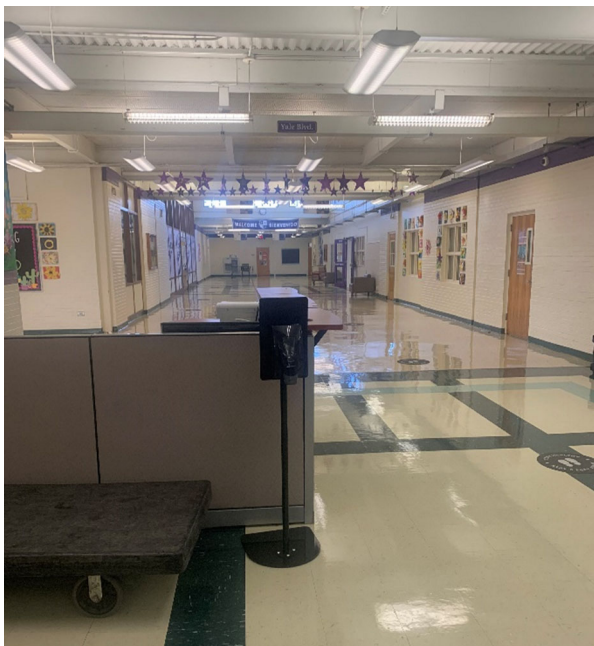
Main entry: [REDACTED] Main corridor is generous in width and could support informal/collaboration spaces.

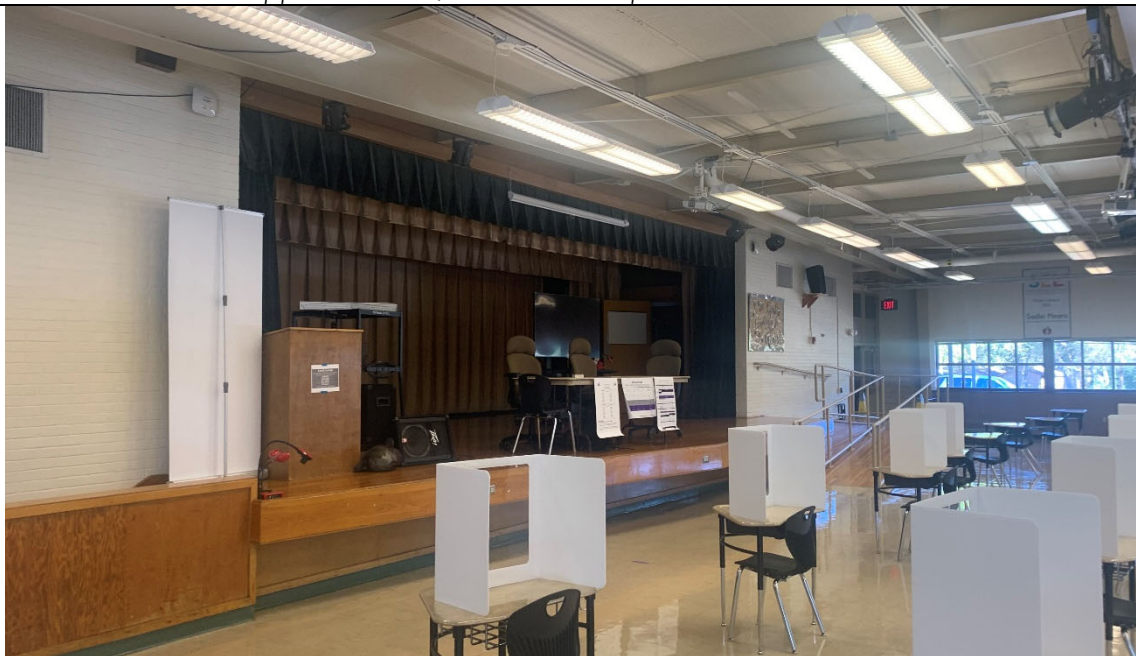
Cafeteria stage: A/V equipment/stage condition is unsatisfactory and difficult to use for productions and meetings.

One area for improvement is the stage and A/V equipment for productions. The A/V is very old and dated, and the equipment is really seen as a hindrance in using this space.

10.6	Are theater and support spaces appropriately configured per the ed spec?		2					Comments	1.00 2.00
	1 Very unsatisfactory - Too small, missing program spaces 2 Unsatisfactory - Too small, poor condition 3 Neutral - Adequate size, adequate condition, needs updates or renovations to function well. 4 Satisfactory - Good size, good condition 5 Very Satisfactory - Generous size, excellent condition N/A Does not apply	AV for cafeteria stage does not function.

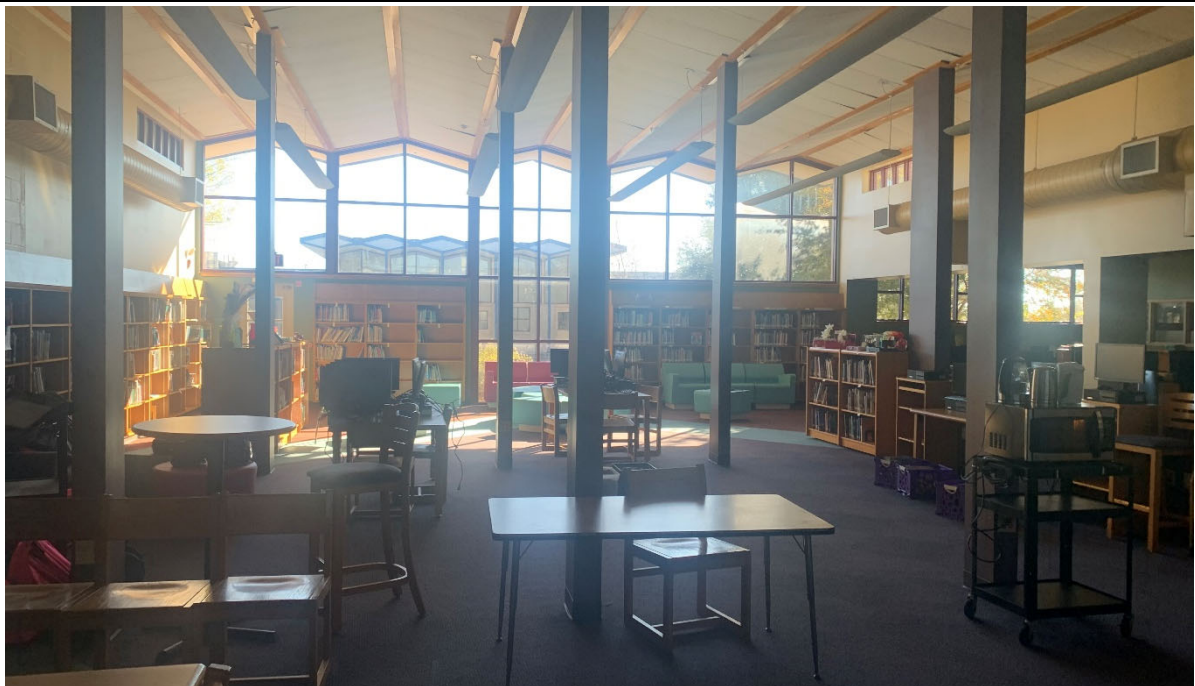
Media Center: Daylit tall generous space with different seating options. Location is off main corridor. Limited transparency to courtyard beyond and into main corridor.

There is new flexible furniture for small groups to meet, but the library is all one space and not acoustically separate for various groups to meet. In the corner of the library, they are creating a maker space for media and is one of the areas that the principal is trying to increase participation.

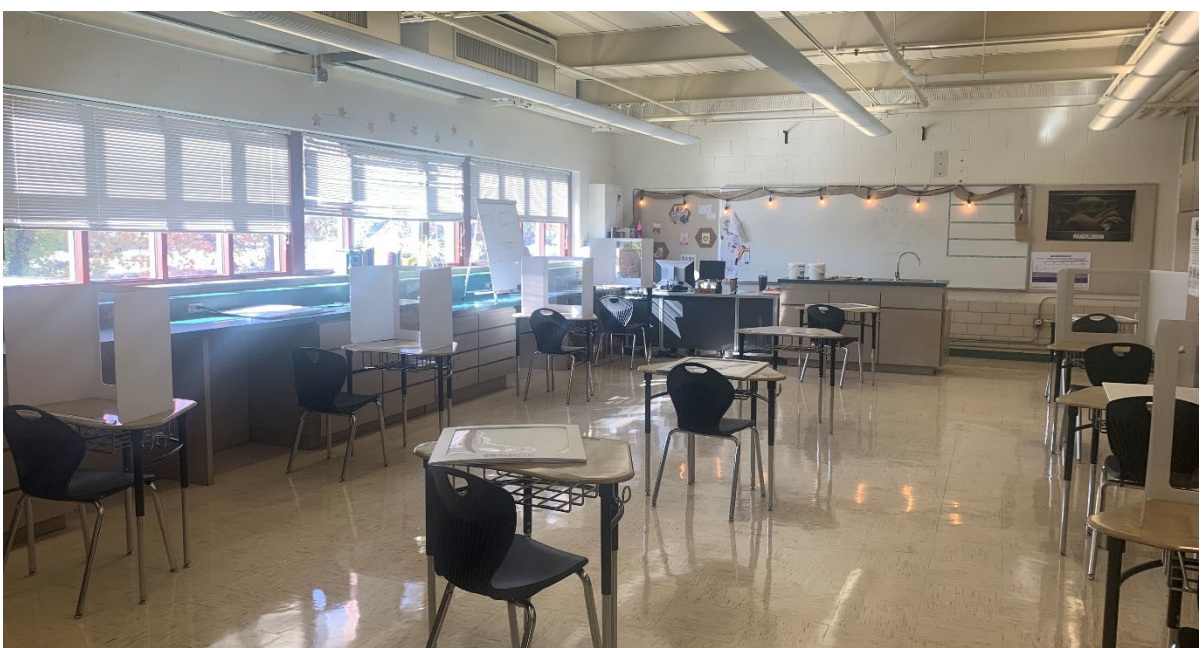
Studios: All studios have access to natural daylight. S.F. is below Ed Spec requirements and does not allow for multiple teaching modalities.

Studios are very traditional and undersized at 740 S.F. There are no group rooms for small or medium groups and no collaboration space aside from the library and some exterior areas.

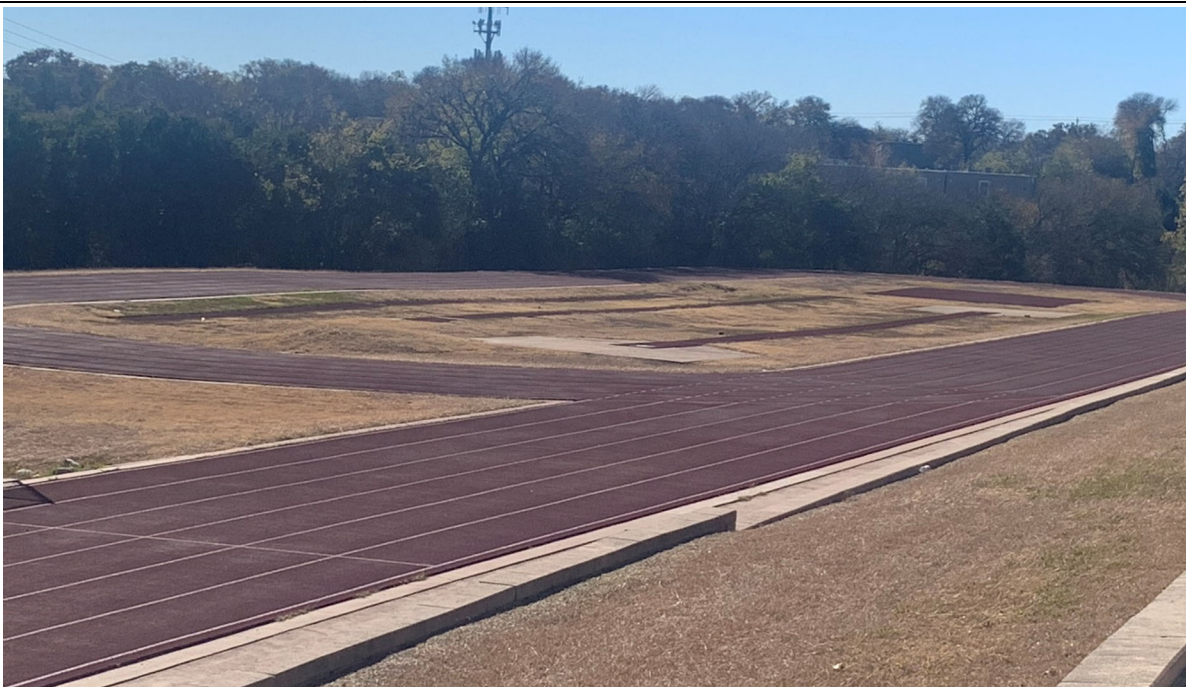
Track is undersized at 1/8th mile and steep grade from the school to the track is problematic.

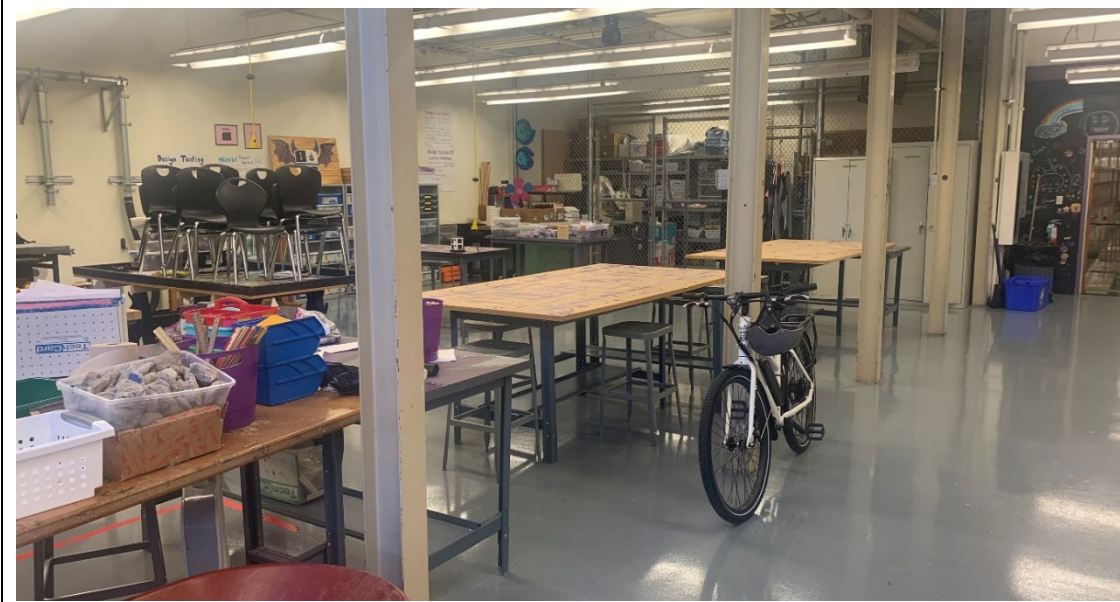
Maker space/wood shop (Room 112) is in good shape and well used. Adjoining classroom with additional technologies (3D printer) is available. During large rain events, the room does flood where an overhead coiling door used to be located. Floor has recently been replaced and a dust collector was added. The HVAC in this room will be replaced in summer 2022.

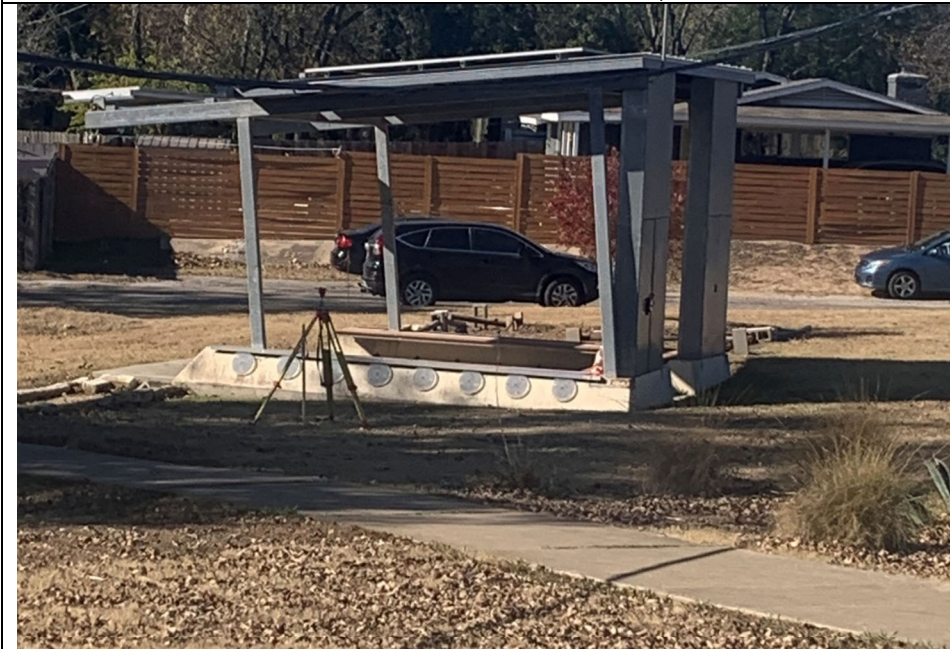
Outdoor studio space: Pavilion for outdoor learning but is far removed from school building and not flexible in its use.

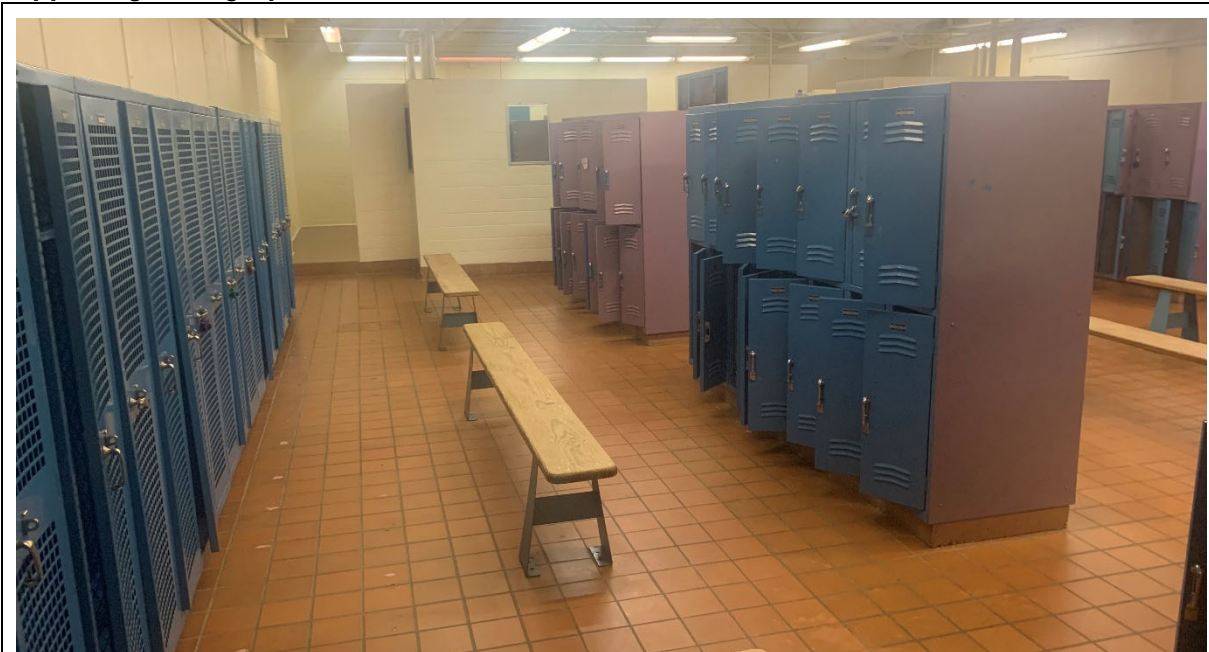
Locker rooms: Dated finishes and there are accessibility issues.

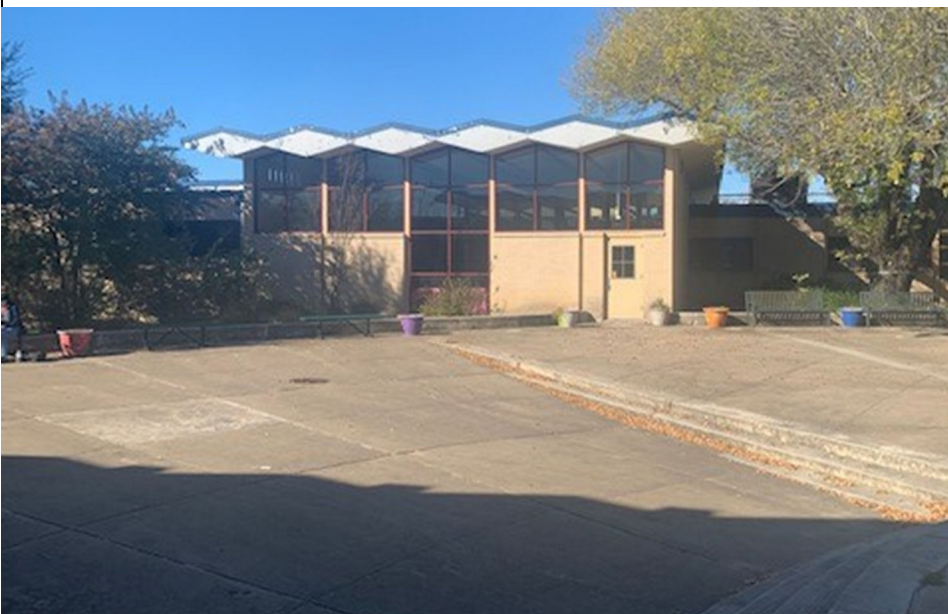
Exterior courtyard: Generous size but lacks connections to library/cafeteria. Accessibility issues with steps within courtyard. Project in summer of 2022 will address courtyard repairs.
