## **Educational Suitability Summary Report**

Navarro Early College High School

Date: 12/14/2020

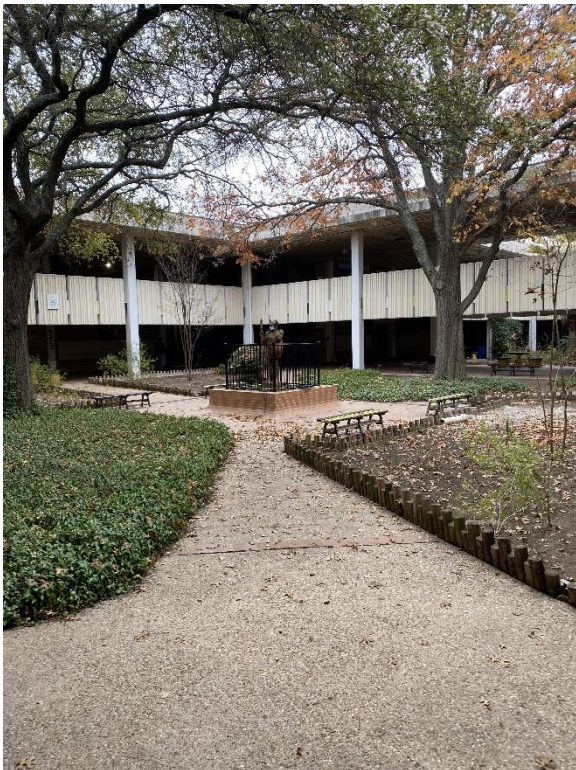
*Courtyard of the main building is a large space and could be utilized for outdoor learning with proper maintenance, irrigation and furniture and equipment upgrades. In the summer months, there is a mosquito problem due to drainage issues and standing water.*

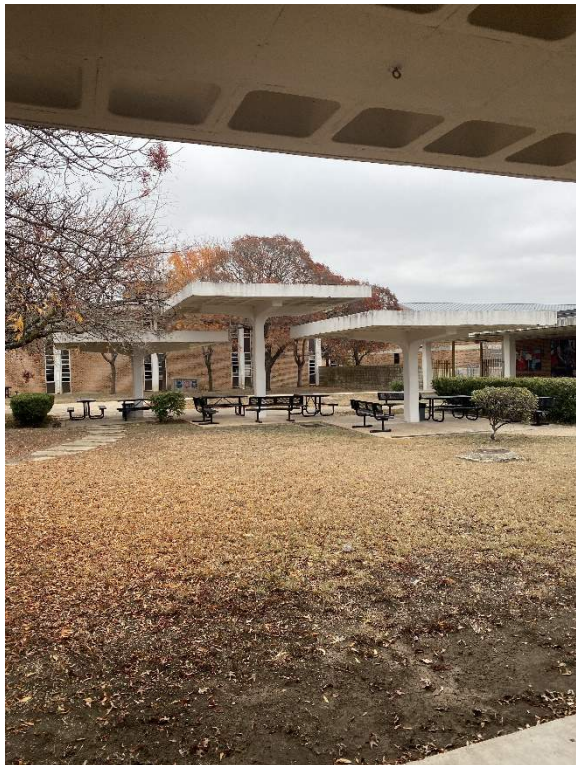
*Variety of outdoor spaces for sitting, gathering and eating. Some of these spaces could be outfitted for collaborative/outdoor learning.*

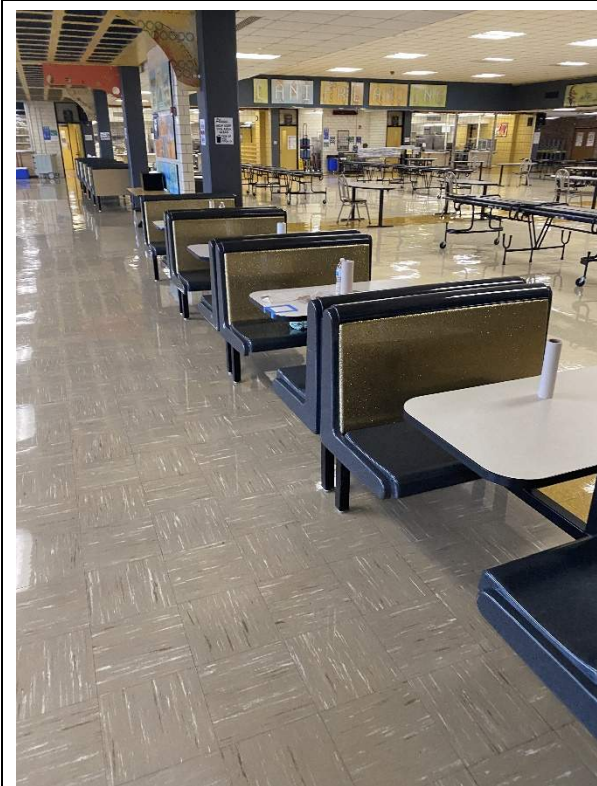
*The cafeteria is large and provides multiple types of seating options. The seating is outdated.*

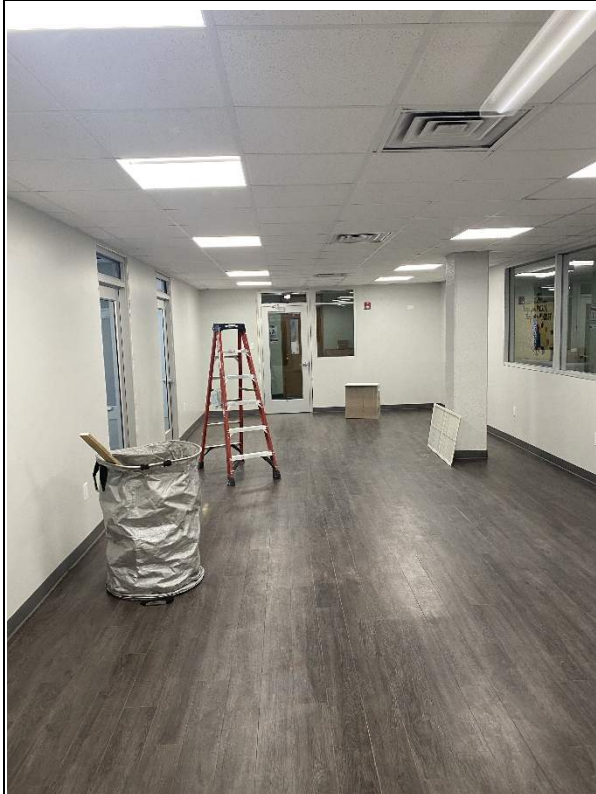
*One of the studio clusters has an updated central support space for collaboration.*

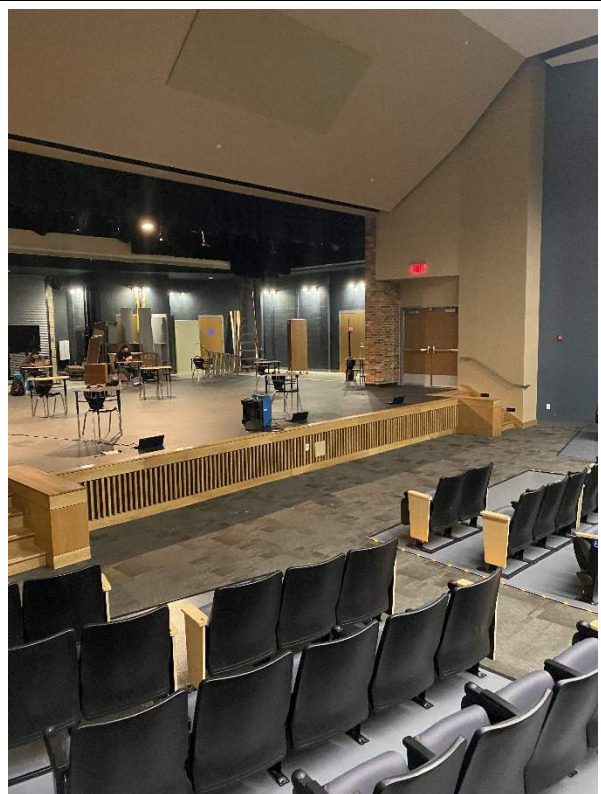
*Performing arts auditorium is in good condition and functions well.*

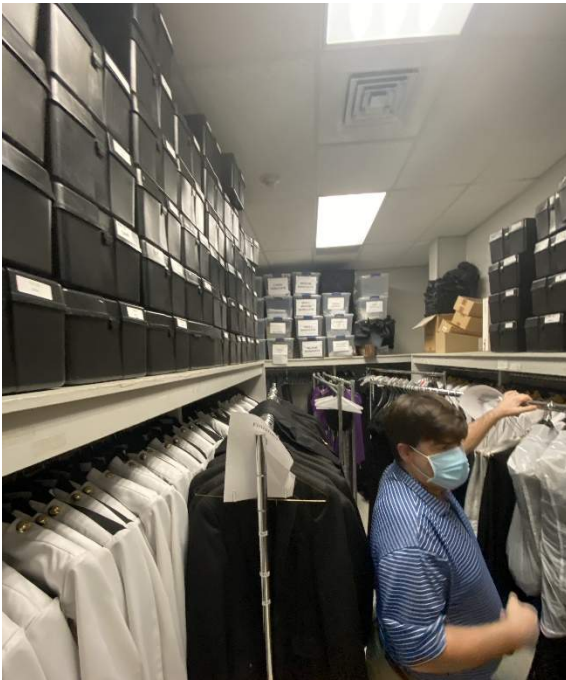
*Band hall requires additional storage for instruments and uniforms.*

10.2	Are band and support spaces (rehearsal and storage) appropriately configured per the ed spec?		2					Comments	1.00	<b>2.00</b>	
1 Very unsatisfactory - Too small, missing program spaces 2 Unsatisfactory - Too small, poor condition 3 Neutral - Adequate size, adequate condition, needs updates or renovations to function well. 4 Satisfactory - Good size, good condition 5 Very Satisfactory - Generous size, excellent condition N/A Does not apply								Band hall is in average condition. Not enough storage. Uniform storage is cramped and larger instruments (tubas) are sitting on the ground in the band hall.

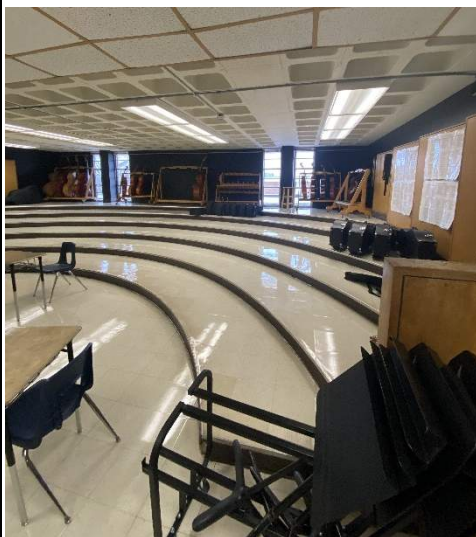
Orchestra and choir currently share a choir room in the main building. It is set up with permanent risers, and as the orchestra grows, this space will not be suitable. Dance studio is in auxiliary gym and is satisfactory. The band hall is in average condition. The lack of storage is problematic. Large instruments are sitting on the ground and are too accessible and not secured. The uniform storage room does not allow a person to enter without moving a rack first. The theater and black box theater are in good condition with accessible dressing rooms and stage. The visual arts studio has some deficiencies. There is a lack of sinks and storage.

*Orchestra and choir share a room in the main building. Currently set up as a choir room and as orchestra grows, the room setup is not conducive for orchestra.*

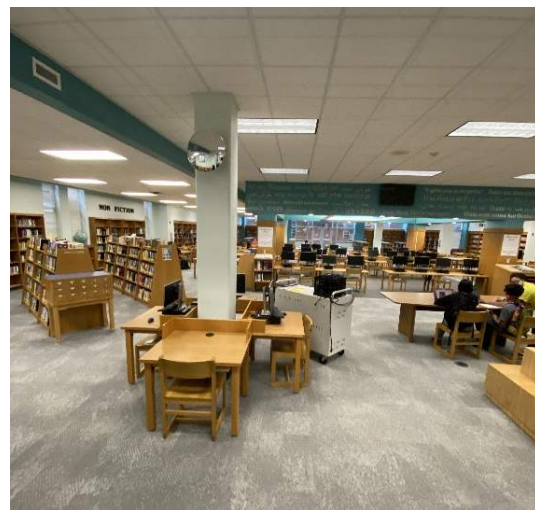
Location of library does not allow for public access after-hours. Furniture is bulky and not easily movable. The space is large and open and doesn't provide small group rooms for quiet study or group projects.

*Media Resources: Library is in good condition and is adequately sized. Furniture throughout is dated and heavy (though in decent condition). More power/data is needed as messy power strips and cords cause clutter.*

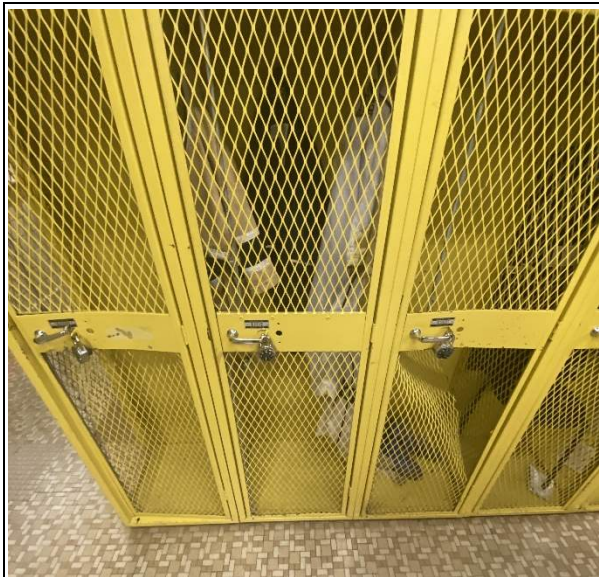
*Athletics lockers throughout are dated – products and their parts have been discontinued, so maintenance is nearly impossible.*

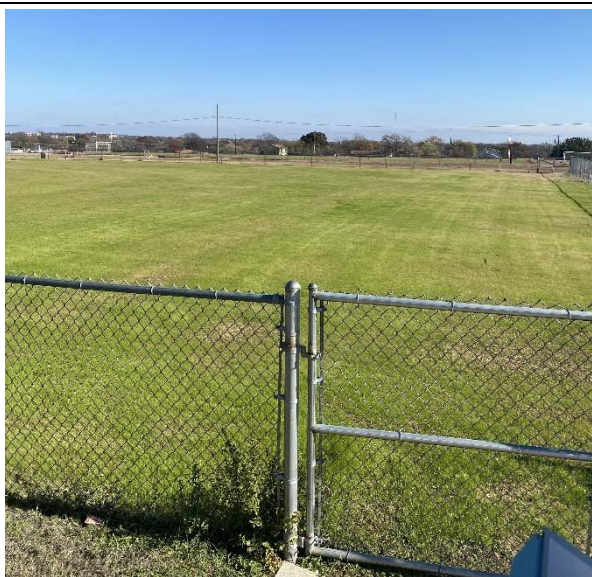
The campus does not meet the Ed Spec for physical education programs. Weight room (former stage) is undersized and in poor condition. The campus hosts UIL athletic events for varsity (volleyball and basketball) and some field sports for junior varsity and freshman teams. The storage and locker rooms are very unsatisfactory. The playing fields outside are in poor shape and are uneven. All finishes (walls and floors) need to be upgraded.

*Athletics surfaces are not in great shape for practices and competitions – unevenness, dips and holes have led to sprained ankles and torn ACLs.*
