Educational Suitability Summary Report

New Middle School in Northeast Austin

Date: 03/29/2021

Score 92% Very Satisfactory

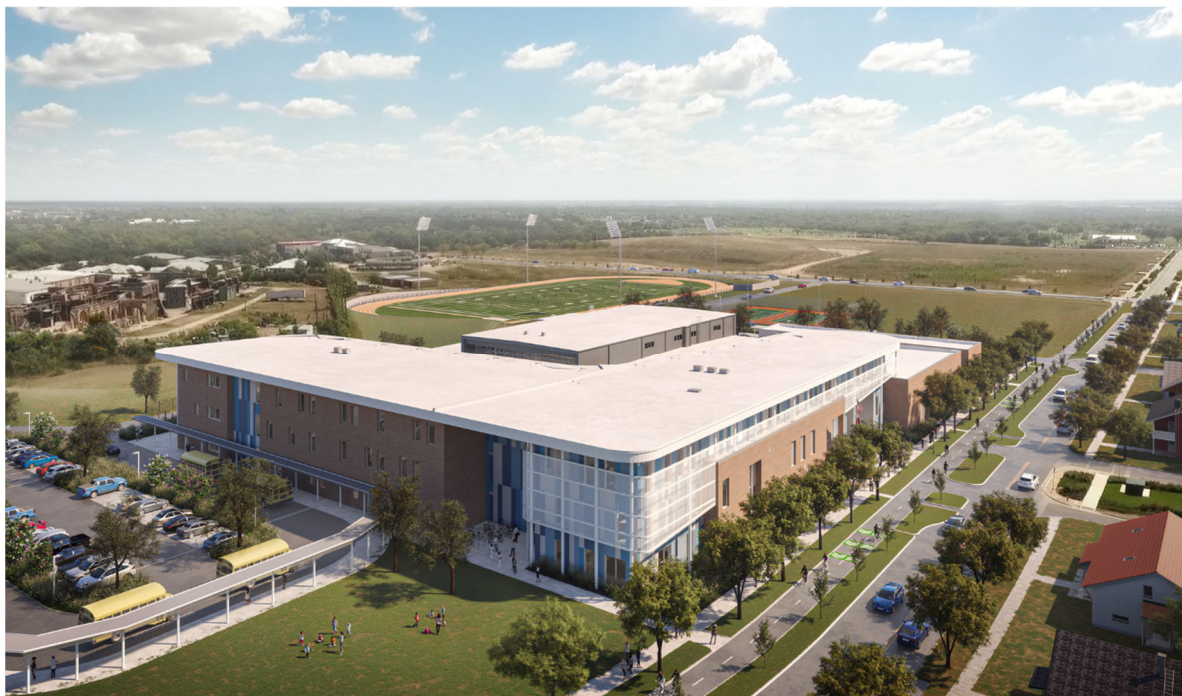
Rendering via Architect: Overall site with building, parking lot, and athletic fields shown.

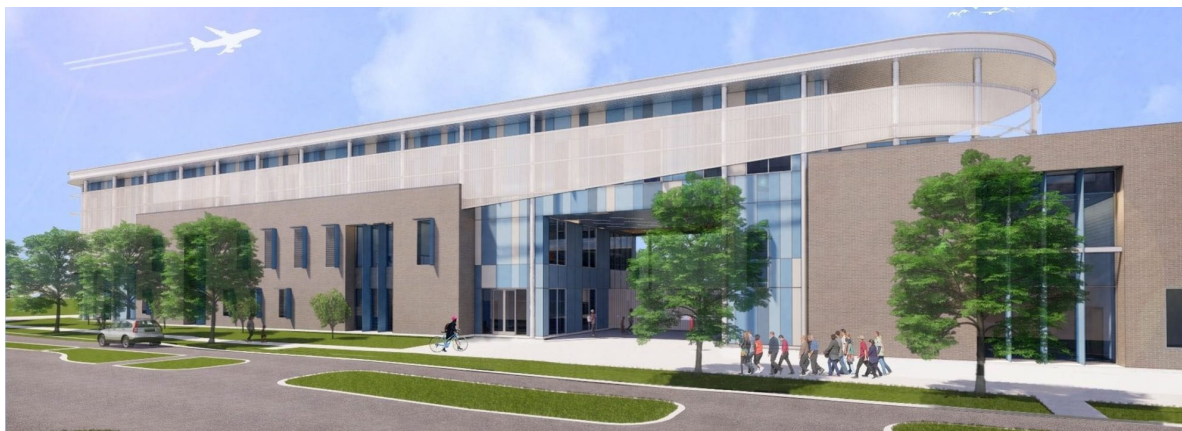
Rendering via Architect: View of gym entry form street.

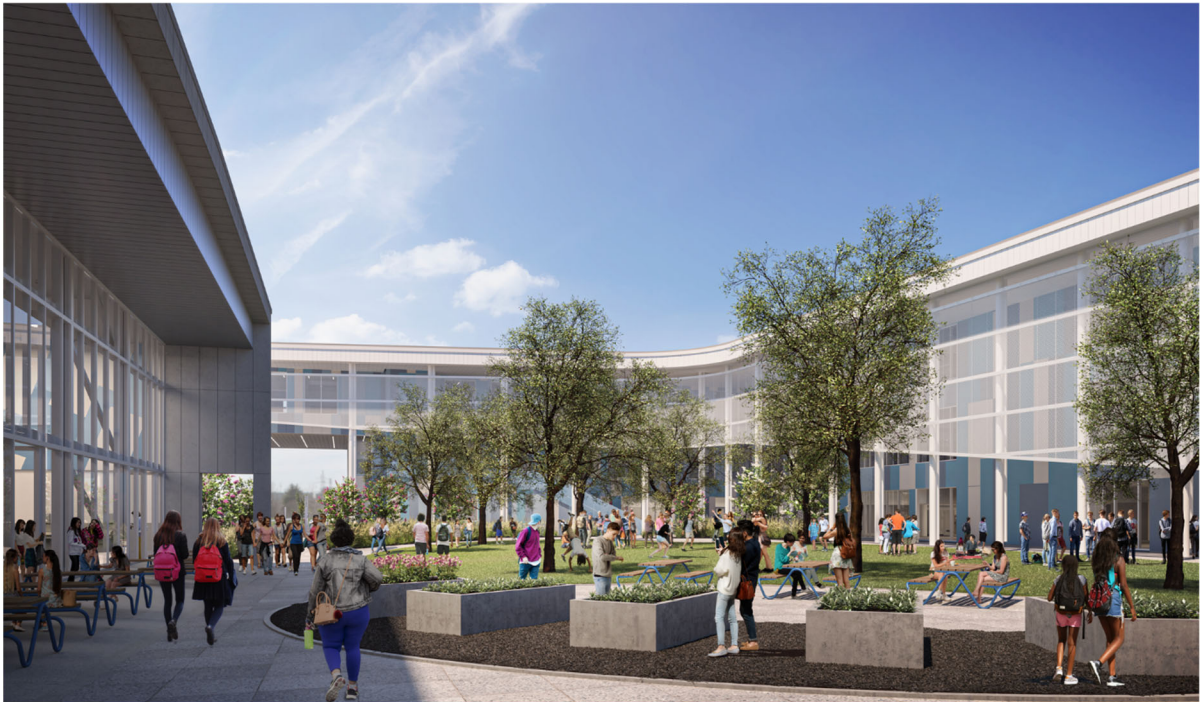
Large courtyard between buildings provides opportunities for outdoor learning but has limited canopies or covered areas. Furniture layouts shown for reference only support outdoor dining as well. Raised planters and garden areas are present in courtyard.

Rendering via Architect: Courtyard between studio wing and athletics/ performing arts building.

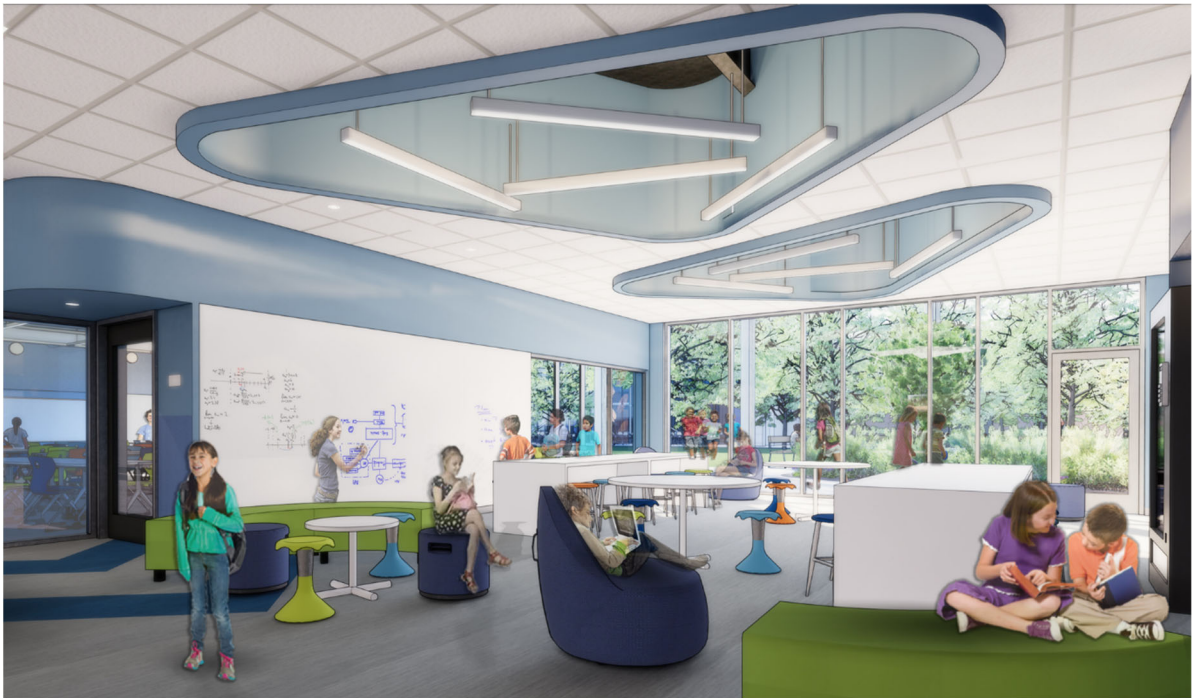
Studios are around 800 sq. ft. on average, with flexibility of walls between studios and to shared collaboration spaces in each neighborhood. All learning neighborhoods have shared small group room and Professional Learning Centers. Special Education spaces have the appropriate support such as ADA restrooms and an appropriately configured life skills room.

Rendering via Architect: Shared collaboration space in learning neighborhoods.
