Educational Suitability Summary Report

Paredes Middle School

Date: 01/25/2021 Score 61% Average

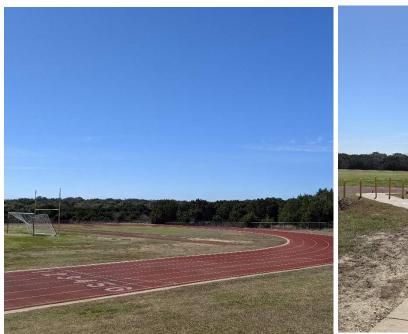
Sporting fields are generously sized but lack facilities for spectators. The school requests bleachers.

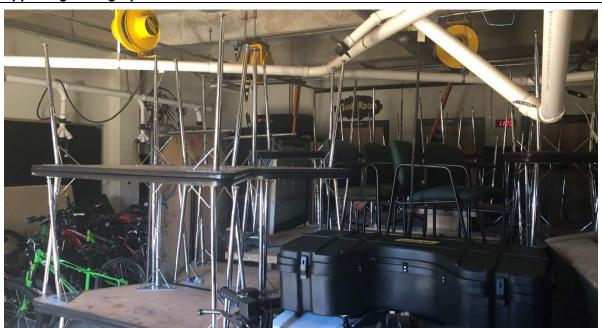
Wood shop studio being used as storage for furniture, bicycles and an AISD police all-terrain vehicle. Program space is underutilized as it has been used for storage prior to COVID.

The campus would like to create more interest in construction trades/hands-on programs by utilizing the existing wood shop that is being used for storage. This area also could be used as a STEM and robotics space. They would like space for a culinary arts program. They expressed a need for working gym bleachers. The bleachers are not easily operable and are in worn condition. Digital media support is also needed in the gym.

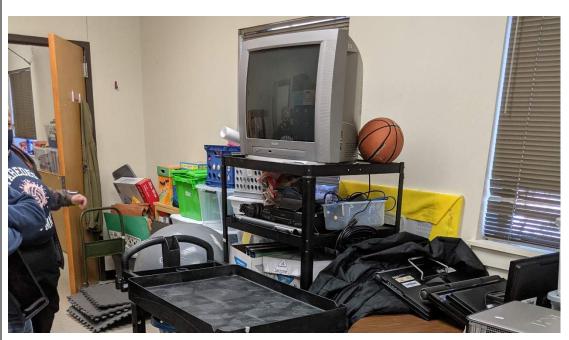
Special education lacks storage. Part of the life skills kitchen area serves as storage for various items. Area also needs a sensory room.

N/A Are Special	Does not apply I Education support spaces, such as storage, space for		1	1	T					
812	yer, appropriately configured per the ed spec?		2					Comments	1.00	2.00
1	Very unsatisfactory - None provided							No storage provided. Equipment needs to be replace	ed.	
2	Unsatisfactory - Too small, disconnected, poor condition									
3 4 5	Neutral - Adequate size, average condition, needs updates or renovations to function well Satisfactory - Good size, connected, good condition Very Satisfactory - Generous size, connected, excellent condition									
N/A	Does not apply

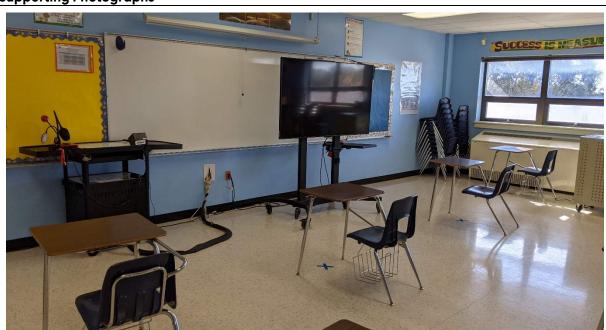
Academics and Learning: Typical studio has adequate daylight, dated furniture and some upgraded technology.

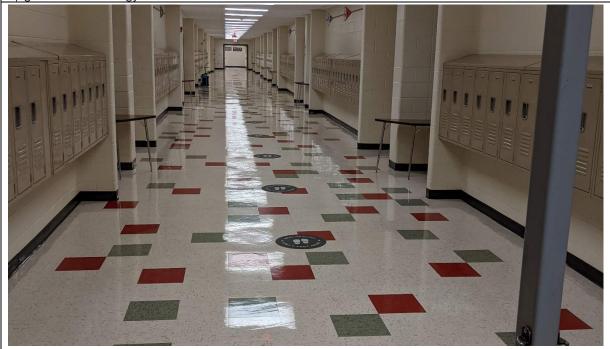
General Building: Corridors are good size and condition. Very little visibility between studios and corridors, limiting the possibility of independent study. School reports hallways lack ventilation.

8 - Academics	& Learning (cont.)	1	2	3	4	5	N/A	4		
8.10 Does the bound work indep	uilding provide adequate opportunities for students to pendently?		2					Comments	1.00	2.00
1 2 3 4 5 N/A	Very unsatisfactory - No breakout rooms/small study spaces Unsatisfactory - Too small, poor condition, no acoustic privacy, only one space for independent work, disconnected from learning neighborhood Average - Adequate size and condition, needs updates or renovations to function well. Satisfactory - Good size and condition, acoustic privacy, variety of independent work space options, connected to learning neighborhood Very Satisfactory - Generous size, excellent condition, acoustic privacy, variety of independent work space options, connected to learning neighborhood Does not apply							Visibility into corridor is minimal.	1.00	2.00
Special Edi	ucation

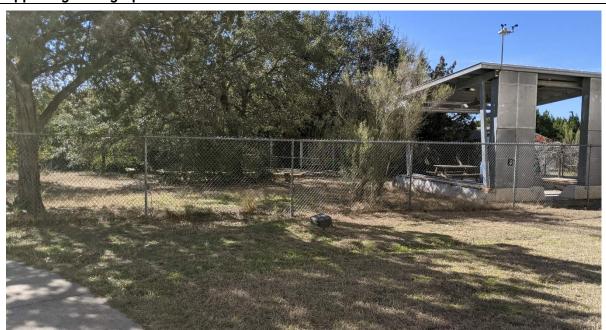
Outdoor studio is provided by Austin Energy pavilion (typical of many schools throughout the District) and is in average shape. School reports this space has been updated since the evaluation occurred.

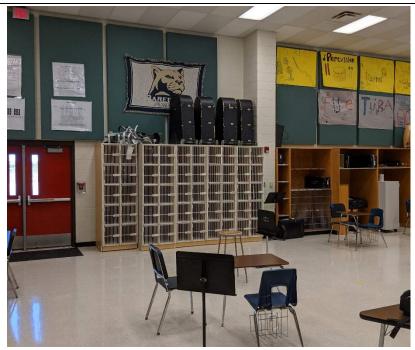
Visual and Performing Arts: Band/orchestra facilities are good size and condition. Bathroom in this area has the problematic sewage smell.

5 - Environme	ntal Quality (cont.)	1	2	3	4	5	N/A	A		
5.5 Does the b	uilding have odor or pest problems?			3				Comments	1.00	3.00
1	Very unsatisfactory - Evidence of both pests and odors							Sewage odor from restrooms noticed near choir roon	n. School repor	ts the
2	Unsatisfactory - Evidence of pests or odors							odor has been an ongoing problem that has been ur	nsuccessfully	
3	Average - Limited evidence of pests, no odors							addressed.	·	
4	Satisfactory - No evidence of pests / odors, school									
	cleanliness in good condition									
5	Very Satisfactory - No evidence, school cleanliness in									
	excellent condition									
N/A	Does not apply									
6 - Controllab	ility of Systems	1	2	3	4	5	N/A	A	12.50	60%

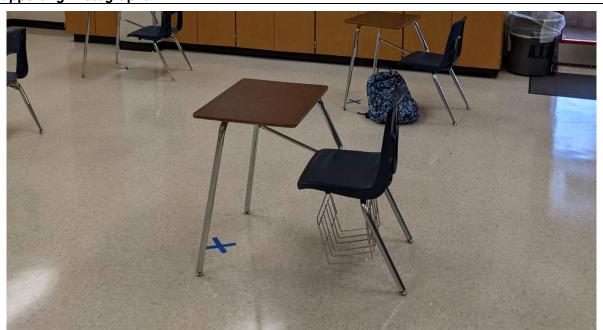
Studio furniture is unsatisfactory. Attached desks and chairs limit the ability to reconfigure for various teaching formats.

7 - Furniture, Fixtures & Equipment	1	2	3	4	5	N/A		18.75	44%
7.1 What is the current condition of the furniture?			3				Comments	0.75	2.25
 Very unsatisfactory - Damaged or broken, non- 							Several pieces in poor condition, attached chairs to de	sks.	
functioning									
2 Unsatisfactory - Torn/ bent/ wrong size									
3 Average - Scratched/dented/marked									
4 Satisfactory - Not new, but sturdy and clean									
5 Very satisfactory - New									
N/A Does not apply									
Are a variety of furniture types being accommodated throughout the		2					Comments		
school - learning commons, dining commons, other multi-use spaces?								1.00	2.00
1 Very Unsatisfactory - Same furniture used in all spaces							The only furniture variety noted in library.	1.00	2.00
o and a second s									
onsatisfactory Turnitare variety in one mater ass space									
3 Average - Furniture variety in more than one multi-use

7.4 Is the furniture ergonomic and size appropriate for grade level?		2					Comments	1.00	2.00
Very unsatisfactory - Desk with attached chair				ı		L	Some desks with attached chairs noted		
combinations too small for grade level									
2 Unsatisfactory - Desk with attached chair combinations									
3 Average - Mix of studios with tables/loose chairs and									
desks with fixed seats									
4 Very satisfactory - Tables with loose chairs									
5 Very satisfactory - Tables with loose chairs that allow									
students to be active									
N/A Does not apply

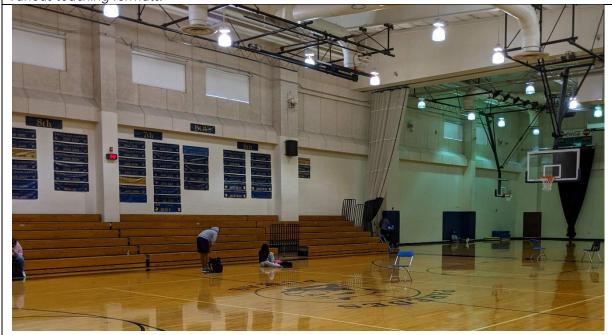
Athletics and Wellness: Gym is large and in good condition, but bleachers do not work well. Half are not usable.

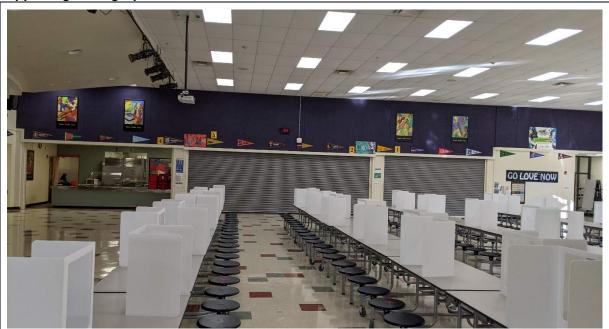
Food Services: Cafeteria is in good shape but only has one type of seating available. Stage is in good shape.

12 - Food Se	rvices								10.00	70%
12.1 Is the Di	ning Commons appropriately configured per the ed spec?				3				Comments 1.00	3.00
1	Very unsatisfactory - Too small, missing program spaces			•					Options for seating not provided but could be available in outdo courtyard space.	or
2	Unsatisfactory - Too small, poor condition, only one									
	option for eating space provided, inadequate circulation									
3	Average - Adequate size and condition, needs updates									
4	or renovations to function well Satisfactory - Good size and condition, good circulation,									
4	multiple options for eating space (ex: connection to									
	outdoor eating space)									
5	Very Satisfactory - Generous size, excellent condition and	1								
	circulation, multiple options for eating space (ex:									
	connection to outdoor eating space)									
N/A	117									
122	Food Services support spaces appropriately configured per				4	1			Comments

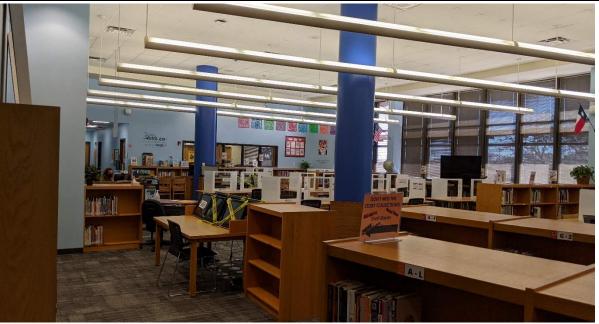
Media Resources: Library is open light filled space. Some furniture is heavy and not easily reconfigurable. Library was updated last year.

13 - Media Res	sources - Continued	1	2	3	4	5	N/A	4		
13.2 How well d	does the Library/Media Center support quiet study?		2					Comments	1.00	2.00
1 2 3 4 5	Very unsatisfactory - No quiet study spaces Unsatisfactory - One area in poor condition, poor acoustic privacy Average - One or more areas provided, needing updates or renovations to function well Satisfactory - Clusters or small rooms adjacent to media center, good condition, good acoustic privacy Very Satisfactory - Multiple clusters or small rooms adjacent to media center, excellent condition, excellent acoustic privacy Does not apply							No small study spaces available.		
	does the Library/Media Center support social interaction?			3				Comments	1.00	3.00
1 2 3 4 5	Very unsatisfactory - No space Unsatisfactory - Too small, poor condition, layout and furnishings do not support informal interaction well Average - Adequate size and condition, needs updates or renovations to function well. Satisfactory - Good size, good condition, layout and furnishings support informal interactions Very Satisfactory - Generous size, excellent condition, layout and furnishings support informal interactions							Open but congregation spaces are not large.
