## Educational Suitability Summary Report

Webb Middle School

Date: 01/14/2021

**Score 59% Average**

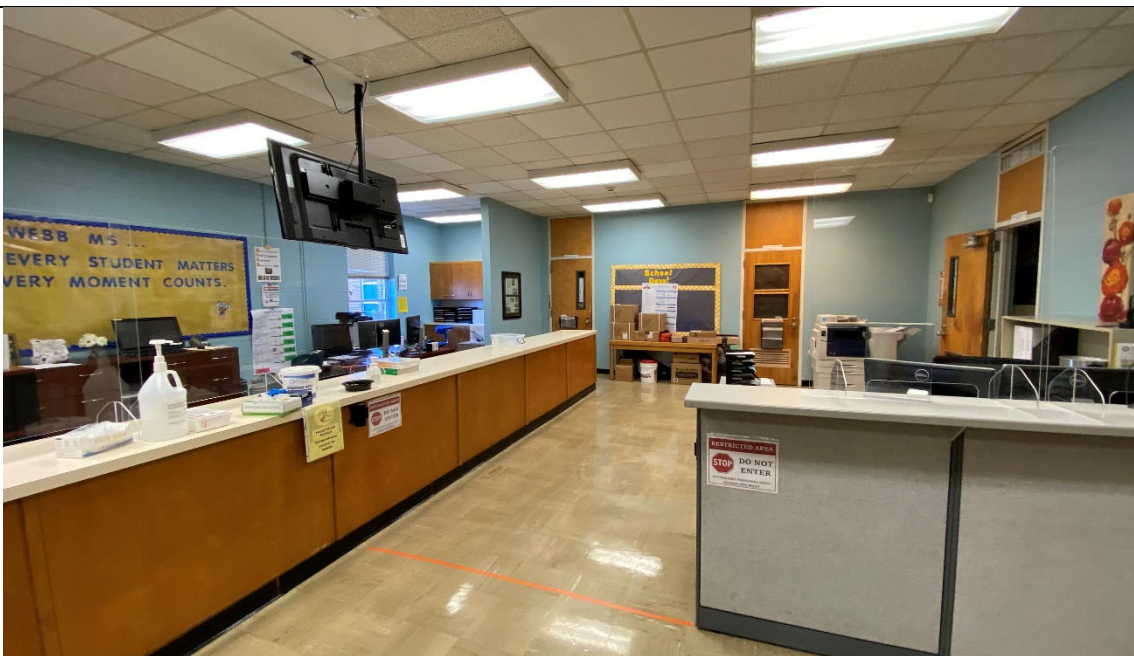
The administration area is adequately sized, but with no seating and no transparency to the main

corridor, it feels unwelcoming. A conference room is not available for public/parent use. [REDACTED]

*Administration: Space is large but does not have seating in the reception area and does not feel welcoming.*

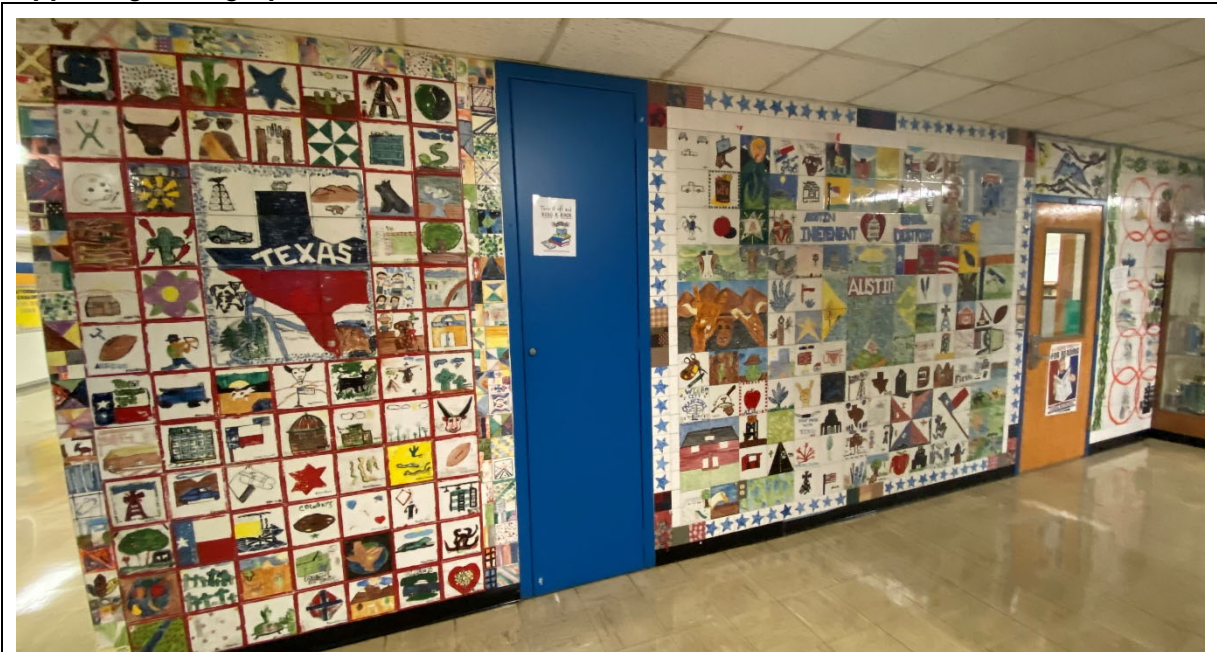
The school has a few items on their list that should never change due to community importance. The community quilts in the main hallway are ceramic tiles and were completed through a program with the Smithsonian. The outdoor garden between the main building and fine arts building was created through a grant and highlights native Texas plants. The school is also proud of the fine arts building and also likes that the library is located at the heart of the school.

*School Pride: The community quilt is very important to the school and is an item that should not change due to campus importance.*

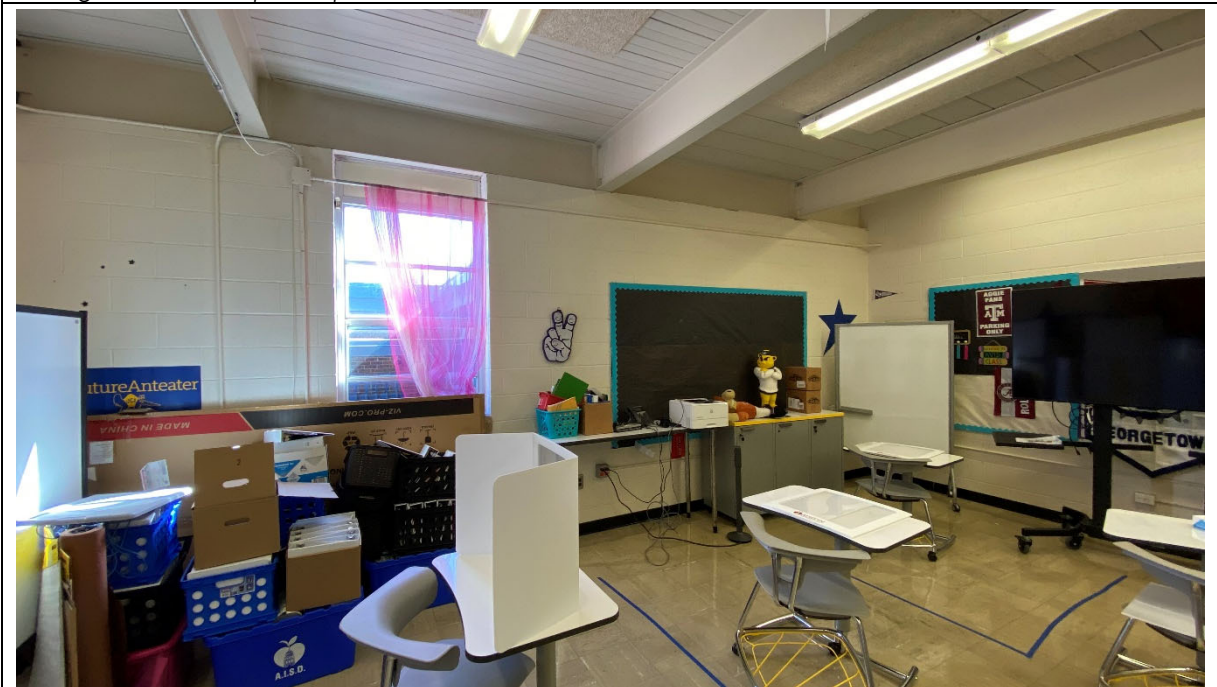
[REDACTED]. Most studios have access to windows and daylight, but the windows are small and do not let in much light in the main 1961 building.

Studios are undersized at 730 square feet; science rooms are undersized at 920 square feet. There is limited collaboration space. There are no group/breakout rooms, and only certain locations, such as the library and courtyard, support informal interaction. The Life Skills studio is adequate, but the restroom, while attempting to be accessible, does not have the proper clearances around the toilet and door swings.

*Typical studio is undersized, but all have new, updated furniture. Small windows are provided in most studios.*

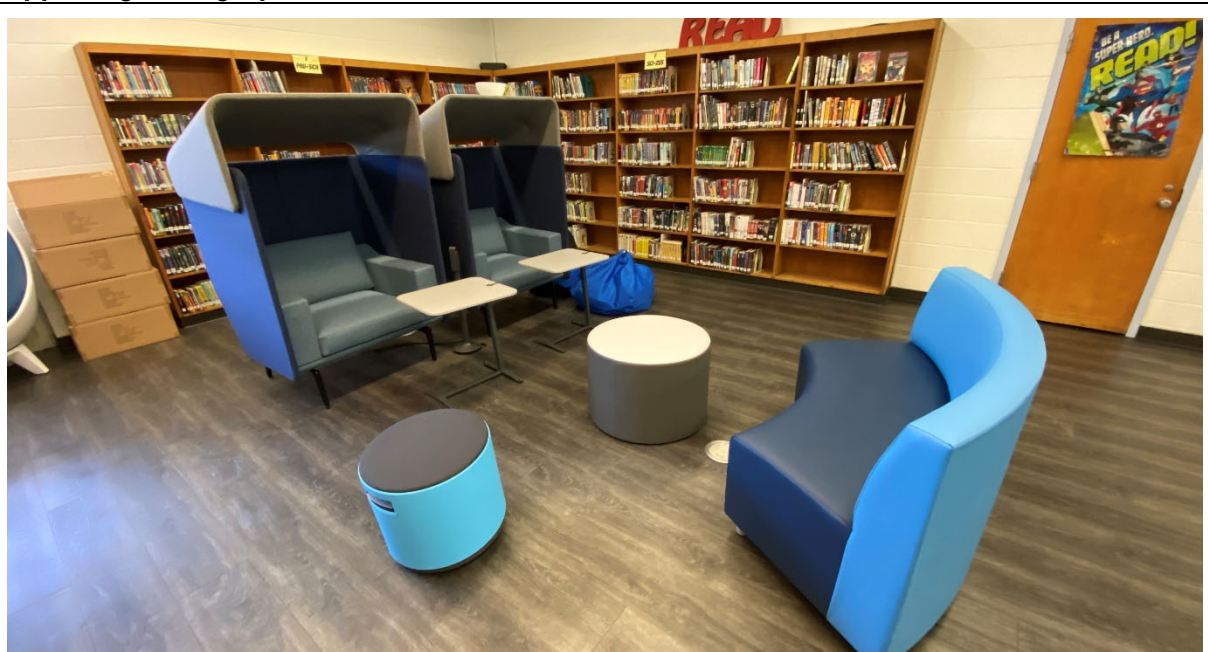
The library is sized appropriately and has different areas set up for different types of study. The furniture is new and allows for flexibility and adequate locations for charging.

*Media Center: Library and rest of school have received updated/new furniture. The media center doesn't have small group breakout rooms but does provide a variety of furniture for different types of studies.*

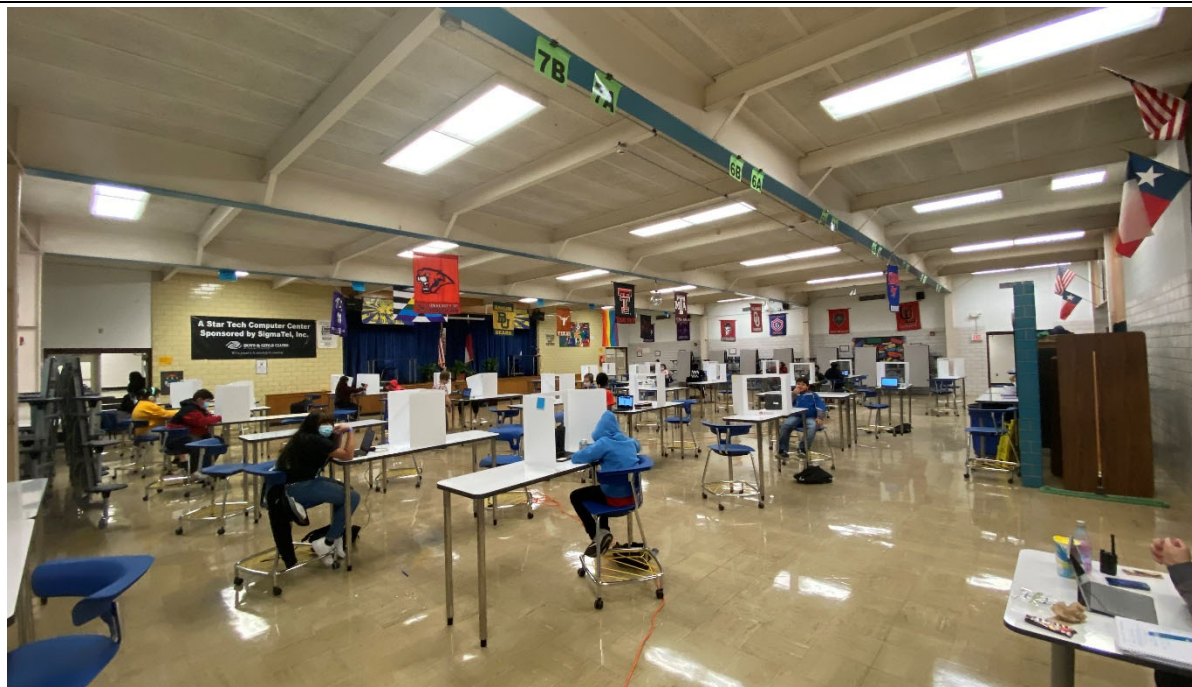
The cafeteria/kitchen are appropriately sized. There is no chair/stage storage, and the stage does not function well.

Library has adequate charging. The remainder of the school does not. The A/V in the cafetorium is old and does not function well.

*Food Services: Cafeteria is appropriately sized. The stage is not big enough for performances and has unsatisfactory A/V equipment.*

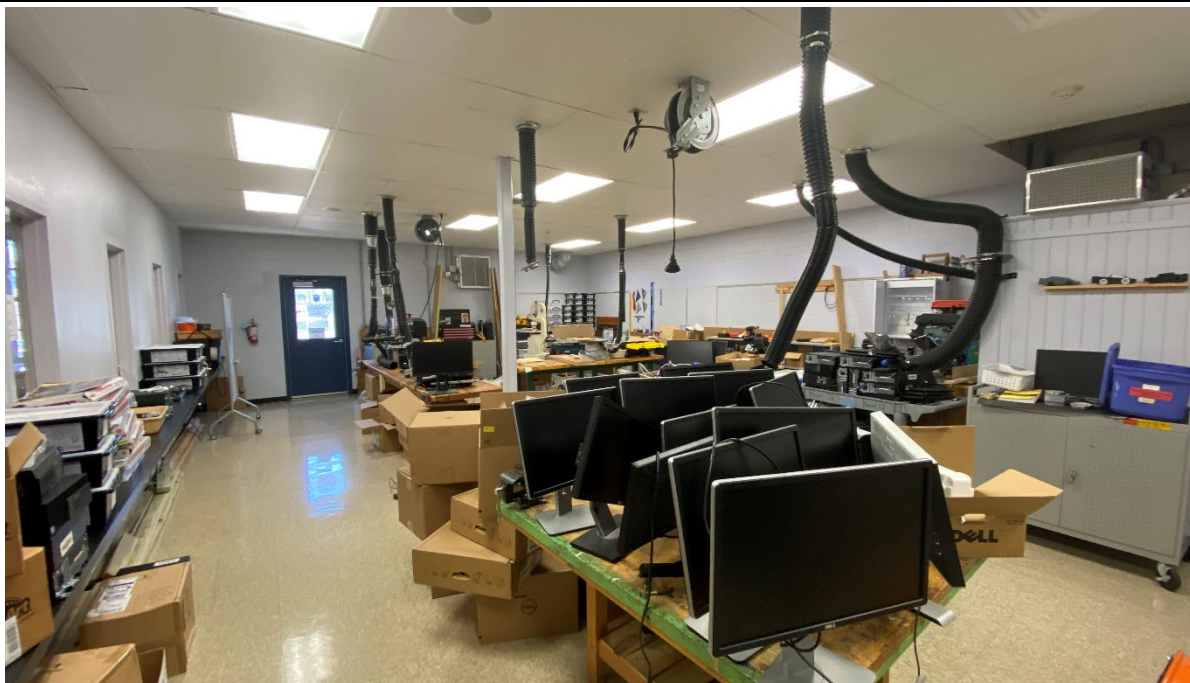
*CTE: Computer Lab and adjacent wood shop have had recent upgrades with the addition of flexible overhead power and overhead exhaust in the back of the room. The computer monitors are being installed, and their current location does not represent the typical state of the studio.*

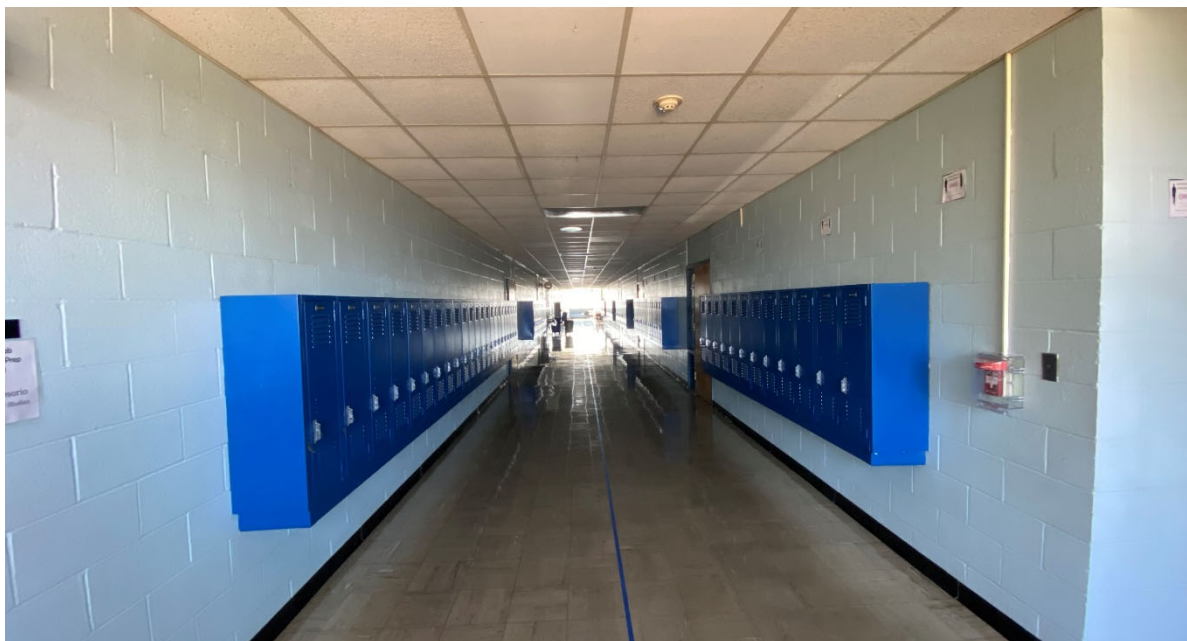
*Corridors are approximately 10' wide but there is limited to no transparency into studios.*

Studio doors have small sidelight. Very limited to no transparency.

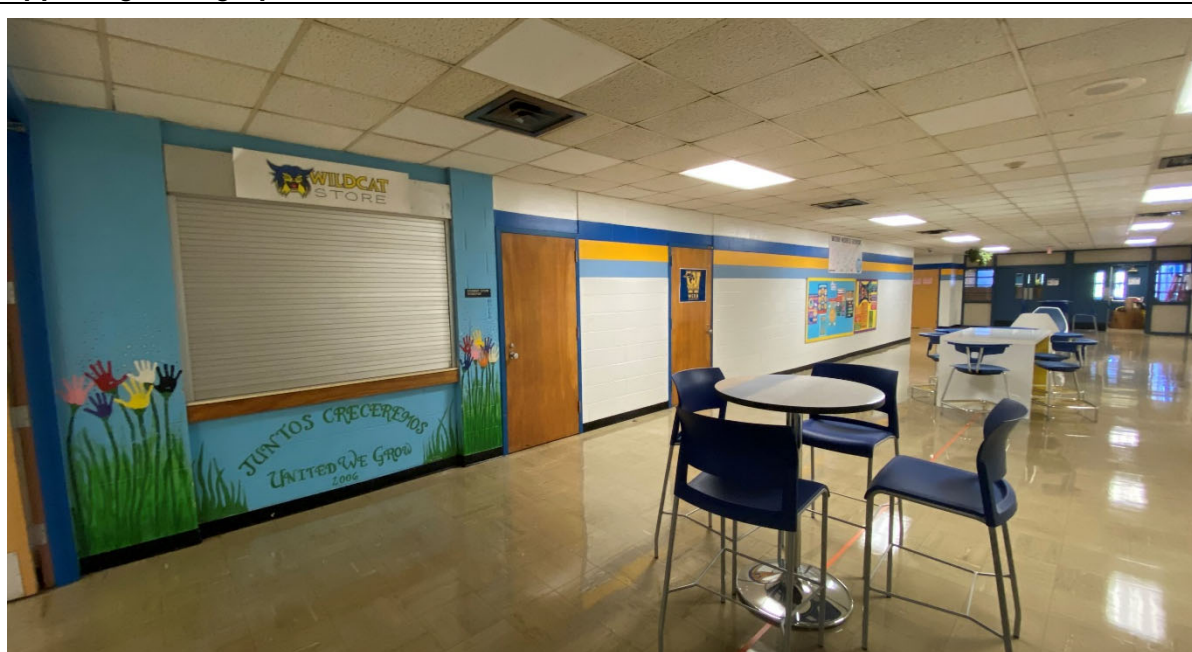
*Updated furniture in main hall outside of cafeteria provides some group collaboration space. No collaboration or small group space provided near the studios.*

8.9	Does the building provide opportunities for informal interaction?			3				Comments	1.00 <b>3.00</b>	
1	Very unsatisfactory - No space								Yes. New furniture solutions in main hallway.	
2	Unsatisfactory - Too small, poor condition, layout and furnishings do not support informal interaction well									
3	Average - Adequate size and condition, needs updates or renovations to function well.									
4	Satisfactory - Good size, good condition, layout and furnishings support informal interactions									
5	Very Satisfactory - Generous size, excellent condition, layout and furnishings support informal interactions									
N/A	Does not apply

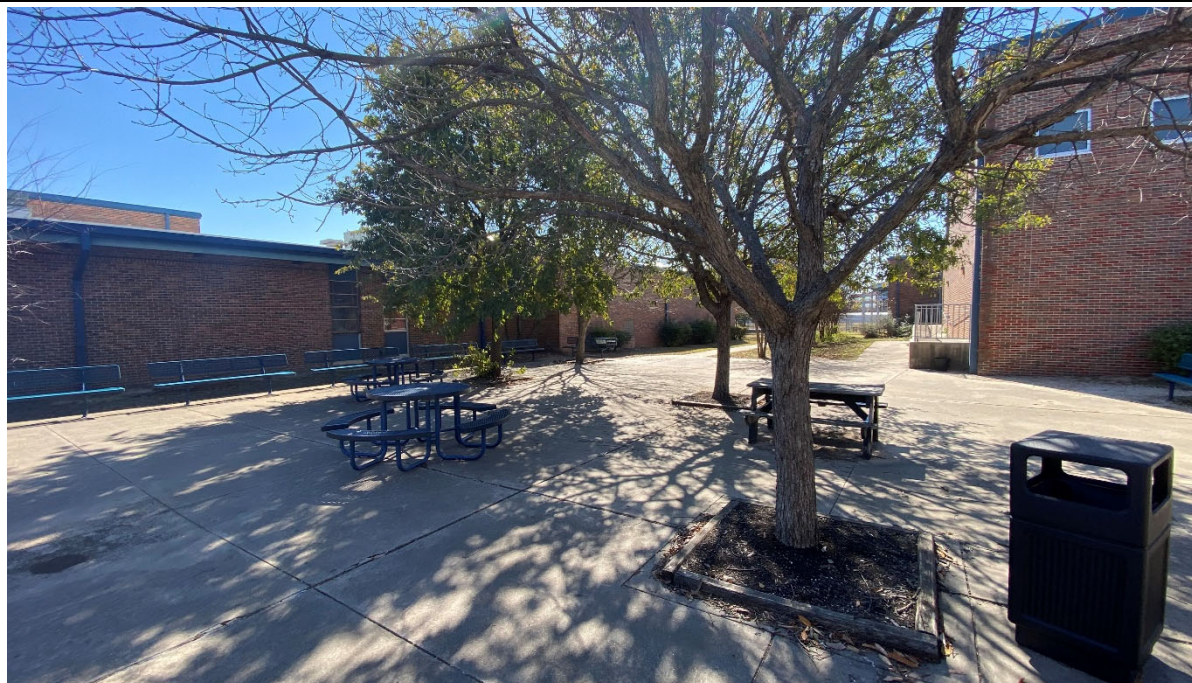
The group also feels that the outdoors could be better utilized. Currently, the school does not have outdoor studios. There is a nicely sized courtyard, but it needs more flexible furniture, shade and technology for students to use it. There need to be outlets outside for charging.

*Outdoor Learning: Courtyard between school and fine arts building is well utilized but needs additional upgrades, such as shade, furniture and technology, to function well.*
