Educational Suitability Summary Report

Andrews Elementary School

Date: 12/15/2020

Score 56% Average

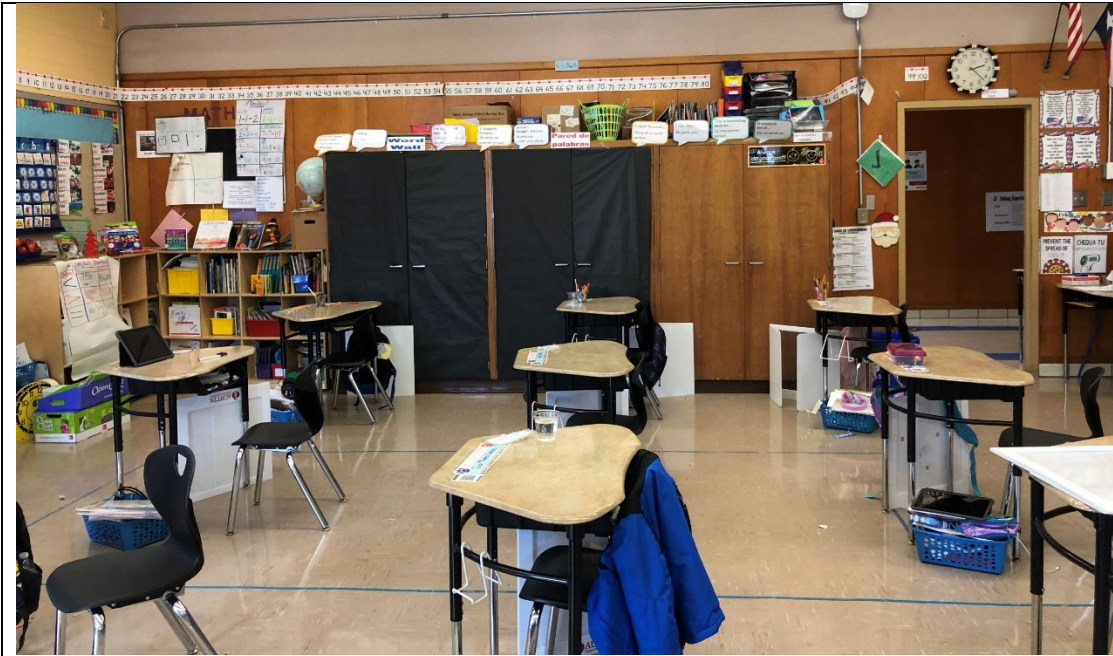
All studios have flexible furniture with loose tables and chairs, and some have cabinet storage, although dated.

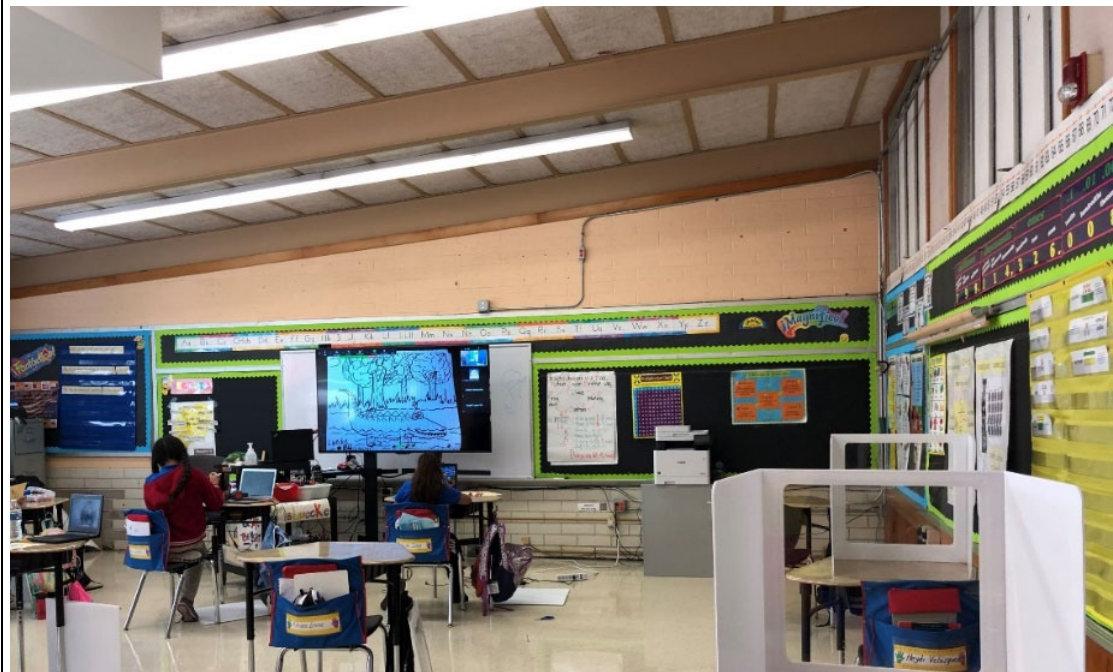
Some studios have movable louvers at the top of the corridor wall (top right of image) that allow sound to transmit between the hallway and the studios.

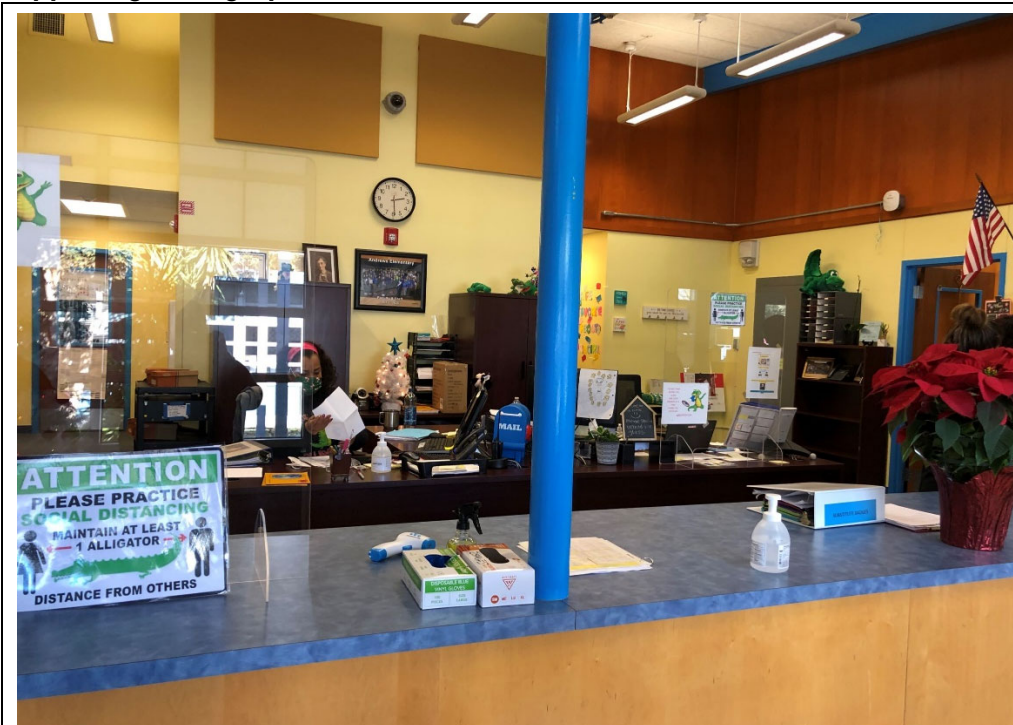
Administration Spaces: Reception is adequately sized and feels welcoming, but finishes need updates.

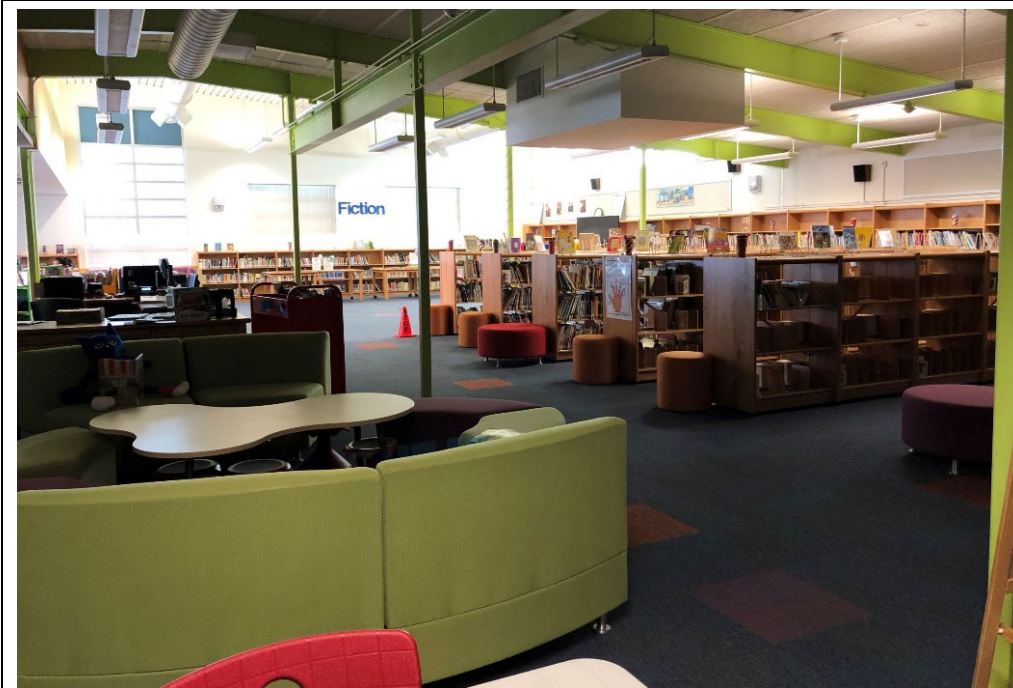
Media Resources: The library is generously sized and can accommodate different group sizes with flexible seating. The library is at the back of the school and not easy to find.

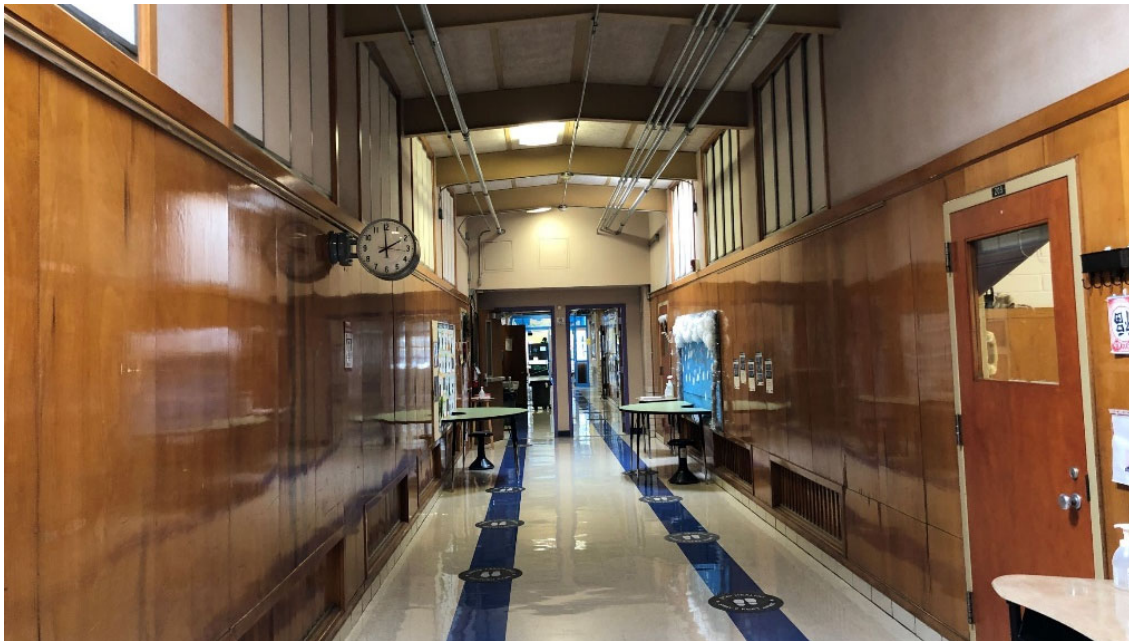
The corridors are 10 feet wide and wood paneling makes them feel dark and dated.

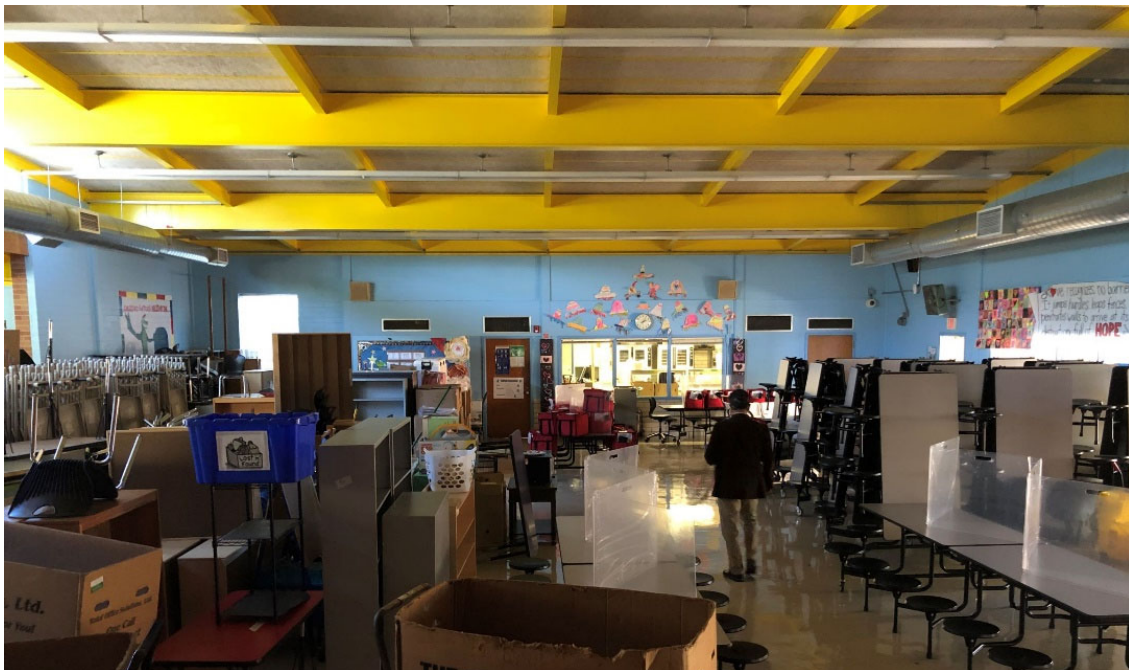
Cafeteria is adequately sized but finishes need updates. Current setup reflects storage required for COVID-19 protocols. There is no storage space for tables and chairs in the cafeteria or for the stage area.

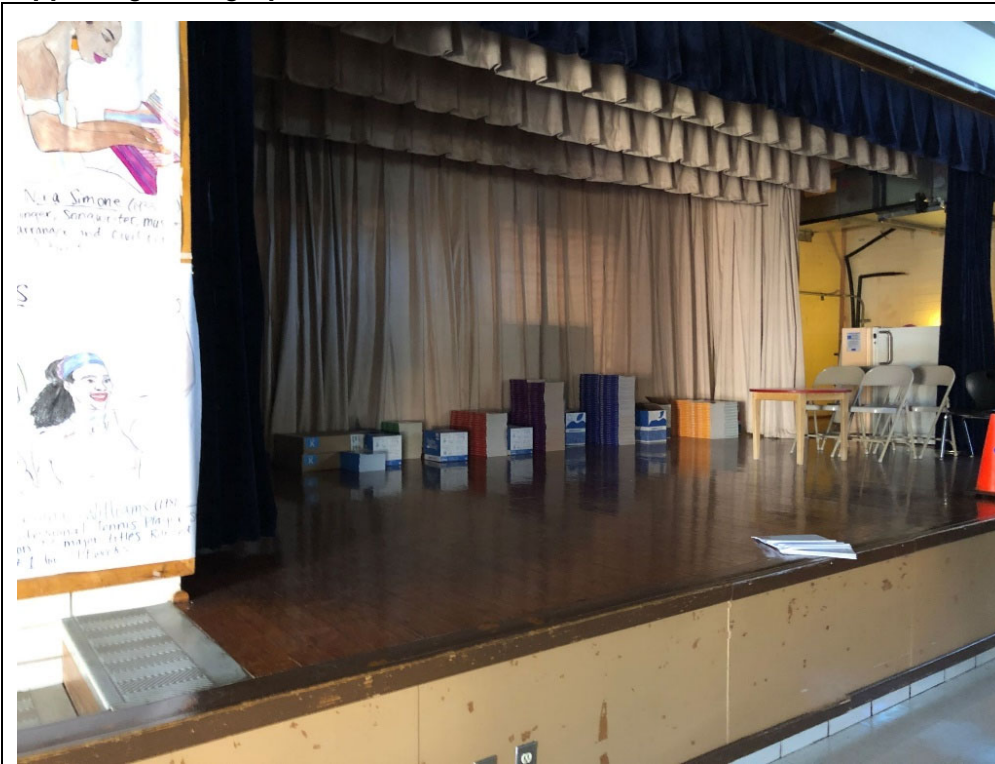
Visual and Performing Arts: Cafeteria stage needs updates, including lighting, audio system, flooring and curtains. A lift is provided for accessibility.

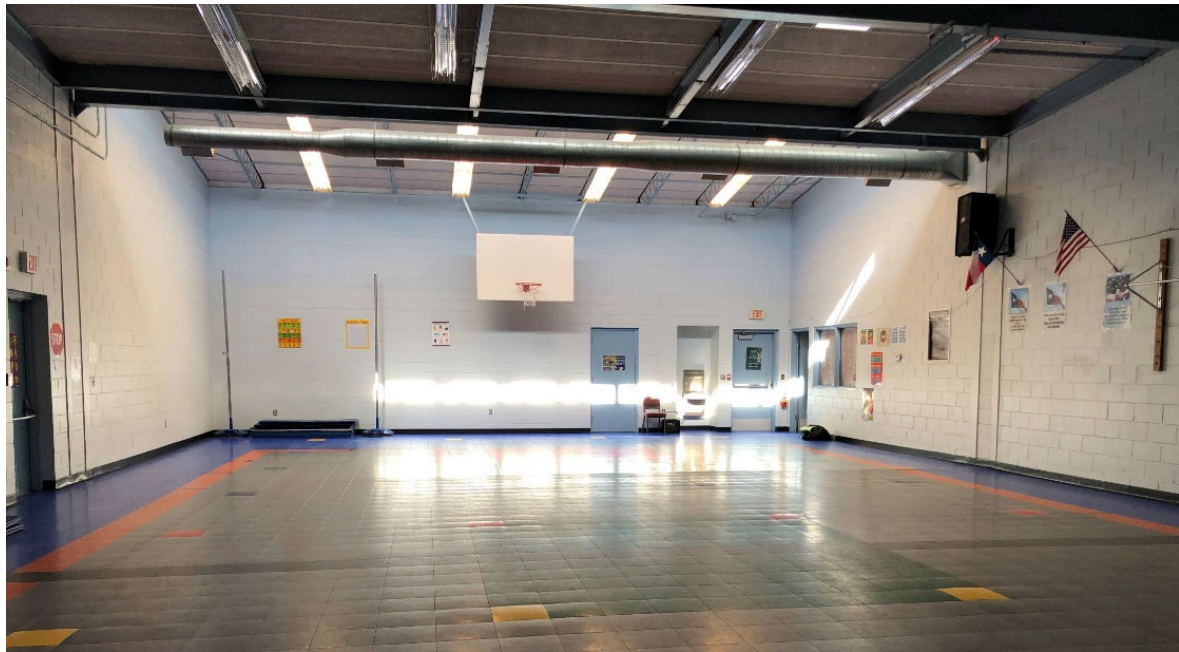
Gym is adequately sized and has some access to daylight but needs finish updates. Storage space is inadequate and disconnected. *Gym floor was replaced after assessment walk in December 2020.*

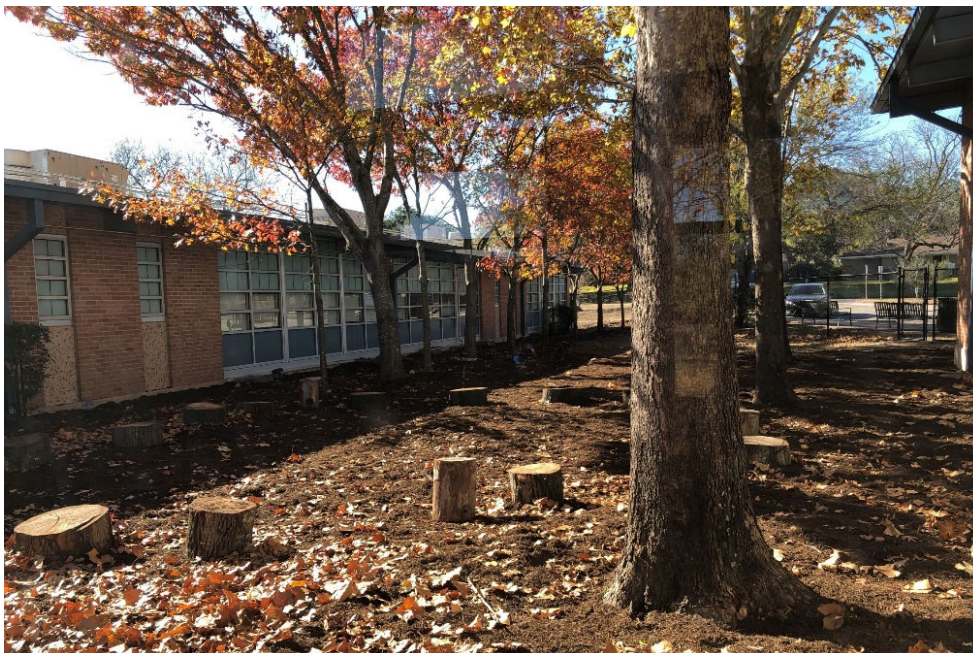
Habitat Courtyard: This space is significant to the school and they want it to remain. Additional seating and shading would benefit the space. This area was under development at the time of the assessment.

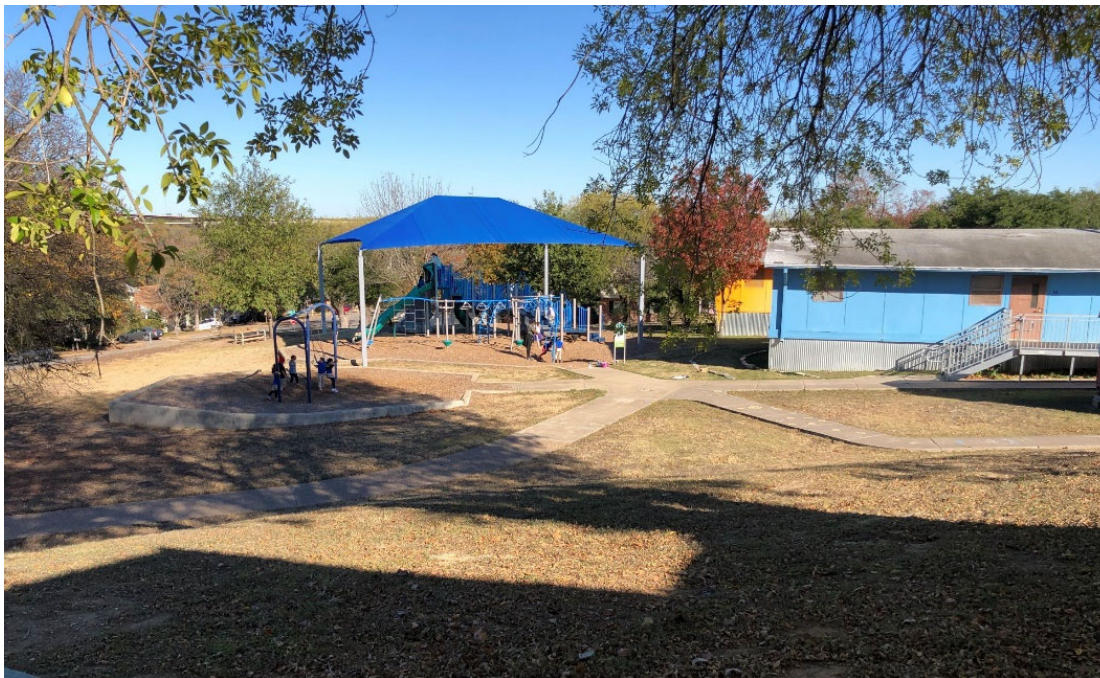
Playscapes are toward the back of the property near the portables. They are adequate size and condition and there is shade coverage over more than 50% of the play structure.

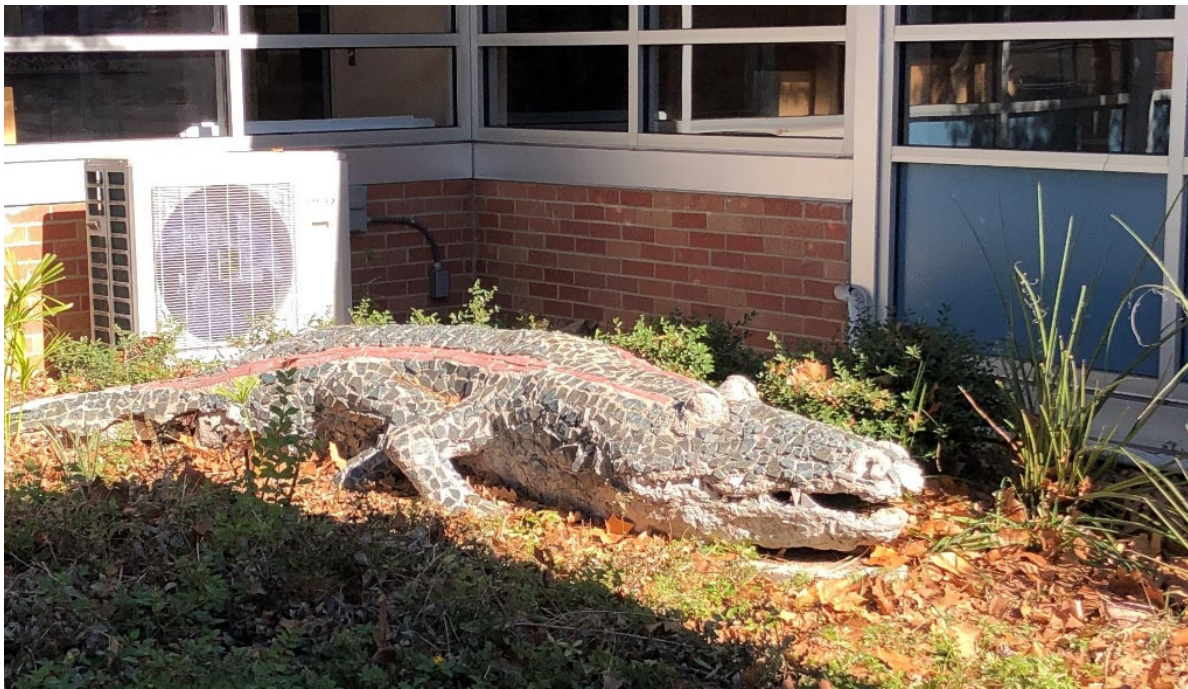
The school loves the alligator statue representing the mascot and it is one feature of the school they say should never change.

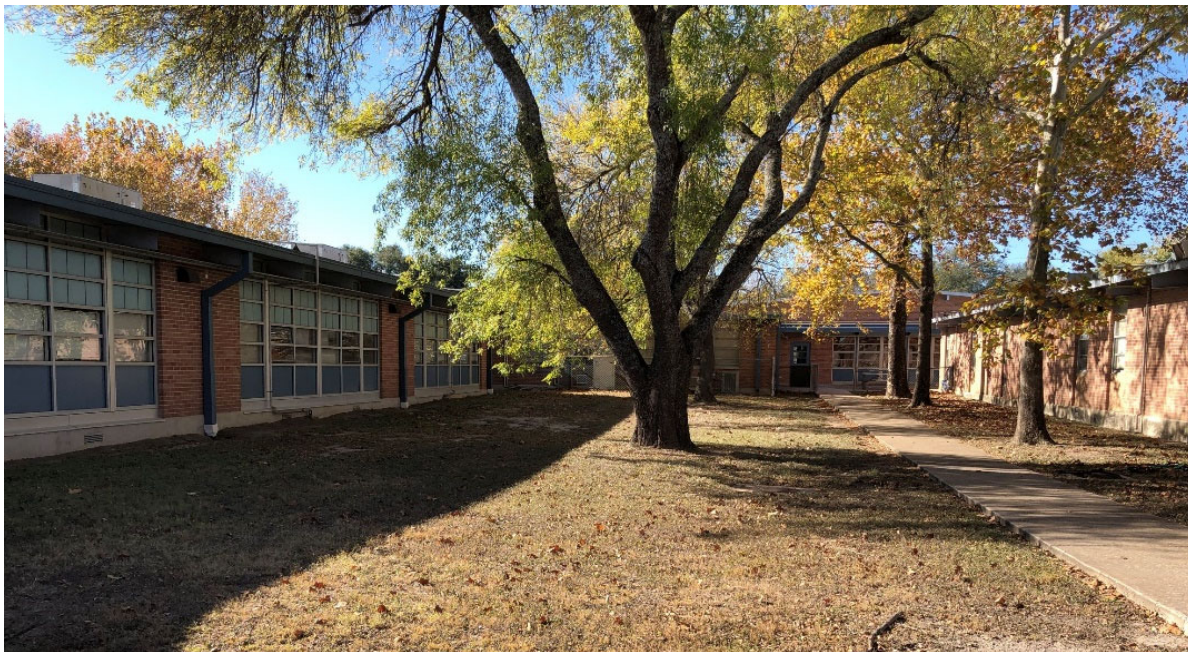
Outdoor space between studio wings could be used for outdoor learning but needs upgrades and is not currently used for any outdoor learning activity.
