Educational Suitability Summary Report

Baranoff Elementary School

Date: 12/15/2020

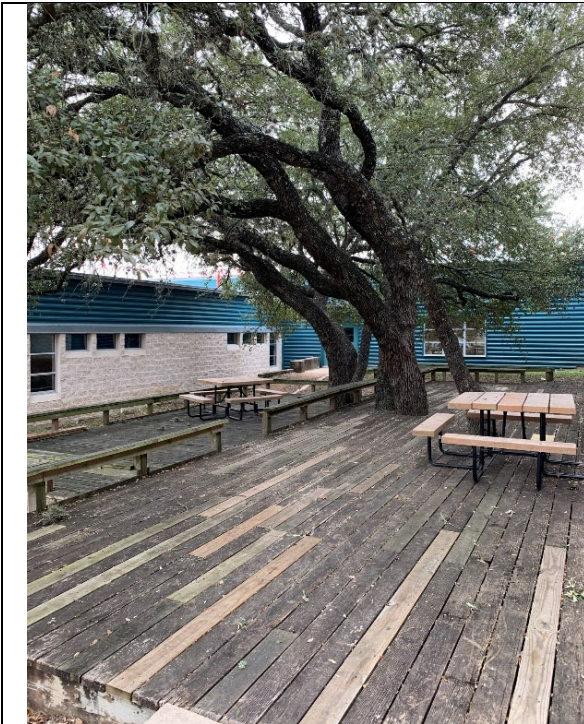
Large wooden deck serves as outdoor learning or dining space but needs updates.

The campus has a multilevel deck that is shaded by trees, which can be used as an outdoor dining or outdoor learning environment. The space is adequate, but the deck needs updating. Two of the three playgrounds have canopy cover, as well as the outdoor basketball court. The small garden area uses reclaimed rainwater in small cisterns, created by a student's Boy Scout project.

2.1	Are outdoor studios and support spaces appropriately configured per the ed spec?			3				Comments	1.00 3.00	
1	Very unsatisfactory - No dedicated outdoor studios							Outdoor deck with multiple levels shaded by trees. The deck needs maintenance or upgrades. The school noted that additional structures are unable to built due to impervious ground cover.		
2	Unsatisfactory - Too small, poor condition, disconnected from learning spaces, no flexibility, no shade provided									
3	Average - Adequate size, adequate condition, needs some renovations or updates to function well, 50% or less shade coverage over studio area									
4	Satisfactory - Good size, good condition, connected to learning spaces, good flexibility, more than 50% shade coverage over studio area									
5	Very satisfactory - Generous size, excellent condition, connected to learning spaces, excellent flexibility, full shade coverage over studio area

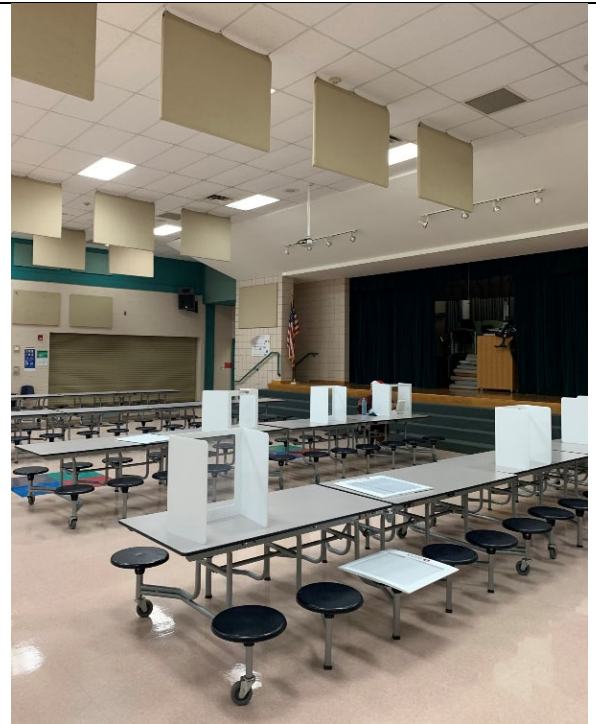
Cafeteria is undersized and only has one type of seating.

Cafeteria is 3,800 square feet but based on current enrollment should be 4,800 square feet. There is no access to natural light or the outdoors. The kitchen is adequately sized and has two serving lines. There is no chair storage and only a very small room for stage storage.

11.1	Is the Dining Commons appropriately configured per the ed spec?		2					Comments	1.00 2.00
	1 Very unsatisfactory - Too small, missing program spaces 2 Unsatisfactory - Too small, poor condition, only one option for eating space provided, inadequate circulation 3 Average - Adequate size and condition, needs updates or renovations to function well 4 Satisfactory - Good size and condition, good circulation, multiple options for eating space (ex: connection to outdoor eating space) 5 Very Satisfactory - Generous size, excellent condition and circulation, multiple options for eating space (ex: connection to outdoor eating space) N/A Does not apply	Cafeteria is 3800 SF. For current enrollment, size should be larger at around 4,800 SF. There is also no natural light.

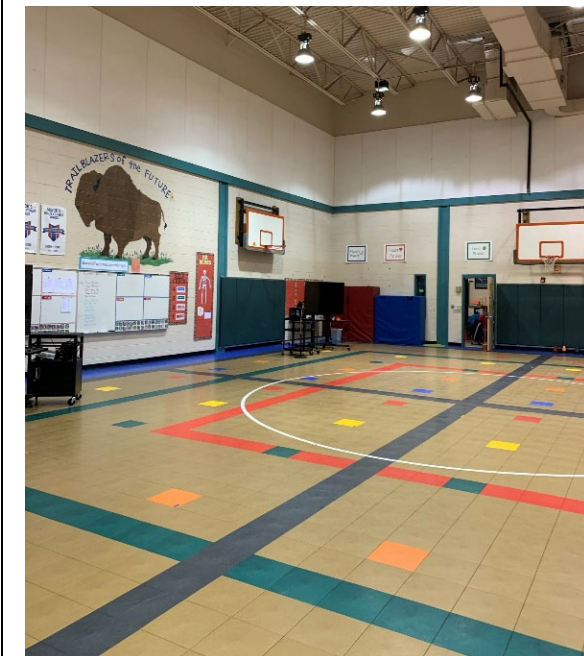
Gym and cafeteria are connected by an operable wall. Flooring is in process of being replaced

Gym is average size and was being prepped to get a new floor during the assessment. There are two large storage spaces and restrooms that connect in a vestibule for both gym and cafeteria use.

10 - PE and Wellness		1	2	3	4	5	N/A	10.00	70%
10.1	Does the campus meet the ed spec standard for physical education program spaces?			3				Comments	1.00 3.00
	1 Very unsatisfactory - Too small, missing program spaces 2 Unsatisfactory - Too small, poor condition 3 Average - Adequate size, adequate condition, needs some renovations or updates to function well 4 Satisfactory - Good size, good condition 5 Very Satisfactory - Generous size, excellent condition N/A Does not apply	Gym space is average size. Getting new floor. Restrooms connected to gym.

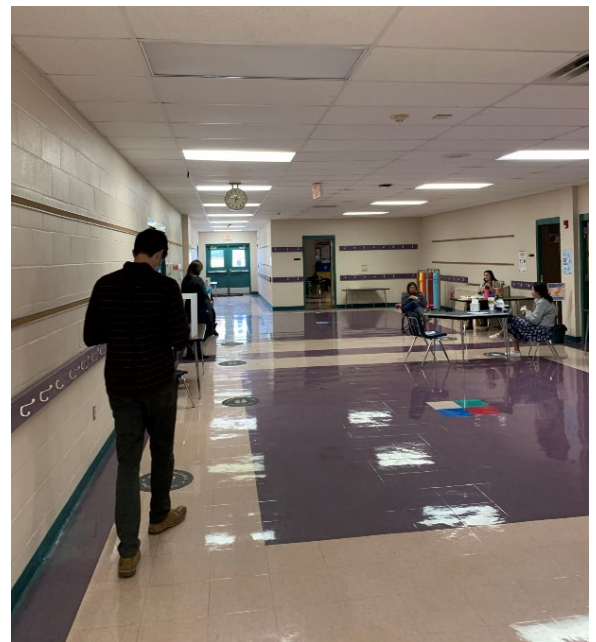
Corridors are mostly narrow, but two learning neighborhoods have a larger flex space to be shared by studios.

Interior corridors are between 8 and 10 feet wide, with two of the learning neighborhoods having a larger, shared-corridor flex space. The library, cafeteria and gym can all be closed off from the rest of the school to allow for after-hours functions.

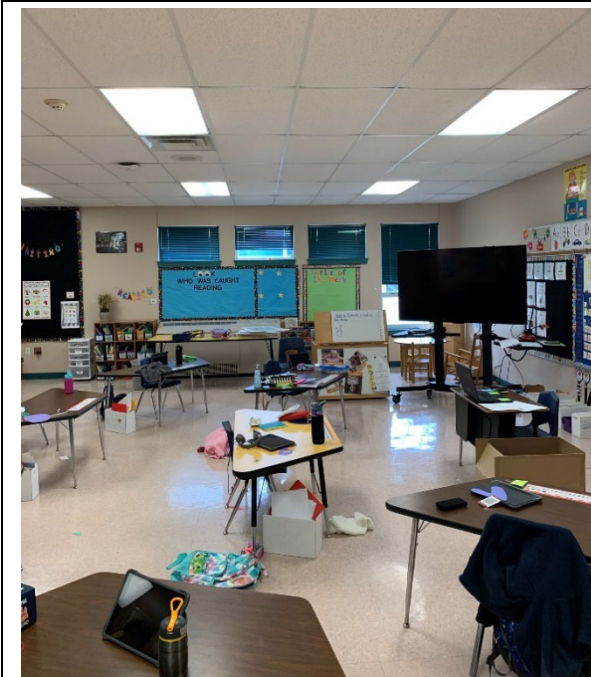
Environmental Quality: All studios have windows and access to natural light.

General acoustics are good. Studios are paired together with an open vestibule for shared restrooms, but it does not seem to adversely affect sound. All studios have windows and access to natural light, but with higher clerestory windows not all studios have views.

5.3	Is there access to natural light in studios?					5		Comments	1.00	5.00	
1	Very unsatisfactory - No learning spaces have natural light							All studios have windows.			
2	Unsatisfactory - 1-25% of learning spaces have natural light or windows are too small to let in light										
3	Average - 26-50% of learning spaces have natural light										
4	Satisfactory - 51-75% of learning spaces have natural light										
5	Very satisfactory - 76-100% of learning spaces have natural light										
N/A	Does not apply

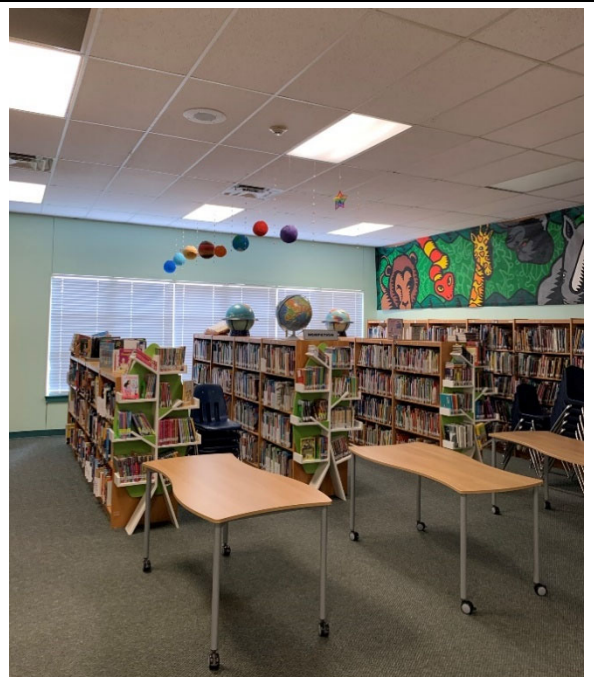
Media Resources: Mix of old and new furniture present, but limited space for larger groups.

The library is close to the main entry of the school, but limited signage and transparency make it hard to find. There are no quiet study areas, and the current configuration of the stacks limits the size of

groups that can work collaboratively. More informal seating could improve opportunities for social interaction. Two projection areas and a computer station are available for group and individual use.

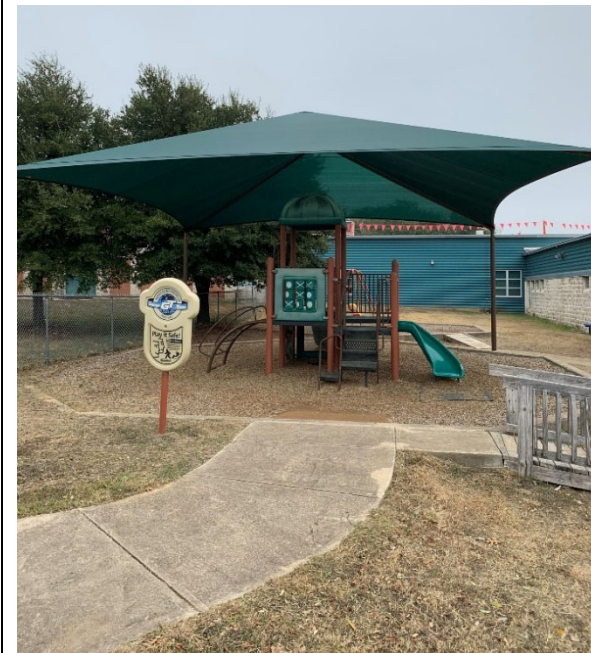
Two of the three playgrounds have a canopy and are in good condition.

N/A	Does not apply									
2.2	Are active playgrounds (elementary only) and support spaces configured per the ed spec?				4			Comments	1.00 4.00	
1	Very unsatisfactory - No dedicated active playground							Playgrounds look to be in good condition. 2/3 play areas are covered.		
2	Unsatisfactory - Too small, poor condition, no shade provided									
3	Average - Adequate size, adequate condition, needs some renovations or updates to function well, 50% or less shade coverage over play structure									
4	Satisfactory - Good size, good condition, more than 50% shade coverage over play structure									
5	Very satisfactory - Generous size, excellent condition, full shade coverage over play structure									
N/A	Does not apply

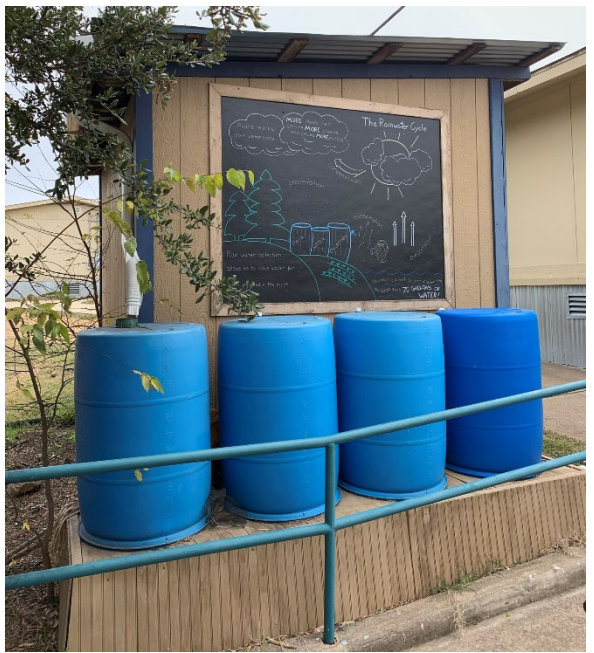
Small cisterns collect rainwater for the gardens. This was completed as a project for a student in Boy Scouts.

N/A	Does not apply										
2.4	Are the rain gardens and/or cisterns appropriately configured per the ed spec?			3					Comments	0.00	0.00
1	Very unsatisfactory - No rain gardens or cisterns							Recording answer, does not affect score for Outdoor Learning and Activity. Small shed with multiple rain barrels and educational display of the benefits of rainwater collection.			
2	Unsatisfactory - Too small, poor condition, not functioning, disconnected										
3	Average - Adequate size, adequate condition, is connected, needs some renovations or updates to function well										
4	Satisfactory - Good size, good condition, functions properly										
5	Very Satisfactory - Generous size, excellent condition, exceptional functionality, connected to learning spaces, educational signage provided										
N/A	Does not apply
