Educational Suitability Summary Report

Bryker Woods Elementary School

Date: 02/08/2021

Score 58% Average

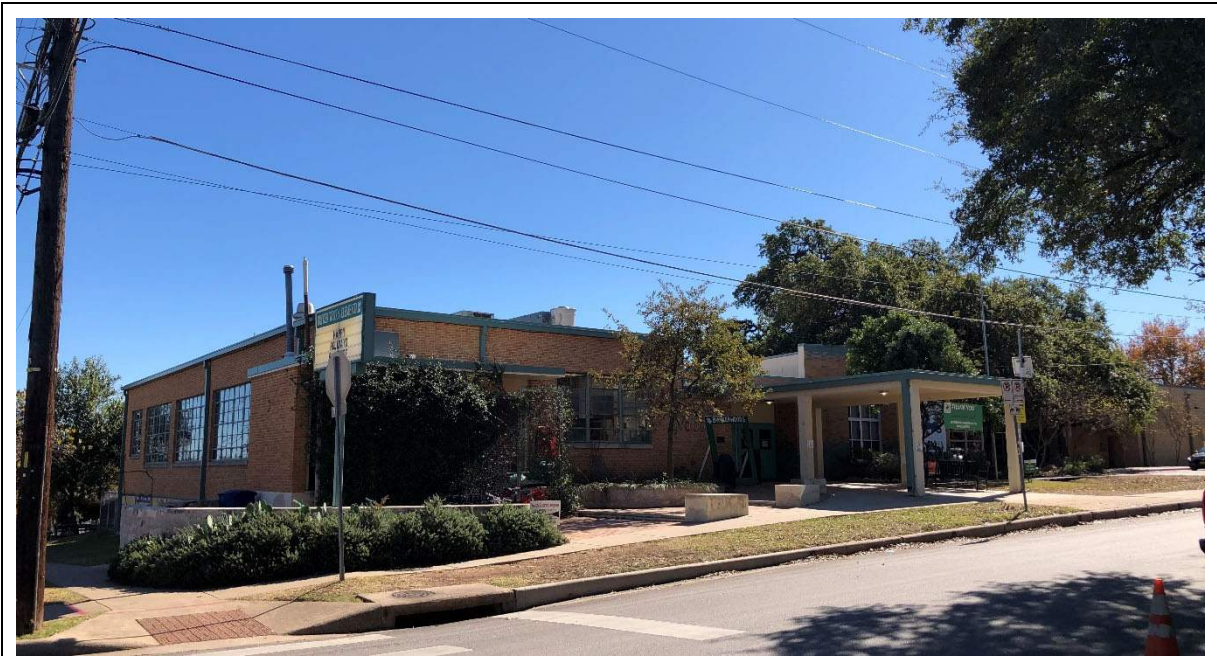
School Entry: A single canopy indicates the location of the main entry.

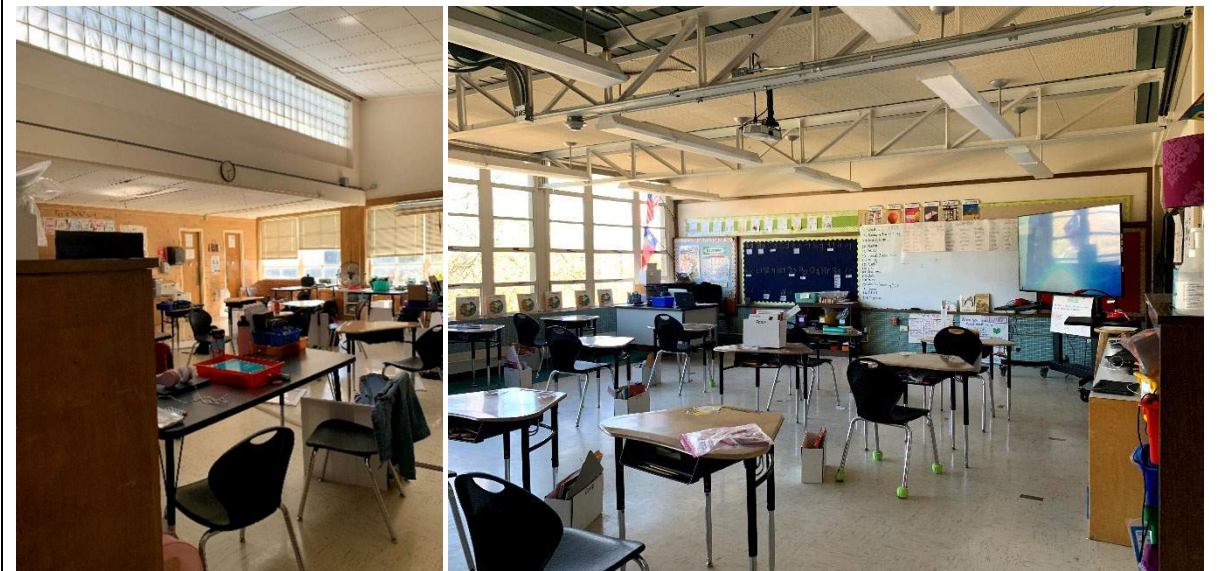
Studios: There is ample daylight in most of the studios due to orientation and clerestory windows. Furniture in studios is sturdy and in good condition and has flexibility with separate desks and chairs.

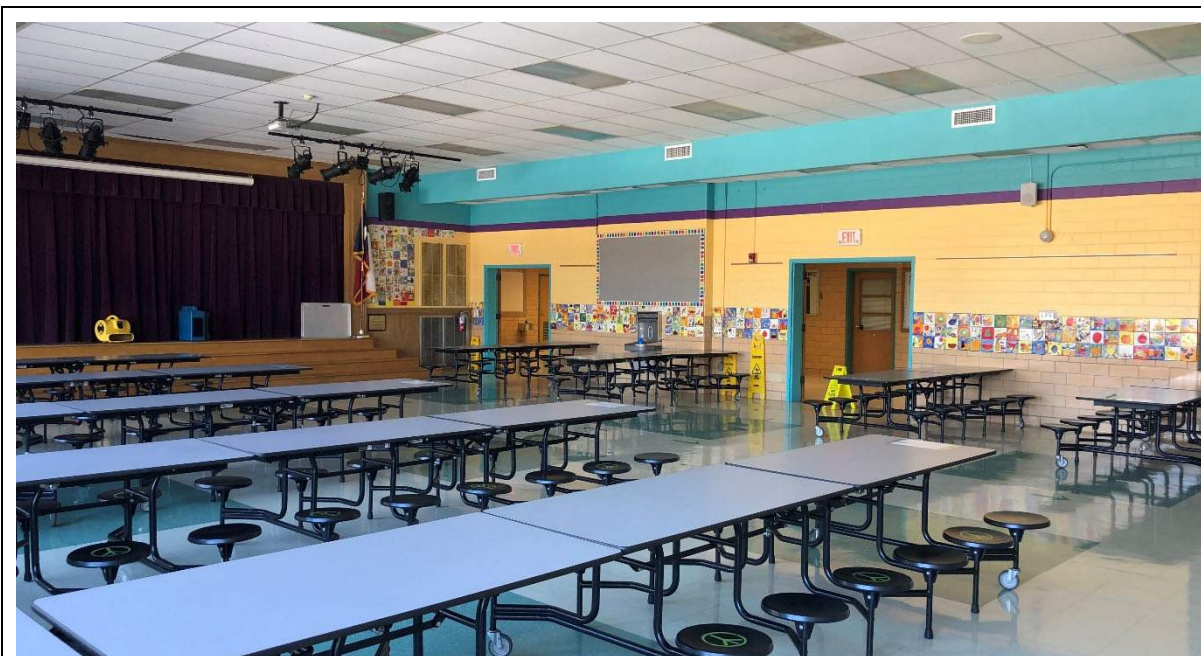
Cafeteria: The size of the cafeteria is adequate and has great daylight, however no designated place for trash, composting and recycling.

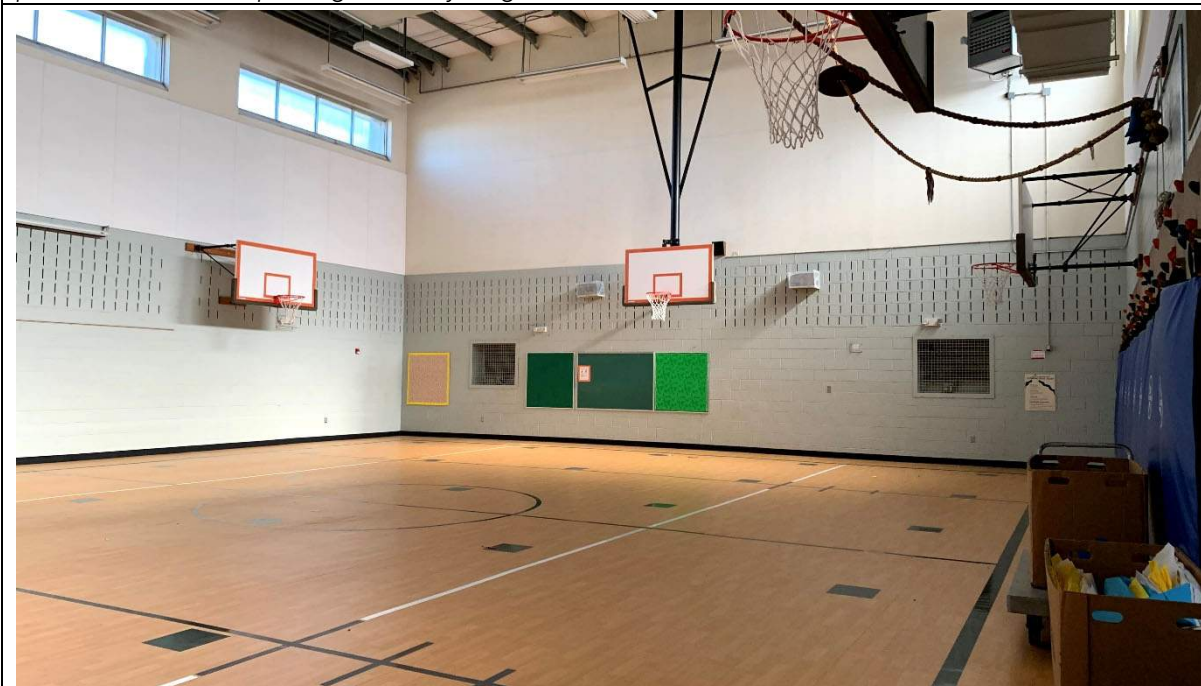
Gymnasium: The gym is in satisfactory condition and is adequately sized.

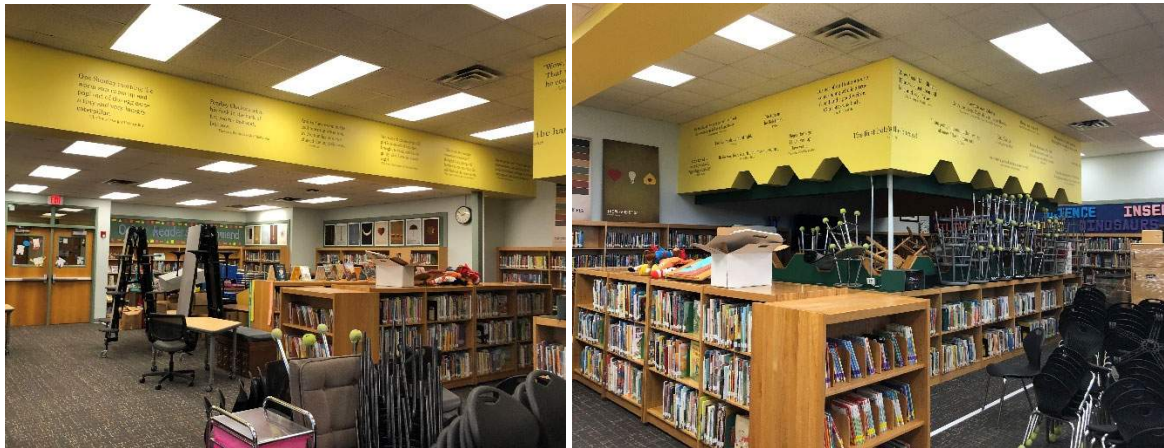
Library: Due to COVID restrictions, pictures do not reflect normal conditions; however, they show the book layout and the larger group reading "stadium" seating area. There is a need for small breakout areas.

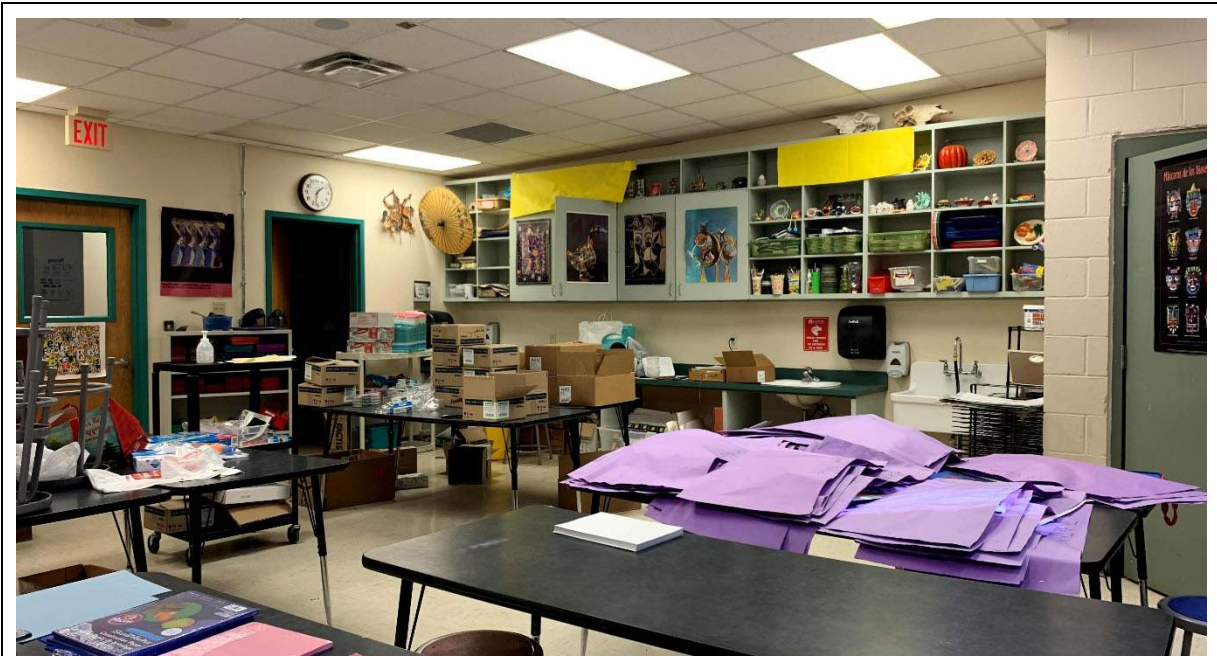
Art Room: Due to COVID restrictions, this picture does not reflect normal conditions; however, it shows the furniture and storage/plumbing amenities. .

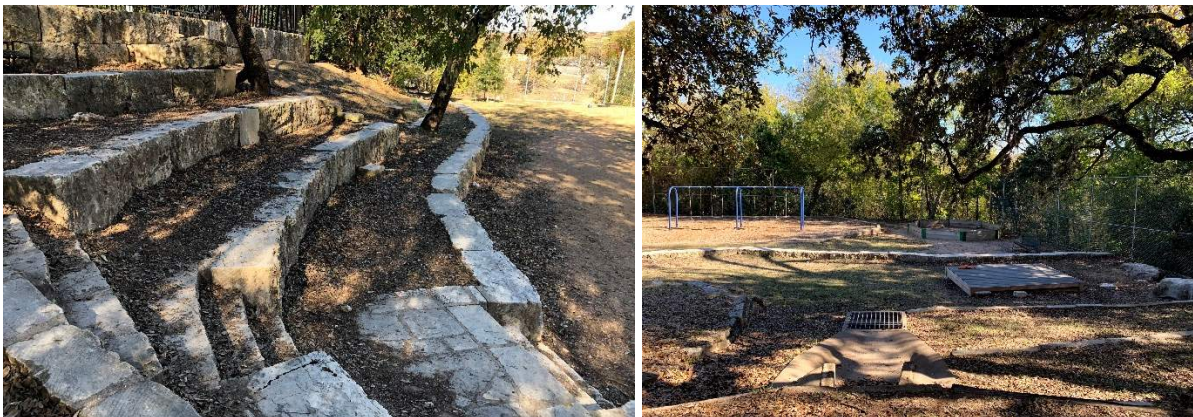
Outdoor Studio: The outdoor studio consists of stadium seating and a small stage platform and is shaded by a large oak tree. The space can accommodate a large group of people. Sloped site appears to be a visibility concern.

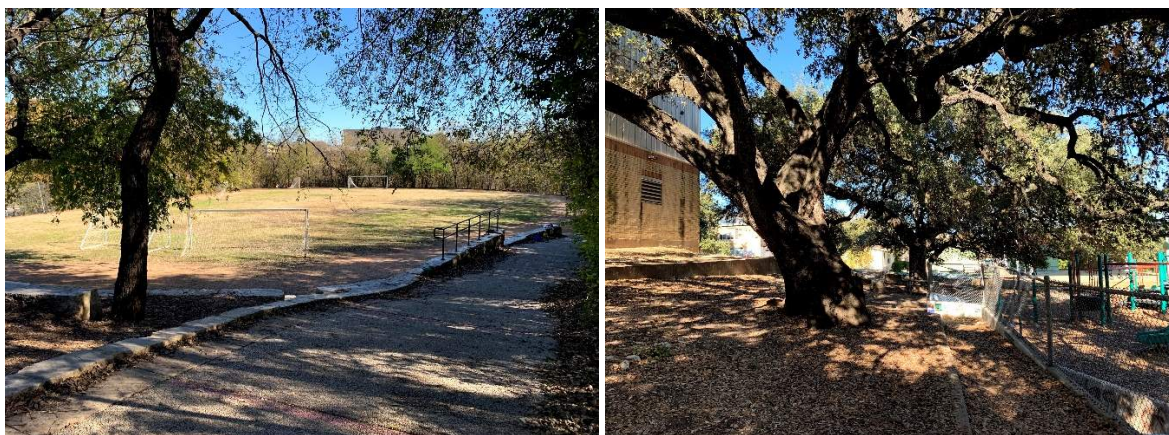
Outdoor Paths: The image on the left shows the path to and around the multipurpose field. The image on the right shows one of many large oak trees on site that shade paths and seating areas.

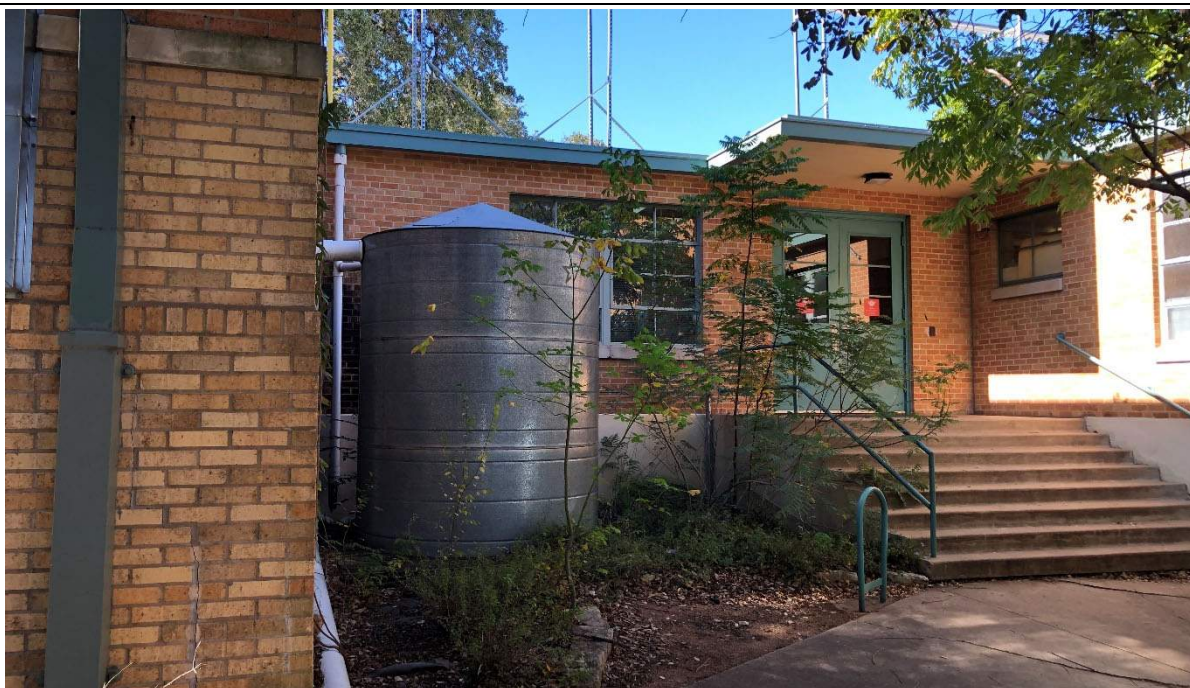
Back Entry: The back entry from the playground showing one of the cisterns on site.
