Educational Suitability Summary Report

Cook Elementary School

Date: 12/15/2020

Score 53% Average

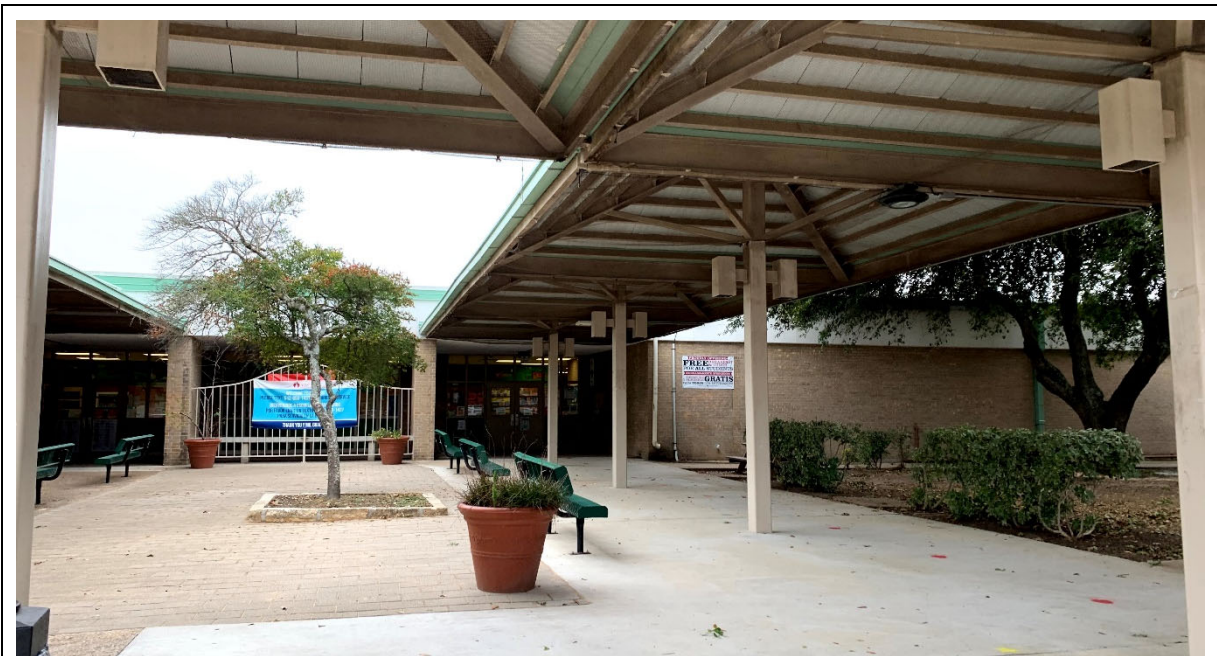
Entry Canopy: Generous canopy but limited glass at main entry.

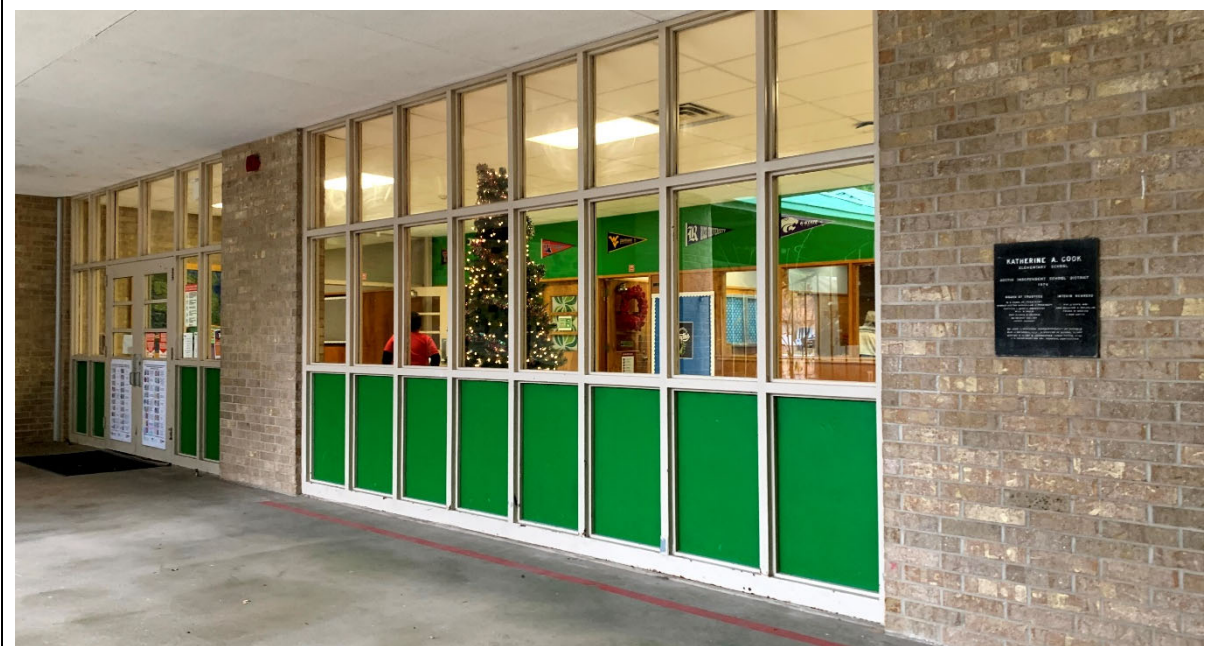
Front entry door has limited glass. **There is no secure vestibule.** Main office is at front entry and has limited line of sight to the front door.

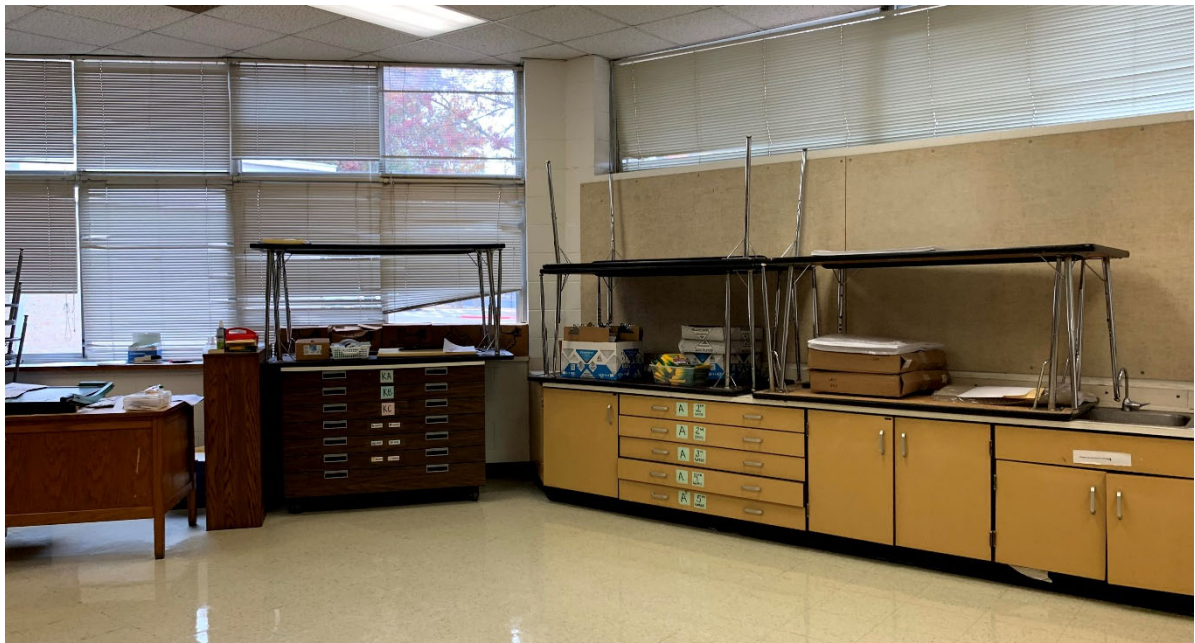
Art studio is undersized per current Ed Spec and does not have adequate storage. Ample windows provide daylight, but mini blinds are in unsatisfactory shape.

9.3	Are Visual Arts spaces and storage appropriately configured per the ed spec?			3				Comments	1.00 3.00
	1 Very unsatisfactory - Too small, missing program spaces							Room 9. Has nice daylight. Not enough storage. Room has kiln.	
	2 Unsatisfactory - Too small, poor condition								
	3 Average - Adequate size, adequate condition, needs some renovations or updates to function well								
	4 Satisfactory - Good size, good condition								
	5 Very Satisfactory - Generous size, excellent condition								
	N/A Does not apply

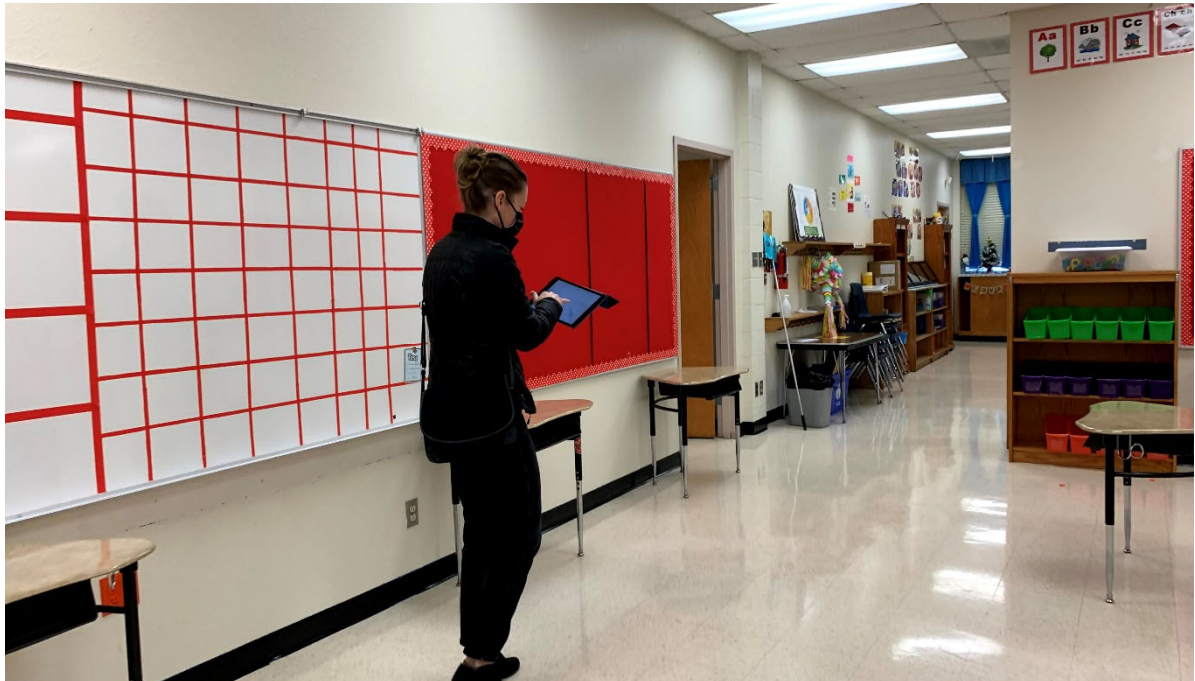
Studios (numbered 1-7 and 18-25) are horizontally stacked and have a large opening from front to back studio, creating acoustical and disruption issues for students traveling from a studio to the hallway.

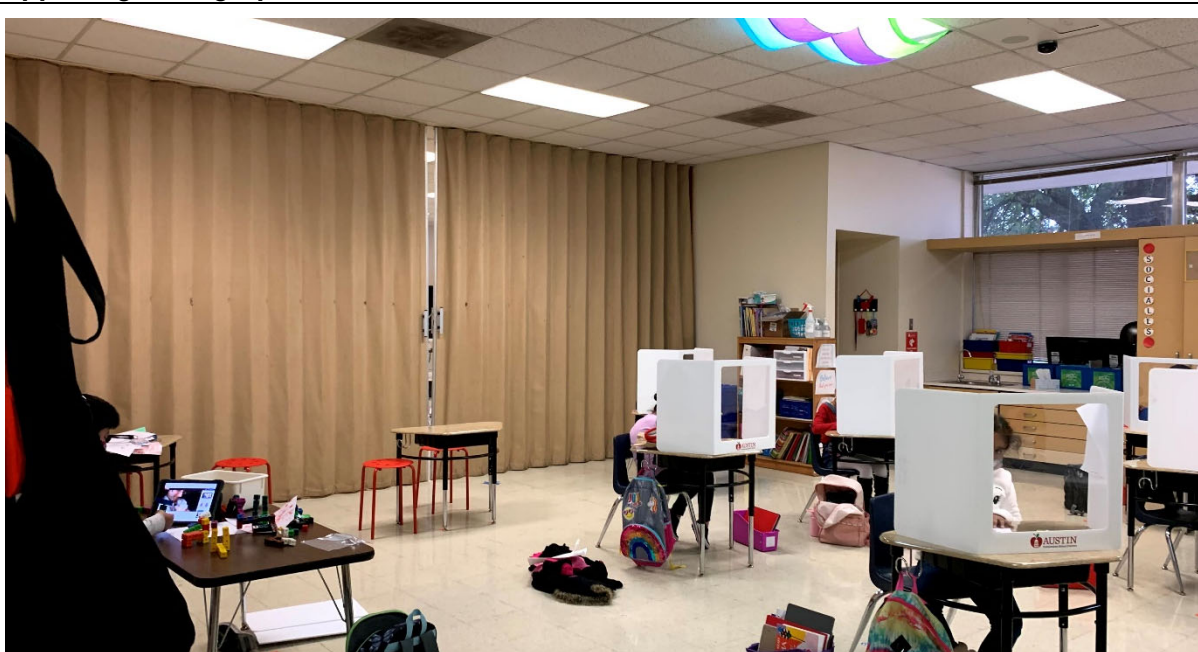
Studios (numbered 10-17) have accordion partition. They are not used very often and create acoustical issues.

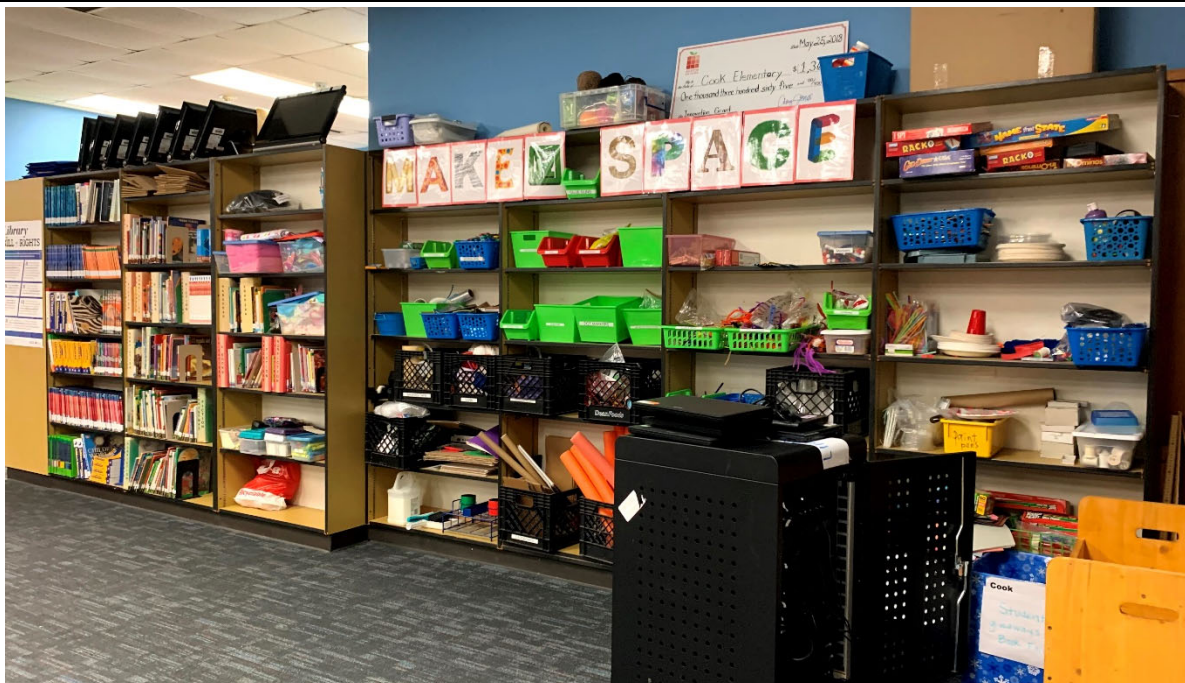
Library has a small maker space. There is not adequate library storage, and the media resources furnishings are dated.

8 - Academics & Learning (cont.)		1	2	3	4	5	N/A			
8.6	Are Maker Spaces and support spaces appropriately configured per the ed spec?		2					Comments	1.00 2.00	
1	Very unsatisfactory - No dedicated maker spaces							Maker space is one corner in the library.		
2	Unsatisfactory - Too small, poor condition, disconnected from learning spaces, no flexibility									
3	Average - Adequate size, adequate condition, needs some renovations or updates to function well									
4	Satisfactory - Good size, good condition, connected to learning spaces									
5	Very Satisfactory - Generous size, excellent condition, connected to learning spaces									
N/A	Does not apply

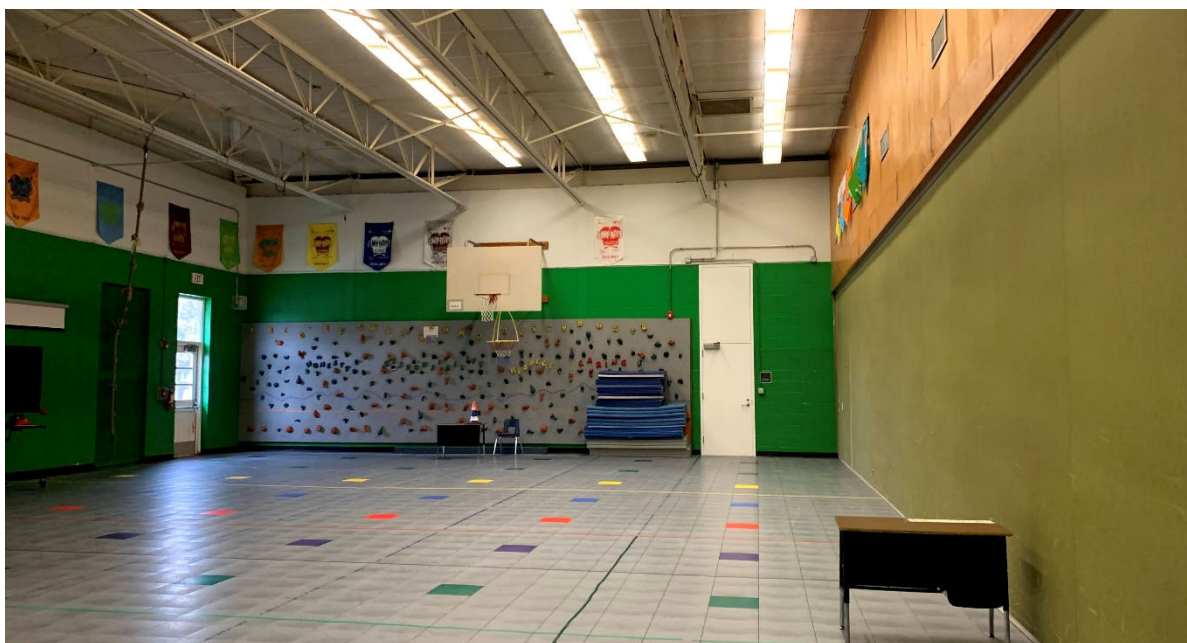
Gym is adequately sized per Ed Spec and opens to cafeteria. Flooring and lighting are unsatisfactory.

10 - PE and Wellness		1	2	3	4	5	N/A	10.00	50%		
10.1	Does the campus meet the ed spec standard for physical education program spaces?			3				Comments	1.00	3.00	
1	Very unsatisfactory - Too small, missing program spaces								Floor is not in good shape. No natural daylight. Climbing wall.		
2	Unsatisfactory - Too small, poor condition										
3	Average - Adequate size, adequate condition, needs some renovations or updates to function well										
4	Satisfactory - Good size, good condition										
5	Very Satisfactory - Generous size, excellent condition										
N/A	Does not apply

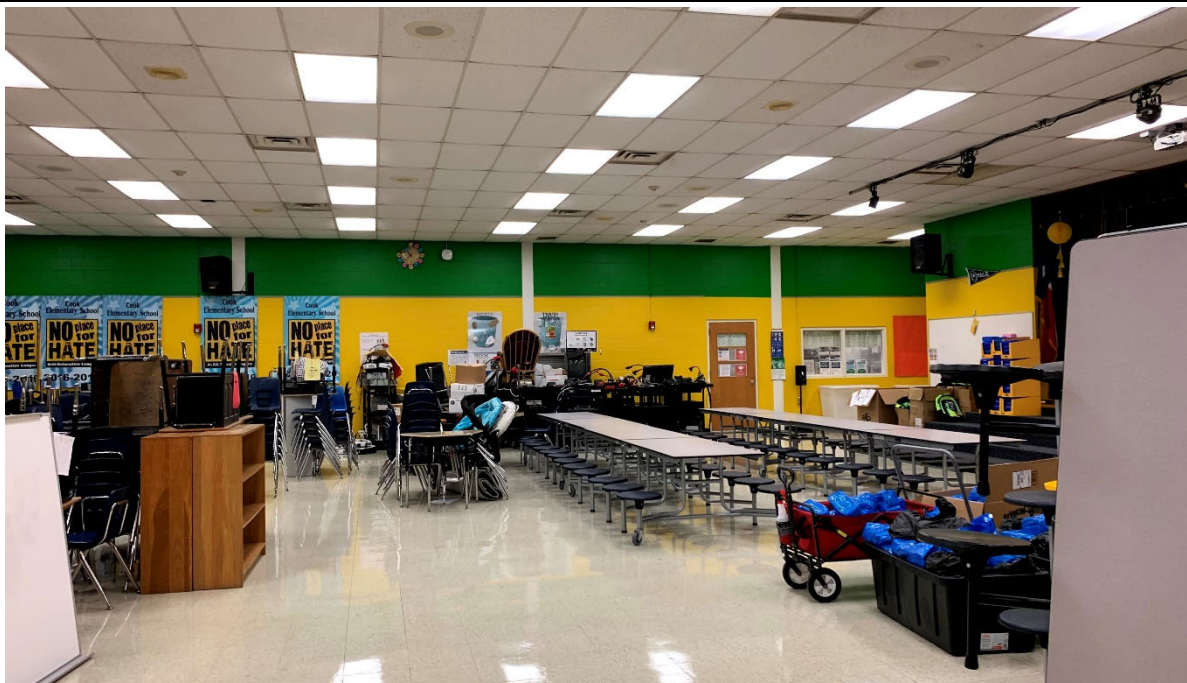
Cafeteria is adequately sized. Stage to the right of the image does not have adequate A/V for presentations.

13.4	Is there adequate AV for presentations spaces – cafeteria and gym?		2					Comments	1.00	2.00	
1	Very unsatisfactory - AV not present in one or more space							Cafeteria A/V is average. Gym has speakers and small projection screen.			
2	Unsatisfactory - AV undersized for room, poor condition										
3	Average - Adequately sized / poor condition OR AV undersized / adequate condition										
4	Satisfactory - Good size, good condition										
5	Very Satisfactory - Generous sized, excellent condition										
N/A	Does not apply

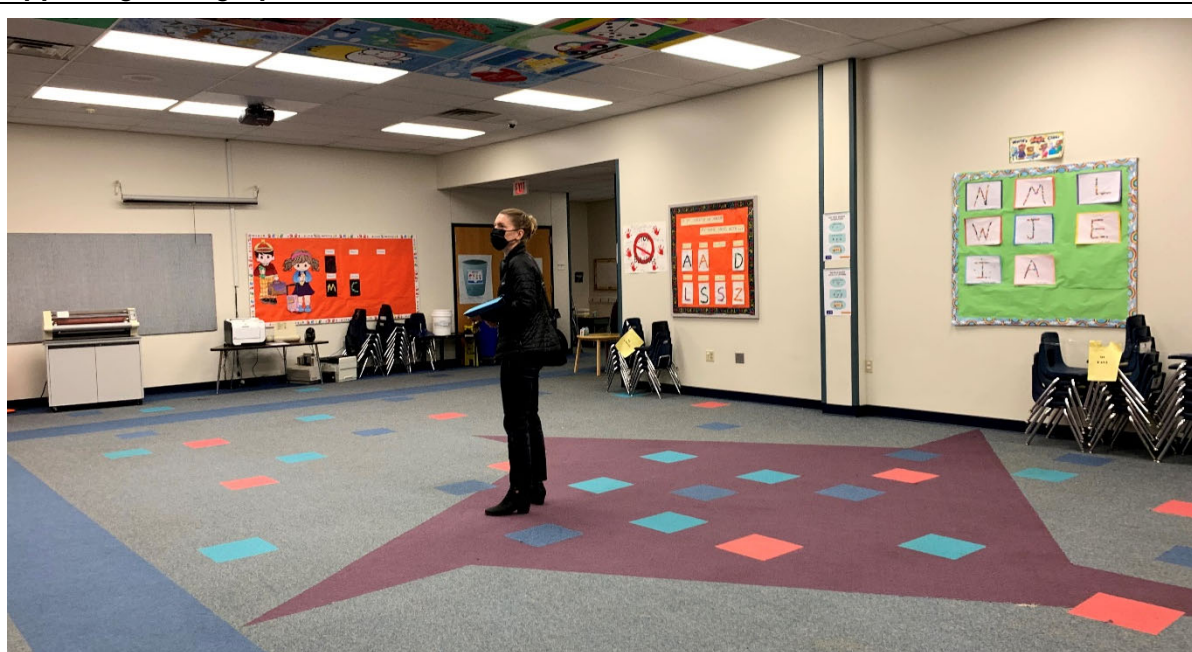
Stand-alone studio building has 9,000 SF and was built in the late '90s. It has adequate collaboration space that all studios share.

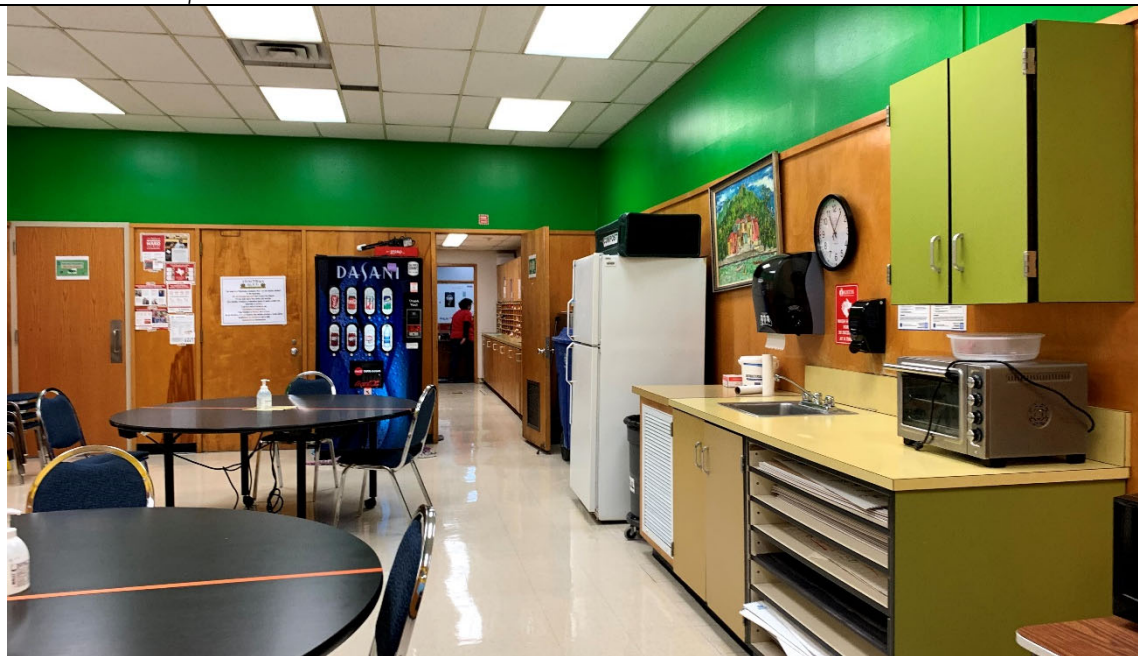
Teachers' lounge is undersized and not welcoming or seen as a place for relaxation. All administration spaces do not have access to daylight or windows.

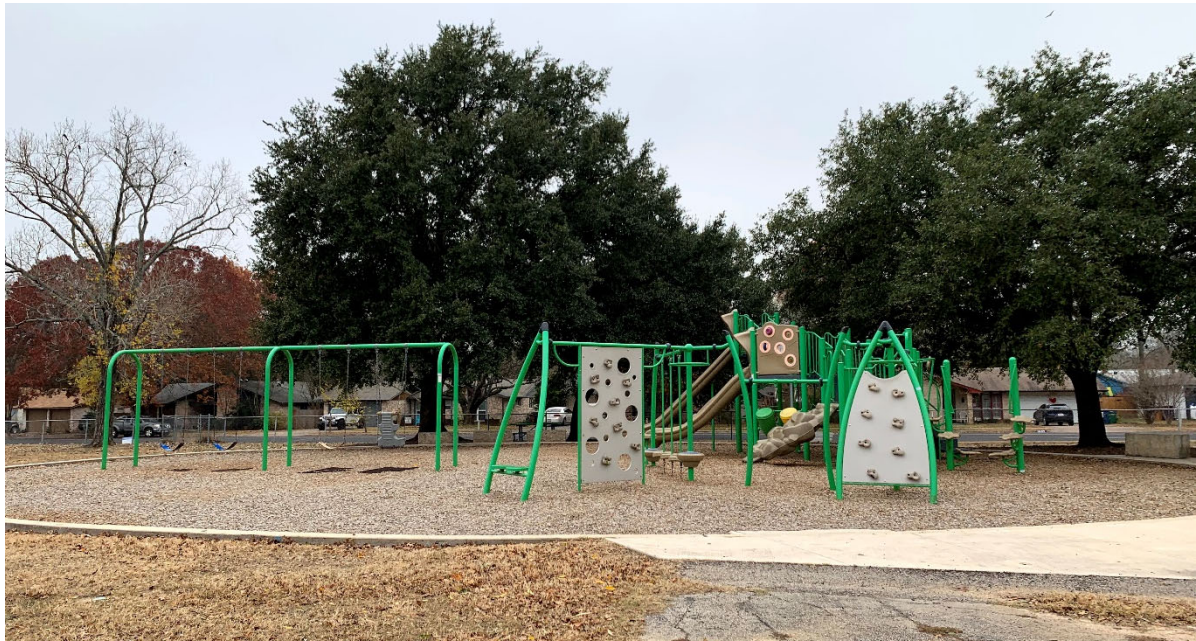
There are two generously sized active playgrounds. Neither has shade.

2.2	Are active playgrounds (elementary only) and support spaces configured per the ed spec?			3					Comments	1.00	3.00
1	Very unsatisfactory - No dedicated active playground	Nice active playgrounds for two age groups. No shade over either of them.									
2	Unsatisfactory - Too small, poor condition, no shade provided										
3	Average - Adequate size, adequate condition, needs some renovations or updates to function well, 50% or less shade coverage over play structure										
4	Satisfactory - Good size, good condition, more than 50% shade coverage over play structure										
5	Very satisfactory - Generous size, excellent condition, full shade coverage over play structure										
N/A	Does not apply

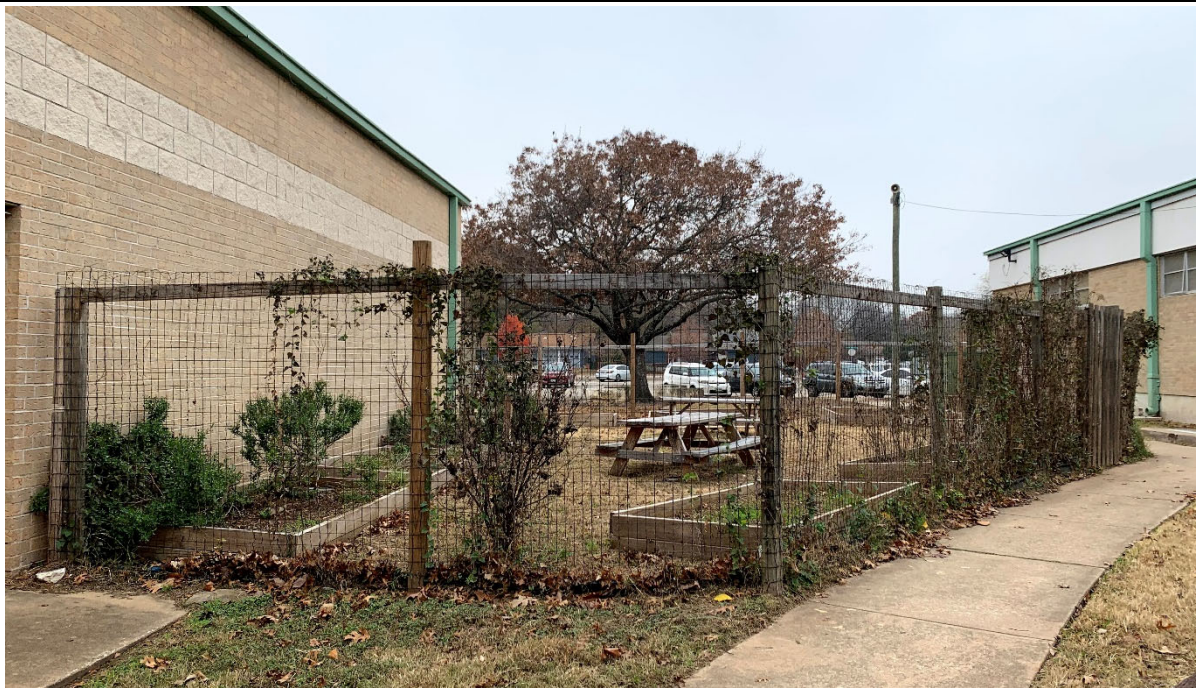
Outdoor garden space is in development. School is applying for grants to provide upgrades for landscaping and outdoor furniture.
