# **Educational Suitability Summary Report**

Cunningham Elementary School

Date: 01/28/2021 Score 59% Average

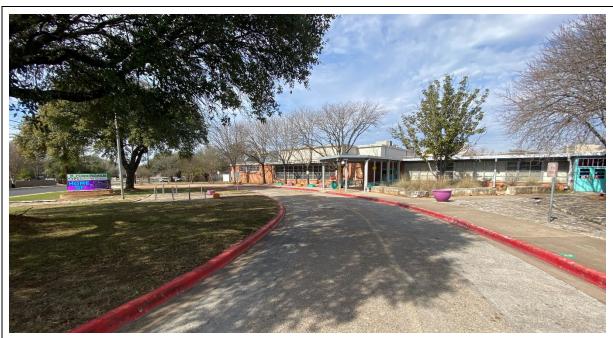
Bus and parent drop-off are in the same pull-through. The adjacent parking lot (to the right of this photo) is another place for bus and parent drop-off. There is a new digital marquee on campus and the canopy identifies the main entrance.

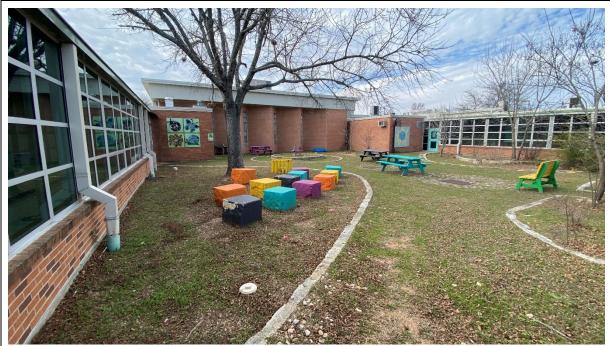
The internal courtyard has plenty of seating and creates a welcoming outdoor learning area.

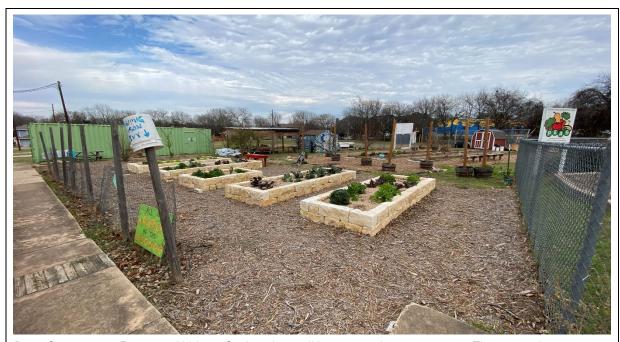
Peas Community Farm and Urban Orchard is well known in the community. This space has gardens, a cistern and an outdoor studio.

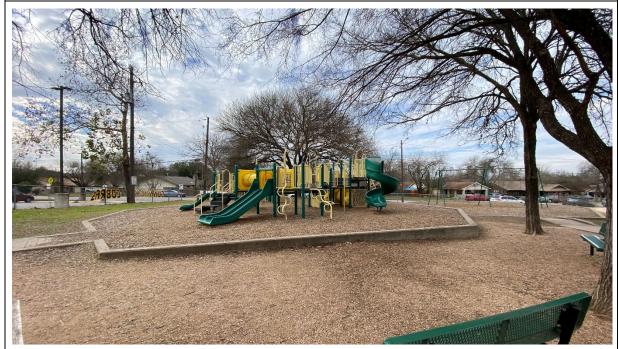
The playscapes are left uncovered and are in average condition.

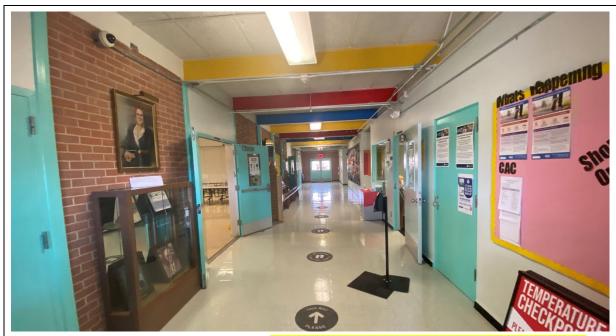
View from inside the main entrance doors. Reception is near the entrance but does not act as a security checkpoint for visitors to the school.

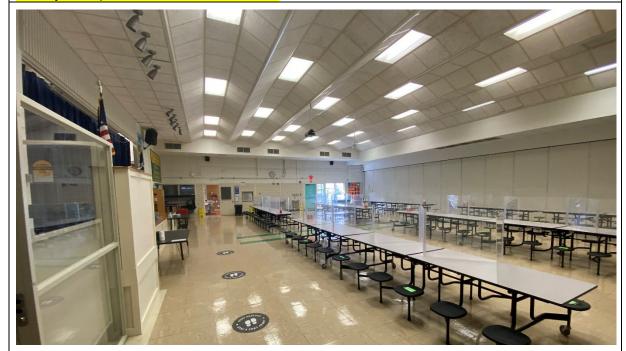
The cafeteria is undersized but is close to the entrance. There are minimal windows and natural lighting in the space and there is no connection to the outdoors. The kitchen has one serving line and is undersized.

Cafeteria is small and lacks a visual connection to the outdoors.

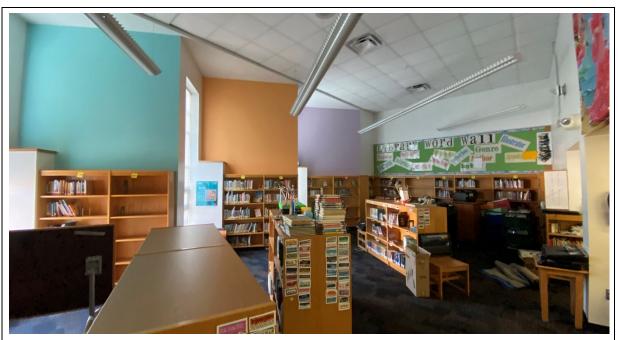
The unique sawtooth shape of the back room of the library creates informal seating areas and allows diffused natural light.

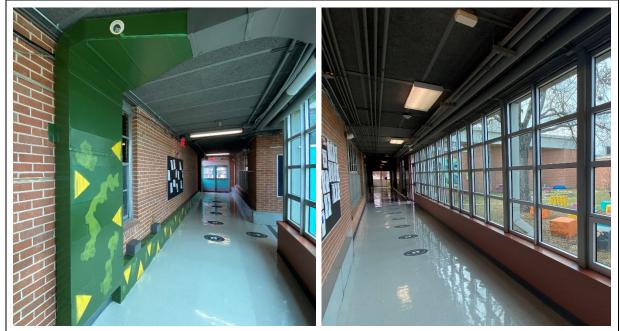
Single-loaded corridors surround the internal courtyard with glass and flood the inside with natural light. Painting creates a fun environment for students and conveys school pride.

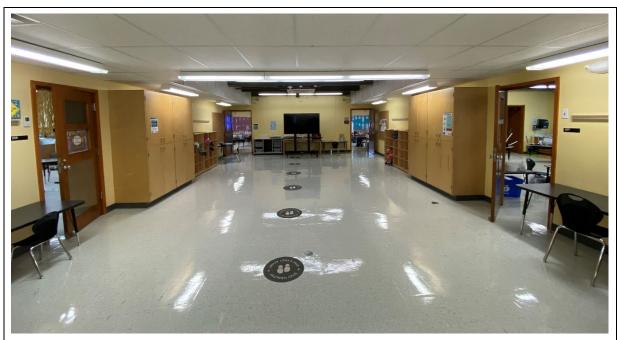
The learning pod between kindergarten and first-grade studios allows flexible and collaborative space, though it lacks natural daylight or views to the outside.

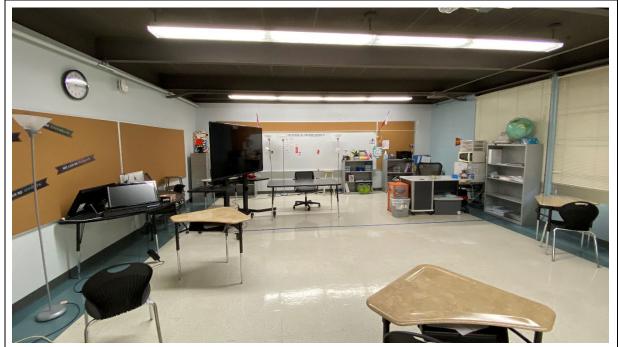
Studios have new whiteboards and tackable surfaces. Most studios have large exterior windows, but a few of the windows look out to the single-loaded corridors.
