## **Educational Suitability Summary Report**

Dawson Elementary School

Date: 01/19/2021

**Score 58% Average**

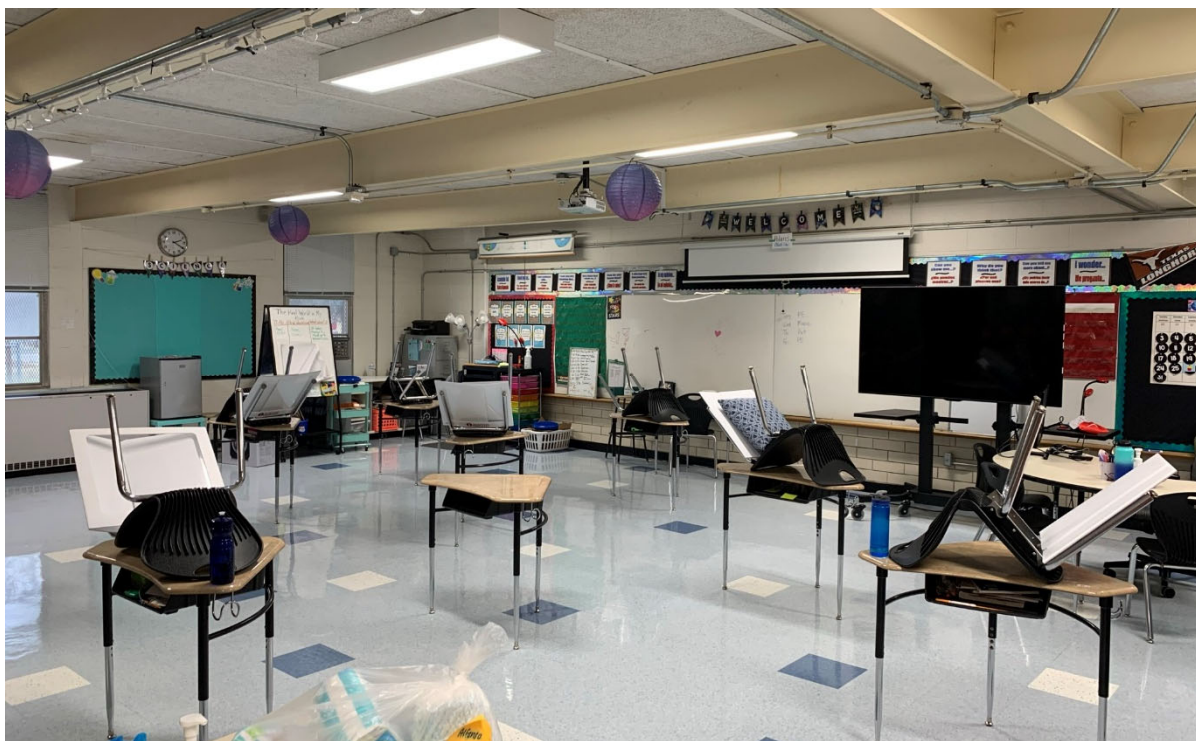
*All studios have access to natural light, varying between a few small windows in a room, as shown here, to two full parallel walls of windows.*

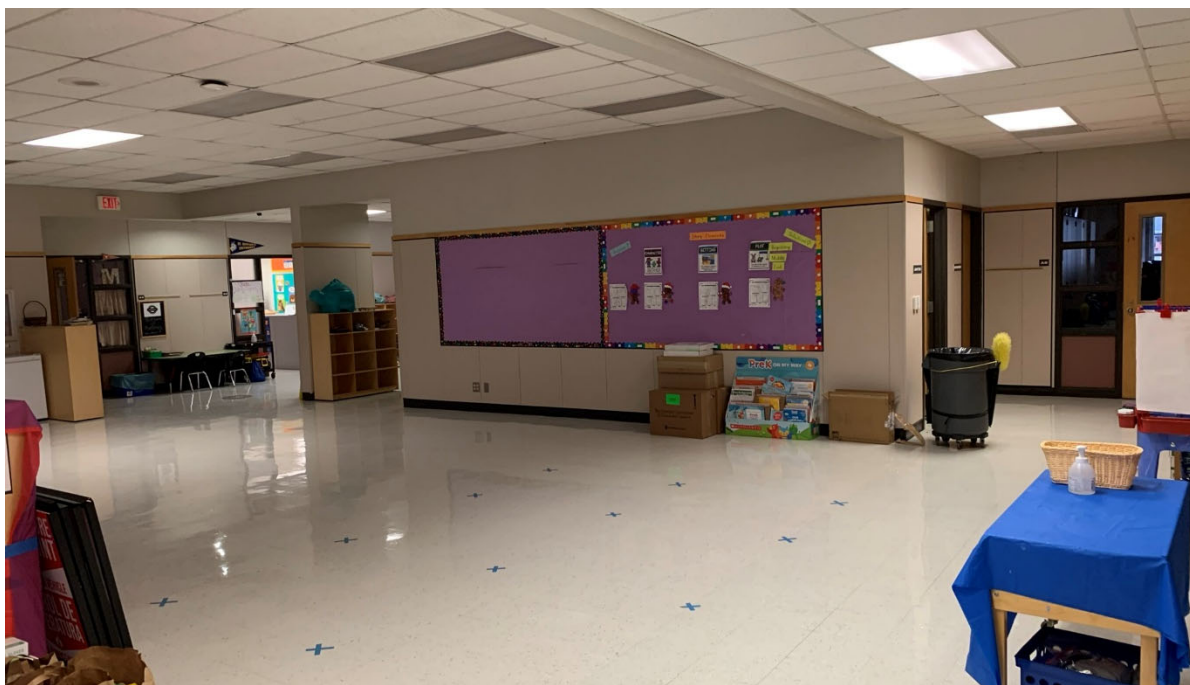
*Most corridors on the original building are exterior, but the pre-K and kindergarten addition has a shared flex space in the center of the building for collaboration.*

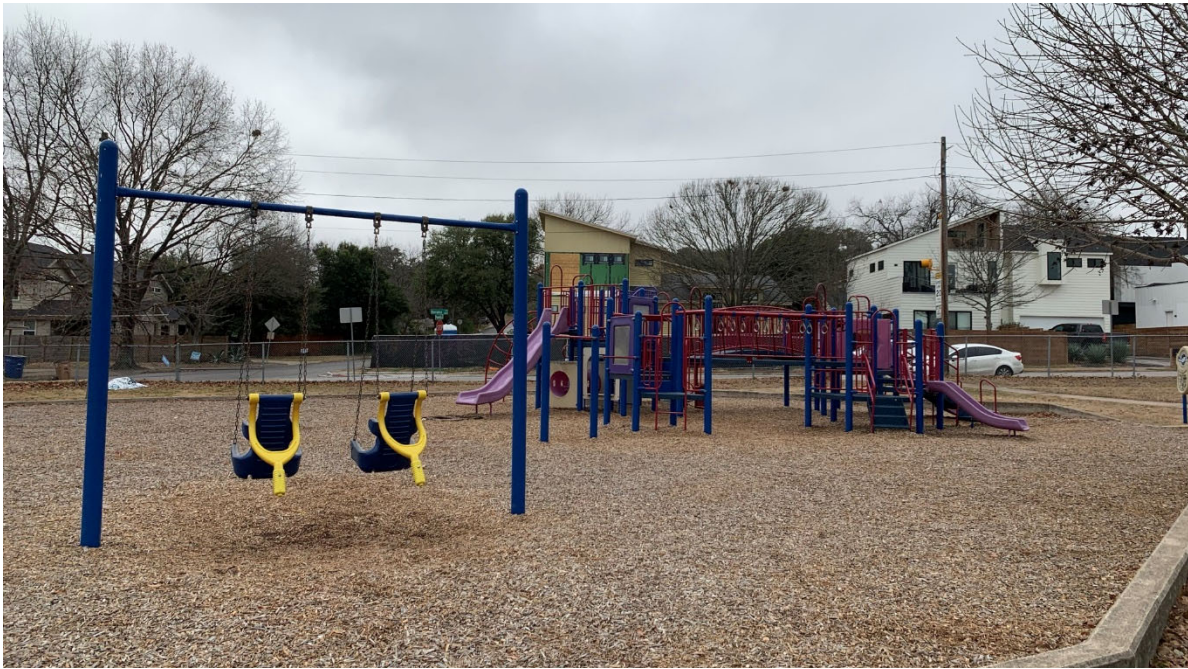
*All playgrounds on campus have no shade coverage. There is a small playground dedicated to pre-K and kindergarten that is located near the studio wing.*

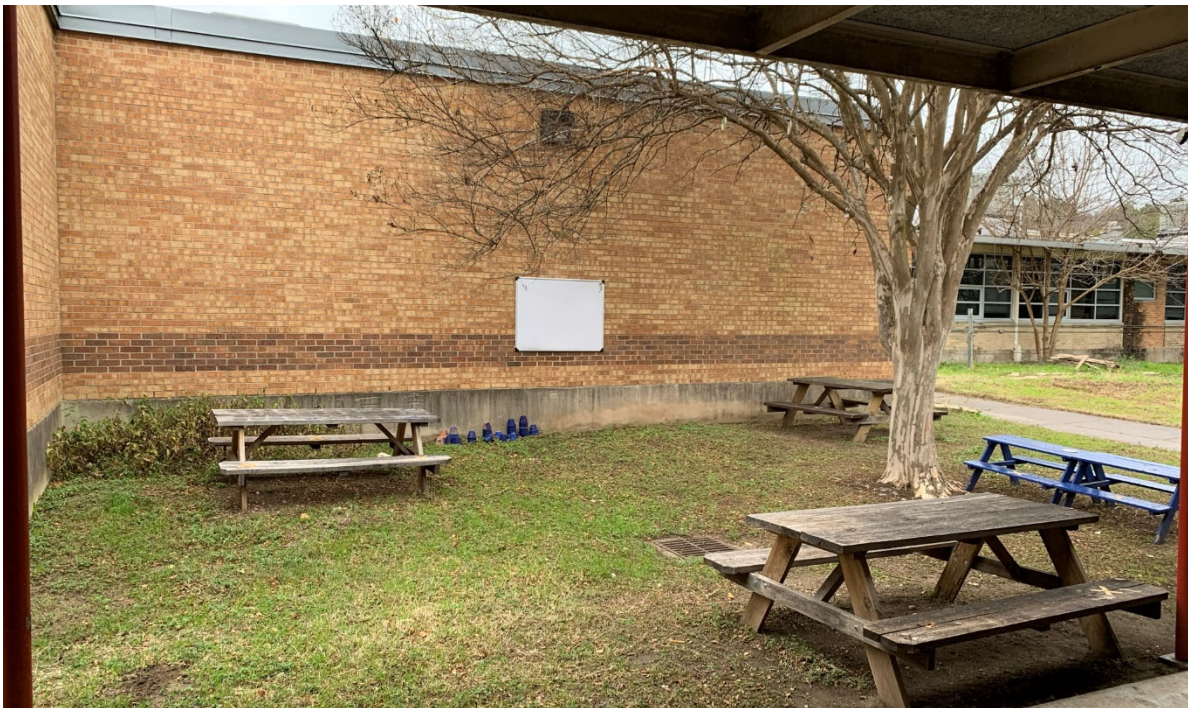
*The courtyards throughout campus are well used due to their close connection to each studio wing, as each room opens to the exterior. Furniture needs updates.*

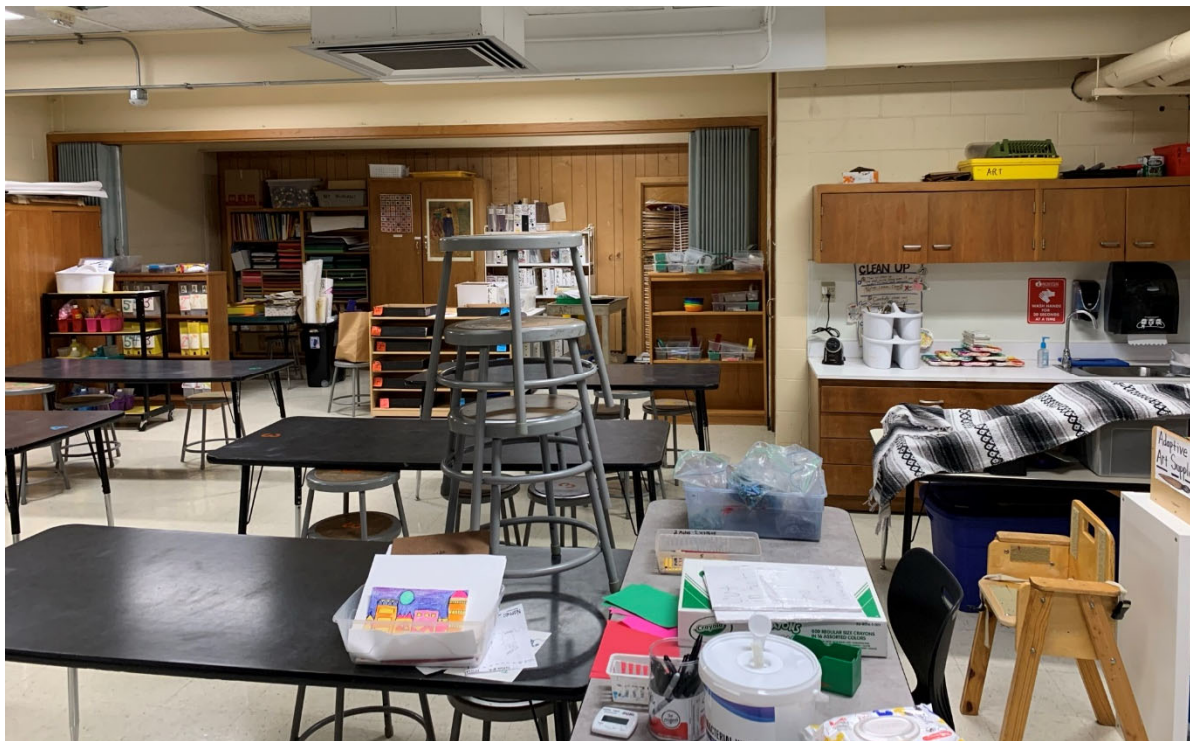
*Art is in a standard studio space with no dedicated storage and only one sink. The kiln is not connected to the room and is located far from the room.*

9.3	Are Visual Arts spaces and storage appropriately configured per the ed spec?		2					Comments	1.00 <b>2.00</b>
	1 Very unsatisfactory - Too small, missing program spaces							Currently in a typical studio. Only has one sink. Kiln is disconnected from studio (in another wing on the other side).	
	2 Unsatisfactory - Too small, poor condition								
	3 Average - Adequate size, adequate condition, needs some renovations or updates to function well								
	4 Satisfactory - Good size, good condition								
	5 Very Satisfactory - Generous size, excellent condition								
	N/A Does not apply

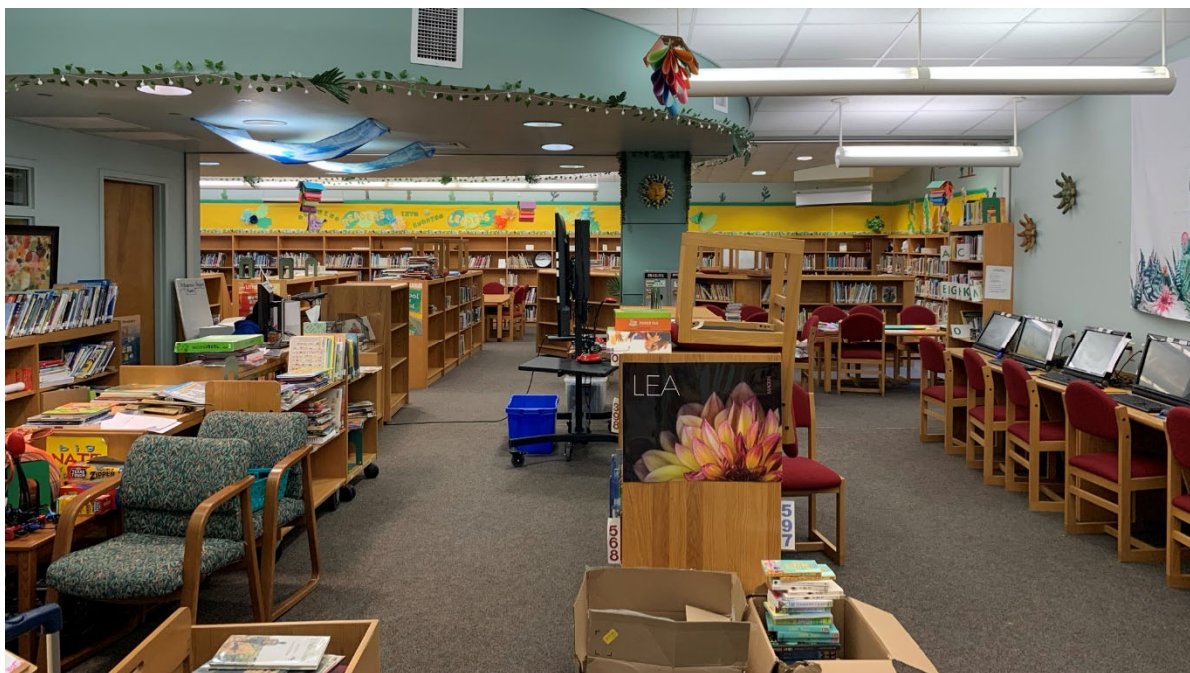
*Media Resources: The library is small with dated furniture that is cumbersome to move, causing the space to lack adequate flexibility.*

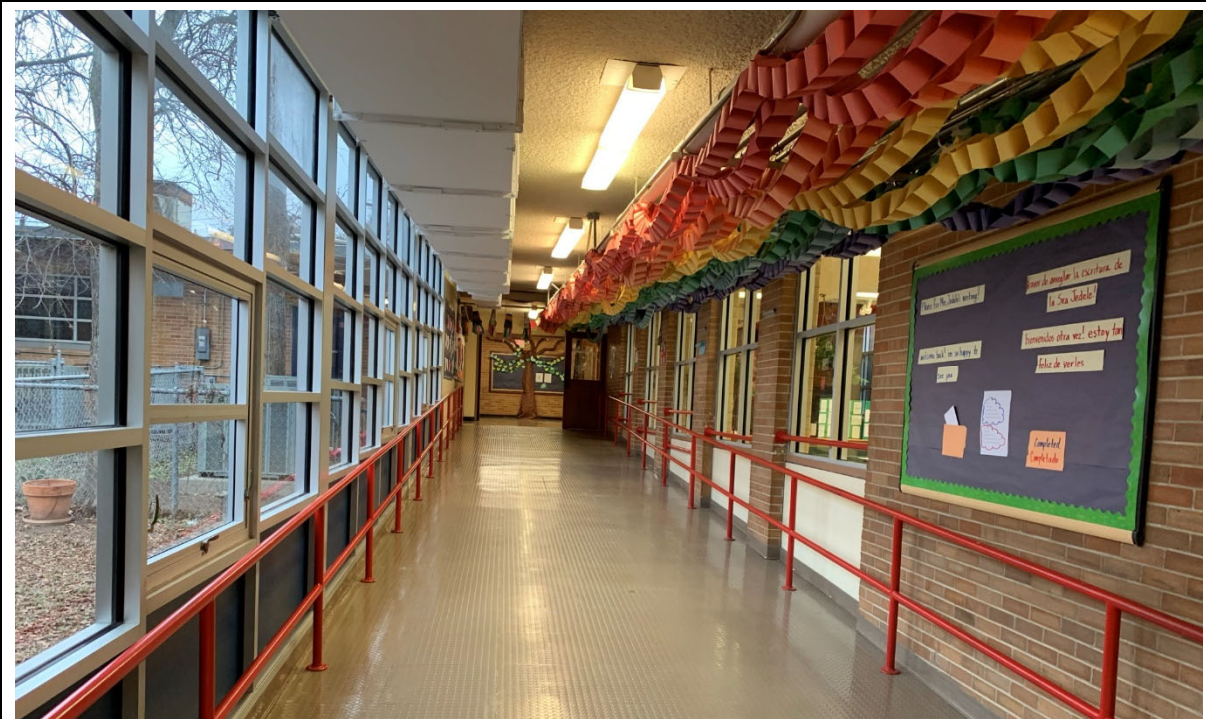
*There are not many interior hallways due to the courtyards and connection to the outdoors that the studios have, but the campus is still able to adequately display student work.*

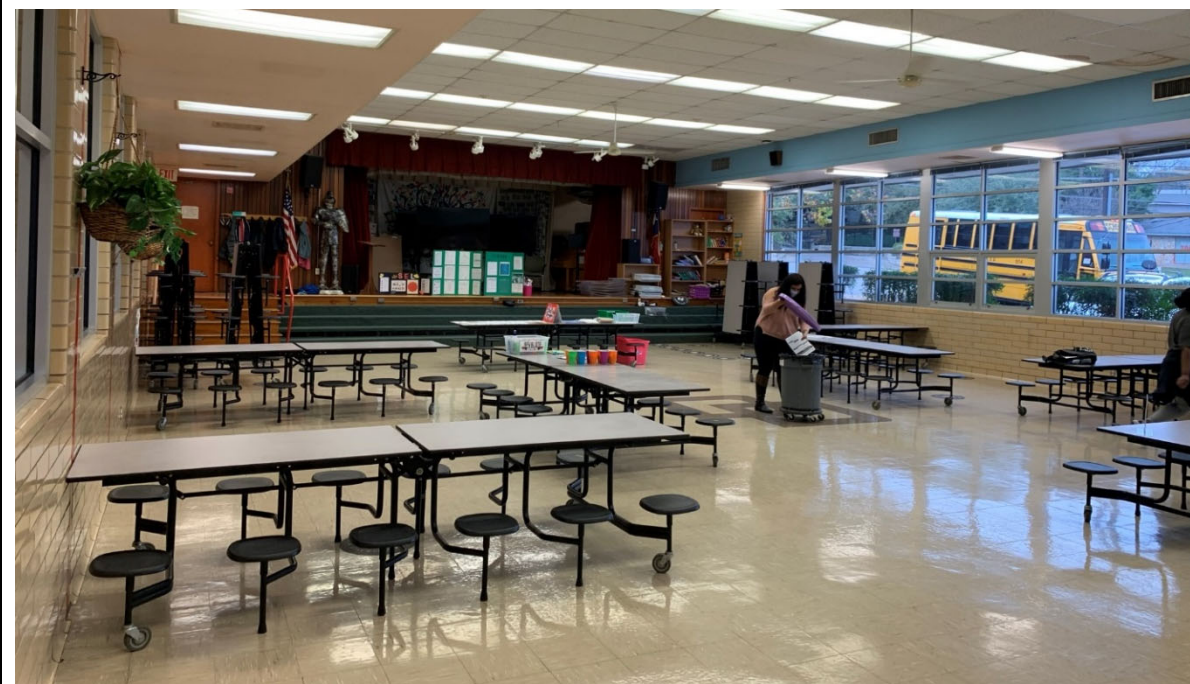
*Cafeteria is undersized but has great access to natural light and good visibility to the campus.*

11.1	Is the Dining Commons appropriately configured per the ed spec?			3				Comments	1.00 3.00	
	1 Very unsatisfactory - Too small, missing program spaces							Cafeteria is undersized; some connection to outdoor dining.		
	2 Unsatisfactory - Too small, poor condition, only one option for eating space provided, inadequate circulation									
	3 Average - Adequate size and condition, needs updates or renovations to function well									
	4 Satisfactory - Good size and condition, good circulation, multiple options for eating space (ex: connection to outdoor eating space)									
	5 Very Satisfactory - Generous size, excellent condition and circulation, multiple options for eating space (ex: connection to outdoor eating space)									
	N/A Does not apply

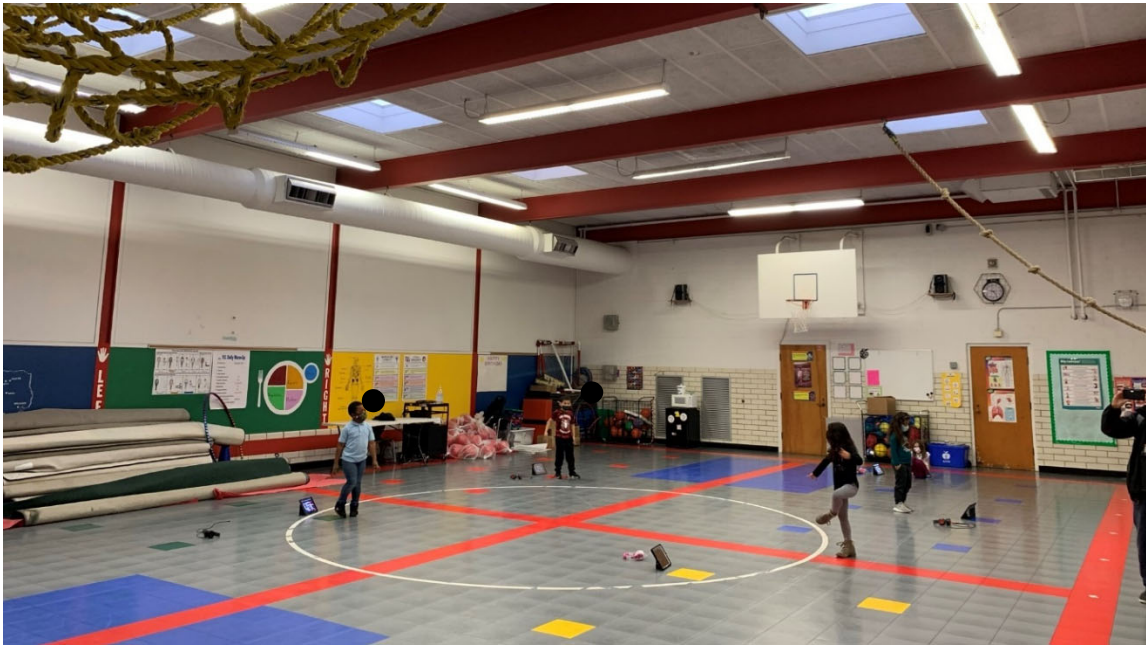
*The gym is undersized and needs updates. Flooring appears to be original and there is minimal storage space.*

<b>10 - PE and Wellness</b>		1	2	3	4	5	N/A	10.00	40%	
10.1	Does the campus meet the ed spec standard for physical education program spaces?		2					Comments	1.00 2.00	
	1 Very unsatisfactory - Too small, missing program spaces							Gym is undersized and needs updates. Flooring is dated.		
	2 Unsatisfactory - Too small, poor condition									
	3 Average - Adequate size, adequate condition, needs some renovations or updates to function well									
	4 Satisfactory - Good size, good condition									
	5 Very Satisfactory - Generous size, excellent condition									
	N/A Does not apply

10.2	Are the physical education storage spaces appropriately configured per the ed spec?		2					Comments	1.00 2.00	
	1 Very unsatisfactory - None provided							Storage is very small.		
	2 Unsatisfactory - Too small, disconnected, poor condition									
	3 Neutral - Adequate size, average condition, needs updates or renovations to function well									
	4 Satisfactory - Good size, connected, good condition									
	5 Very Satisfactory - Generous size, connected, excellent condition									
	N/A Does not apply									
<b>11 - Food Services</b>		1	2	3	4	5	N/A	10.00	60%

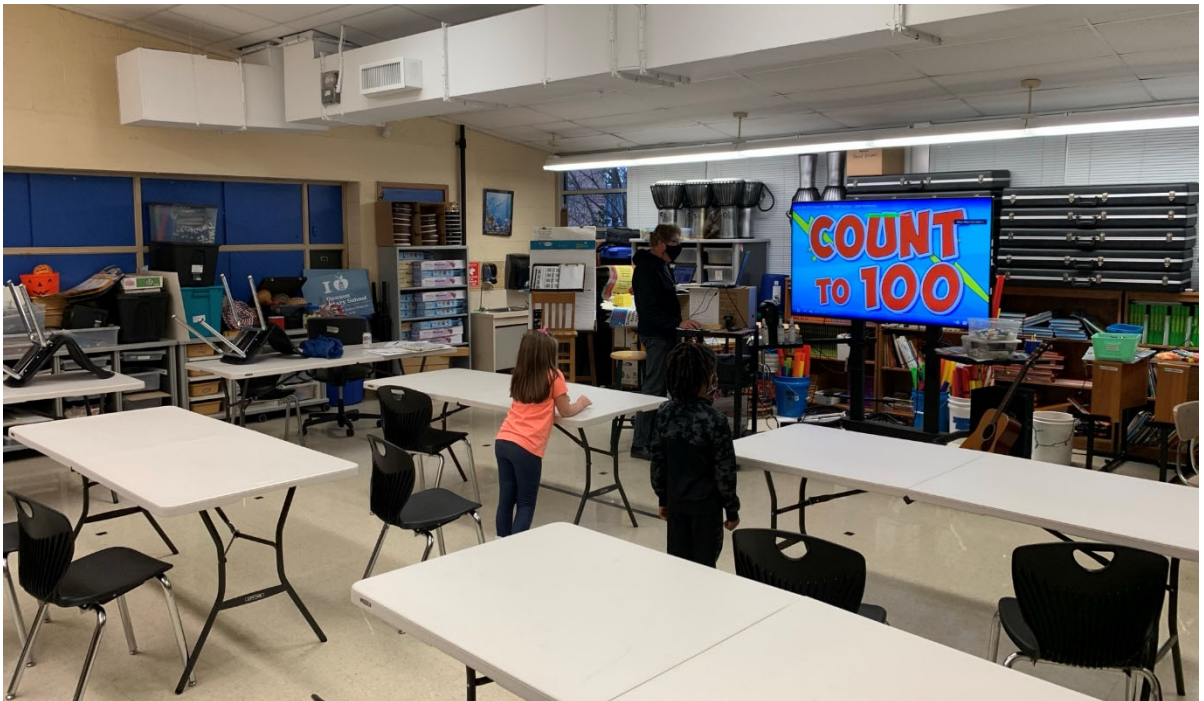
*Music is in a standard studio without adequate storage. Furniture in this classroom is due to Covid protocols and does not accurately reflect a normal school year.*

9.2	Are music and performance storage spaces appropriately configured per the ed spec?		2					Comments	1.00 <b>2.00</b>
	1 Very unsatisfactory - None provided							Music room is not well connected to the cafeteria and stage. Music room is undersized and lacks adequate storage.	
	2 Unsatisfactory - Too small, disconnected, poor condition								
	3 Neutral - Adequate size, average condition, needs updates or renovations to function well								
	4 Satisfactory - Good size, connected, good condition								
	5 Very Satisfactory - Generous size, connected, excellent condition								
	N/A Does not apply
