Educational Suitability Summary Report

Doss Elementary School

Date: 12/22/2020

Score 90% Very Satisfactory

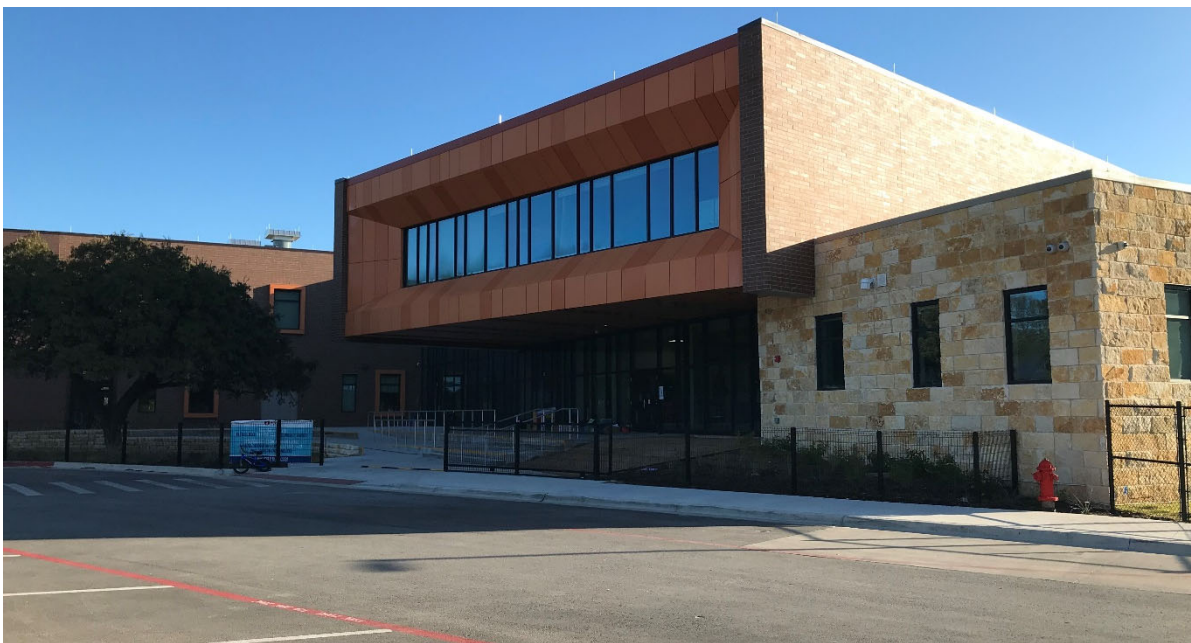
Front entry of school. Overhang from building provides protection from weather at entry door.

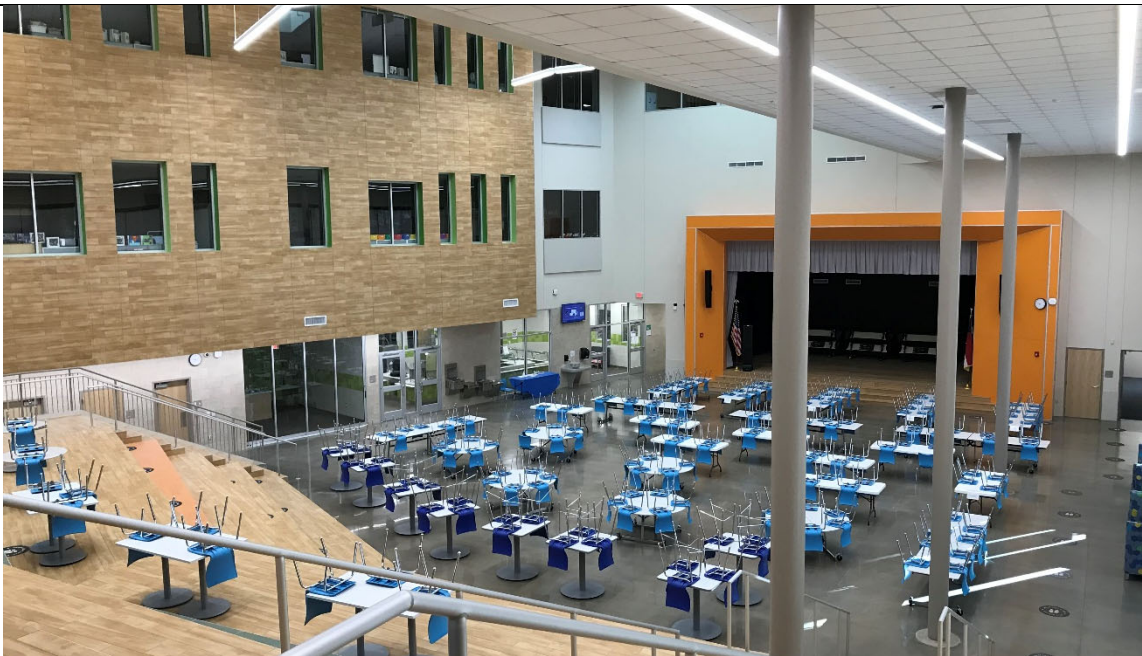
Some teachers expressed concerns about children traveling up and down the atrium steps down to the cafeteria. These steps are difficult for younger students to navigate. On the exterior, there is concern about the railings and safety features around certain site features like the pond and tiered

Cafeteria/atrium space at the heart of the school is a large, light-filled space but some teachers expressed concern about children's safety moving up and down the steps.

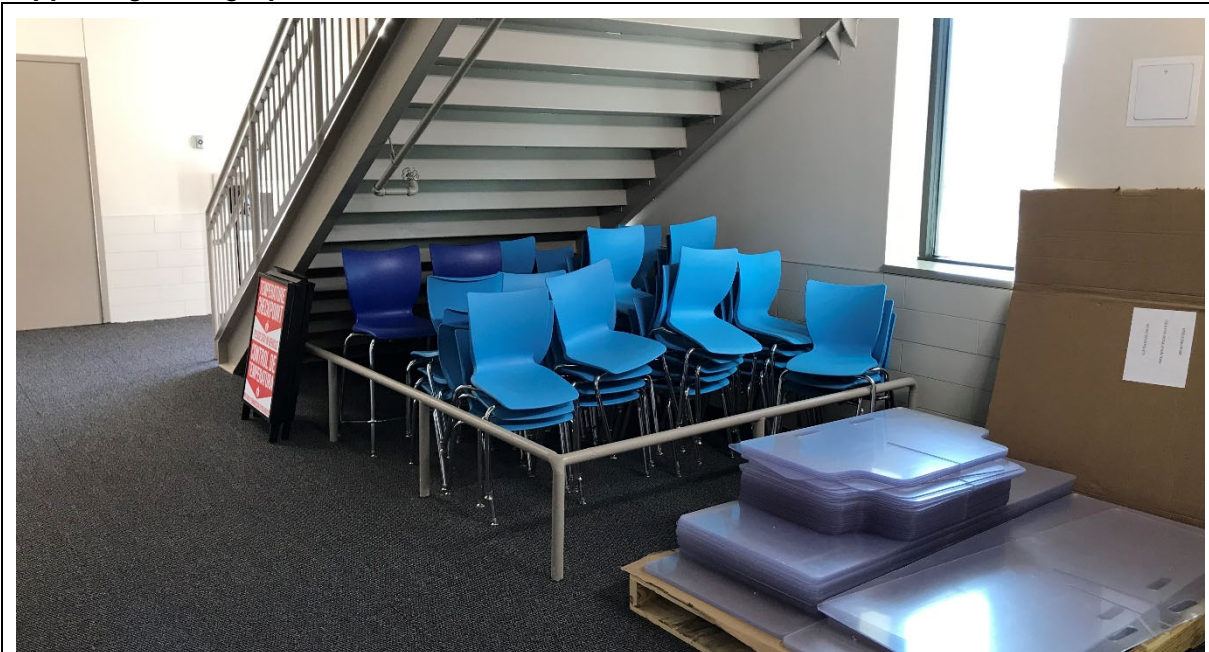
Chair storage underneath stairs. Storage concerns were an issue raised by the users of the school multiple times in the interview.

8 - Academics & Learning (cont.)		1	2	3	4	5	N/A			
8.3	Do studios have appropriate support spaces such as storage per the ed spec?			3				Comments	1.00 3.00	
	1 Very unsatisfactory - None provided							Storage is lacking throughout the school and is an issue that came up during the school interview. Storage is limited to casework storage. It was noted in interview there are no individual storage rooms. (Per Ed Spec, storage rooms are not required in learning neighborhoods.)		
	2 Unsatisfactory - Too small, disconnected, poor condition									
	3 Neutral - Adequate size, average condition, needs updates or renovations to function well									
	4 Satisfactory - Good size, connected, good condition									
	5 Very Satisfactory - Generous size, connected, excellent condition									
	N/A Does not apply

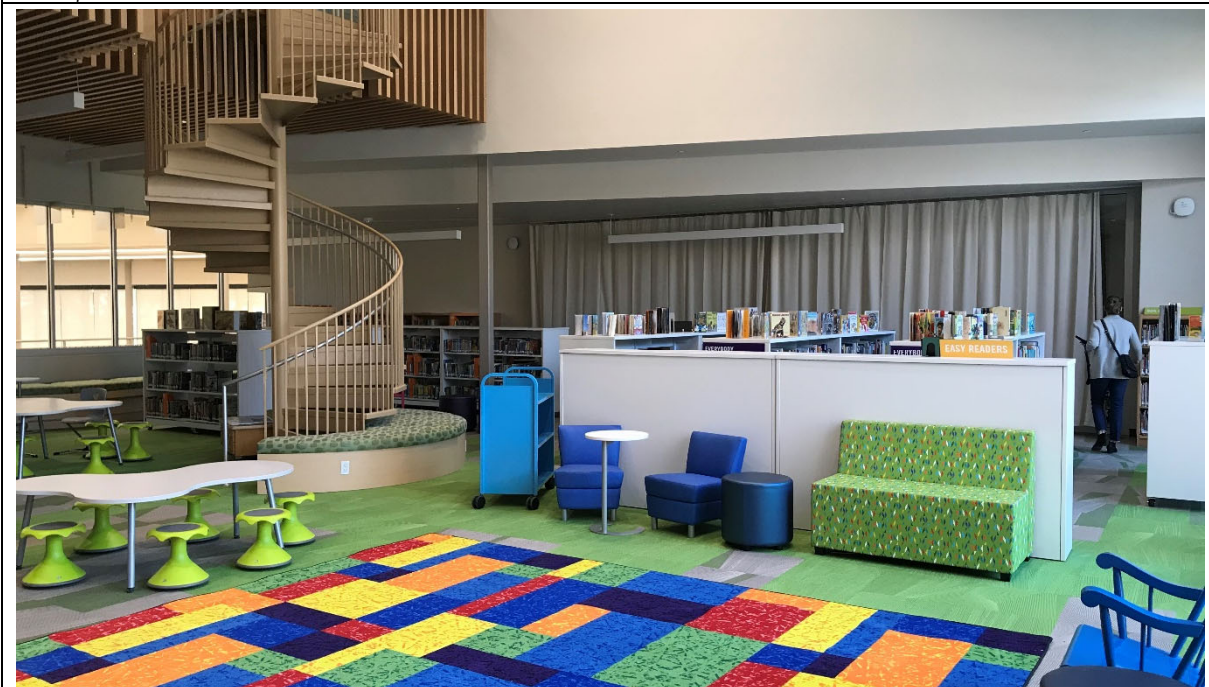
Library is open and nicely daylit. Furniture solutions are available for small groups to meet. Community room and maker space have connections to library allowing for varying group sizes (10-25) to meet.

Media Center connects the second and third floor. The space opens up to the community room beyond. Excellent flexible furniture is found throughout the school.

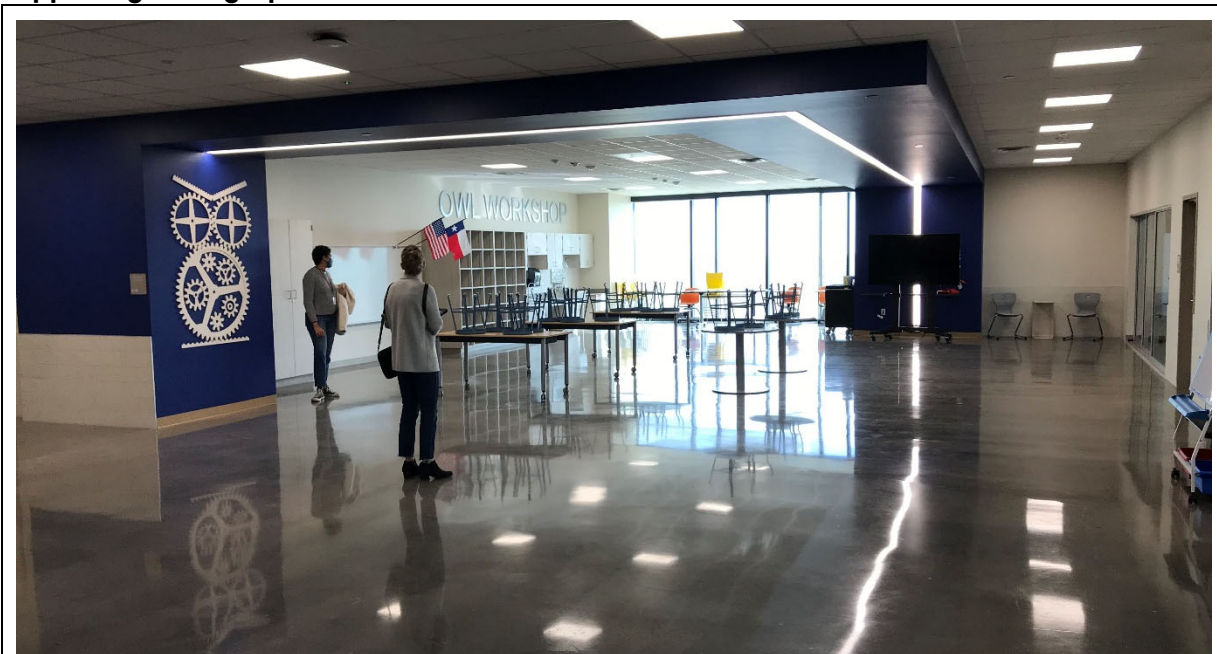
Maker space on upper level. This one is on the upper floor of the school, and it is an open, flexible space with technology, storage and two sinks.

8 - Academics & Learning (cont.)		1	2	3	4	5	N/A			
8.6	Are Maker Spaces and support spaces appropriately configured per the ed spec?					5		Comments	1.00 5.00	
1	Very unsatisfactory - No dedicated maker spaces									
2	Unsatisfactory - Too small, poor condition, disconnected from learning spaces, no flexibility									
3	Average - Adequate size, adequate condition, needs some renovations or updates to function well									
4	Satisfactory - Good size, good condition, connected to learning spaces									
5	Very Satisfactory - Generous size, excellent condition, connected to learning spaces									
N/A	Does not apply

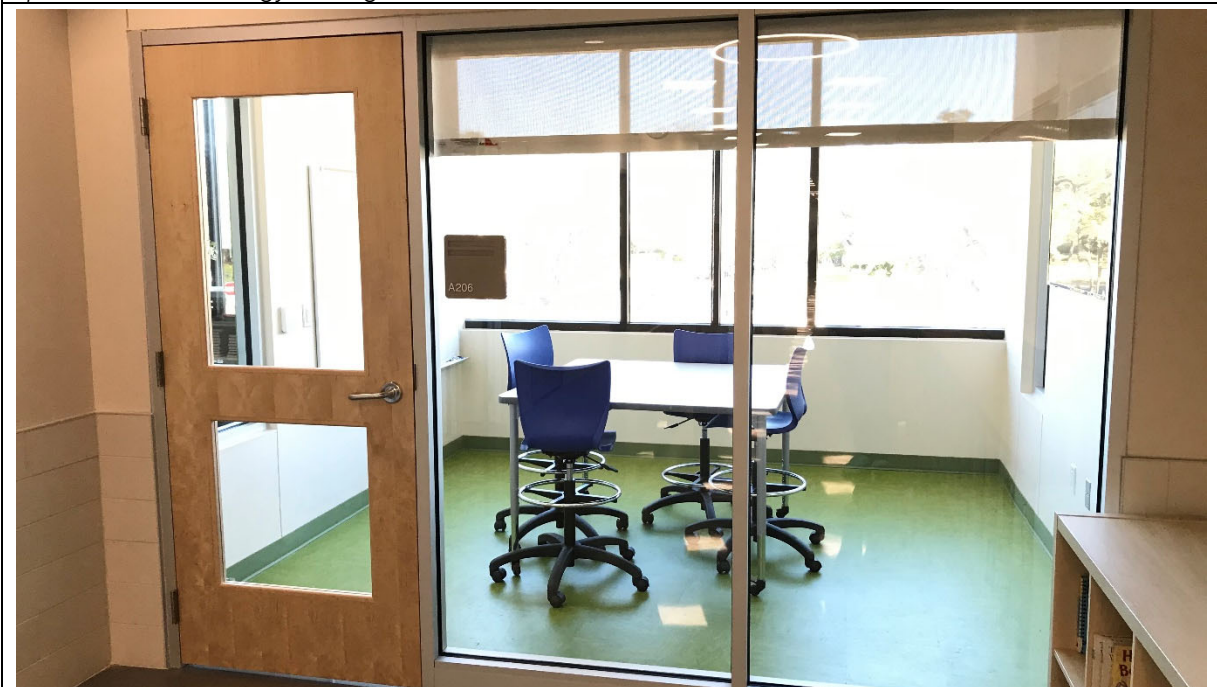
Example of a small group room. Each learning neighborhood has a small group room with varying types of furniture.

8.4	Do typical learning neighborhoods have small group rooms and open collaboration space?					5		Comments	1.00 5.00	
	1 Very unsatisfactory - No breakout rooms or open collaboration spaces are provided									
	2 Unsatisfactory - Too small or too few, poor condition, no flexibility, lacks visual connection to learning neighborhood, poor acoustic privacy									
	3 Average - Adequate size, adequate condition, needs some renovations or updates to function well									
	4 Satisfactory - Good size, good condition and flexibility, transparency and connection to learning neighborhood, acoustic privacy									
	5 Very Satisfactory - Generous size, excellent condition and flexibility, transparency and connection to learning neighborhood, acoustic privacy									
	N/A Does not apply

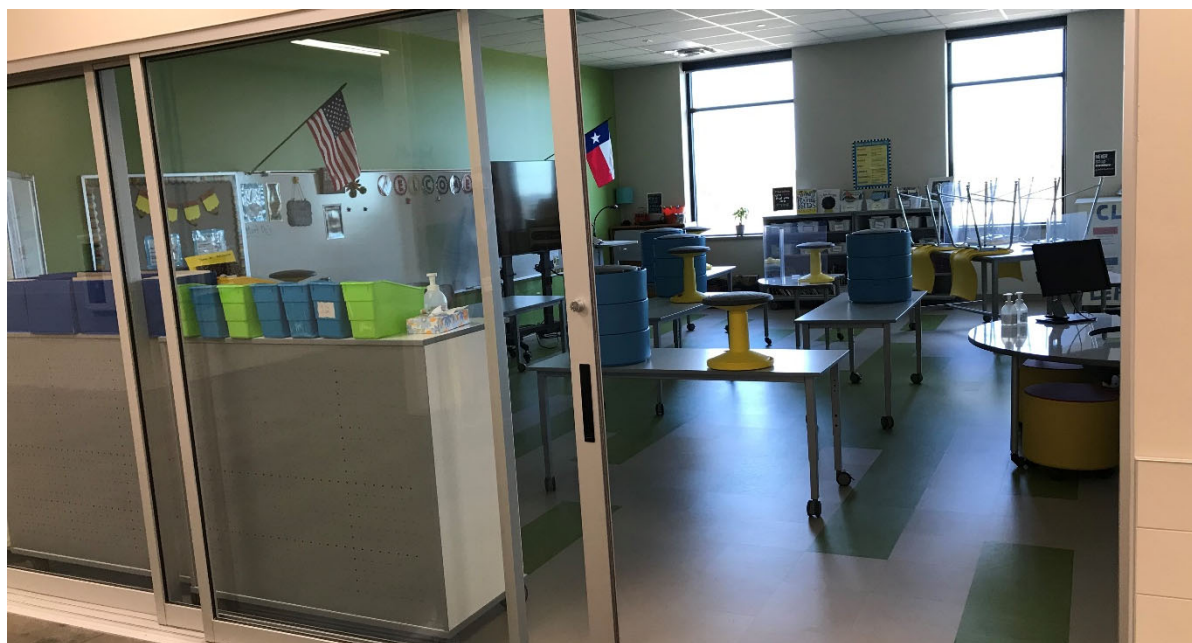
Acoustics are satisfactory. The whole school is well-daylit. Certain interior studios only receive daylight from skylight and the atrium. Studios on the exterior wall can receive a lot of daylight, and if blinds are not drawn at certain times of day, there can be glare issues. No odors or pest problems observed or noted in the interview.

A few studios have sliding glass partitions that can open the space to the hallway. Most studios have large windows to the exterior. Some studios are interior facing to the atrium and have access to overhead daylight but do not have windows to the exterior.

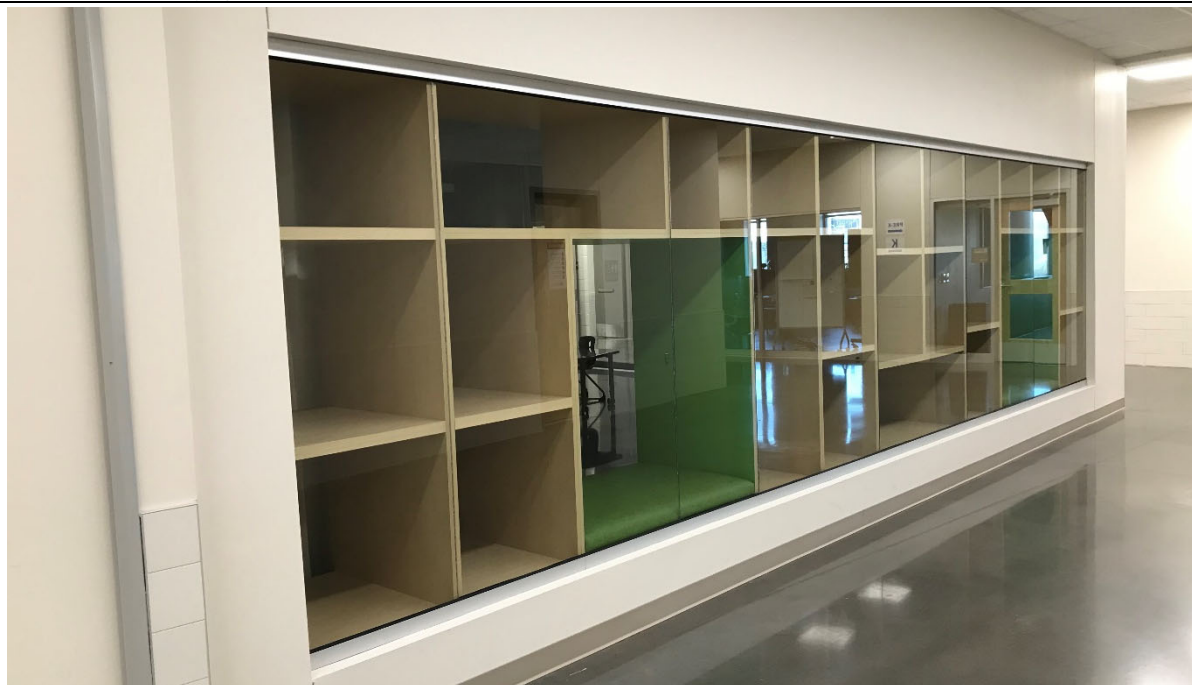
Display case at maker space. Throughout the school, there are opportunities to display 2D and 3D learning artifacts.

8.9	Are there adequate places to display the evidence and artifacts of learning (both 2D and 3D)?					5		Comments	1.00 5.00	
1	Very unsatisfactory - No dedicated space							Maker space has nice cubbies to display artifacts.		
2	Unsatisfactory - Too small, non-dedicated, poor condition									
3	Average - Adequate size, adequate condition, needs updates or renovations to function well									
4	Satisfactory - Good size, good condition									
5	Very Satisfactory - Generous size, excellent condition									
N/A	Does not apply

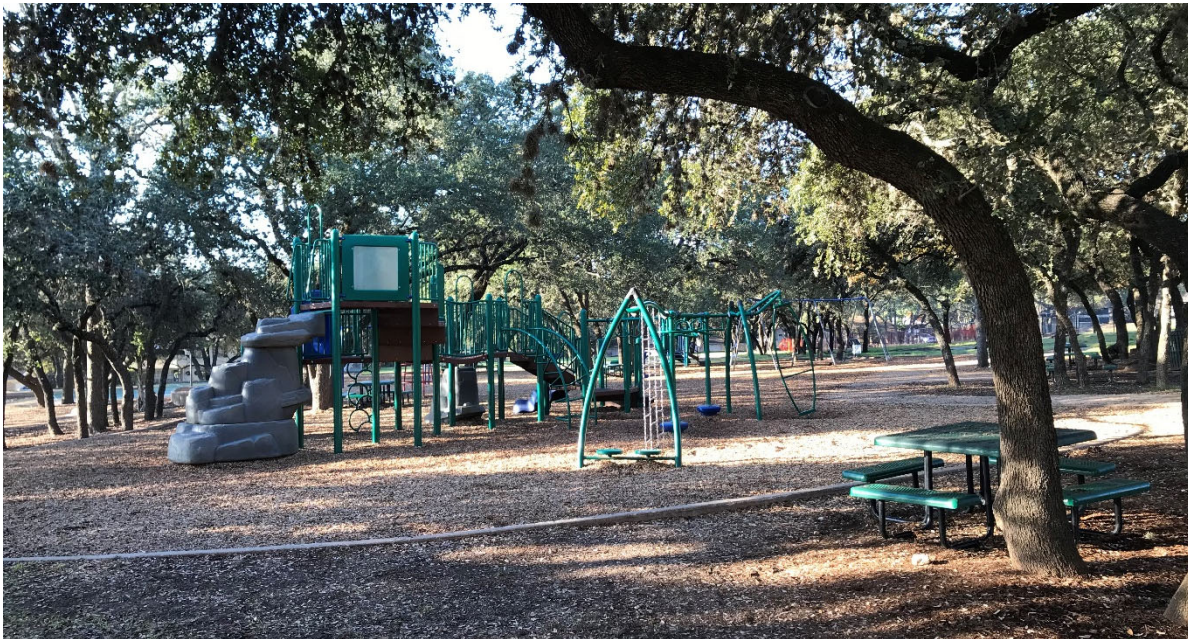
Active playground nestled within grove of live oak trees.

2.2	Are active playgrounds (elementary only) and support spaces configured per the ed spec?					5		Comments	1.00 5.00	
1	Very unsatisfactory - No dedicated active playground							Grove of trees is providing shade on playgrounds.		
2	Unsatisfactory - Too small, poor condition, no shade provided									
3	Average - Adequate size, adequate condition, needs some renovations or updates to function well, 50% or less shade coverage over play structure									
4	Satisfactory - Good size, good condition, more than 50% shade coverage over play structure									
5	Very satisfactory - Generous size, excellent condition, full shade coverage over play structure									
N/A	Does not apply

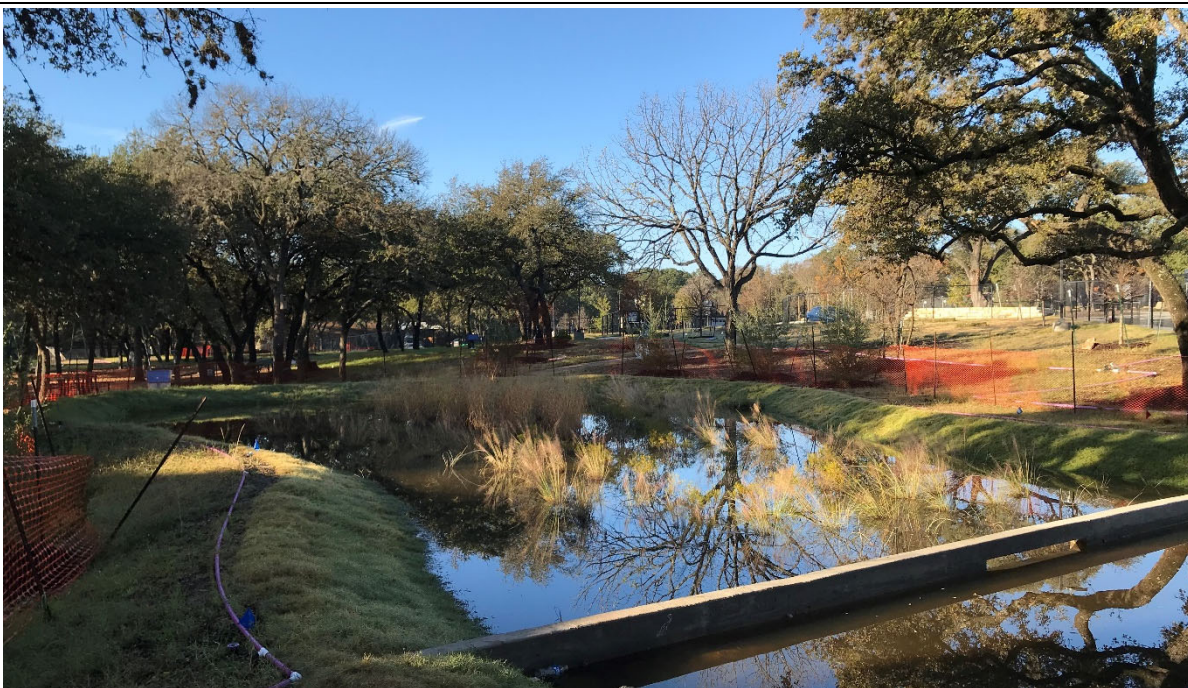
seating.

Pond for water detention integrated within the landscape. Adding appropriate safety features around the pond was mentioned in the interview.
