Educational Suitability Summary Report

Galindo Elementary School

Date: 01/27/2021

Score 66% Satisfactory

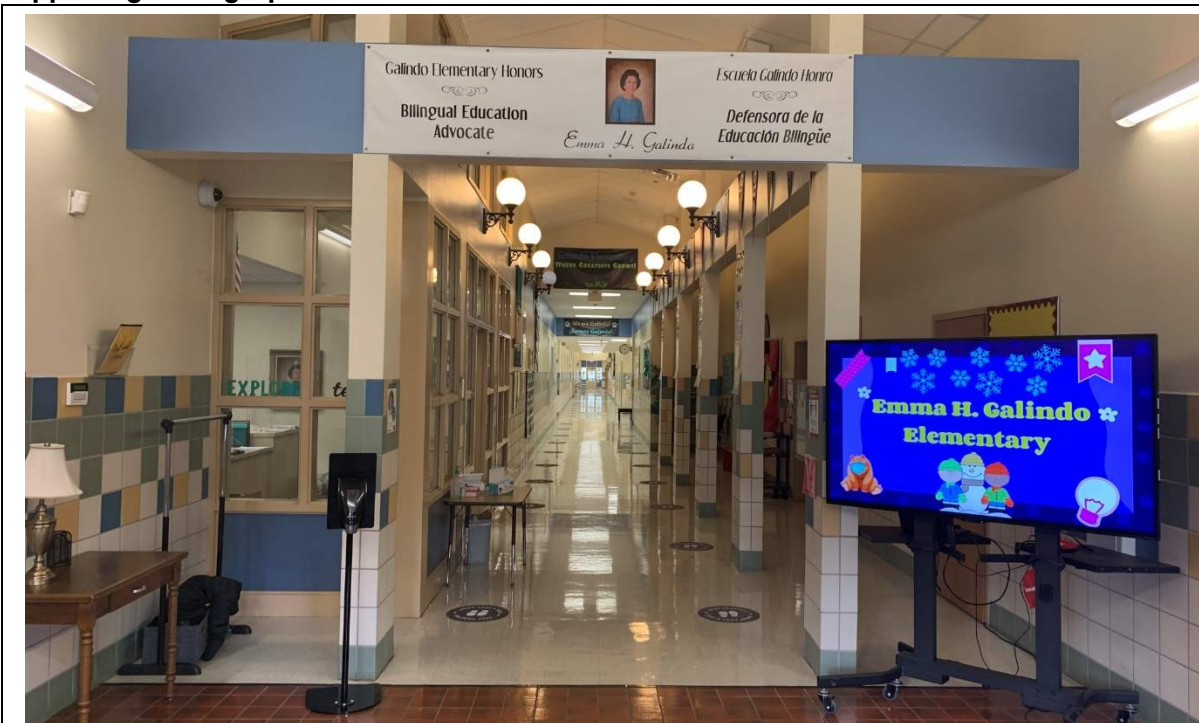
There is no secure vestibule at the main entry, but the reception space is close to the main entry doors. There is no permanent digital TV display but a mobile one is used.

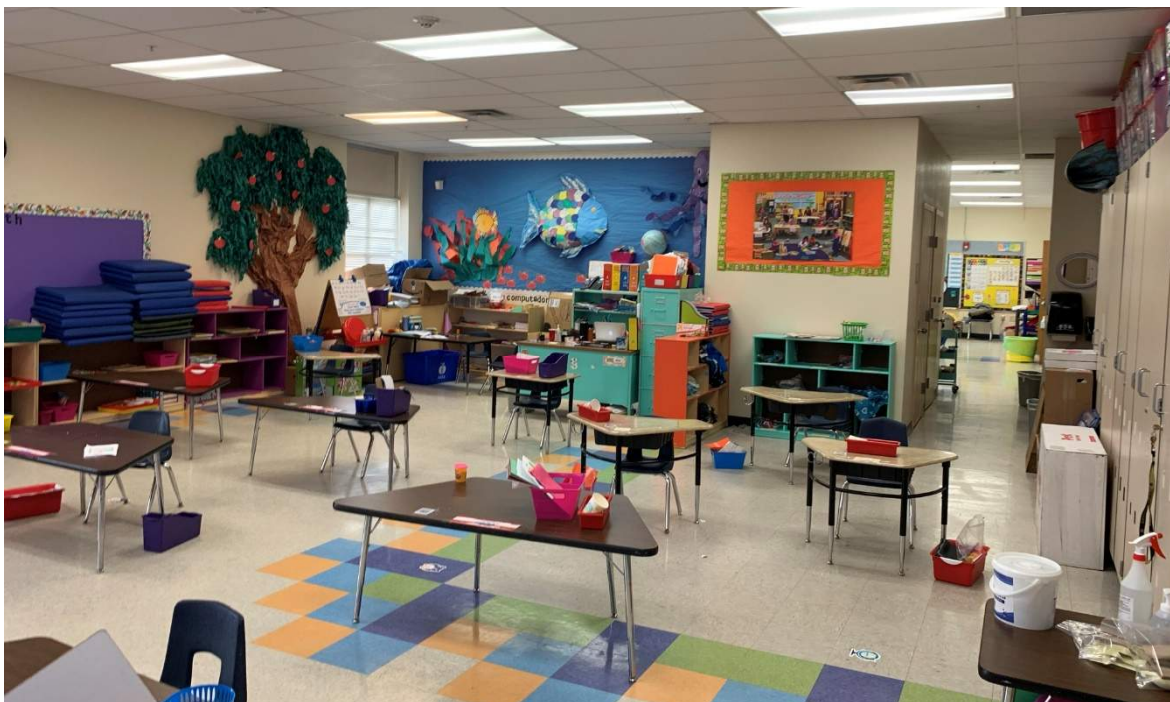
Most studios are connected to an adjoining room and a shared restroom. Furniture is a mix of old and new, with some flexibility.

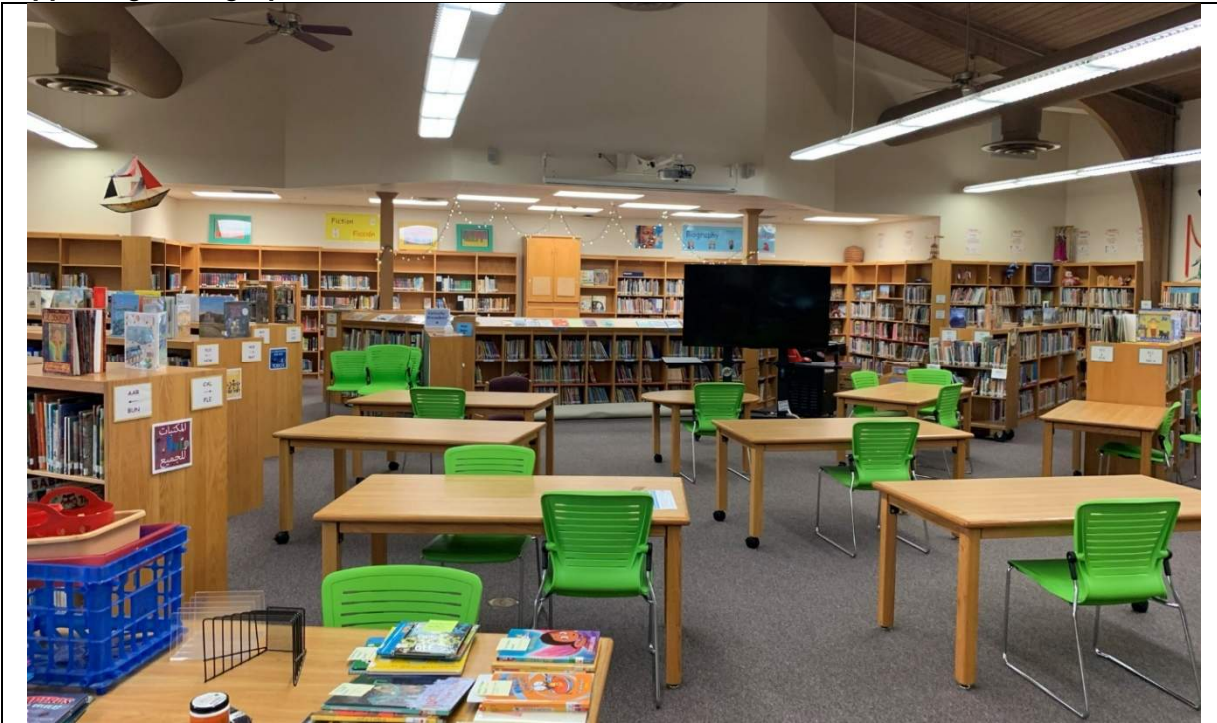
Media Resources: The library is generously sized and has a variety of furniture. It is laid out so that zones for different activities can be created.

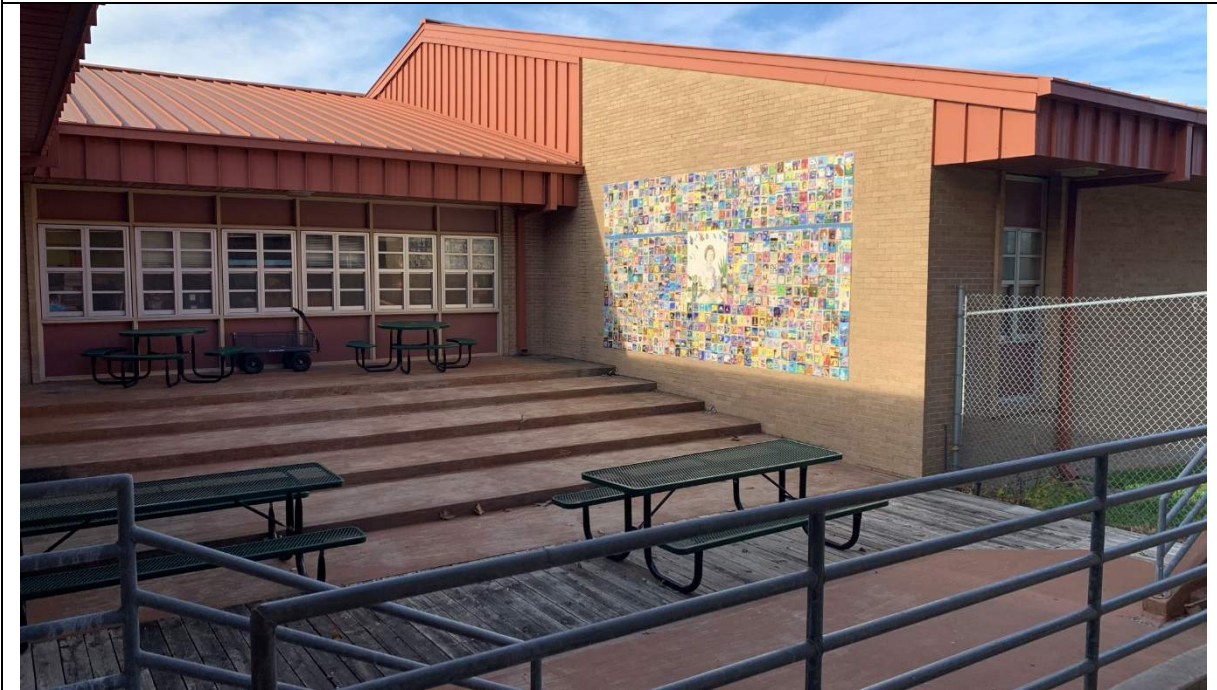
The Emma Courtyard contains artwork honoring the namesake of the school that the campus would like to keep. It is off the cafeteria and could be used for outdoor dining as well as an outdoor studio space.

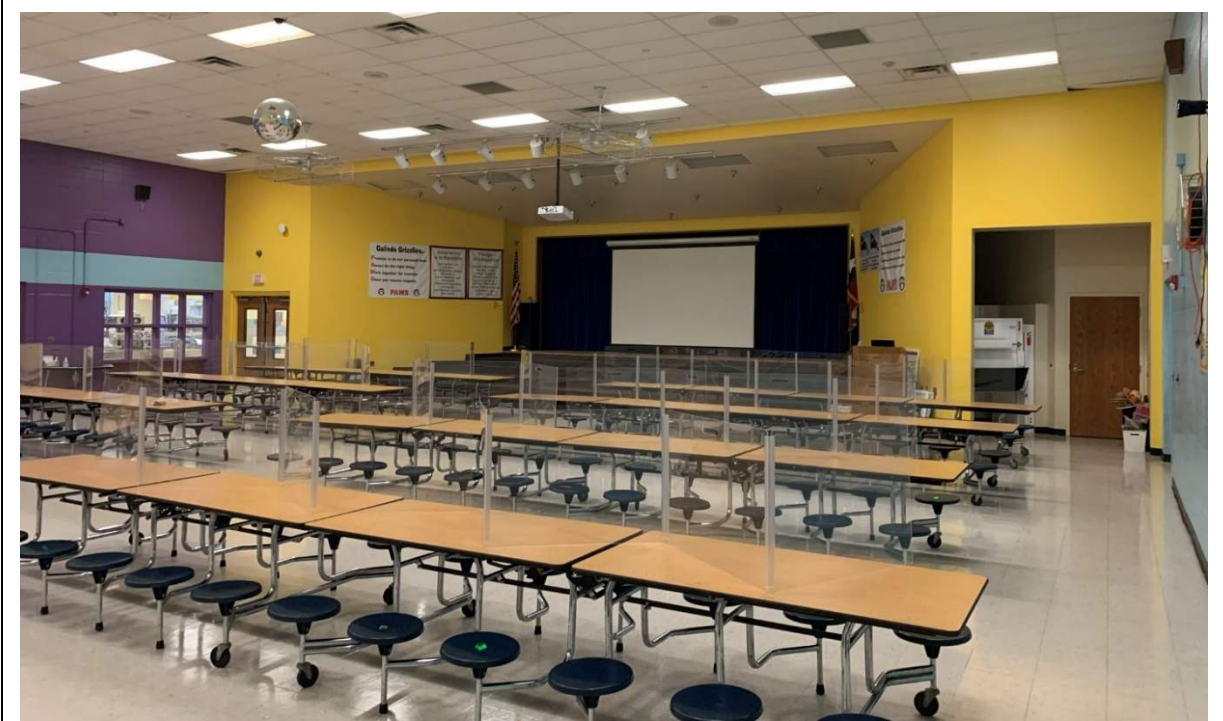
The cafeteria is appropriately sized but only has one option for furniture. It is well connected to the music room for easy access to the stage.

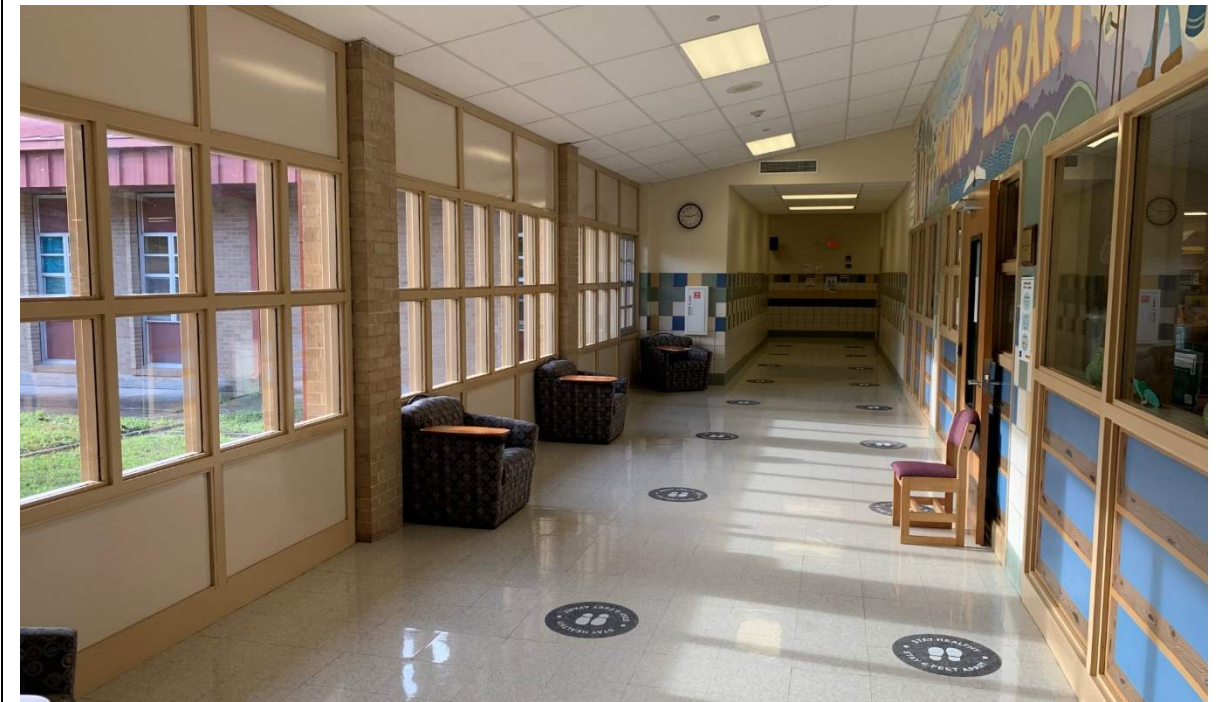
Primary corridors are wide and have opportunities for informal interaction and breakout spaces for students and teachers, with furniture available to support them.

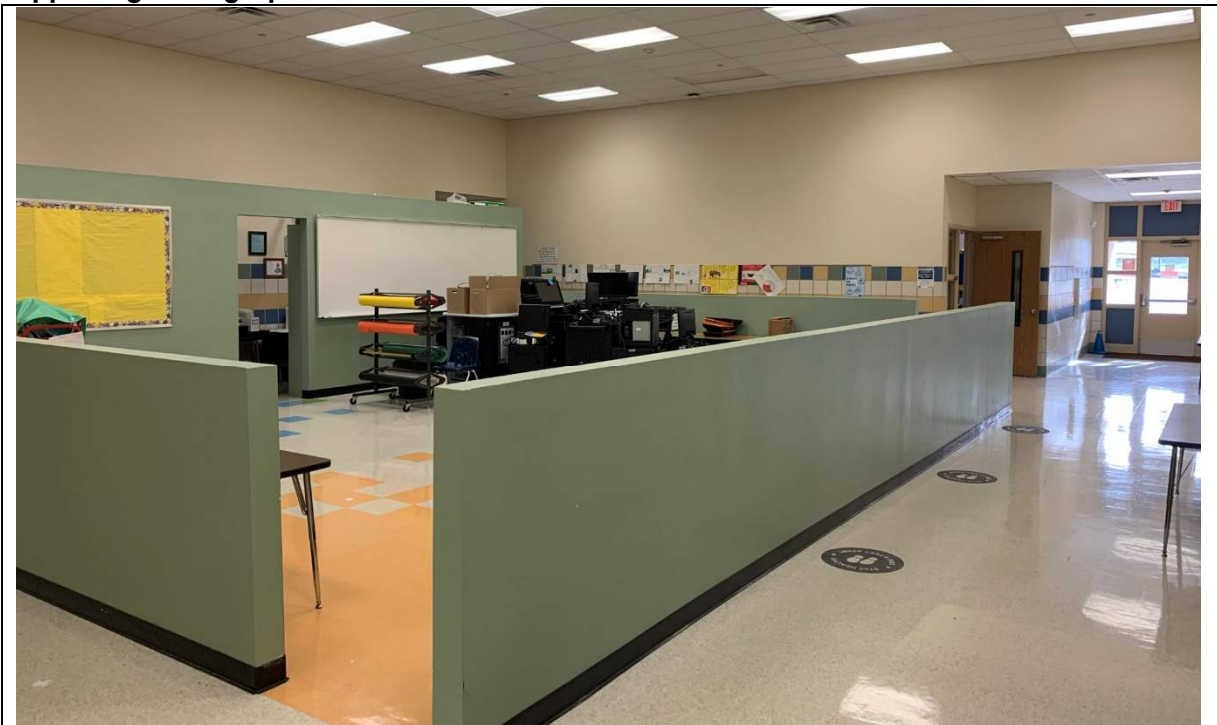
Three of the four studio wings have a large, shared flex space in the corridor. This space is used for science activities with materials stored behind the back wall.

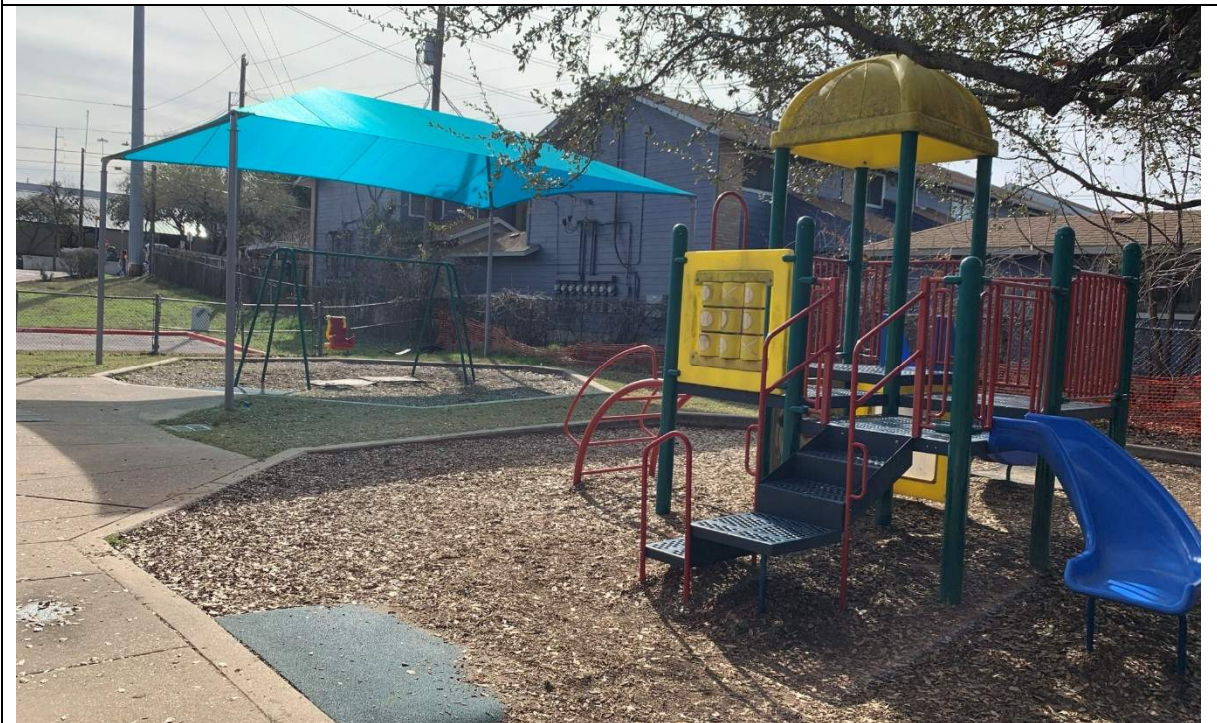
Pre-K and kindergarten have a separate playground with easy access to the studio wing. It is only partially shaded.

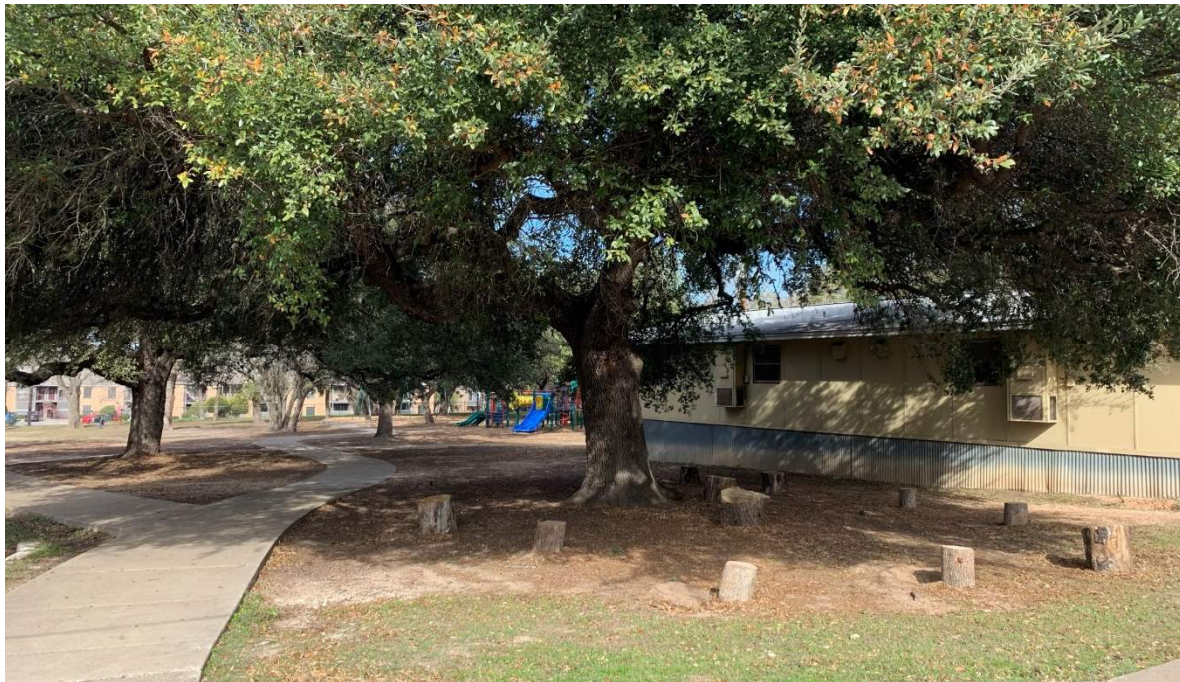
On the back of campus there is a playground for upper grade levels, a play field and walking trails, and portables, as well as areas for outdoor studios. A covered outdoor concrete court is present (not shown in photograph). A water source for their bee apiary (not shown in photograph) is a high priority for the campus.
