Hart Elementary School

Date: 01/07/2021

Educational Suitability Summary Report

Supporting Photographs

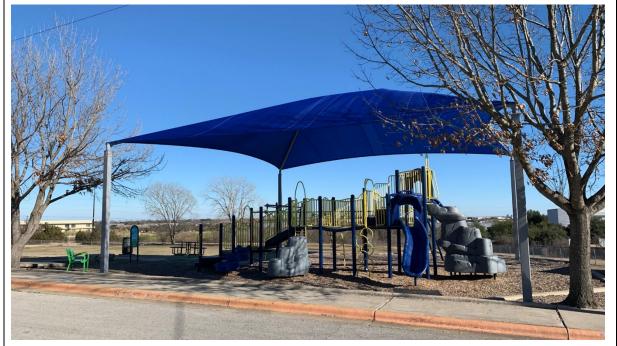
There are two covered playgrounds on campus for different grade levels. They have good connection to the gym and other outdoor activity spaces.

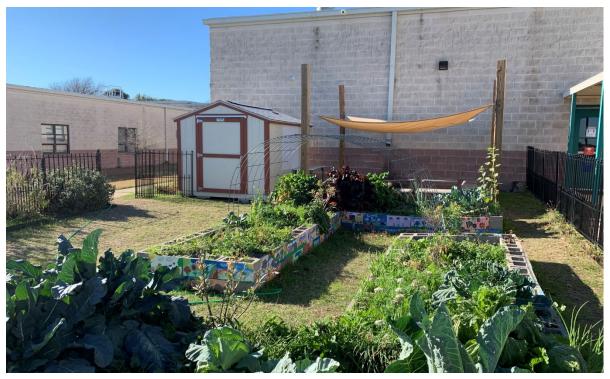
The campus has a thriving garden with access to water and a small outdoor classroom with a whiteboard under a canopy structure for shade.

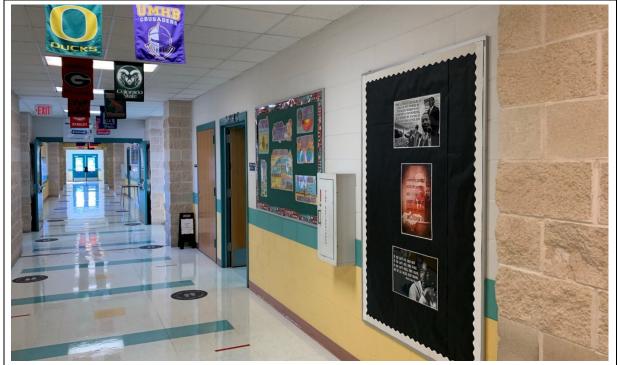
Corridors throughout the building are adequate in width and have opportunity for 3D or 2D display of student work.

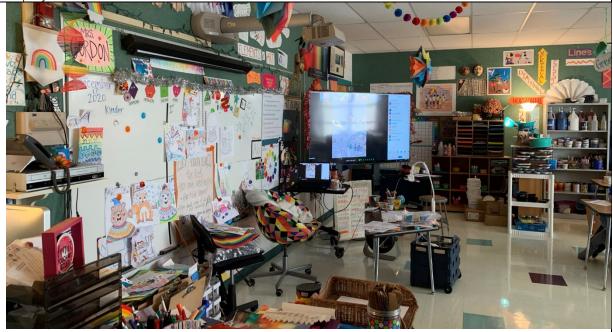
The art studio is appropriately sized per the district's Education Specifications and has the appropriate support spaces, including storage and a kiln.

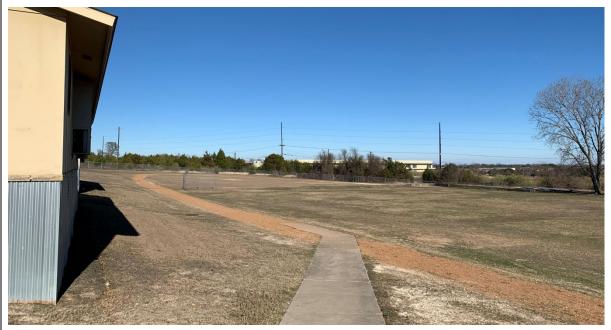
A large track is located at the back of the campus; it needs updates to function well.
