Educational Suitability Summary Report

Houston Elementary School

Date: 12/23/2020

Score 55% Average

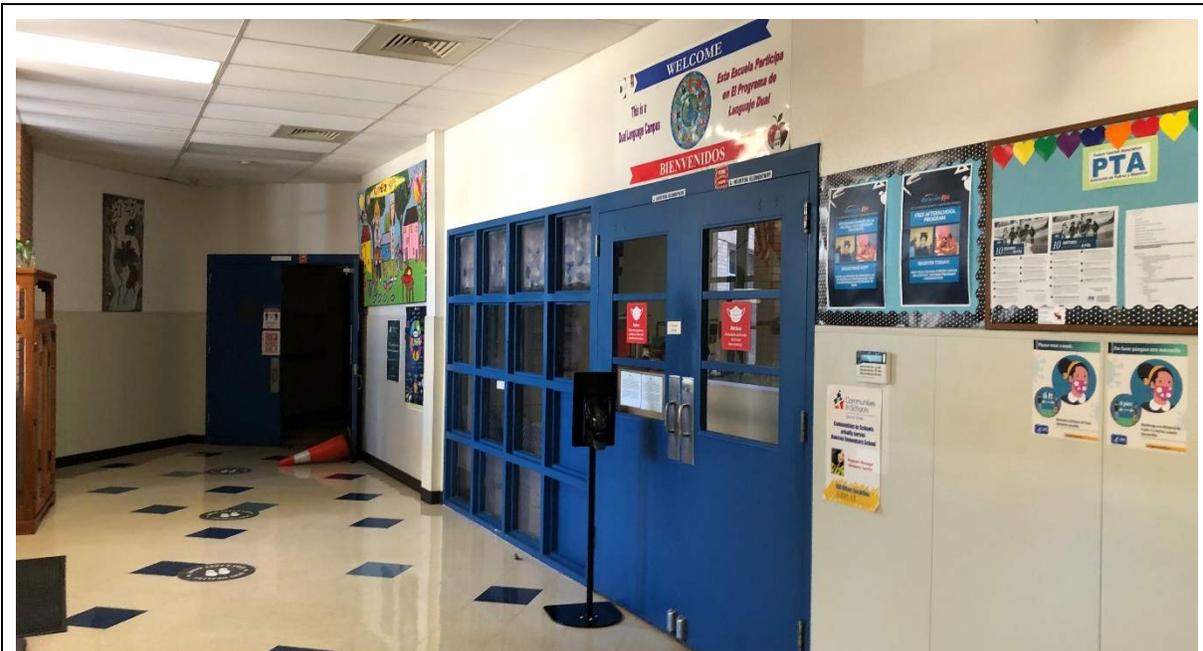
The main entry is not overly generous and not an inviting entry space.

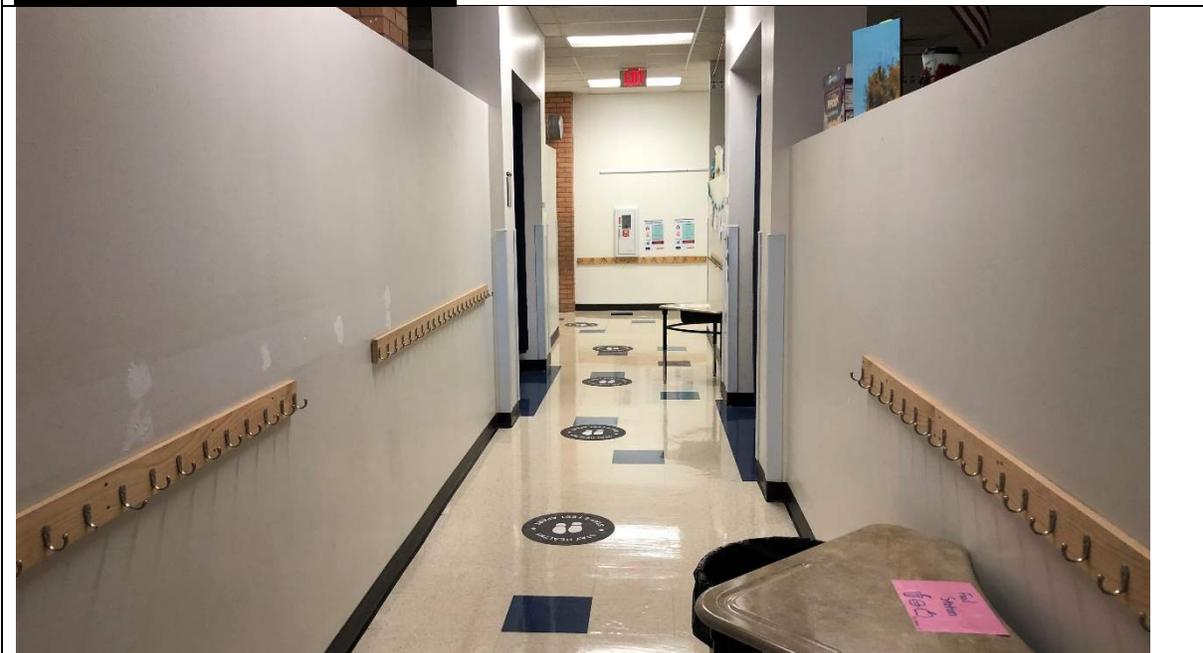
Corridors are narrow (6' to 7') leading into the learning studios. Some corridors have columns obstructing the pathway. There is not a dedicated community room that is accessible to the public. The gym is the only community use area that can be opened from rest of the school after-hours. In general, the appearance of the school is average.

Narrow corridor from main corridor to access studios.

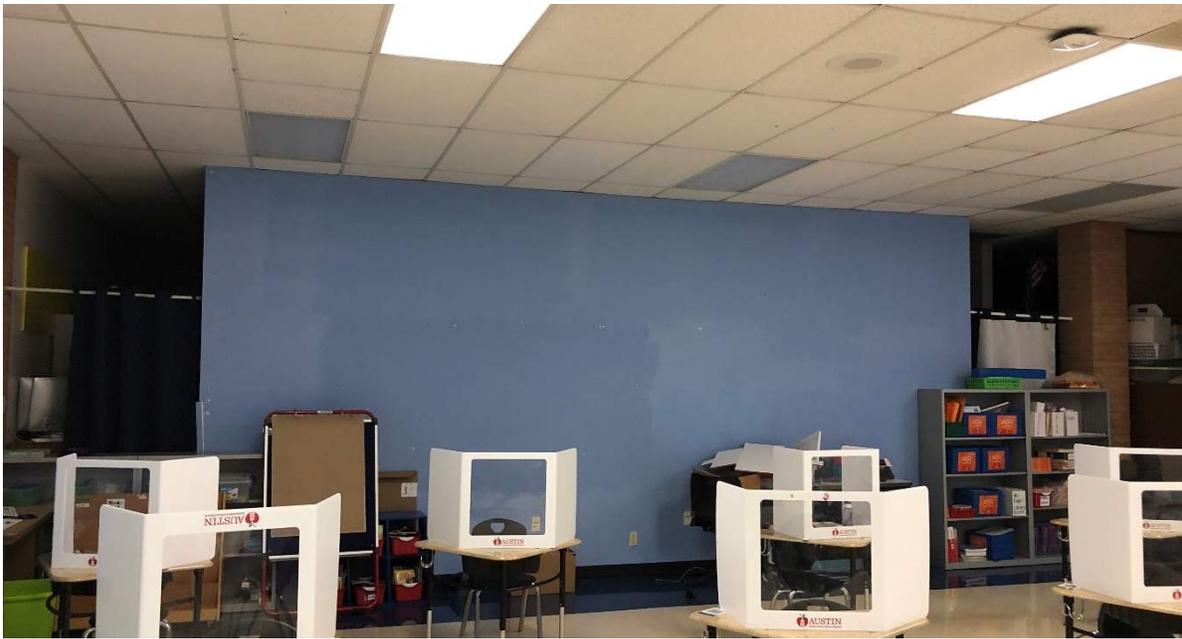
Openings into adjacent studios enclosed with curtains and furniture.

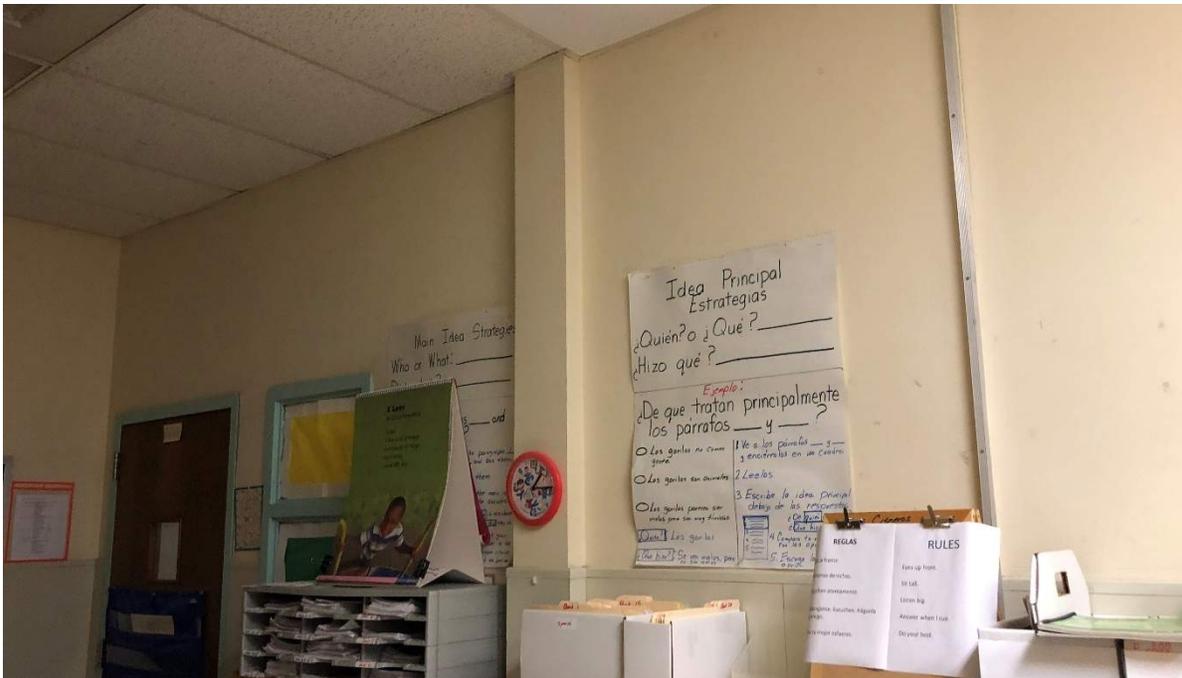
Attached small group room to studios. Operable partition is unable to close completely due to furniture placed in conflict with wall track.

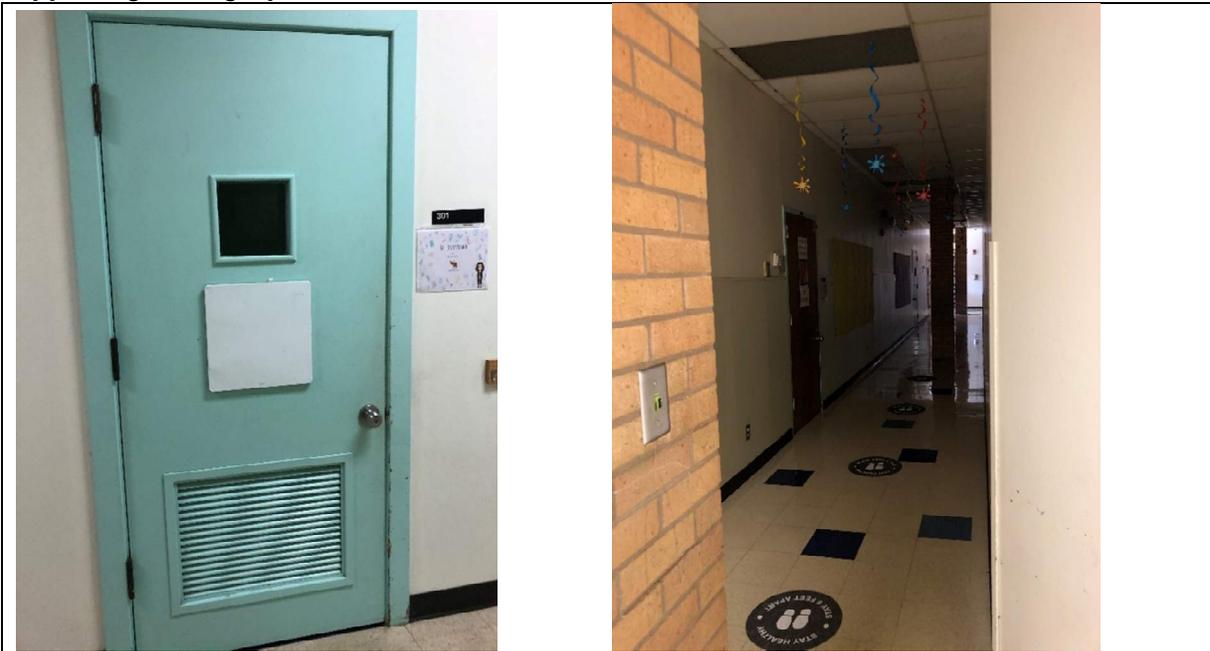
Columns located in middle of the back corridor.

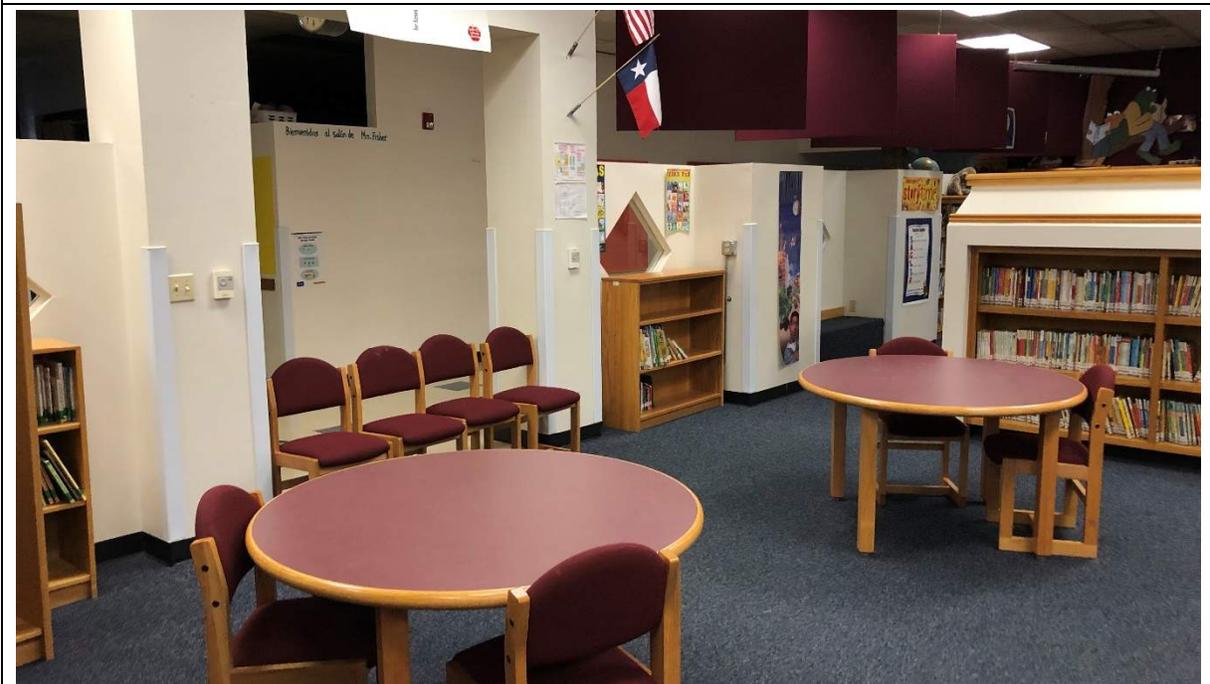
The library is accessible by walking through the corridors past studios and other spaces. There are no dedicated quiet study spaces or reading rooms. Library is open to exterior noise from corridors and studios across the hall. No collaboration rooms for smaller groups.

Open-concept library with partial-height walls. Open to corridor and acoustically open to studios across corridor.

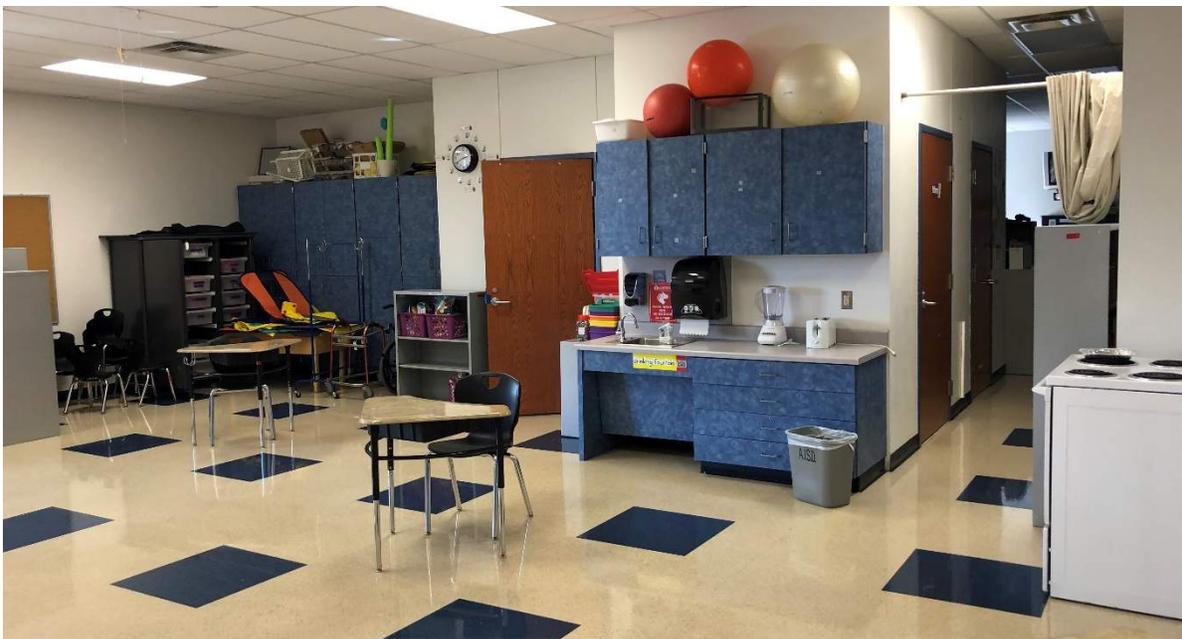
Typical studio in building addition. This typical studio is being used as a Life Skills special education studio without a washer and dryer.

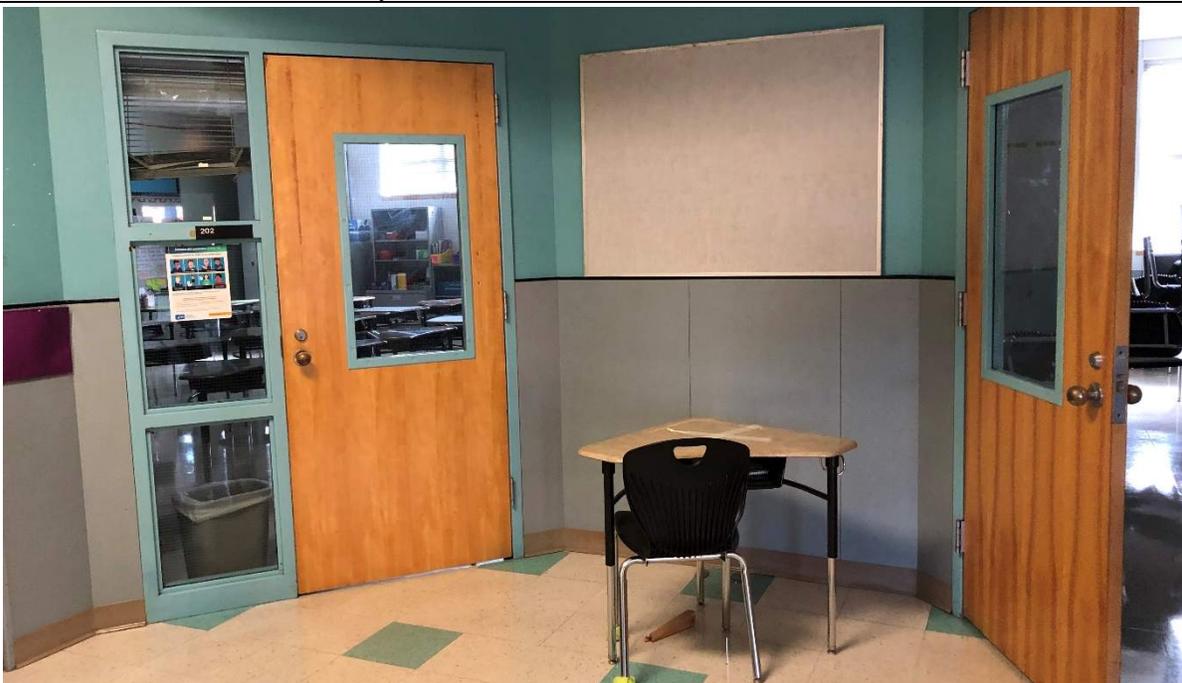
In building addition, some transparency is provided from studios into corridor.

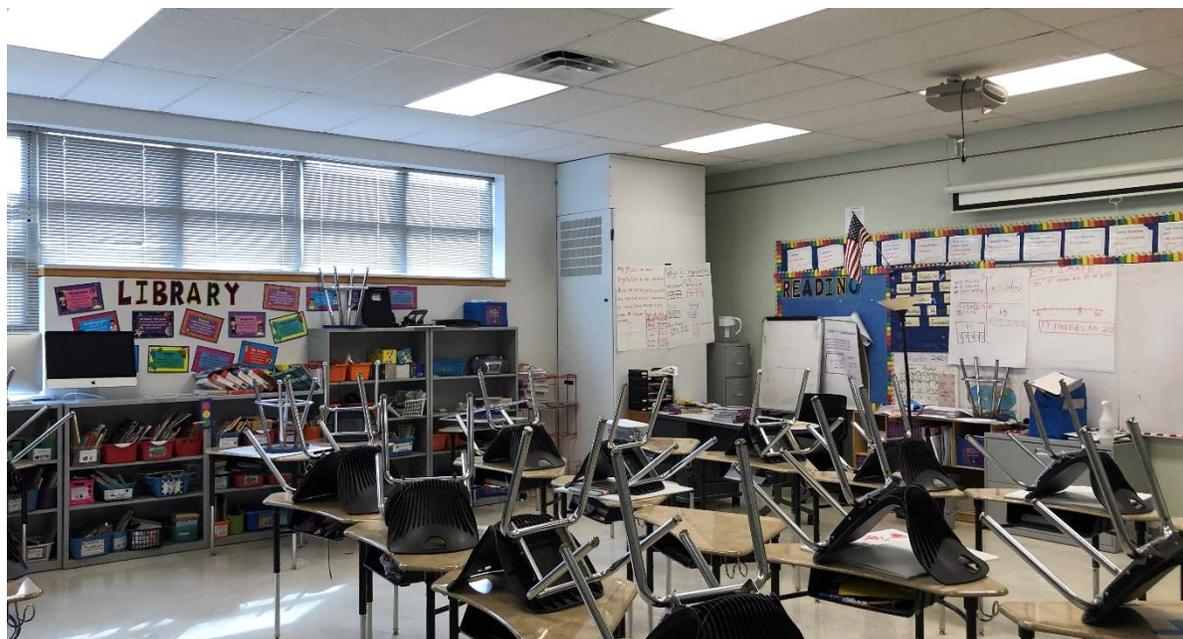
Typical studio in addition. Furniture is in good condition and flexible. Studio has plenty of access to natural light.

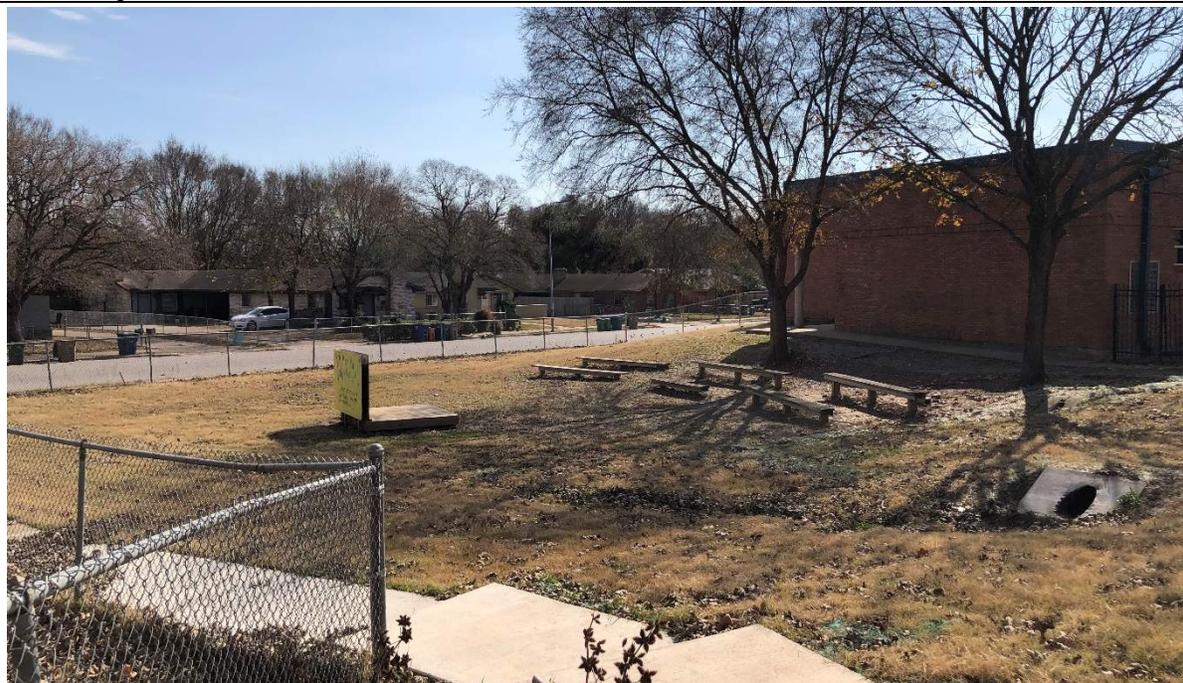
Main outdoor learning space with benches and platform. Some raised garden beds nearby but there is no water source or power outlets. The surface is not level due to erosion, which impacts accessibility.

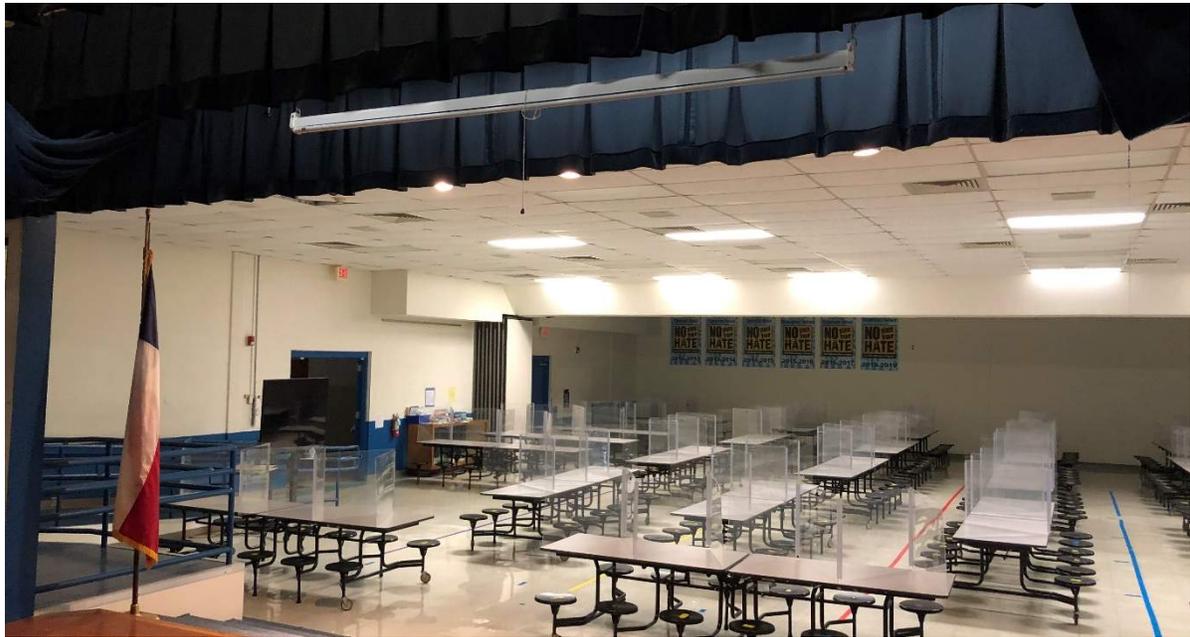
The cafeteria is adequately sized and in good condition. Finishes need updates to make the space more appropriate for an elementary school.

Cafeteria and stage are in good condition. Cafeteria only has one type of seating and finishes need updates to make the space more appropriate for an elementary school.

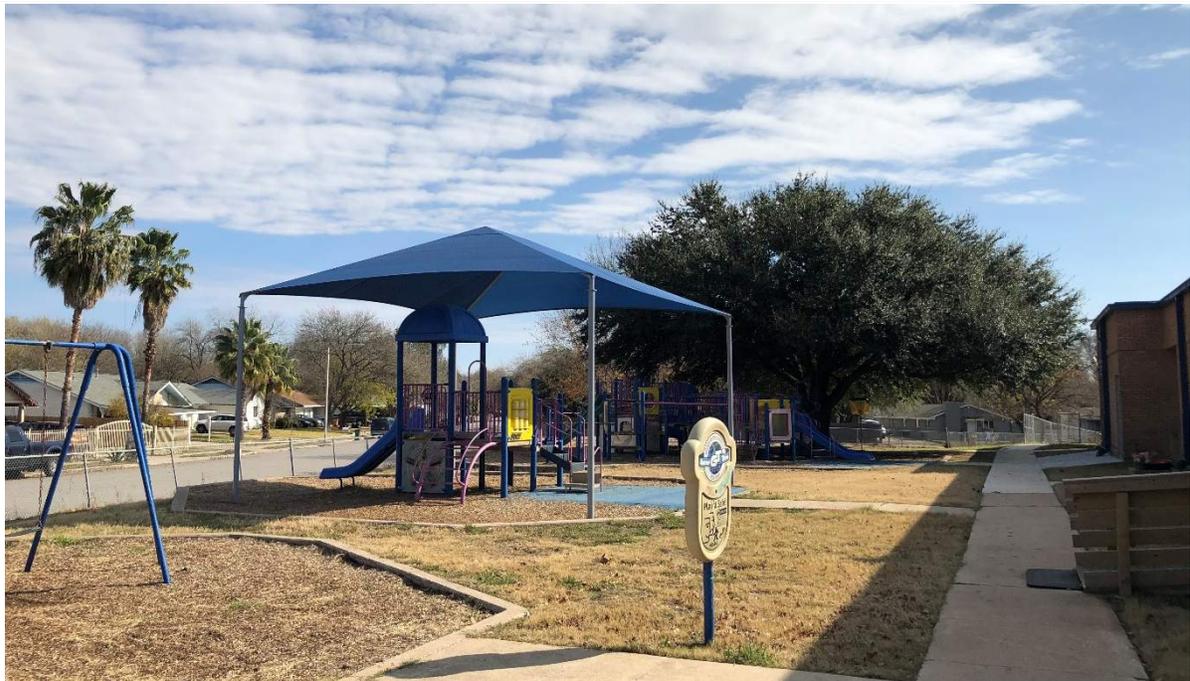
Active playgrounds are a good size and in adequate condition. Both have shade from canopy and from trees.
